Inspection/Audit Photos

Location Name: QB ENERGY OPERATING LLC UNOCAL 2 696 Pad

Location ID: 335687

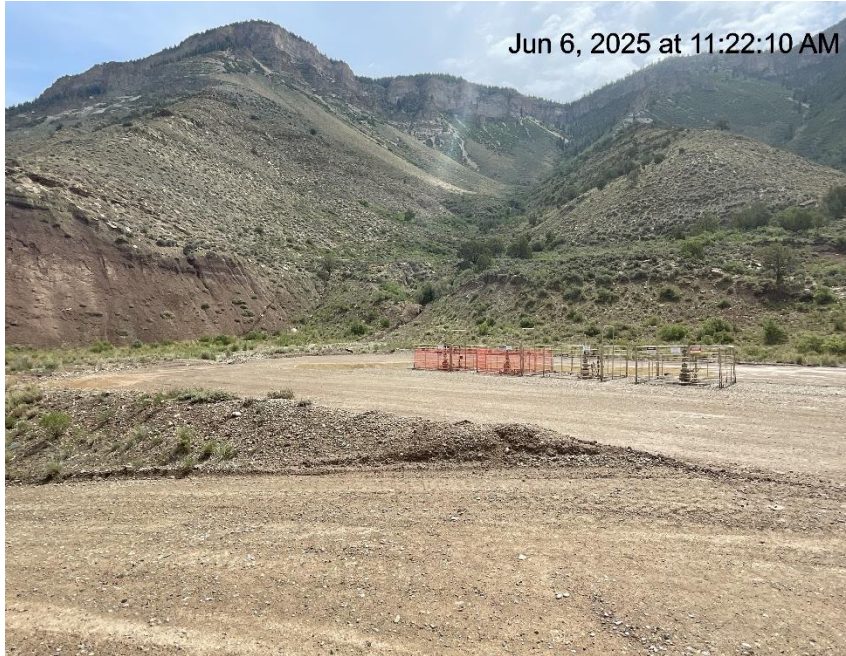
Photo # 7202 From entrance to location

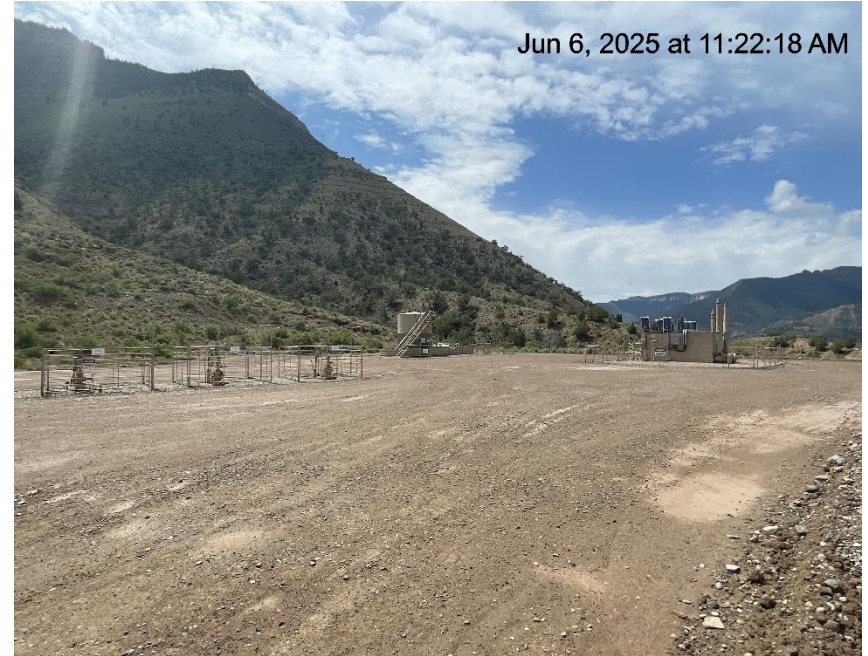
Photo # 7203 From entrance to location

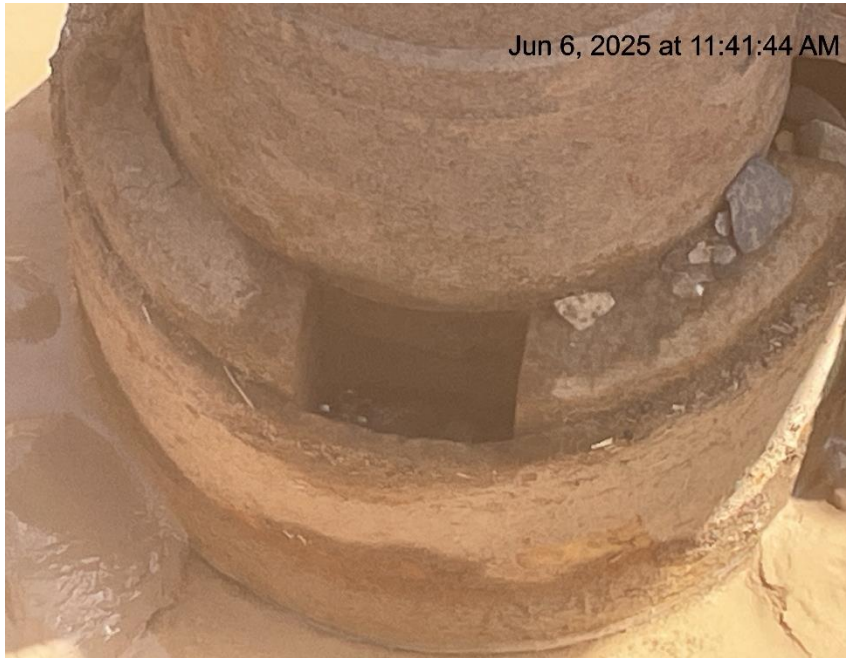
Photo # 7212 UNOCAL-ENCANA 14A-9D wellhead leak

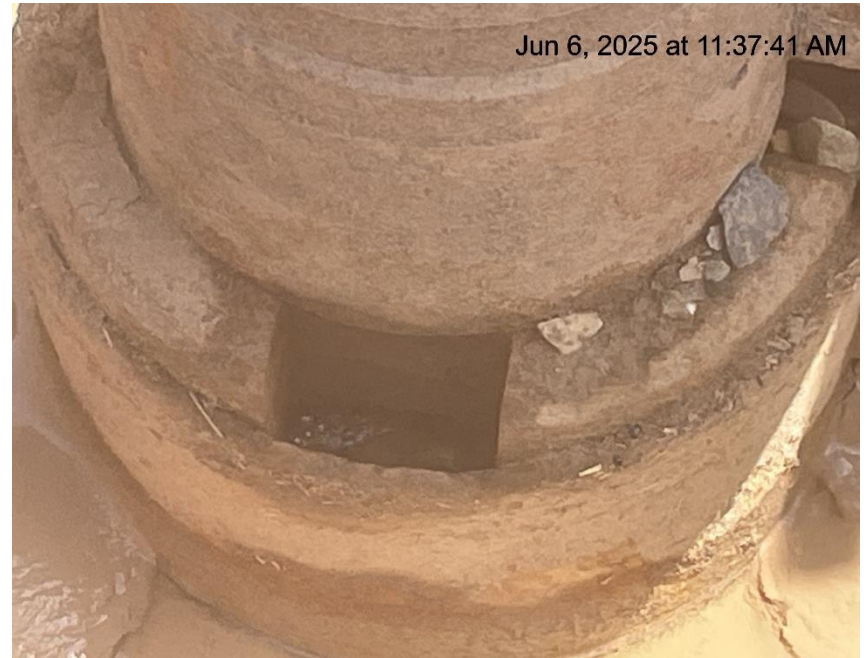
Photo # 7213 UNOCAL-ENCANA 14A-9D wellhead leak

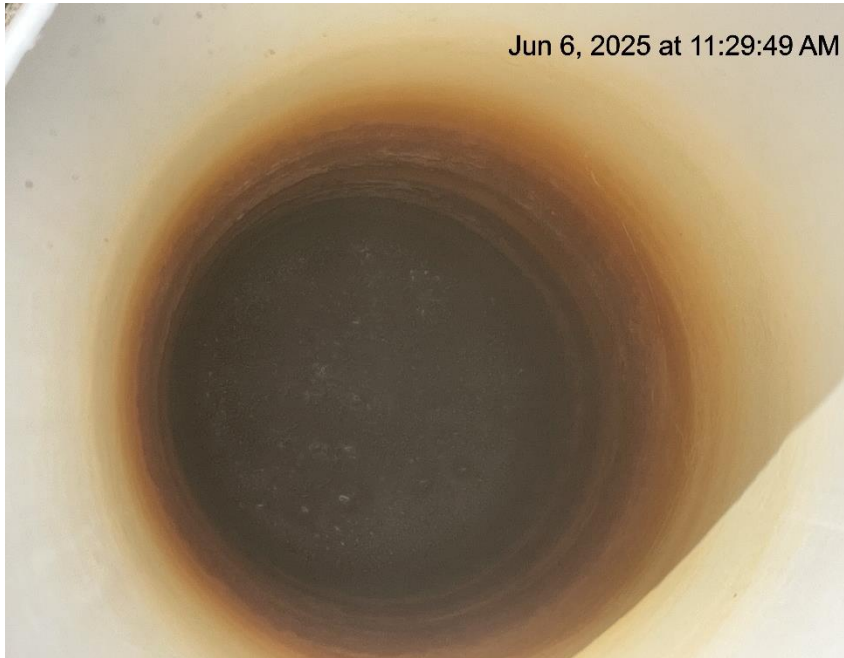
Photo # 7214 UNOCAL 24-9DRD leak

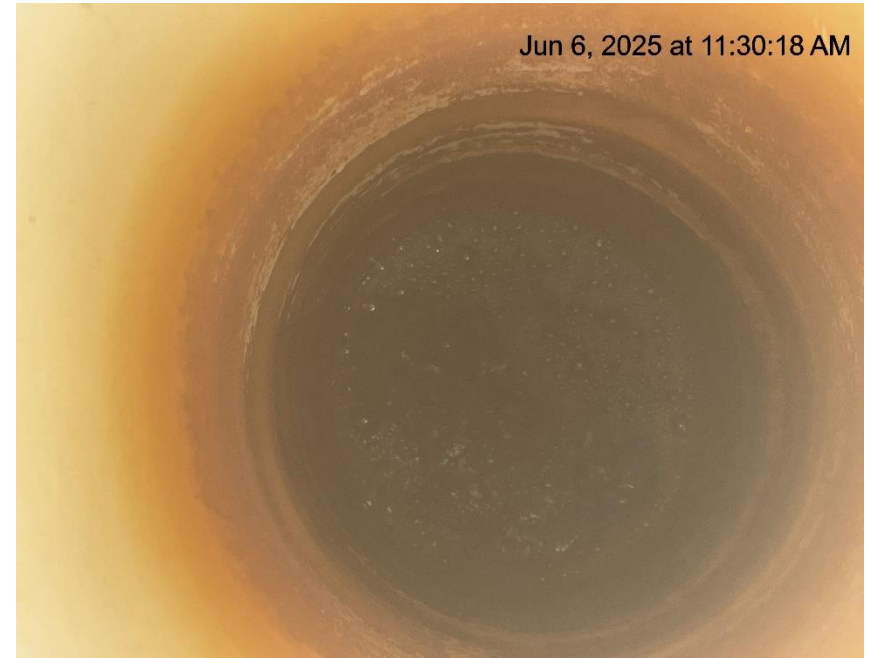
Photo # 7215 UNOCAL 24-9DRD leak

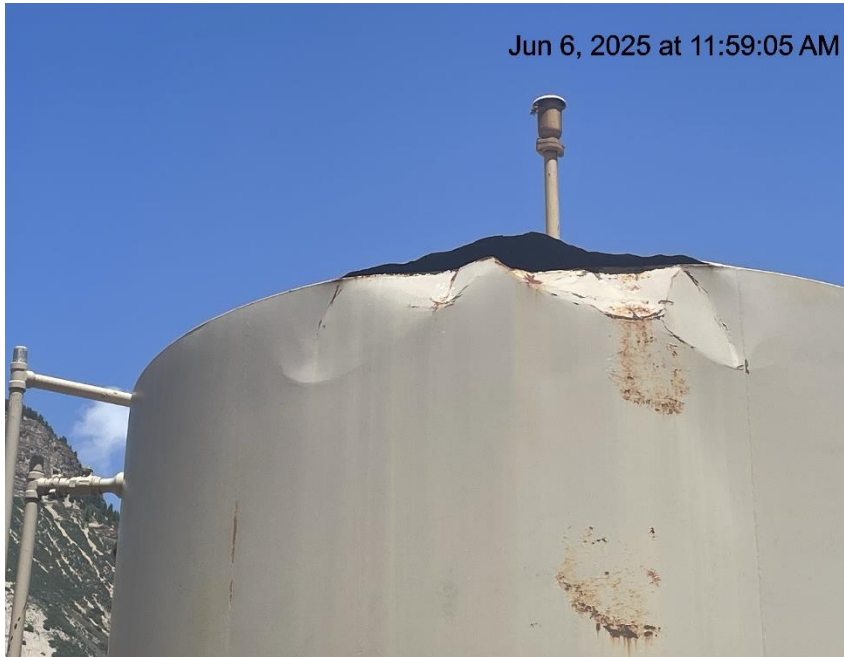
Photo # 7216 Tank failure - Tank damaged/hole in tank/tank lacks integrity

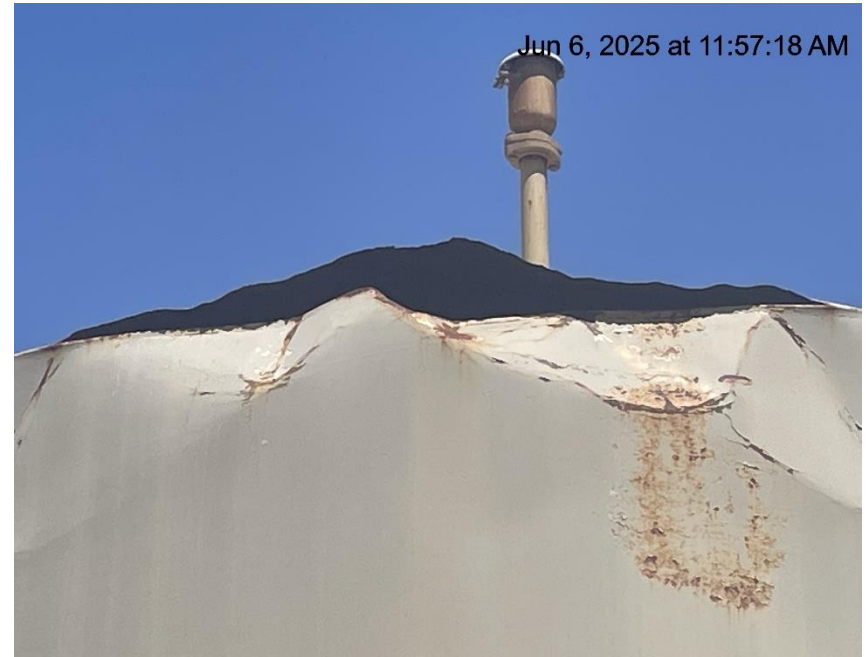
Photo # 7217 Tank failure - Tank damaged/hole in tank/tank lacks integrity

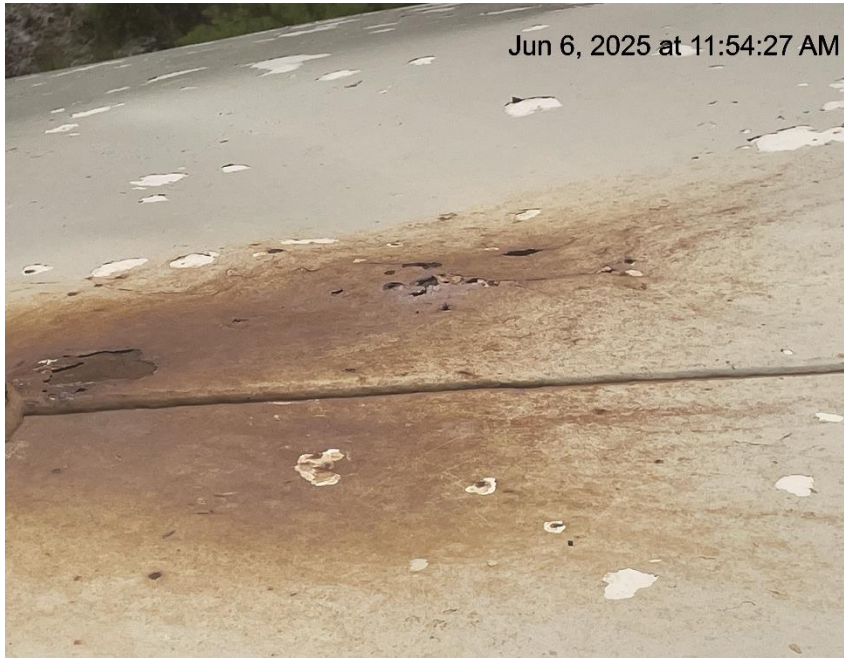
Photo # 7218 Tank failure - Multiple holes in tank/tank lacks integrity

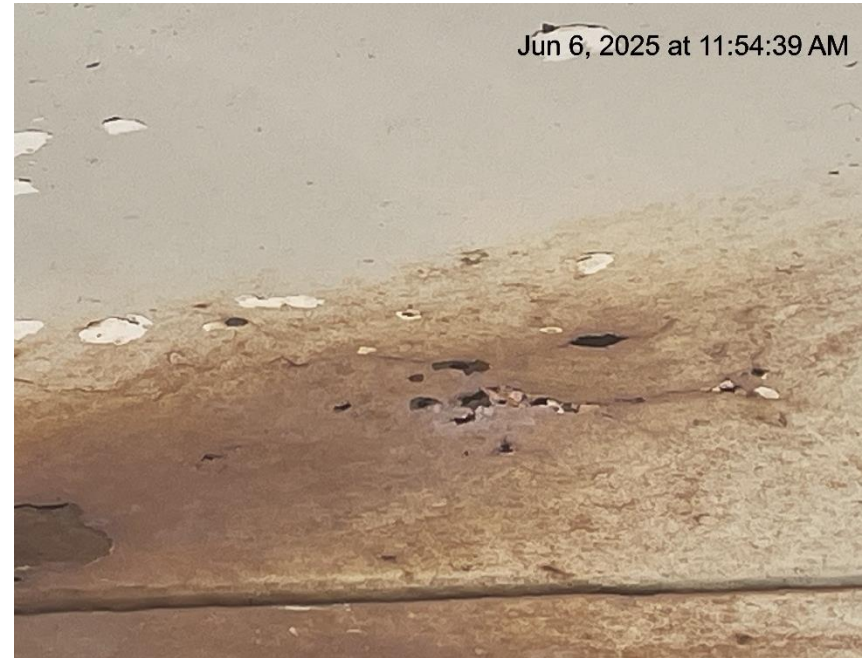
Photo # 7219 Tank failure - Multiple holes in tank/tank lacks integrity

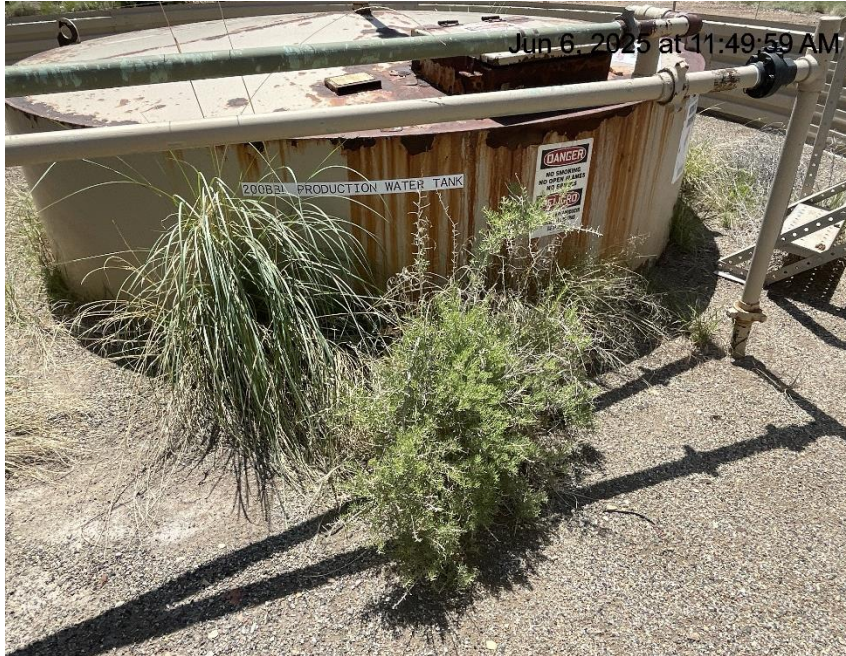
Photo # 7220 Weeds/undesirable plant species in secondary containment

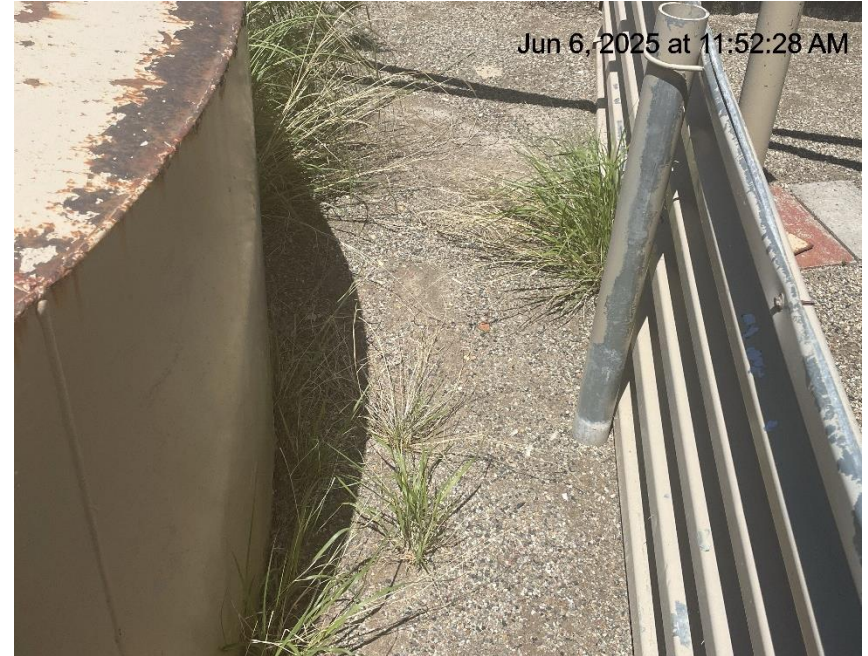
Photo # 7221 Weeds/undesirable plant species in secondary containment

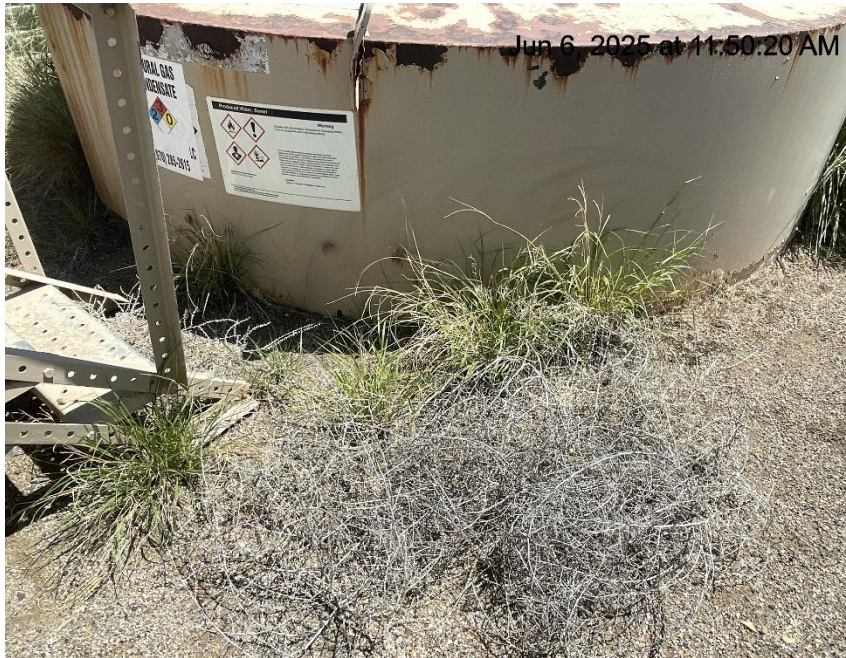
Photo # 7222 Weeds/undesirable plant species in secondary containment

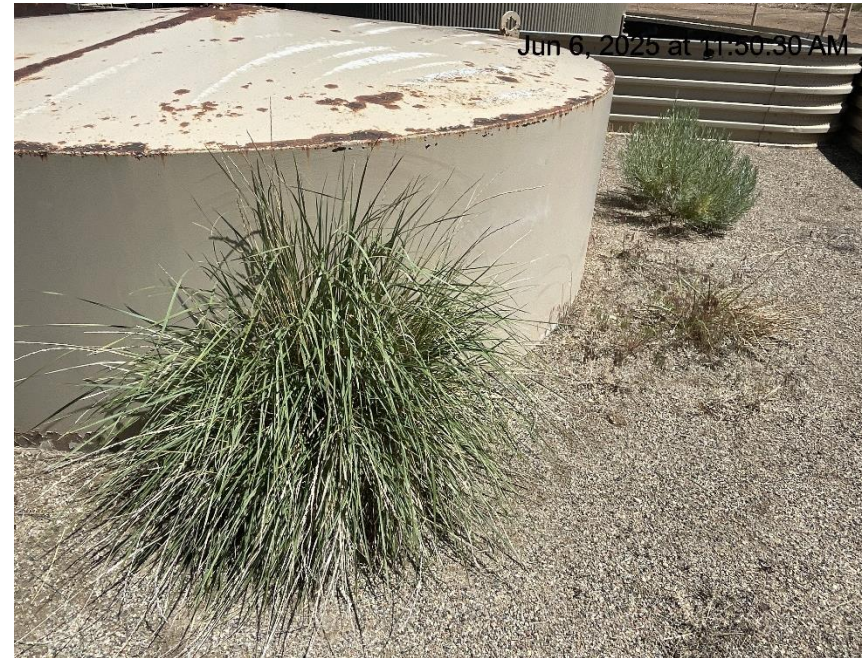
Photo # 7223 Weeds/undesirable plant species in secondary containment

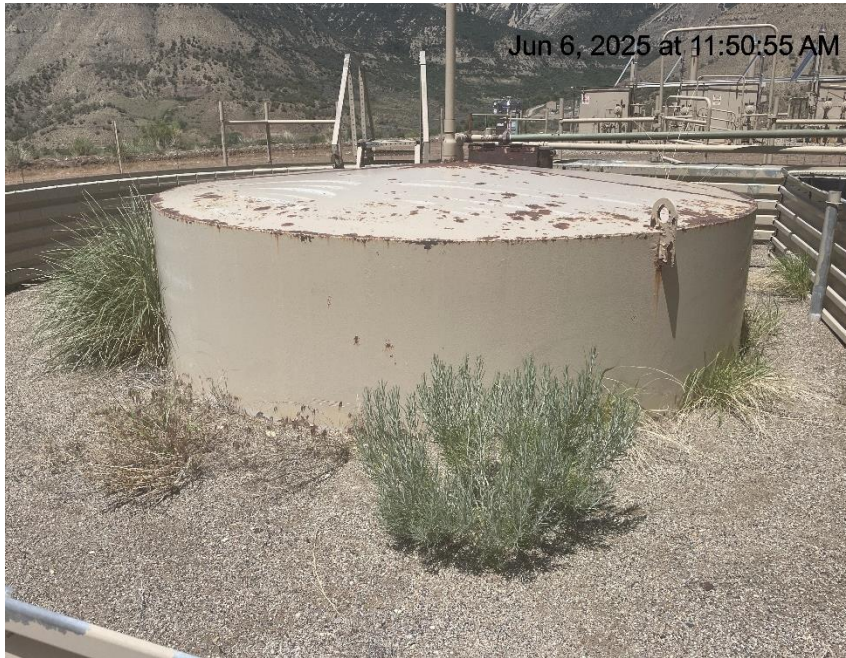
Photo # 7224 Weeds/undesirable plant species in secondary containment

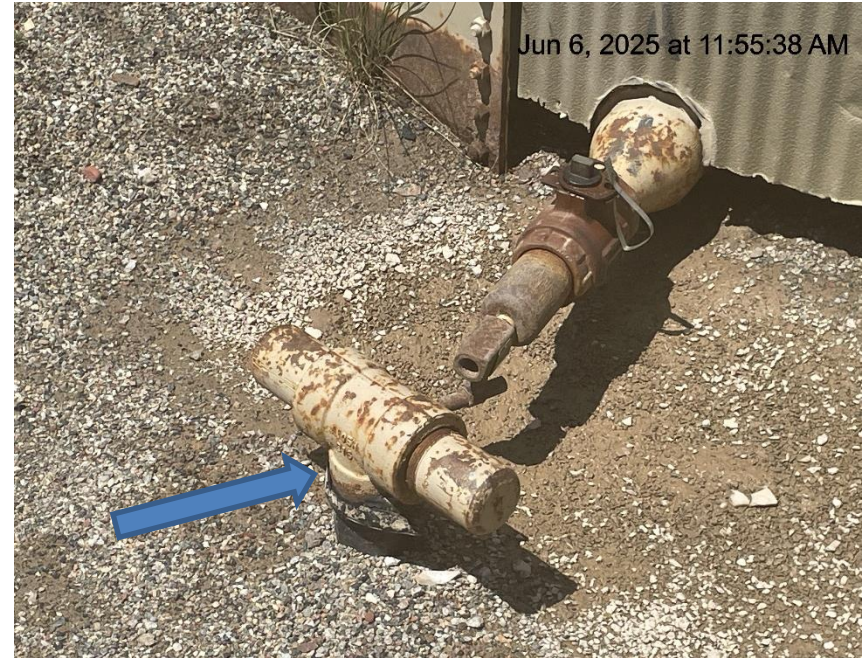
Photo # 7225 Unused flowline does not comply with CECMC 600 & 1100 series rules

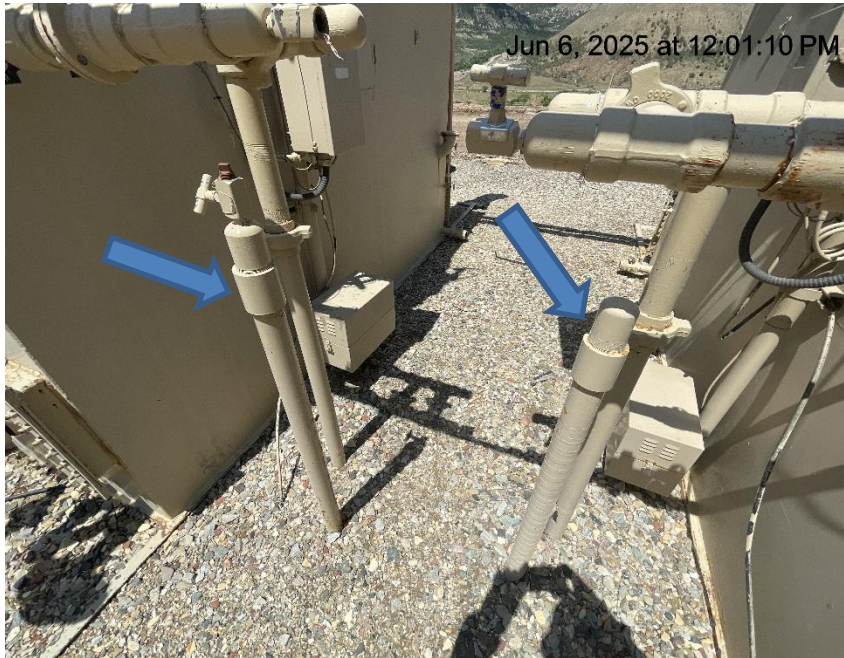
Photo # 7226 Unused flowlines do not comply with CECMC 600 & 1100 series rules

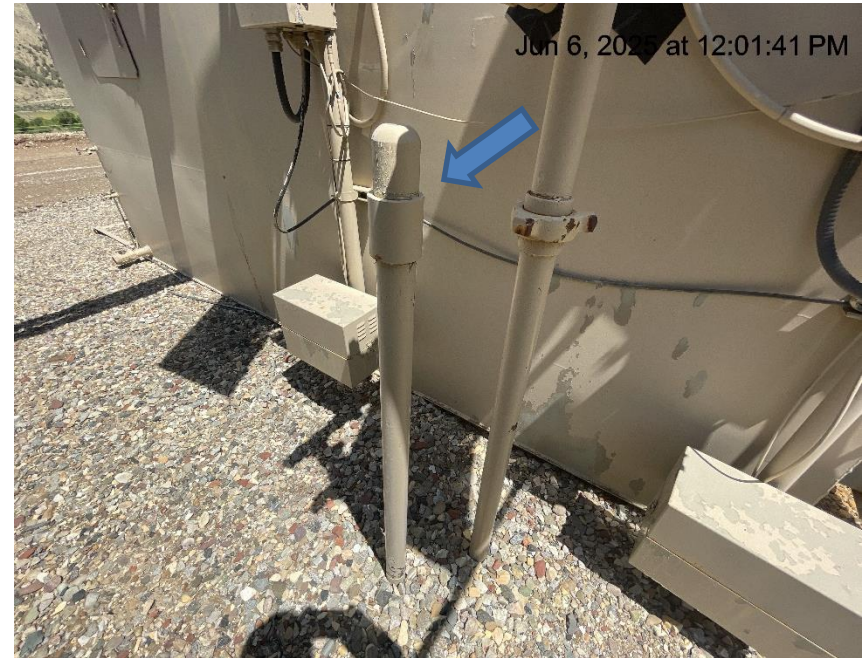
Photo # 7227 Unused flowline does not comply with CECMC 600 & 1100 series rules

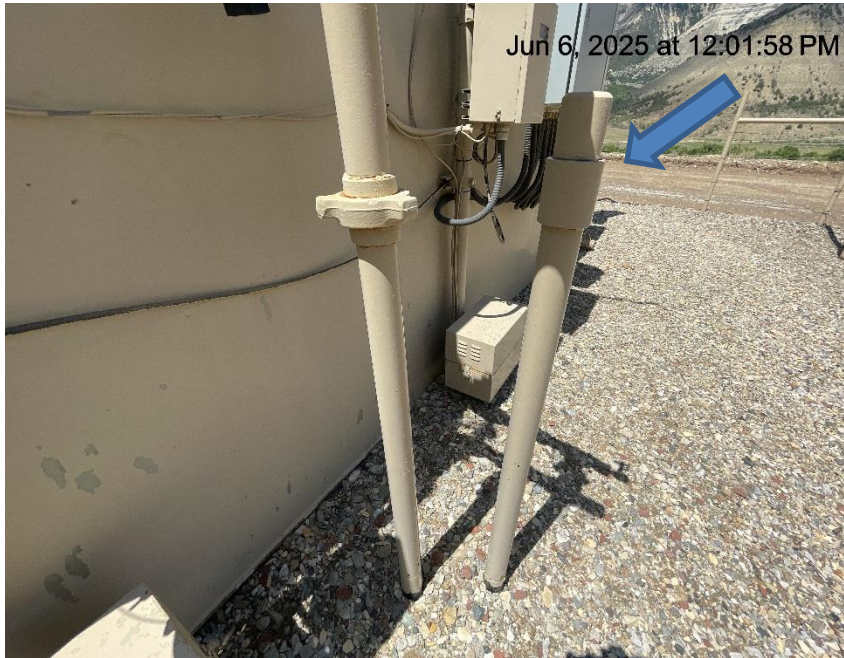
**Photo # 7228 Unused flowline does not comply with CECMC
600 & 1100 series rules**
