Inspection/Audit Photos

Location: LARAMIE ENERGY LLC Horseshoe Canyon/1-34 Pad

Location ID: 312481

Date: 06/4/2025

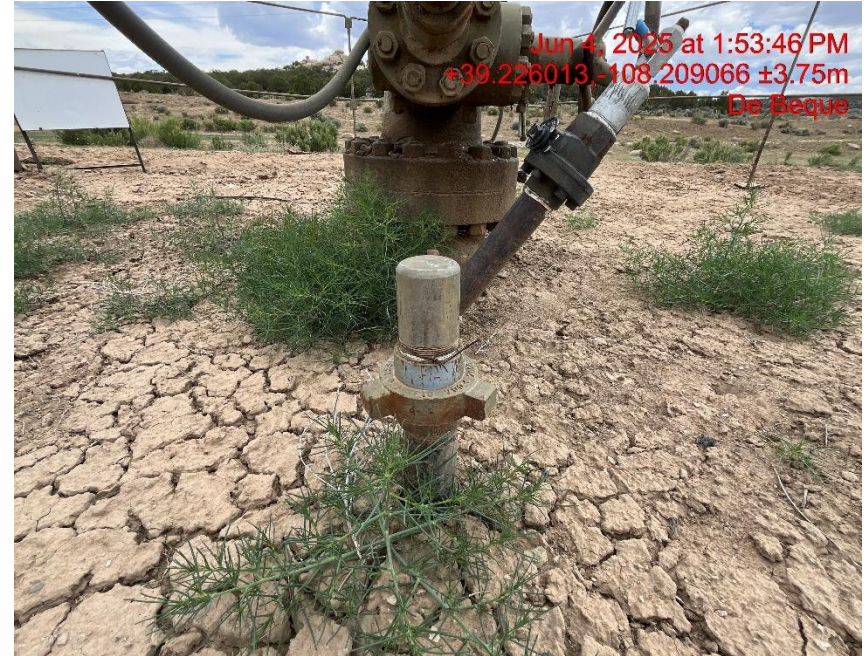
Photo # 7715 Intermediate Casing valve is buried/not in compliance with CECMC rules

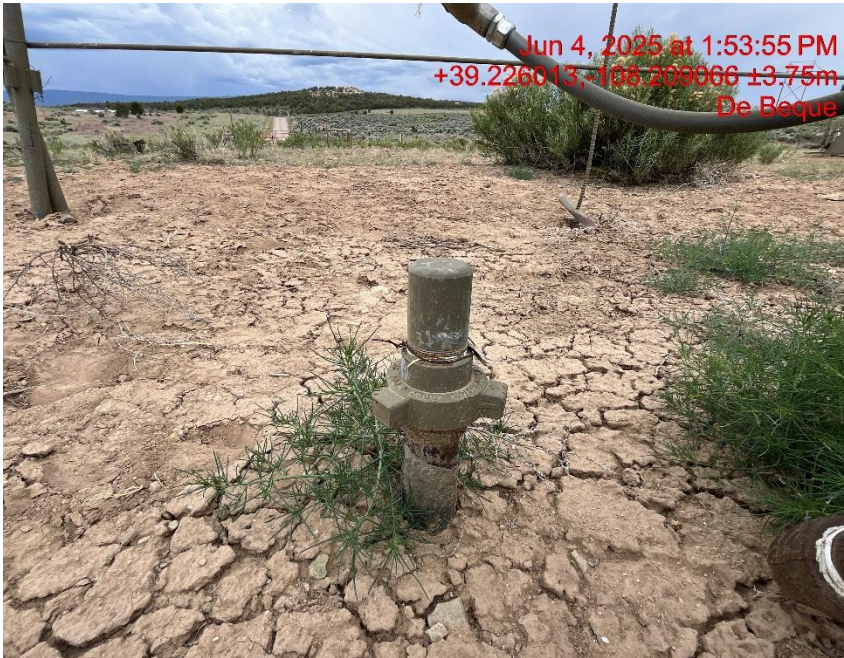
Photo # 7716 Intermediate Casing valve is buried/not in compliance with CECMC rules

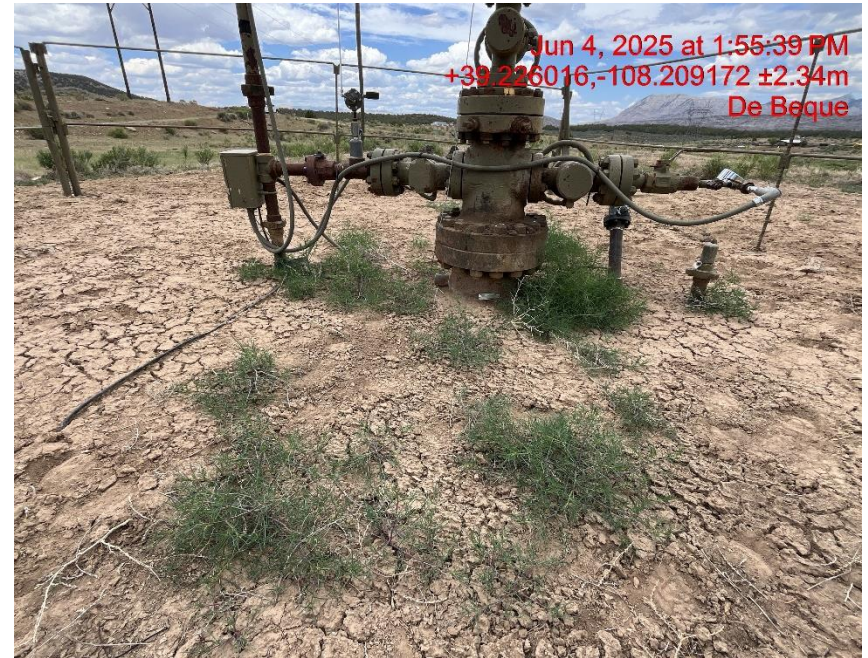
Photo # 7717 Small amount of weeds around wellhead

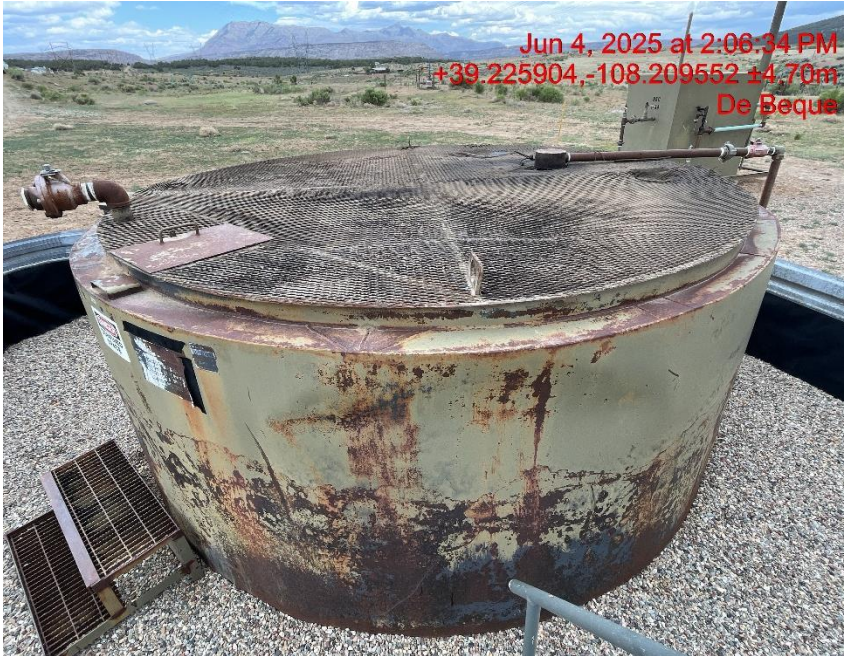
Photo # 7733 Tank is dented, also rusted in most areas

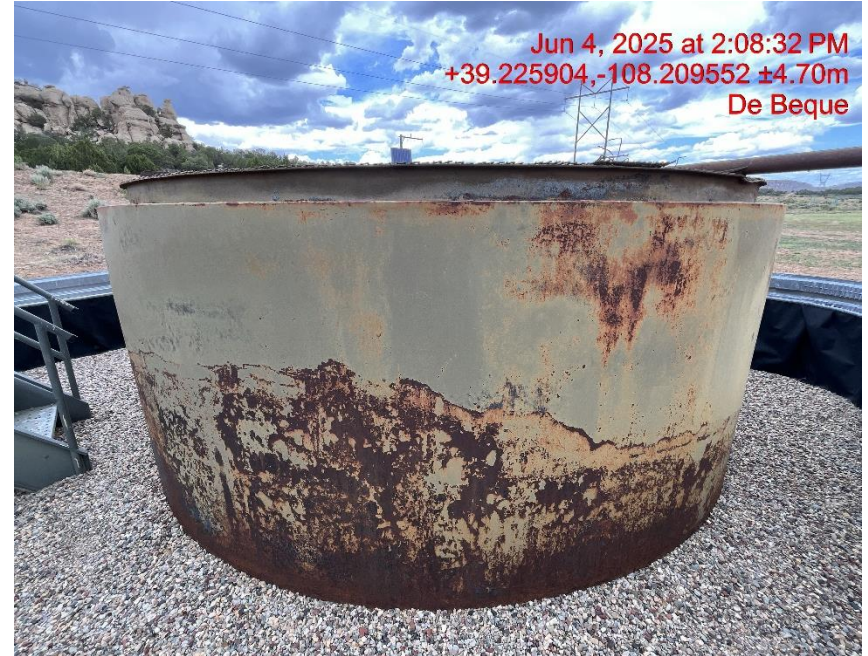
Photo # 7739 Tank is dented, also rusted in most areas
