ECMC
Environmental
Field Inspection

Jillson 5
© 22-May-25 08:59:05 AM
ECMC Environmental Inspection

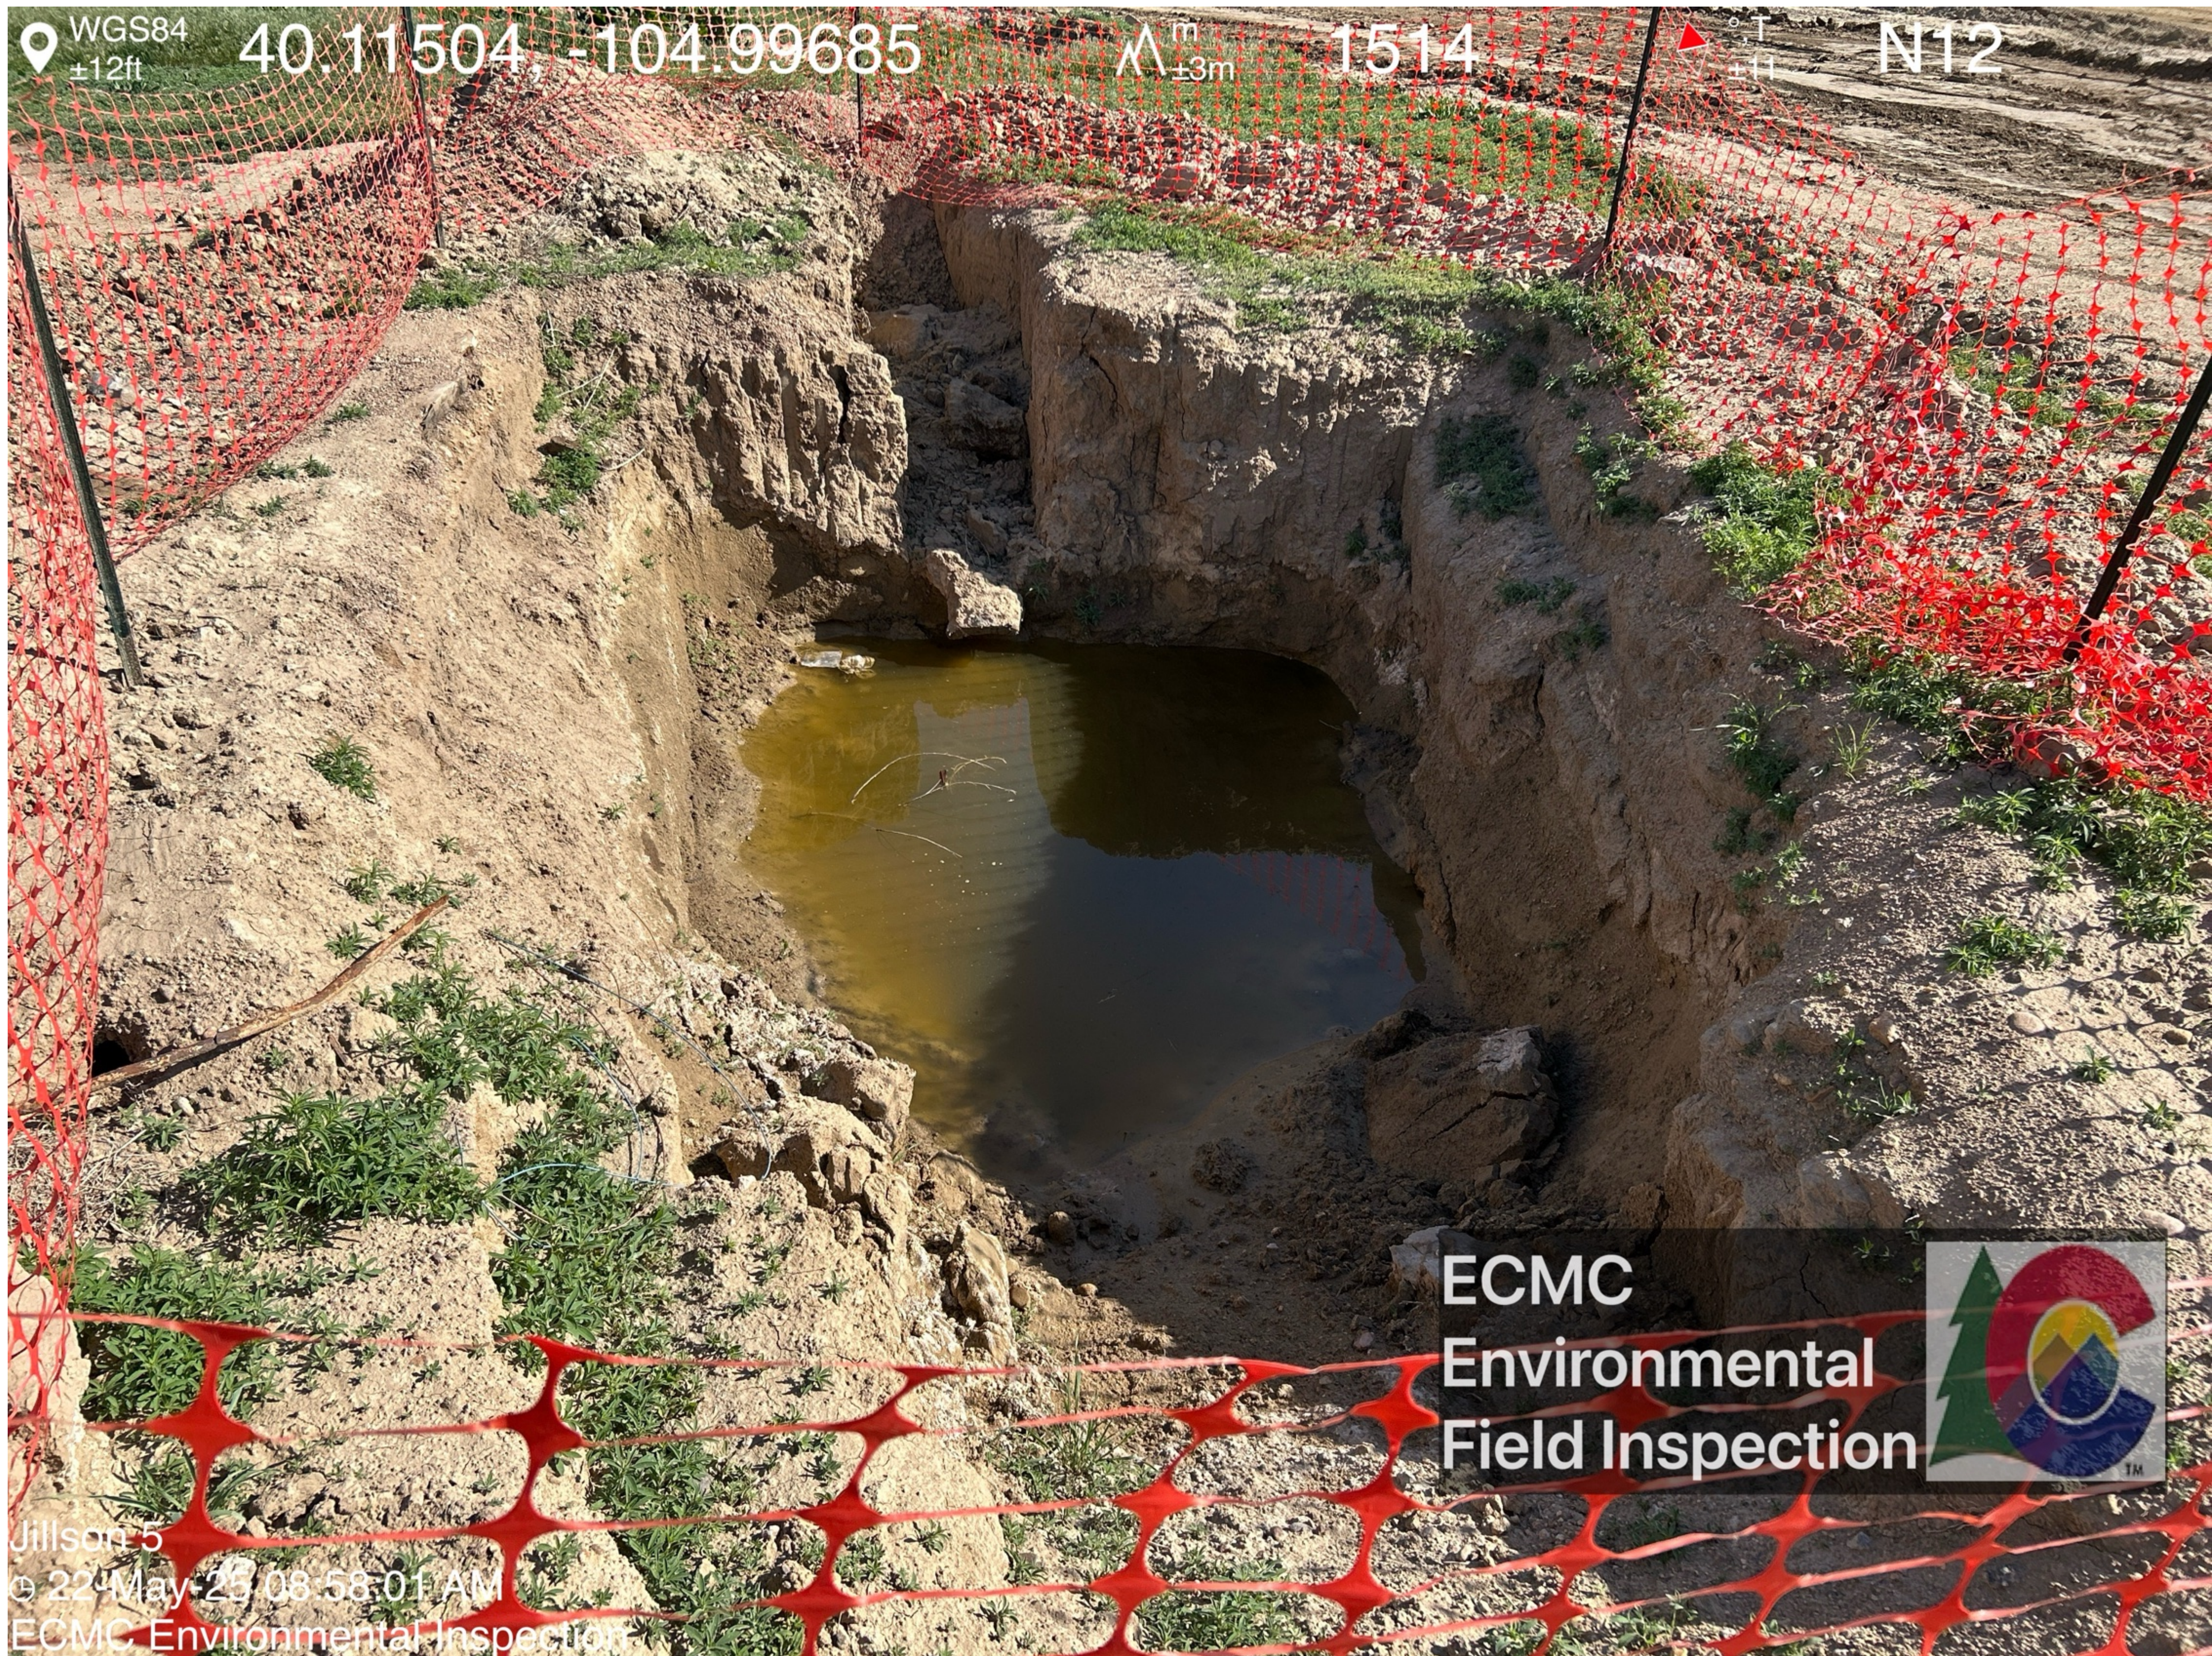
An excavation remains open at the spill location (former wellhead). Groundwater is visible at the base of the excavation. Gray staining is visible on portions of the excavation sidewalls.
