Form Resolution To Document Number: 696307330 & 696307553

Horsetail 33M Photo Documentation

Submit FIRR for Doc#: 696307330 & 696307553

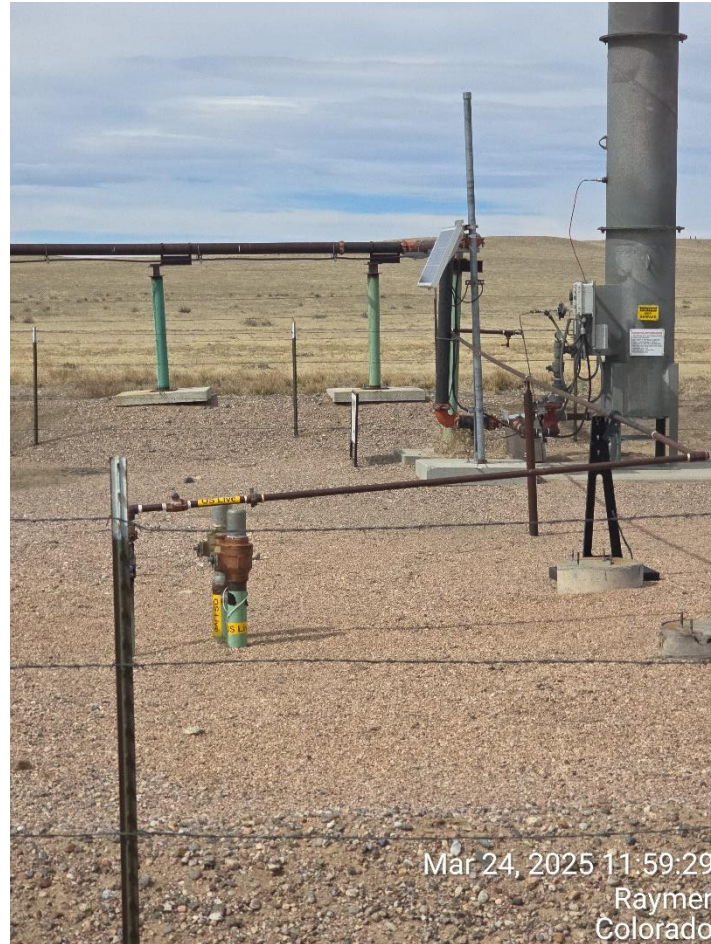
Horsetail 33M –

Unmarked Risers at Tanks & Flare Site –

All Unmarked Risers Have Been Properly Labeled

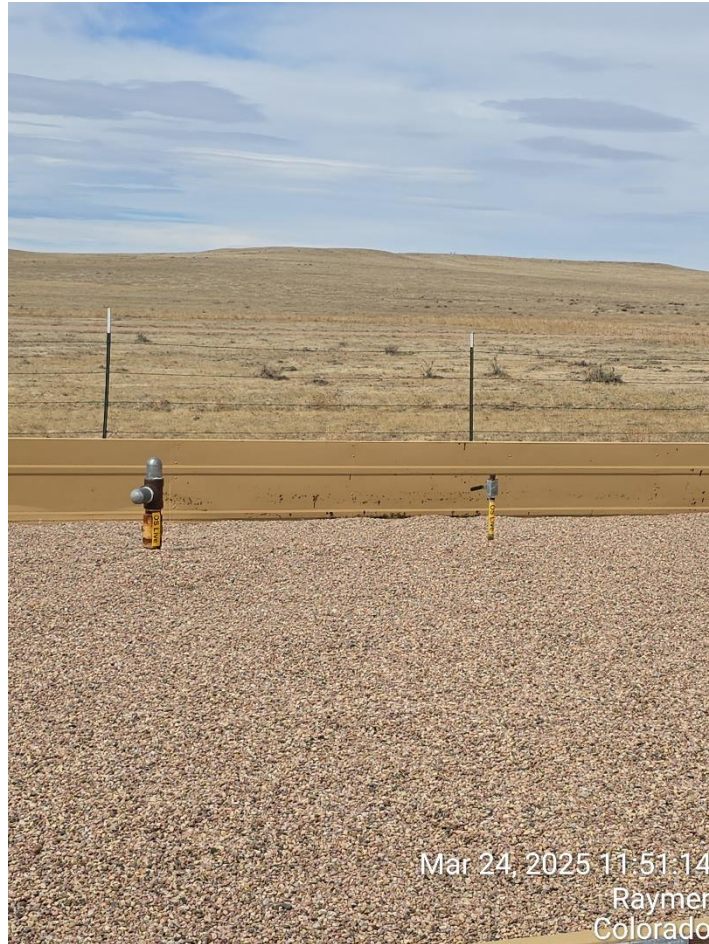
Horsetail 33M –

Unmarked Risers at Tanks & Flare Site –

All Unmarked Risers Have Been Properly Labeled

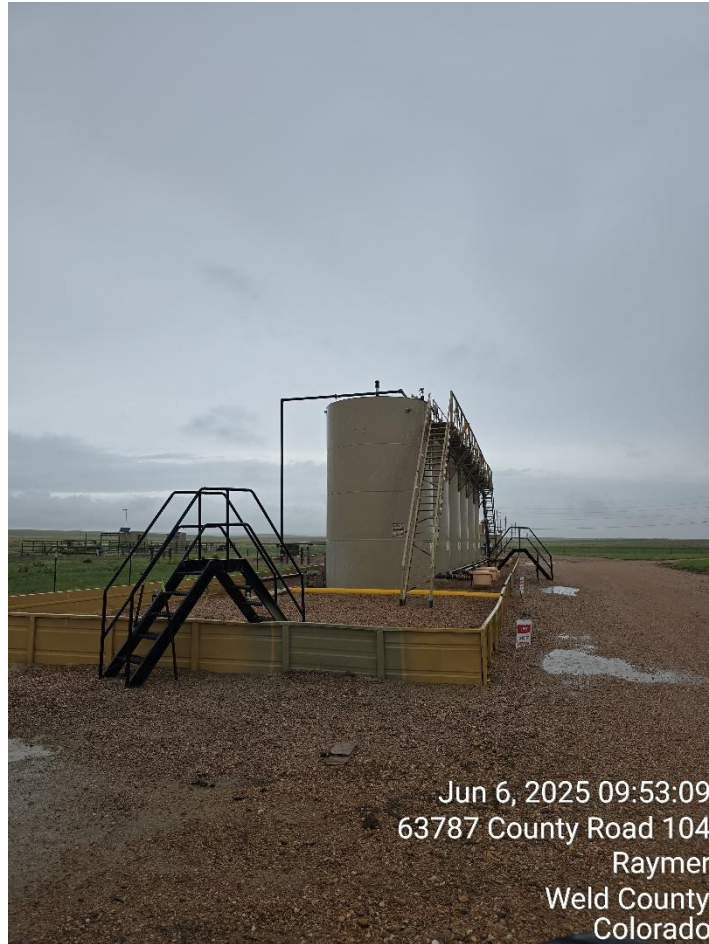
Horsetail 33M –

Repair or Install Berms or Other Secondary Containment Devices per Rule
603.o. –

All Damaged Tank Berms Have Been Properly Replaced In Compliance With
Rule 603.o.

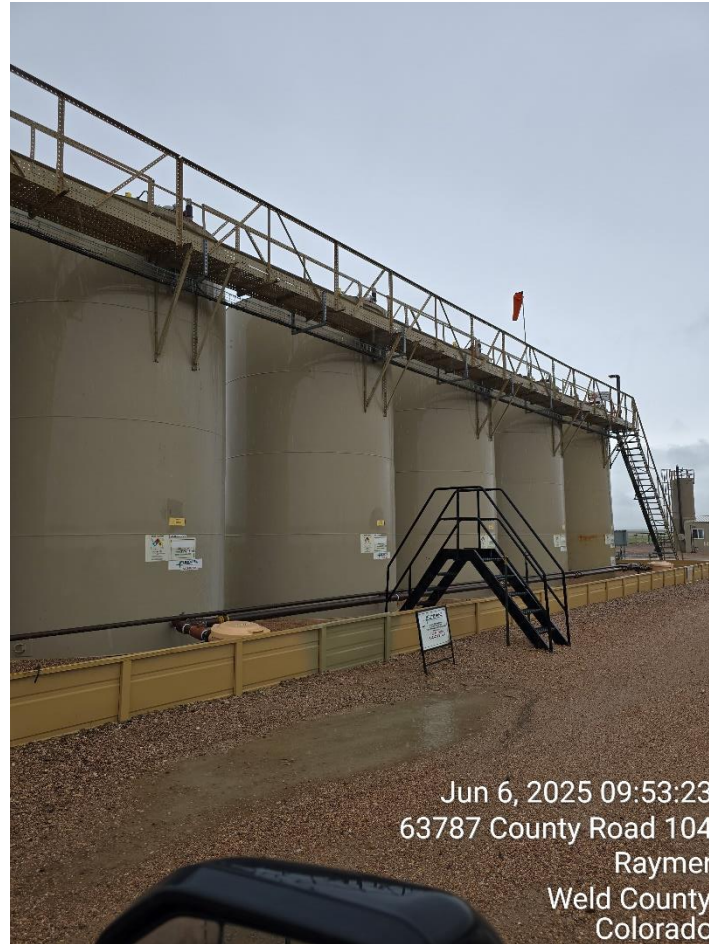
Horsetail 33M –

Repair or Install Berms or Other Secondary Containment Devices per Rule
603.o. –

All Damaged Tank Berms Have Been Properly Replaced In Compliance With
Rule 603.o.
