# Final Reclamation and Stormwater Inspection

Location ID: 327396

Well Name: GLENS GAS UNIT #12-6

Inspection Document #: 718600656

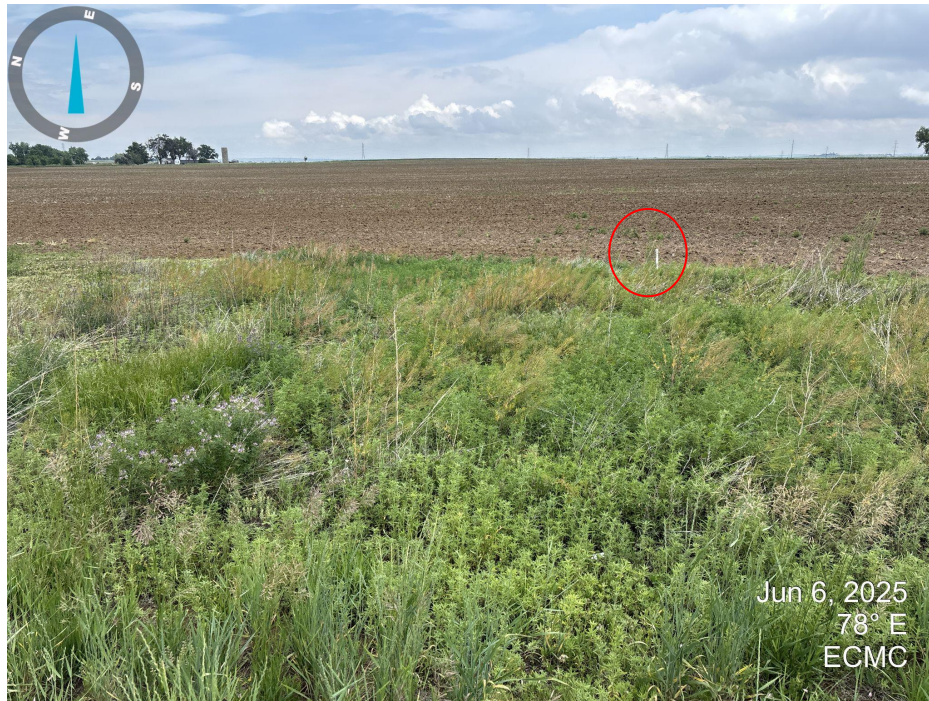
**Photo 1.** Looking east across the wellbore. The well location is adjacent to fallow cropland. Undesirable weed Kochia is present throughout the location. A monitoring well/pvc pipe is present near the wellbore (red circle).

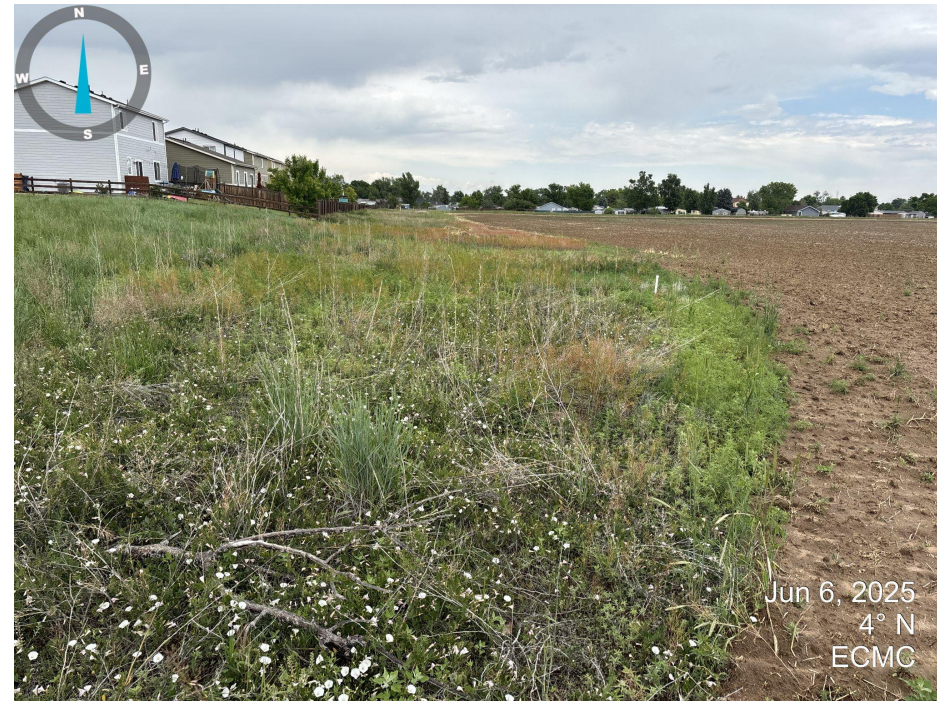
**Photo 2.** Looking north across the well location down the former access road. See photo 1 comments.

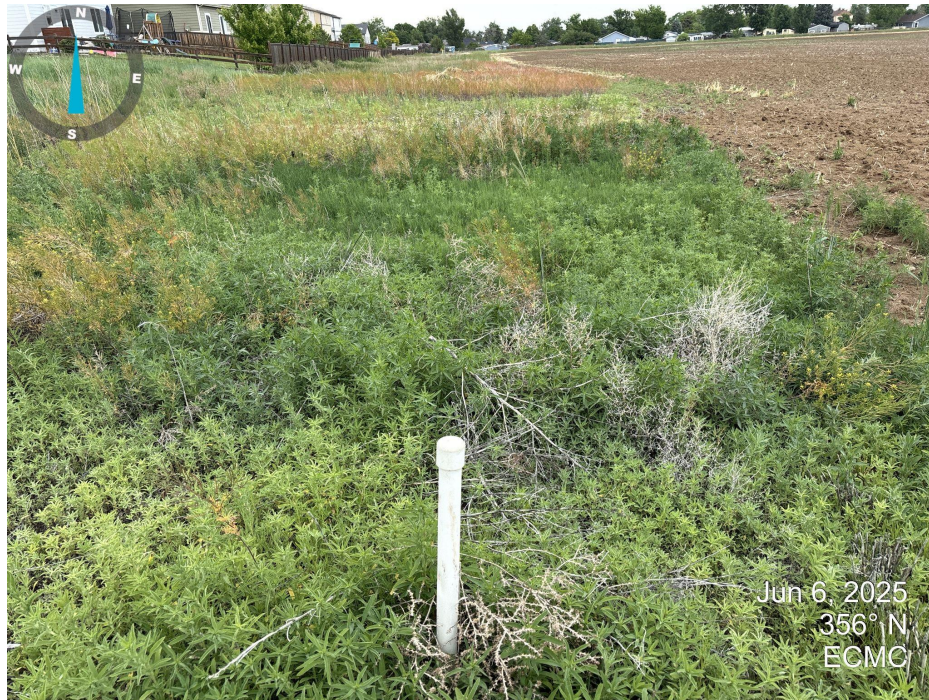
**Photo 3.** PVC pipe near the wellbore.

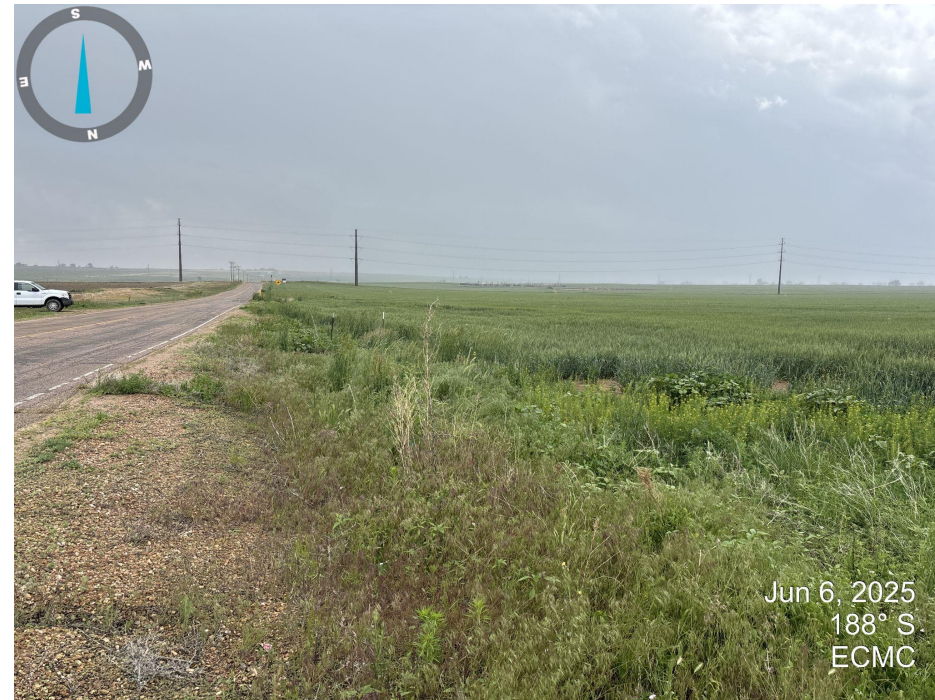
**Photo 4.** Looking south across the tank battery location. The tank battery is located 1500 ft to the southeast. The tank battery is located in an active crop field.

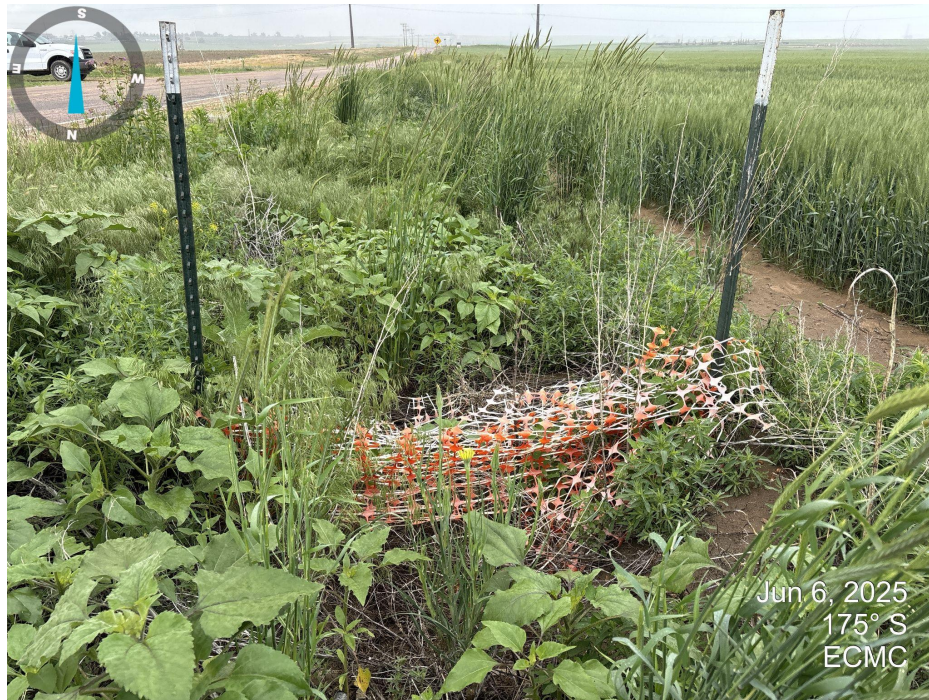
**Photo 5.** Picture taken on the east side of location. T posts and net are present around a box set in ground.

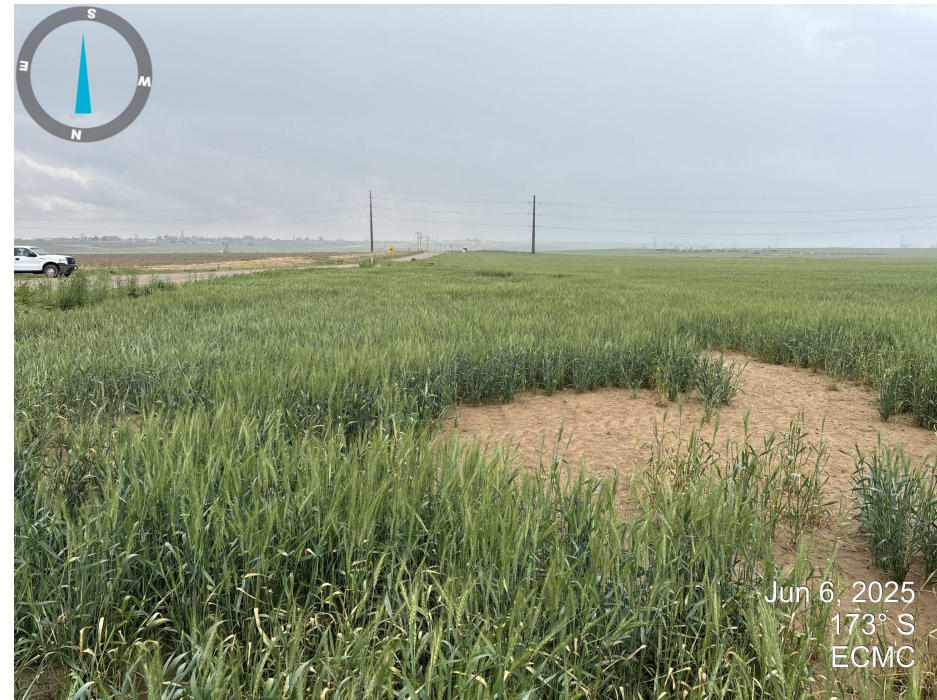
**Photo 6.** Looking south across the tank battery. Bare soil is present approximately where the PWV and tanks were located.

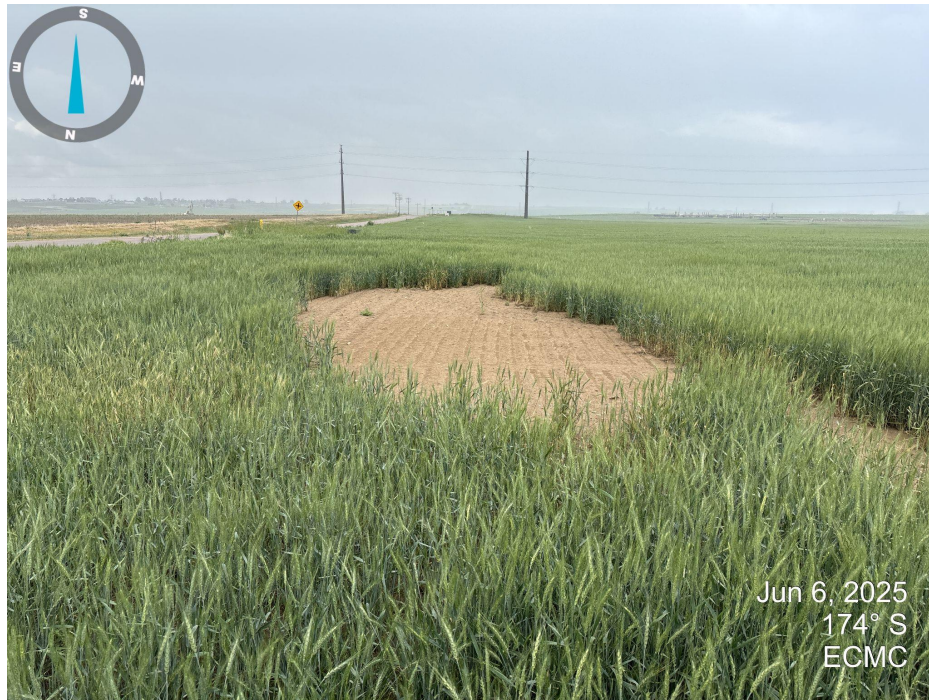
**Photo 7.** Looking south across the southern portion of the tank battery. A bare soil is present.

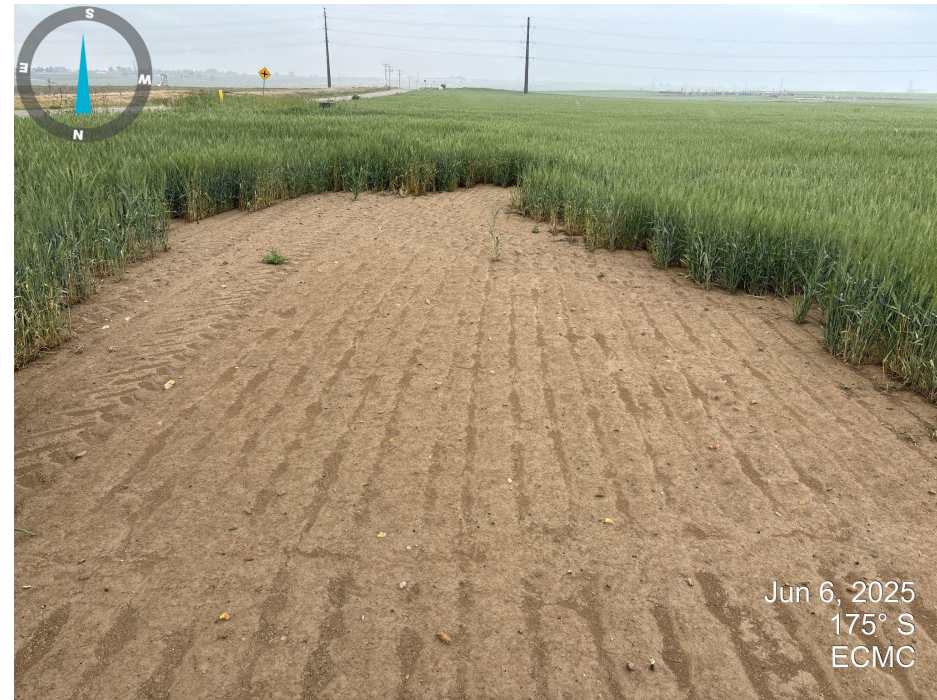
**Photo 8.** The bare patches appear to have been seeded/cultivated.
