# Inspection Photos

API: 073-06665

Operator: WIEPKING-FULLERTON ENERGY

Inspection Date: 6/10/2025

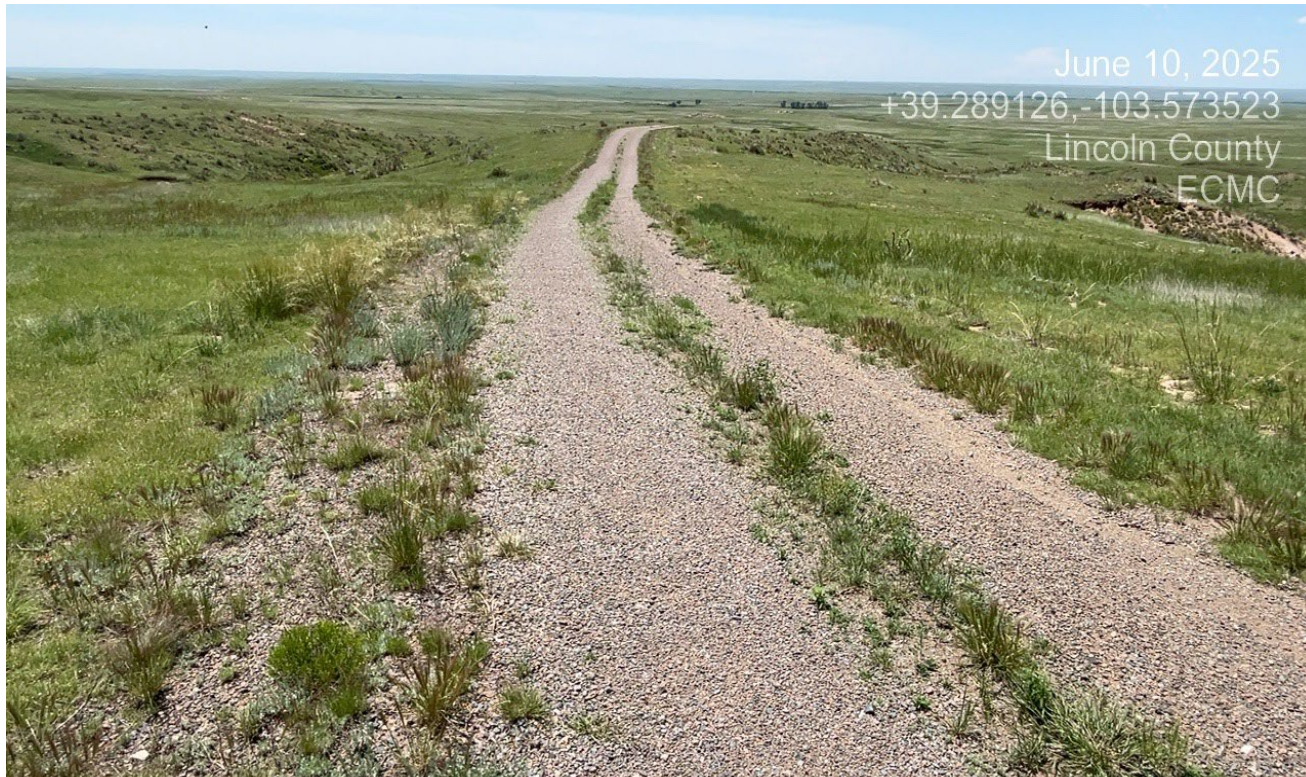
**Photo 1.** Facing south along the access road. Gravel along the road will need to be removed and the road will need to be reclaimed.

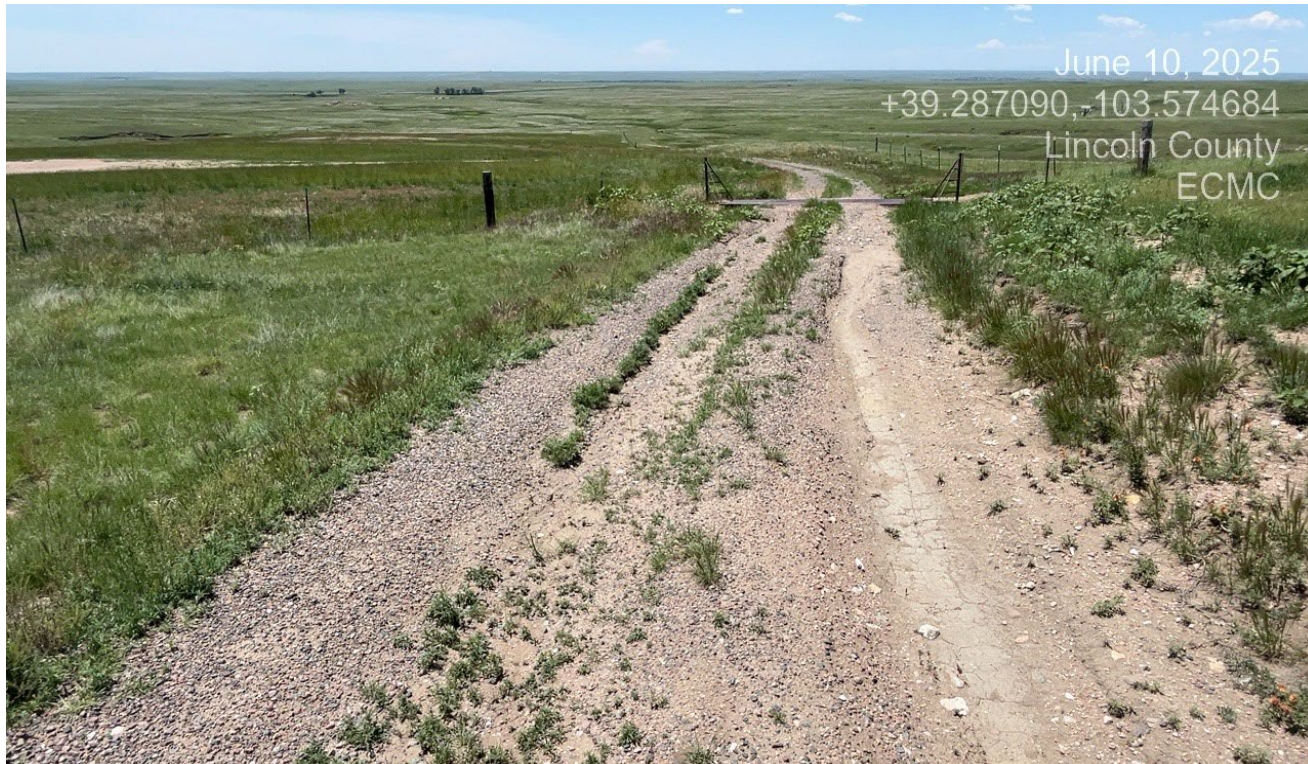
**Photo 2.** Facing south further down the road. There is erosion at this area of the road. The cattleguard will need to be removed.

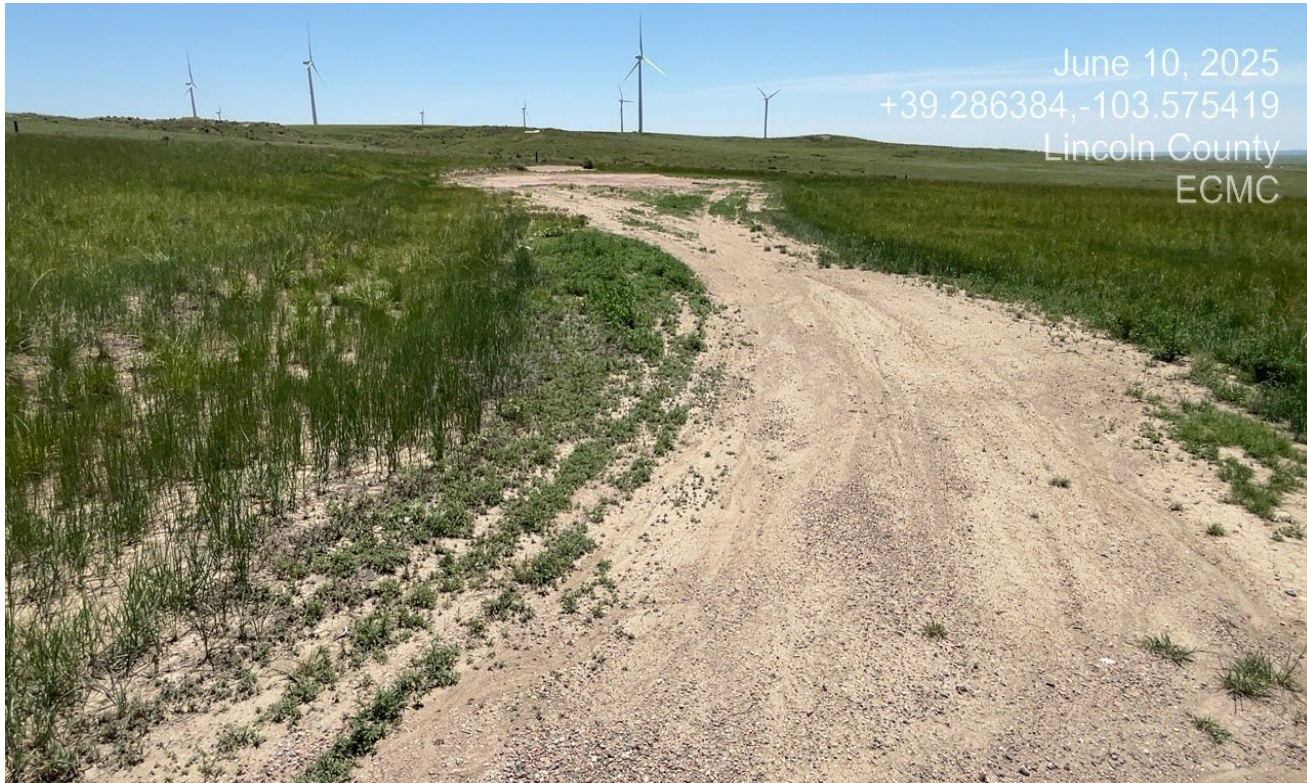
**Photo 3.** Facing southeast at the location. The location has not been recontoured and reclaimed.

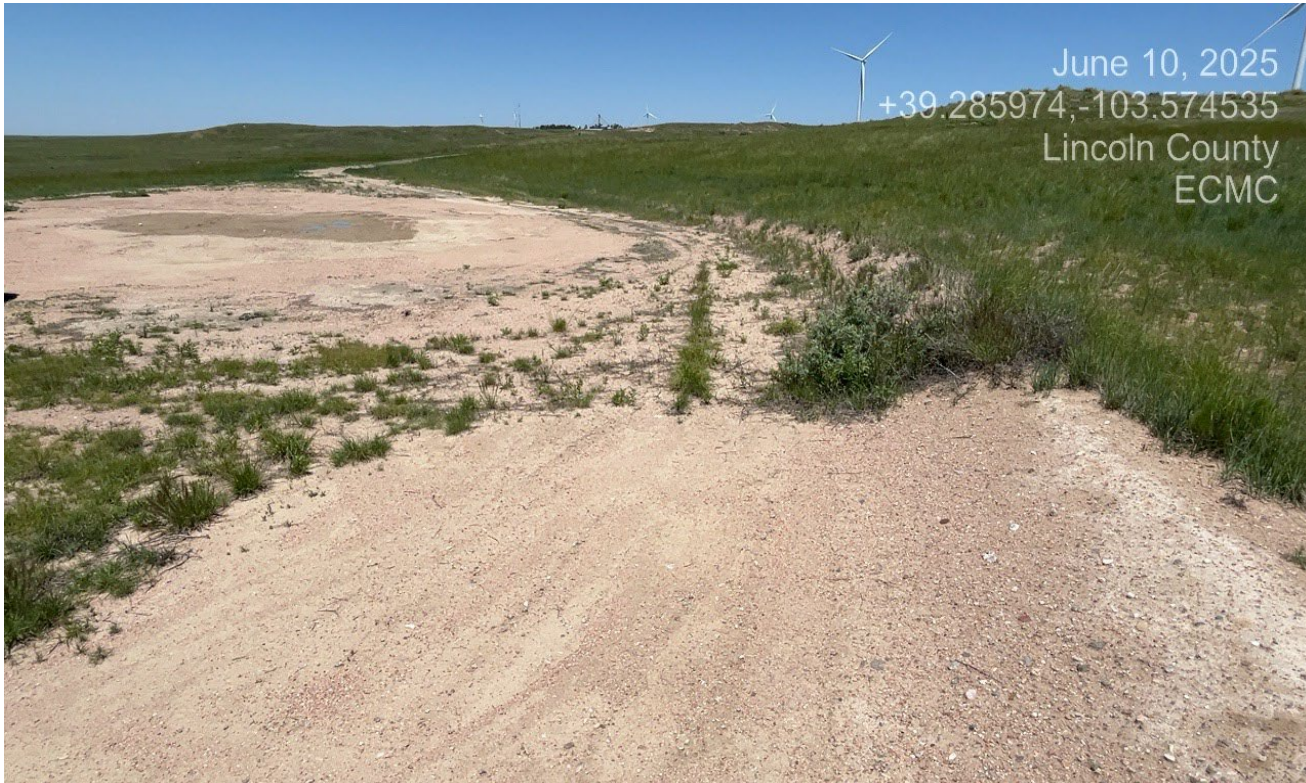
**Photo 4.** Facing orthwest at the location. Gravel has not been removed and soils are not decompacted and regraded.
