DOVER ATWOOD CORP/ENVEX BACA, LLC  
20165 N. 67th Ave. • Glendale, AZ 85308

ECMC  
Environmental  
Field Inspection

Hancock M-631S43W (321046)  
© 04-Jun-25 12:45:02

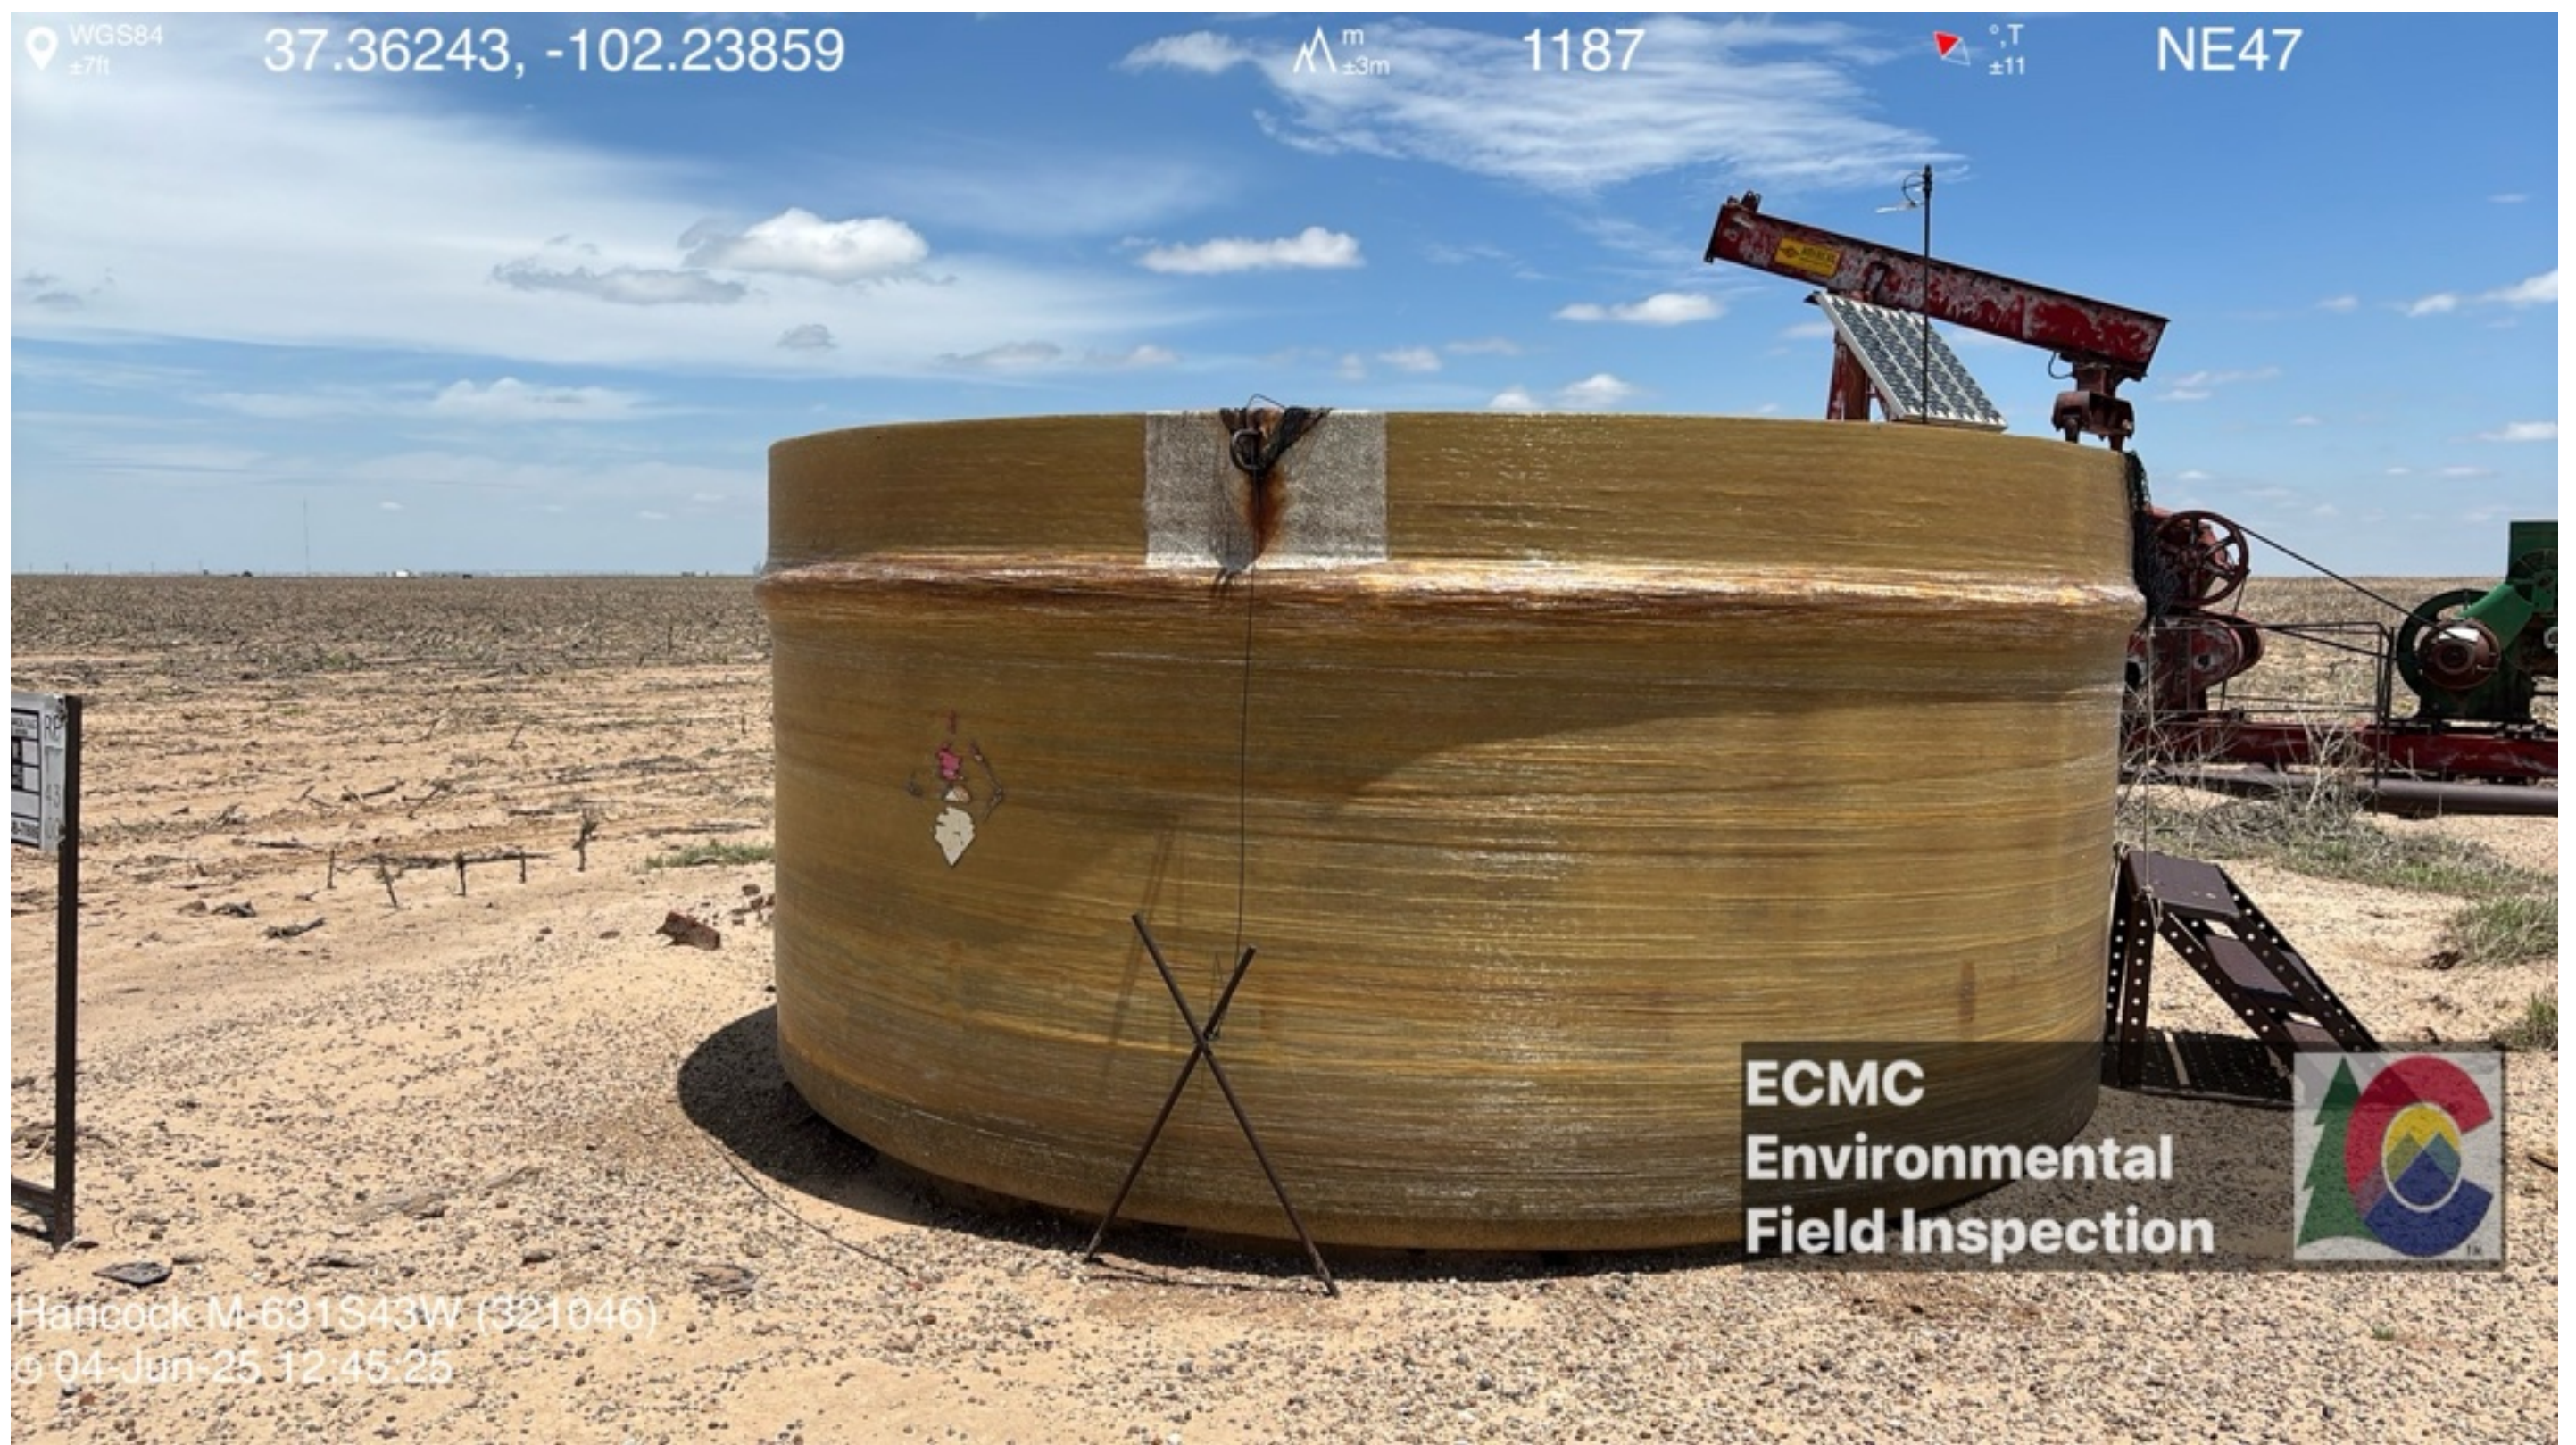
~100-bbl open top fiberglass produced water storage tank missing contents/volume labels and hazard/NFPA placards.  
Inadequate secondary containment.

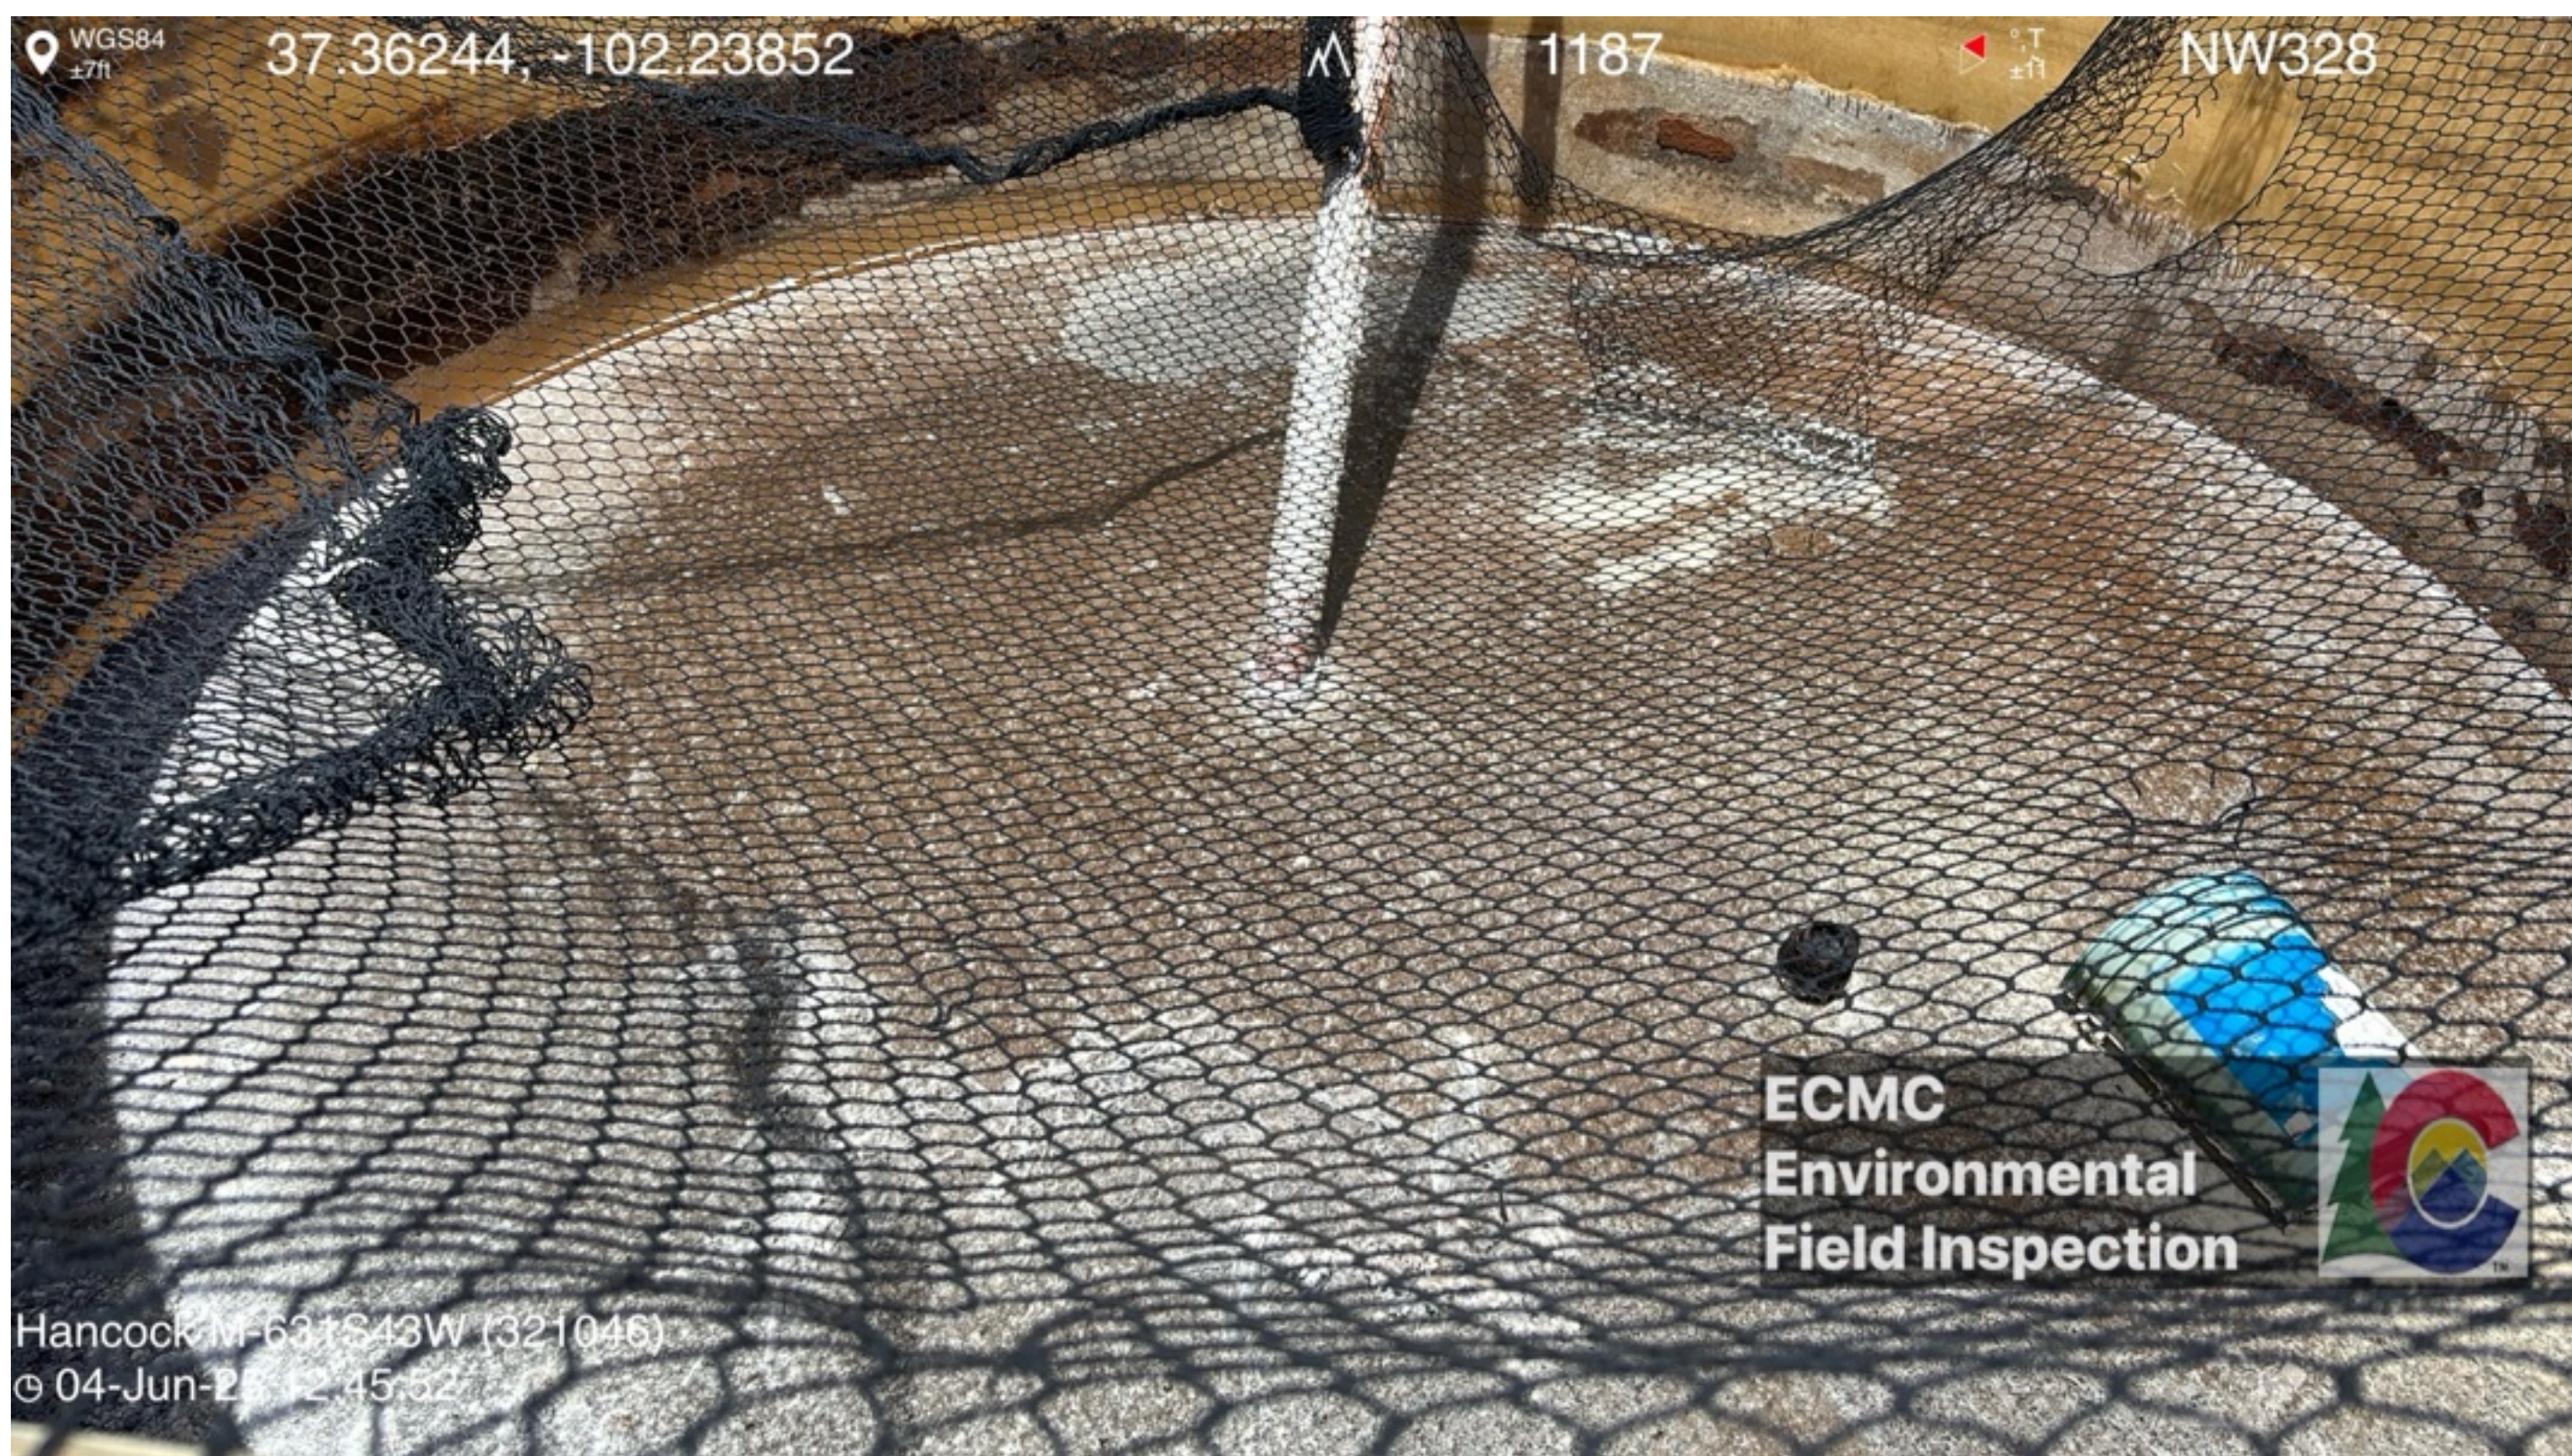
~100-bbl open top fiberglass produced water storage tank has trash/debris in base and wildlife protection equipment (netting) has fallen and requires maintenance/repair.

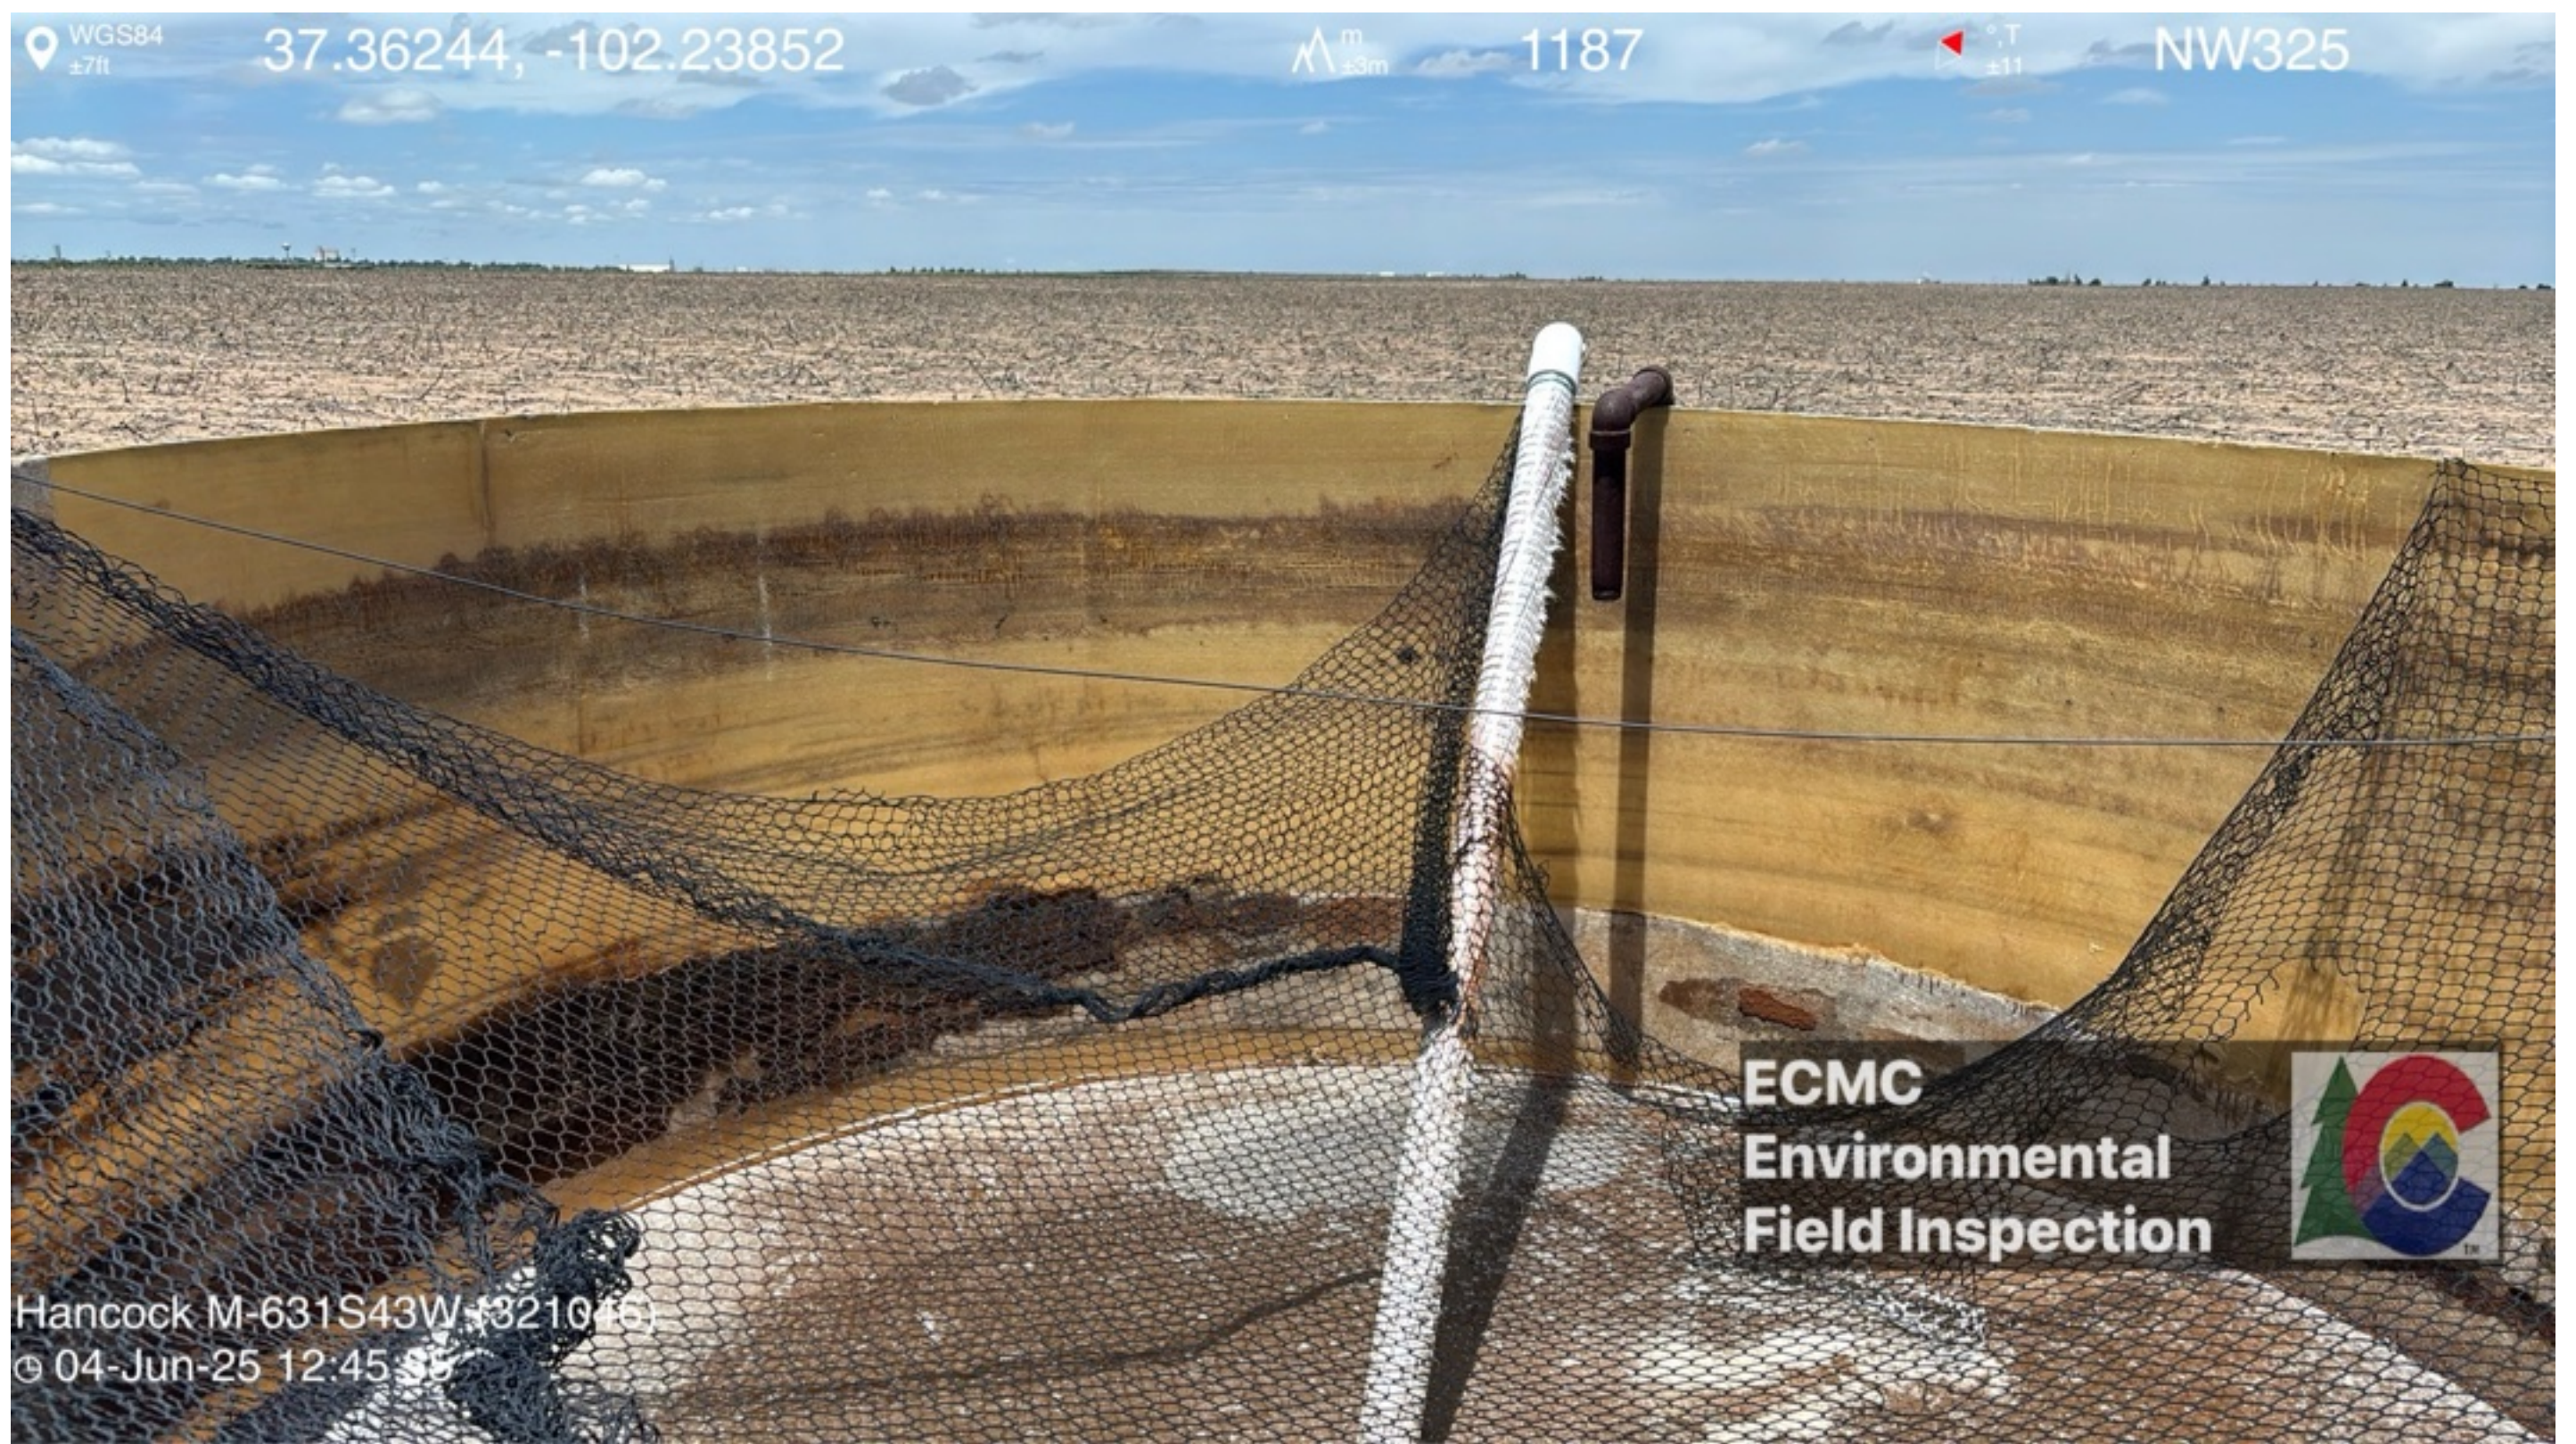
~100-bbl open top fiberglass produced water storage tank wildlife protection equipment (netting) has fallen and requires maintenance

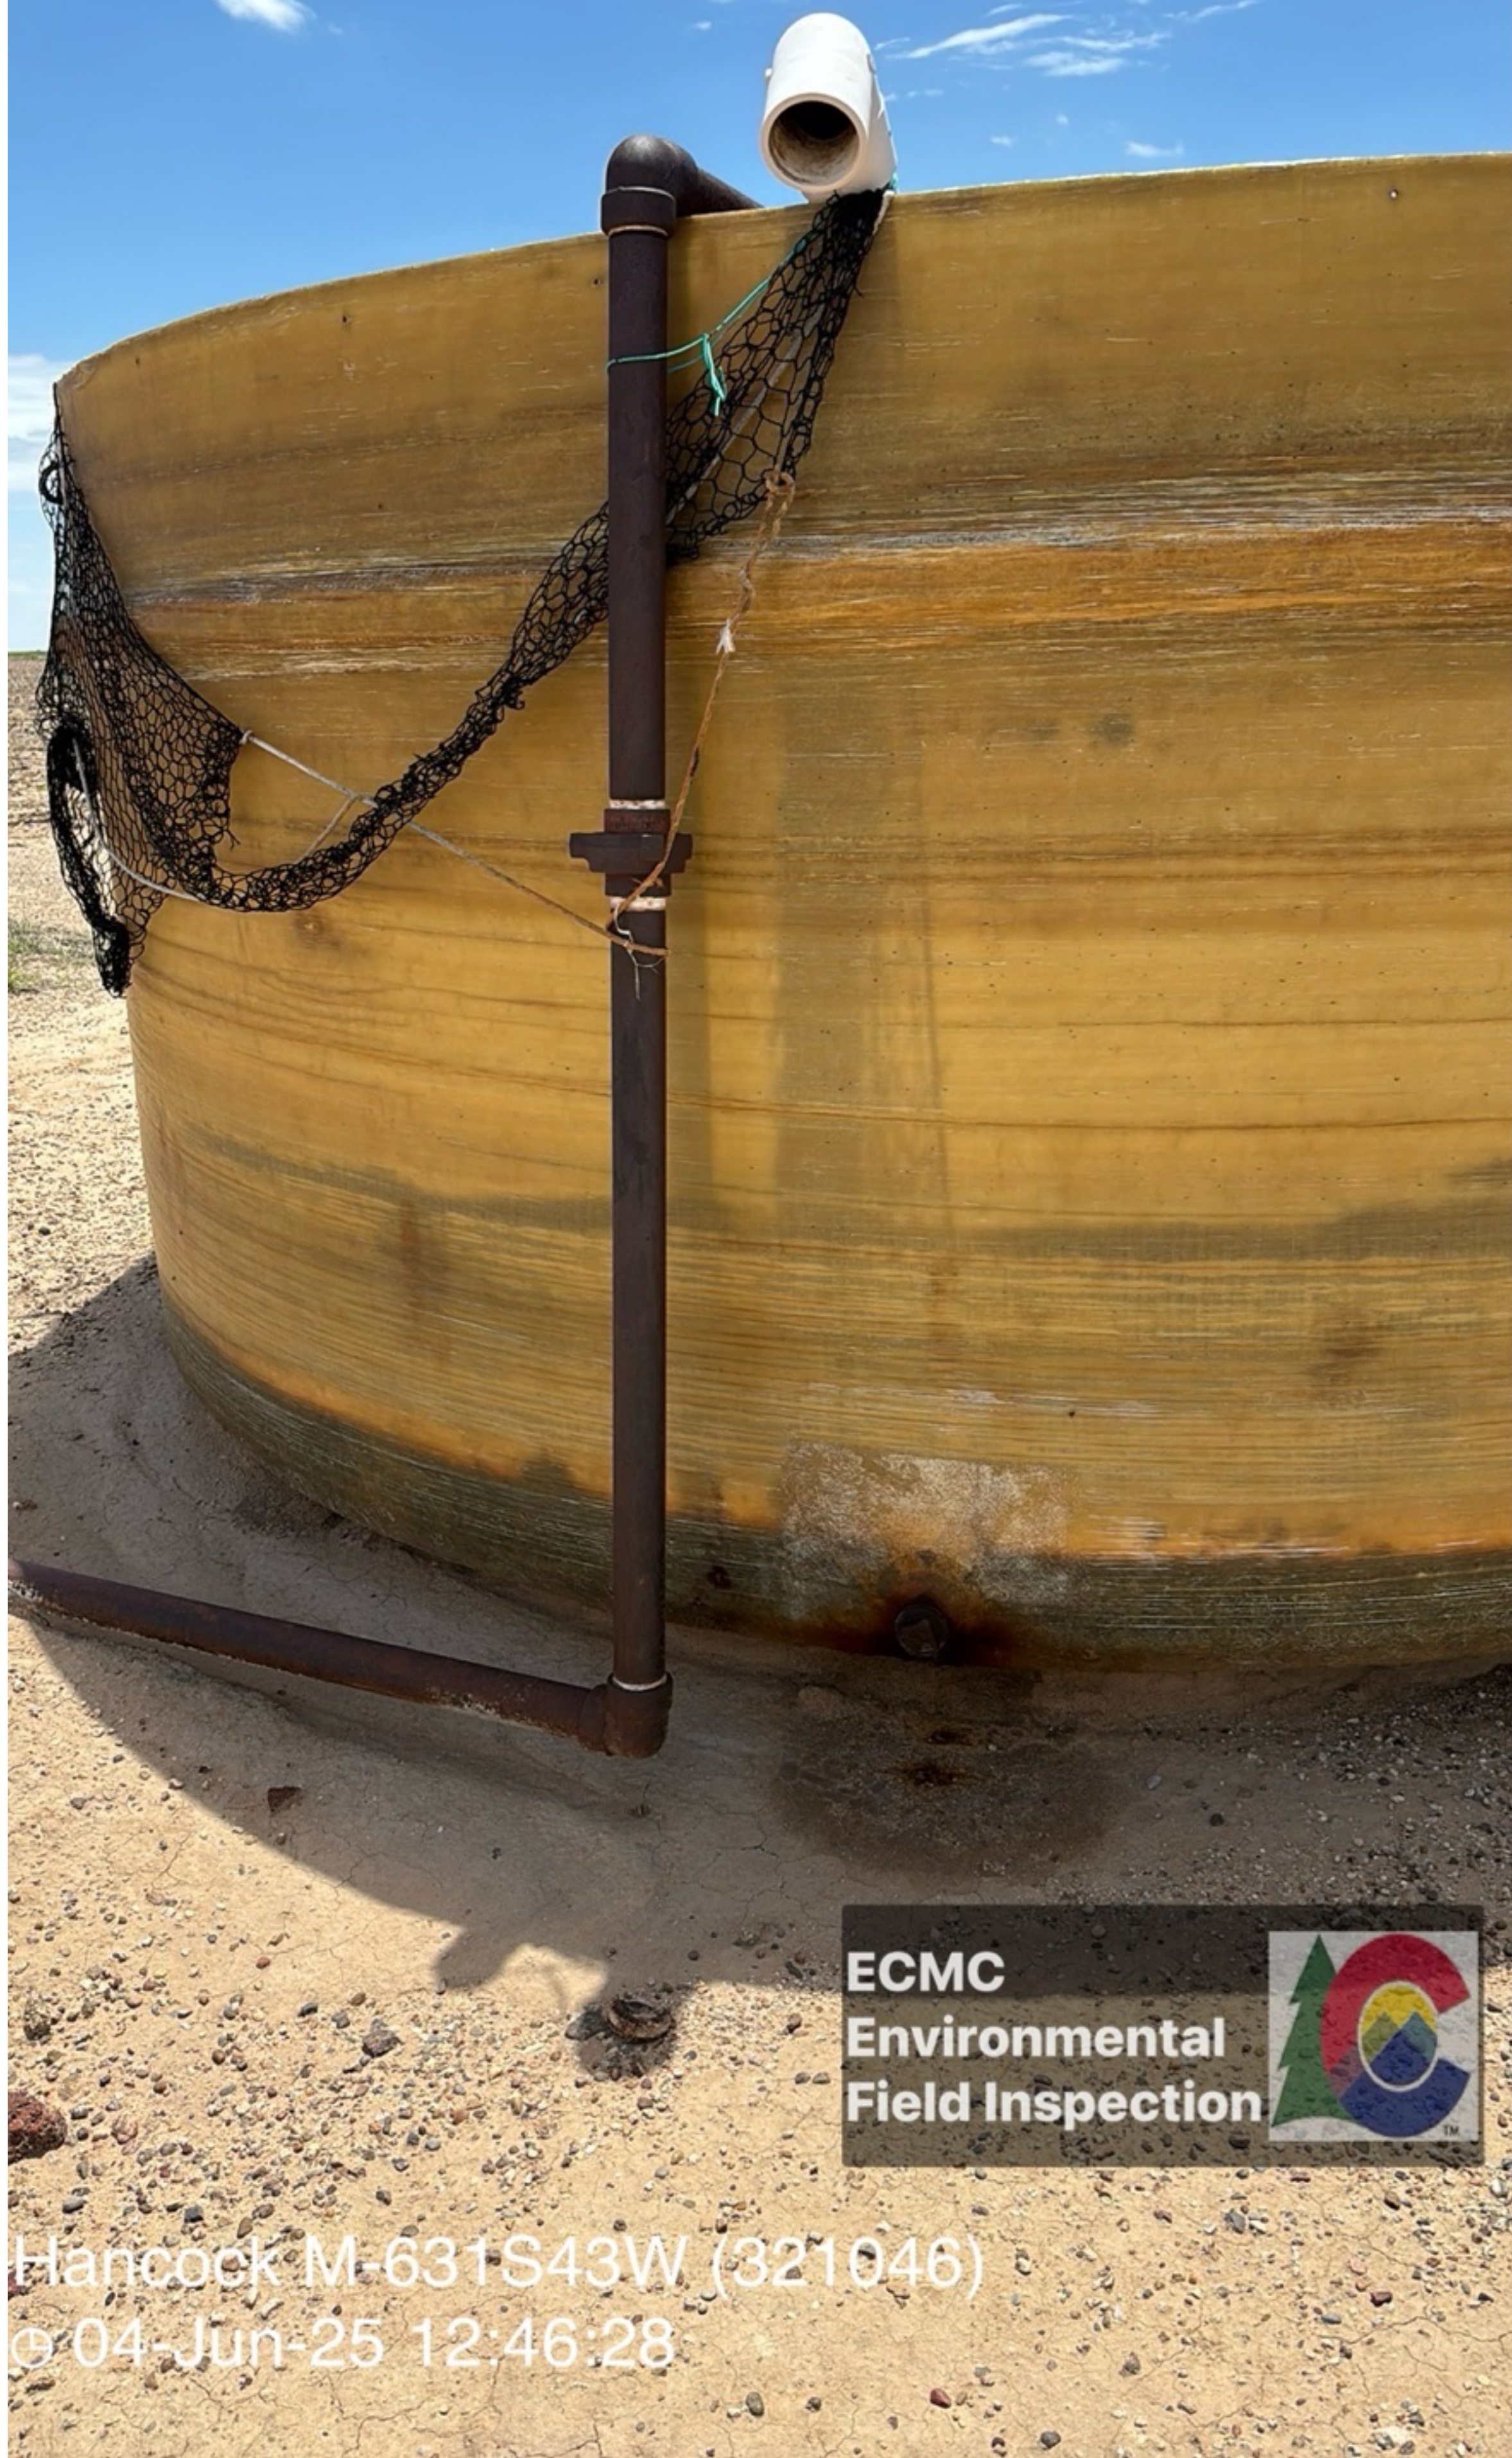
Stained soil observed beneath the bung installed on outlet/drain port on the ~100-bbl open top fiberglass produced water storage tank.

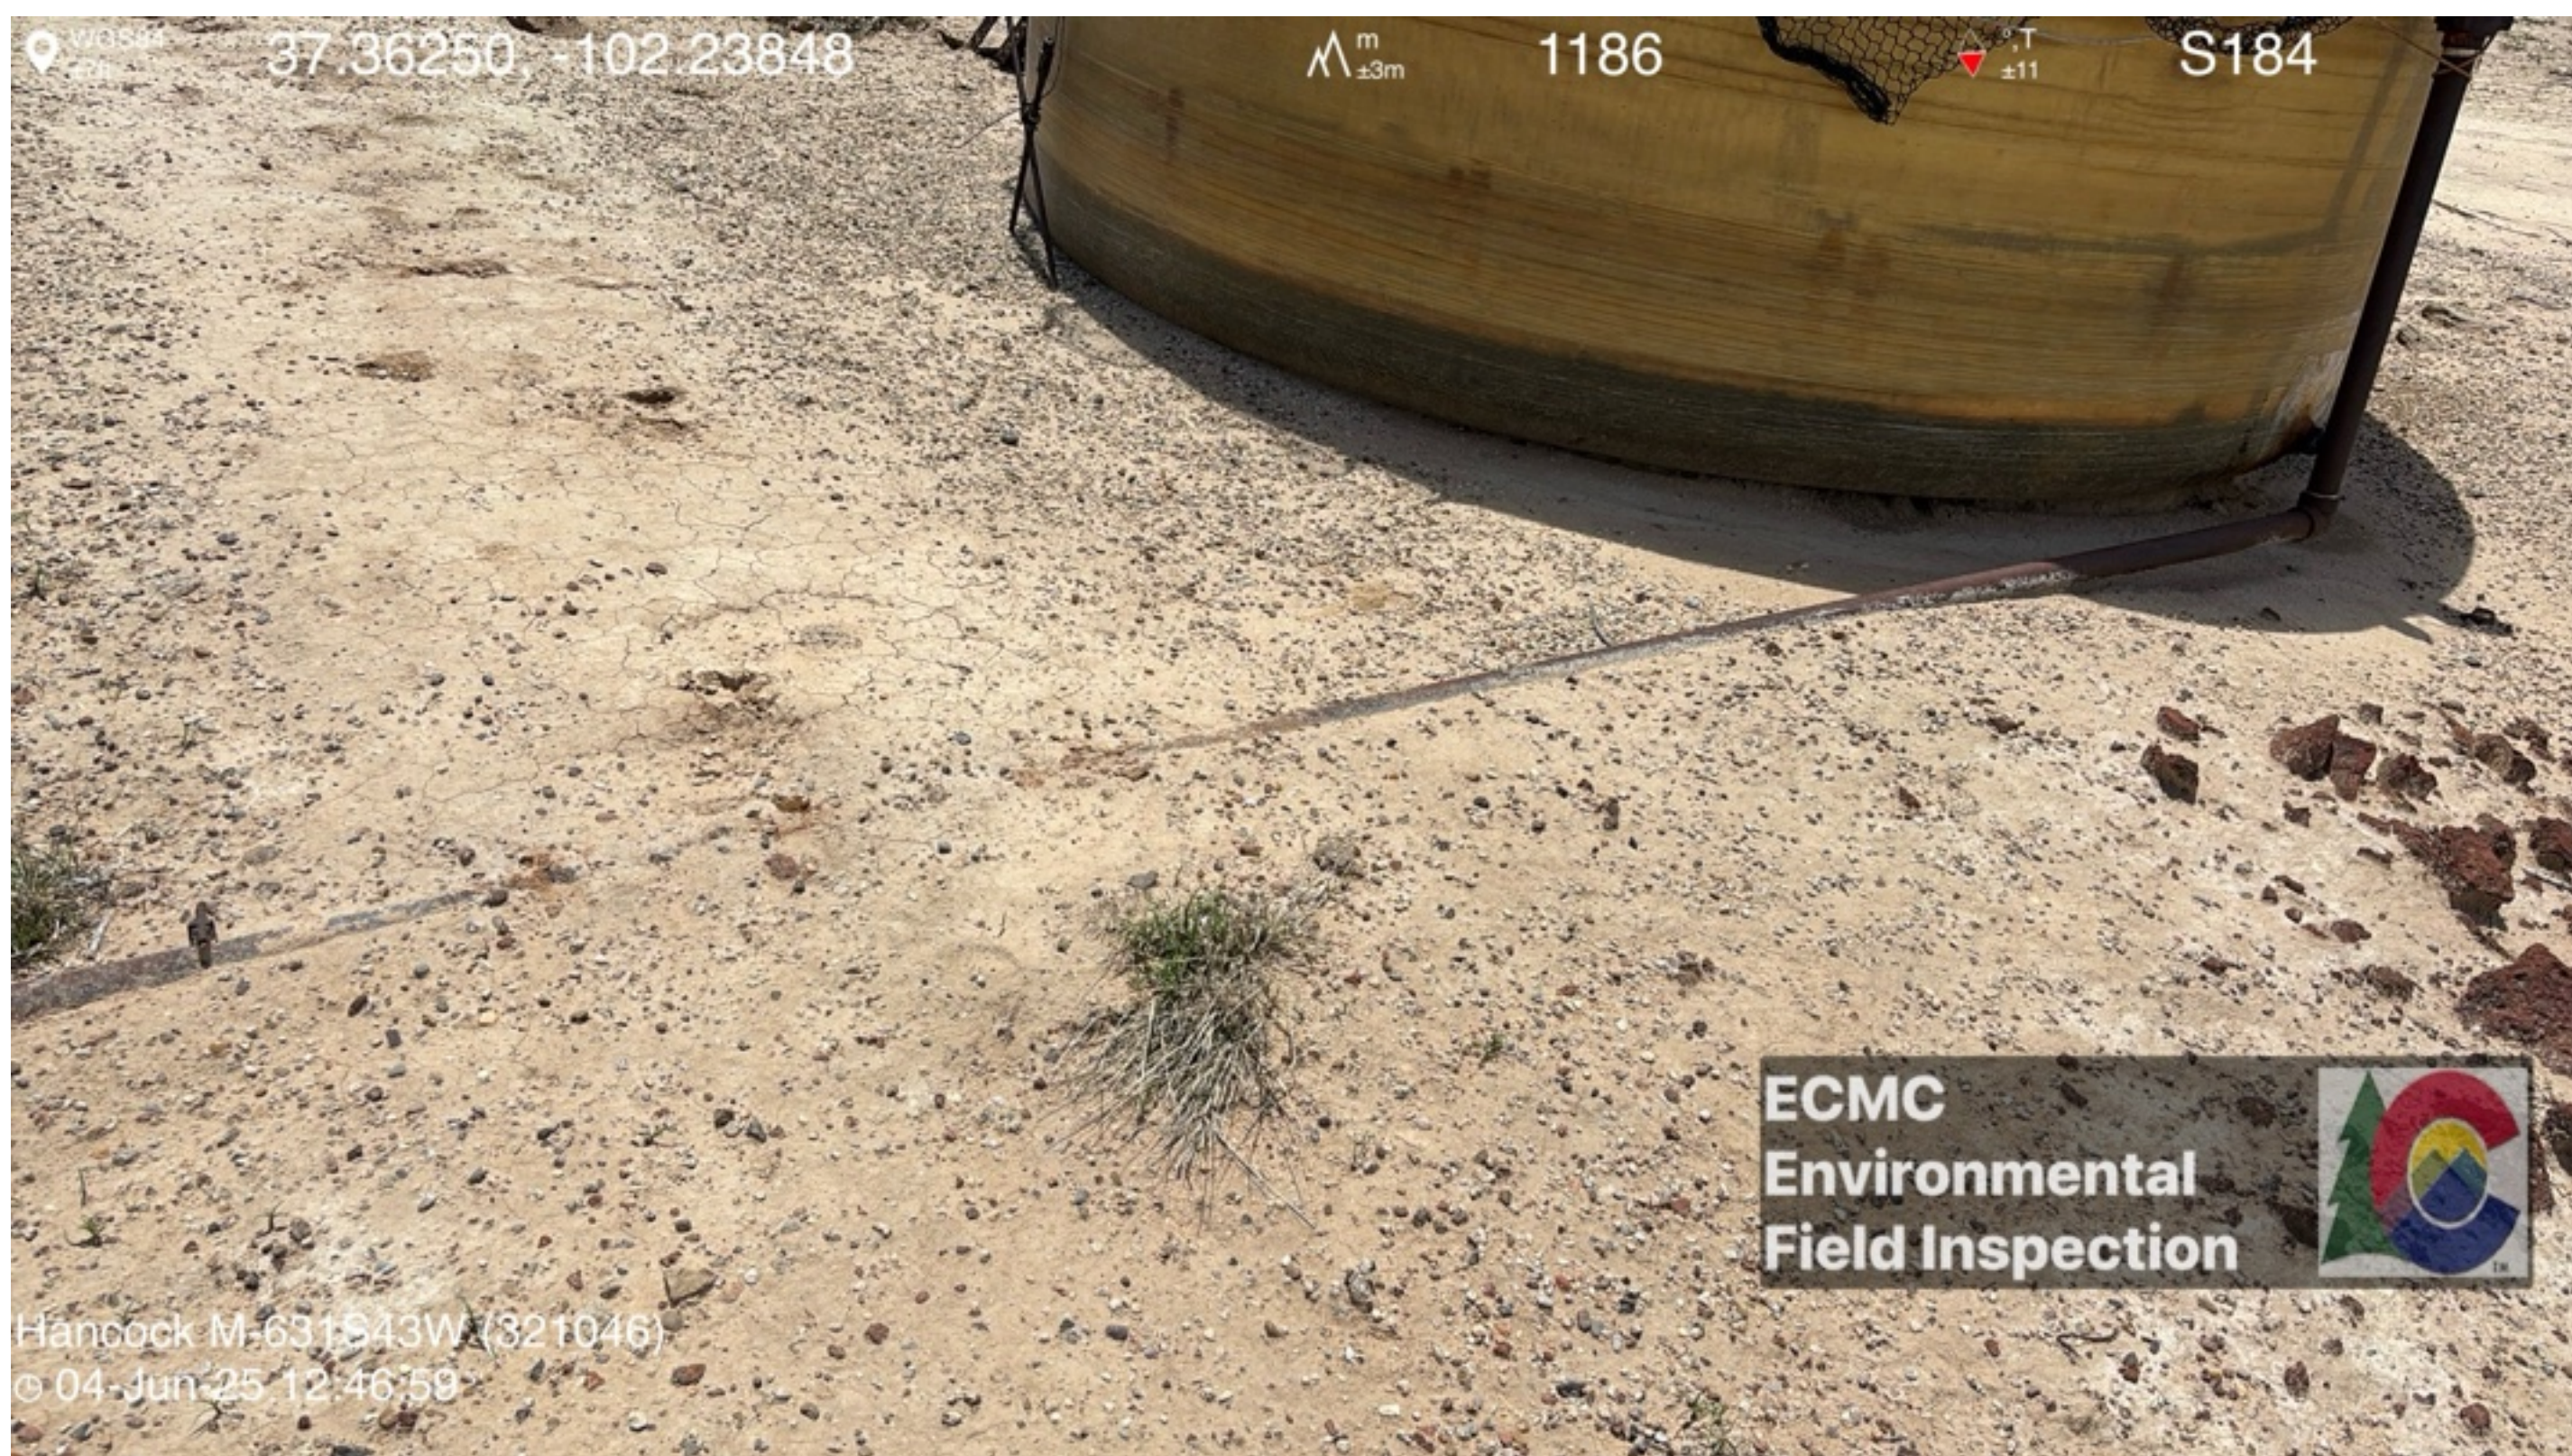
Buried piping is exposed.

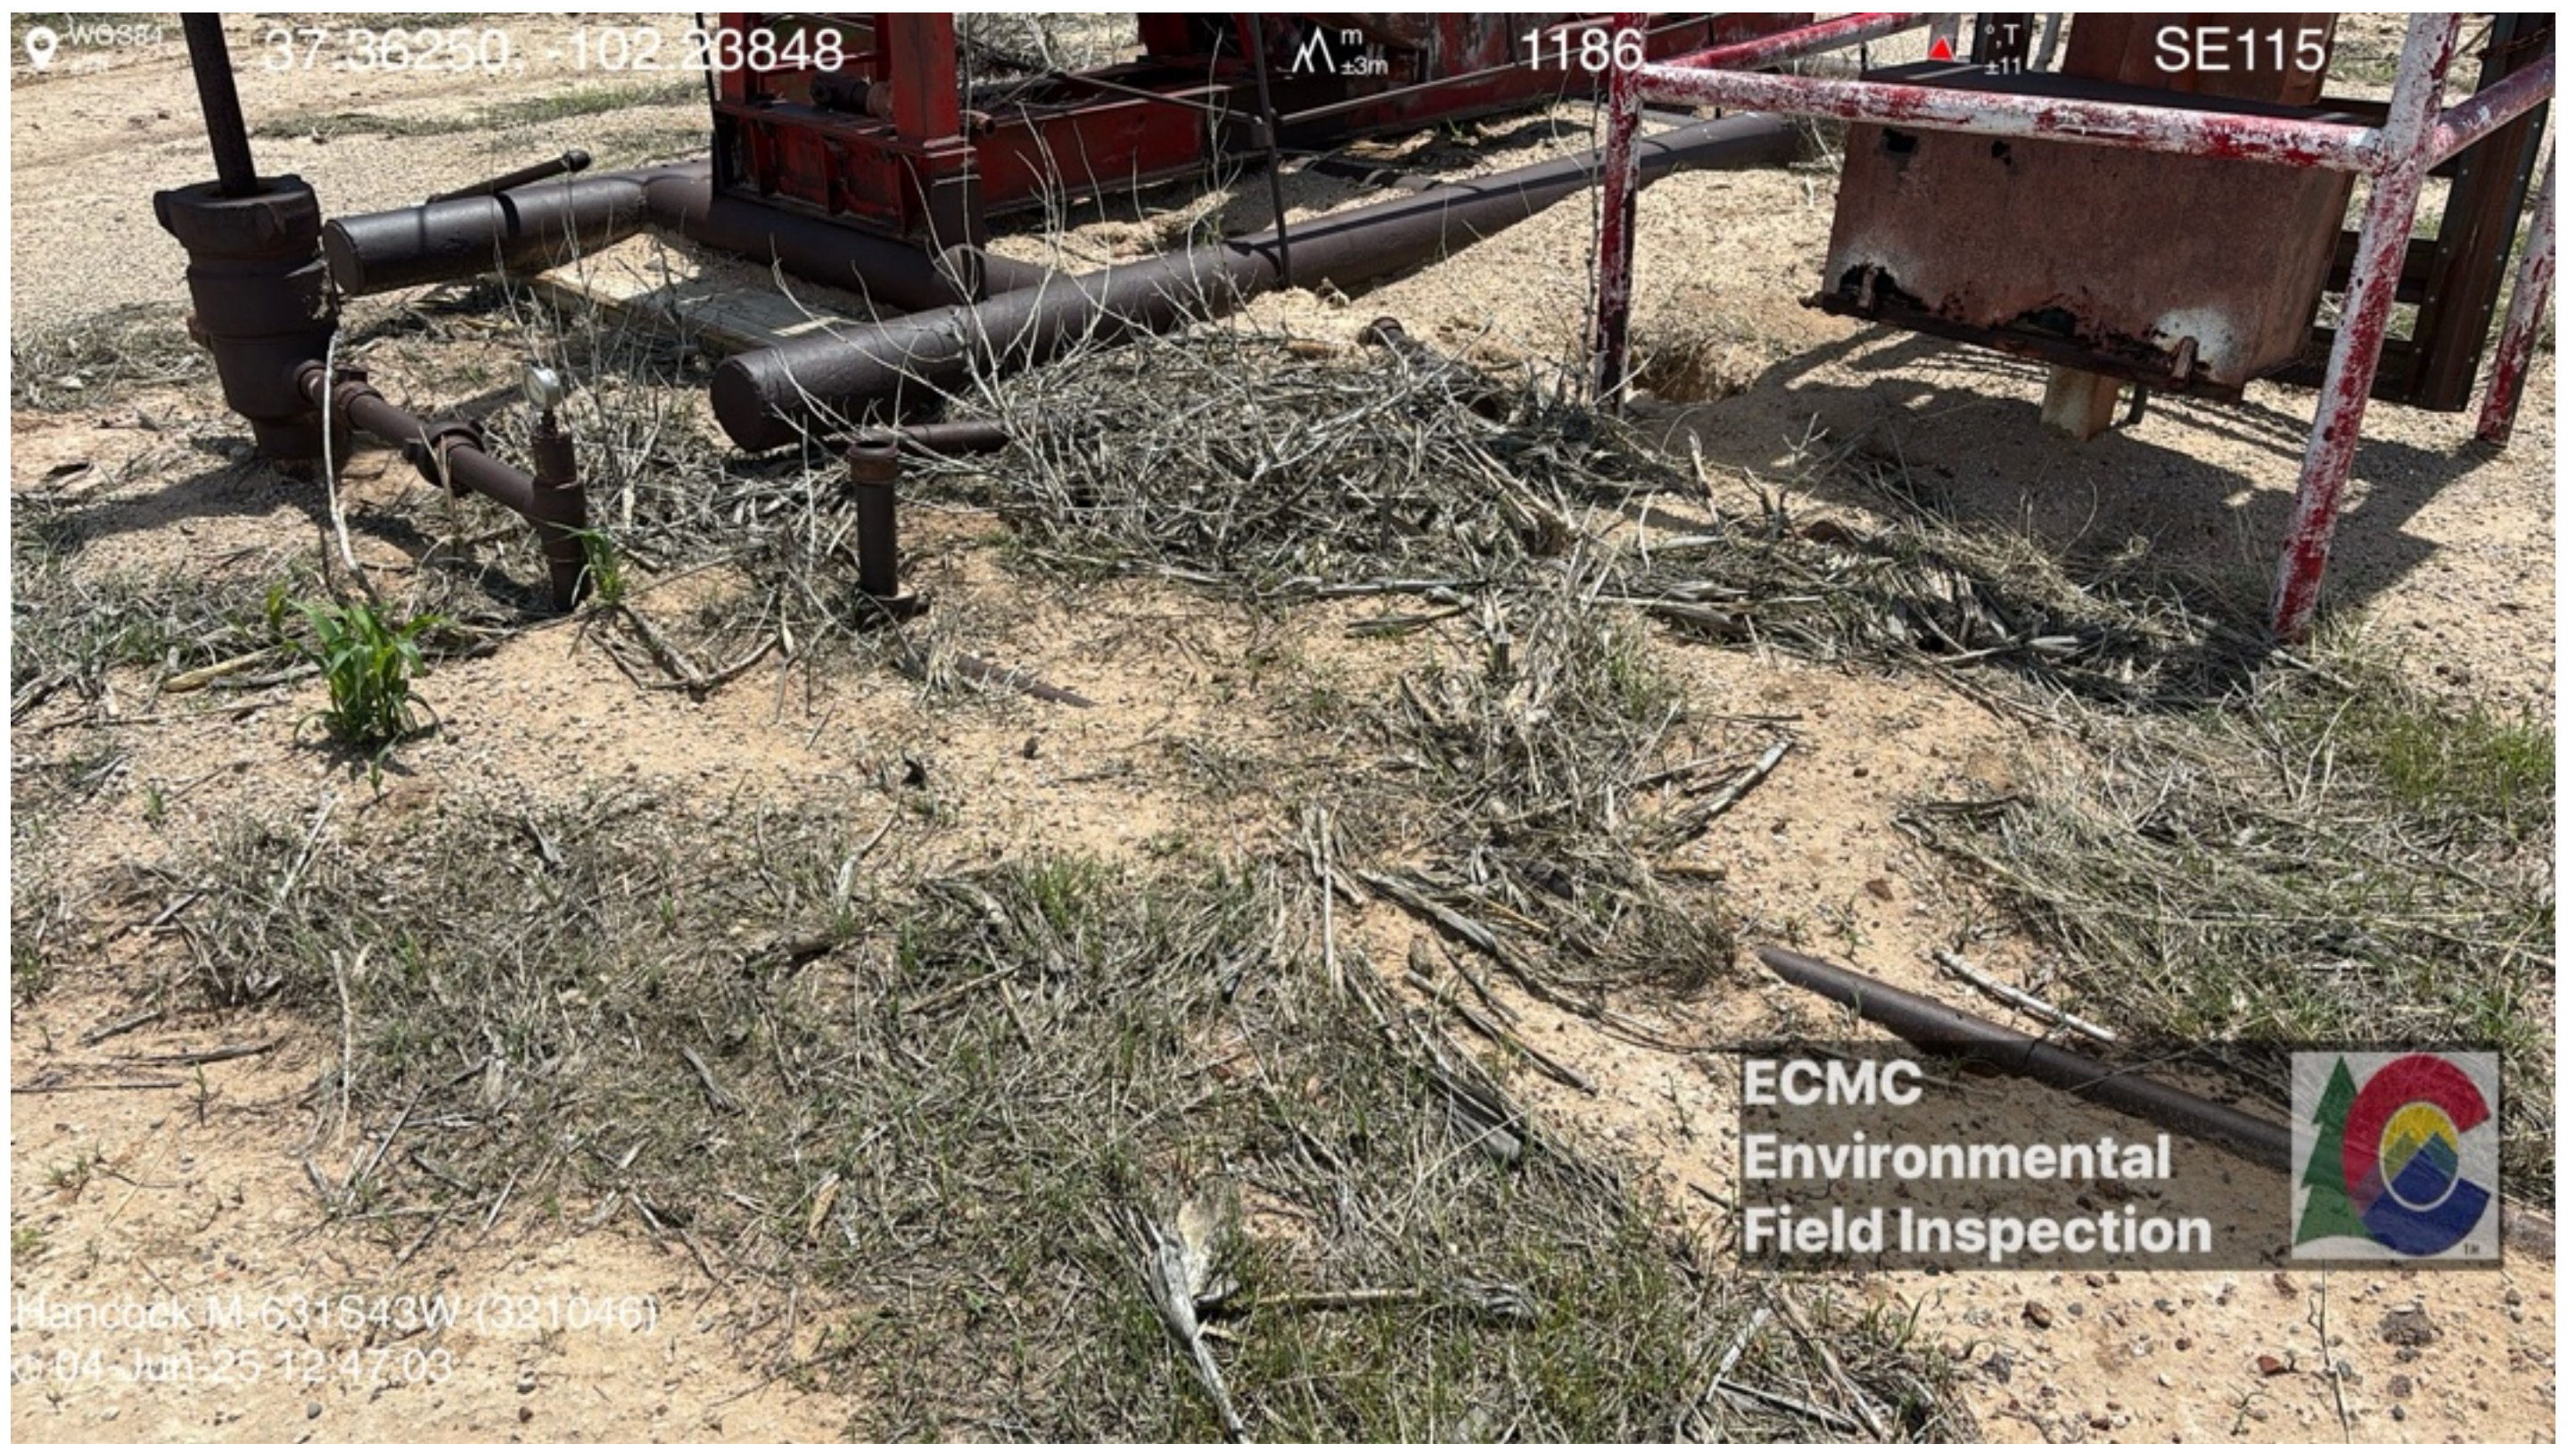
Weeds/debris observed next to wellhead and cathodic rectifier.
