DOVER ATWOOD CORP/ENVEX BACA, LLC  
20165 N. 67th Ave. • Glendale, AZ 85308

ECMC  
Environmental  
Field Inspection

Hancock M-631S43W (321046)  
© 04-Jun-25 12:45:02

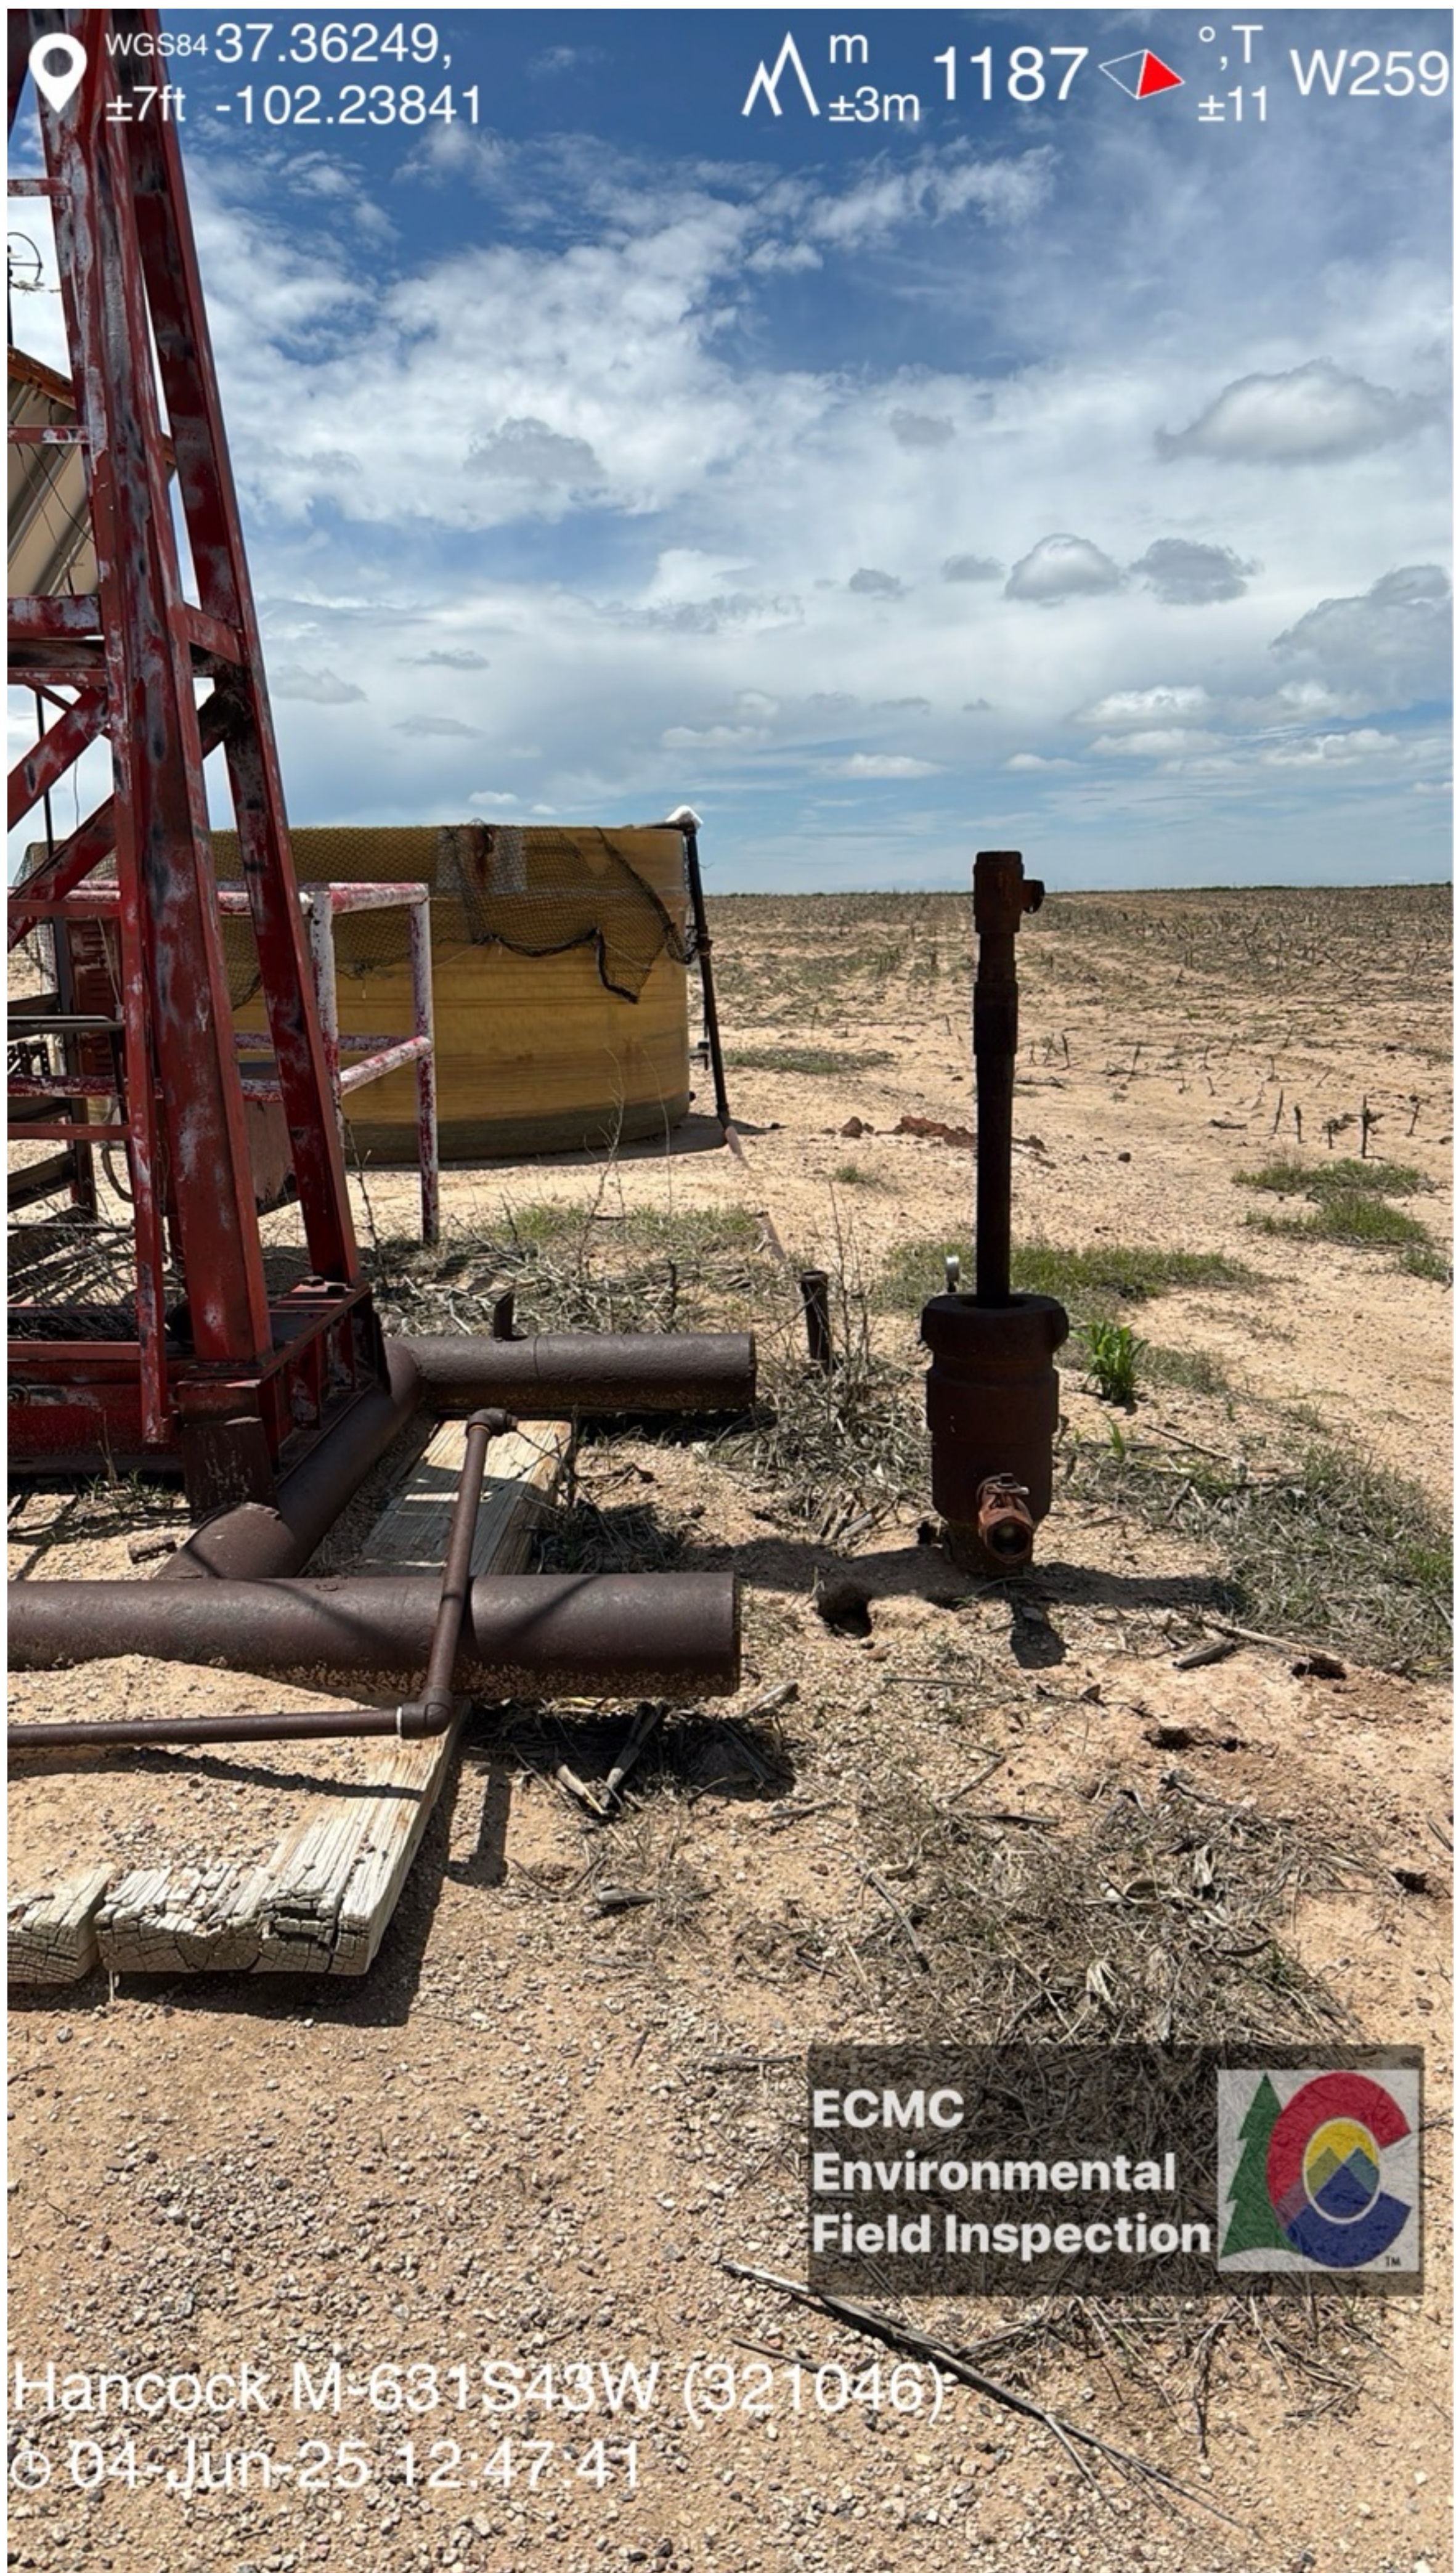
Weeds/debris observed next to welhead and cathodic rectifier.

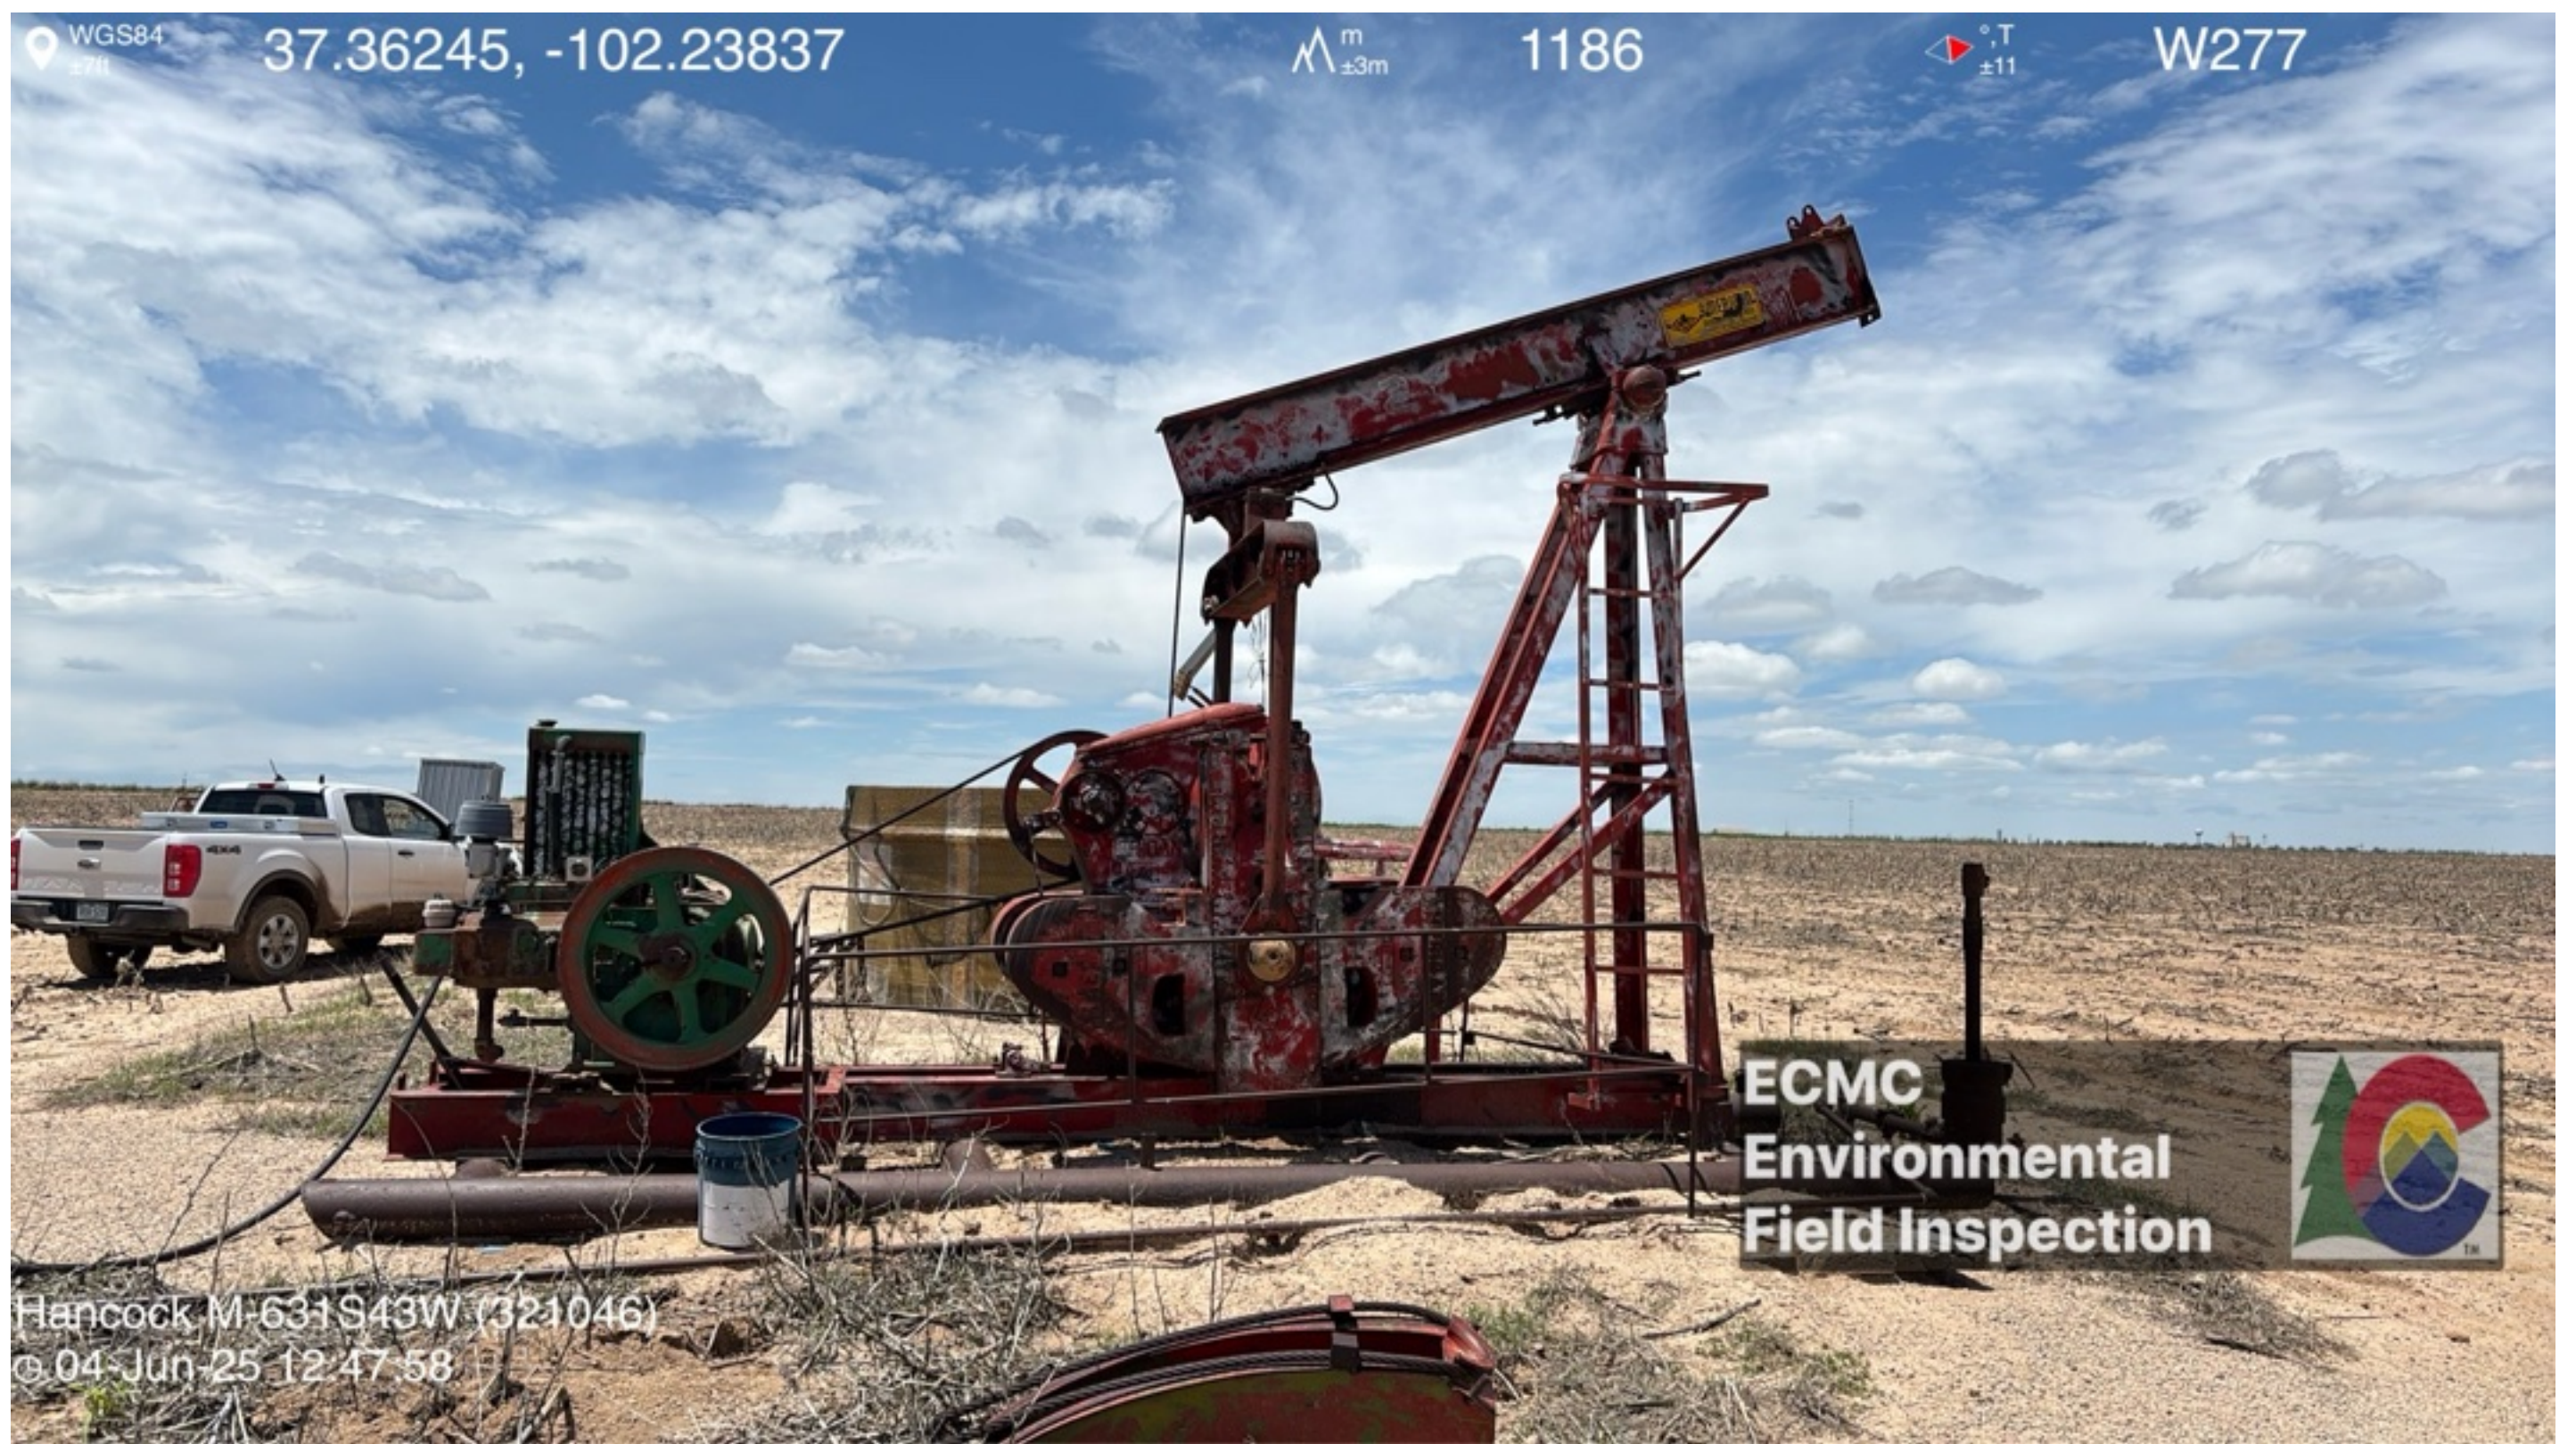
Weeds/debris observed next to welhead and cathodic rectifier.

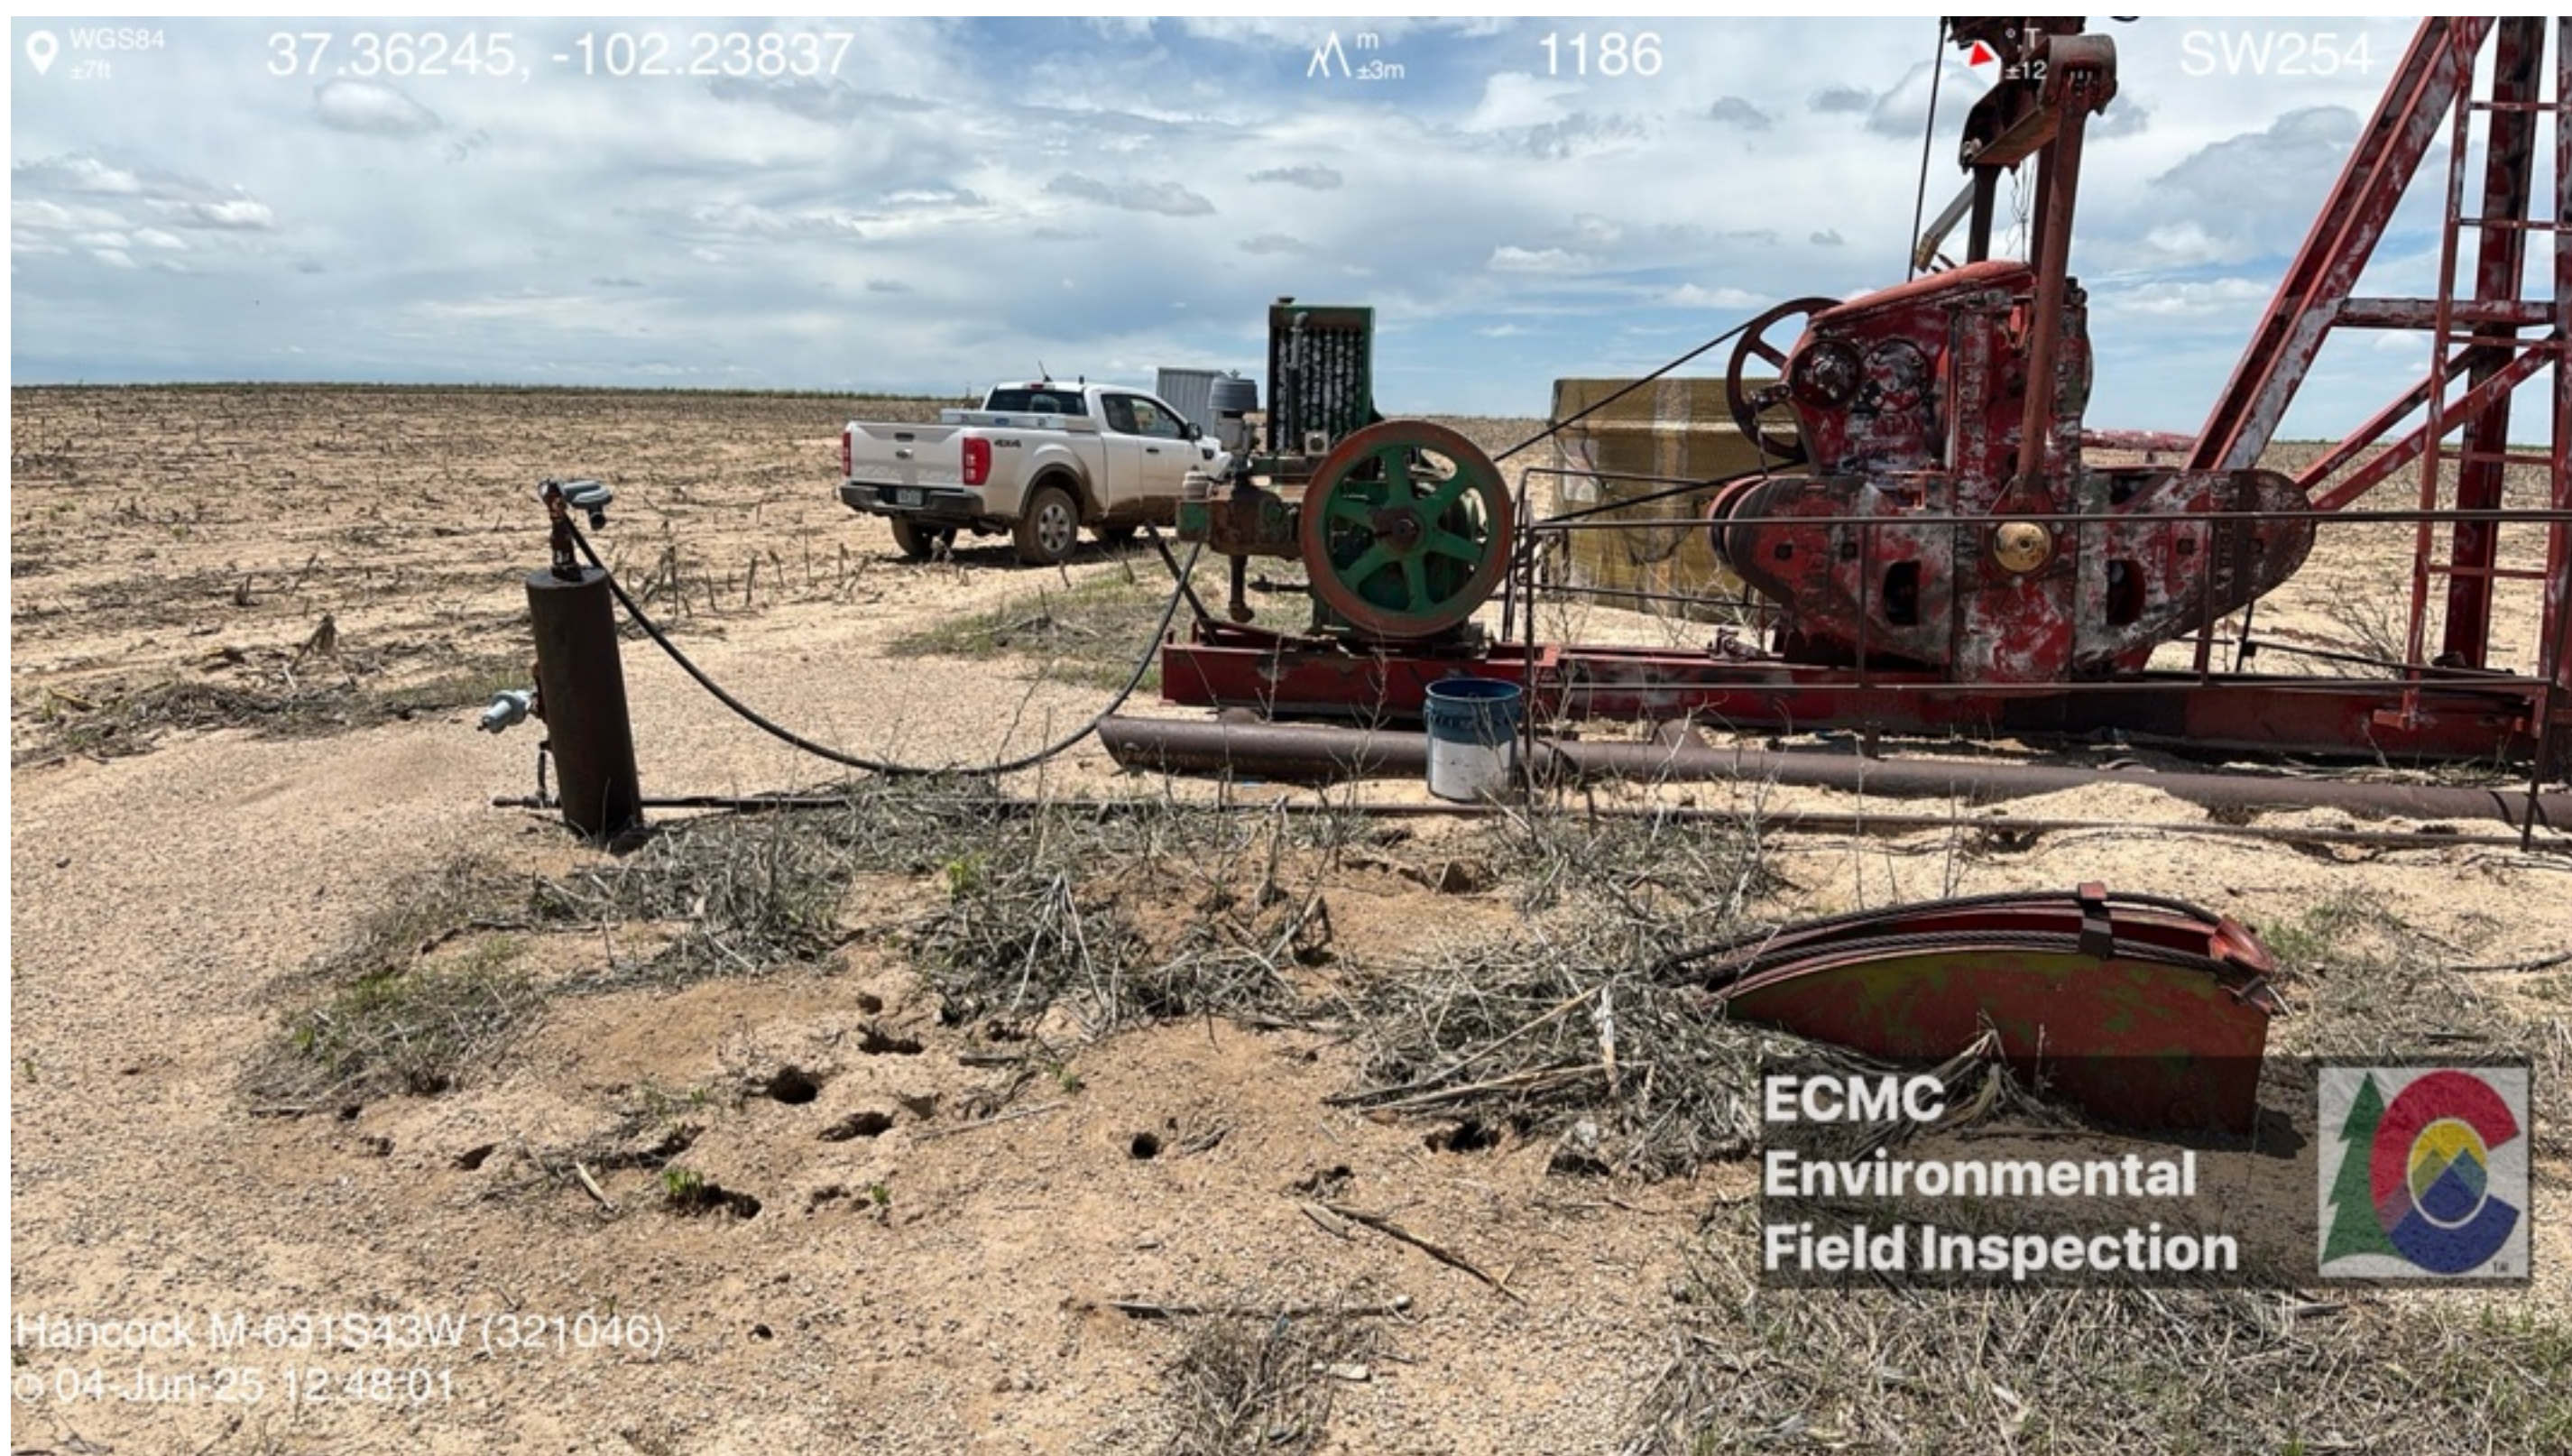
Weeds/debris/unused equipment observed next to welhead and cathodic rectifier.

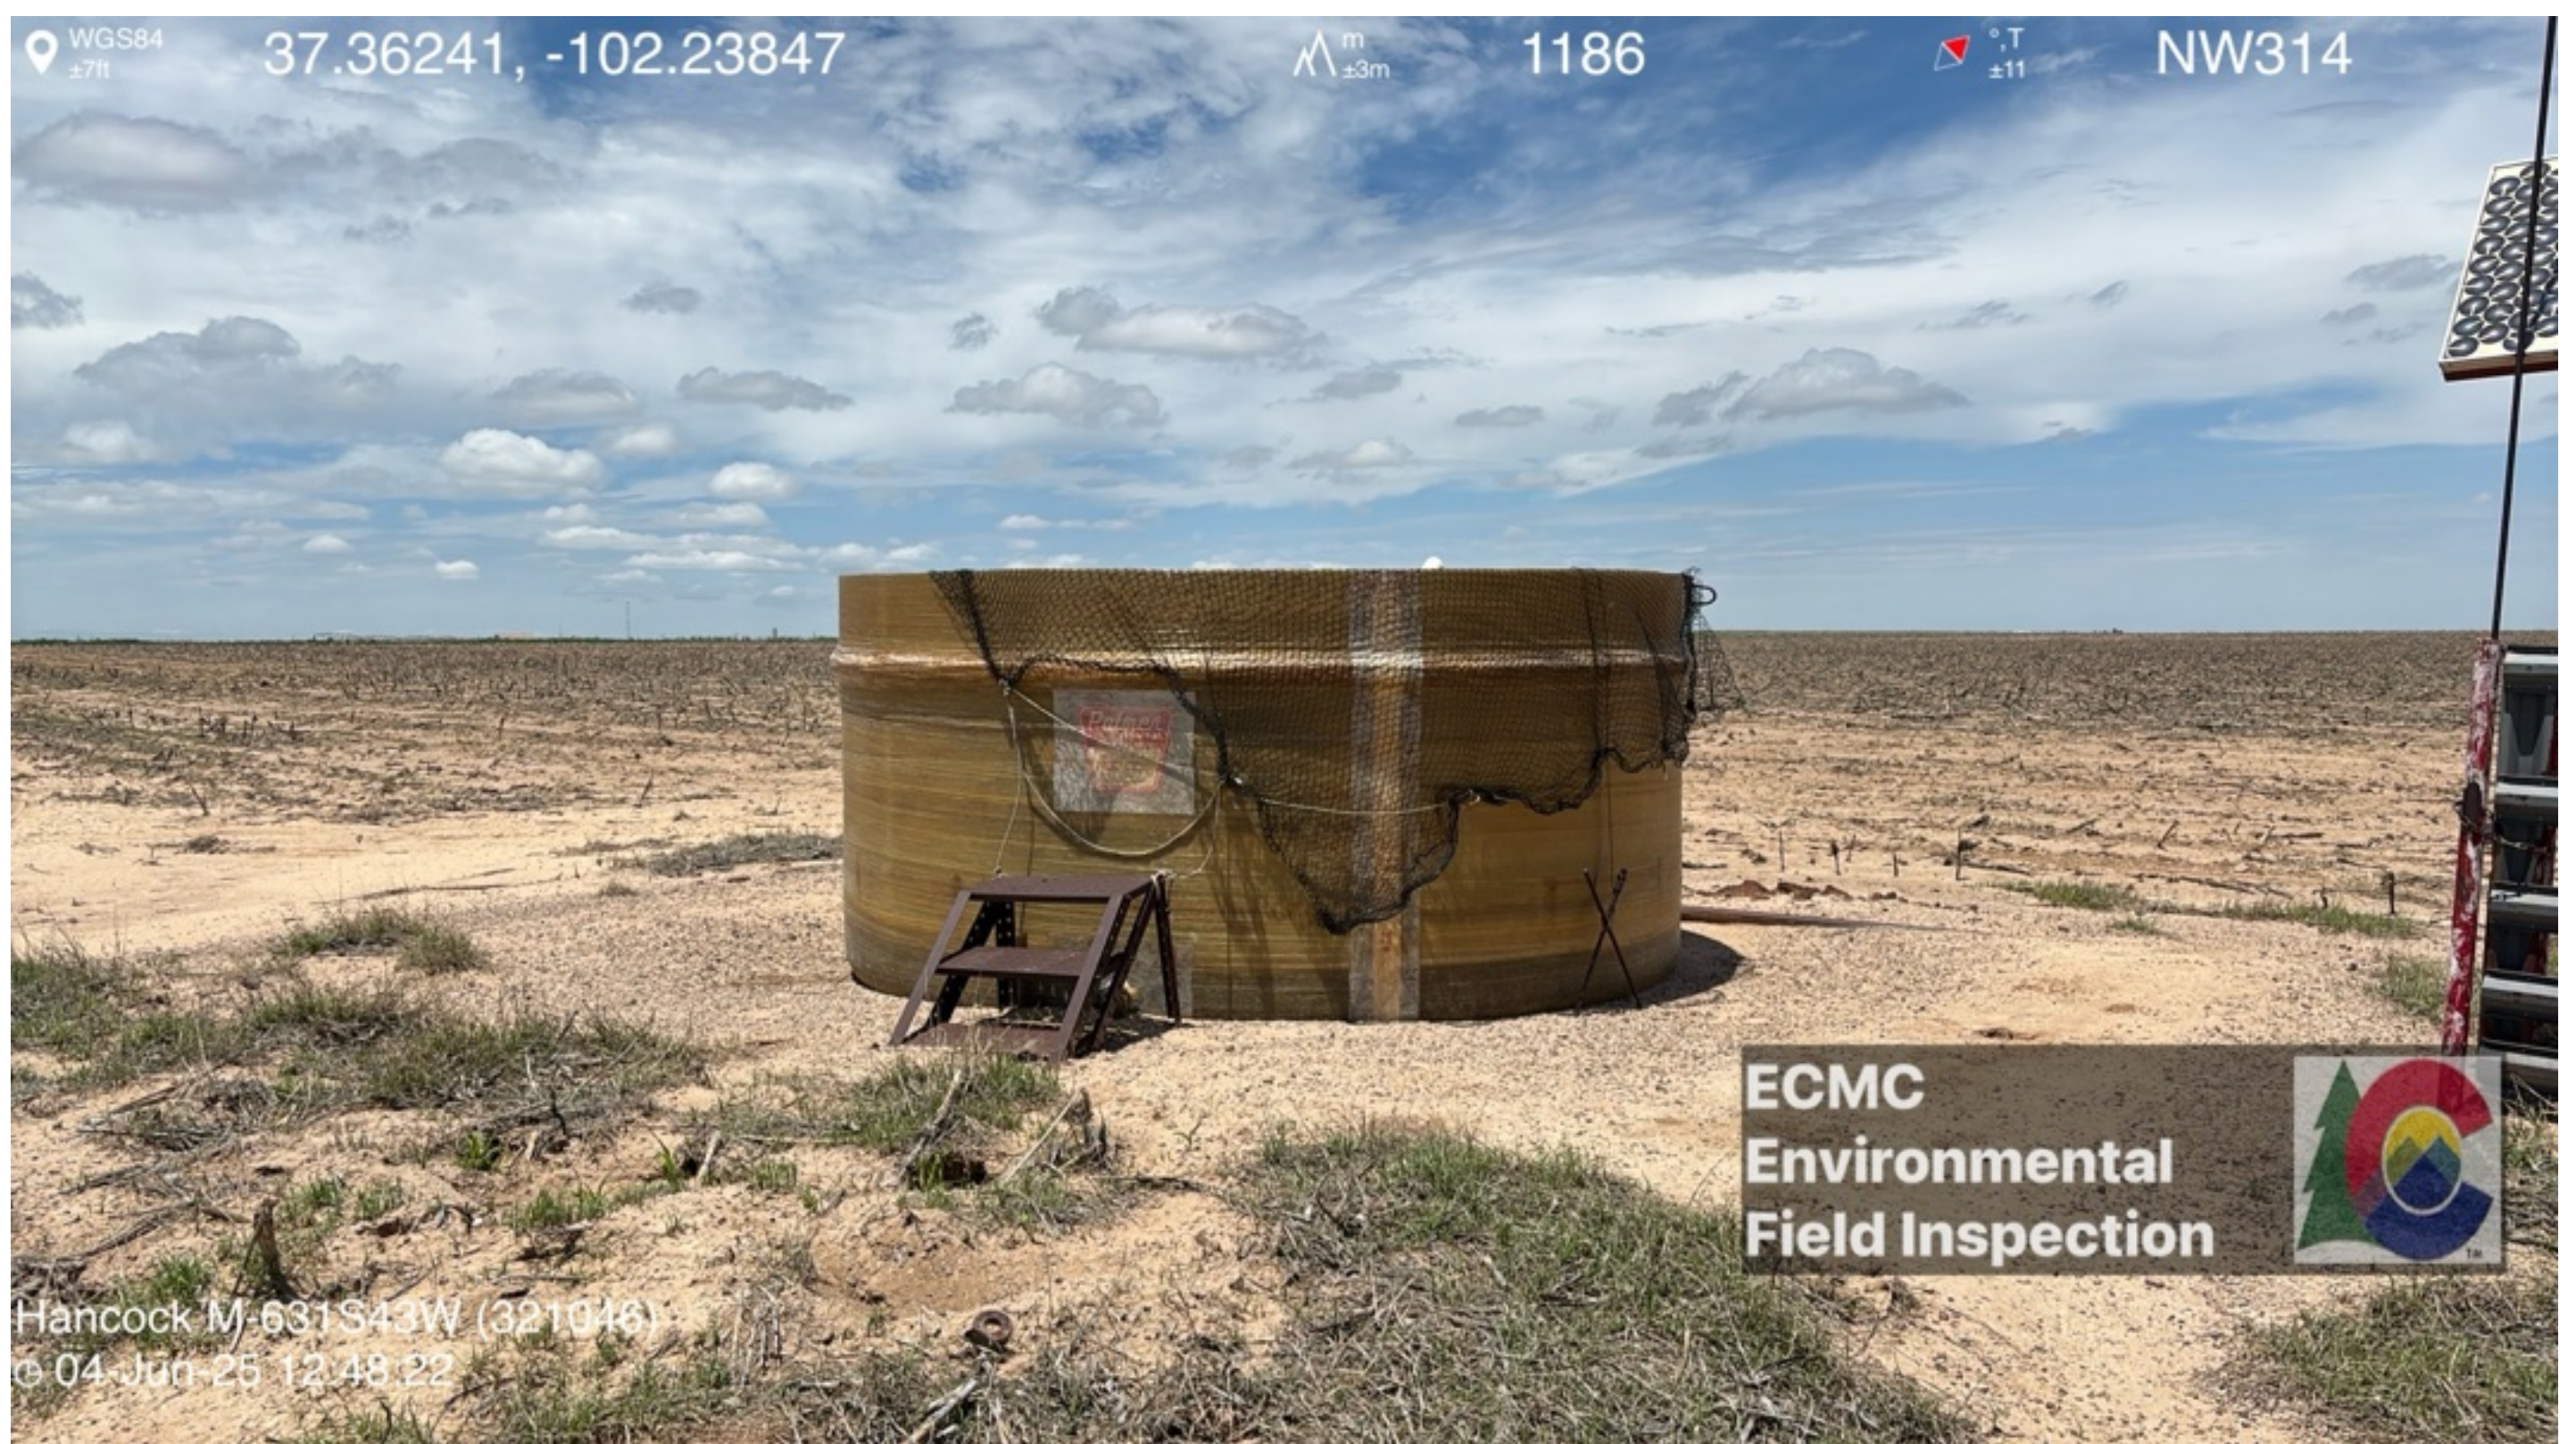
~100-bbl open top fiberglass produced water storage tank missing contents/volume labels and hazard/NFPA placards.  
Inadequate secondary containment.  
Weeds/debris  
Wildlife protection equipment (netting) has fallen and requires maintenance/repair.

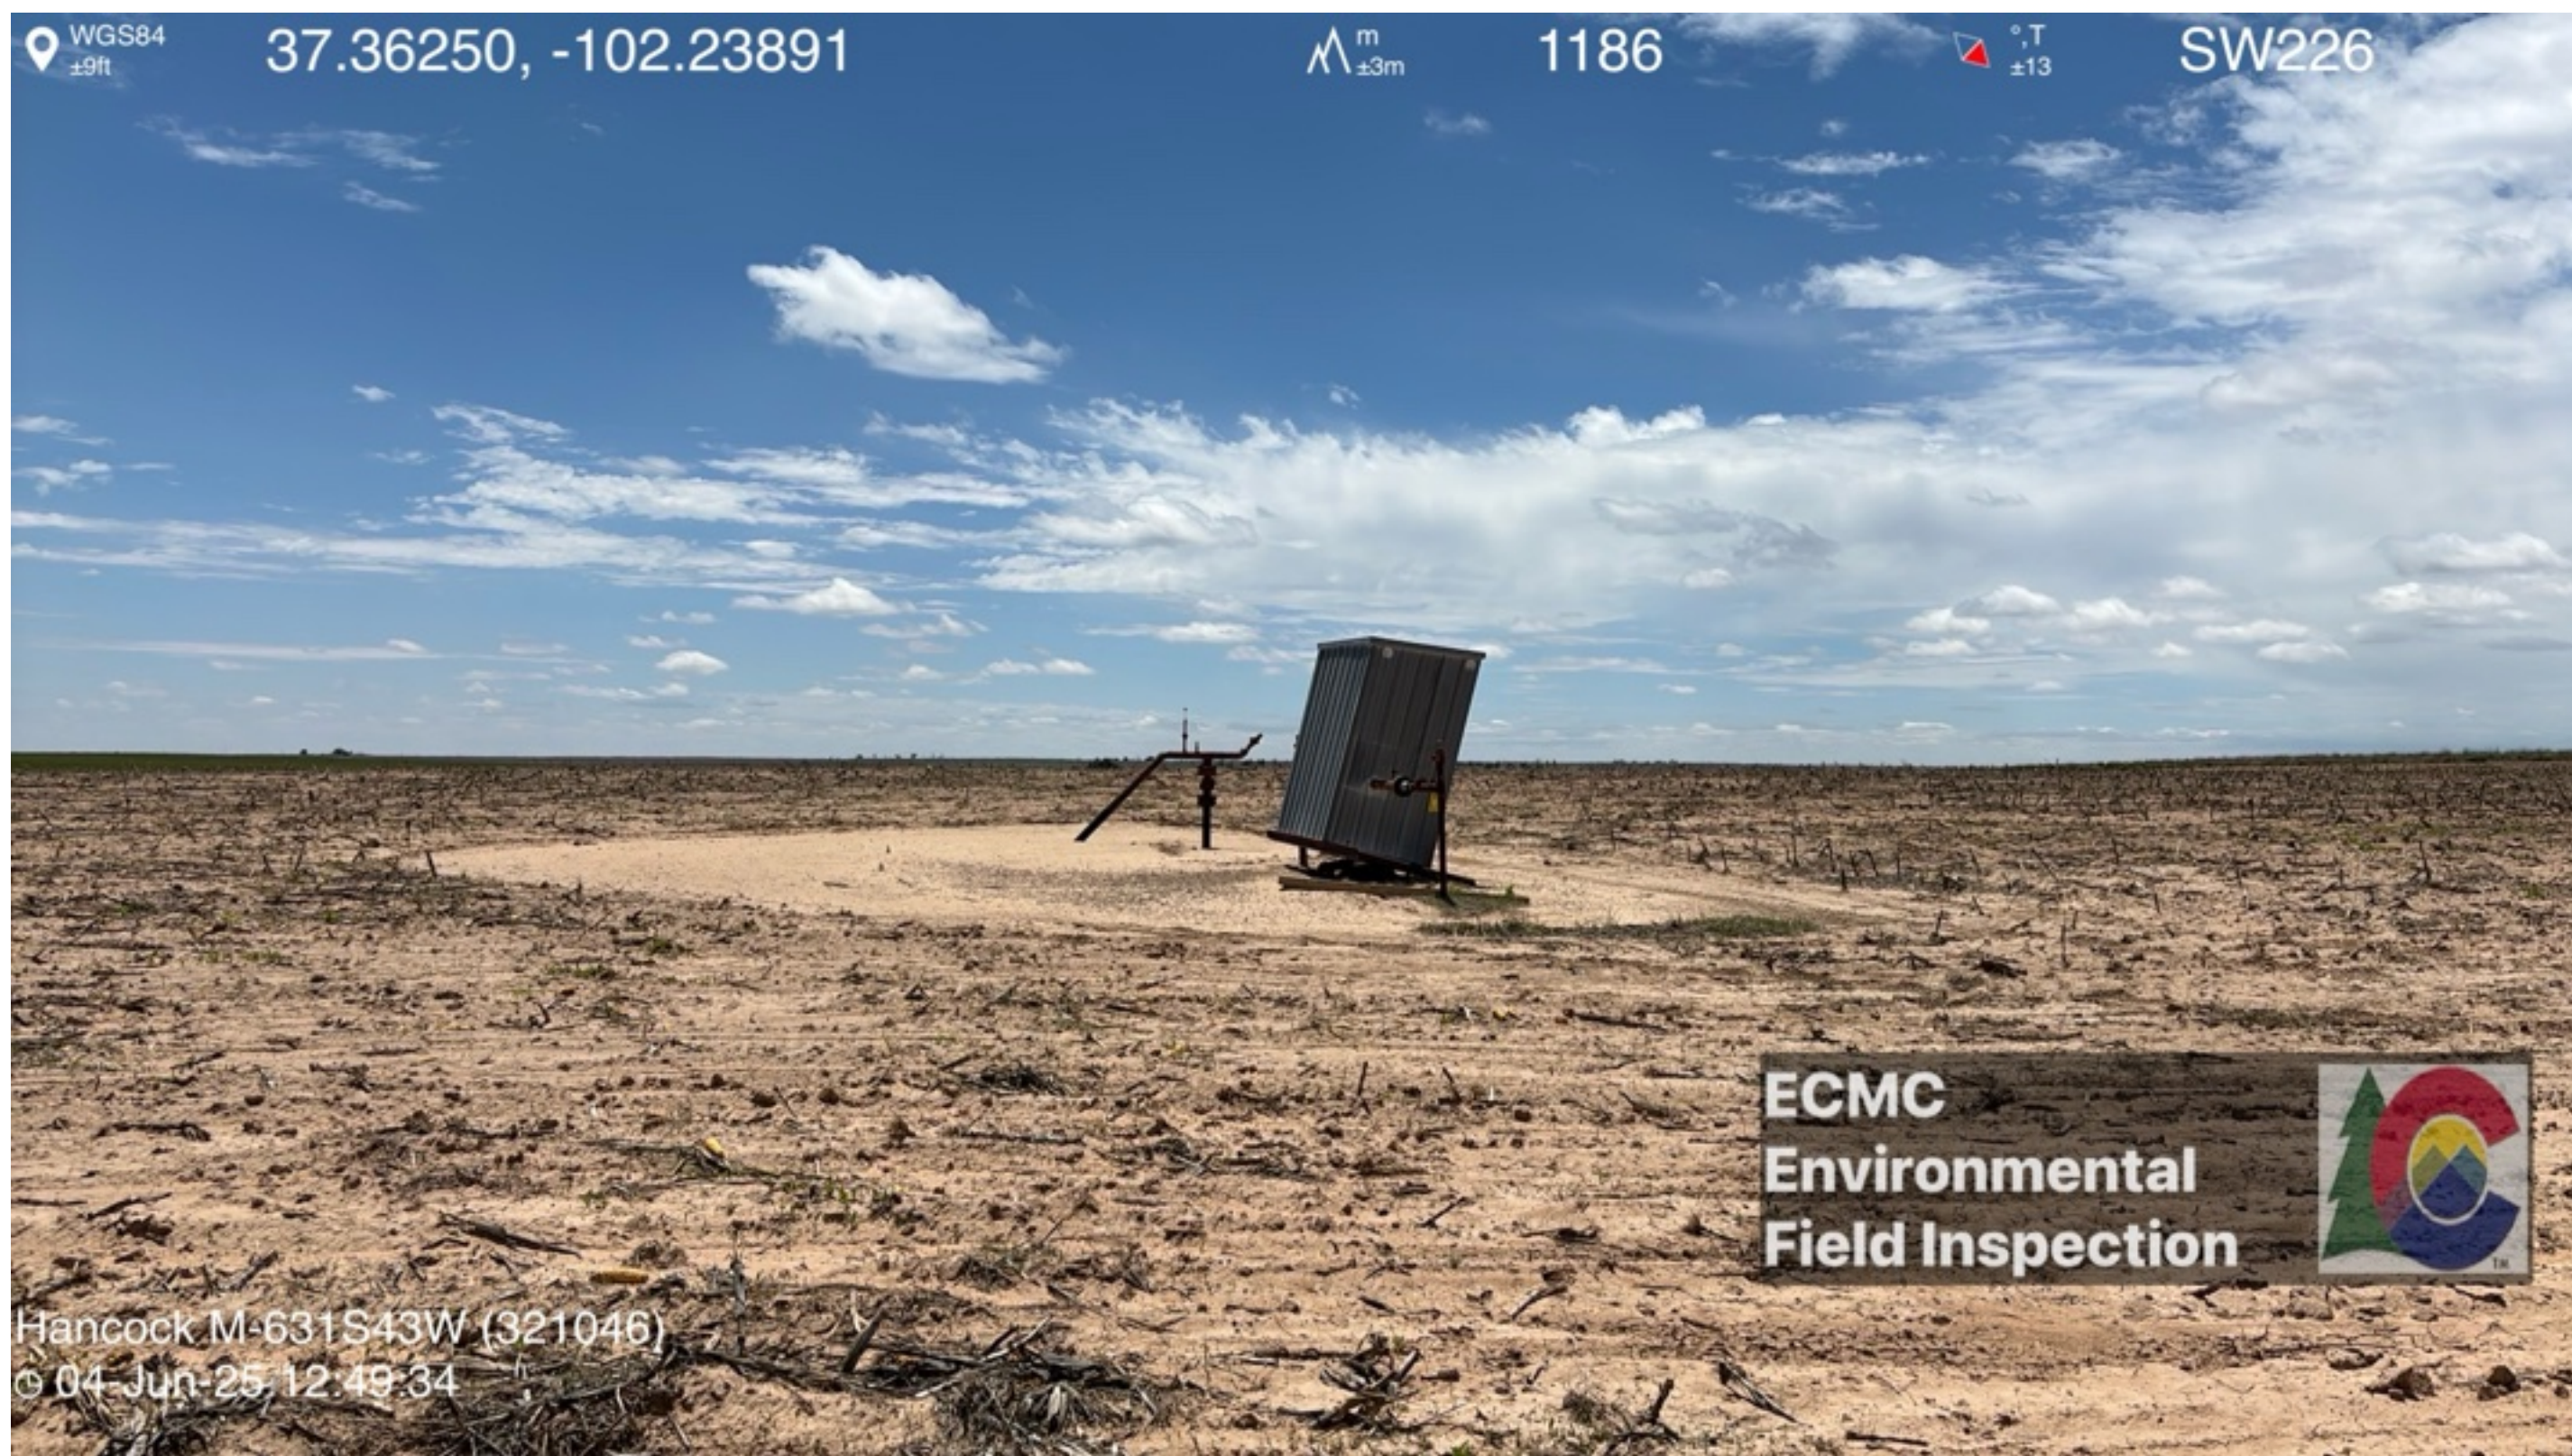
Meter shed is leaning and needs to be fixed.
