# Final Reclamation and Stormwater Inspection

Operator: ENERGY SEARCH CO ADBA ENERGY SEARCH CO  
INC - 27635

Well Name: GINTHER #2

Inspection Document #: 718600595

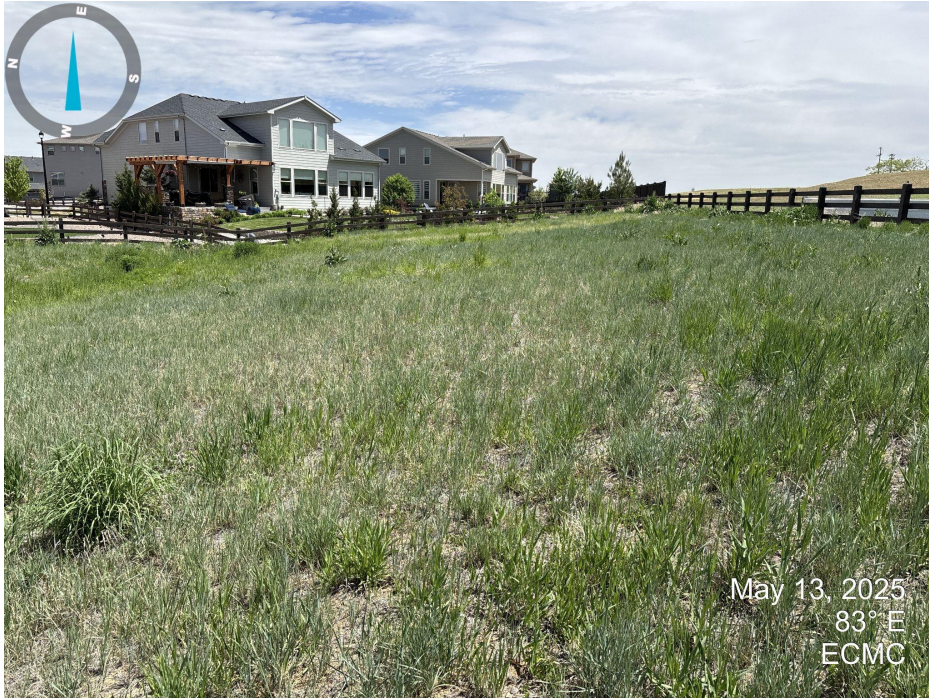
**Photo 1.** Looking east across the former well location. No oil and gas equipment remains on location. Location is now a drainage basin for housing development.

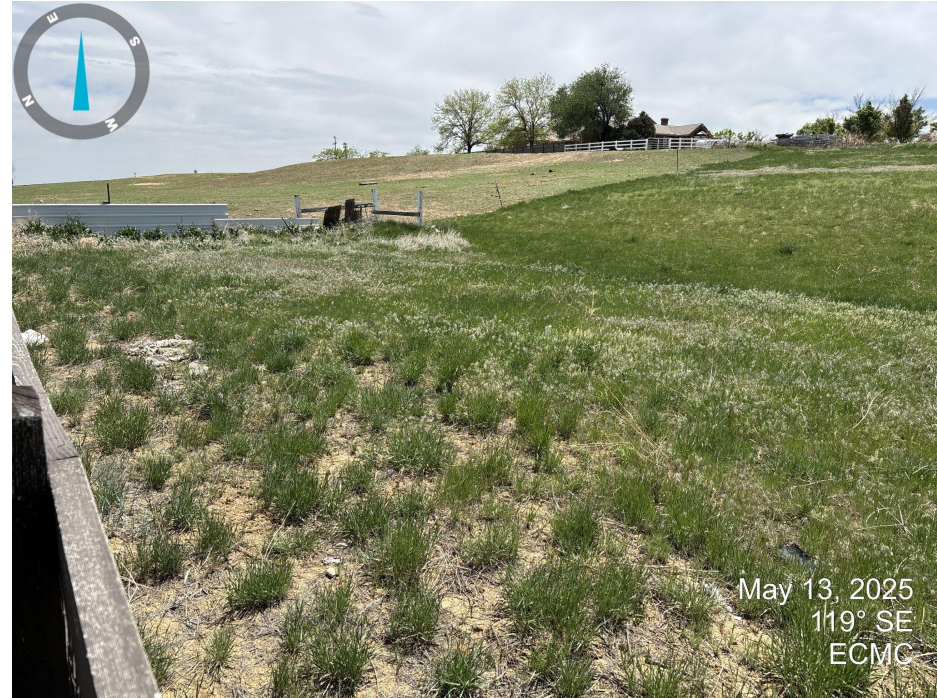
**Photo 2.** Looking at the southeast part of the well location from center. Vegetation coverage appears to be 80% of the reference vegetation.

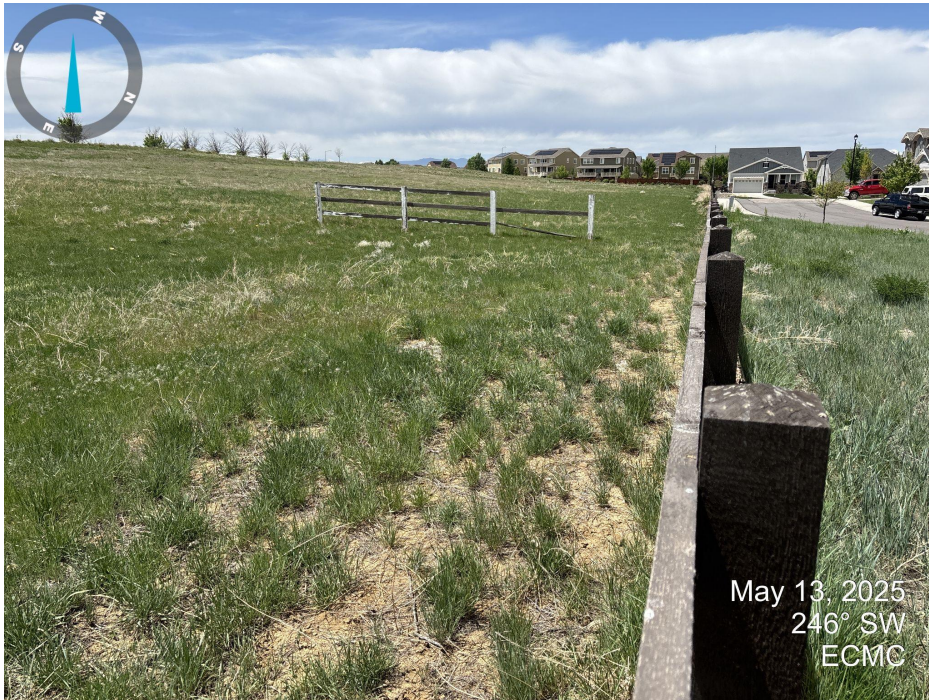
**Photo 3.** Looking southwest across the well location from center. See photo 2 comments.

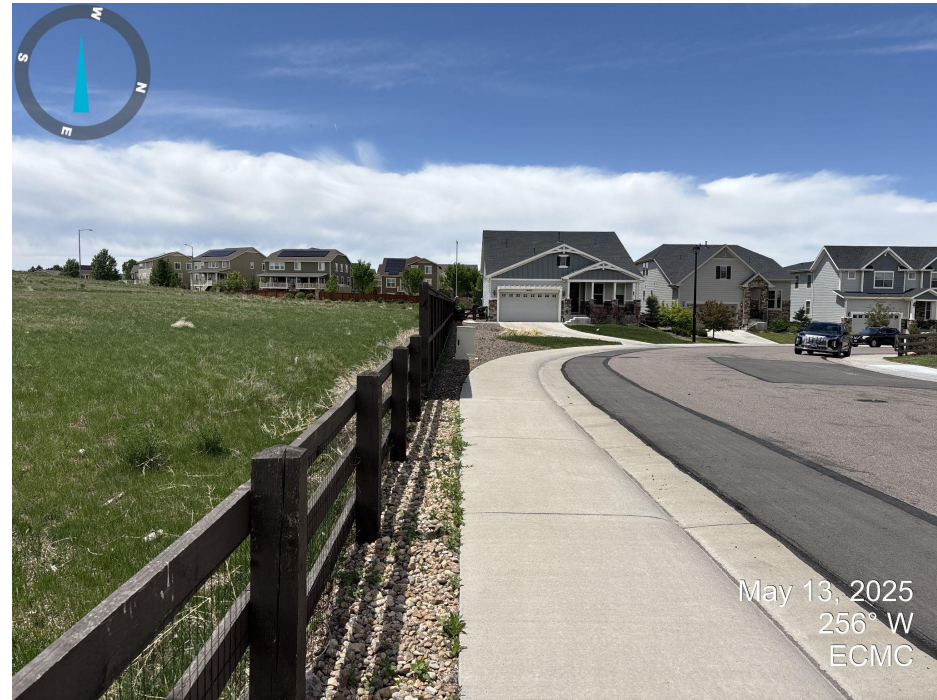
**Photo 4.** Looking west across the former tank battery. Tank battery now appears to be residential development. No oil and gas equipment remains.

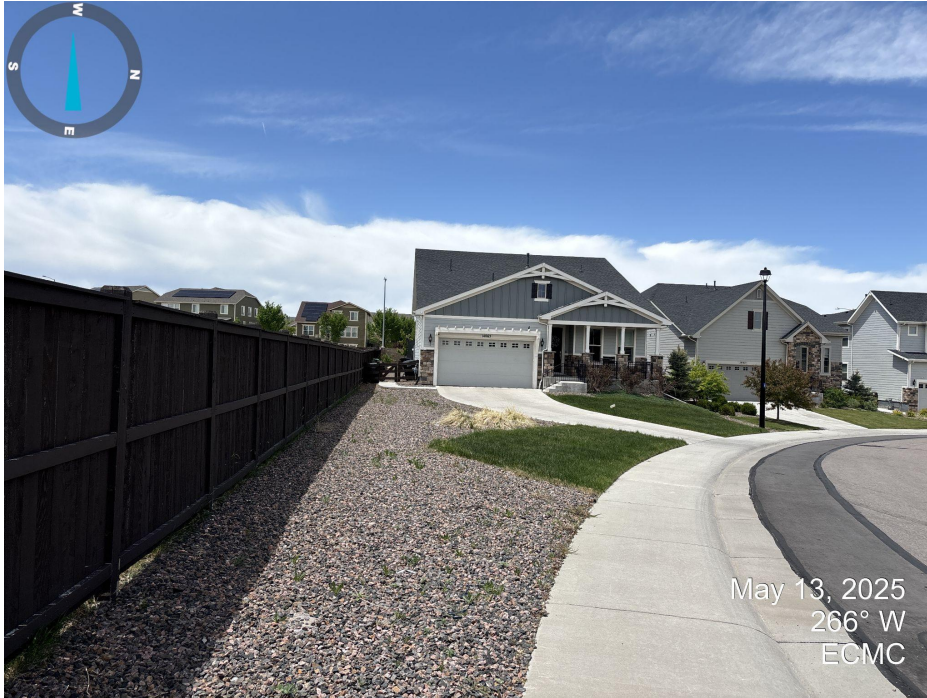
**Photo 5.** Looking west from the center of tank battery. See photo 4 comments.

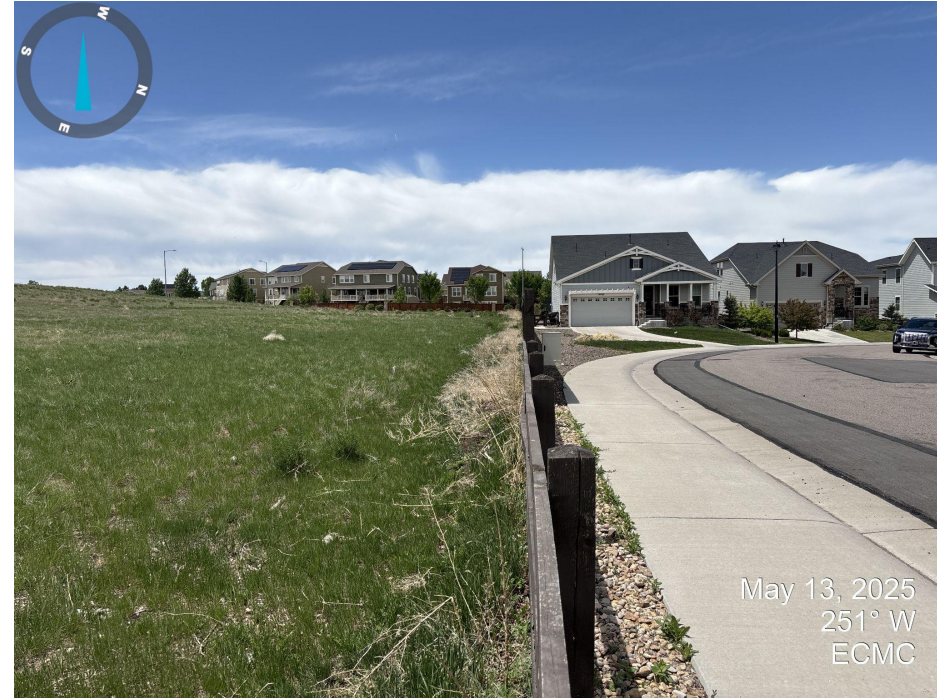
**Photo 6.** Looking west along the south side of the tank battery, on the south side of residential fence.

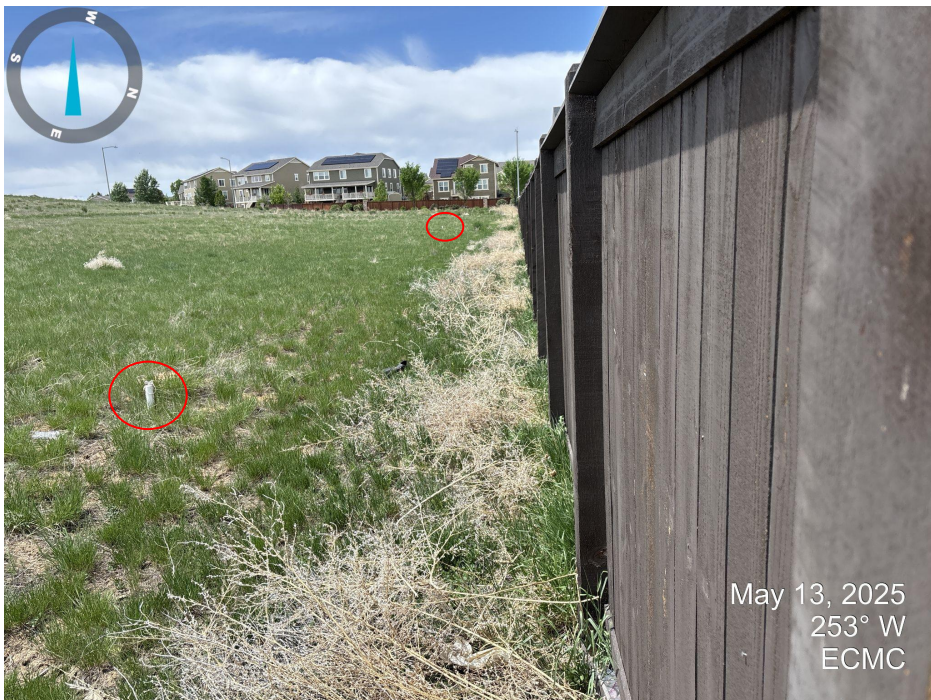
**Photo 7.** Two monitoring wells are present south of the fence (red circles). It does not appear these are associated with the remediation project.

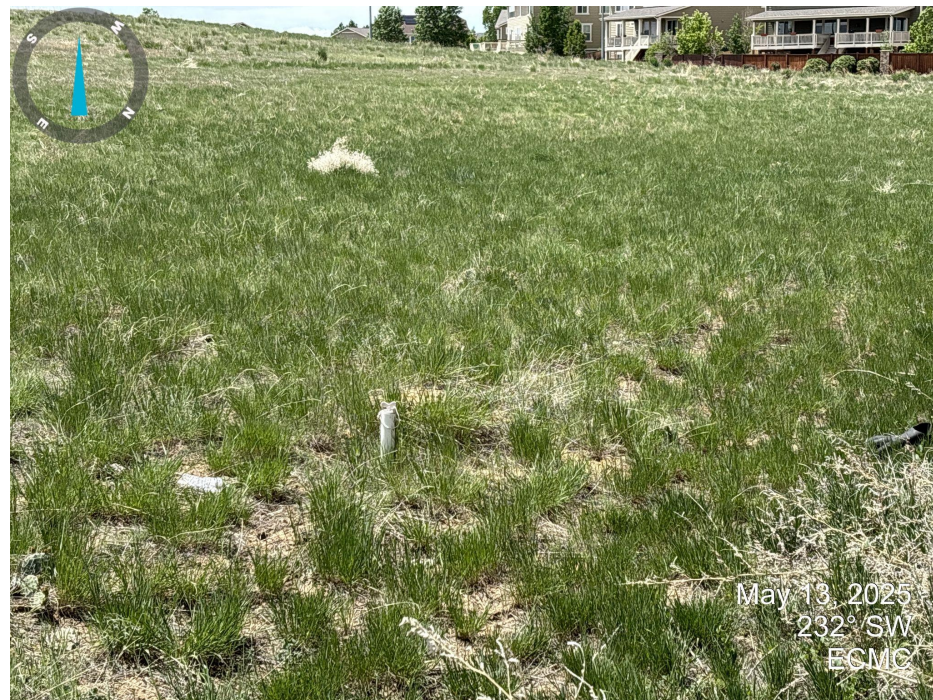
**Photo 8.** Monitoring well.

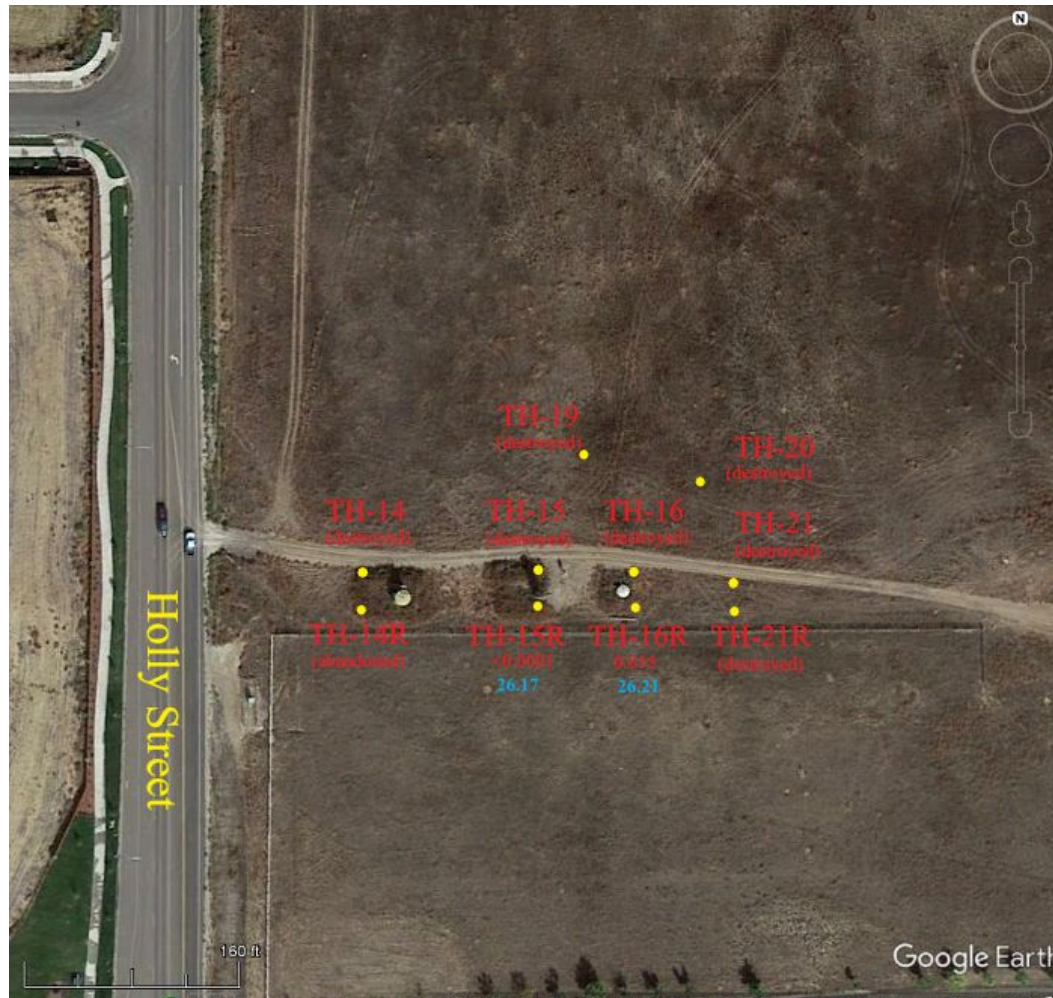
**Photo 9.** The last and most recent groundwater monitoring report (Doc 2528946) included this figure of monitoring wells associated with remediation project 10065

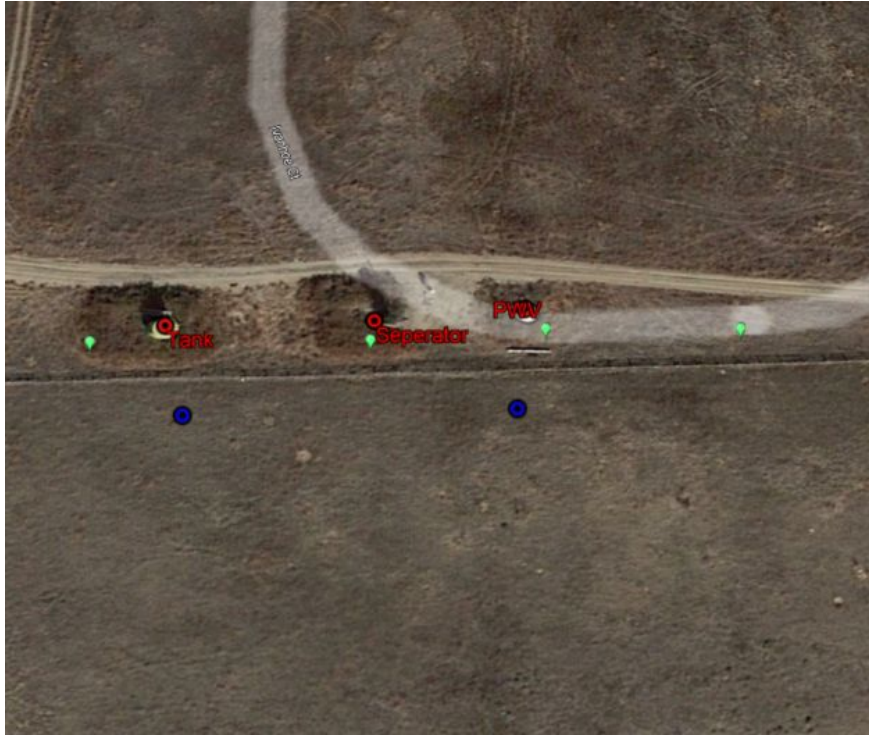
**Photo 10.** Google earth imagery taken 2015 showing tank battery equipment (red dot), approximate sampling well locations (green pins), approximate existing well locations (blue dots).

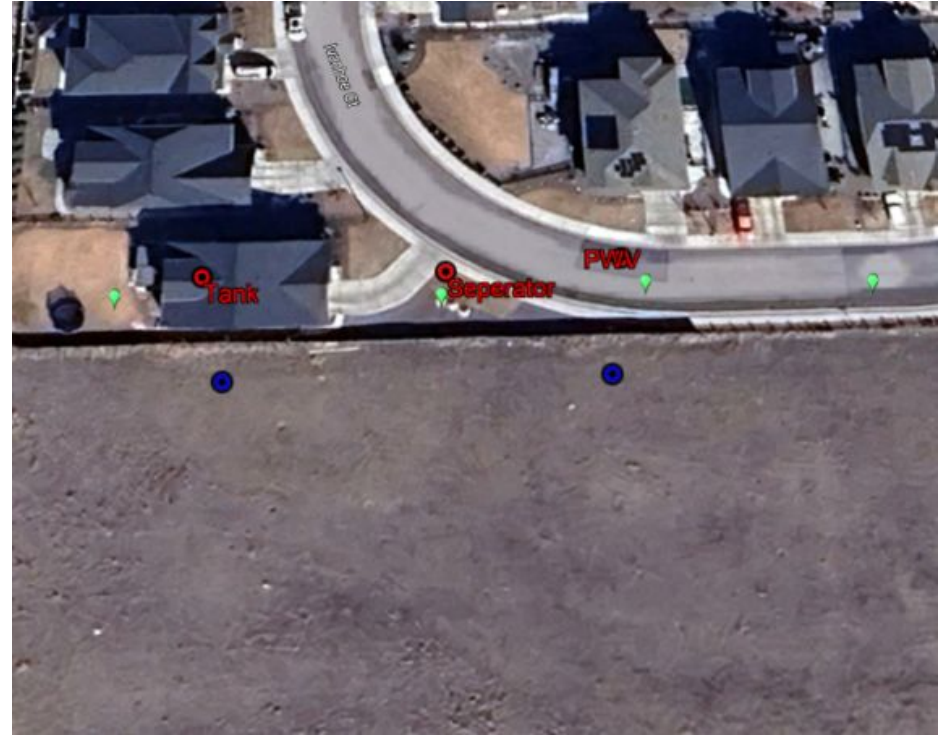
**Photo 11.** Google earth aerial imagery with the same markers as photo 10. It does not appear that the existing monitoring wells are associated with the remediation project.
