NININGER 11-1-1645

Photo Log

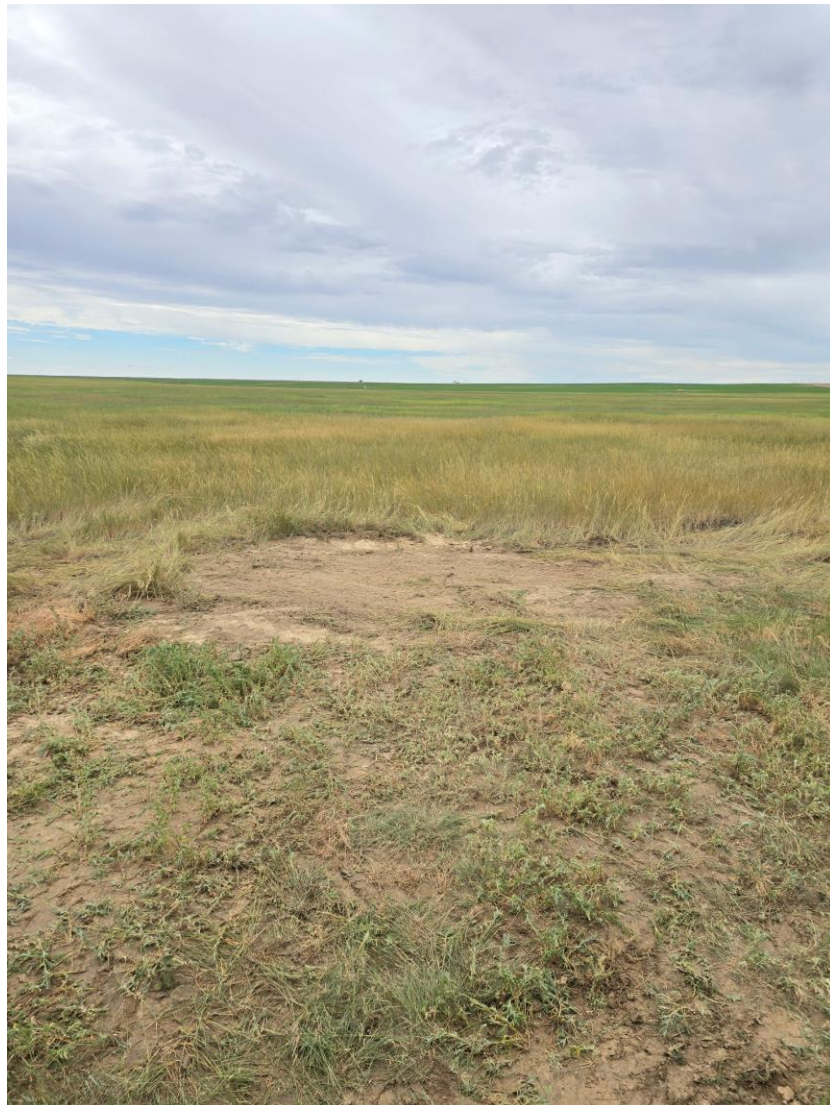
Inspection Comment: No fencing was visible surrounding the excavation southeast of the former wellhead.

Corrective Action Requested: Secure access to excavation in accordance with Rule 913.b.(5).B.i and ECMC Guidance 913.b.(5)B i-v.

Description of Compliance: Excavation area secured with fencing per Rule 913.b.(5)

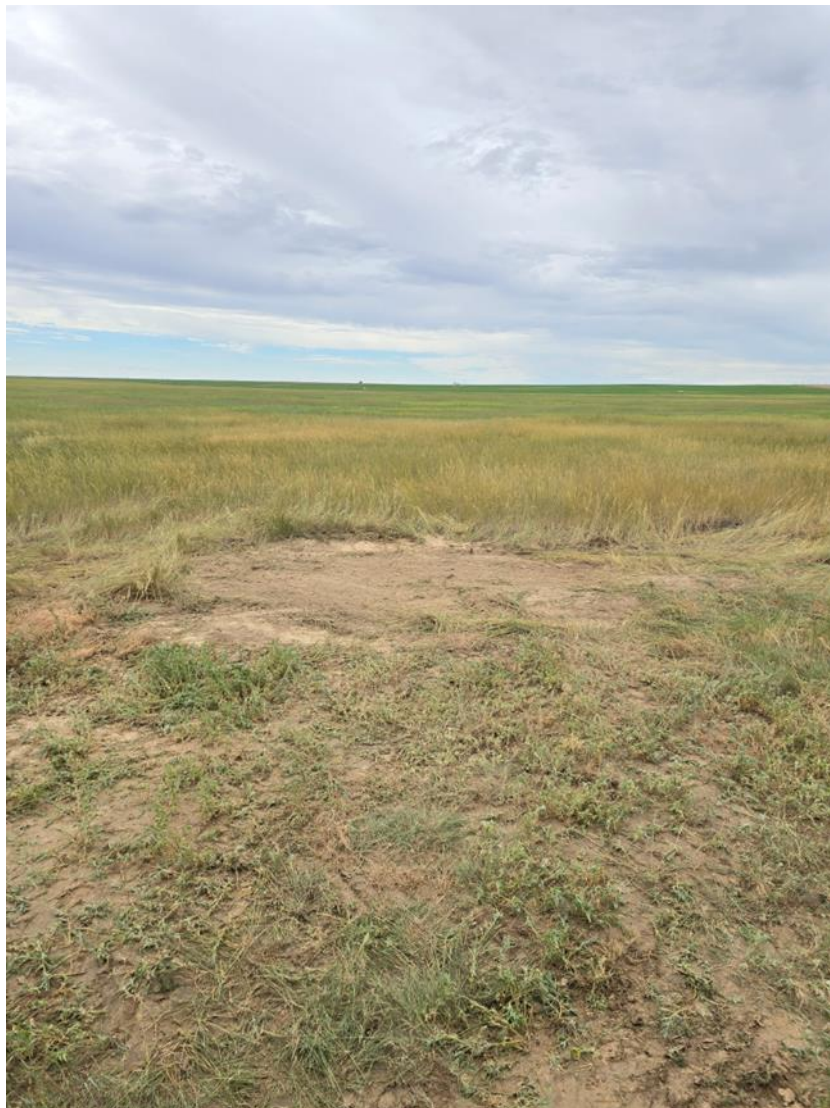
Inspection Comment: An unmarked soil stockpile was visible next to a small excavation southeast of the former wellhead. No stormwater BMPs or liner was visible at the stockpile.

Corrective Action Requested: Operator shall comply with Rule 913.b.(5).B.iv. and properly store, handle, and manage all E&P Waste to prevent contamination of stormwater, surface water, Groundwater, and soil.
