Harker Ranch Morrow Unit (HRMU 7)

Well & Location

Photo Log

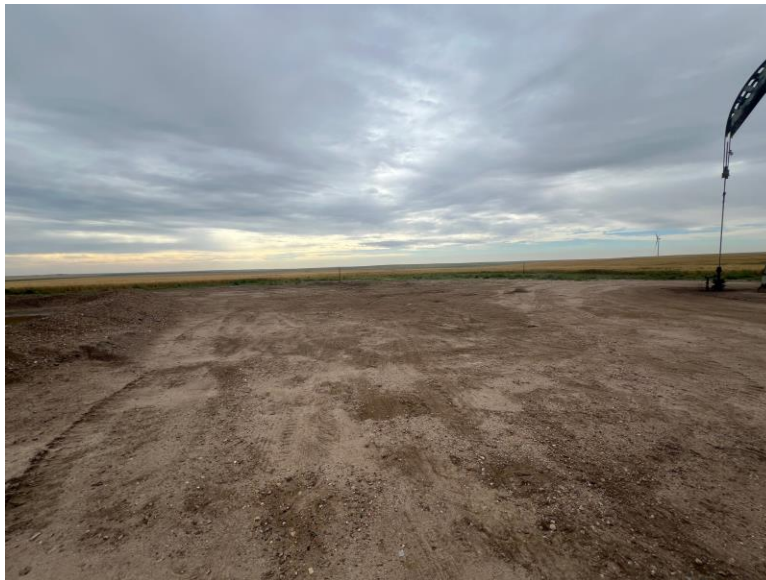
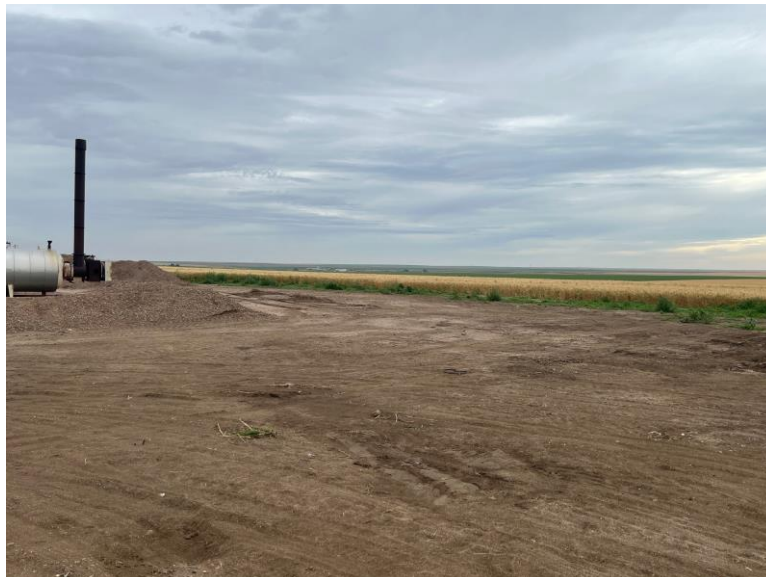
Inspection Comment: There is unused equipment stored at the east side of the location which must be removed.

Corrective Action Requested: Comply with Rule 606

Description of Compliance: All unused equipment has been removed from location.
