# Inspection Photos

API: 071-07204

Operator: OGRIS OPERATING LLC

Inspection Date: 6/30/2025

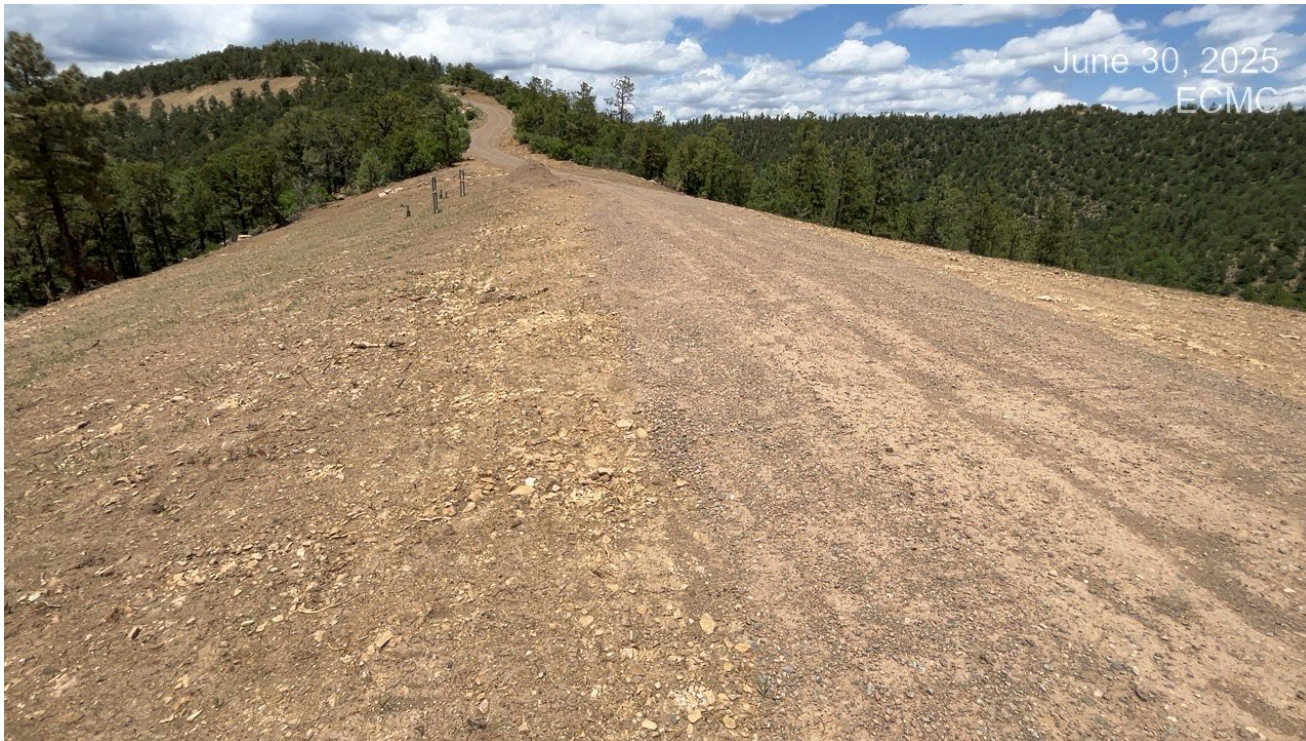
**Photo 1.** Facing northwest at the location which has been recontoured and reclaimed.

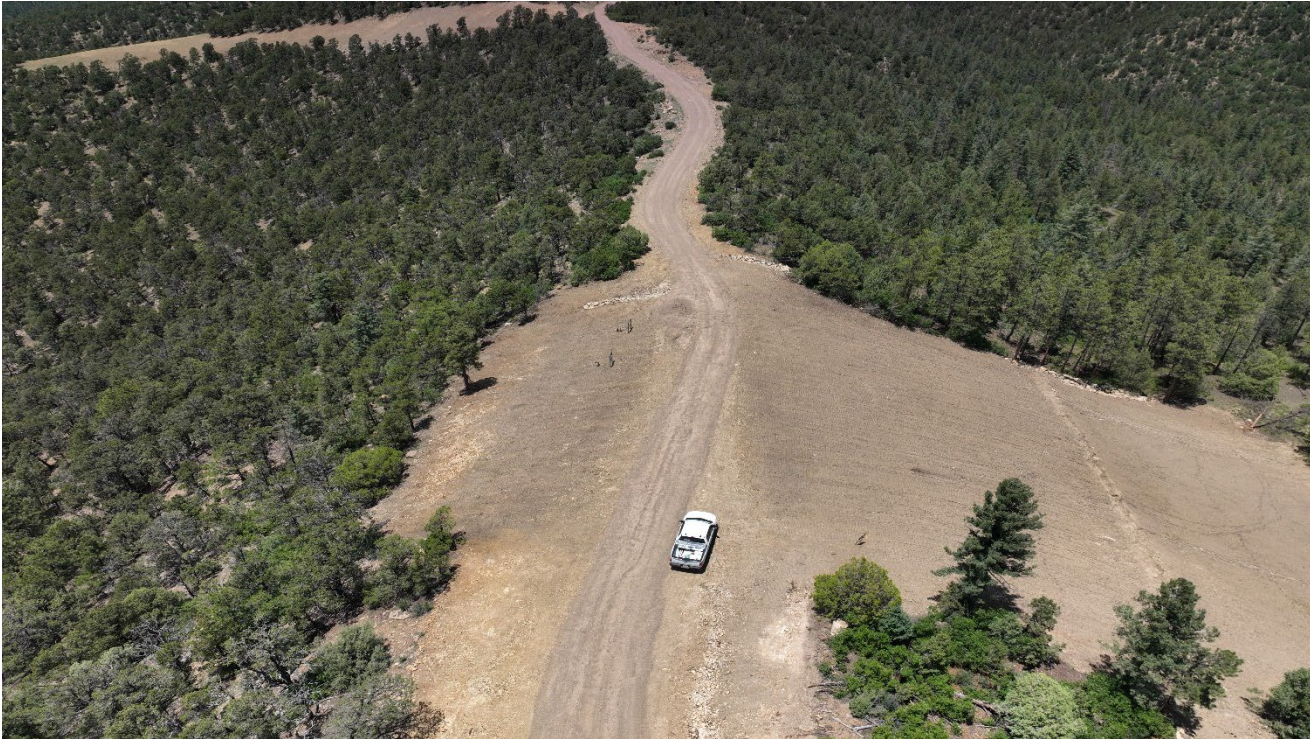
**Photo 2.** Drone aerial photo facing northwest toward the reclaimed location.

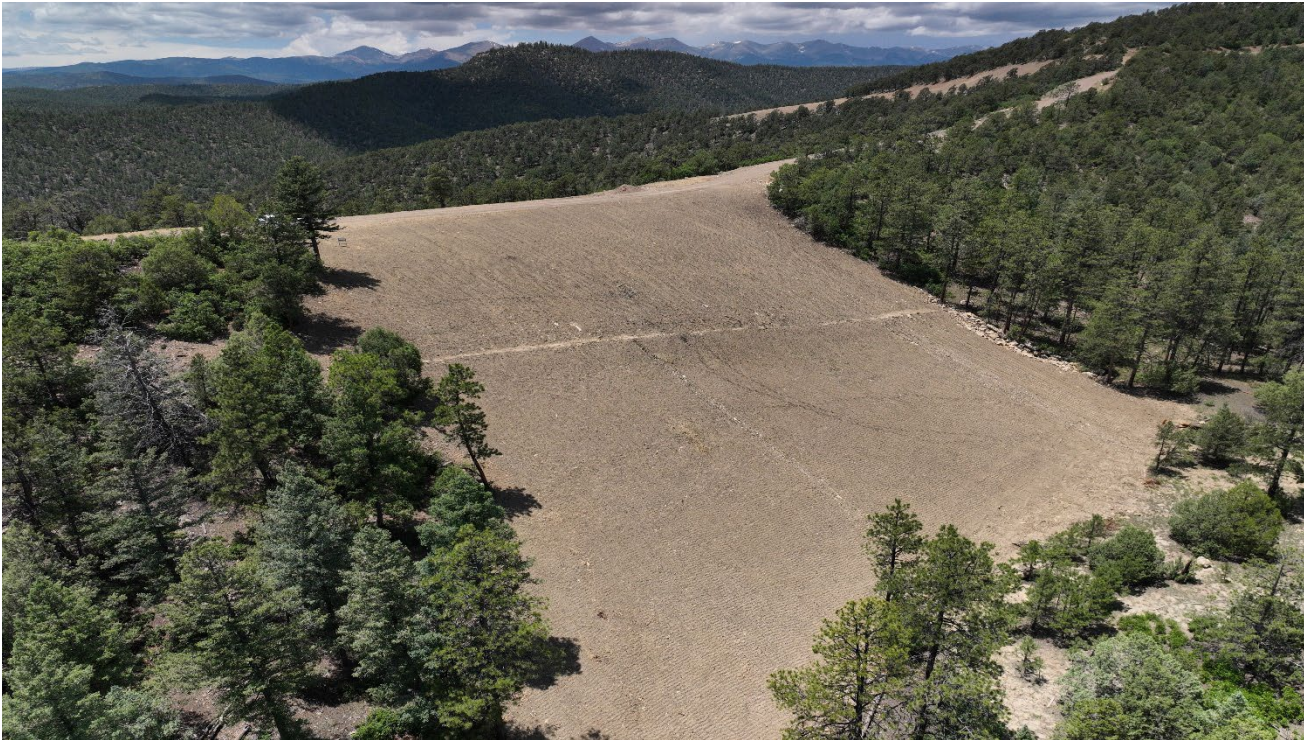
**Photo 3.** Drone aerial photo facing west toward the location.

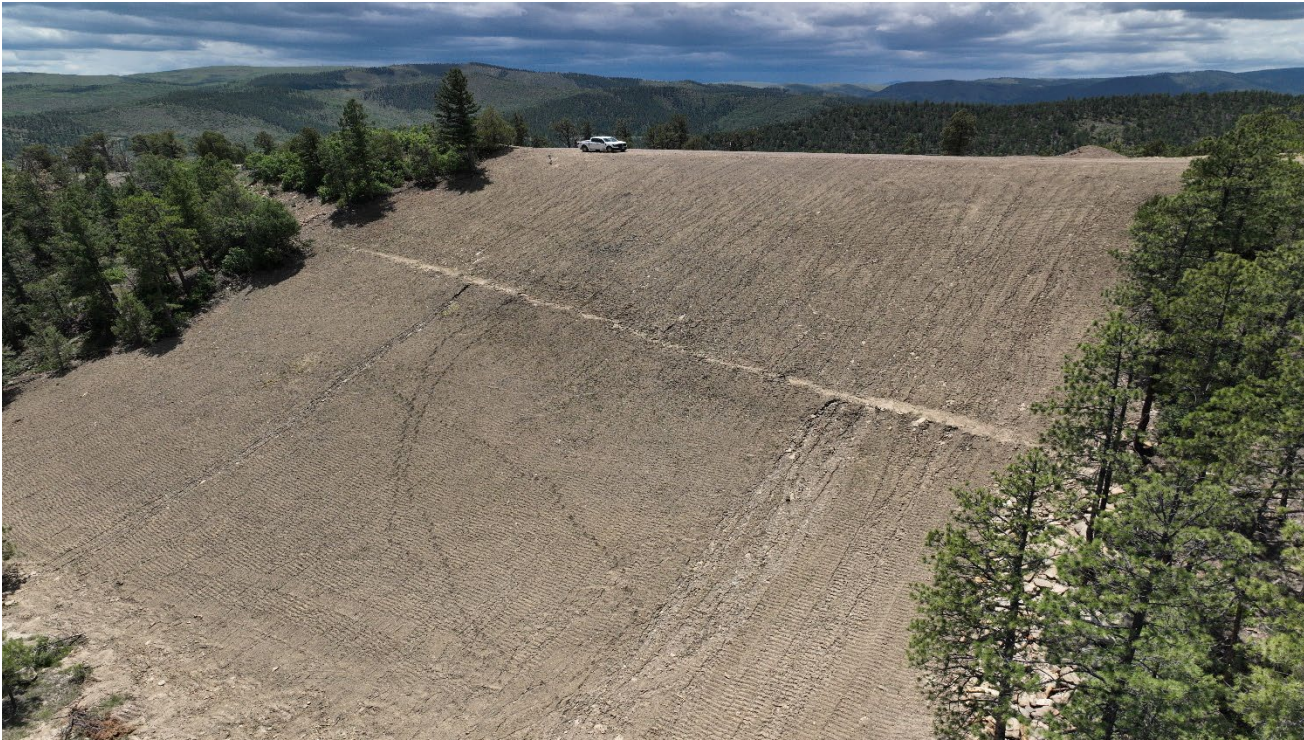
**Photo 4.** Facing southwest. There is erosion beginning to occur. Additional BMP's such as wattles may be needed on the steep areas of the slope.

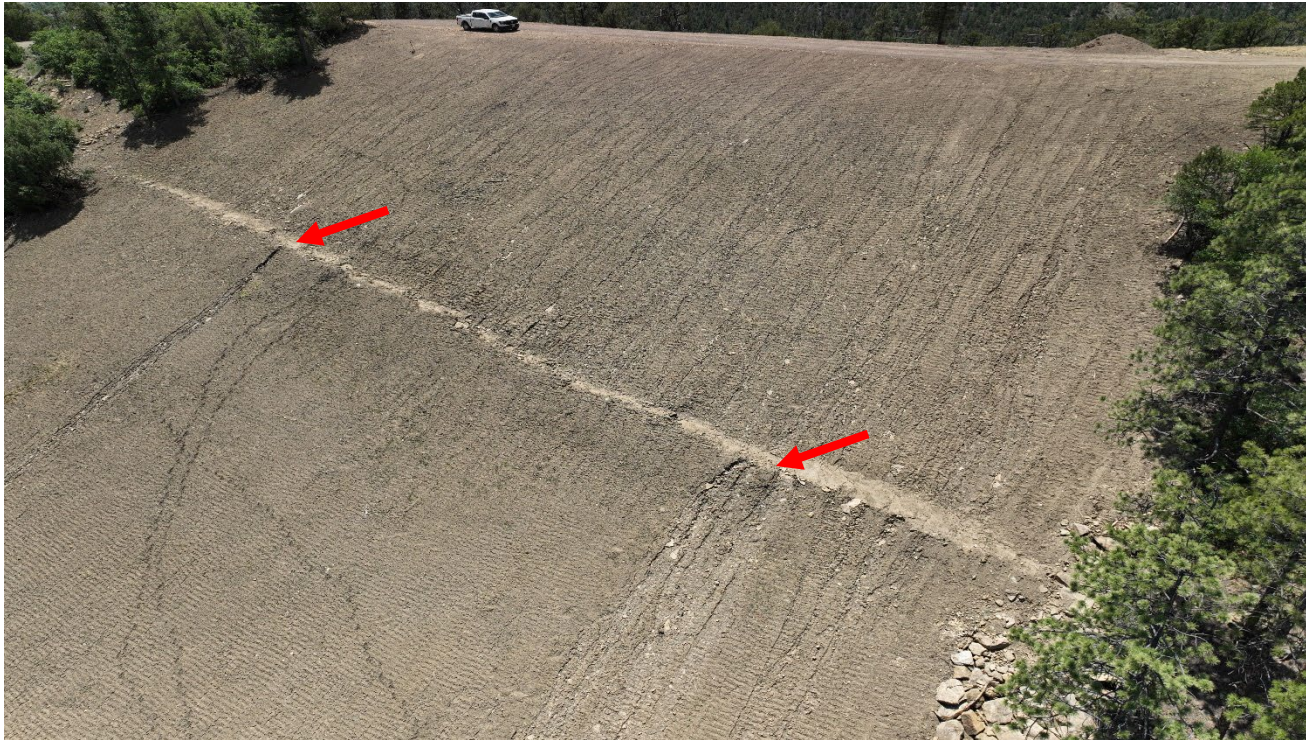
**Photo 5.** Facing toward the slope and diversion ditch. Stormwater is overtopping the ditch at red arrows. Maintenance will be needed.

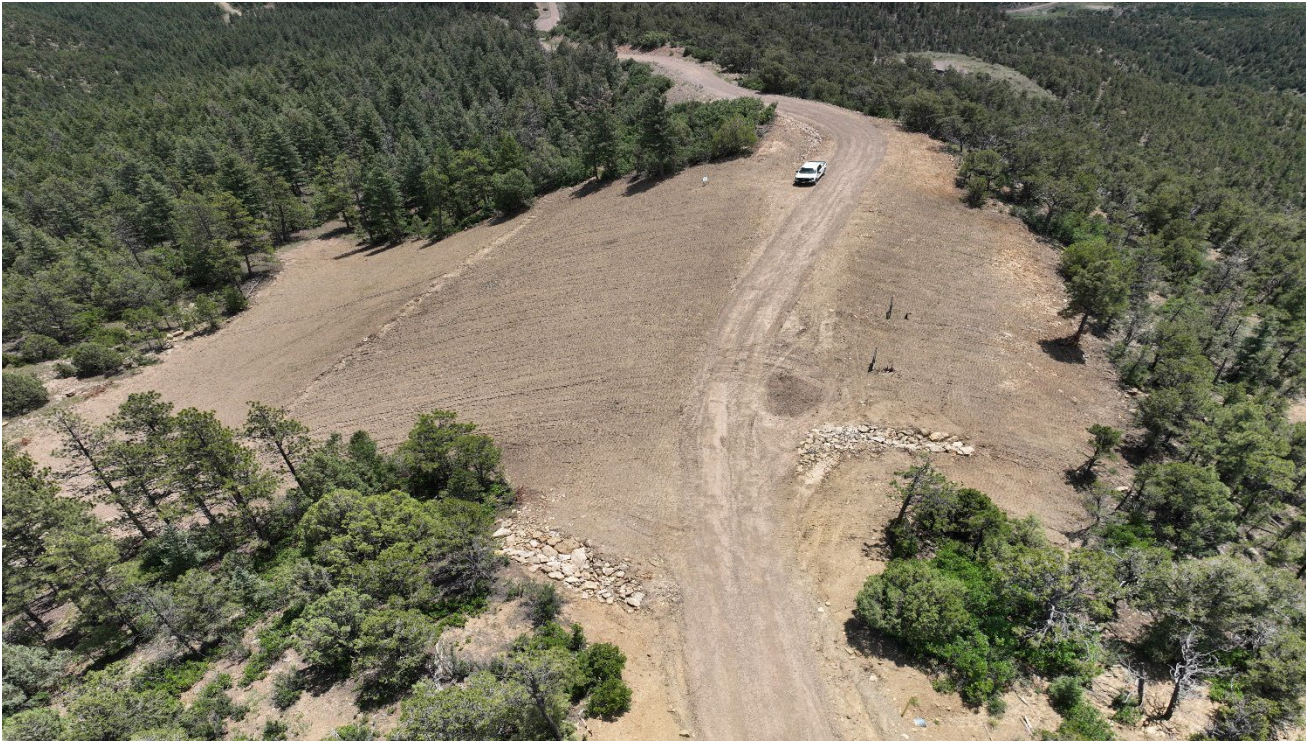
**Photo 6.** Drone aerial photo facing southeast toward the reclaimed location.
