WELL NAME: ULIBARRI 32-6 R, API #: 071-09006, INSP. # 716301186

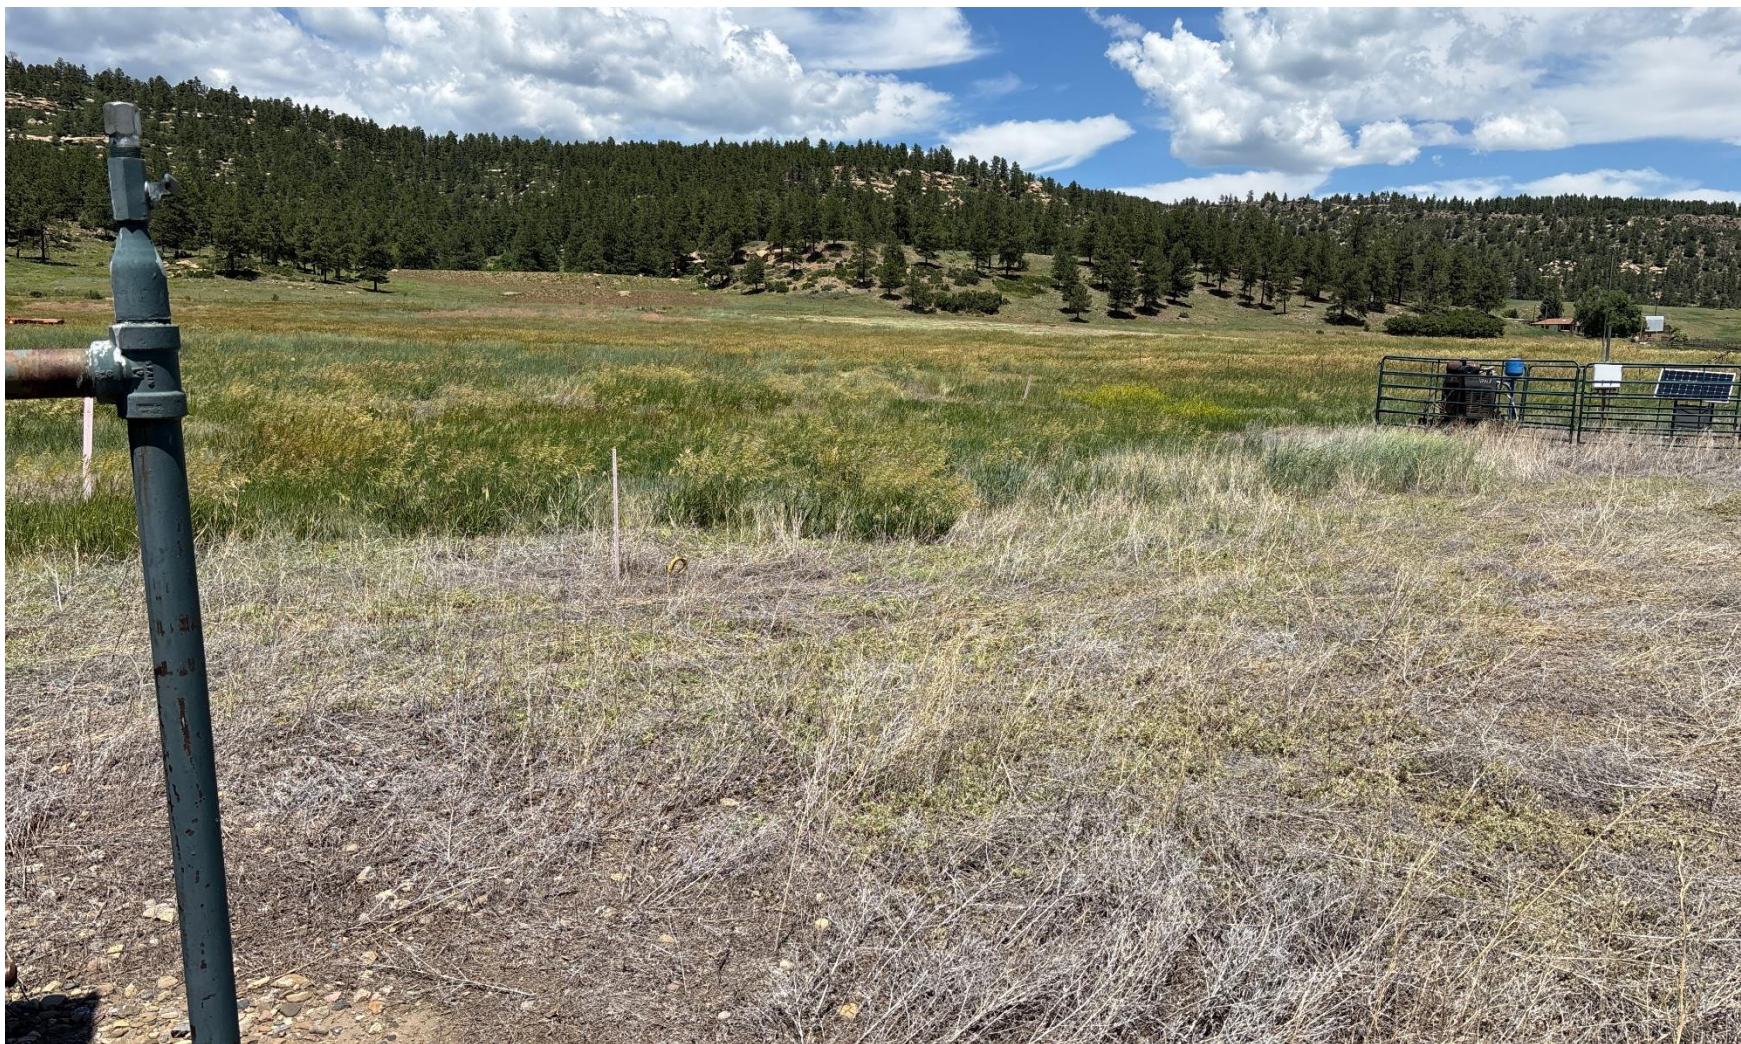
**PHOTO 4: WEEDS OVERGROWN AROUND LOCATION. WEEDS INSIDE ANCHORS NEED TO BE MAINTAINED PER RULE 606 CA DATE 7-12-2025.**

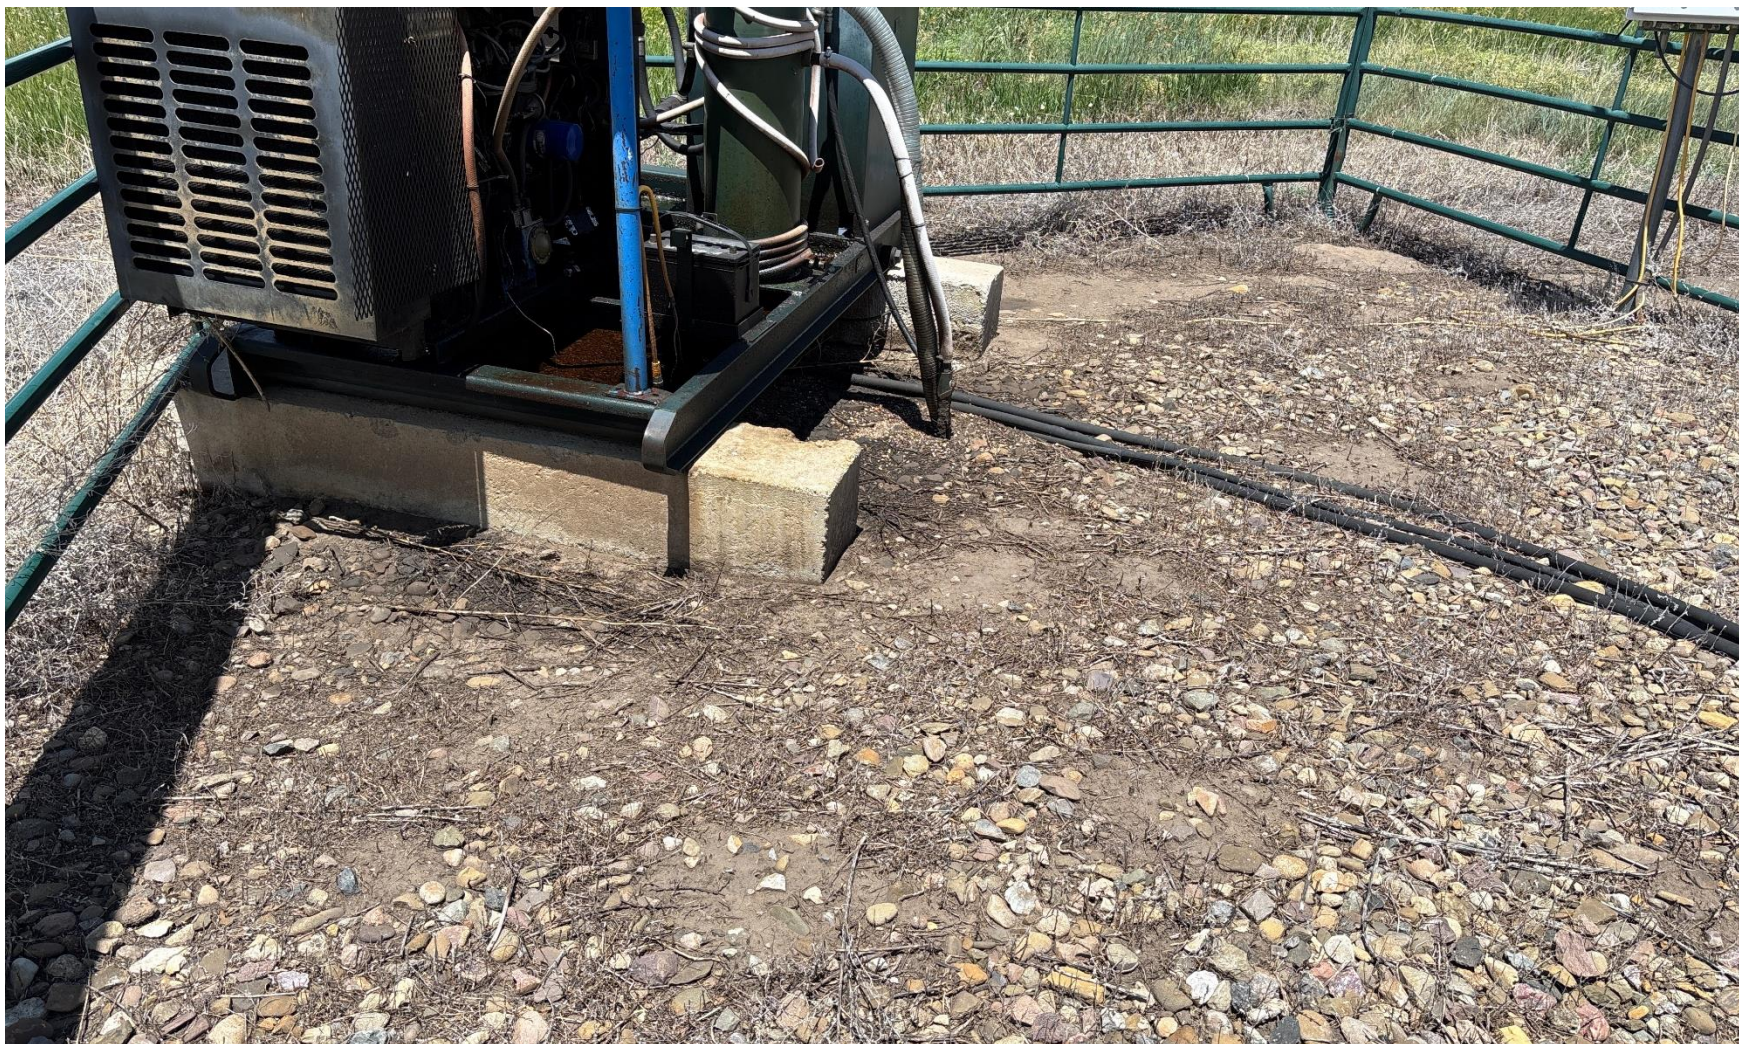
**PHOTO 5: DEAD WEEDS AROUND LOCATION ARE A FIRE HAZARD. CUT AND REMOVE DEAD WEEDS PER RULE 606. CA DATE 7-12-2025.**

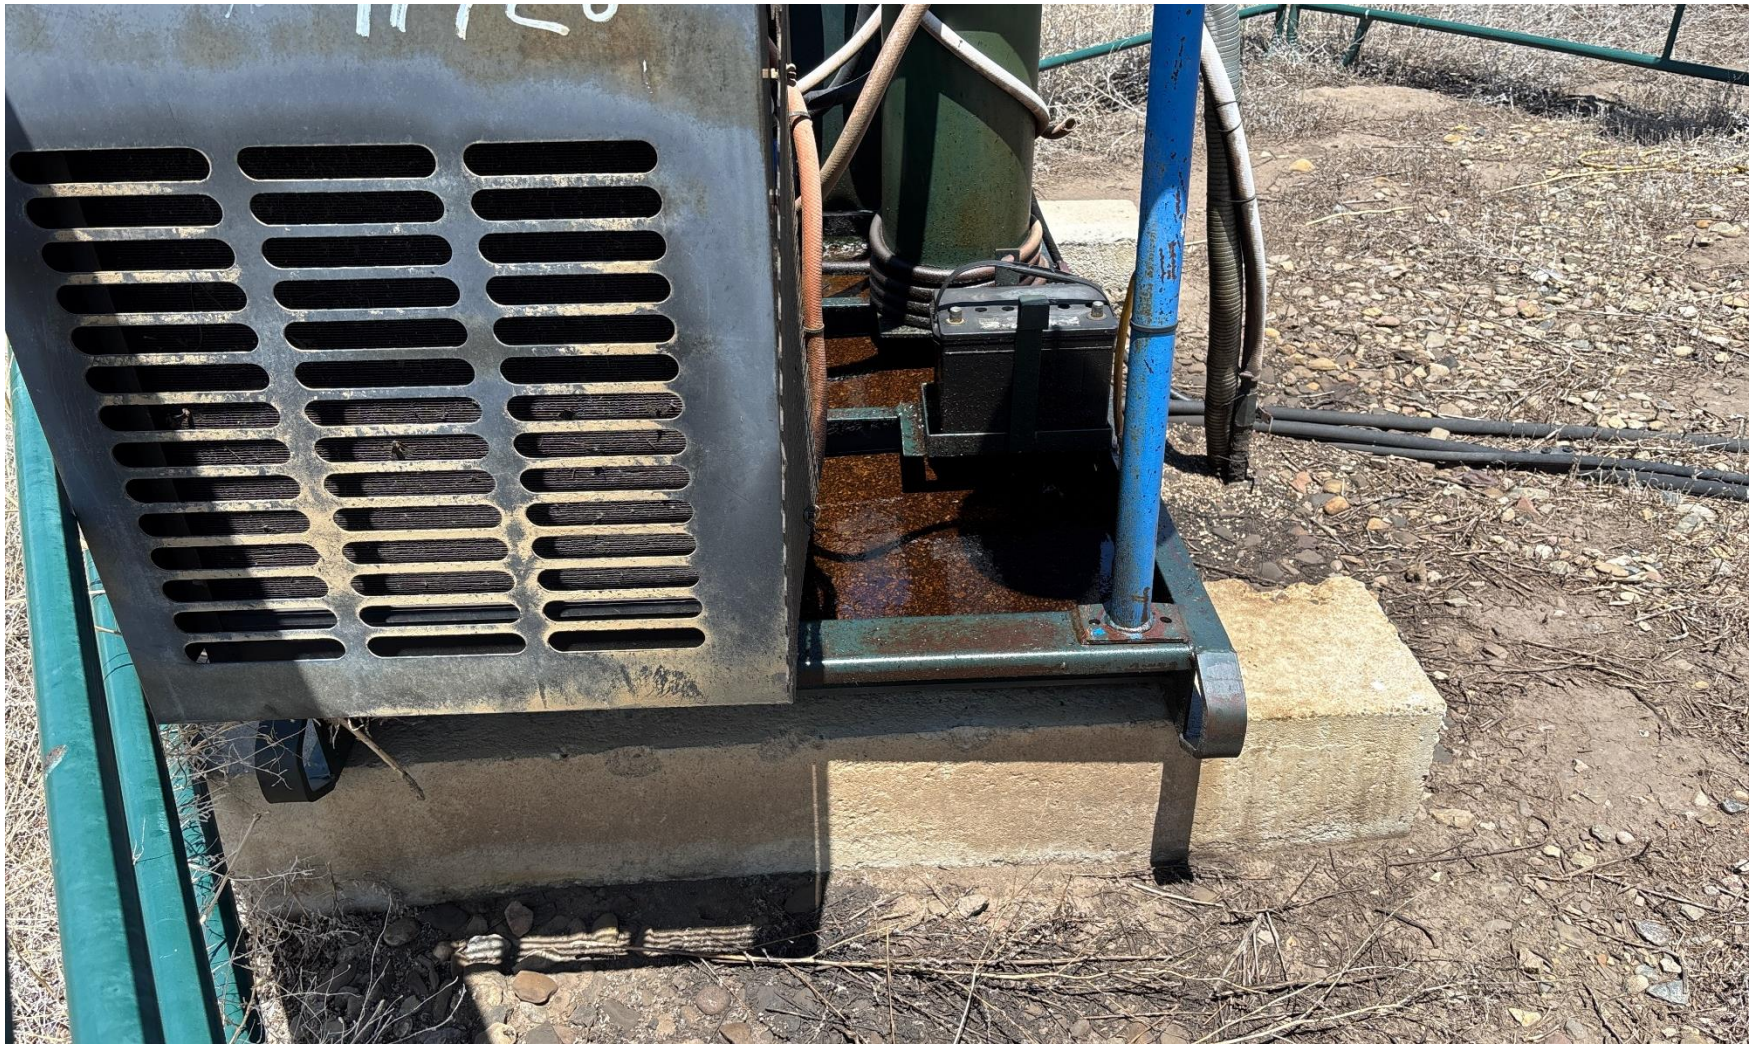
**PHOTO 6: THERE IS AN AREA OF IMPACED SOILS AROUND THE PRIME MOVER ENGINE SKID. Conduct maintenance on equipment, cleanup stained material and review self inspection processes. COMPLY WITH RULE 1002,(2).D CA DATE 7-12-2025.**

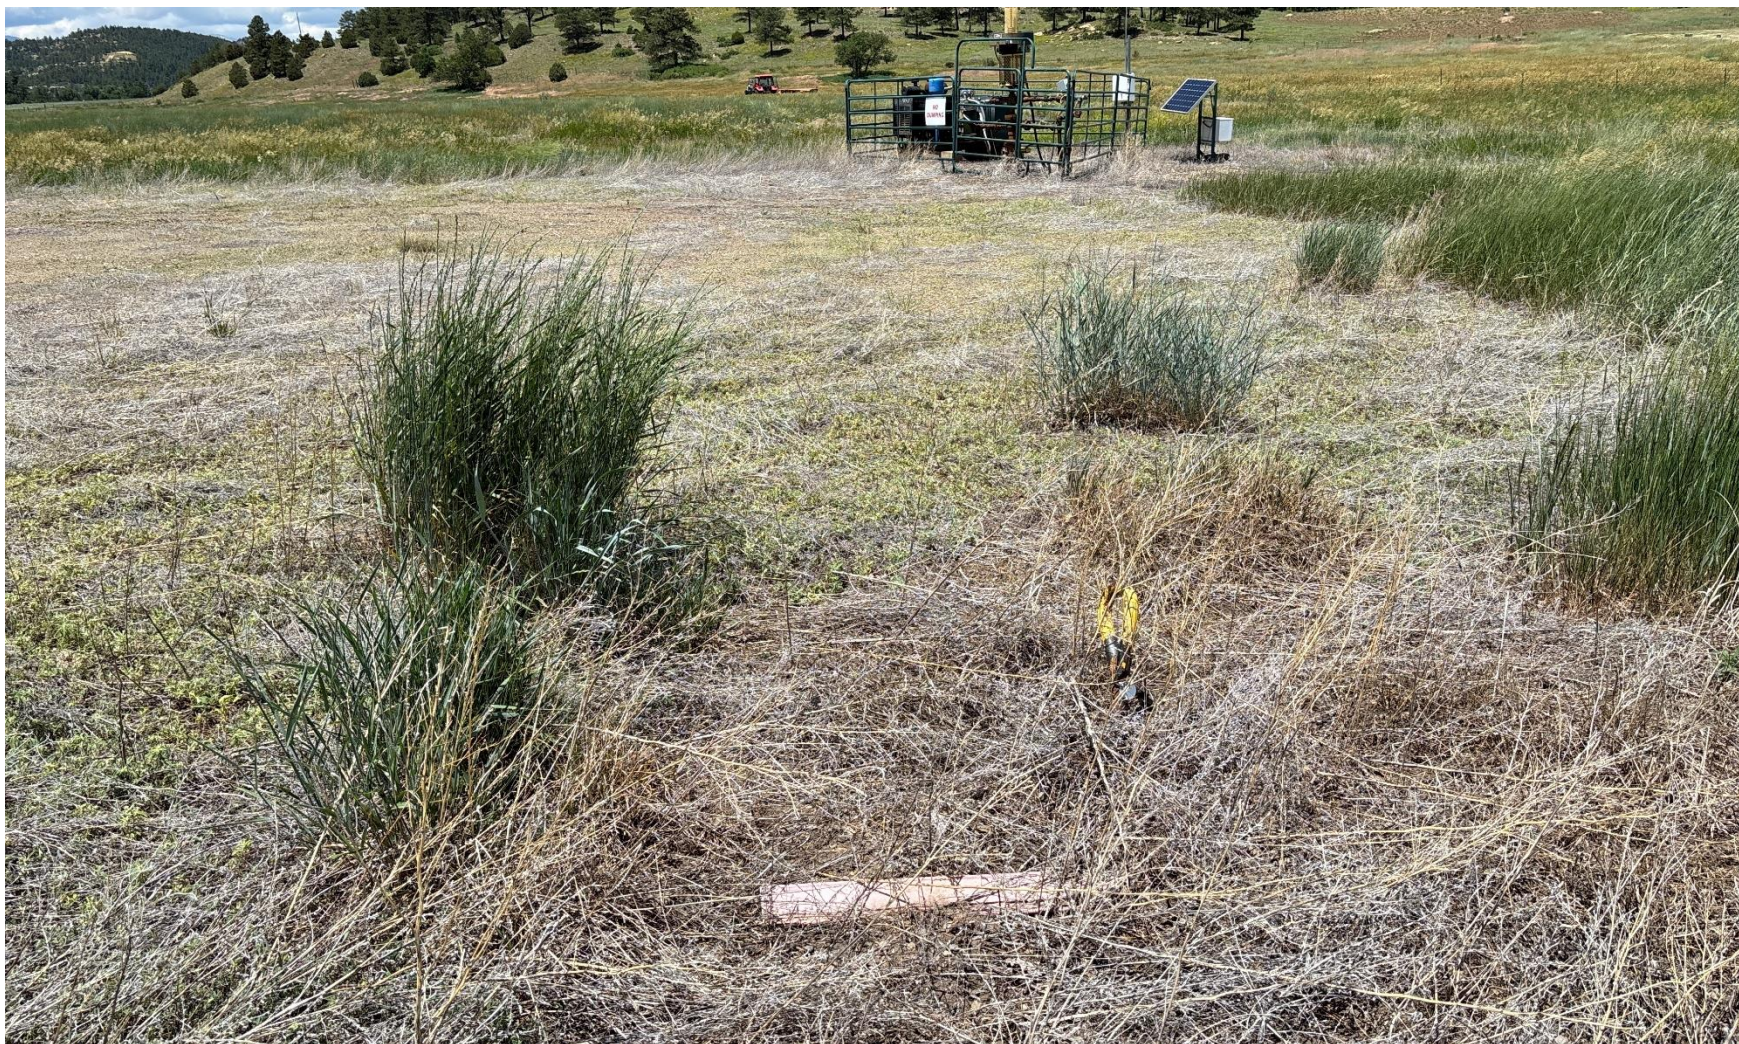
**PHOTO 7: OILY WASTE IN PRIME MOVER ENGINE SKID. DRAIN OILY WASTE REPAIR ALL LEAKS AND REMOVE IMPACTED SOIL PER RULE 1002..(2).D & 1002.f.(2)B, Comply with general provisions of the oil and gas act for wildlife protection AND SB-181. 24 HOURS TO REMOVE OILY WASTE CA DATE 7-12-2025.**
