Jilson 1 Wellhead  
© 20-May-25 17:19:23

Jilson 1 Wellhead excavation

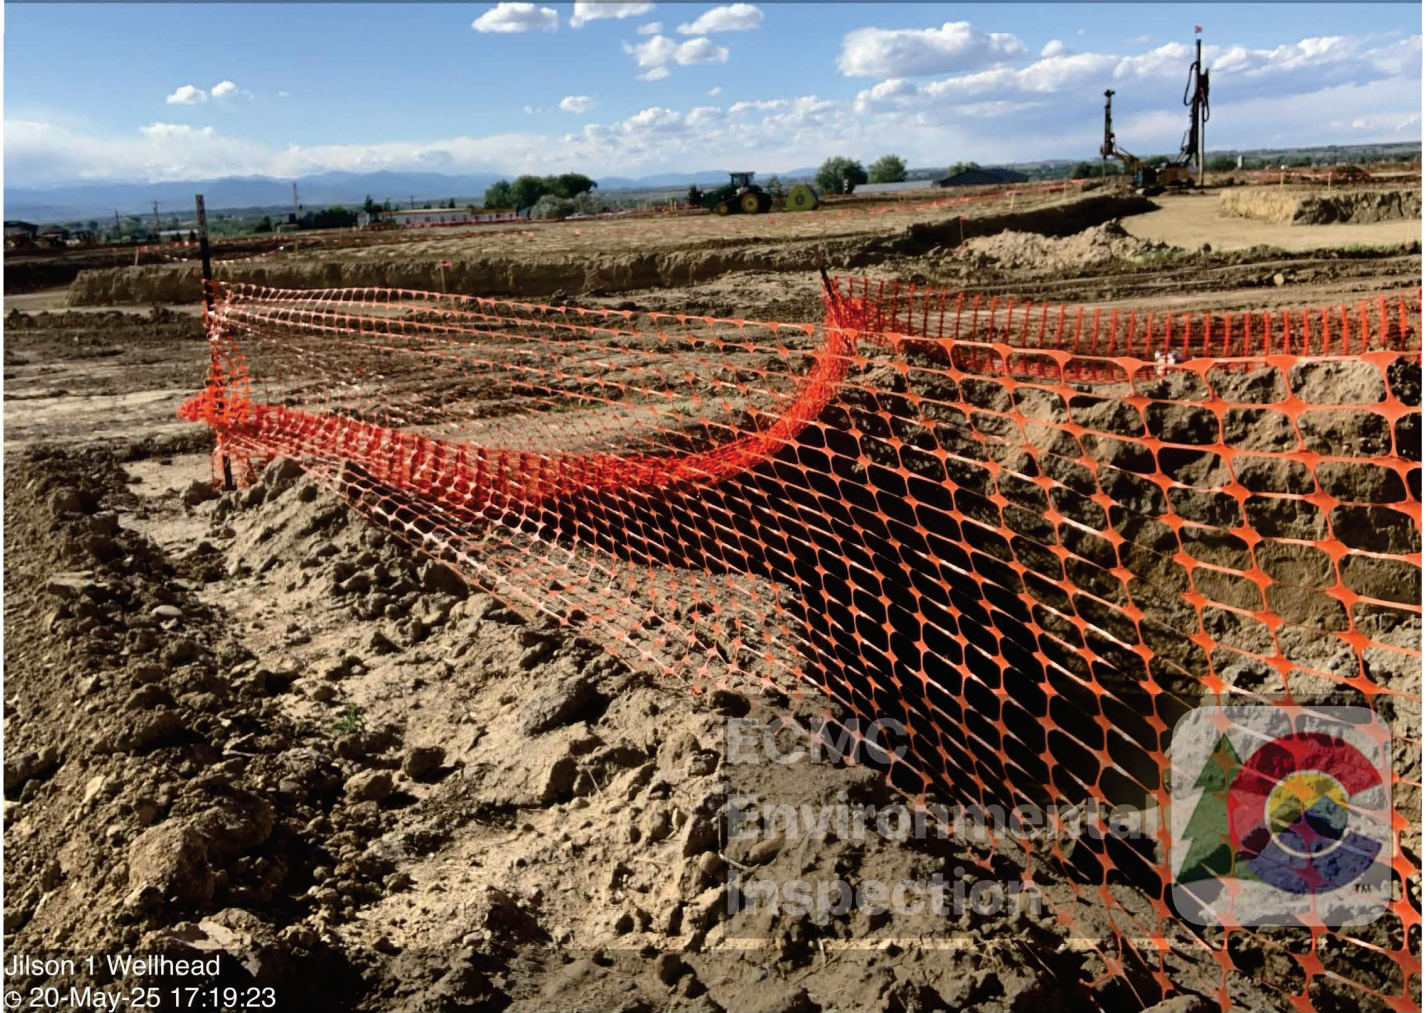
- Inadequate fencing - Orange construction fencing has been installed around portions of the open excavations; However, fencing has been installed too close to unstable sidewalls and is sagging/falling into the open excavation.
- Proximity to occupied structures - <1,300' NNW, <1,000' NW & SW

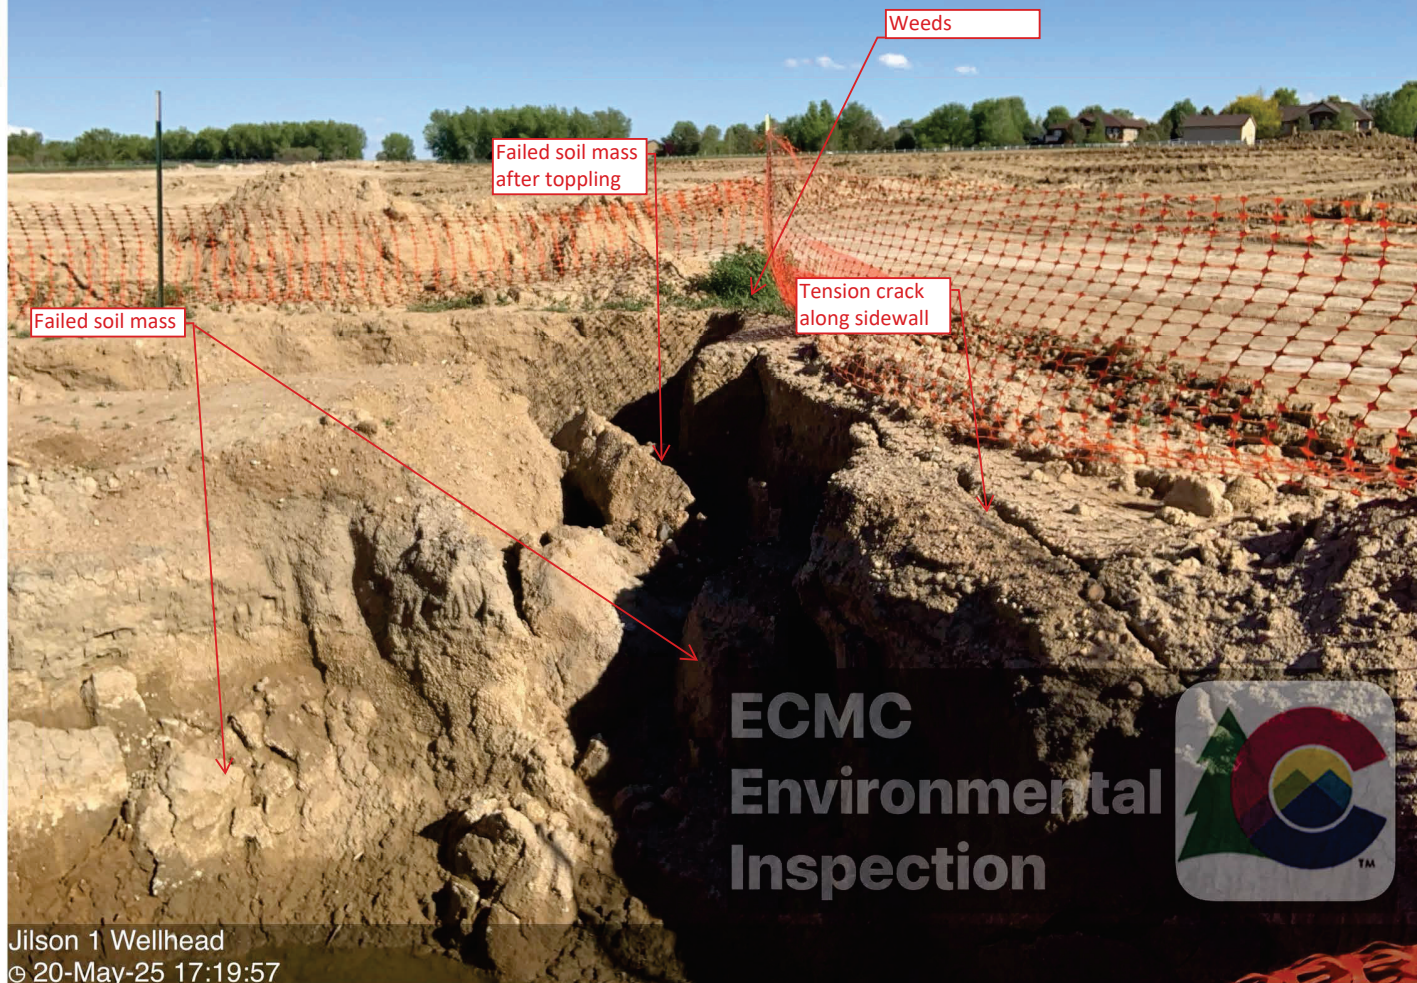
#### Jilson 1 Wellhead excavation - Sidewall collapse

- Excavation sidewalls have not been sloped or benched, are unstable, and have partially collapsed (failed soil mass observed in base of excavation adjacent to sidewall) and are showing signs of additional collapse (tension cracks/fissures, toppling/sloughing/sliding).
- Inadequate fencing - Orange construction fencing has been installed around portions of the open excavations; However, fencing has been installed too close to unstable sidewalls and is sagging/falling into the open excavation.
- Weeds have started to grow along portions of the excavation fencing.
- Proximity to occupied structures (Multiple Residences <1,100' S)

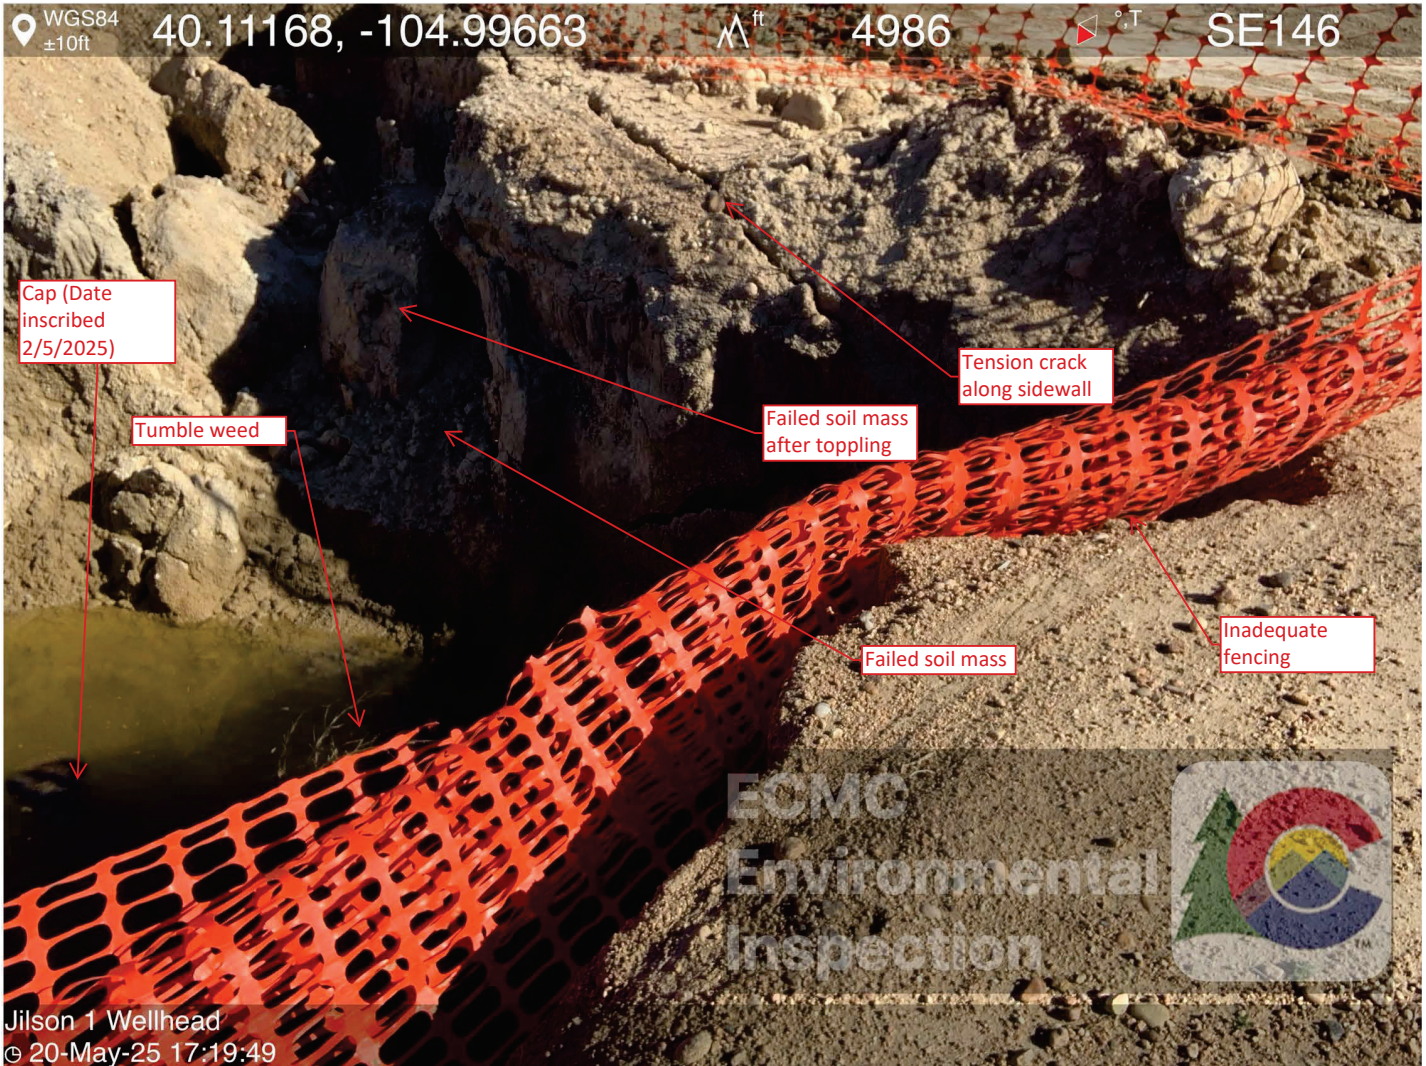
Jilson 1 Wellhead  
© 20-May-25 17:19:49

Jilson 1 Wellhead excavation - Sidewall collapse. Shallow groundwater (~5' bgs)

- Excavation sidewalls have not been sloped or benched, are unstable, and have partially collapsed (failed soil mass observed in base of excavation adjacent to sidewall) and are showing signs of additional collapse (tension cracks/fissures, toppling/sloughing/sliding).
- Inadequate fencing - Orange construction fencing has been installed around portions of the open excavations; However, fencing has been installed too close to unstable sidewalls and is sagging/falling into the open excavation.
- Weeds observed within the base of the open excavation (tumbleweed).

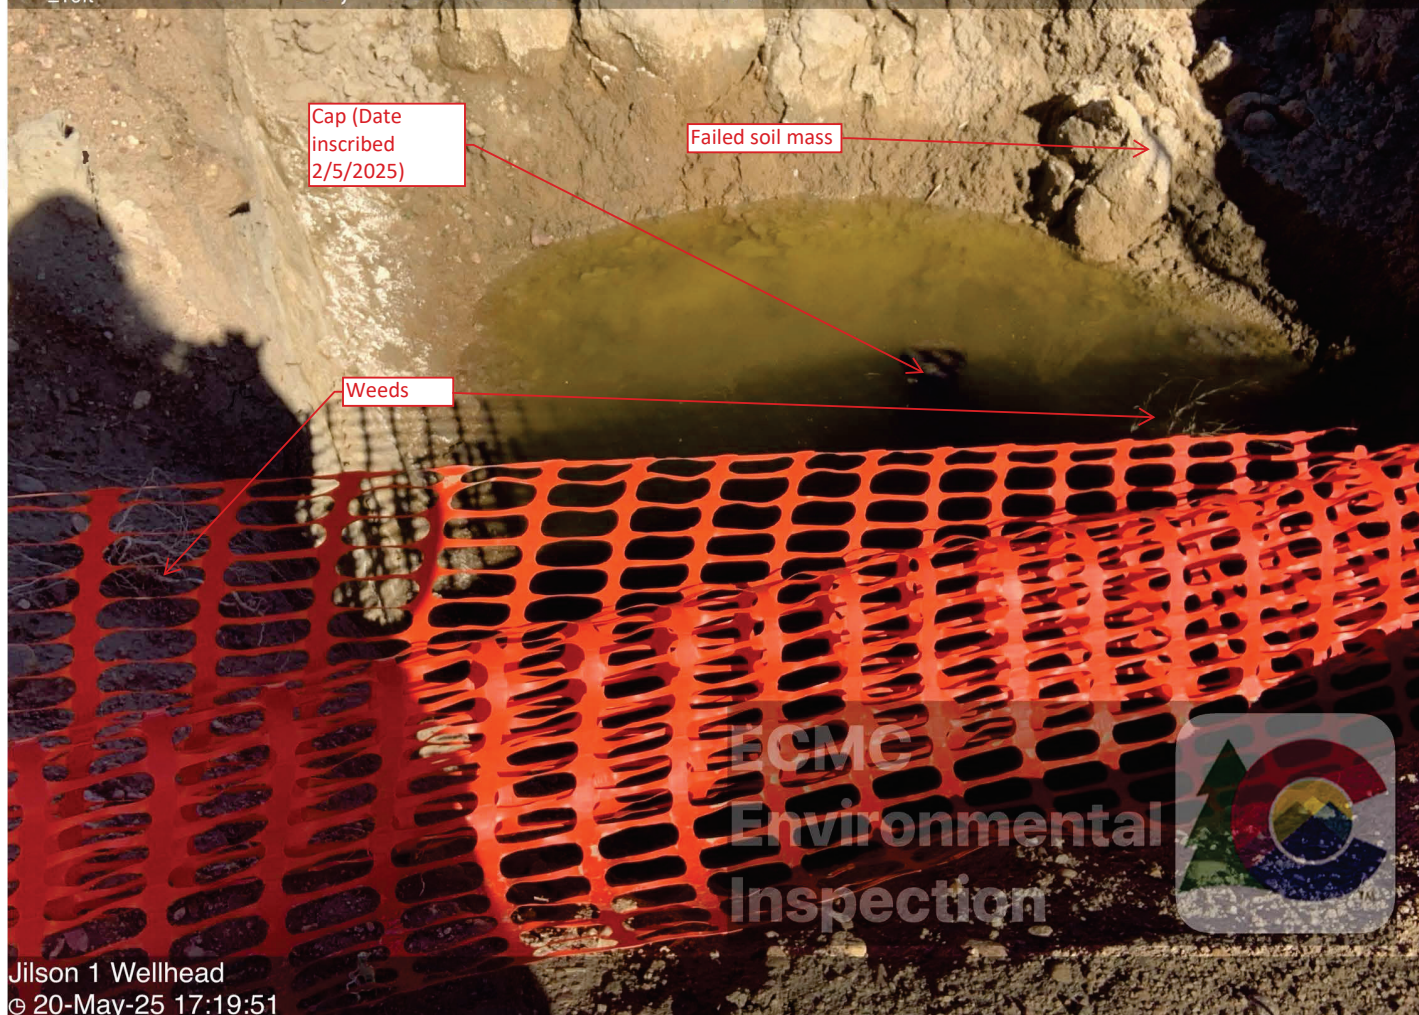
Jilson 1 Wellhead  
© 20-May-25 17:19:51

Jilson 1 Wellhead excavation - Shallow groundwater (~5' BGS). Date on cap: 2/5/2025

-Excavation sidewalls have not been sloped or benched

-Inadequate fencing - Orange construction fencing has been installed around portions of the open excavations; However, fencing has been installed too close to unstable sidewalls and is sagging/falling into the open excavation.

-Weeds observed within the open excavation

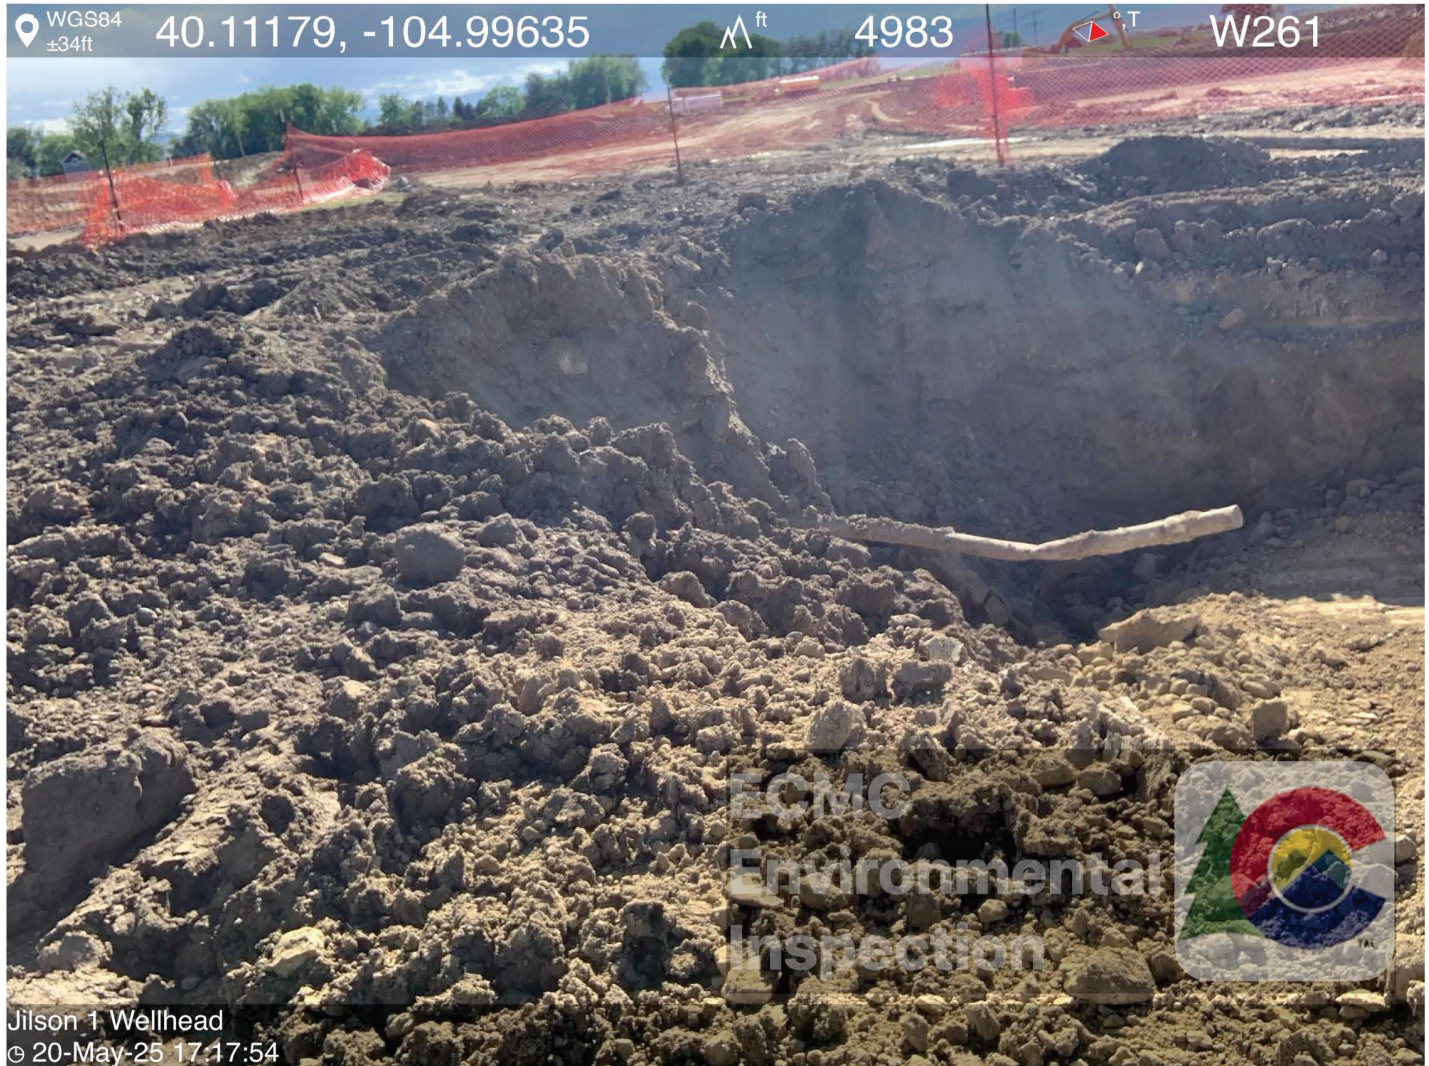
Jilson 1 Wellhead

Flowline Excavation - Flowline exposed in open excavation

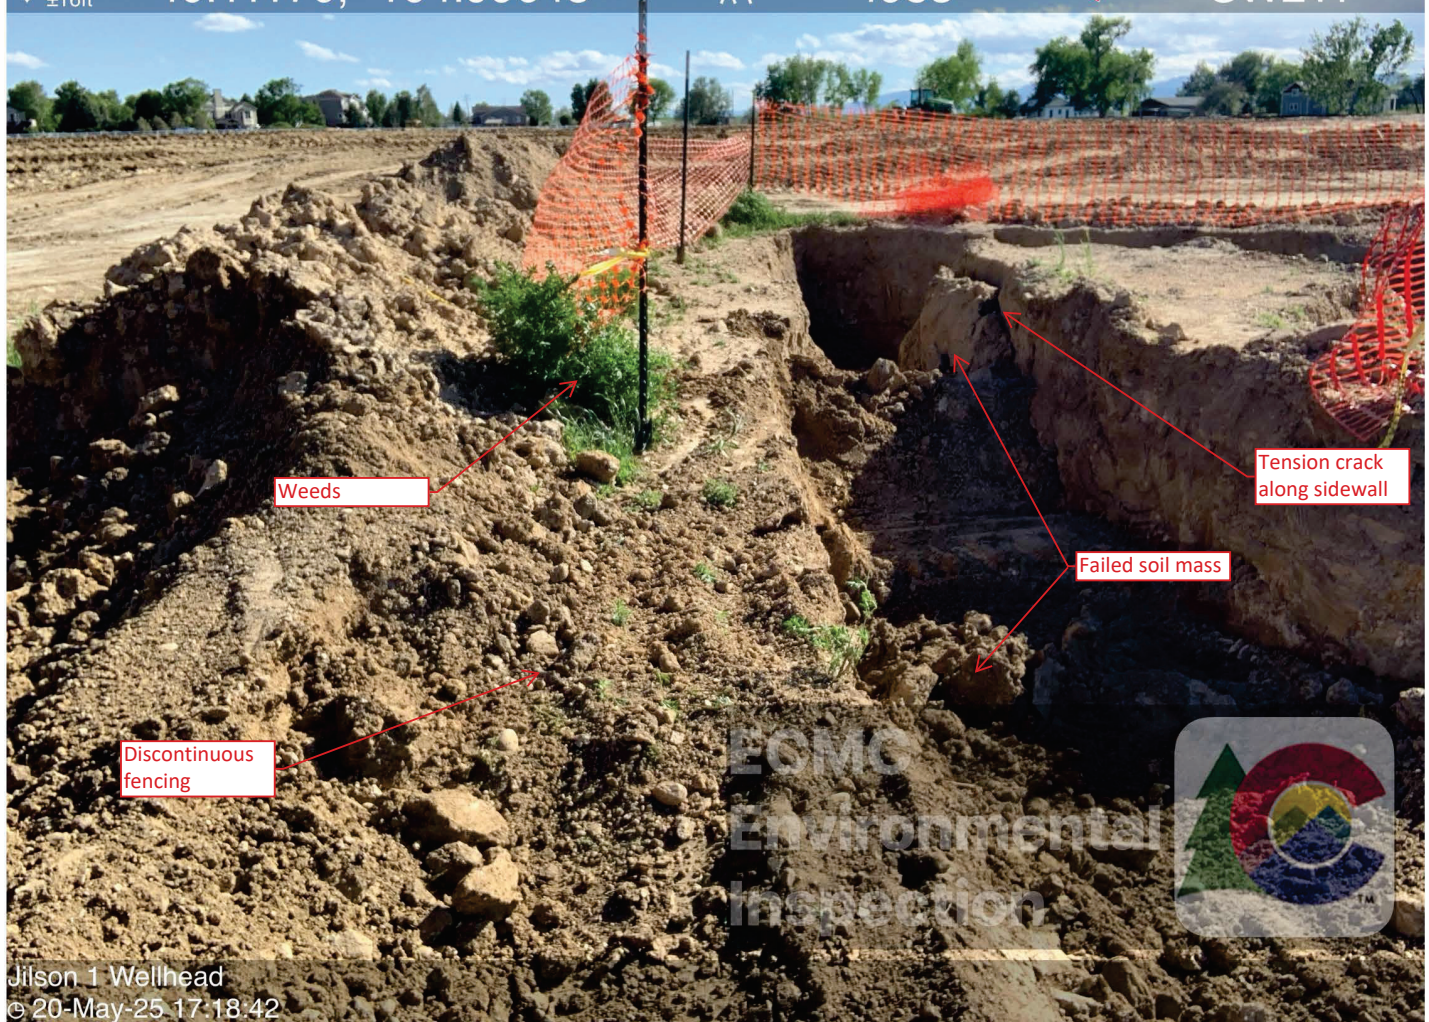
Jilson 1 Wellhead  
© 20-May-25 17:18:42

Jilson 1 Wellhead & Flowline excavation -

- Excavation sidewalls have not been sloped or benched, are unstable, and have partially collapsed (failed soil mass observed in base of excavation adjacent to sidewall) and are showing signs of additional collapse (tension cracks/fissures, toppling/sloughing/sliding).
- Inadequate fencing - Orange construction fencing has been installed around portions of the open excavations; However, fencing has been installed too close to unstable sidewalls and is sagging/falling into the open excavation and is discontinuous.
- Weeds have started to grow along portions of the excavation fencing.

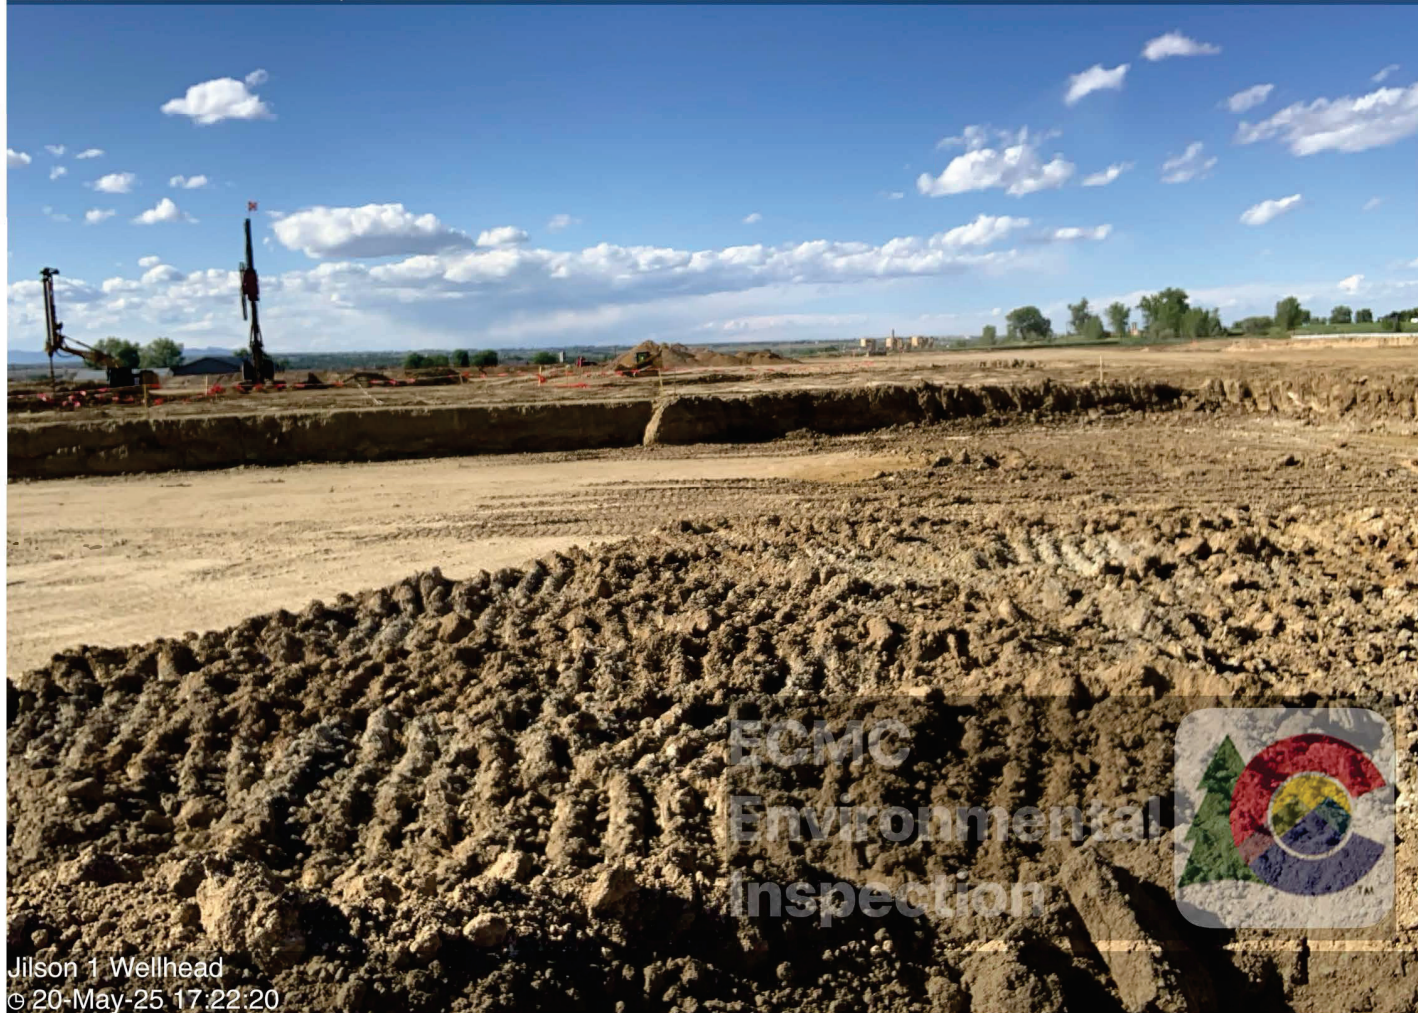
Jilson 1 Wellhead  
© 20-May-25 17:22:20

Excavation/construction activities north of Jillson 1 Wellhead

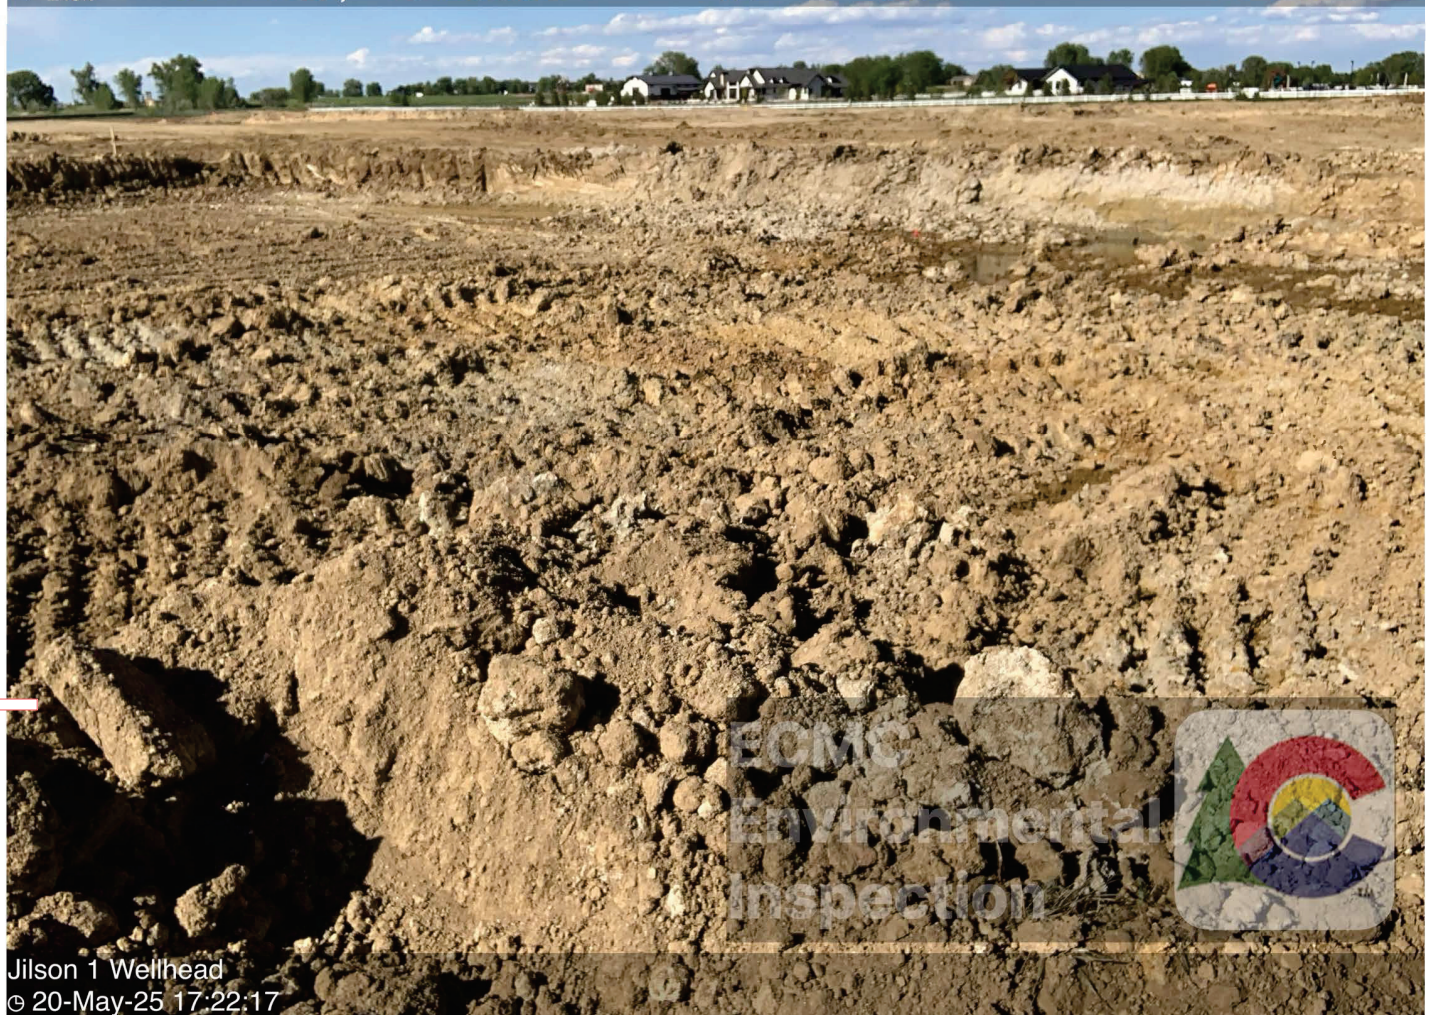
Jilson 1 Wellhead  
© 20-May-25 17:22:17

Excavation north of Jillson 1 Wellhead looking NE - Shallow groundwater infiltrating base of excavation  
-Proximity to occupied structures (~1,200' NE)
