Dechant State 3 Flowline Spill (Spill ID 487984) - Site overview looking NE.

ECMC
Environmental
Field Inspection

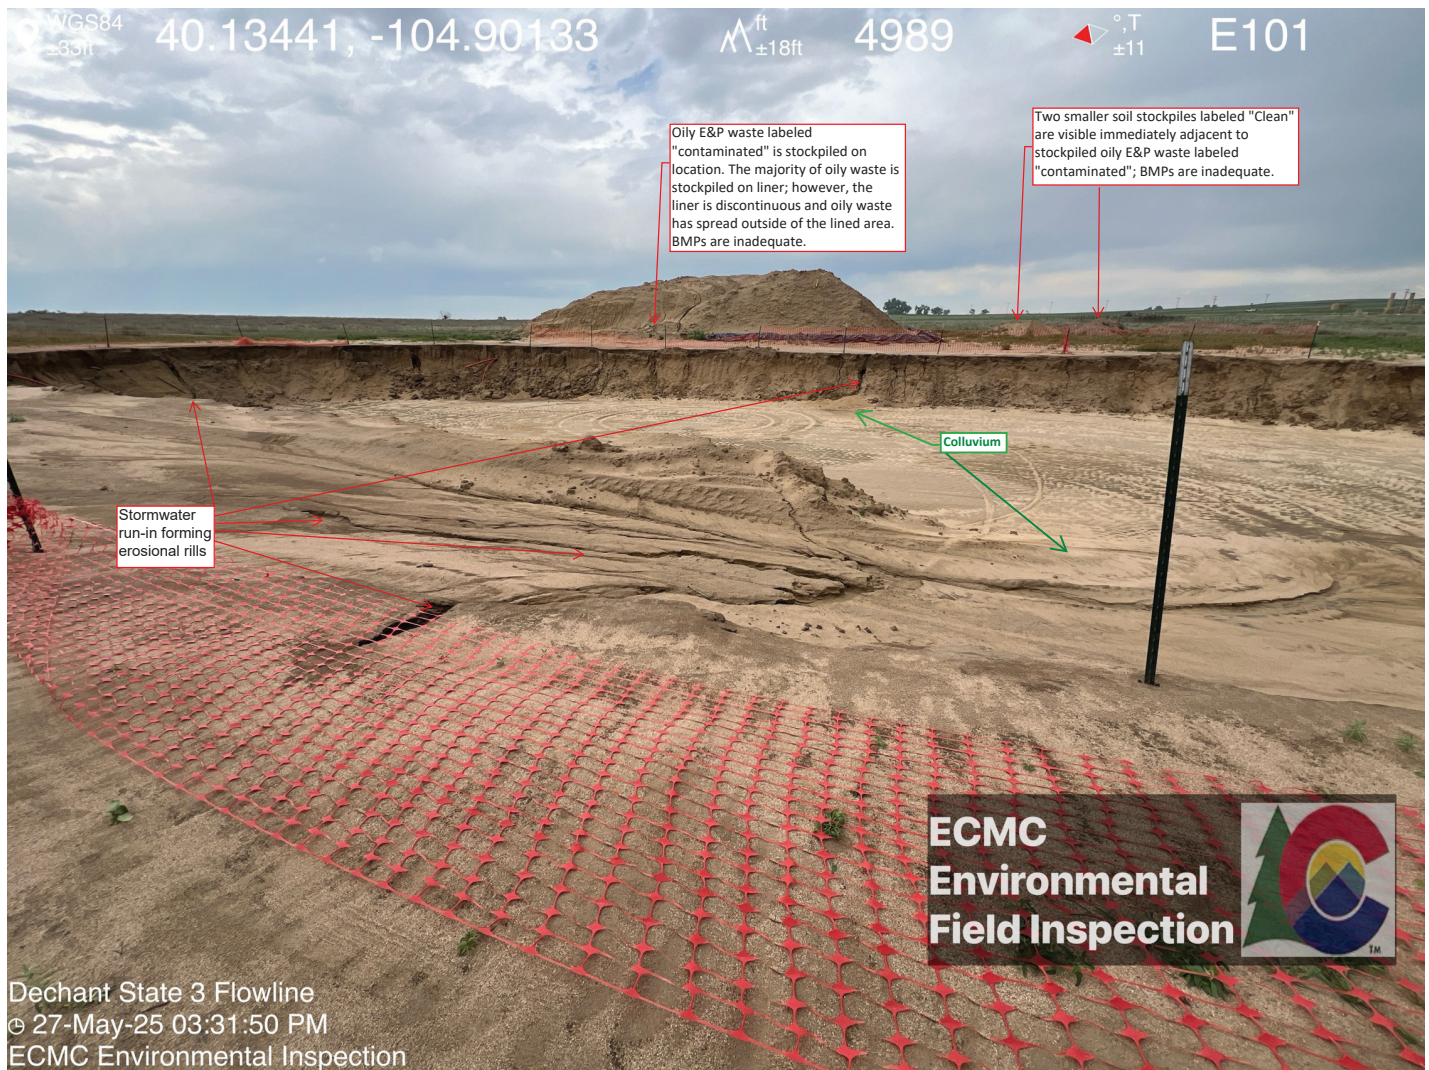
- Stormwater run-in to the open excavation has resulted in rill erosion, sidewall destabilization and transport and accumulation of sediment (**colluvium**) within the open excavation.
- Fencing downed - Fencing not appropriate for site conditions.

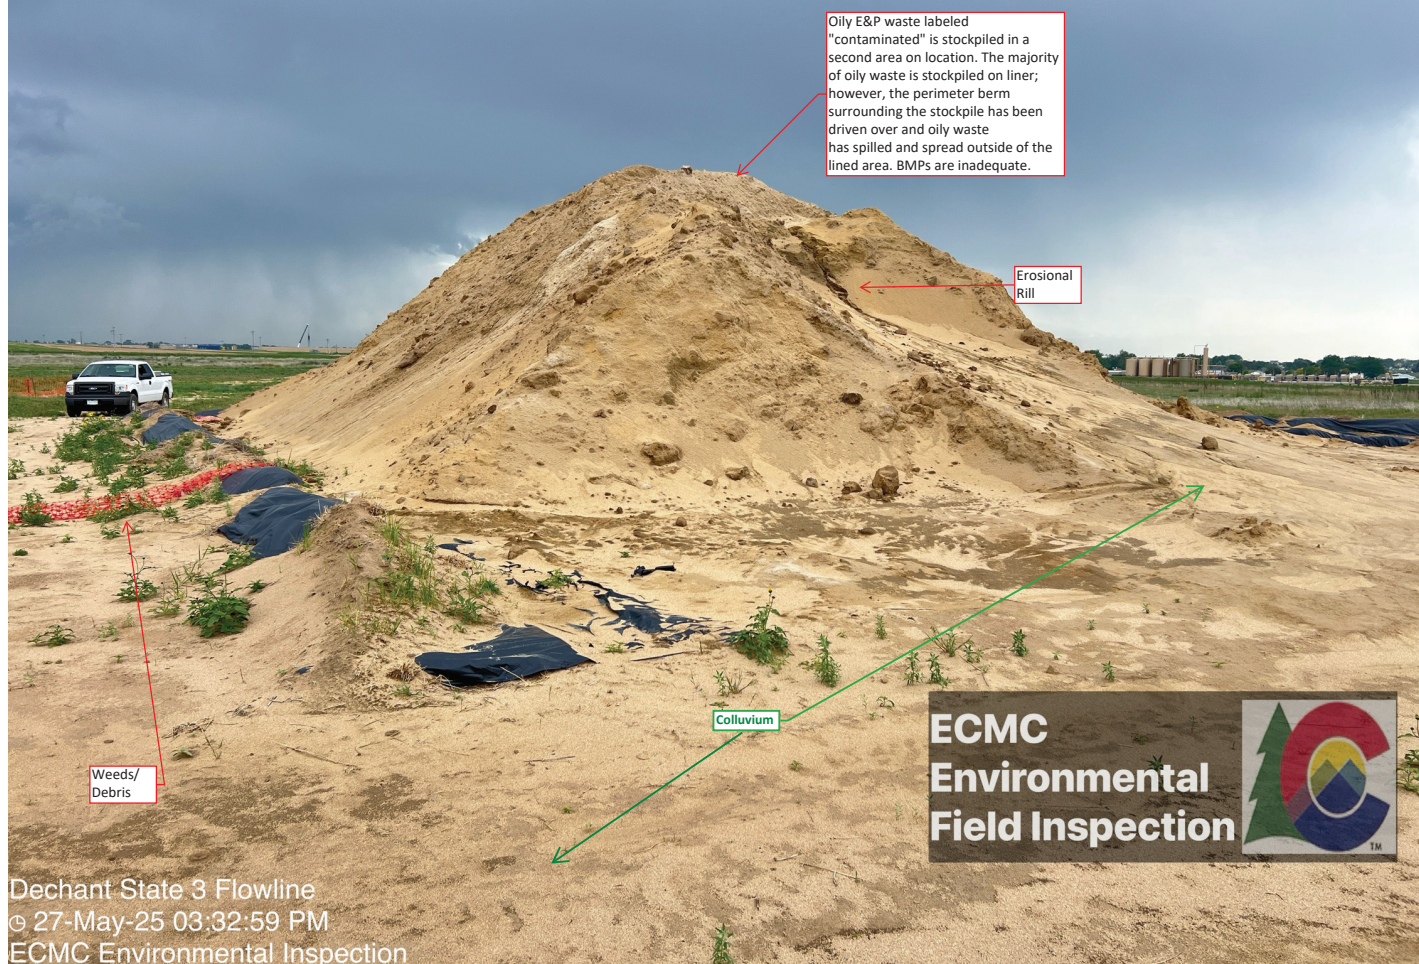
- Weeds/debris
- E&P waste stockpile with inadequate BMPs.
- No fencing installed around stockpiled E&P waste

Oily E&P waste labeled "contaminated" is stockpiled in a second area on location. The majority of oily waste is stockpiled on liner; however, the perimeter berm surrounding the stockpile has been driven over and oily waste has spilled and spread outside of the lined area. BMPs are inadequate.

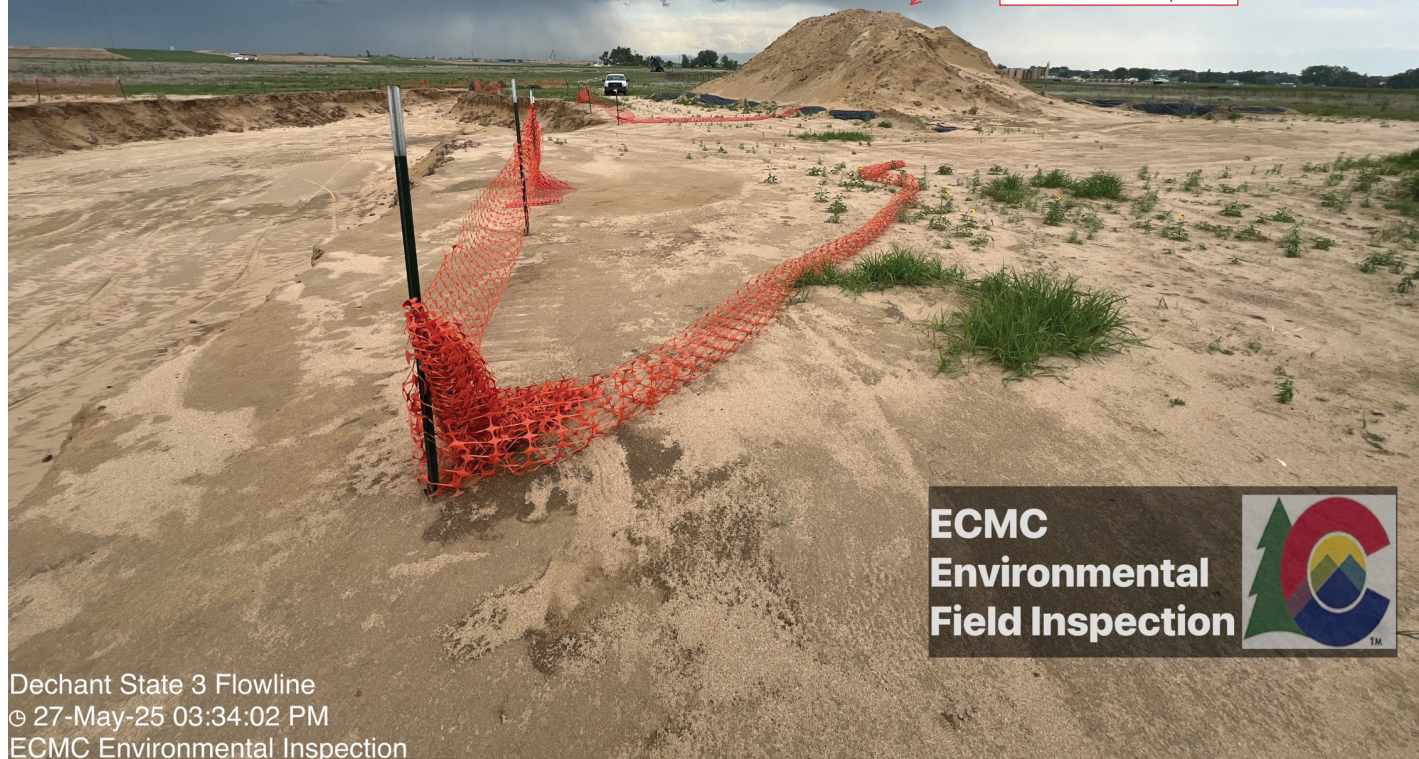
-Downed fencing - Fencing not appropriate for site conditions.

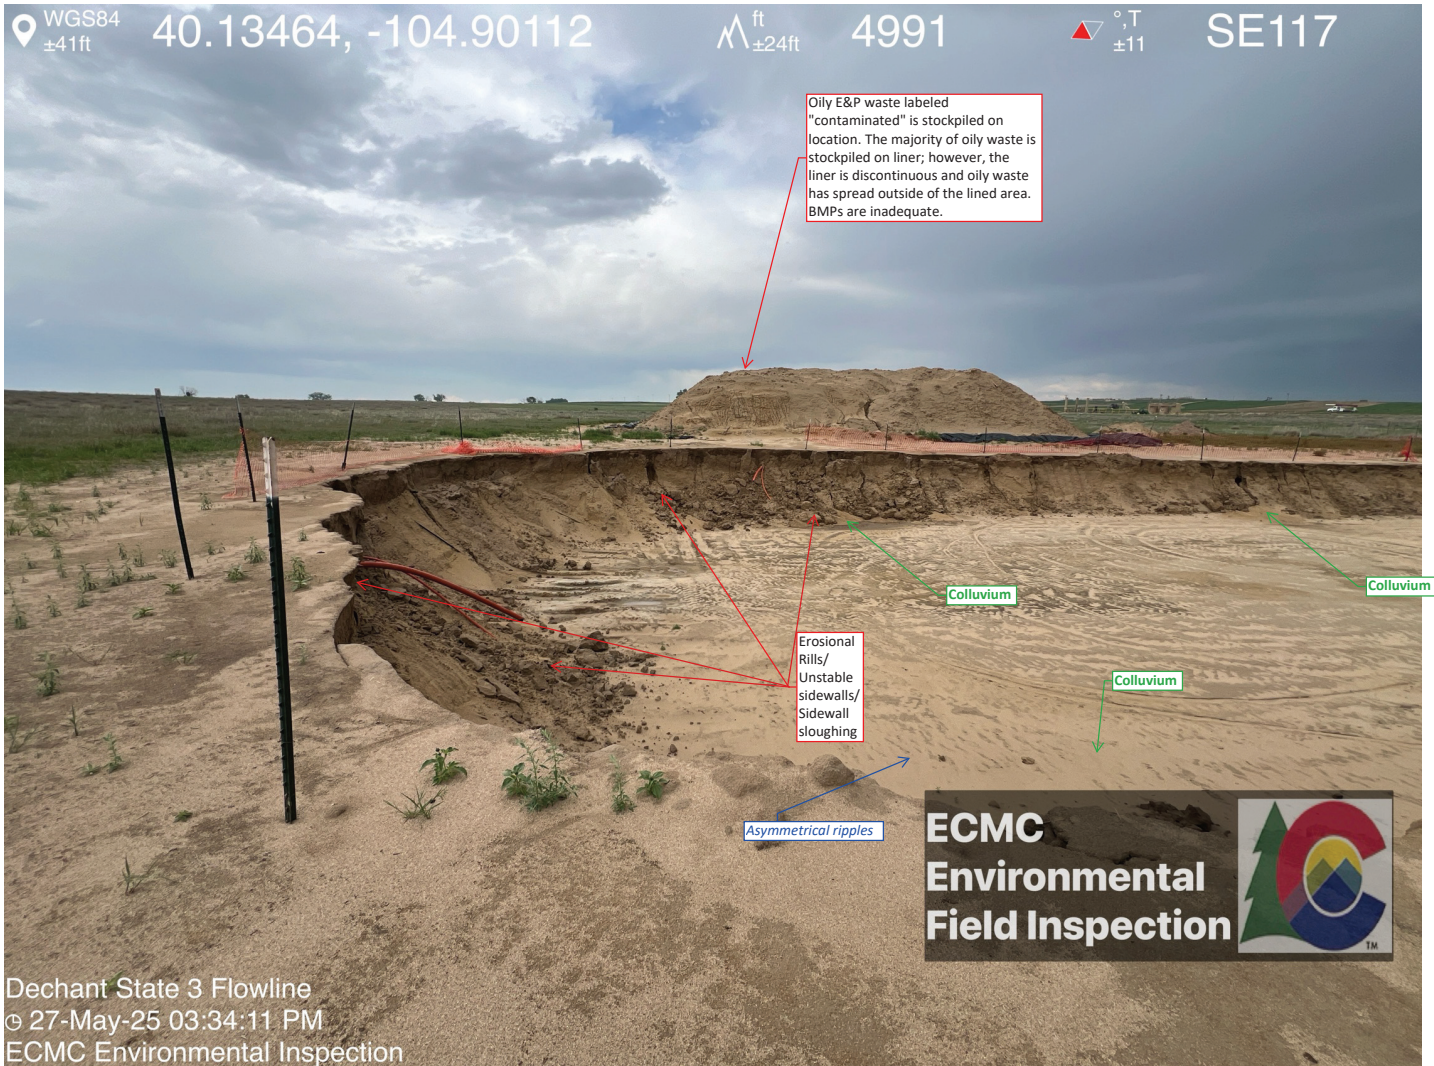
-Weeds

-Wind erosion and stormwater run-in to the open excavation has resulted in rill erosion, sidewall destabilization and collapse, and transport and accumulation of sediment(**colluvium**) within the open excavation.

-Fencing downed - Fencing not appropriate for site conditions.

-*Asymmetrical ripples indicating soil has been transported across the excavation floor by wind.*

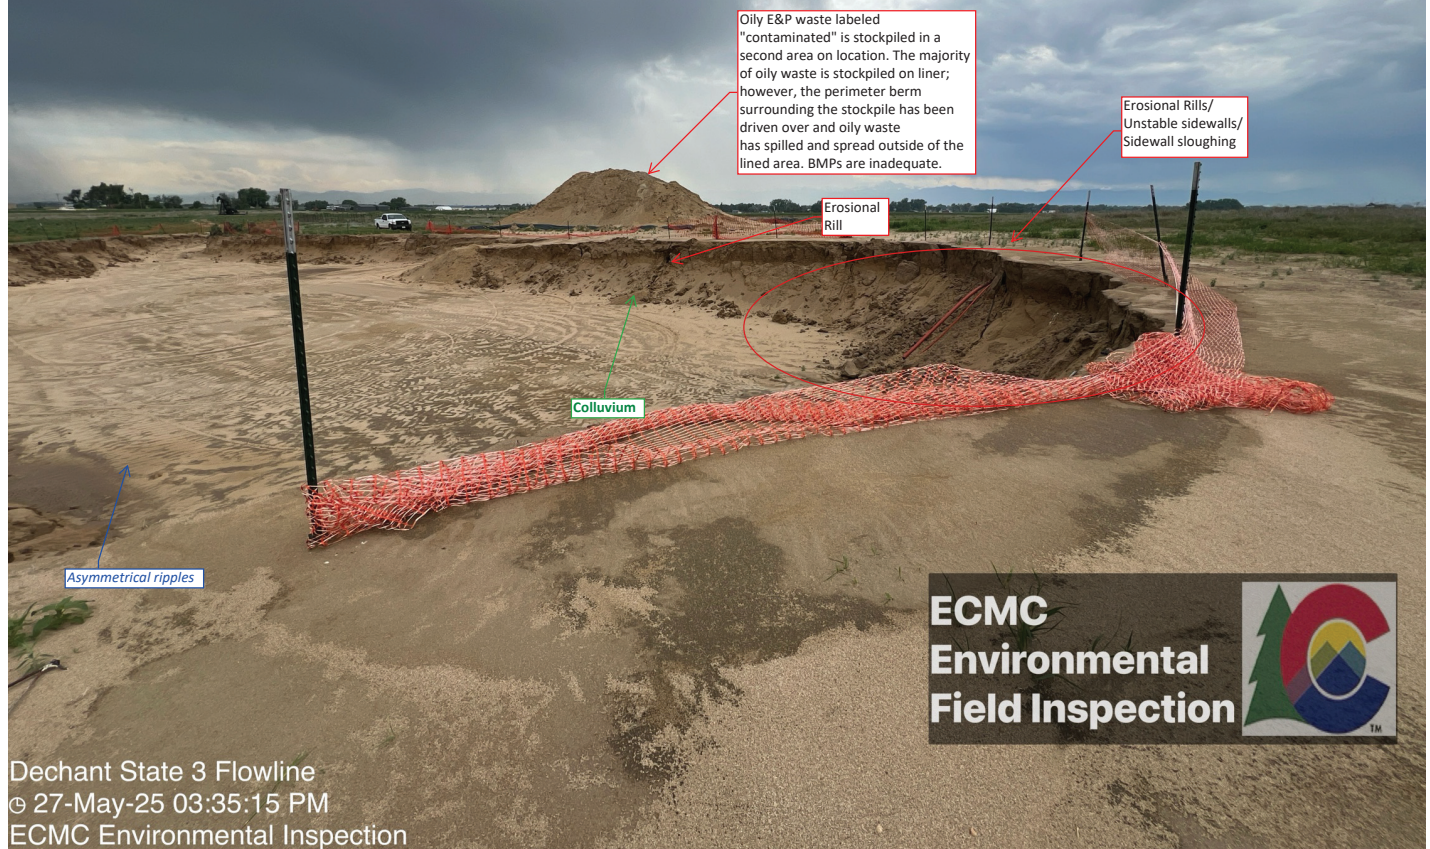
- Fencing downed - Fencing not appropriate for site conditions.
- Stormwater run-in to the open excavation has resulted in rill erosion, sidewall destabilization and collapse, and transport and accumulation of sediment (**colluvium**) within the open excavation.
- Asymmetrical ripples indicating soil has been transported across the excavation floor by wind.

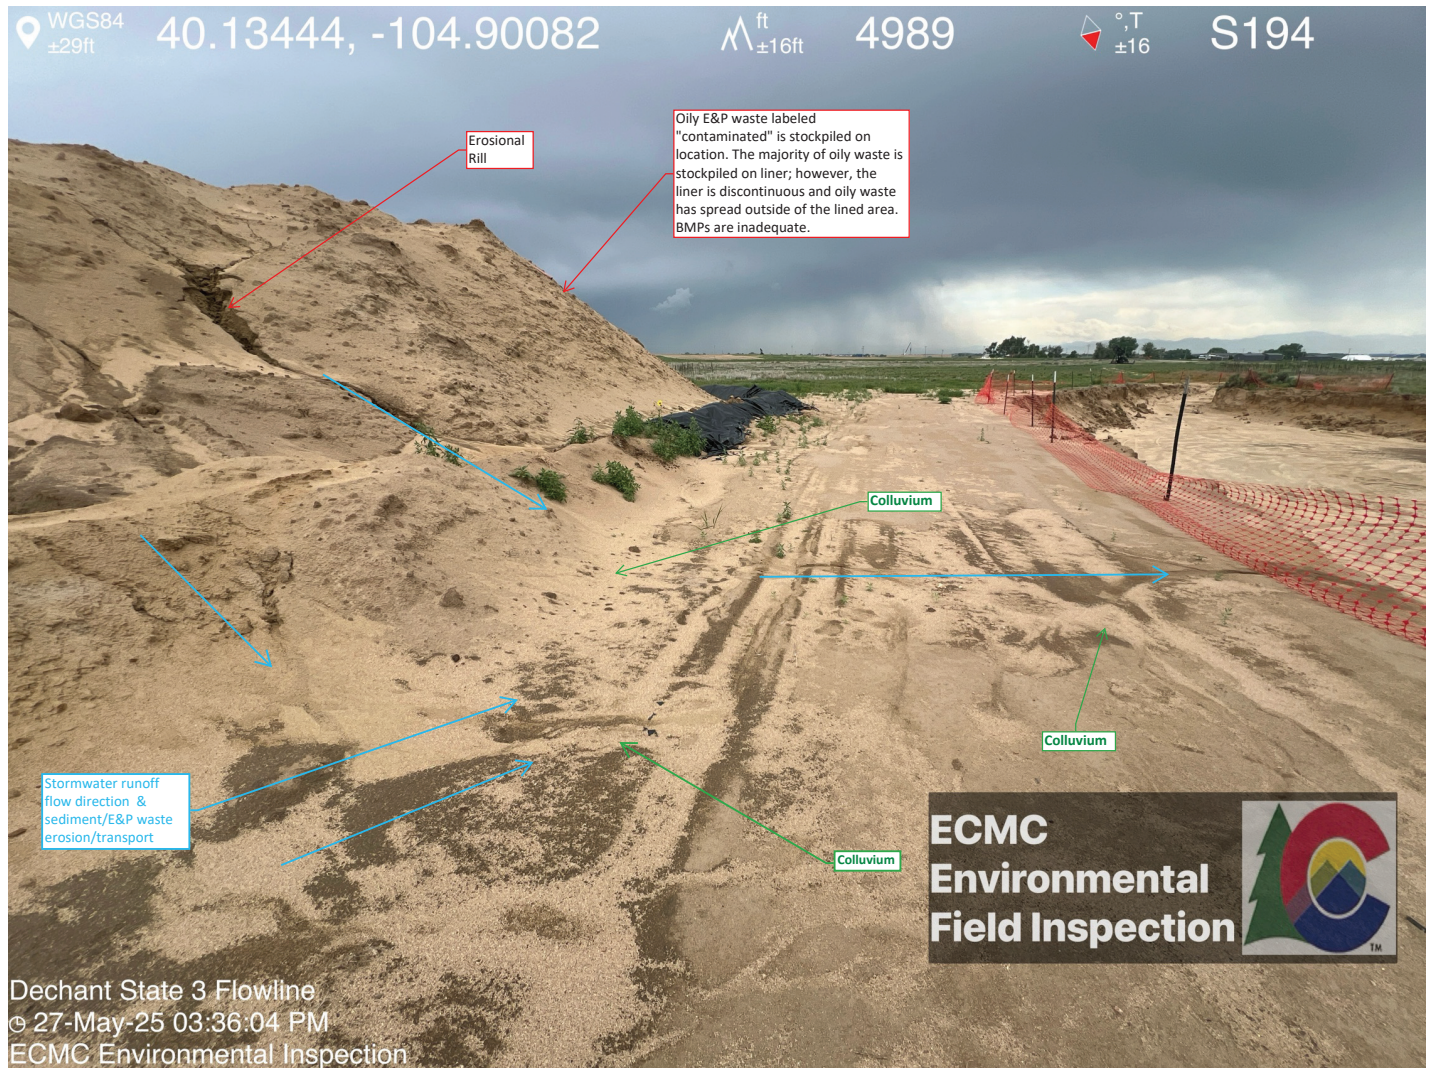
- E&P waste stockpile BMPs are inadequate - Wind erosion and stormwater runoff have transported sediment and E&P waste offsite and throughout the location/into the open excavation.
- E&P waste stockpile is showing signs of erosion and sediment transport/deposition on top and outside of containment
- Weeds
- Fencing downed - Fencing not appropriate for site conditions.

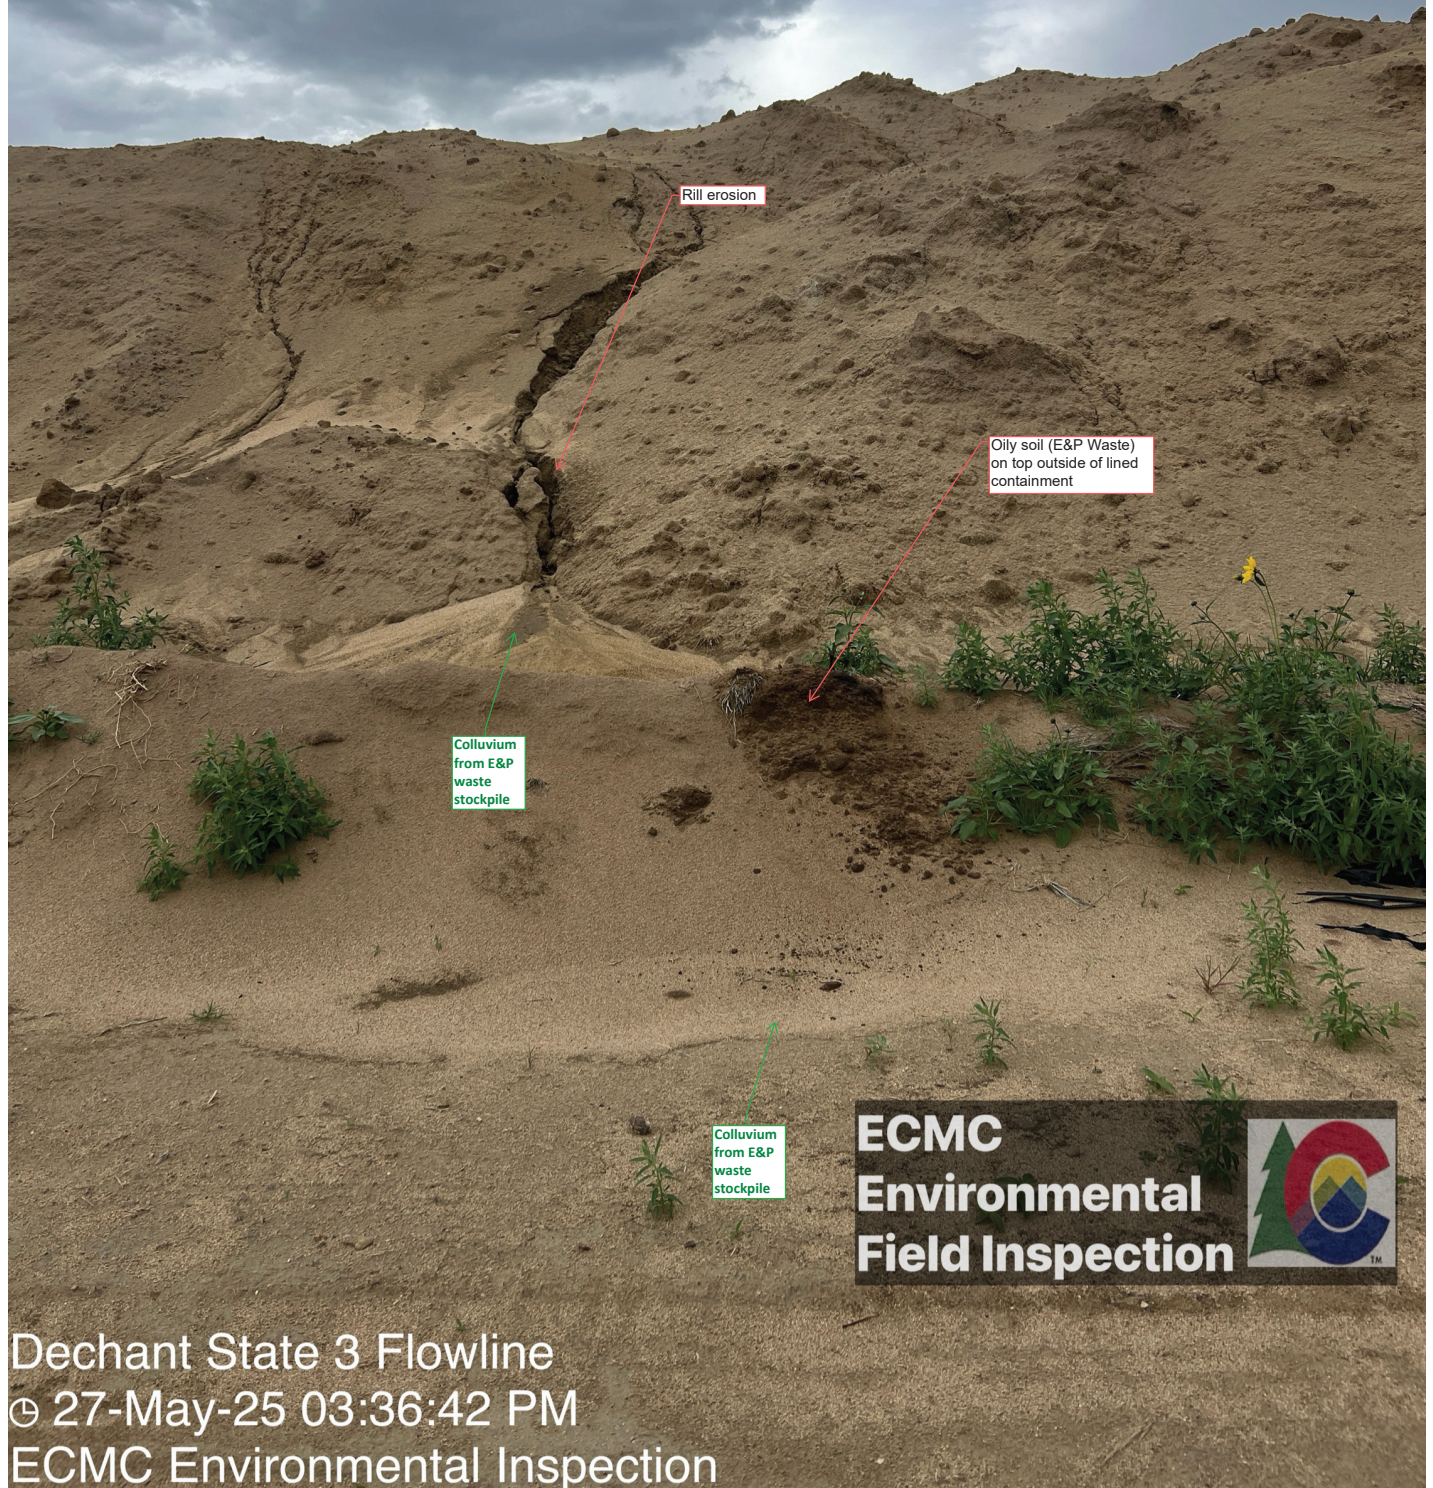
- E&P waste stockpile BMPs are inadequate - Wind erosion and stormwater runoff have transported sediment and E&P waste offsite and throughout the location/into the open excavation.
- E&P waste stockpile is showing signs of erosion and sediment transport/deposition on top and outside of containment
- Weeds

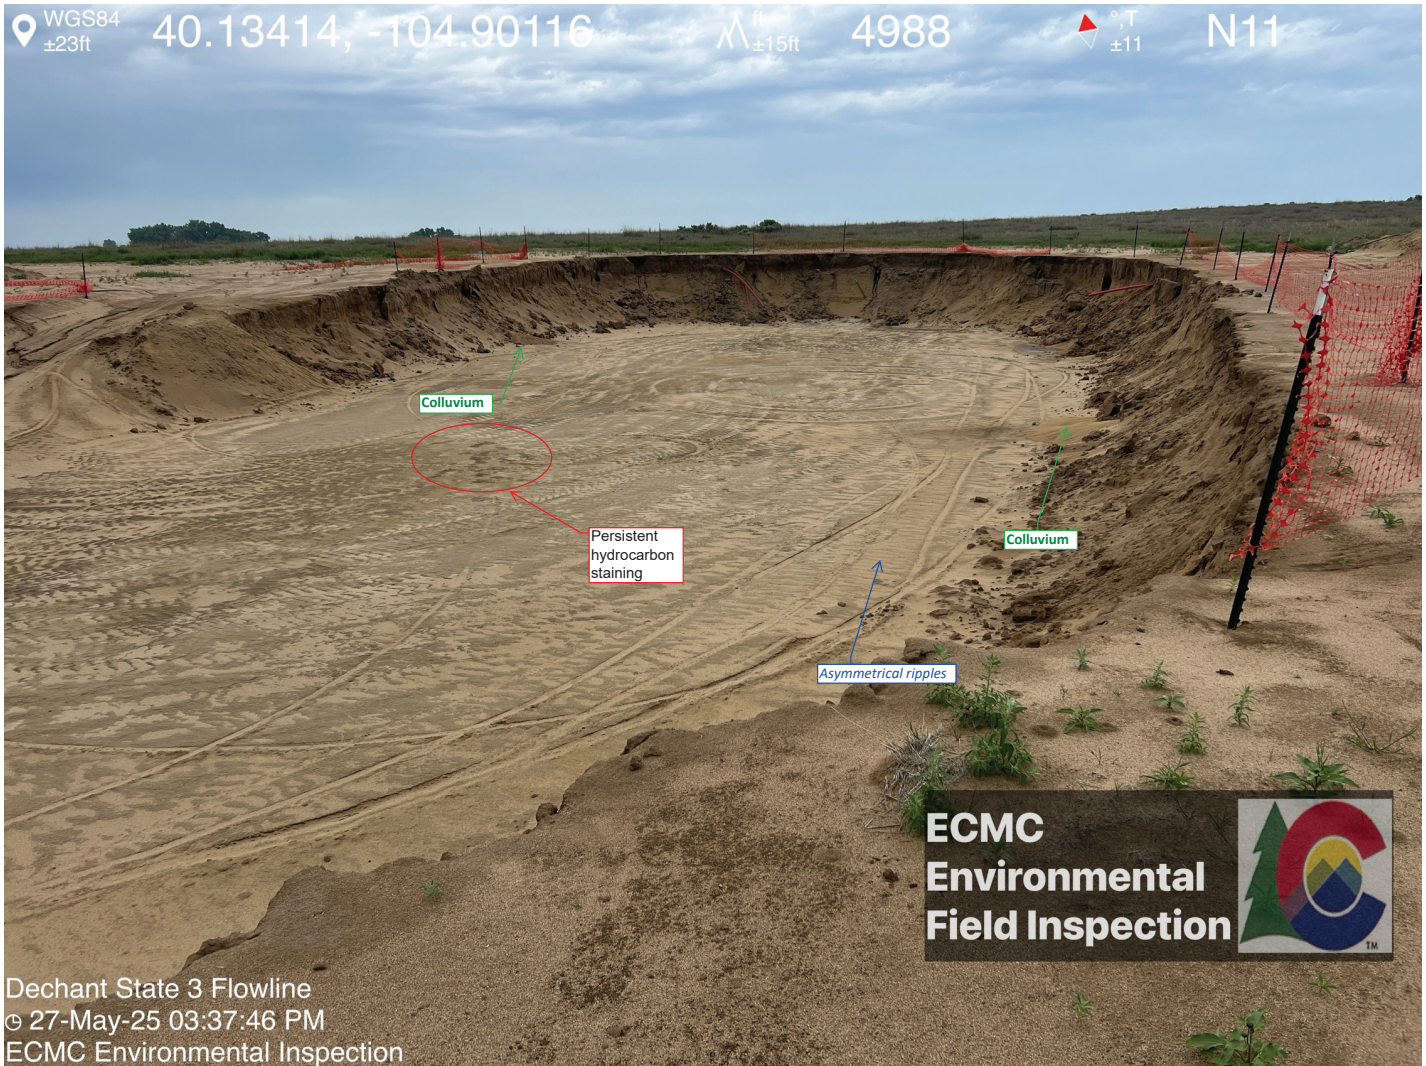
- Weeds
- Fencing downed - Fencing not appropriate for site conditions.
- Wind erosion and stormwater run-in to the open excavation has resulted in rill erosion, sidewall destabilization and collapse, and transport and accumulation of sediment (**colluvium**) within the open excavation.
- Asymmetrical ripples indicating soil has been transported across the excavation floor by wind.*

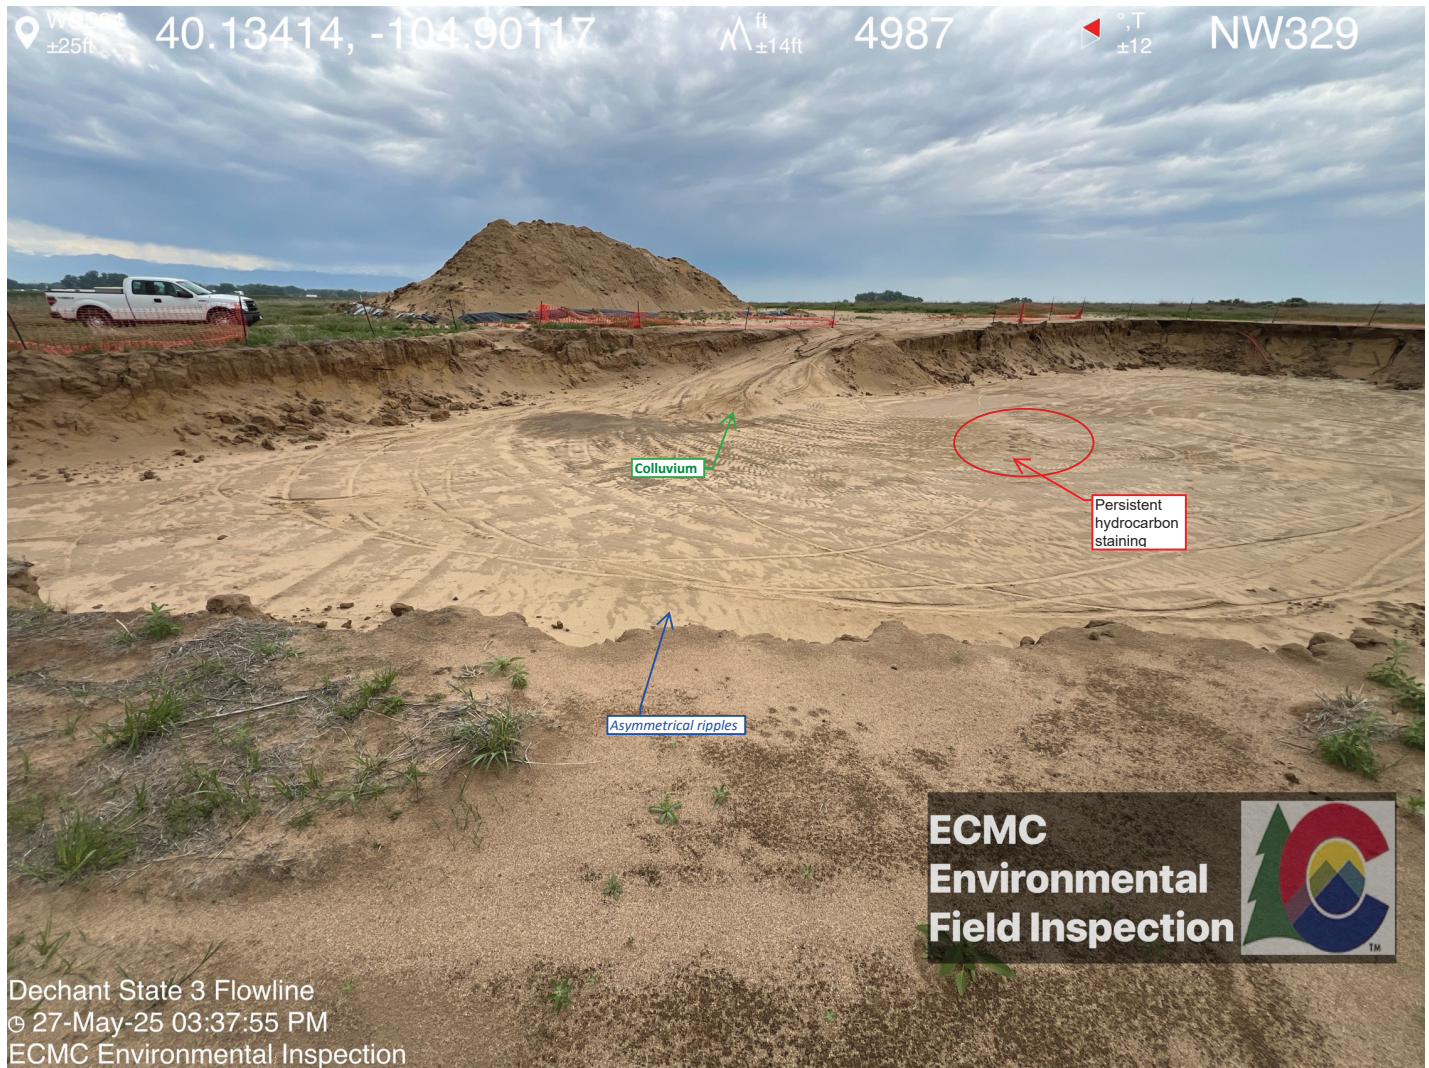
- Fencing downed - Fencing not appropriate for site conditions.
- Wind erosion and stormwater run-in to the open excavation has resulted in rill erosion, sidewall destabilization and collapse, and transport and accumulation of sediment (**colluvium**) within the open excavation.
- Asymmetrical ripples indicating soil has been transported across the excavation floor by wind.

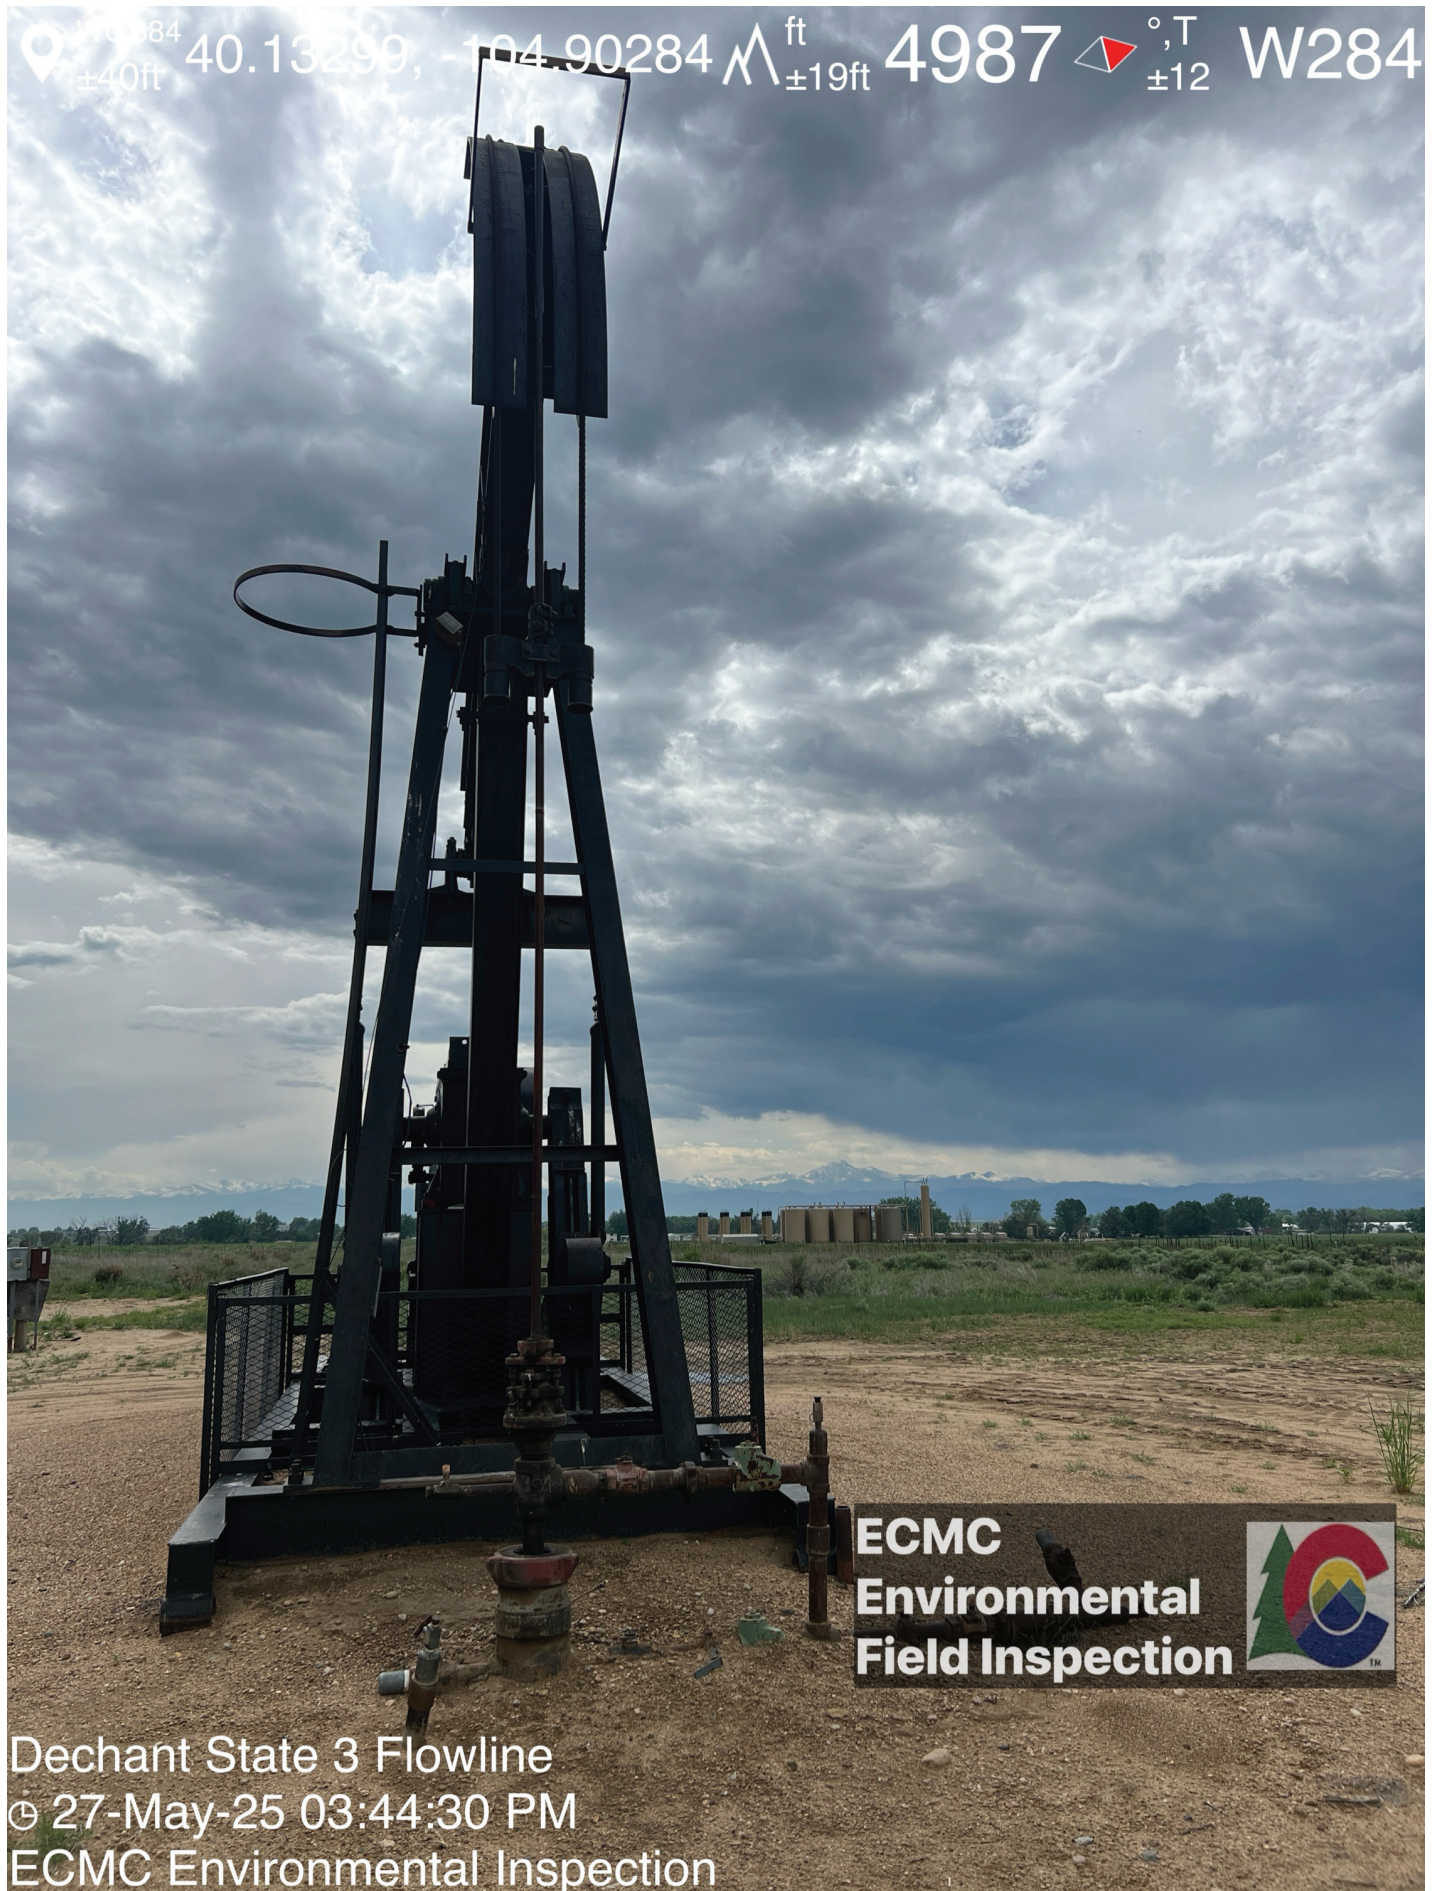
Dechant State 3 Wellhead (API 05-123-07997)
- No fencing installed.
- No signage present.
