Inspection/Audit Photos

Location Name: TEP ROCKY MOUNTAIN LLC CSF-67S91W 10NESW Pad

Location ID: 322442

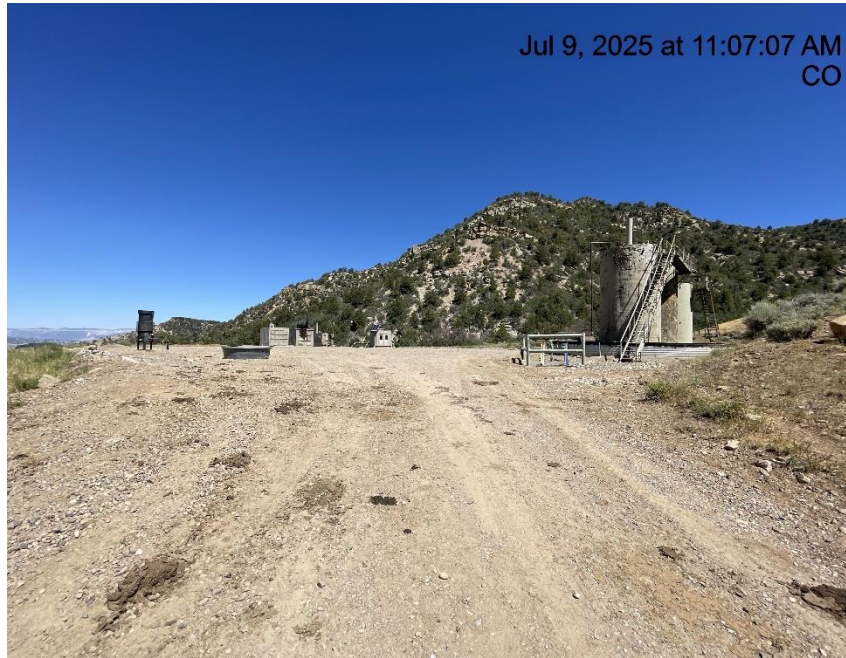
Photo # 88 From entrance to location

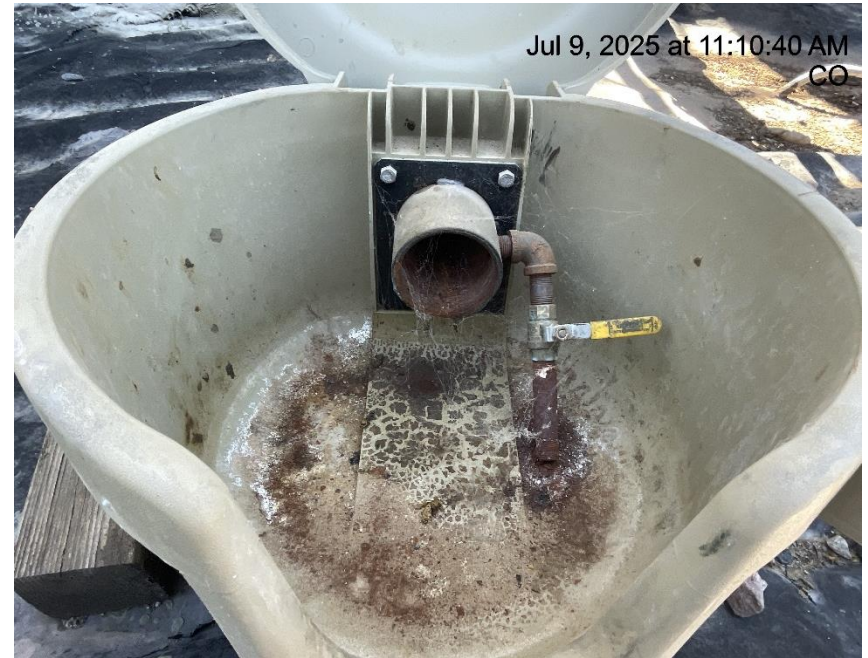
Photo # 95 Open ended load line

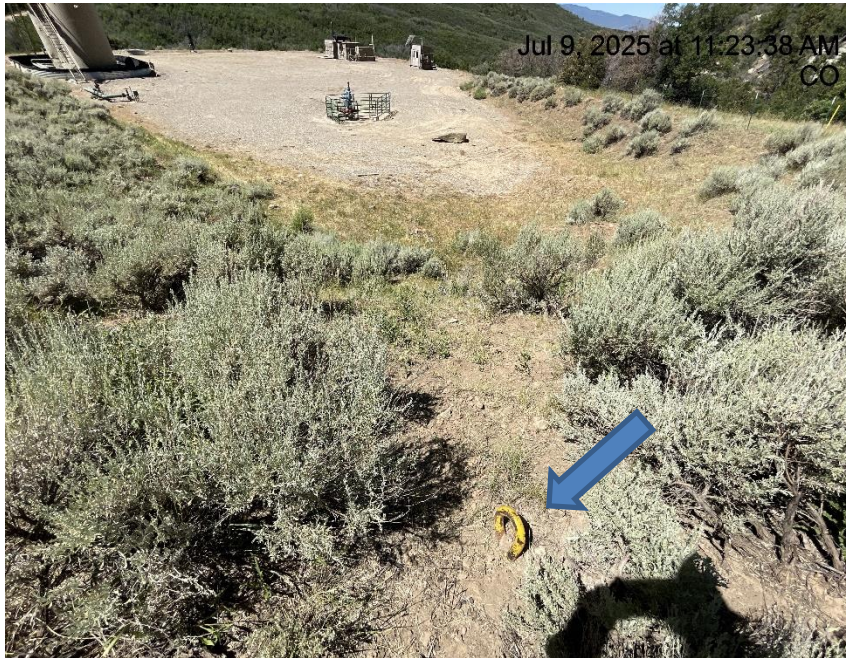
Photo # 96 Unmarked deadman

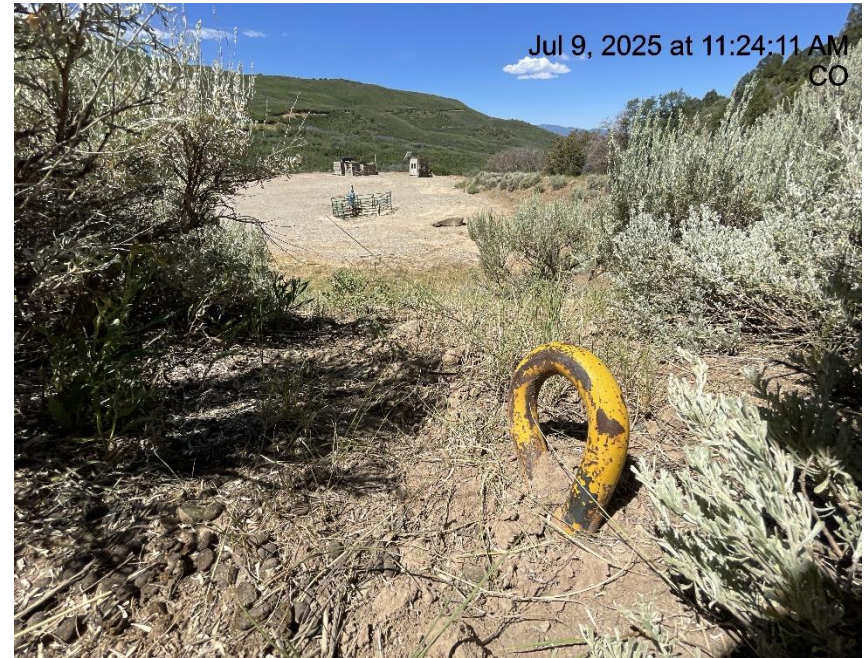
Photo # 97 Same unmarked deadman

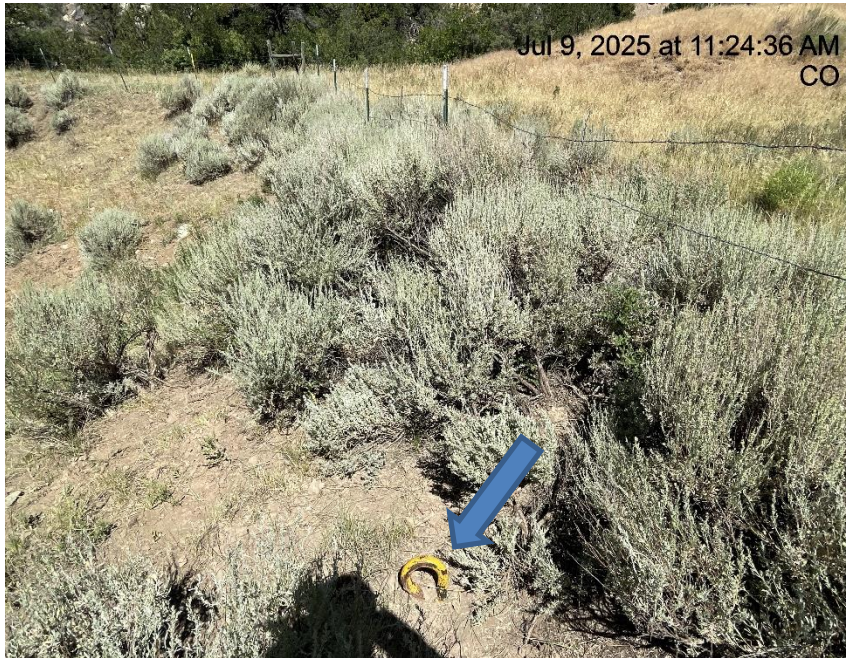
Photo # 98 Same unmarked deadman

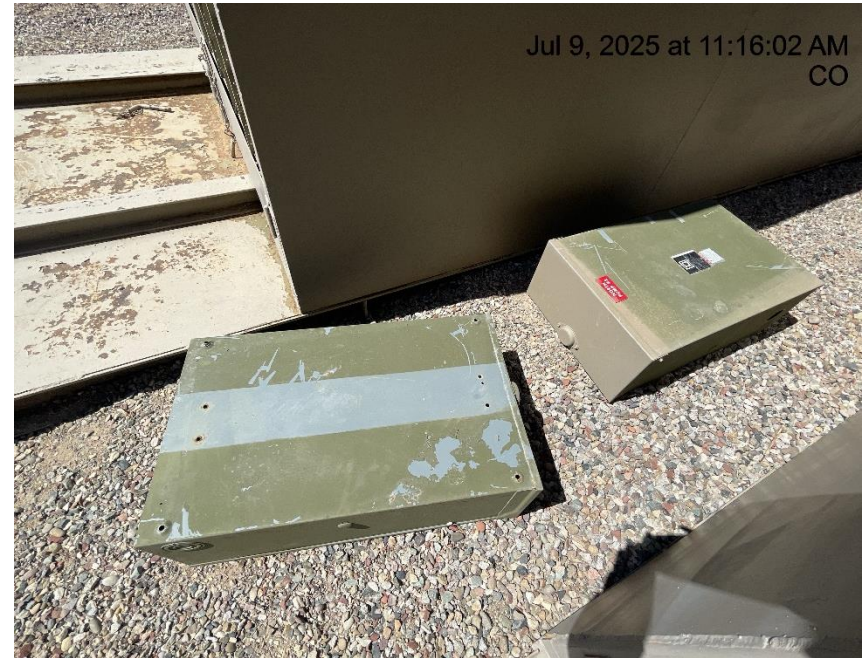
Photo # 99 Debris

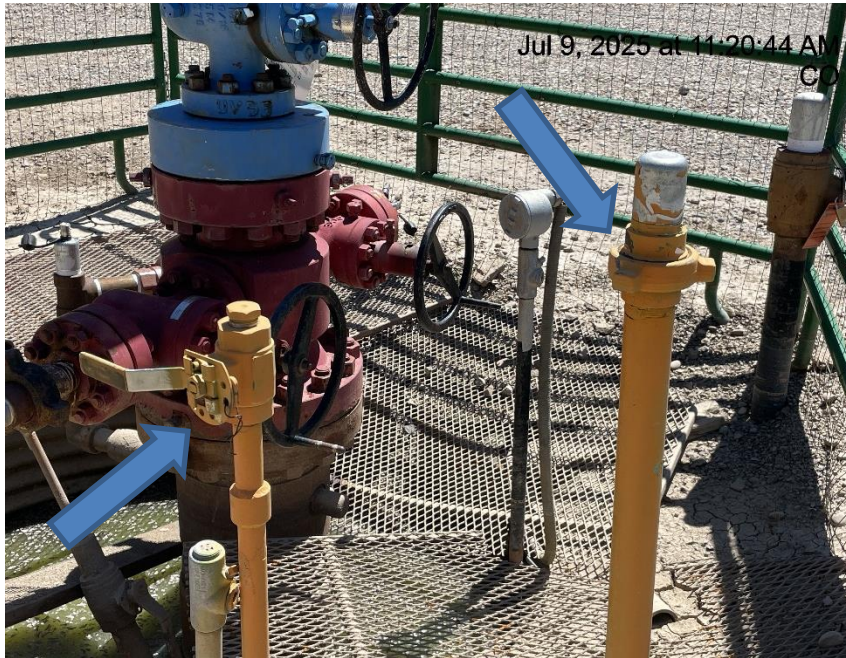
Photo # 100 Unused flowlines lack lockout tagout (OOSLAT)

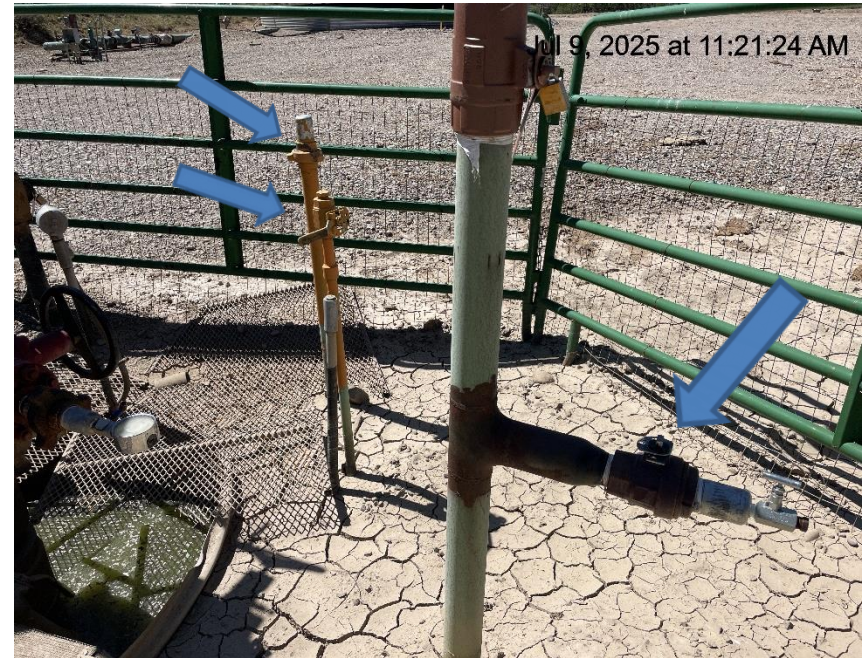
Photo # 101 Unused flowlines lack lockout tagout (OOSLAT)

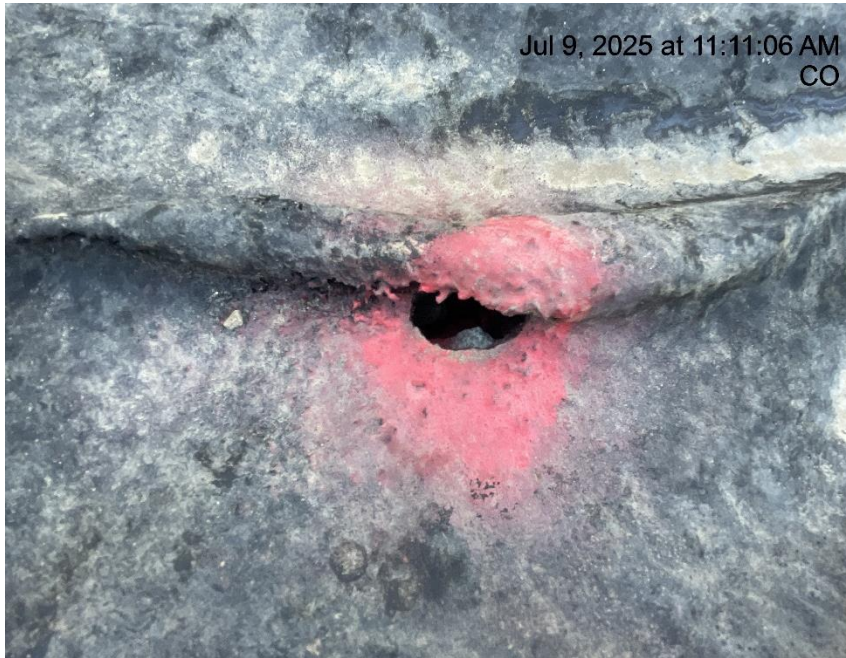
Photo # 102 Hole in liner/liner needs maintenance

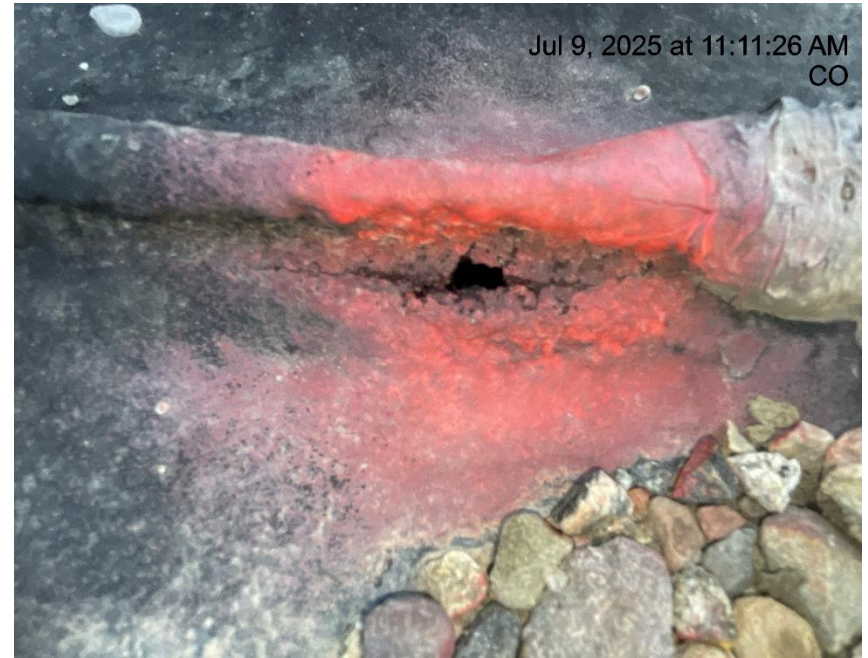
Photo # 103 Hole in liner/liner needs maintenance

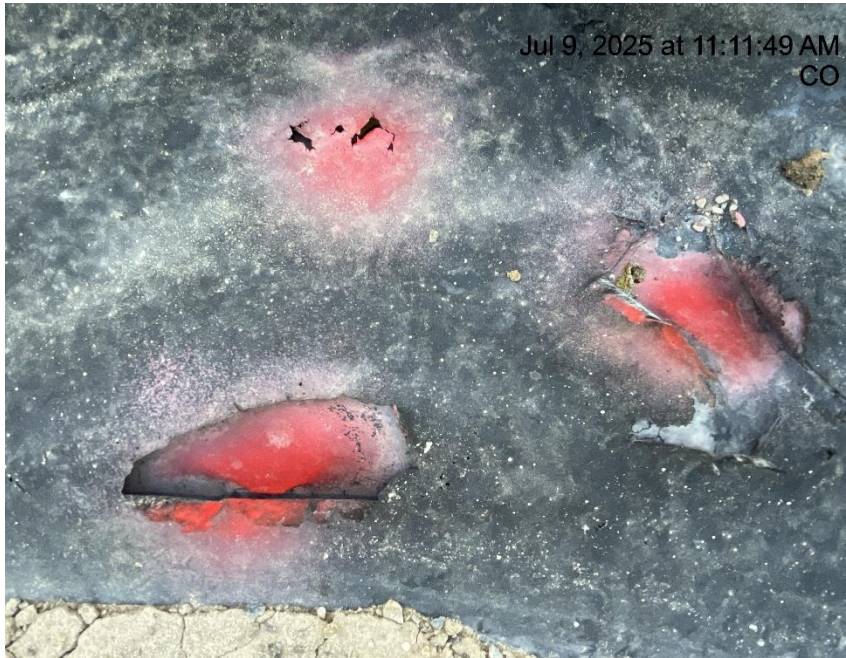
Photo # 104 Holes in liner/liner needs maintenance

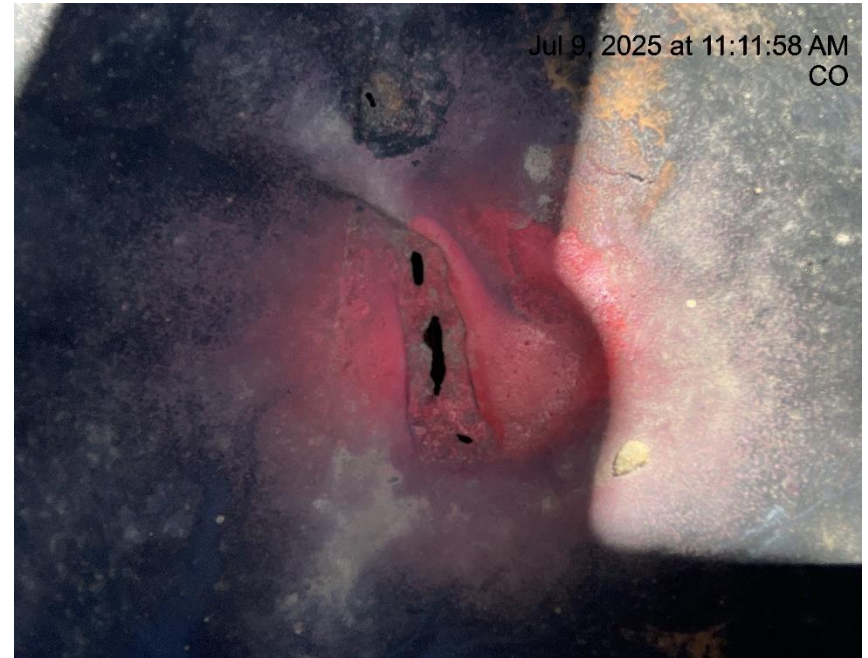
Photo # 105 Hole in liner/liner needs maintenance

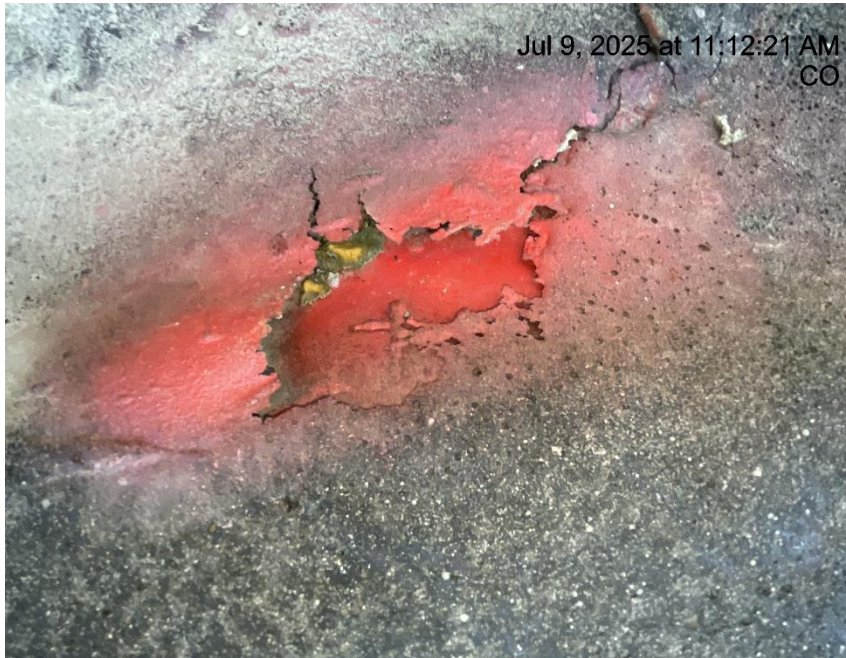
Photo # 106 Hole in liner/liner needs maintenance

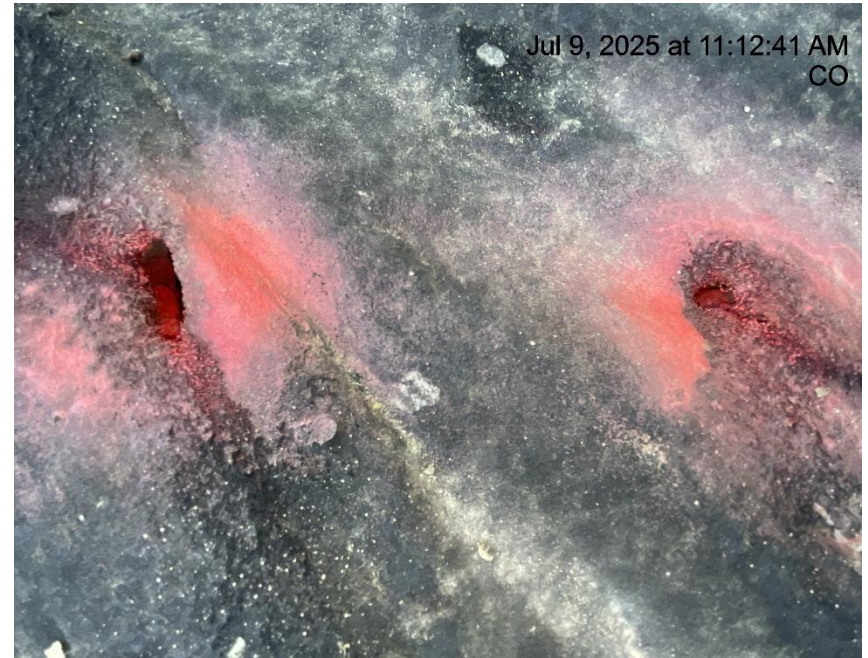
Photo # 107 Holes in liner/liner needs maintenance

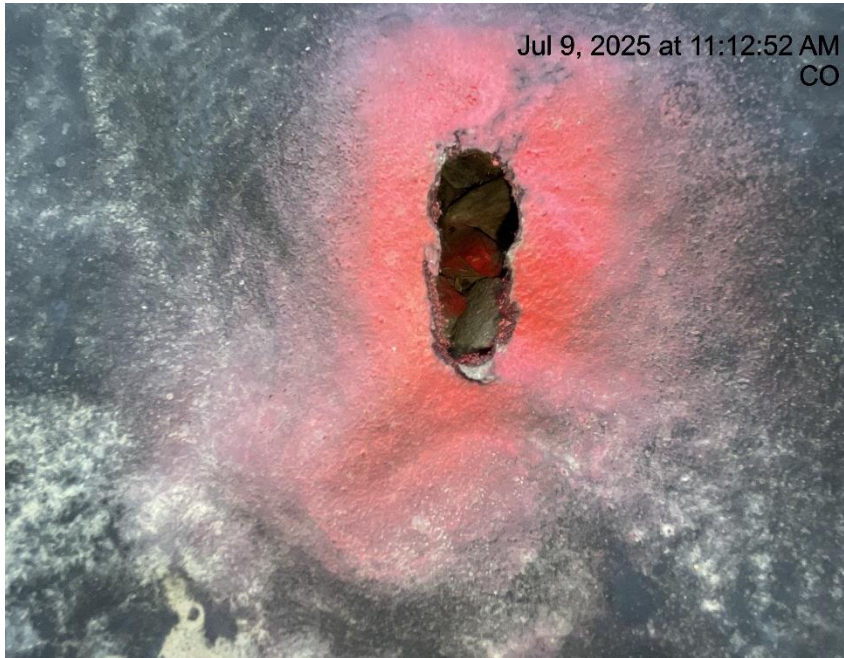
Photo # 108 Hole in liner/liner needs maintenance

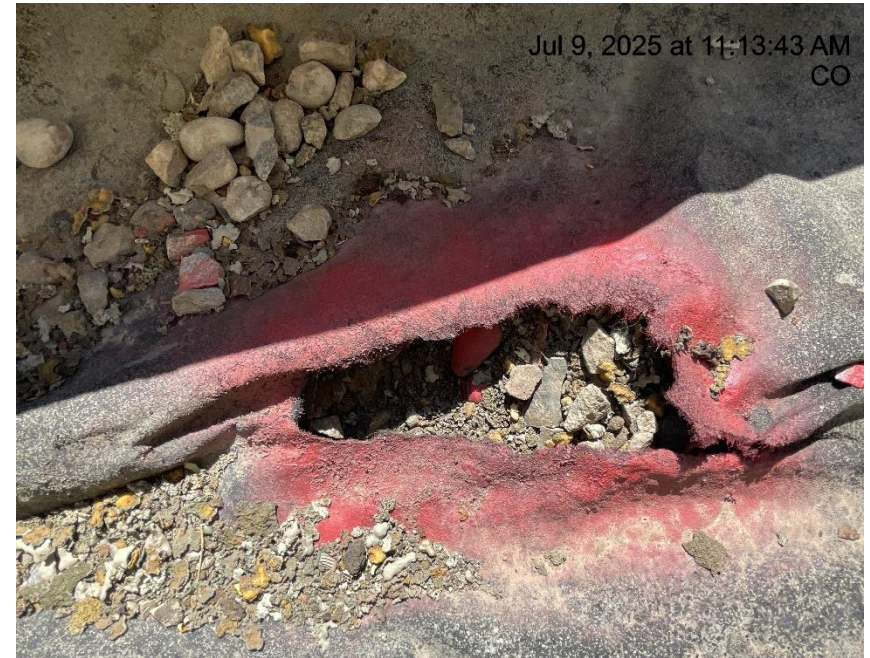
Photo # 109 Hole in liner/liner needs maintenance

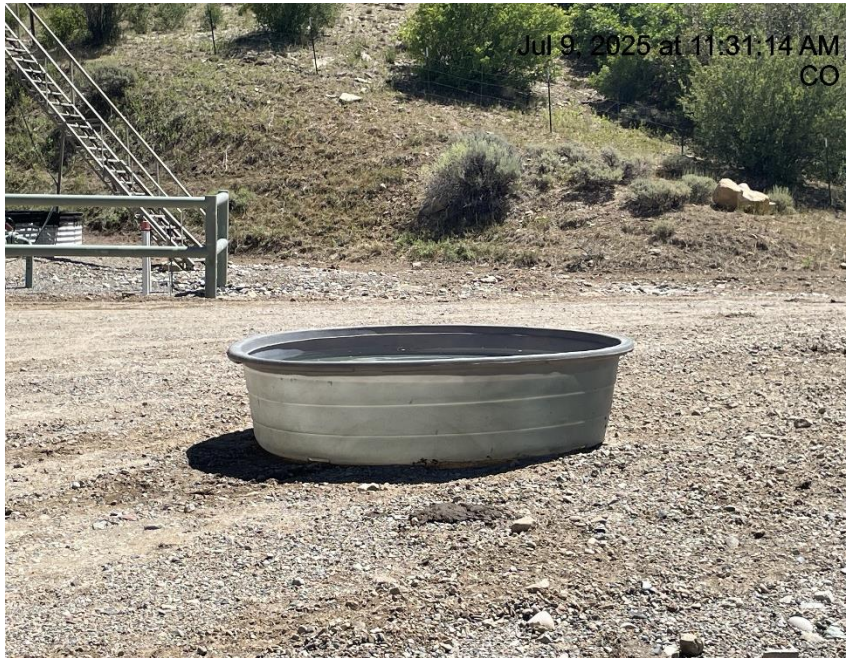
Photo # 110 Debris

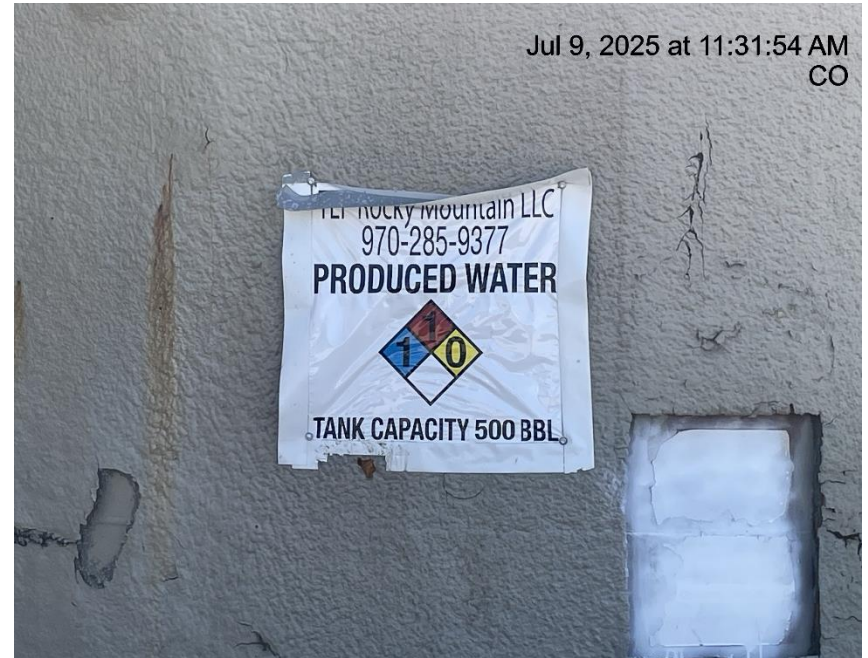
Photo # 111 Tank label starting to peel
