Inspection Photos

Operator: QB ENERGY OPERATING LLC

Location ID: 334844

Inspection Doc: 719200023

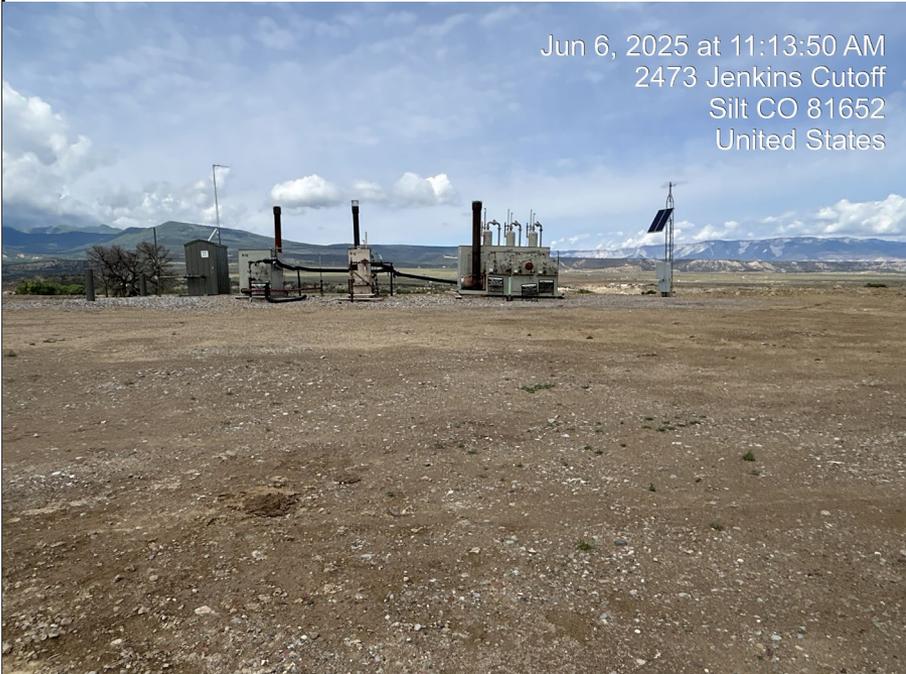
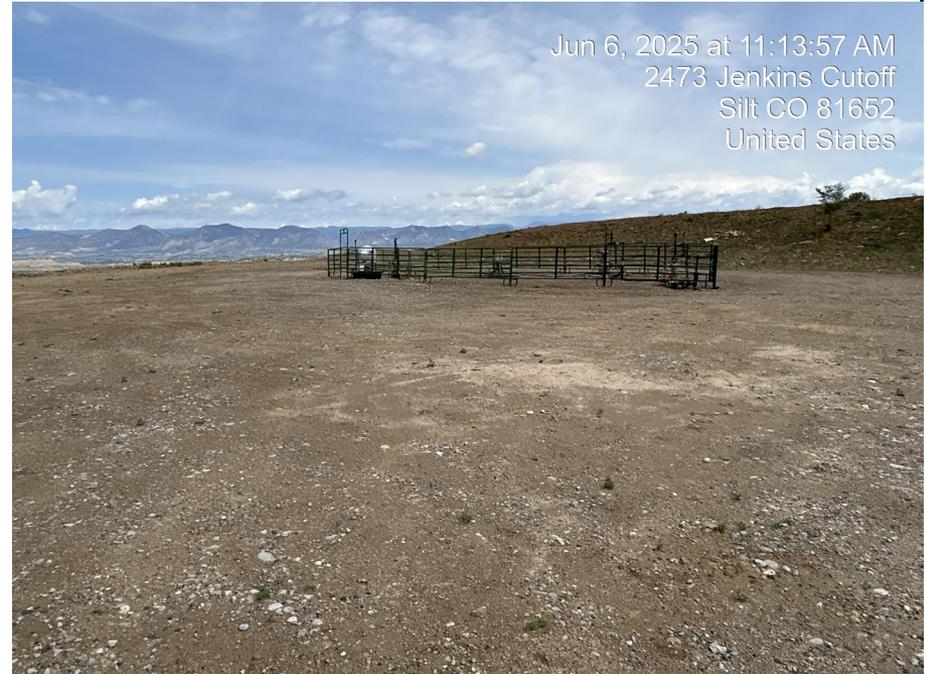
Photo 1: Photos taken from the central portion of the Location and provide an overview looking west and north, respectively.

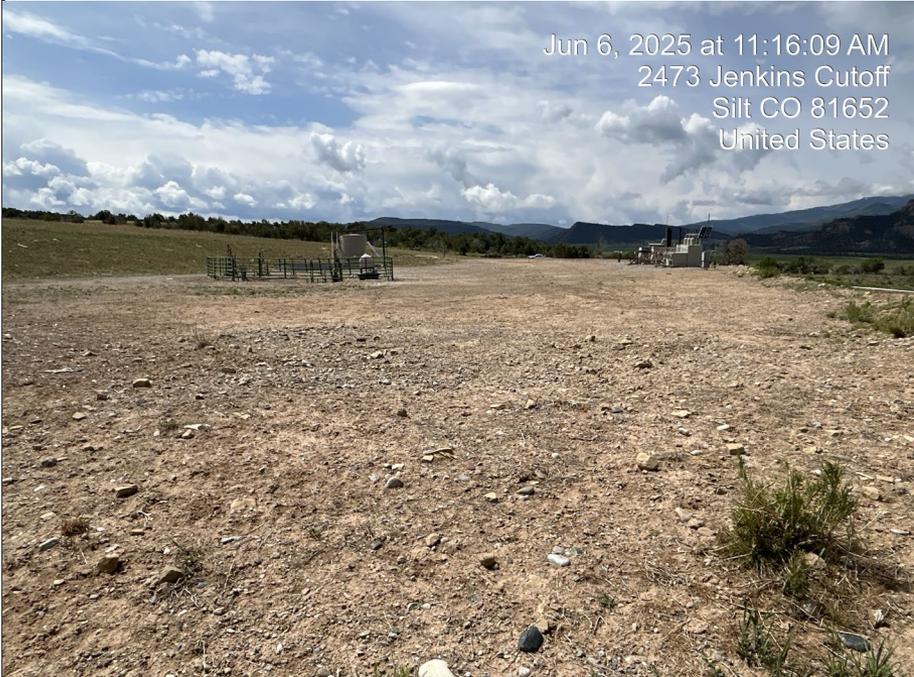
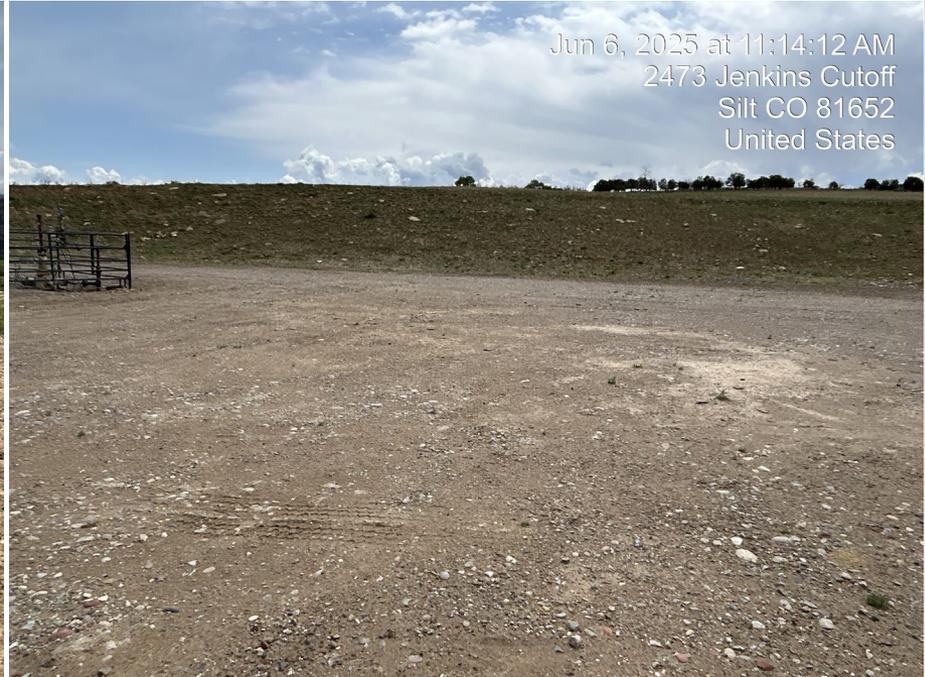
Photo 2: Photos taken from the central portion of the Location looking south and east, respectively.

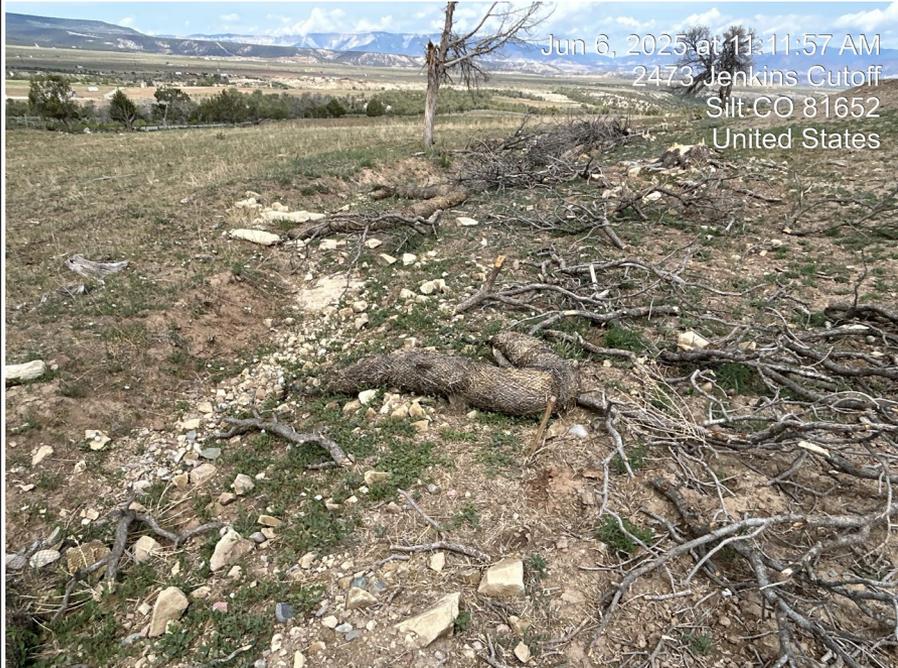
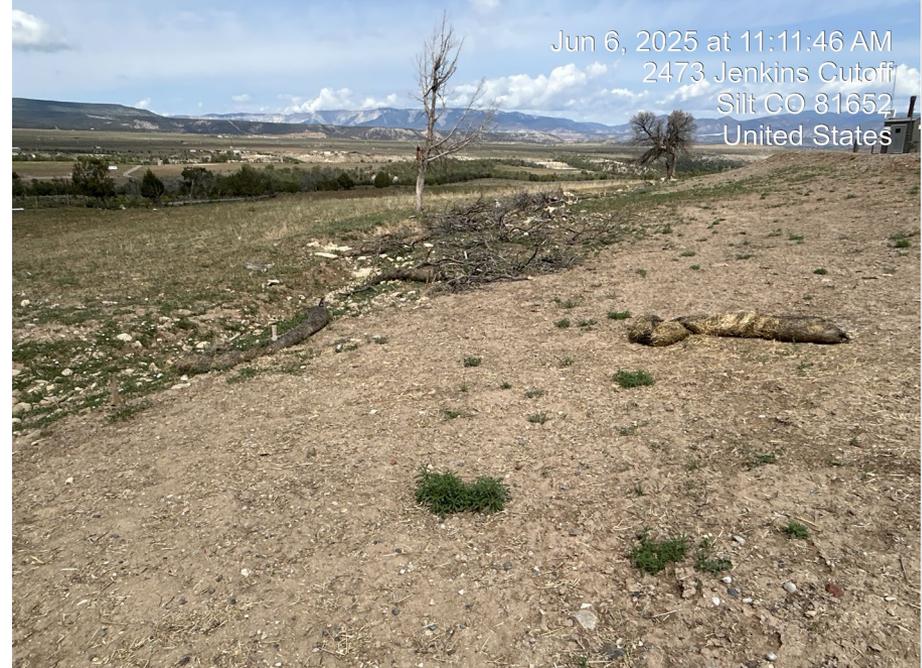
Photo 3: Photo taken from the western perimeter of the Location. Damaged, unused wattles are present. Comply with Rule 606.a and remove debris.

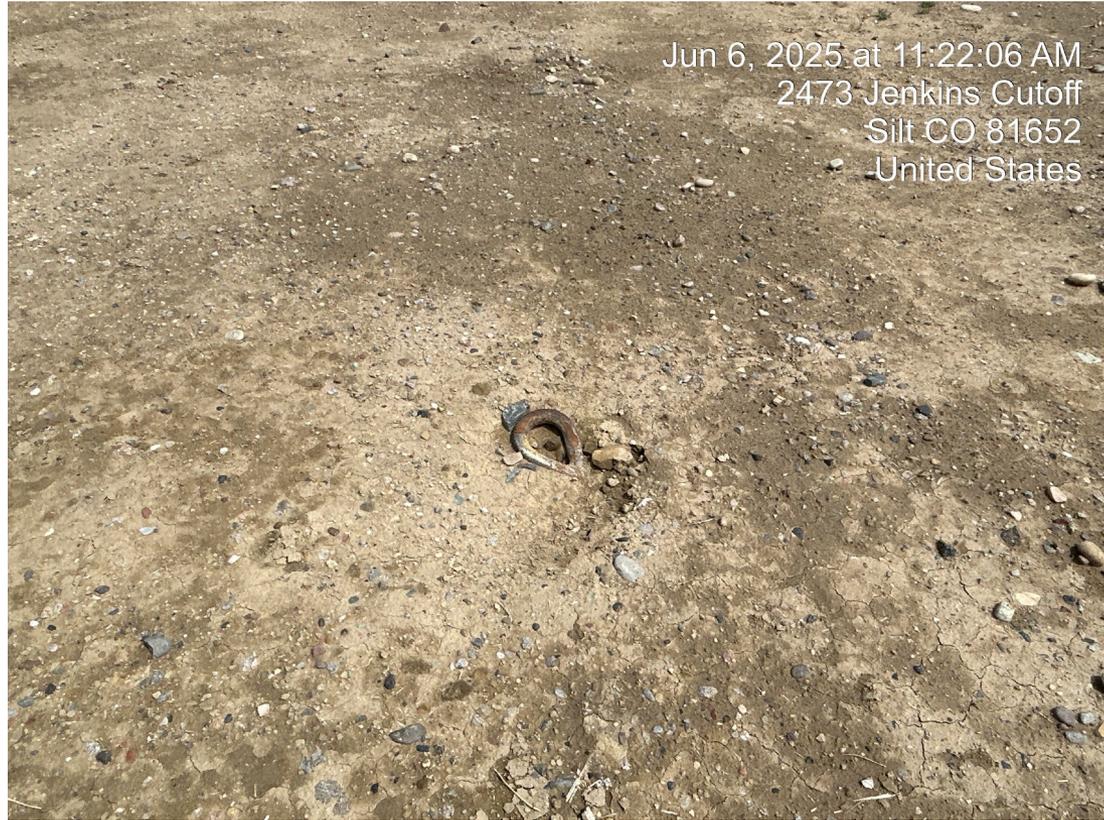
Photo 4: Photo taken from the west-central portion of the Location. An unused guy-line anchor is present. Comply with Rule 606.a and remove unused equipment.

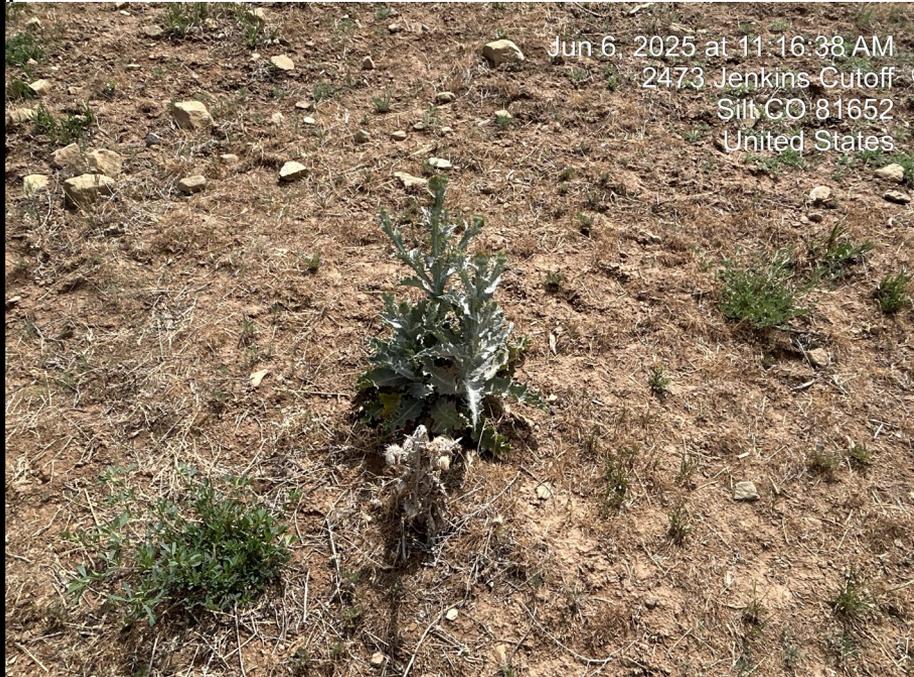
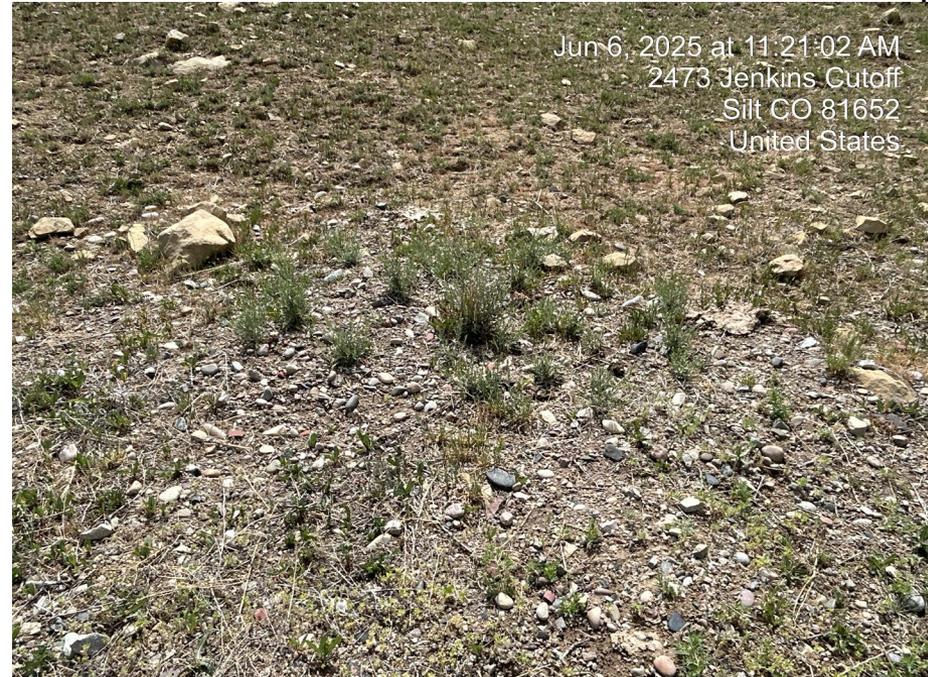
Photo 5: Photos taken at the northern and southwest portions of the Location, respectively. Undesireable weeds like plumeless thistle (left) and Russian knapweed (right) are present in the interim areas. Comply with Rule 606.a and remove undesirable plant species.

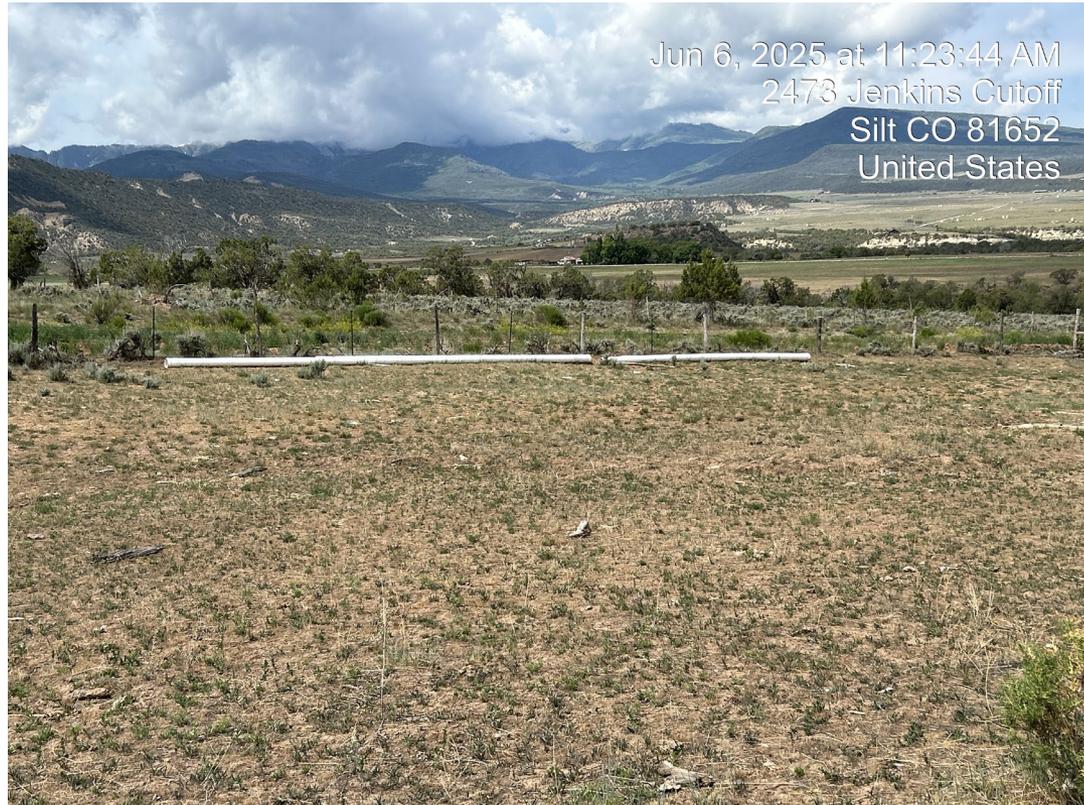
Photo 6: Photos showing unused pipe equipment near the southwestern fence line. Comply with Rule 606.a and remove unused equipment.

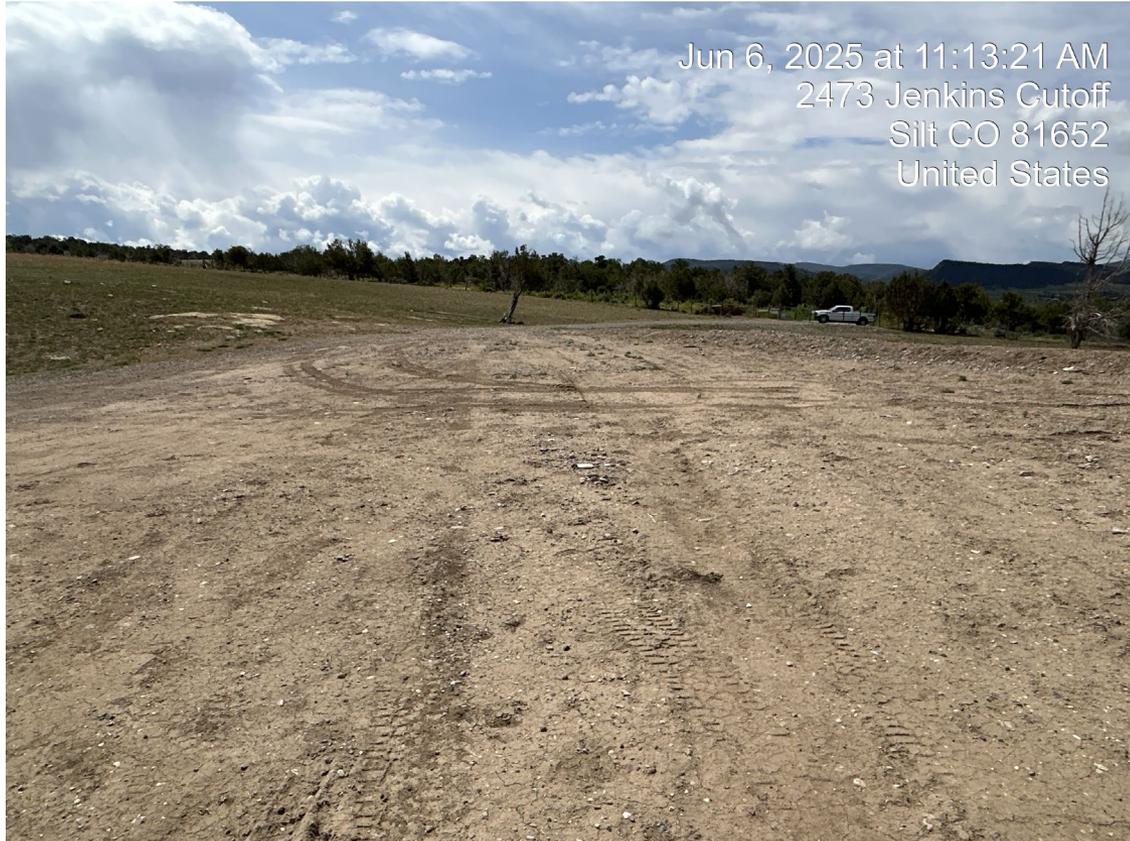
Photo 7: Light sediment tracking was observed throughout the pad. It is recommended that BMPs be maintained to reduce sediment transport off of the Location.

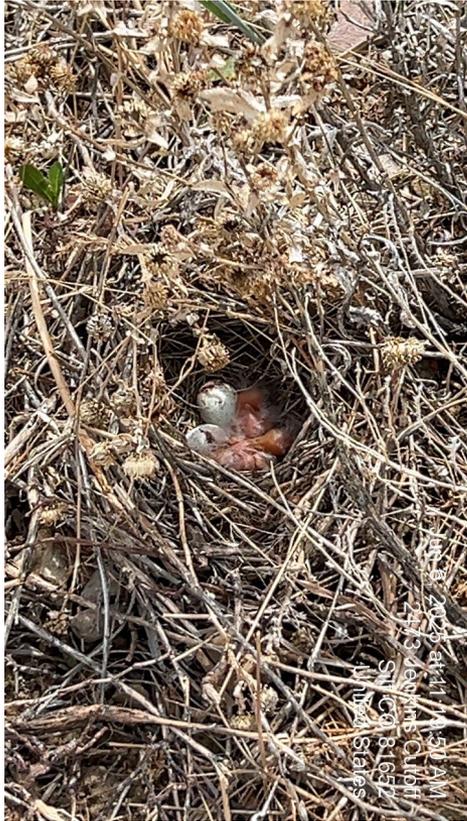
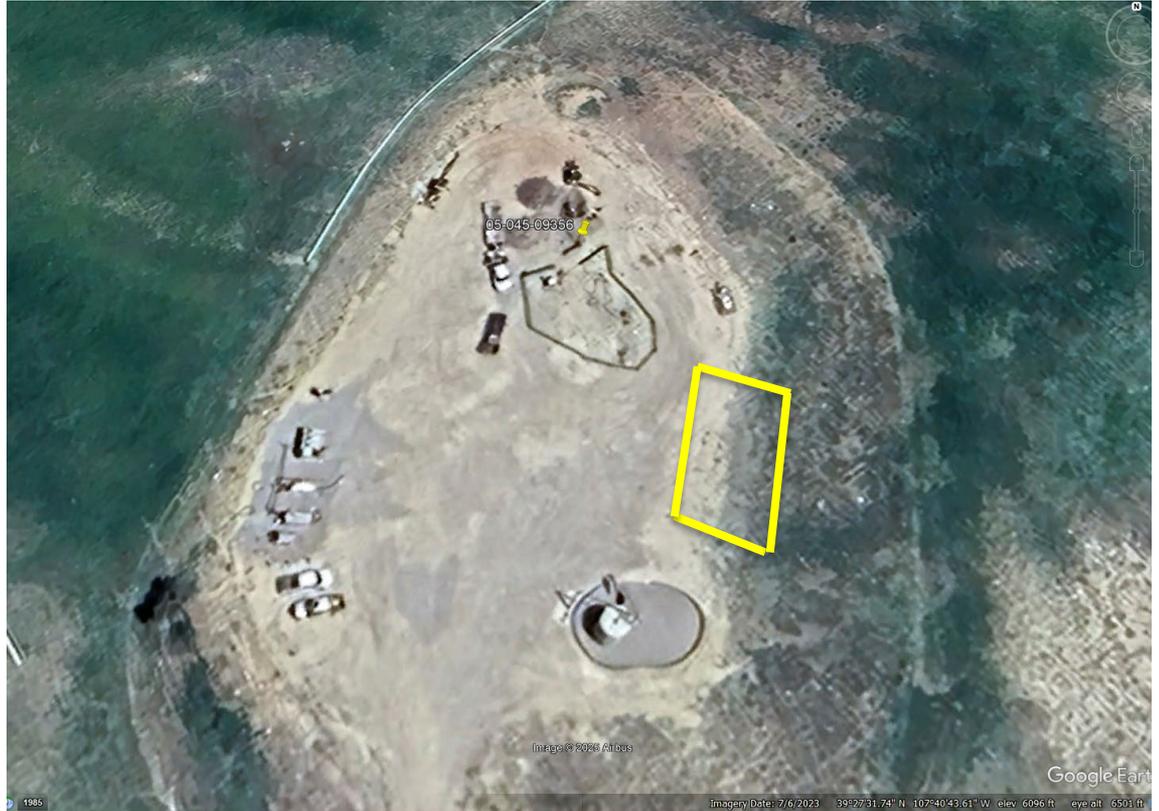
Photo 8: An active ground nest, likely a western meadowlark, was observed on the edge of the eastern cut slope, shown in the yellow highlighted area.
