OWN RESOURCES OPERATING
WELP 10-16
SESE SEC. 10
R0 28 & RD Y, N 1/4 SW 1/8 N10
YUMA COUNTY, CO
WELP 10-16

ECMC
Environmental
Field Inspection

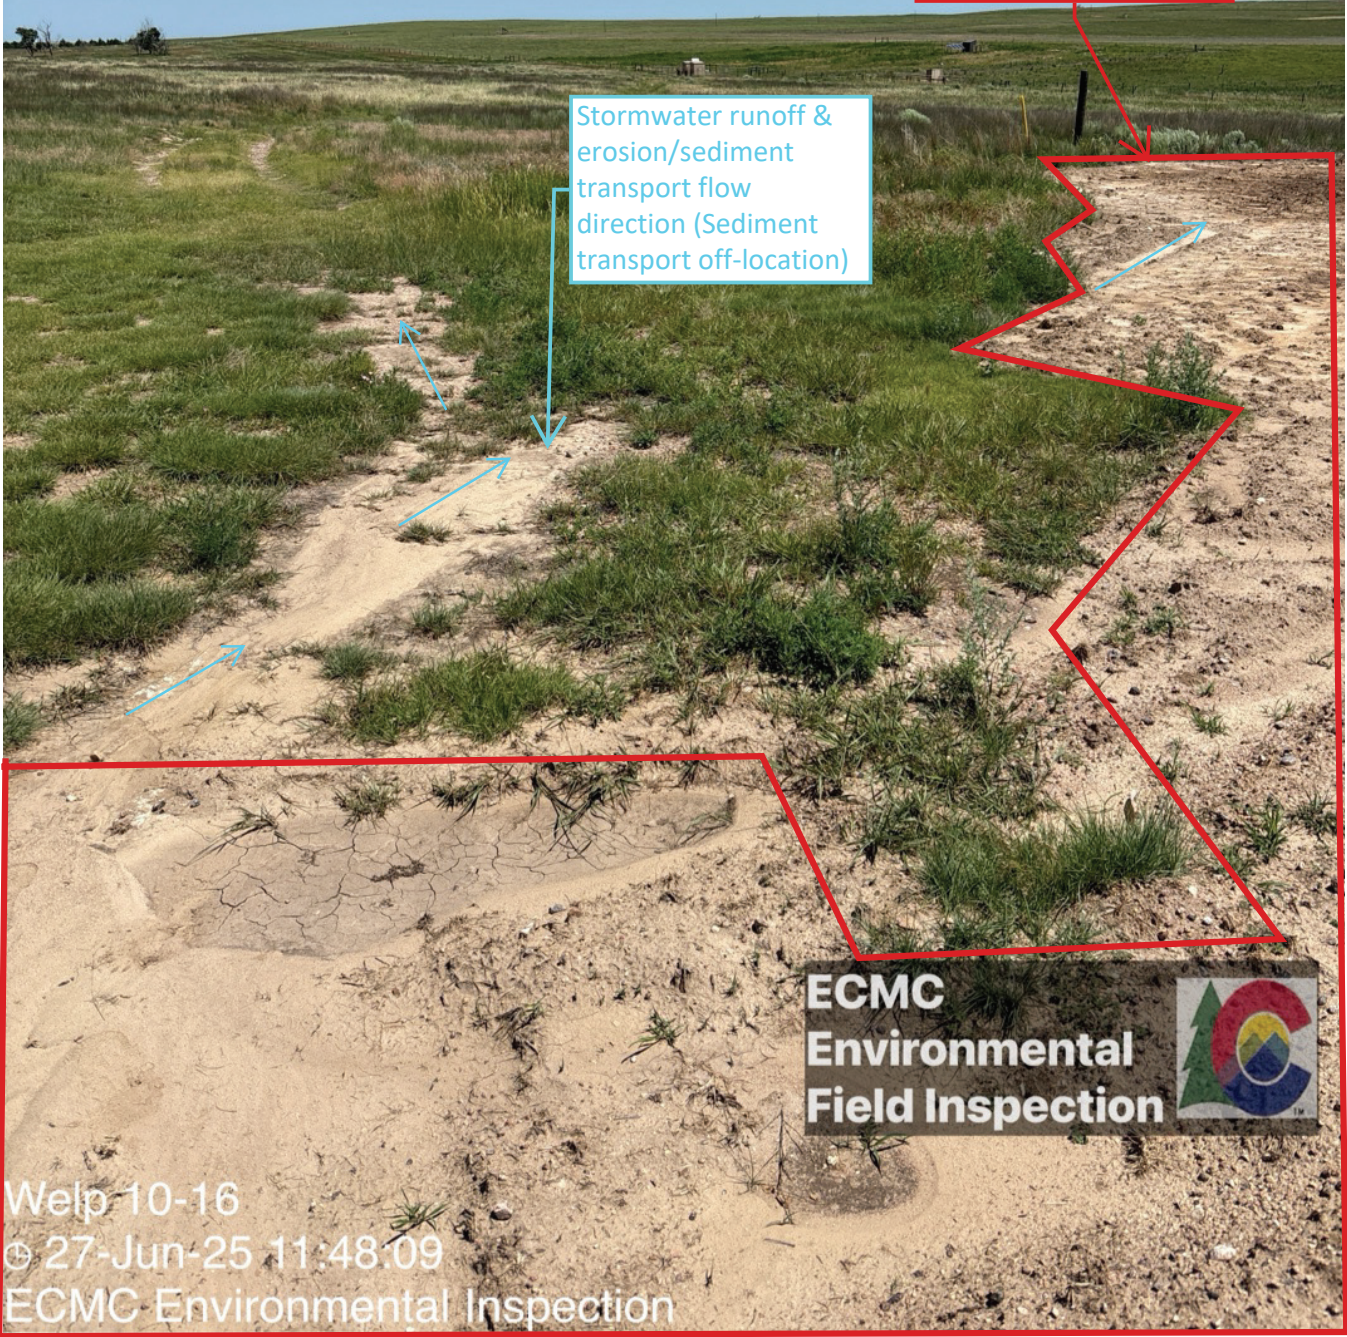
Approximated area immediately downgradient of source which appears disturbed by remediation of Spill ID 490244 based on loose/uncompacted soil susceptible to erosion & sediment transport

Approximate source area - Appears relatively undisturbed

Approximated area downgradient of source which appears to have been disturbed by remediation of Spill ID 490244 based on loose/uncompacted & stained soil susceptible to erosion & sediment transport

Stormwater runoff & erosion/sediment transport flow direction (Sediment transport off-location)

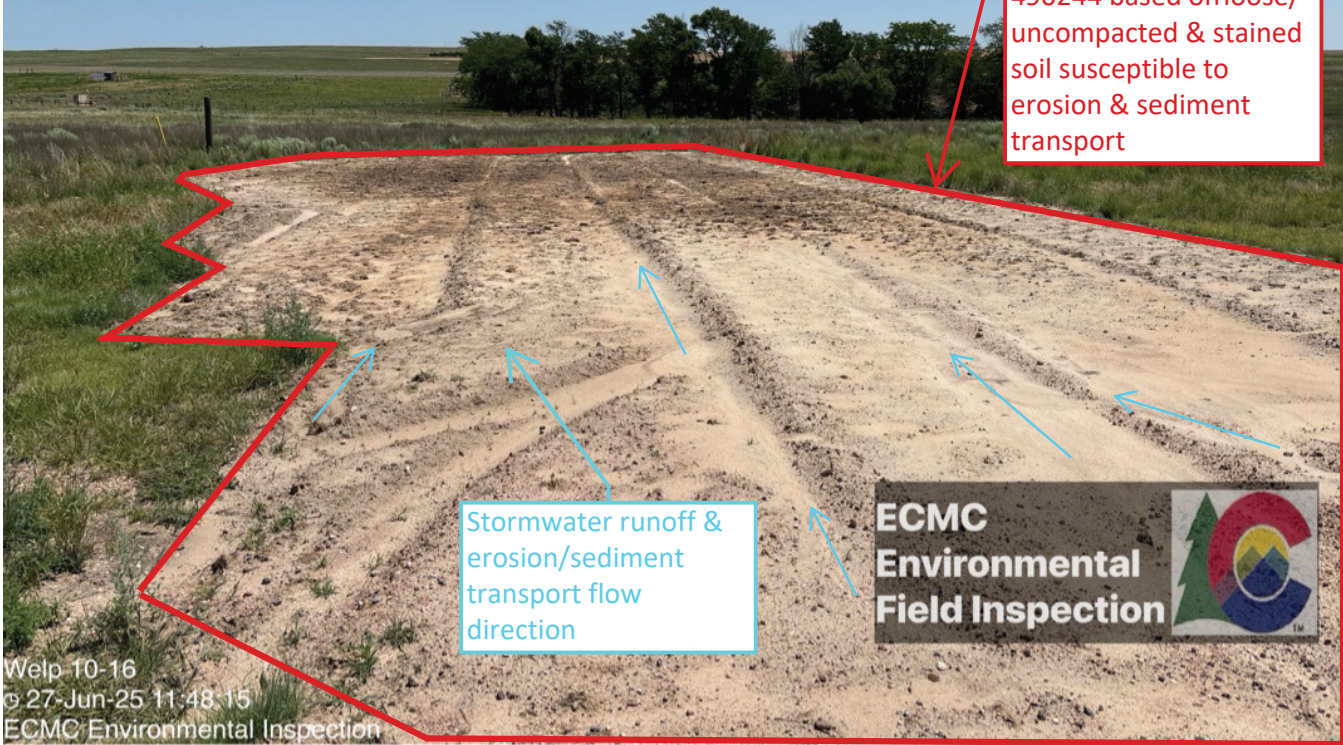
Approximated area
downgradient of source
which appears to have
been disturbed by
remediation of Spill ID
490244 based on loose/
uncompacted & stained
soil susceptible to
erosion & sediment
transport

Stormwater runoff &
erosion/sediment
transport flow
direction

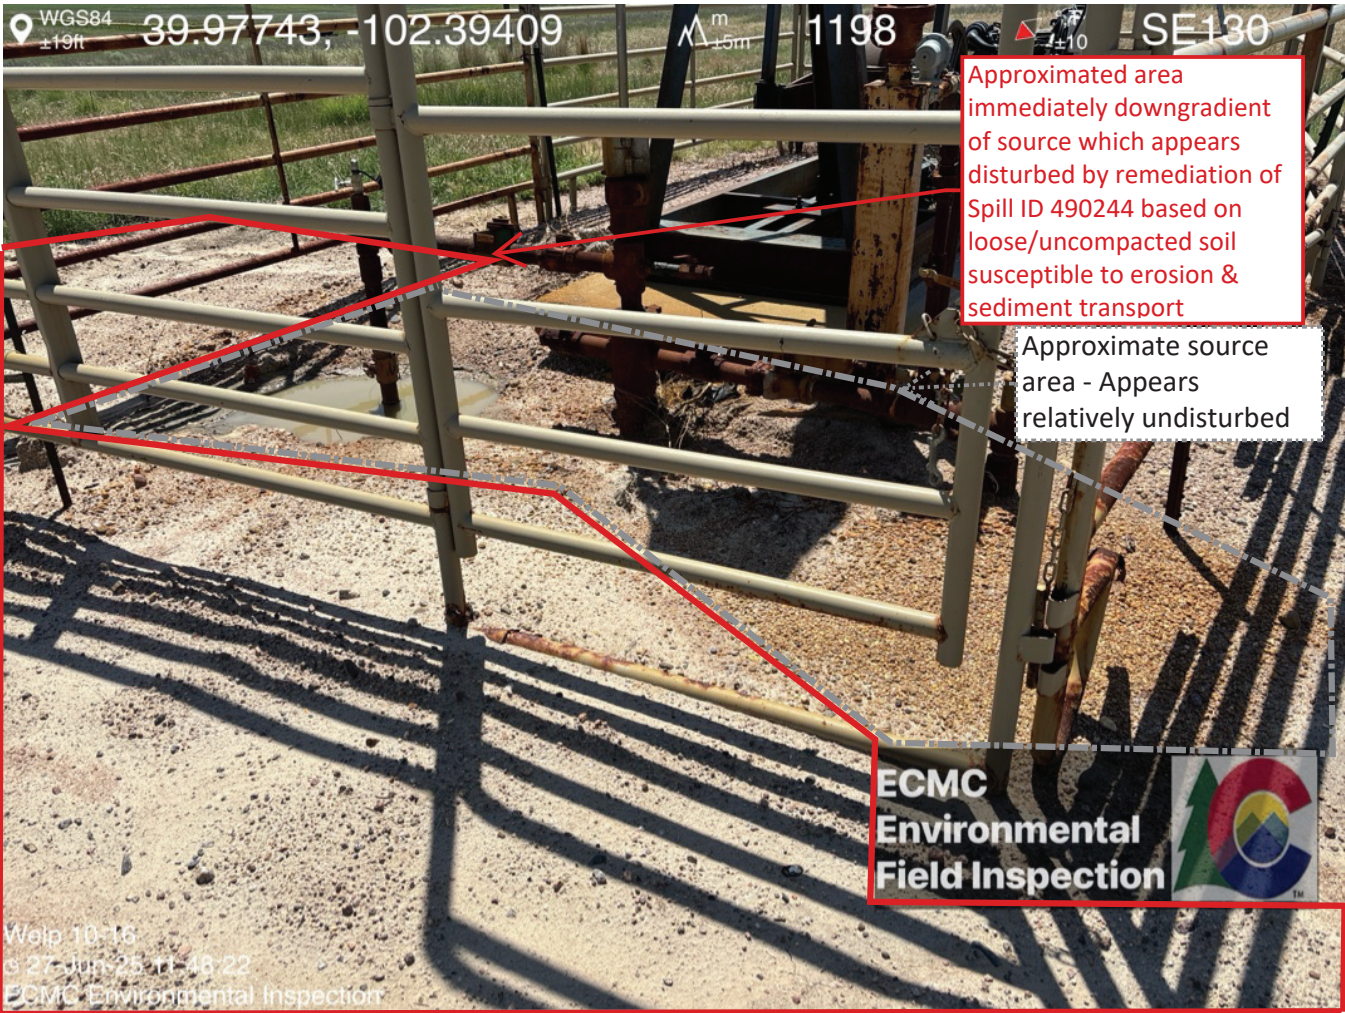
Approximated area immediately downgradient of source which appears disturbed by remediation of Spill ID 490244 based on loose/uncompacted soil susceptible to erosion & sediment transport

Approximate source area - Appears relatively undisturbed

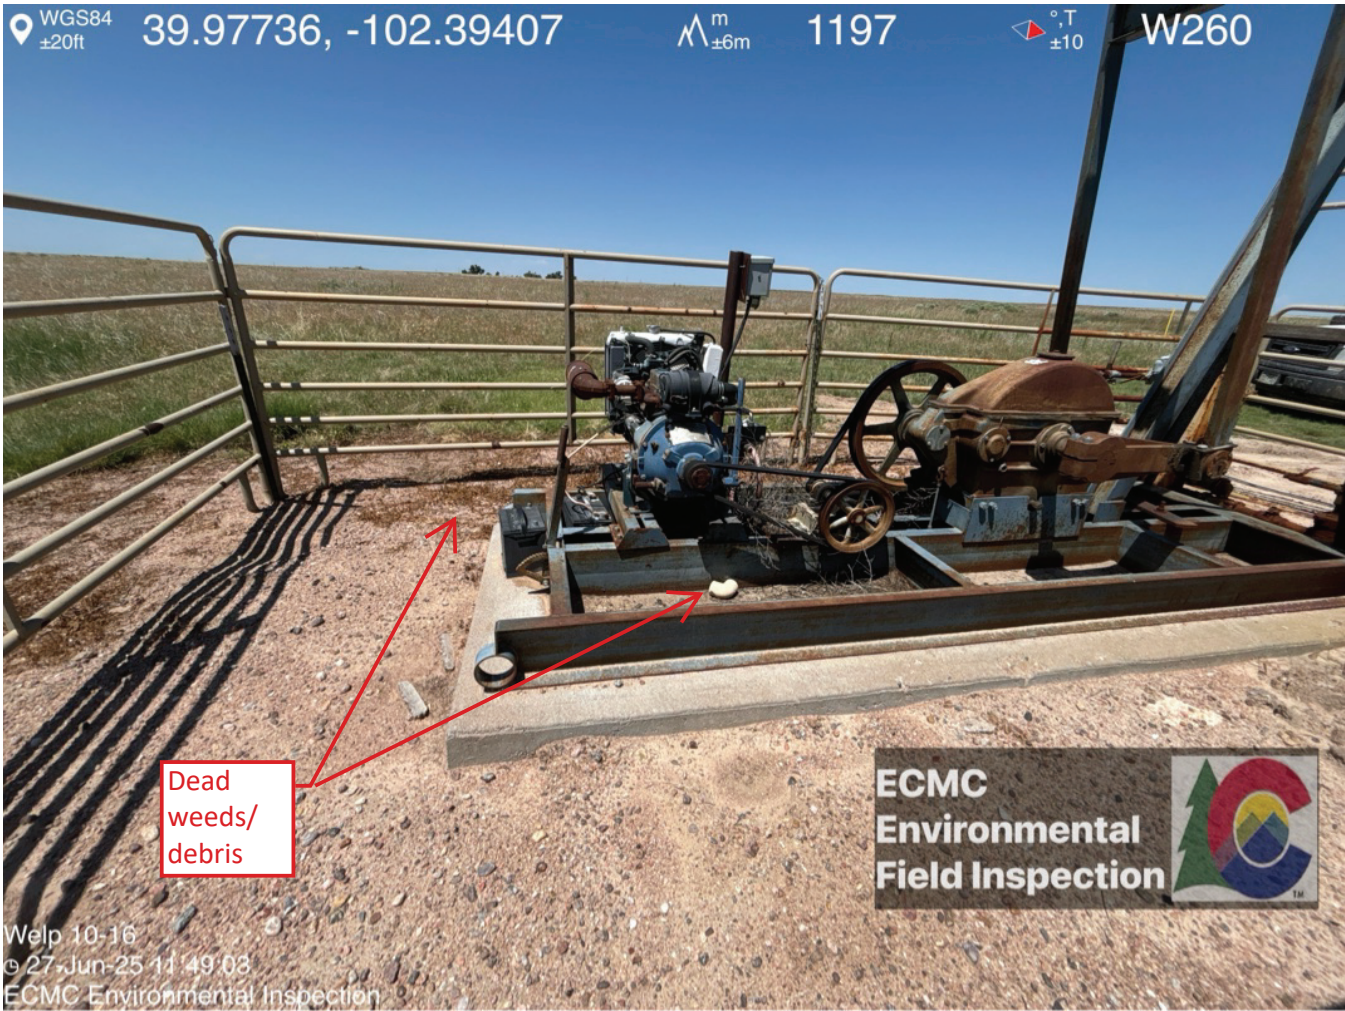
Dead
weeds/
debris

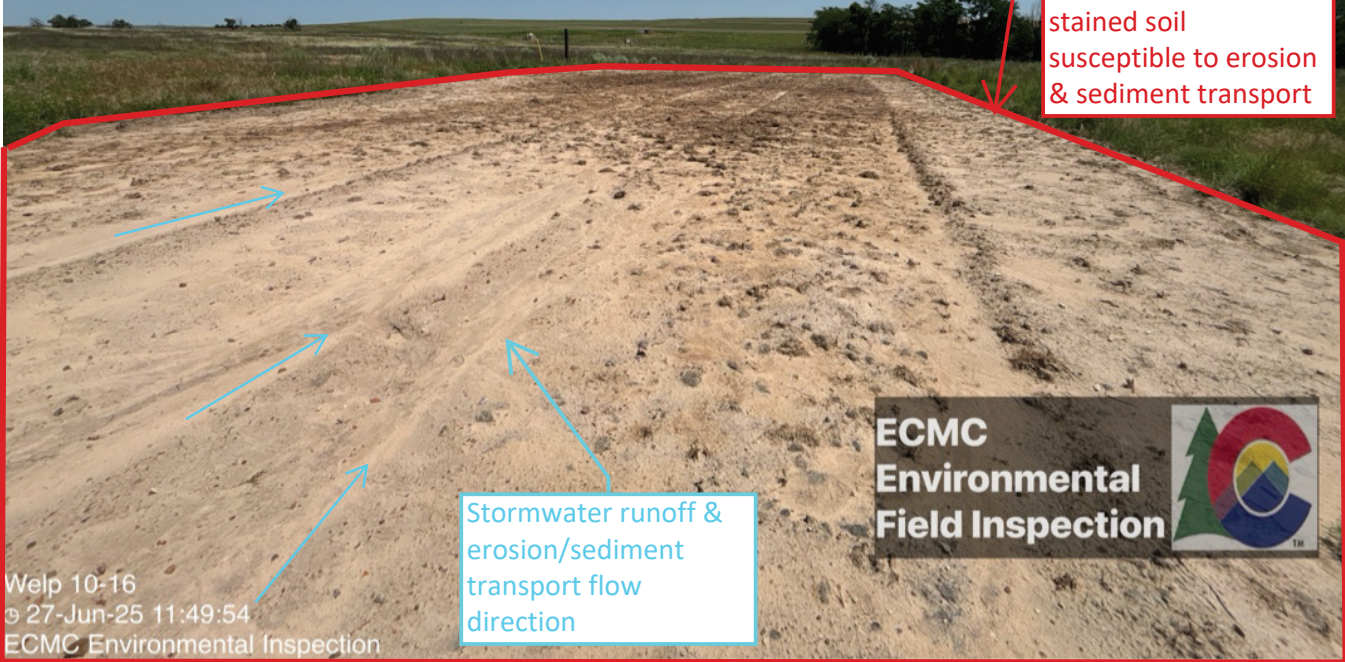
Approximated area
downgradient of
source which appears
to have been
disturbed by
remediation of Spill ID
490244 based on
loose/uncompacted &
stained soil
susceptible to erosion
& sediment transport

Stormwater runoff &
erosion/sediment
transport flow
direction

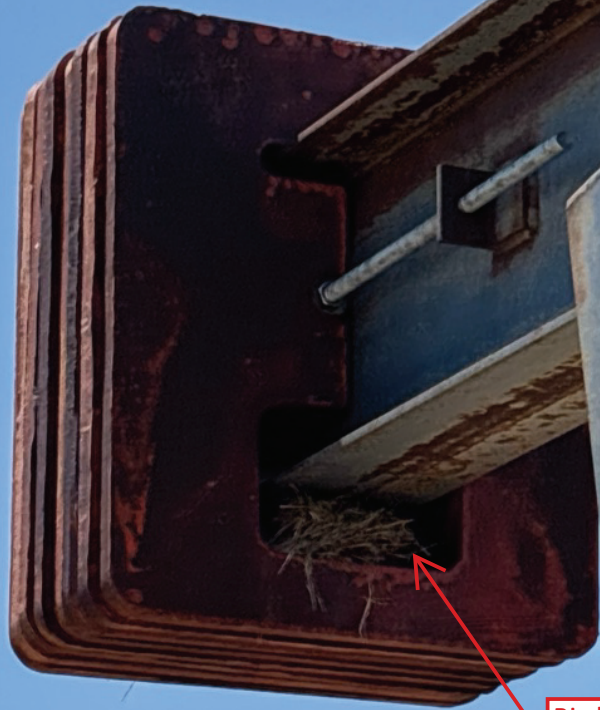
Bird nest in counterweight
