ECMC
Environmental
Field Inspection

Greenfield 15-12
© 27-Jun-25 11:16:53
ECMC Environmental Inspection

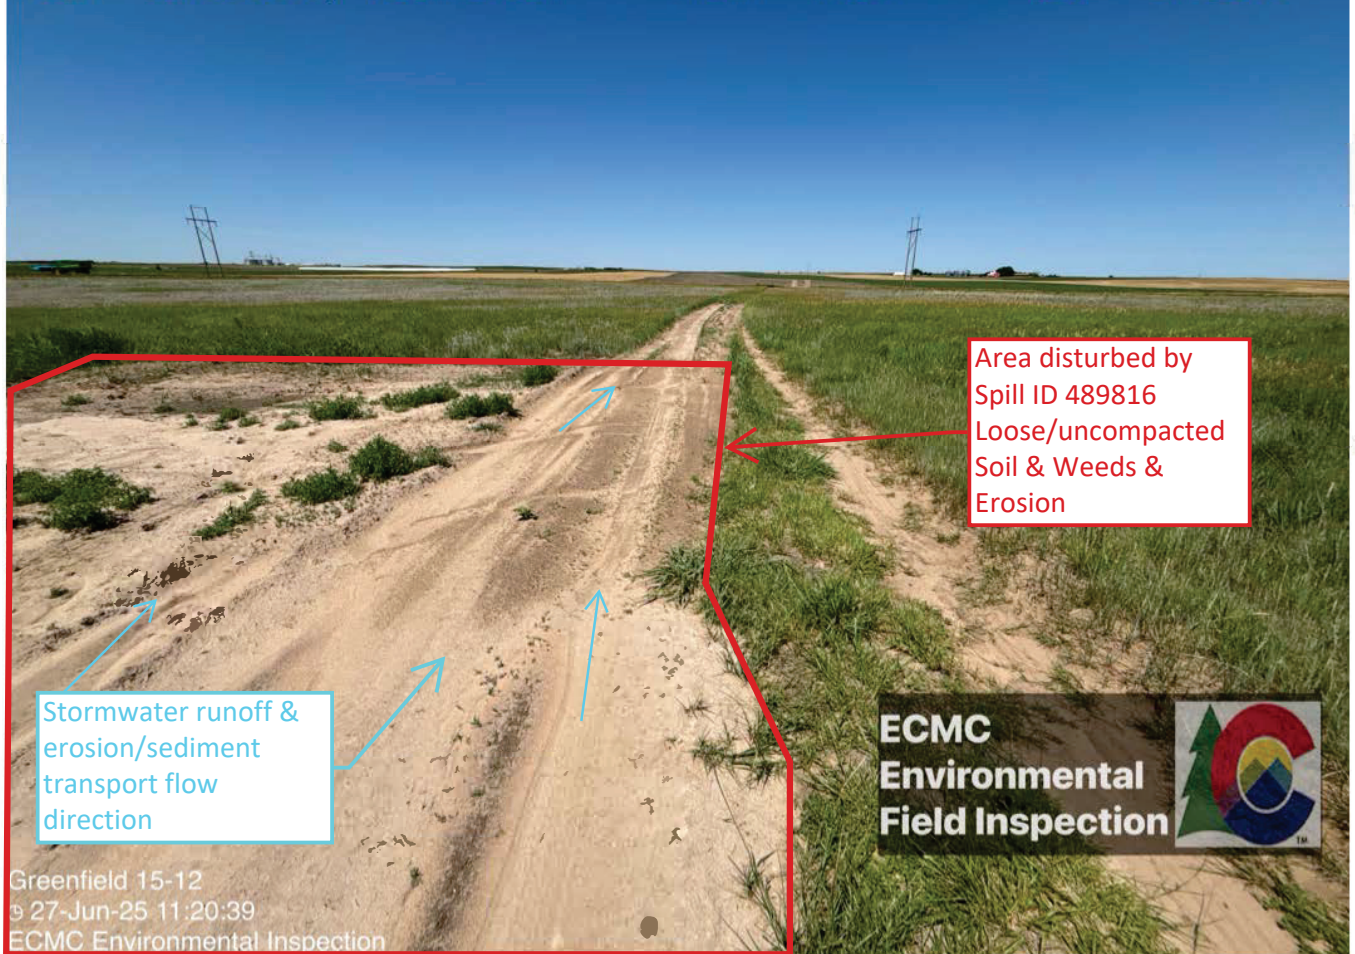
Greenfield 15-12
© 27-Jun-25 11:20:13
ECMC Environmental Inspection

Area disturbed by
remediation of Spill ID
489816 - Loose/
uncompacted Soil &
Weeds & Erosion

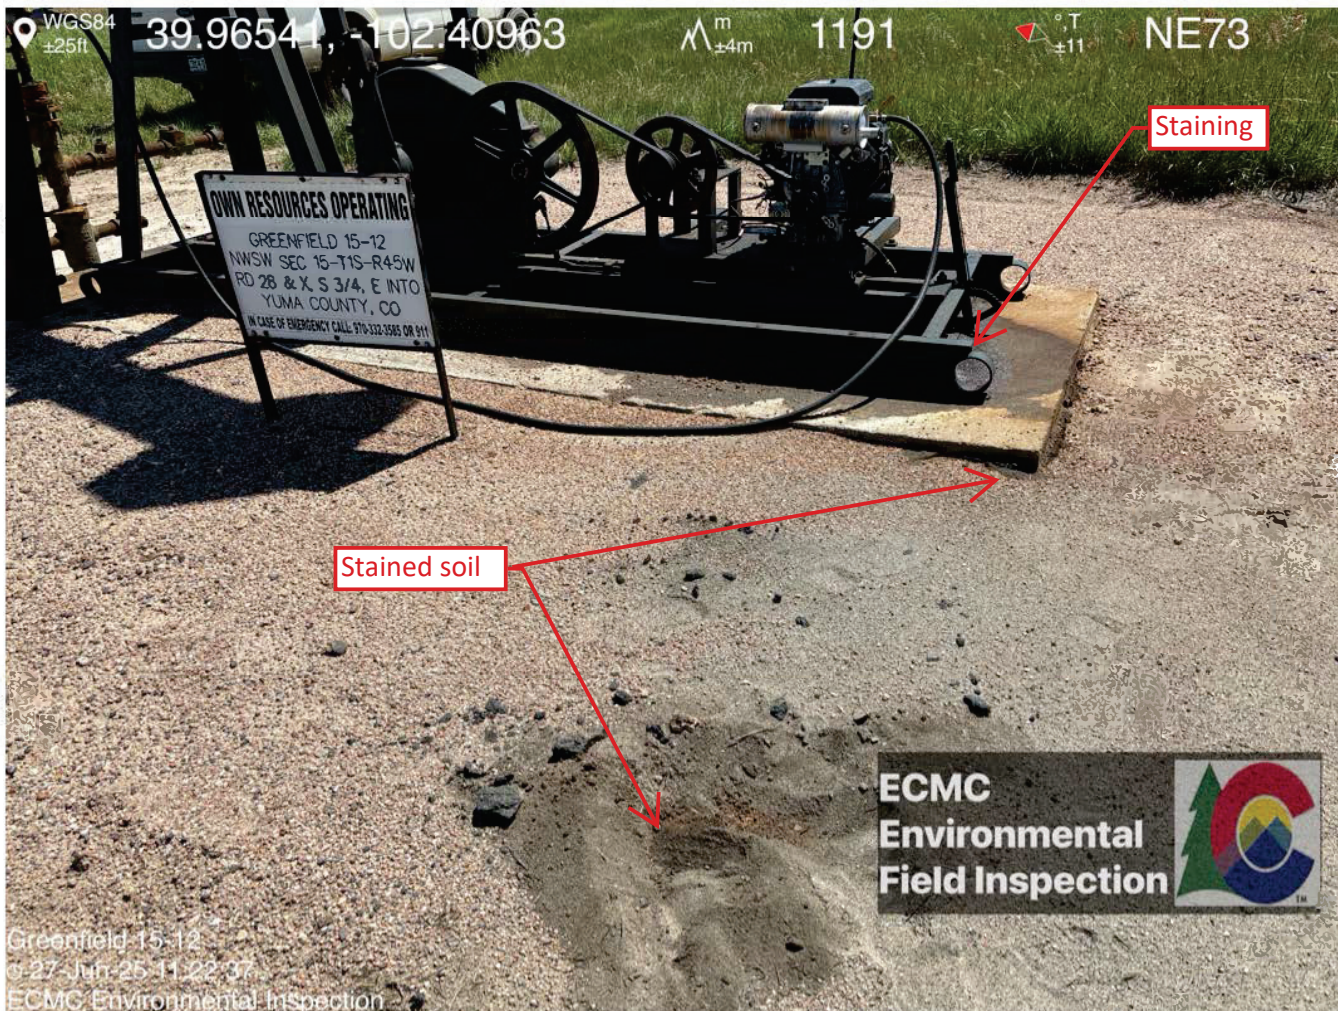
Greenfield 15-12
© 27 Jun 25 11:22:37
ECMC Environmental Inspection

Staining

Stained soil

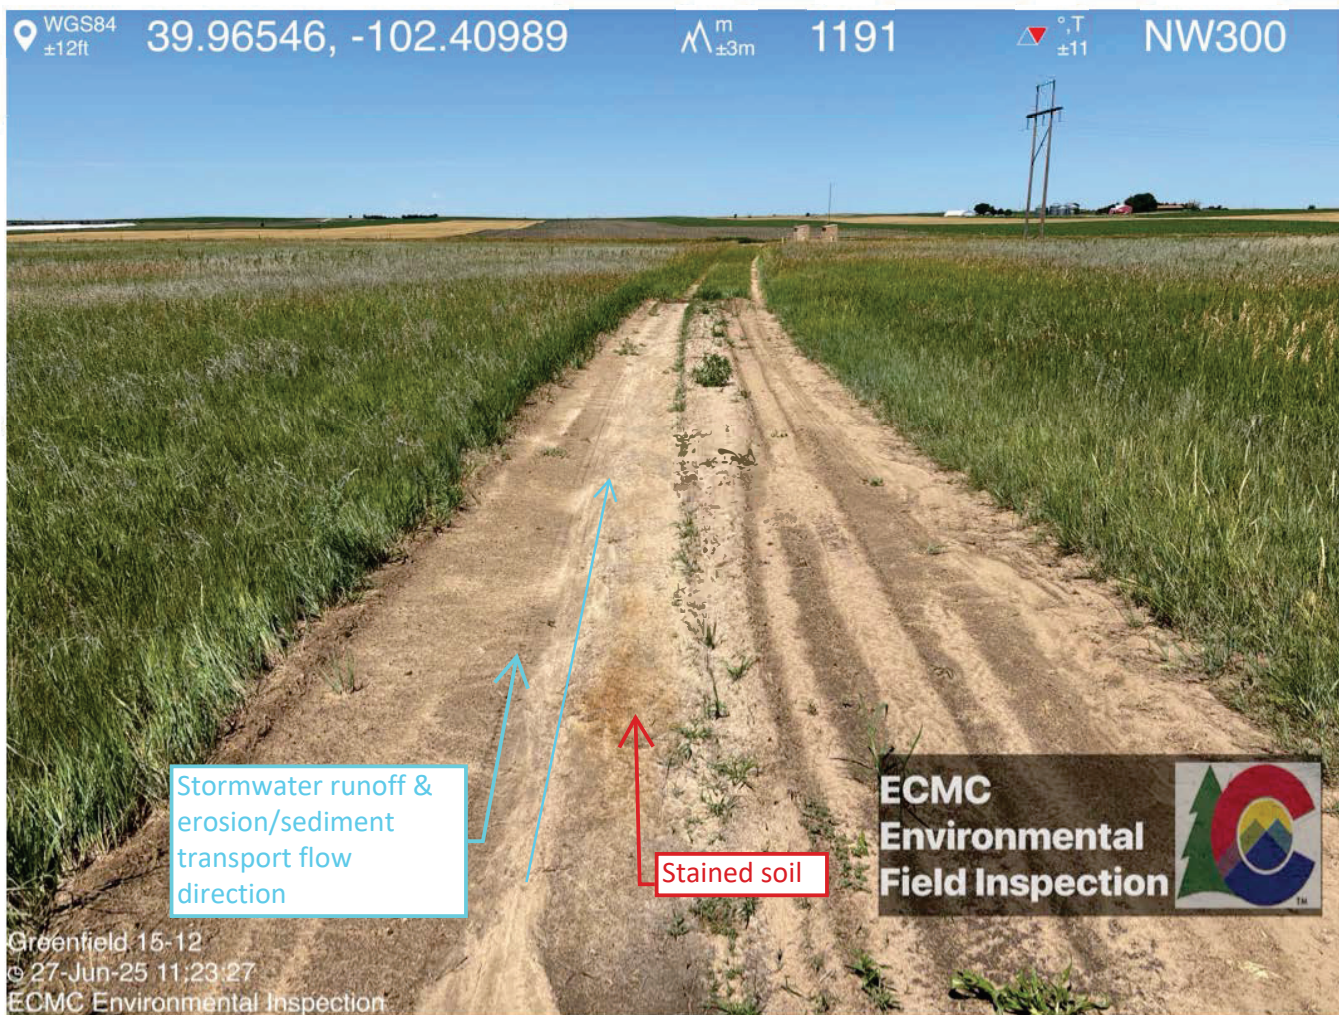
Stormwater runoff & erosion/sediment transport

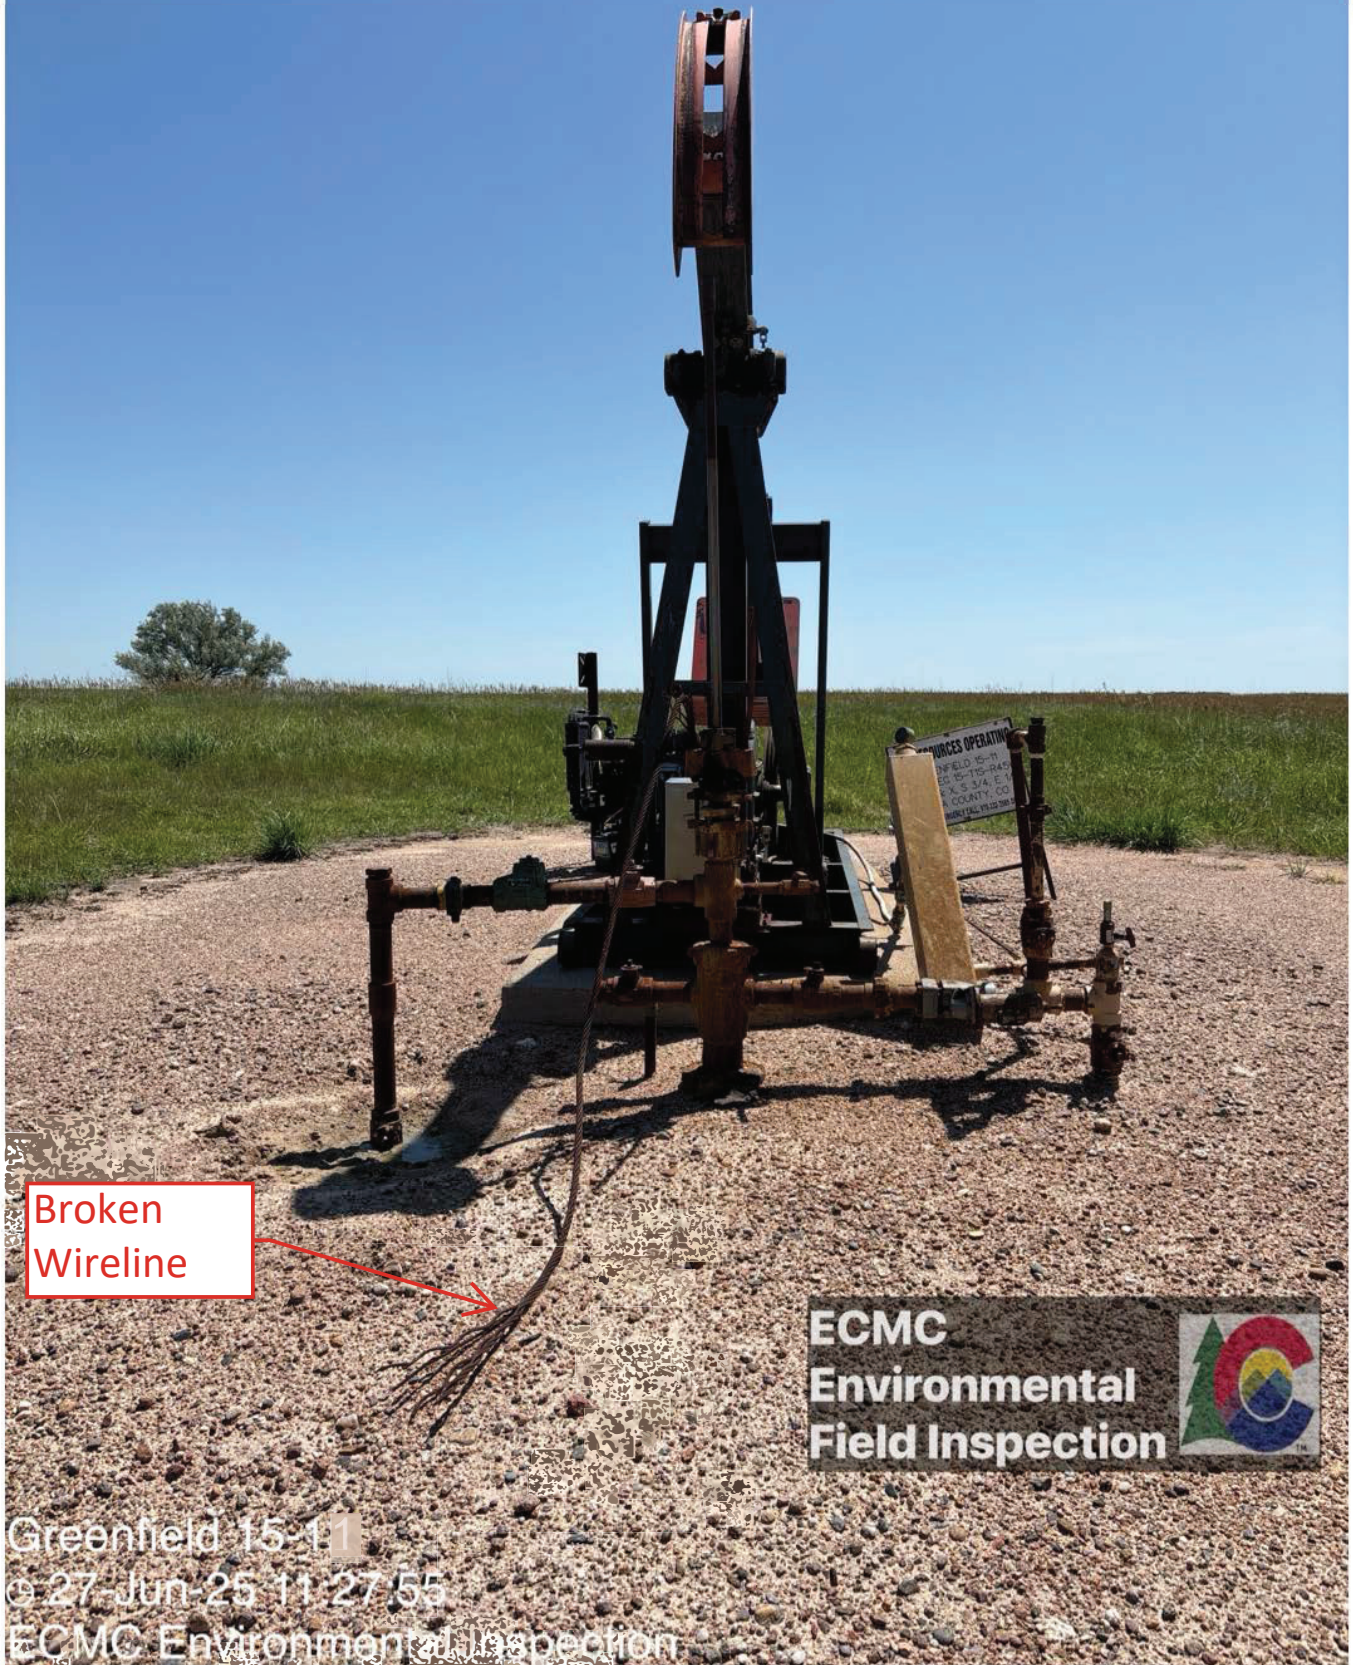
Greenfield 15-11
© 27-Jun-25 11:27:55
ECMC Environmental Inspection
Greenfield 15-11 Well

Debris/
unused
equipment

Staining
