Inspection Photos  
Facility 4 @ UPRR 43 PAN AM AE  
Spill ID 485940/Remediation Project No 34672

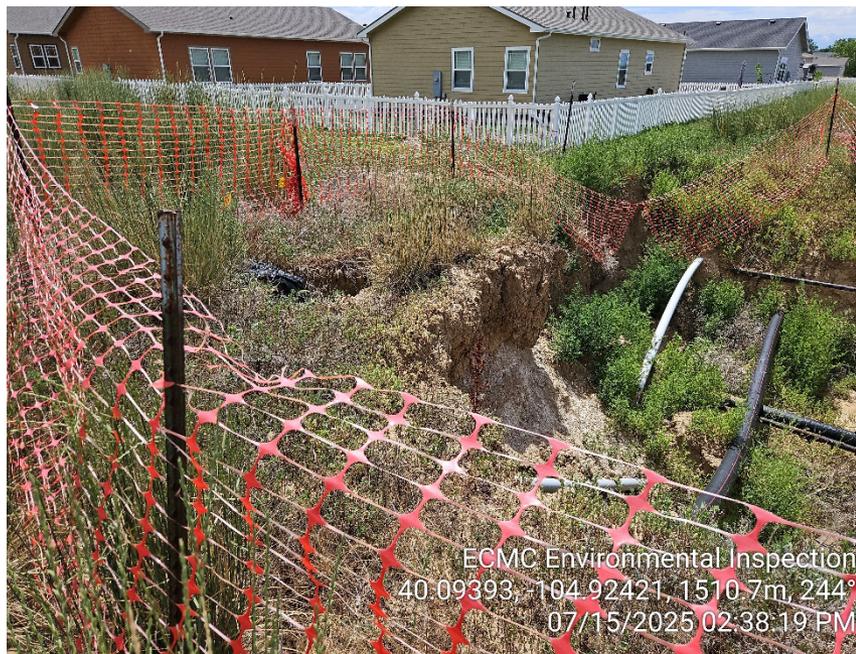
Photo 1 – Open excavation. Downed fencing/weeds.

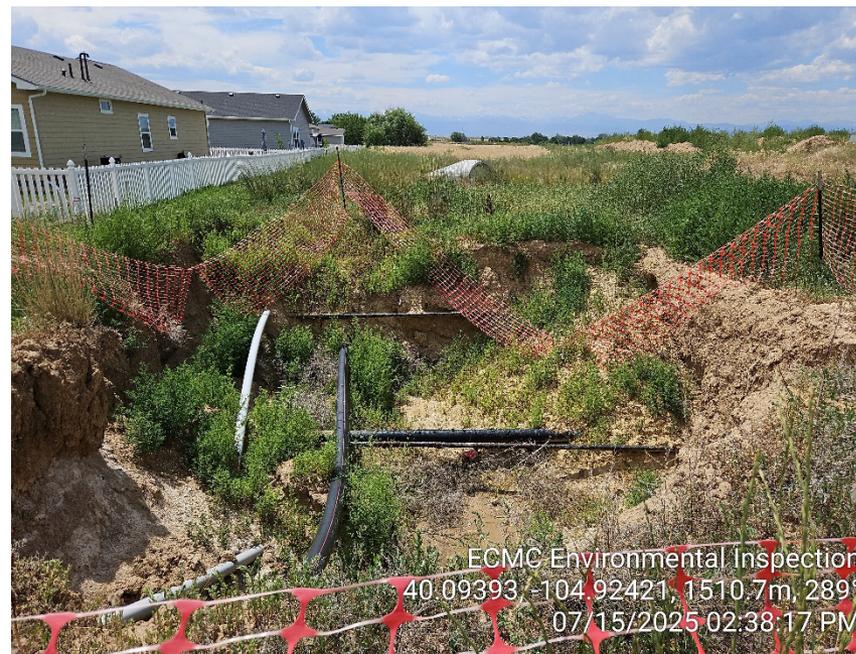
Photo 2 - Open excavation. Downed fencing/weeds.

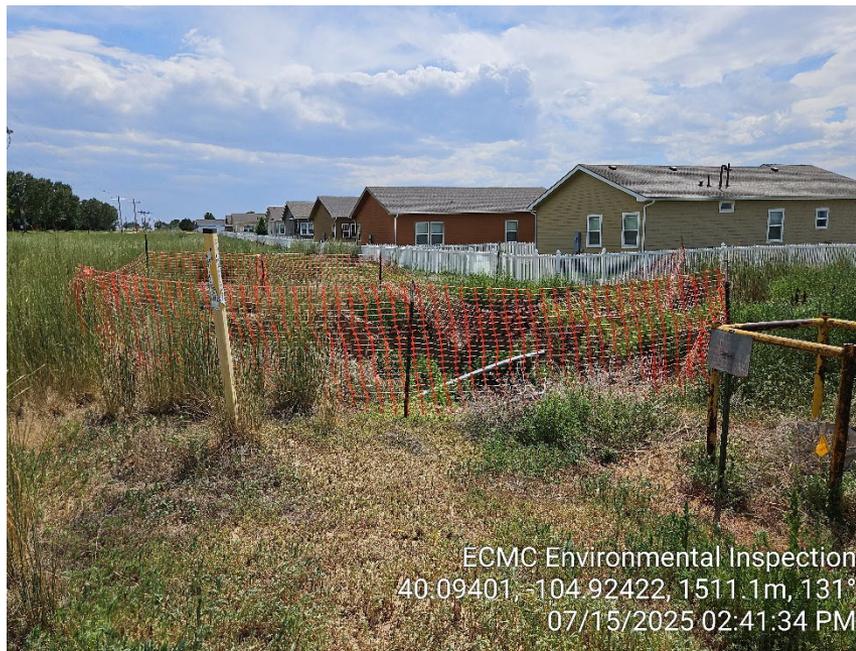
Photo 3 – Open excavation. Downed fencing/weeds.

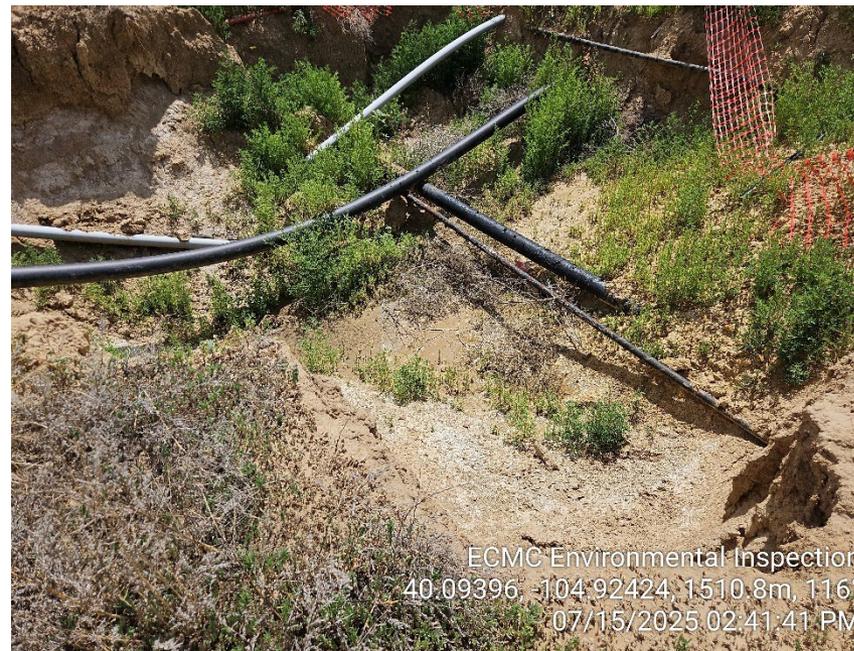
Photo 4 - Open excavation. Downed fencing/weeds.

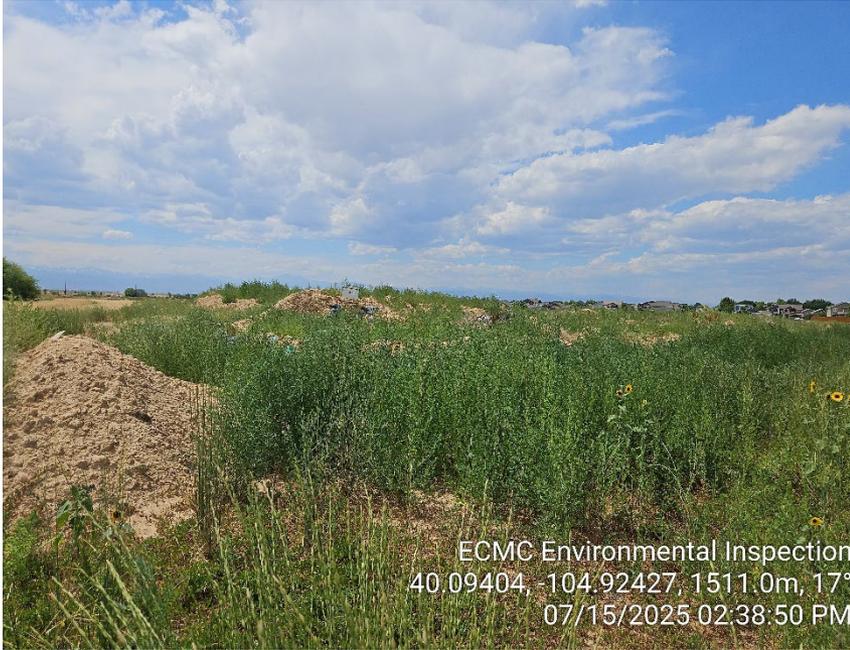
**Photo 5 – Contaminated soil stockpile. Weeds.**

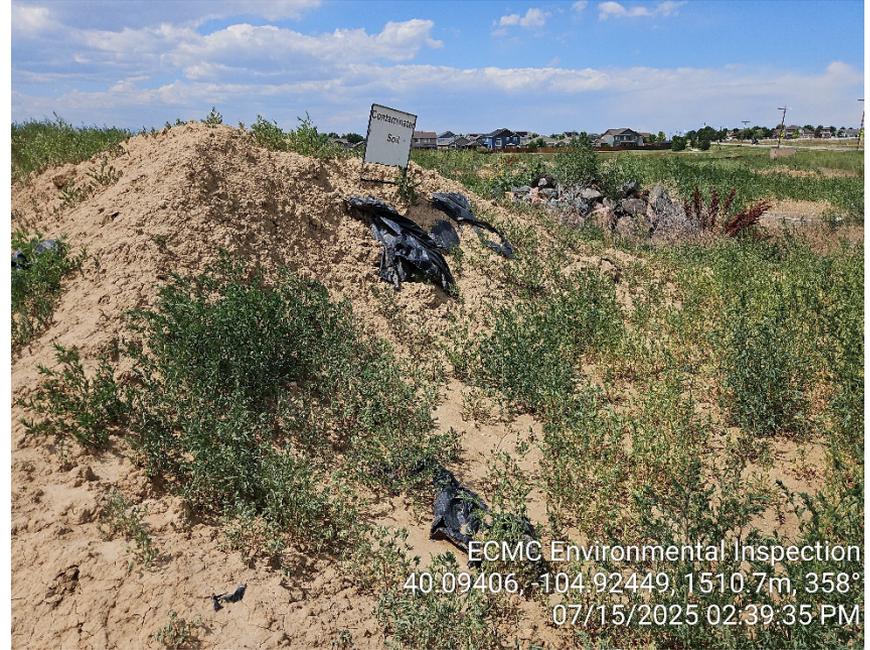
**Photo 6 - Contaminated soil stockpile. Weeds.**

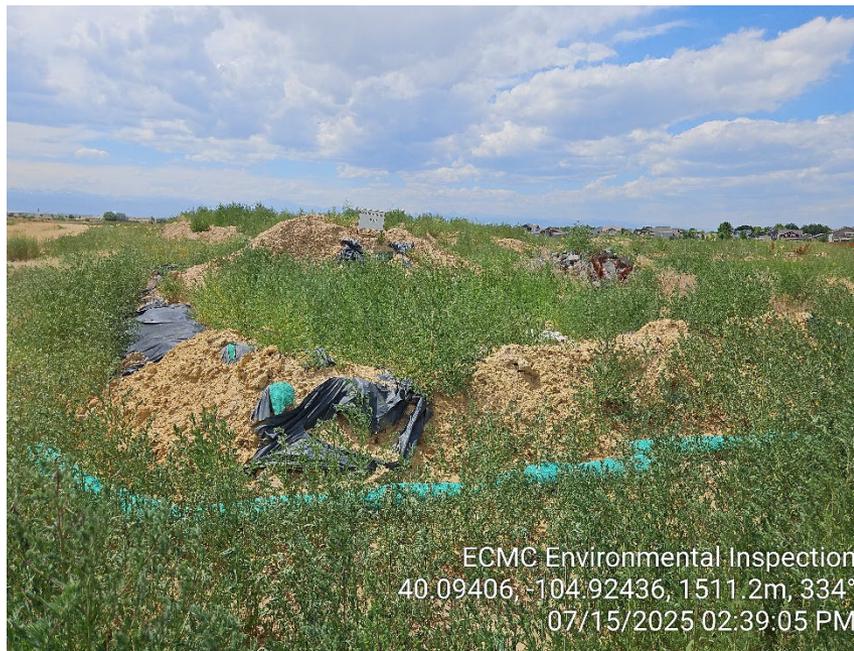
**Photo 7 – Contaminated soil stockpile. Weeds/torn liner.**

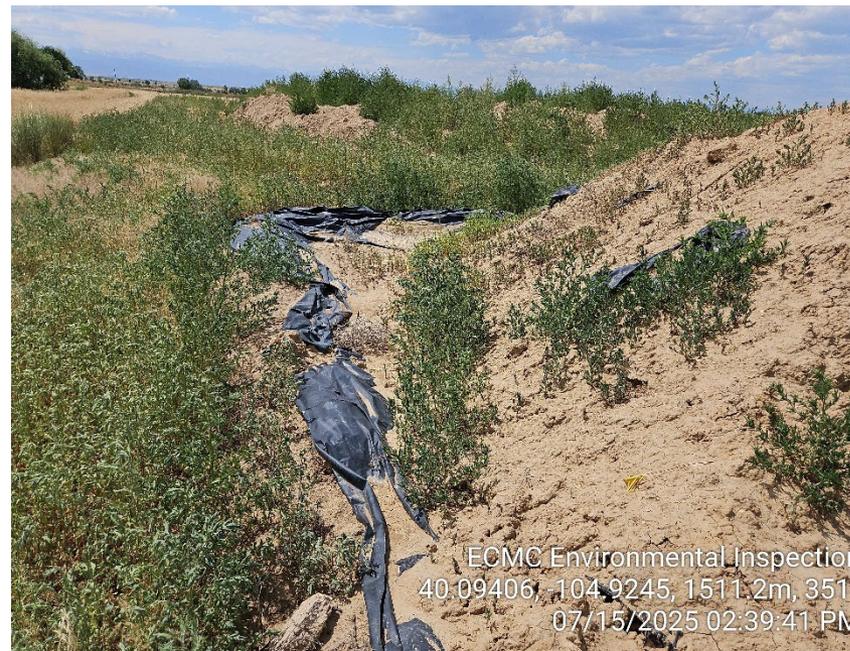
**Photo 8 - Contaminated soil stockpile. Soil stockpile overflowing berms. Weeds.**

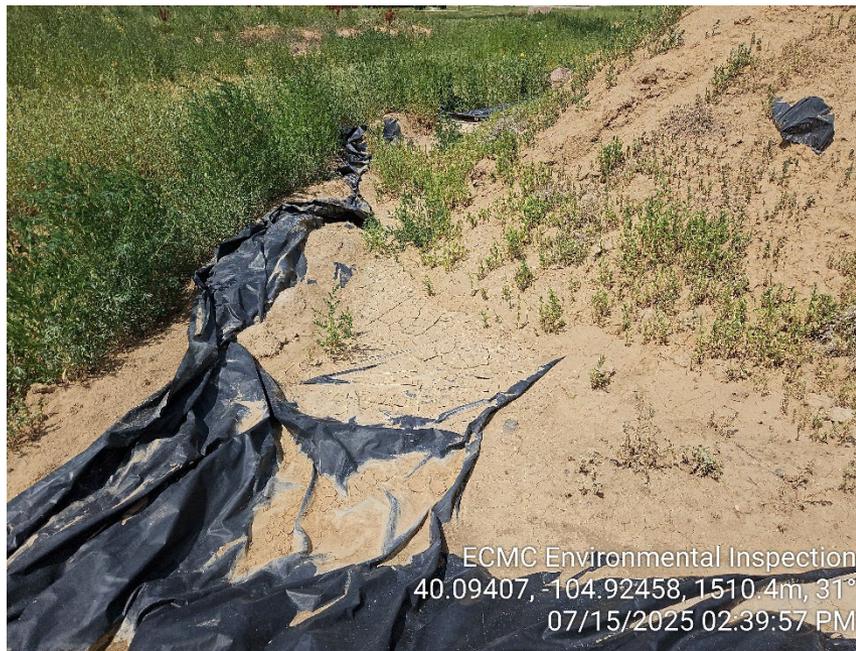
ECMC Environmental Inspection  
40.09407, -104.92458, 1510.4m, 31°  
07/15/2025 02:39:57 PM

**Photo 9 – Contaminated soil stockpile. Soil stockpile overflowing berms. Weeds.**

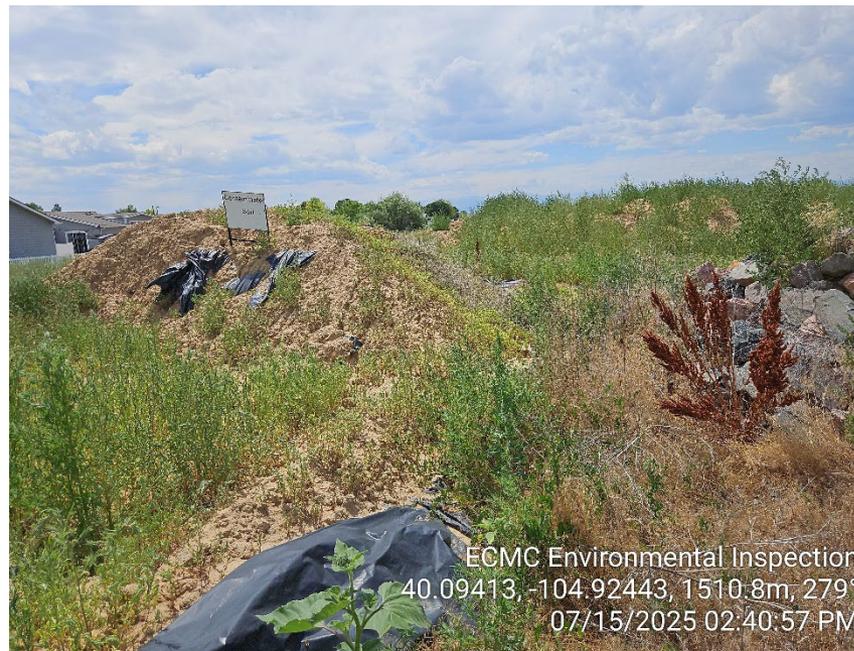
ECMC Environmental Inspection  
40.09413, -104.92443, 1510.8m, 279°  
07/15/2025 02:40:57 PM

**Photo 10 - Contaminated soil stockpile. Soil stockpile overflowing berms. Weeds.**
