# Inspection Photos

API:061-06010

Operator: WESTERN OPERATING COMPANY

Inspection Date: 7/15/2025

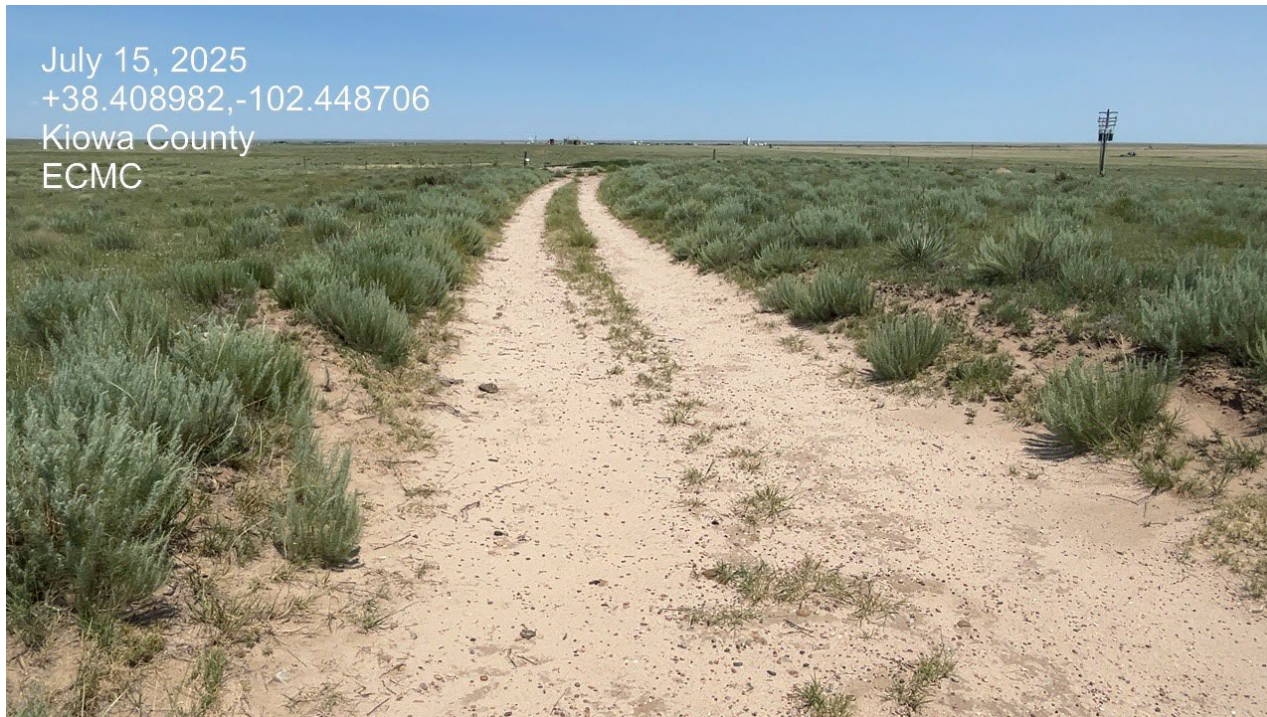
**Photo 1.** Facing north toward the access road which will need to be recontoured and reclaimed.

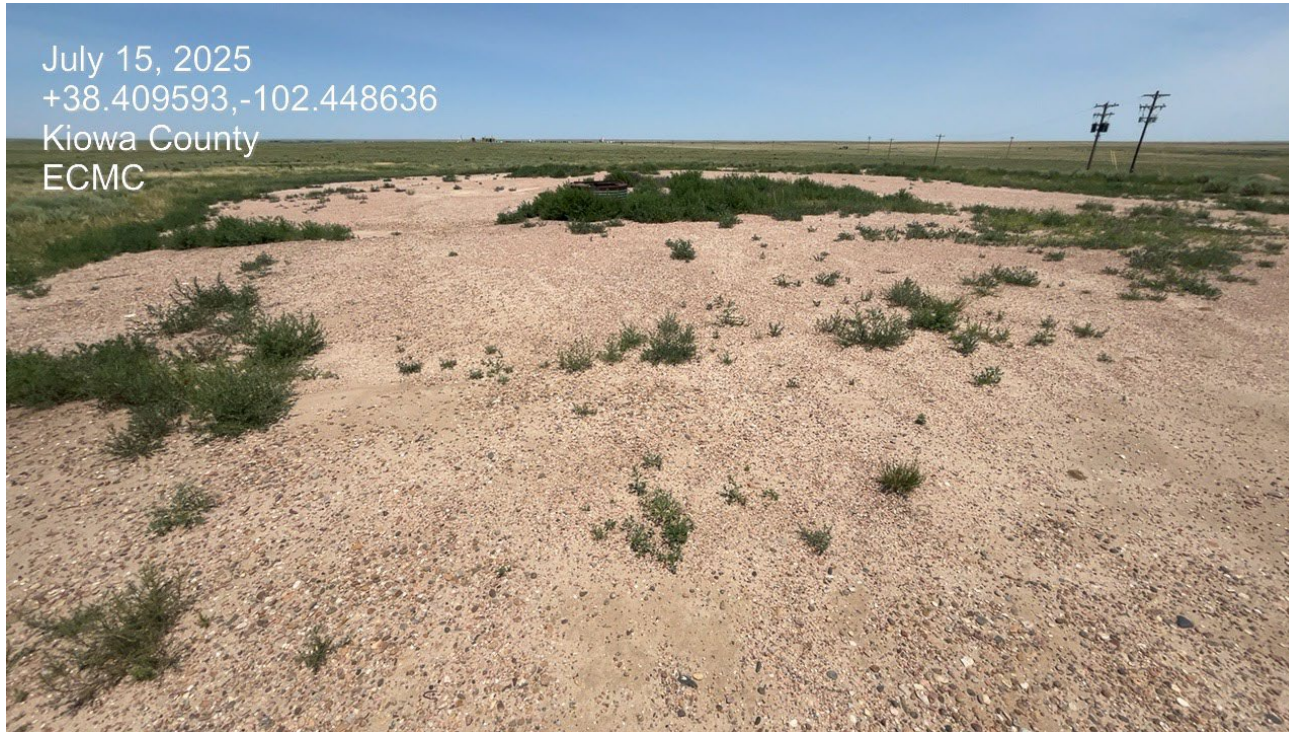
**Photo 2.** Facing north toward the former tank battery location. Reclamation has not been performed.

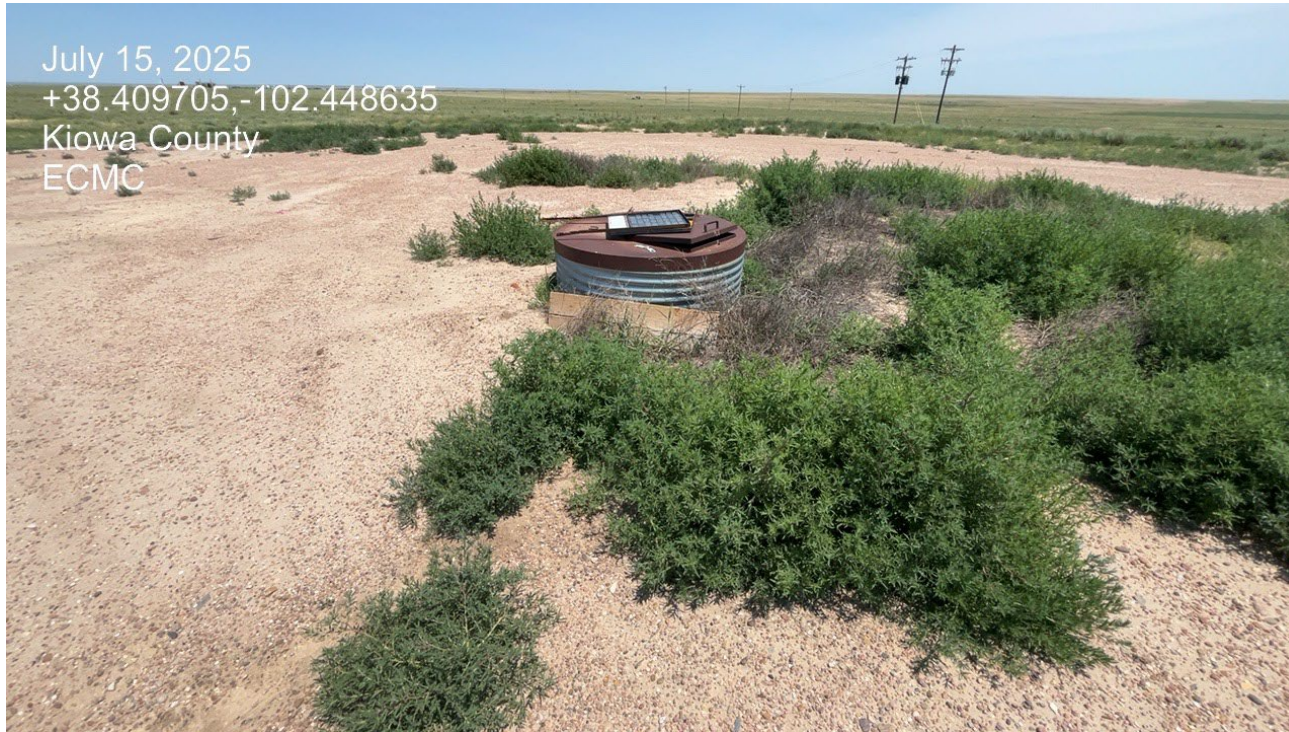
**Photo 3.** There is a metal flowline culvert that needs to be removed. Flowlines must be abandoned per 1100 rules.

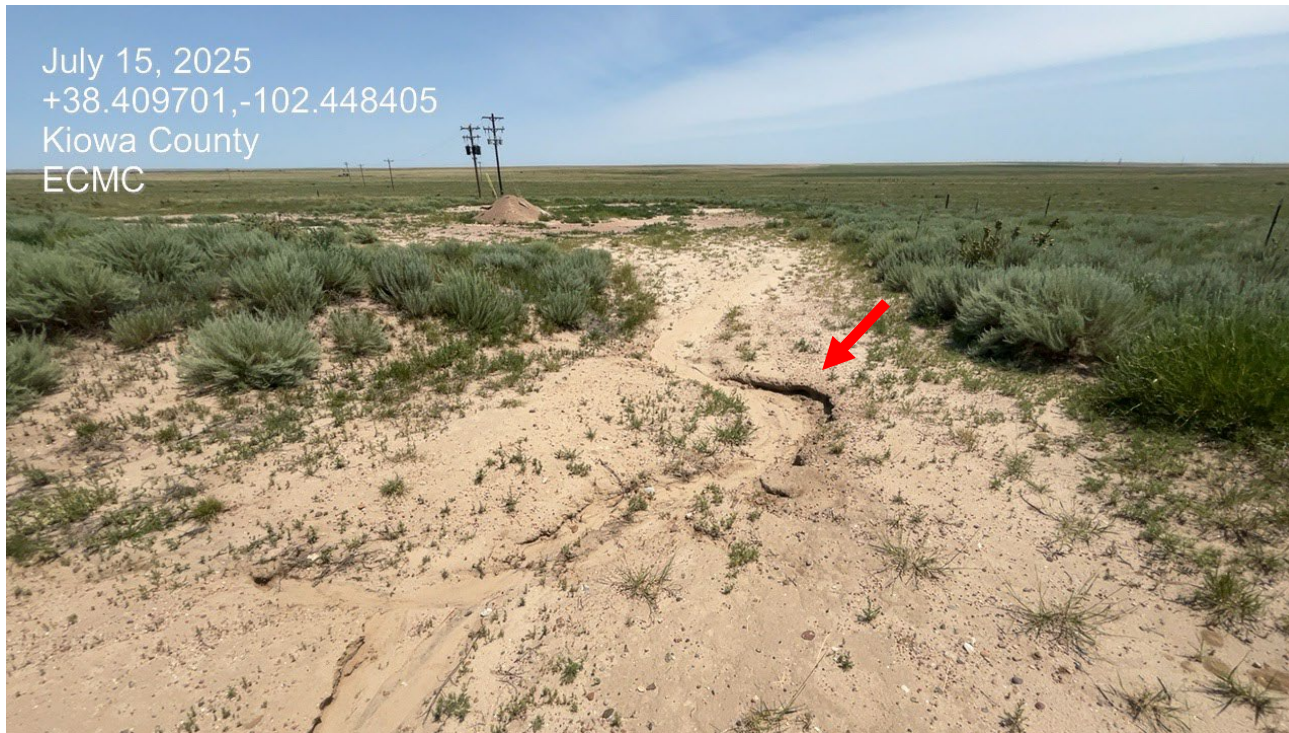
**Photo 4.** Facing northeast toward the wellsite location. There is erosion in this area beginning to occur.

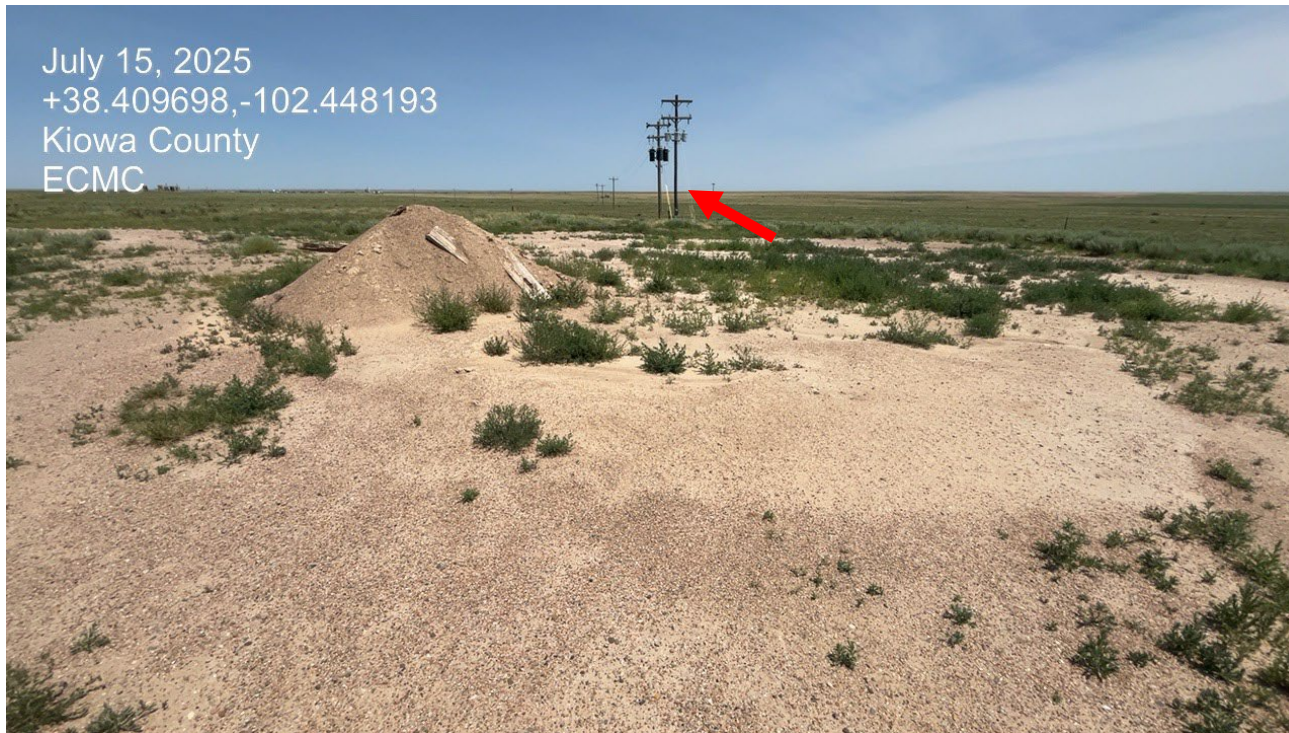
**Photo 5.** Facing northeast at the abandon wellsite. The pumpjack has been removed. The electric power line still remains at the location.

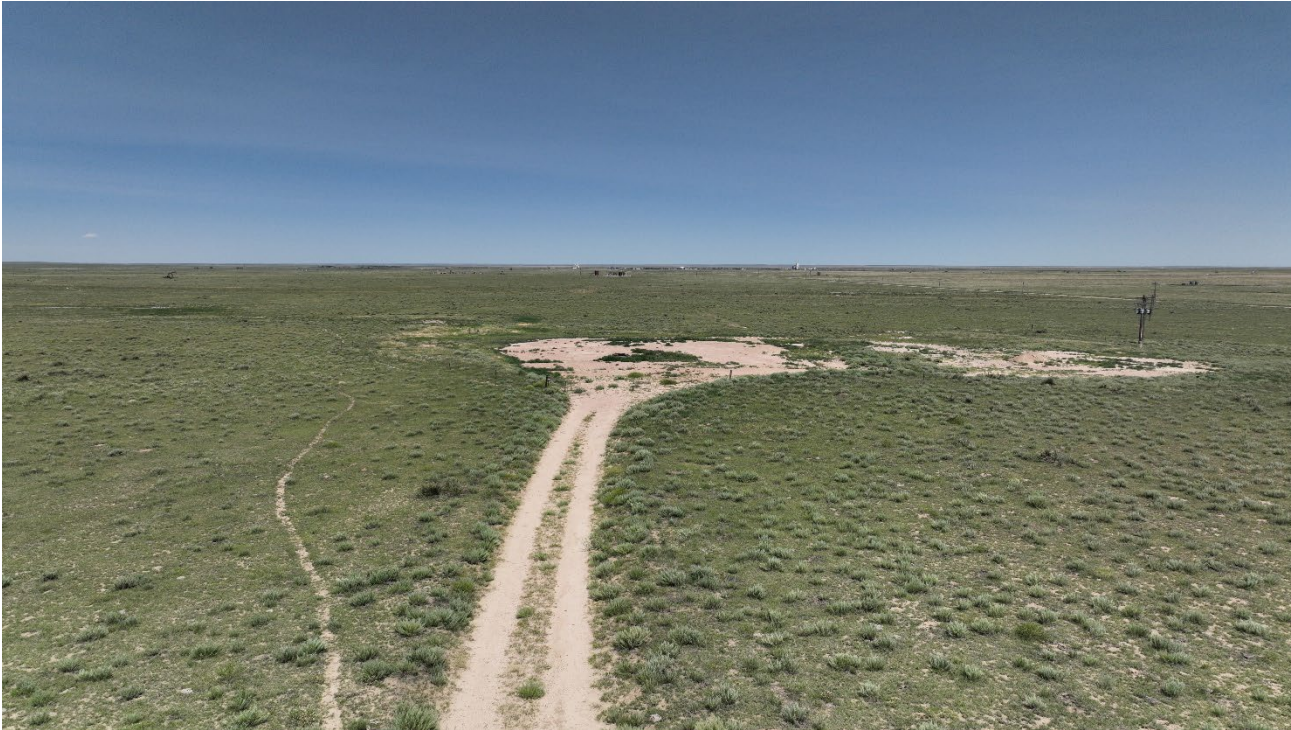
**Photo 6.** Drone aerial photo facing north toward the access road and location.

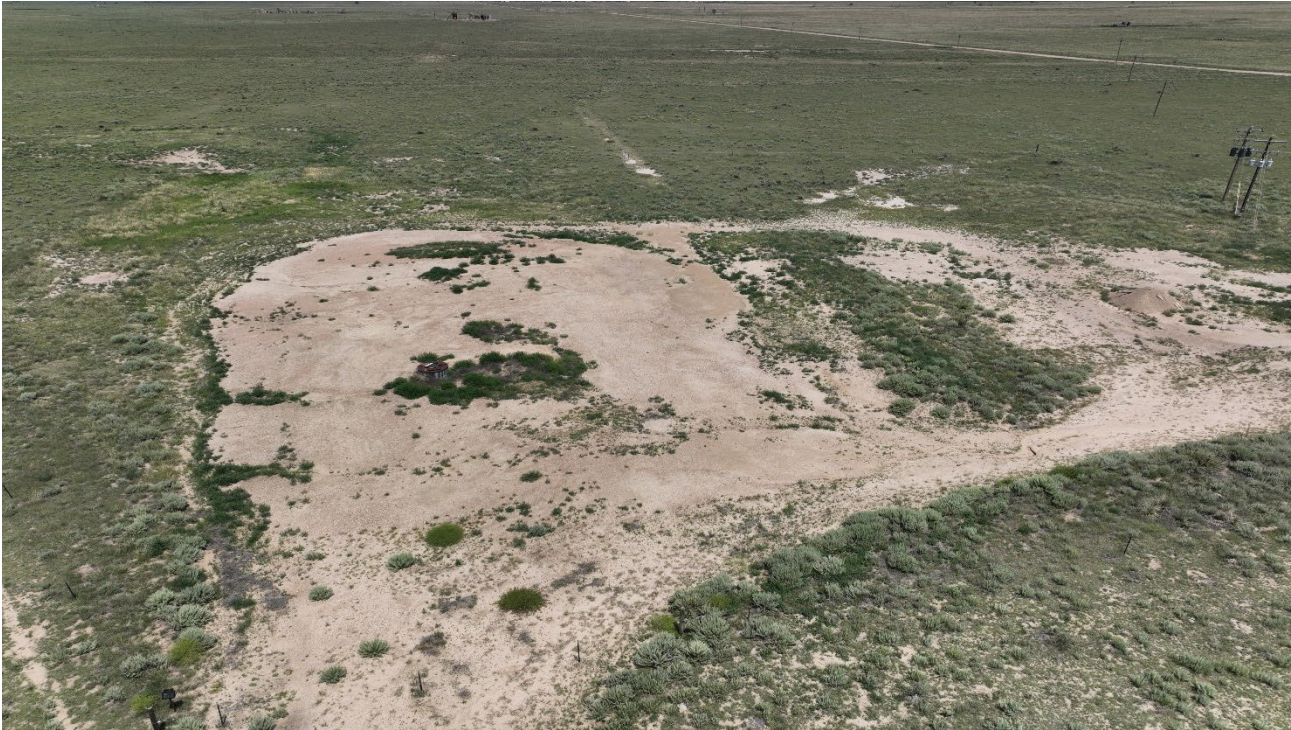
**Photo 7.** Drone aerial photo overlooking the location disturbance.

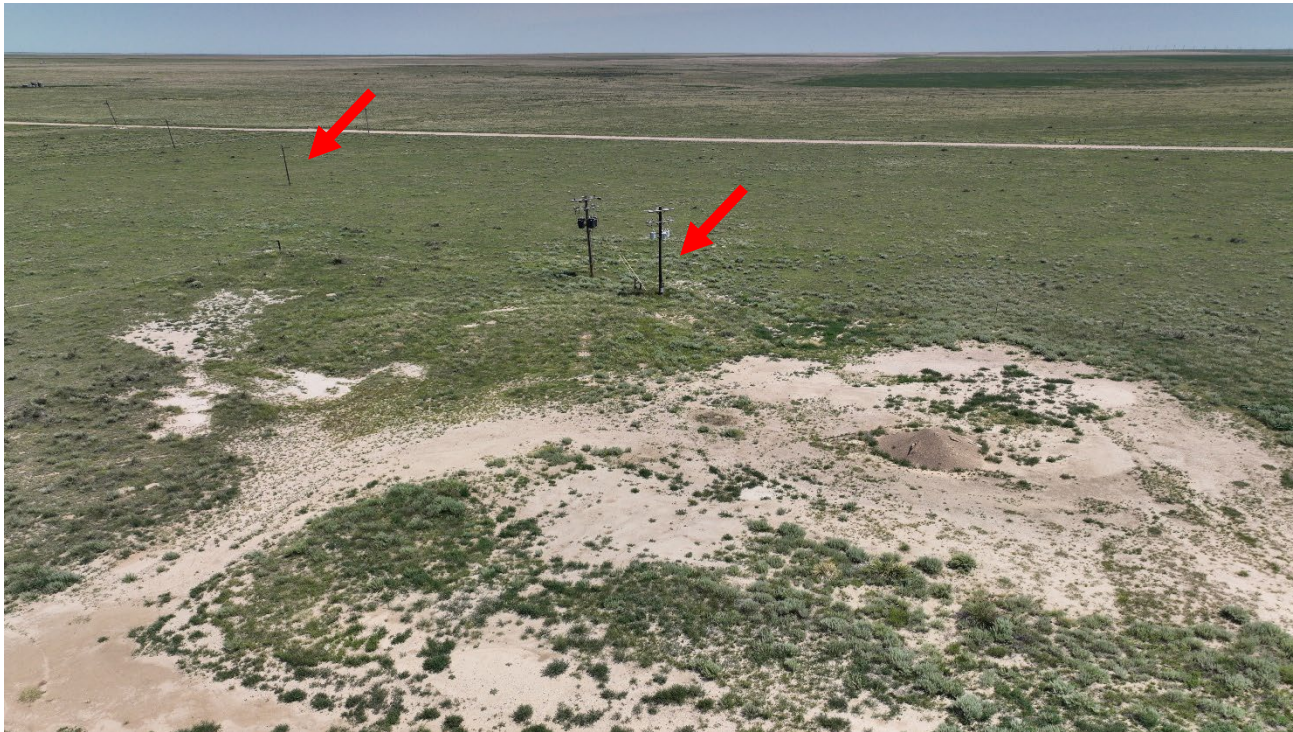
**Photo 8.** Facing Drone aerial photo facing northeast. The power line and poles have not be removed.

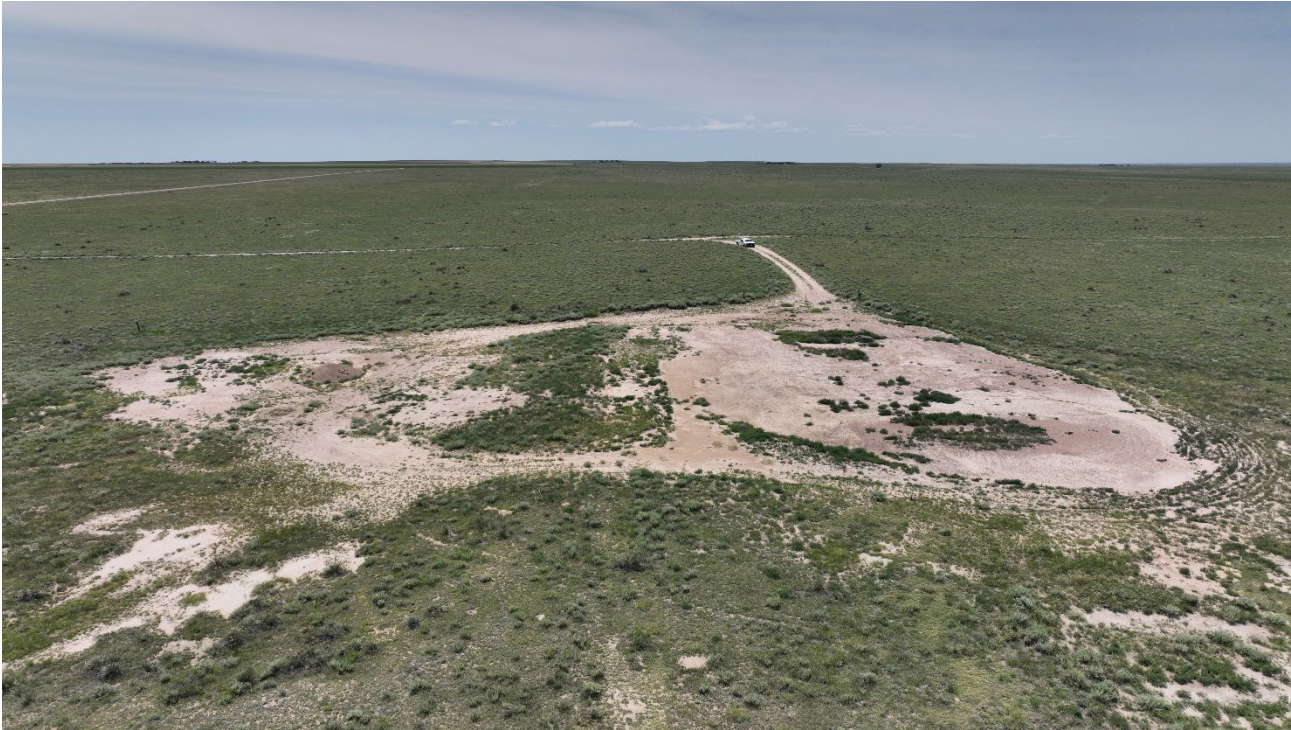
**Photo 9.** Drone aerial photo facing south.

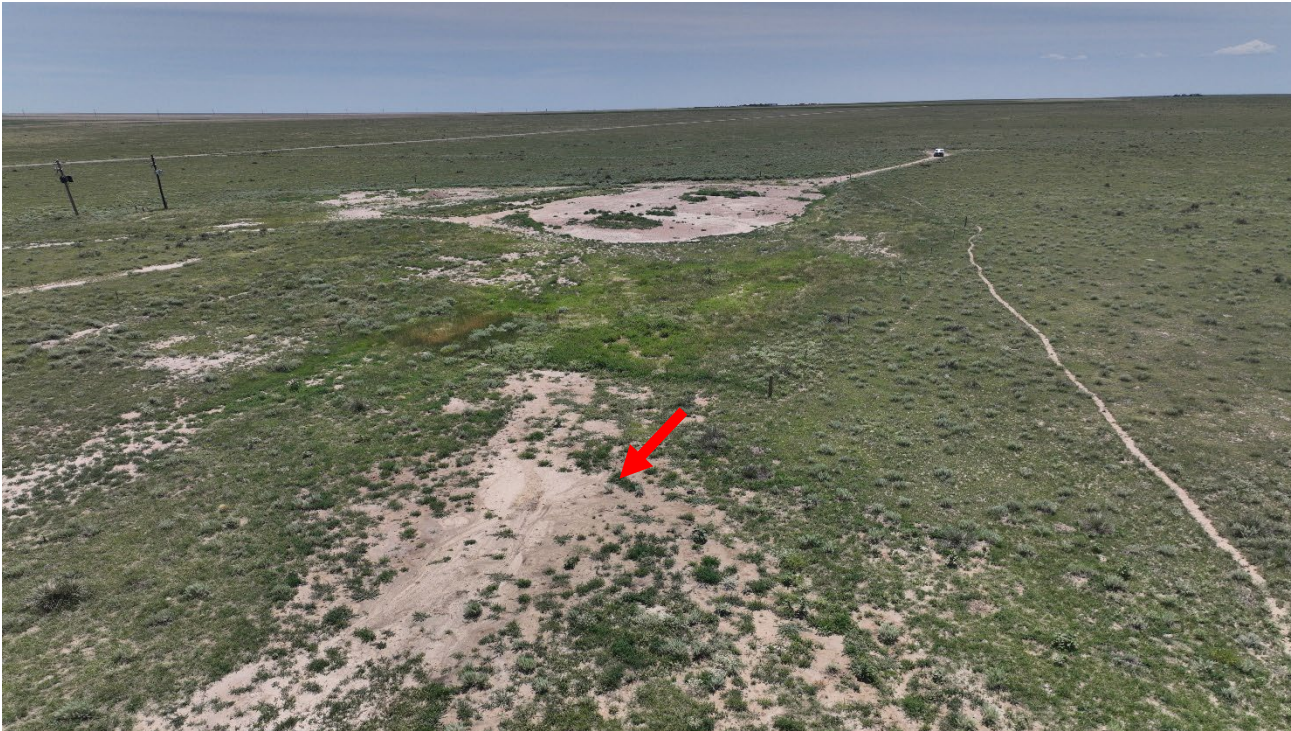
**Photo 10.** Drone aerial photo facing southeast. There is impacted soils shown at red arrow from historical spill.
