Inspection Photos

ID:470759

Operator: WESTERN OPERATING COMPANY

Inspection Date: 7/15/2025

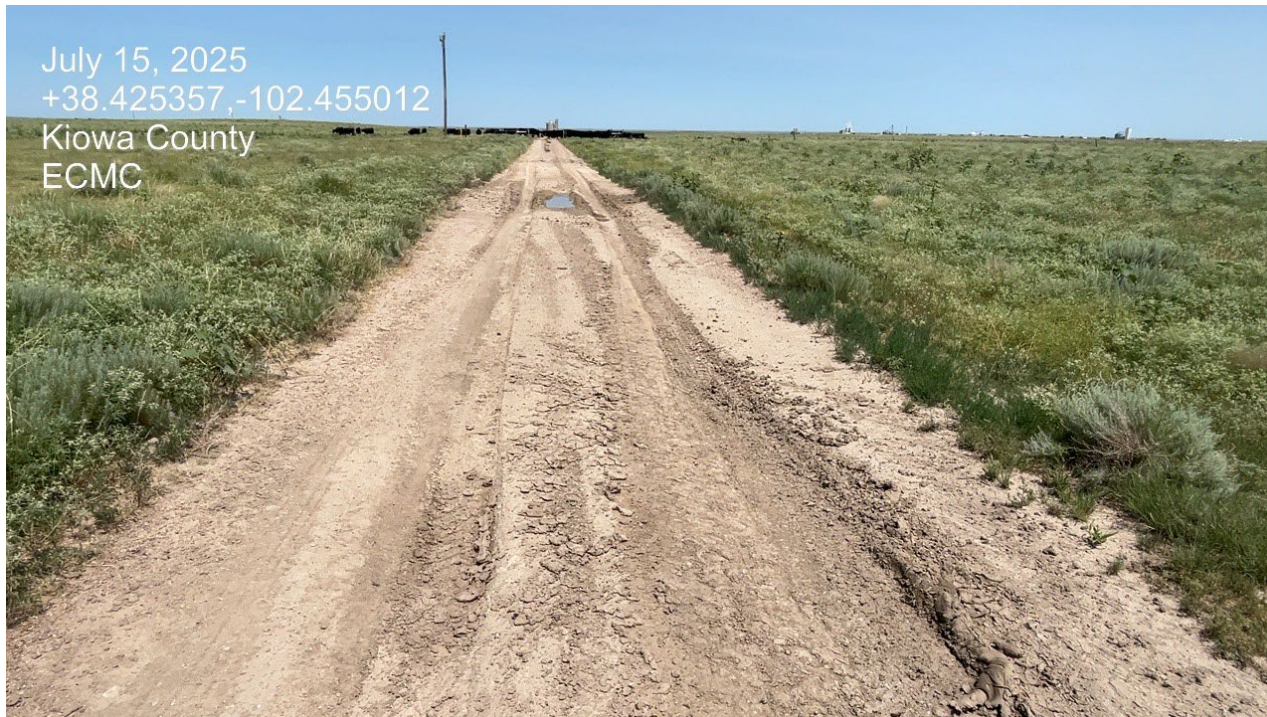
Photo 1. Facing north along the access road. There are areas of vehicle rutting that need to be repaired and stabilized with gravel.

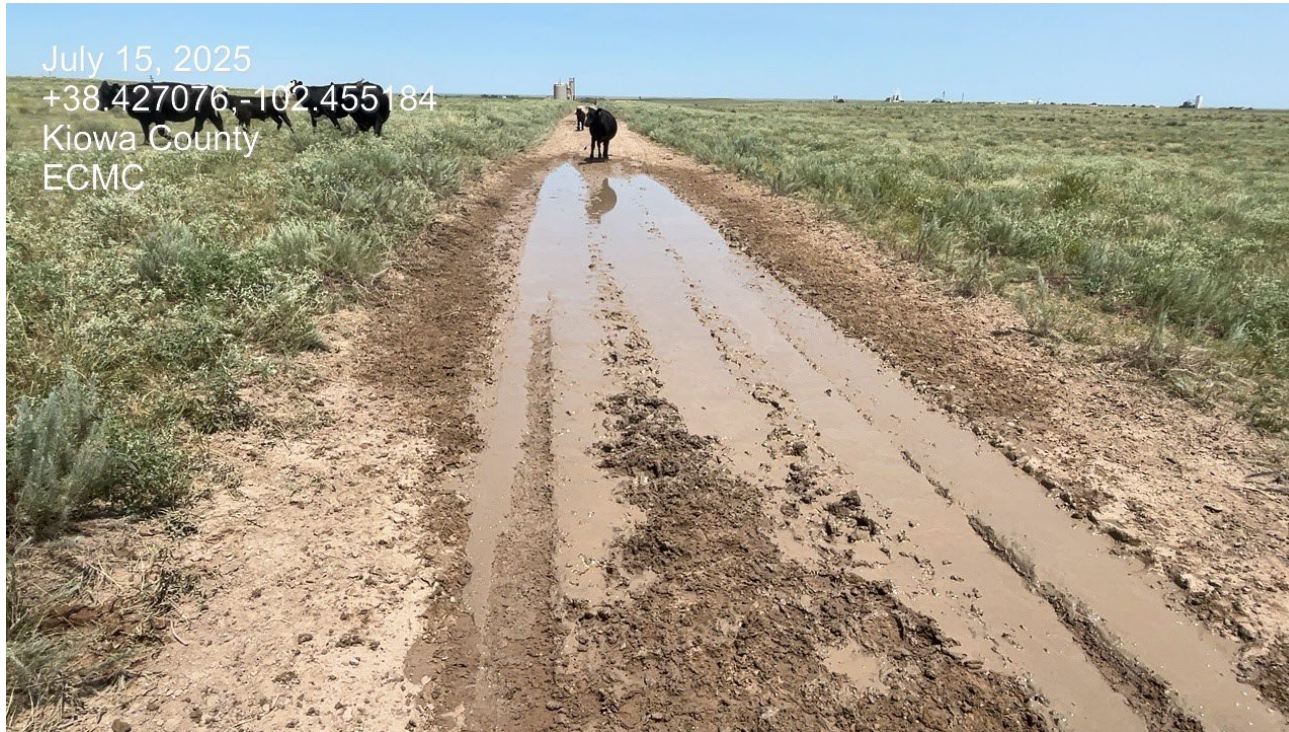
Photo 2. Facing north along the access road. Stormwater needs to be diverted off the road. Areas accumulating stormwater need to be built up with BMP's such as roadbase and gravel.

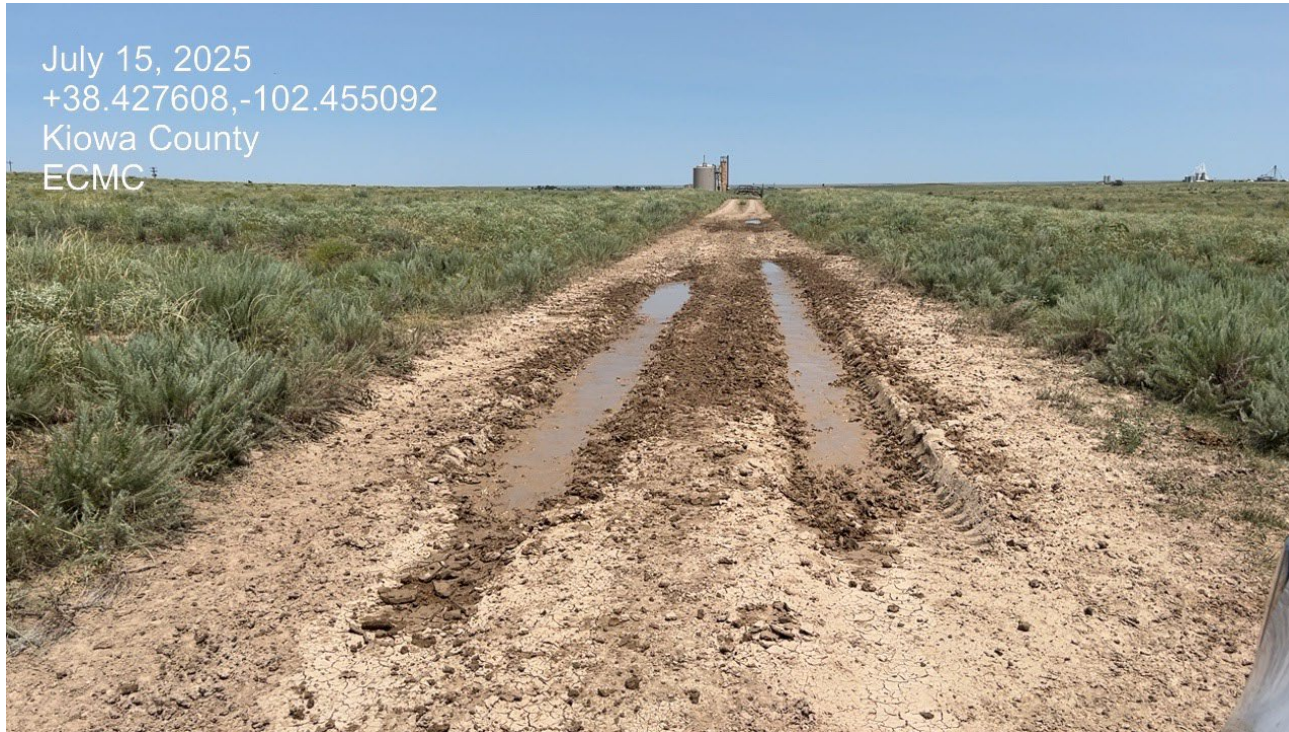
Photo 3. Facing north further along the access road. Areas accumulating stormwater need to be built up with roadbase and gravel.

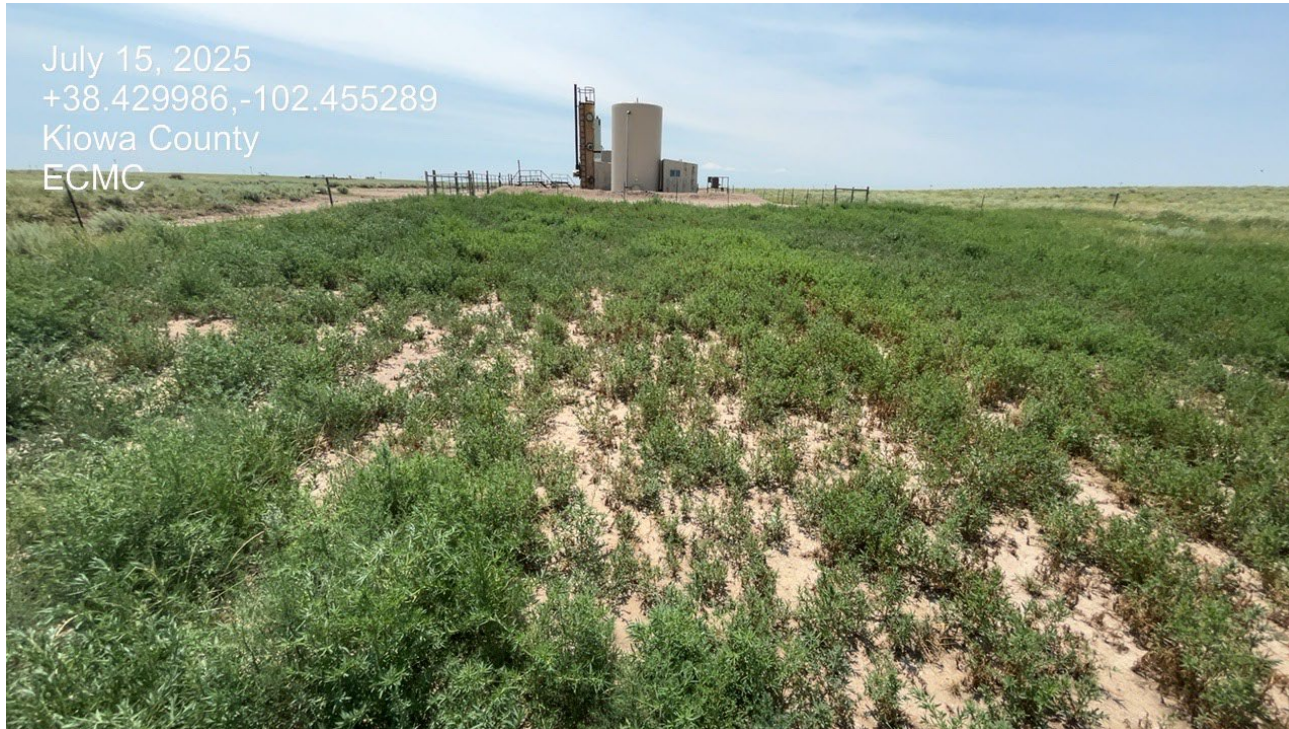
Photo 5. Facing south at the remediation area north of the tank battery. This area has mostly undesirable weeds that need to be controlled. This area needs to be reseeded to establish perennial vegetation..
