Inspection/Audit Photos

Location: UTAH GAS OP LTD DBA UTAH GAS CORP SOUTH DOUGLAS CREEK 7318 PAD

Location ID: 315265

Date: 07/16/2025

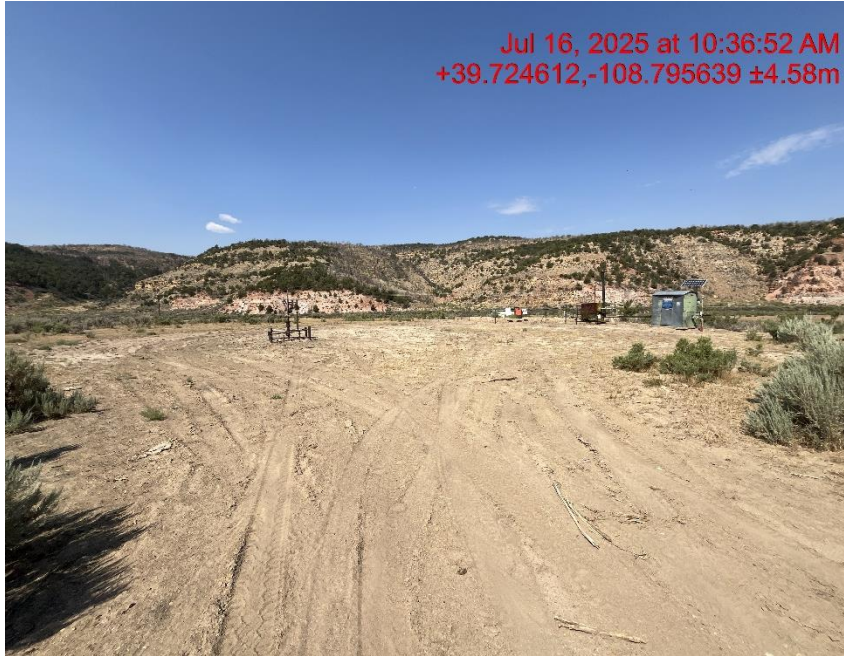
Photo # 0041 Entrance to location

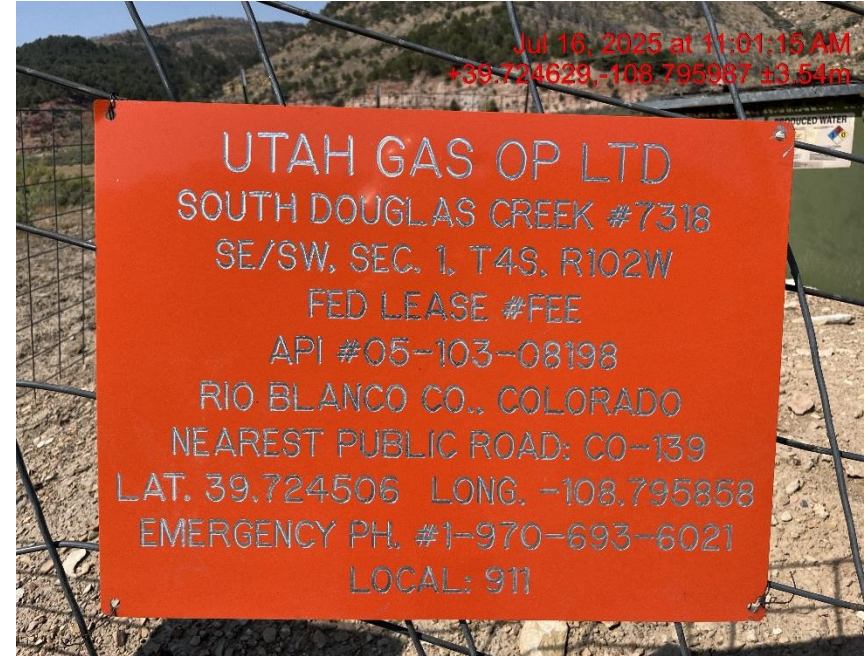
Photo # 0068 Location

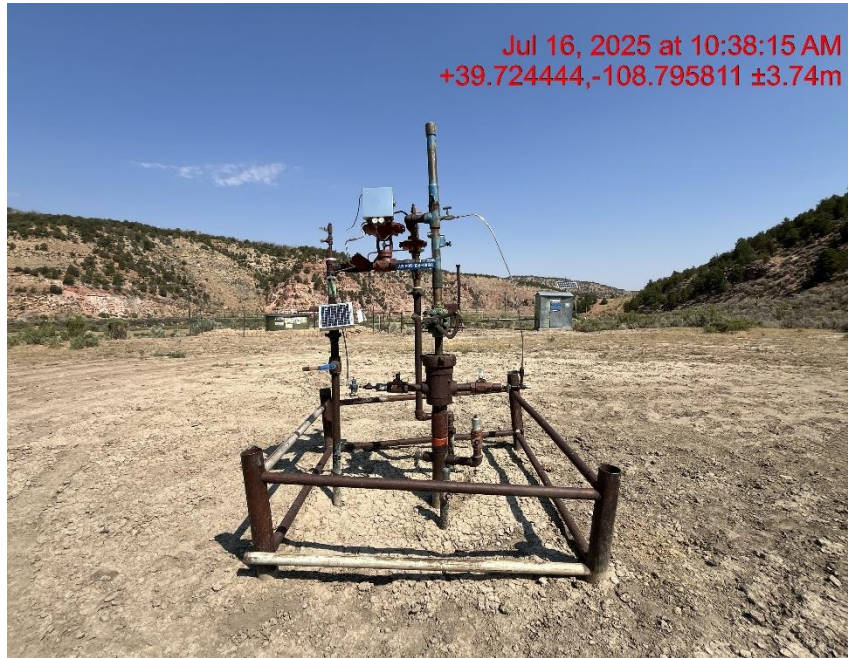
Photo # 0042 Location

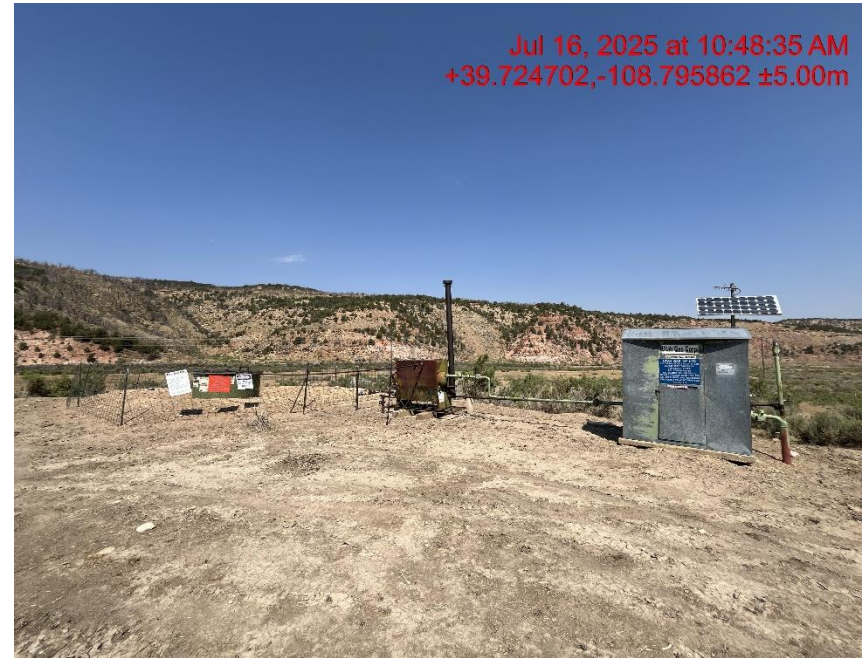
Photo # 0053 Location

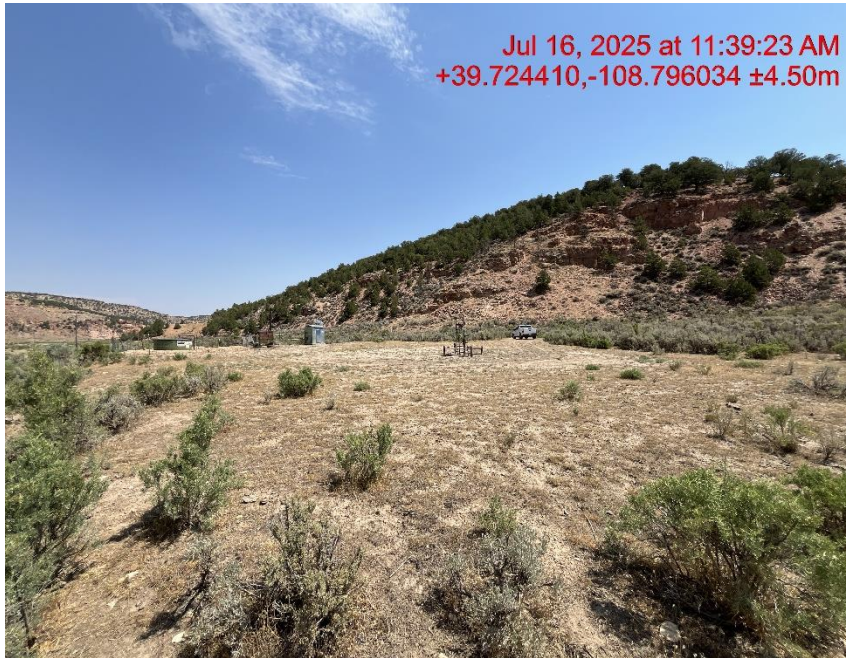
Photo # 0098 SW corner of location

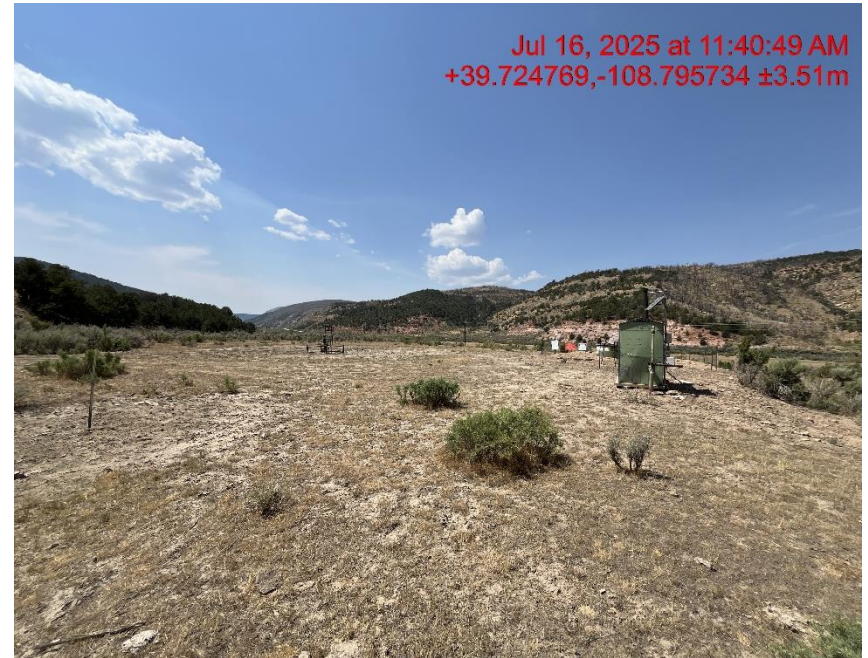
Photo # 0099 NE corner of location

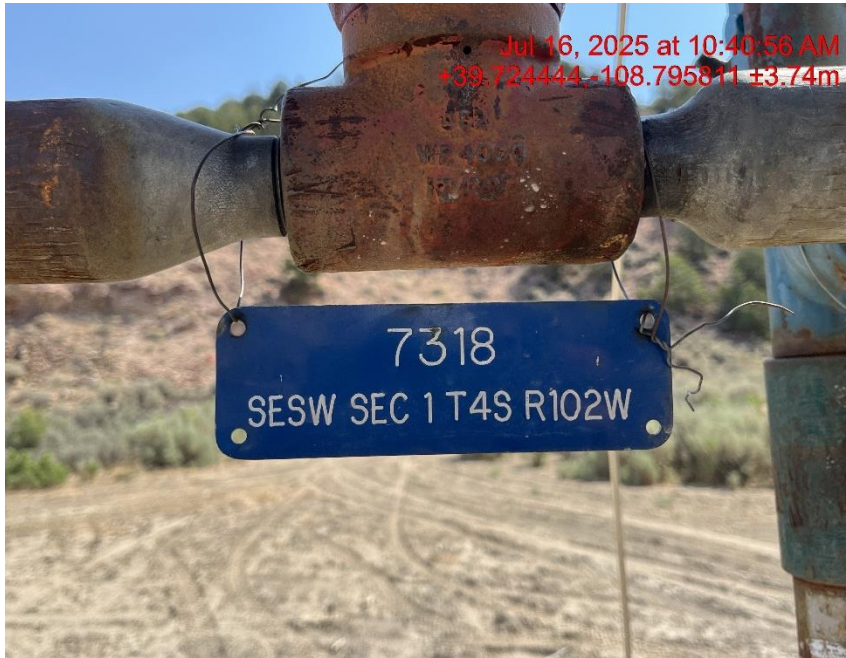
Photo # 0045 Wellhead sign lacks required information/not in compliance with CECMC rules

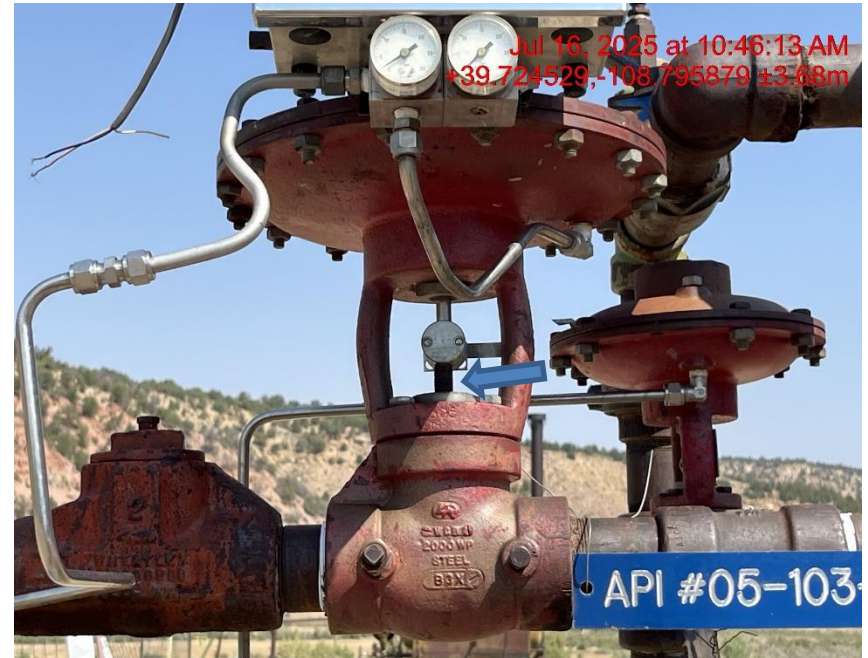
Photo # 0049 Equipment has been modified and is not being operated in a safe manner

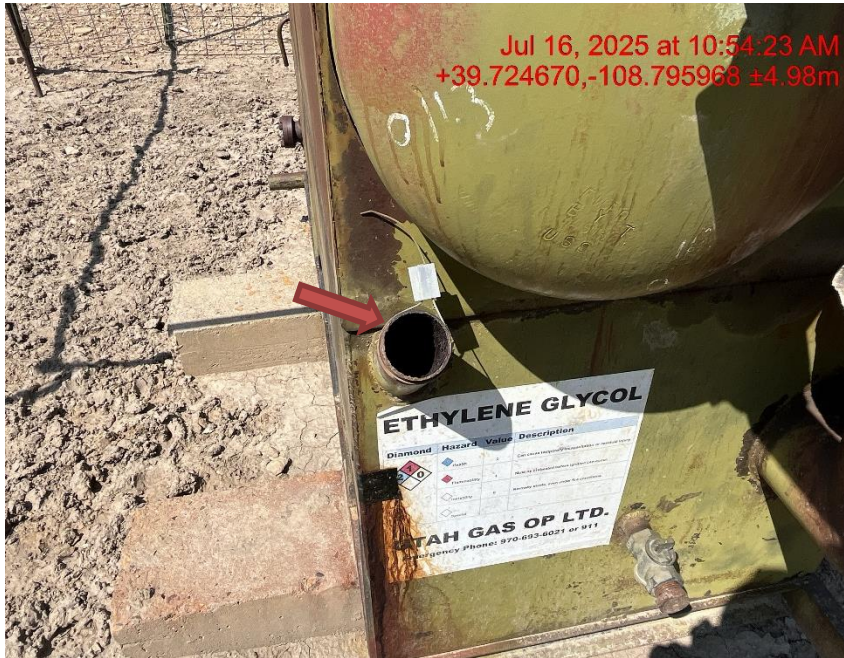
Photo # 0059 Open ended piping/wildlife hazard/available for entry by wildlife

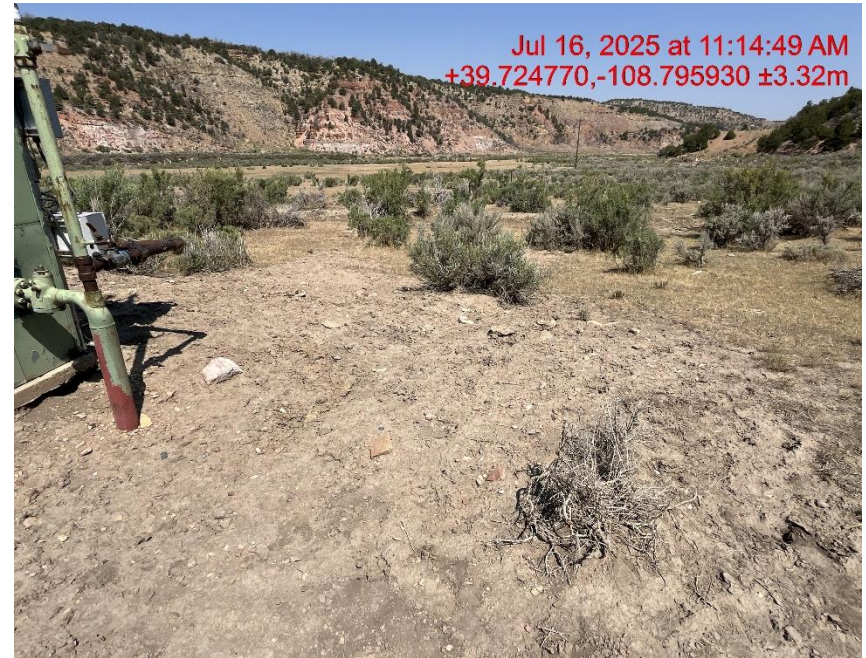
Photo # 0077 Failure to minimize erosion & transport of sediment off location/insufficient BMP's

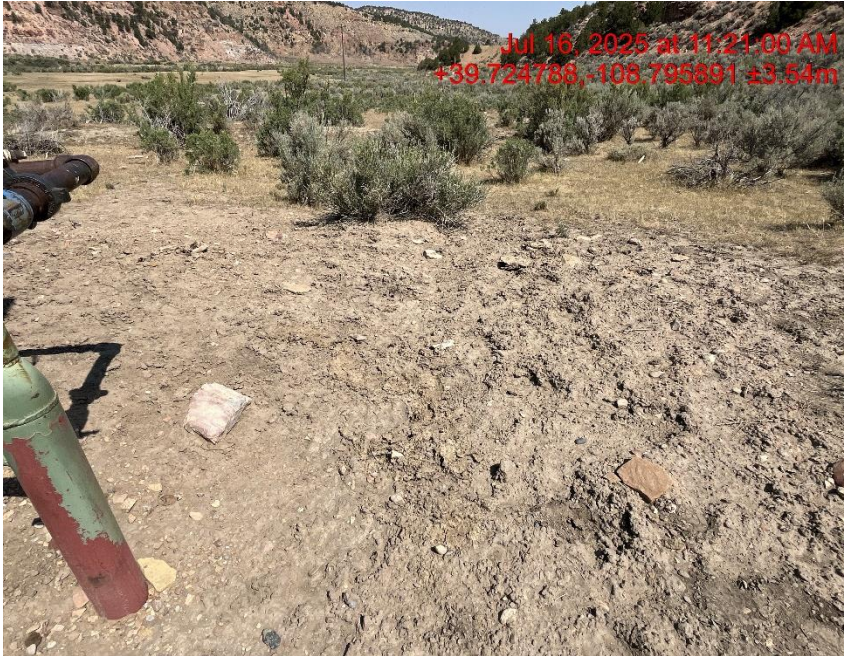
Photo # 0084 Failure to minimize erosion & transport of sediment off location/insufficient BMP's

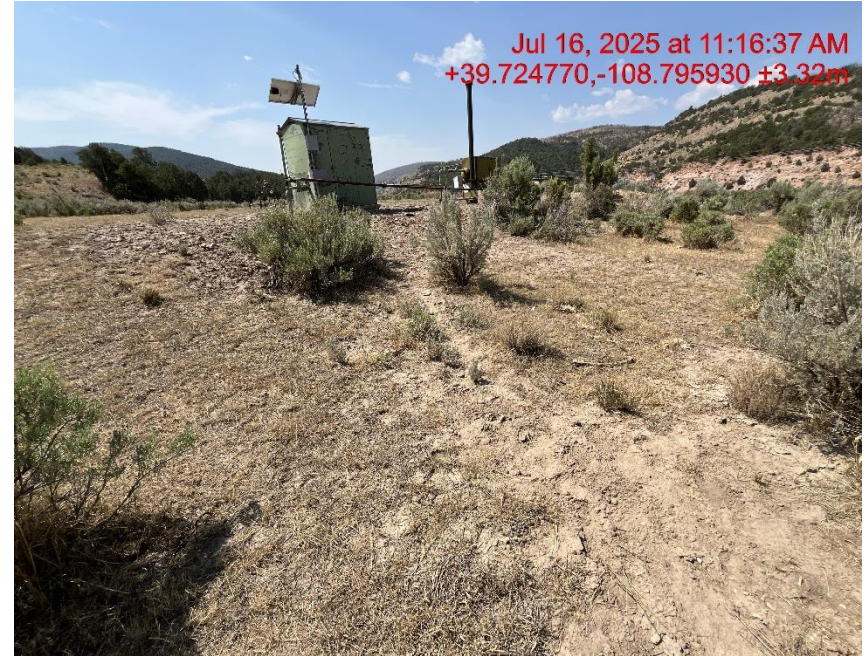
Photo # 0080 Failure to minimize erosion & transport of sediment off location/insufficient BMP's

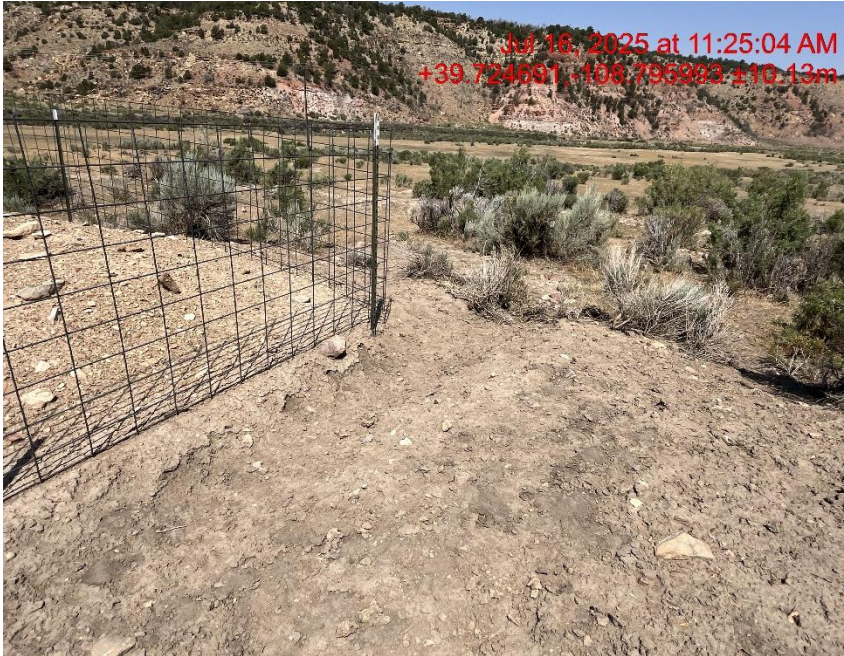
Photo # 0089 Failure to minimize erosion & transport of sediment off location/insufficient BMP's

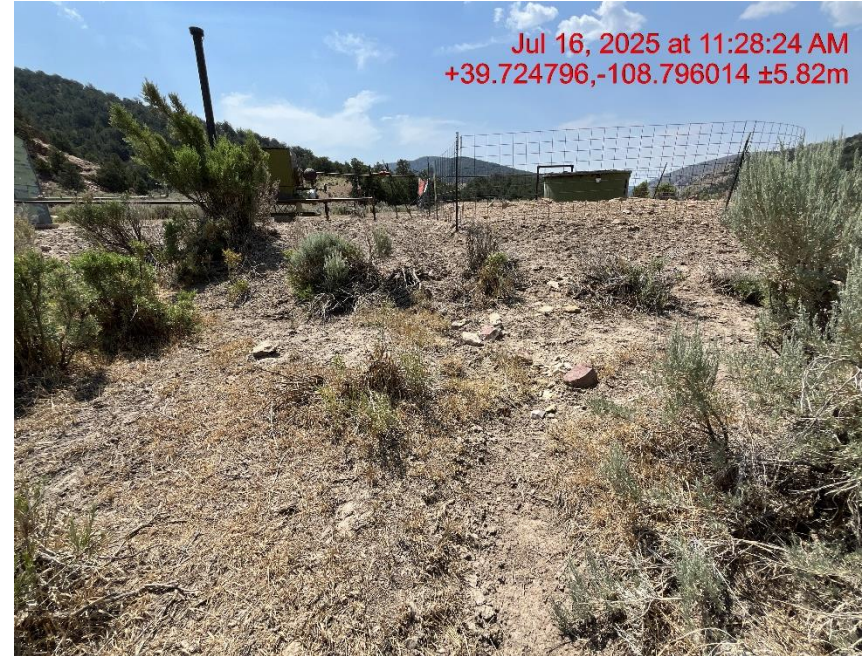
Photo # 0093 Failure to minimize erosion & transport of sediment off location/insufficient BMP's
