Inspection/Audit Photos

Location Name: TEP ROCKY MOUNTAIN LLC CLOUGH 114 Pad

Location ID: 322437

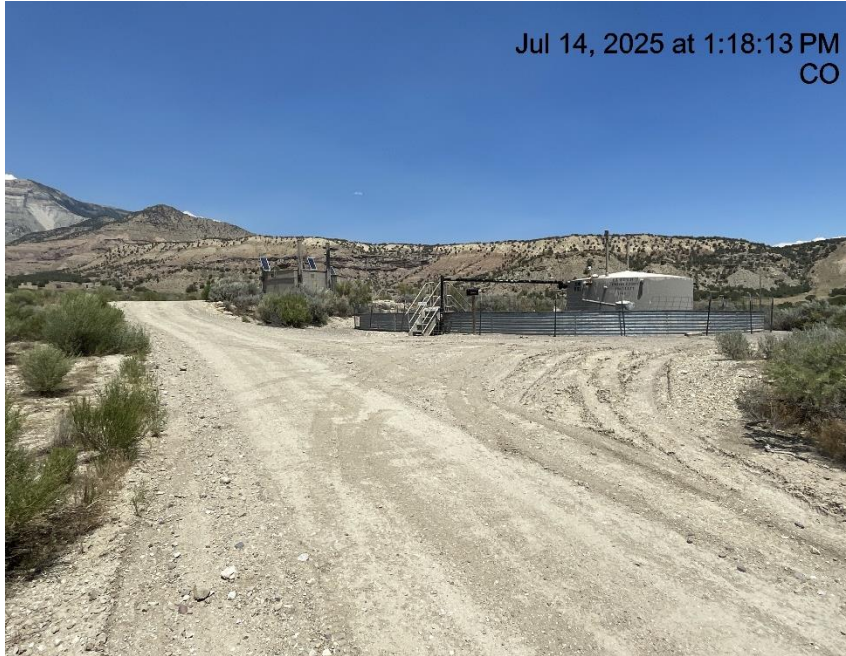
Photo # 2123 From entrance to location

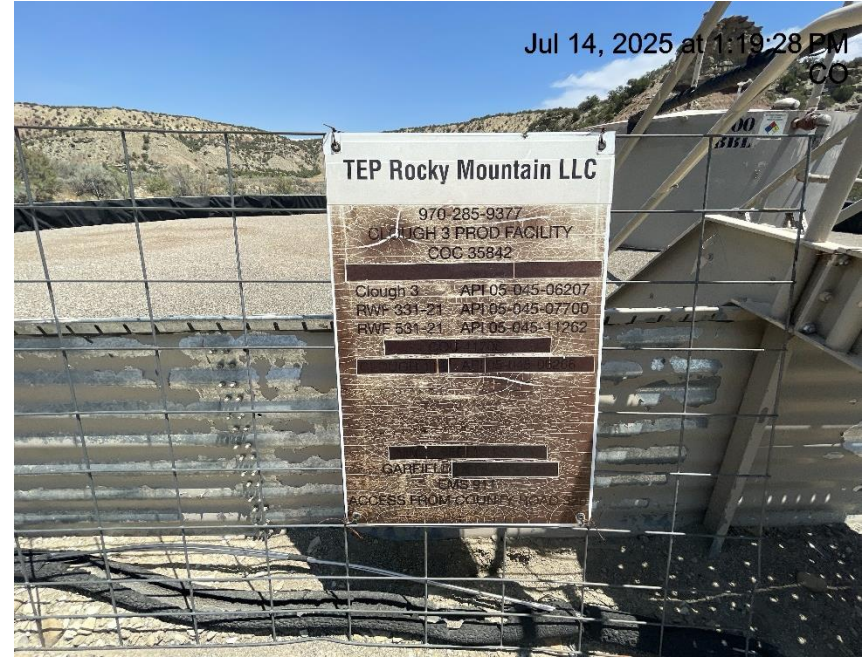
Photo # 2128 Battery sign weathered & becoming illegible & additionally access road info on sign is incorrect

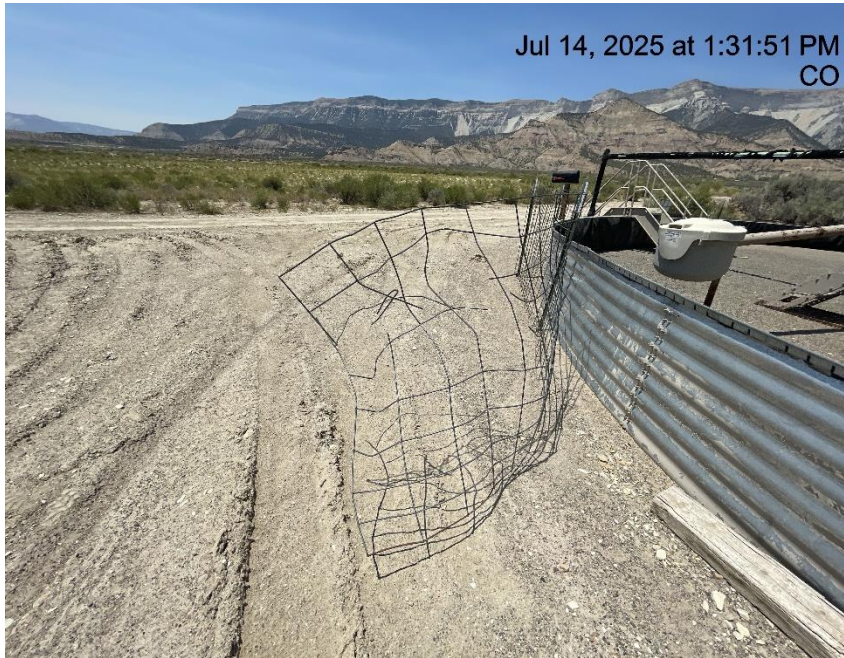
Photo # 2129 Hog panels around tank battery damaged
