# Final Reclamation and Stormwater Inspection

Location ID: 320364

Well Name: DREYER #1

Inspection Document #: 718600796

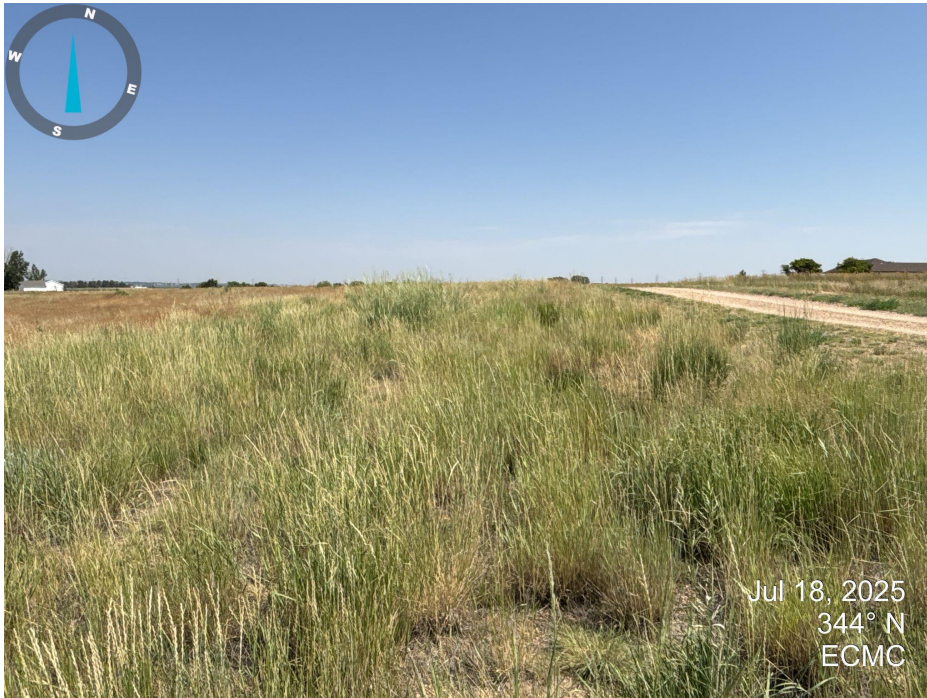
**Photo 1.** Looking north across the tank battery. No oil and gas equipment remains. Desirable perennial vegetation appears to have reached 80% coverage of the reference area.

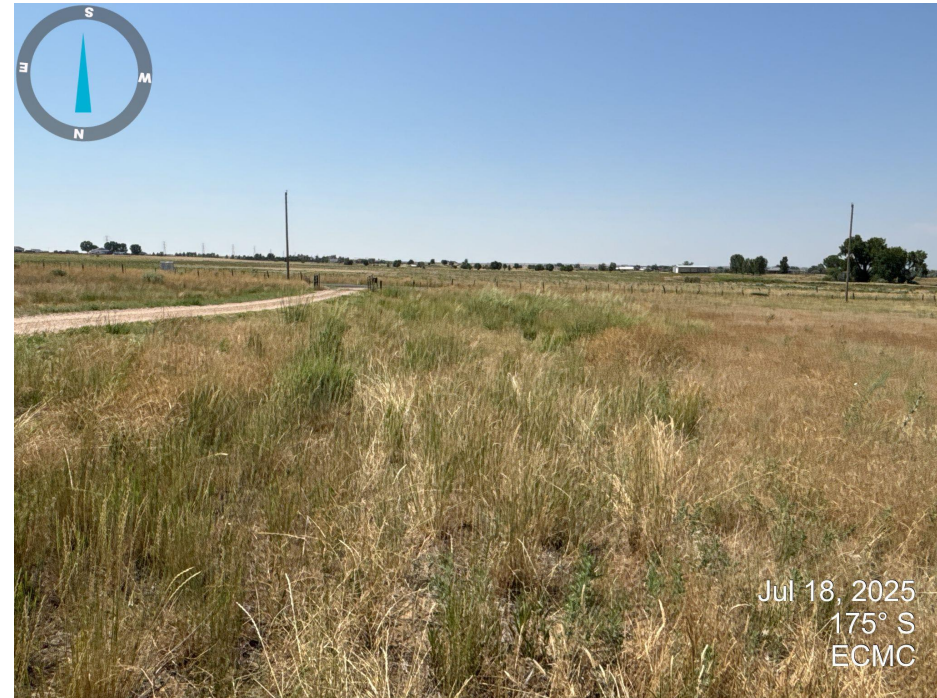
**Photo 2.** Looking south across the tank batter from the north side. See photo 1 comments.

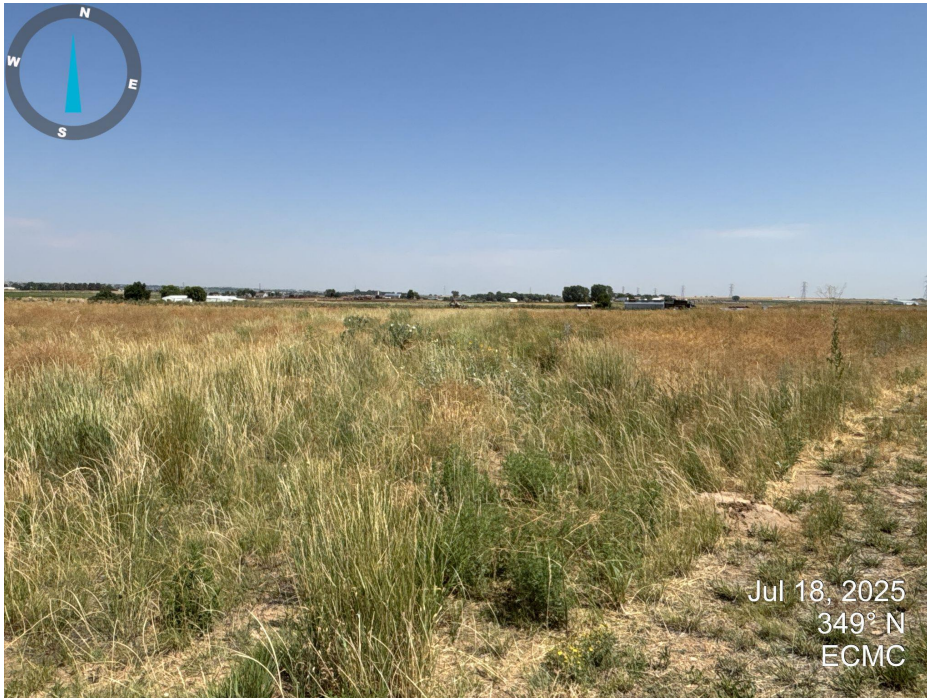
**Photo 3.** Looking north down the former access road. Desirable perennial vegetation on the access road appears to have reached 80% coverage of the reference area.

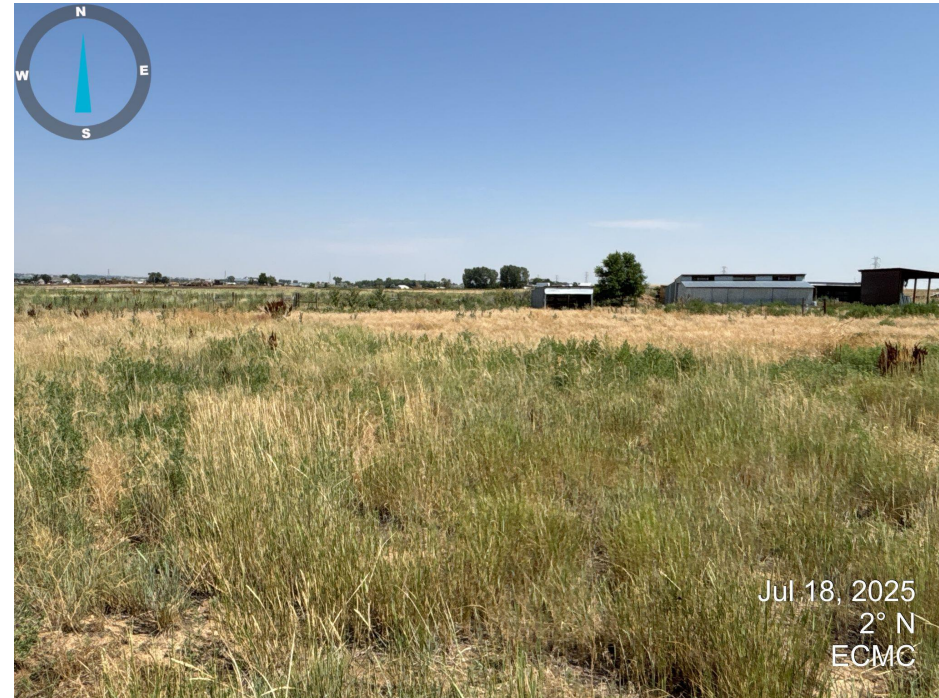
**Photo 4.** Looking north from the wellbore. No oil and gas equipment remains. Desirable perennial vegetation on the access road appears to have reached 80% coverage of the reference area.

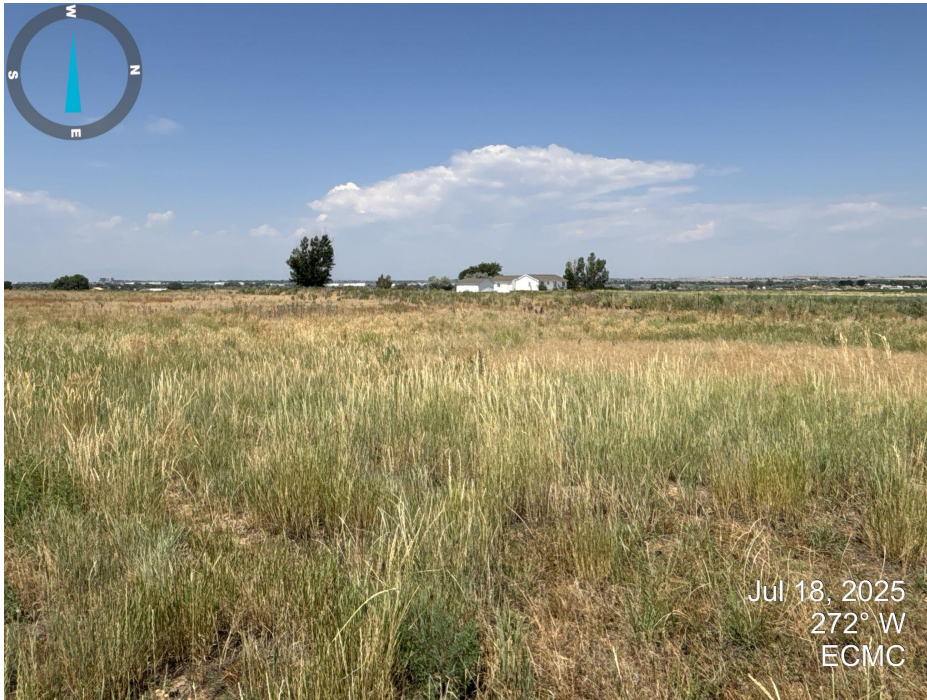
**Photo 5.** Looking west from the center of the location. See photo 4 comments.

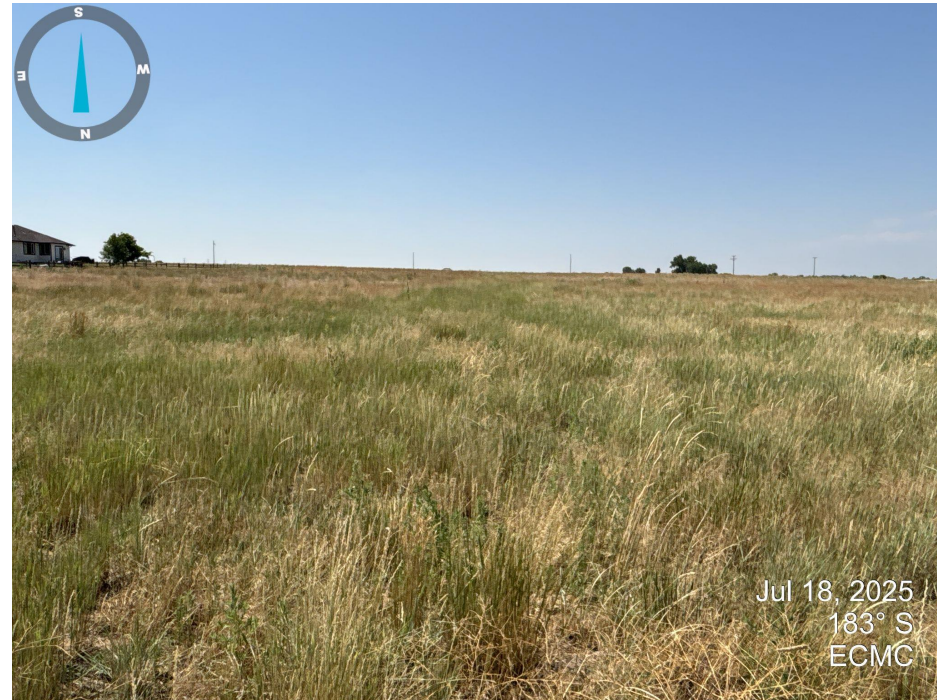
**Photo 6.** Looking south from the center of the location. See photo 4 comments.

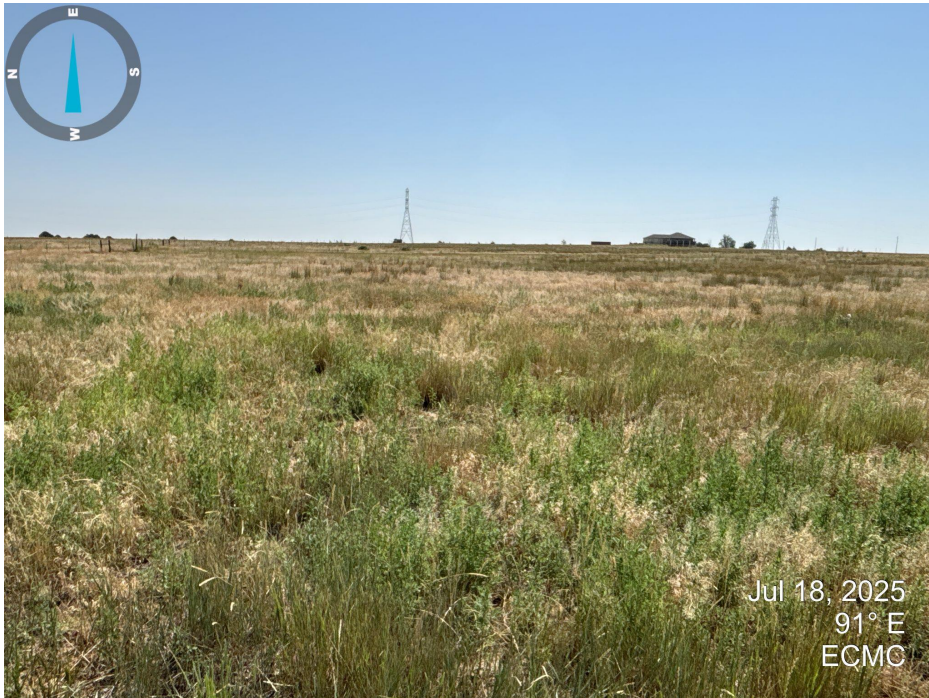
**Photo 7.** Looking east from the center of the location. See photo 4 comments.

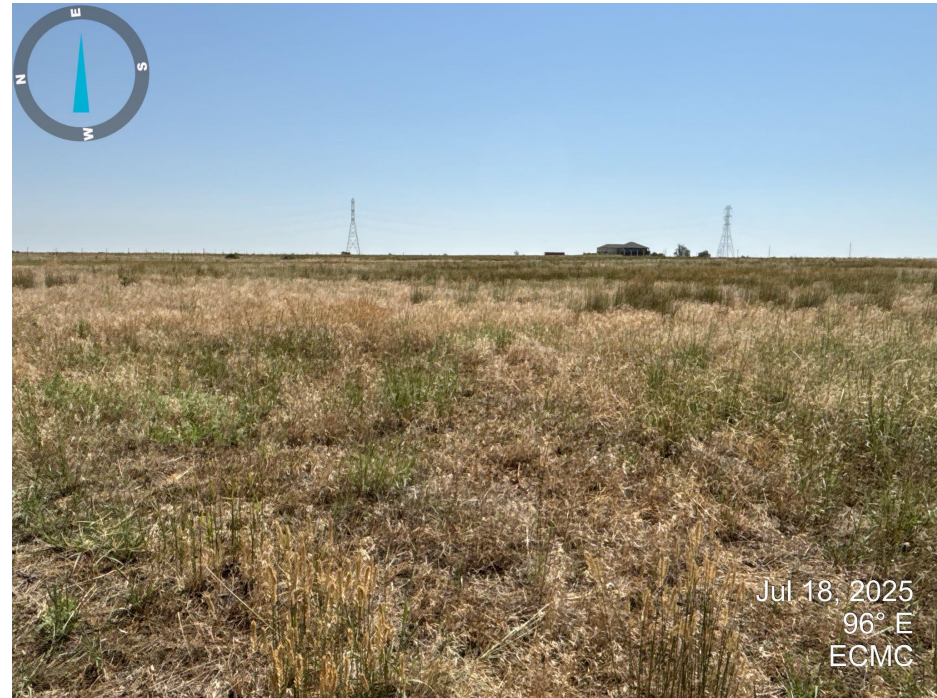
**Photo 8.** Reference vegetation to the east of the location. Reference vegetation is poor, primarily cheatgrass.
