Inspection/Audit Photos

Location Name: TEP ROCKY MOUNTAIN LLC LEVERICH 31-09 Pad

Location ID: 334711

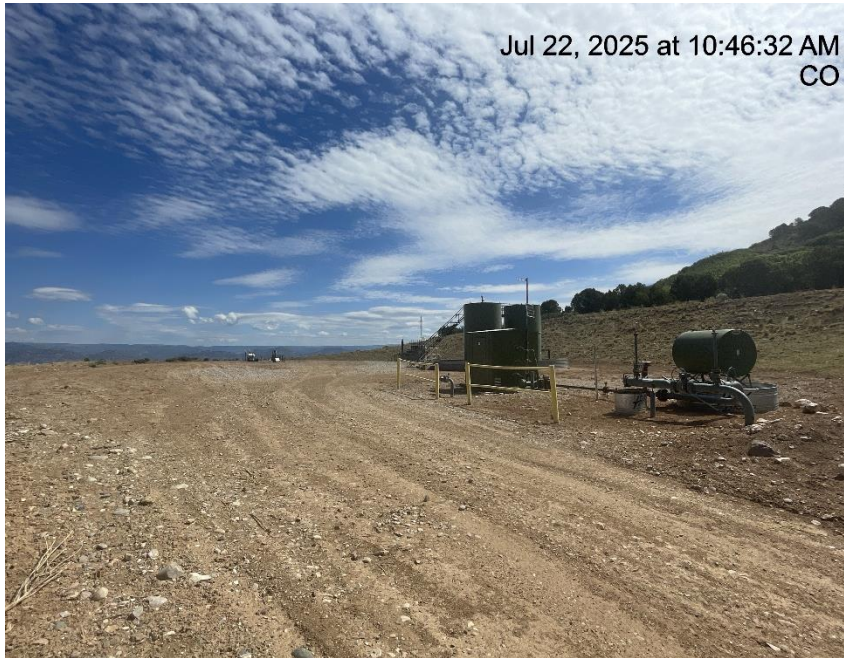
Photo # 3529 From entrance to location

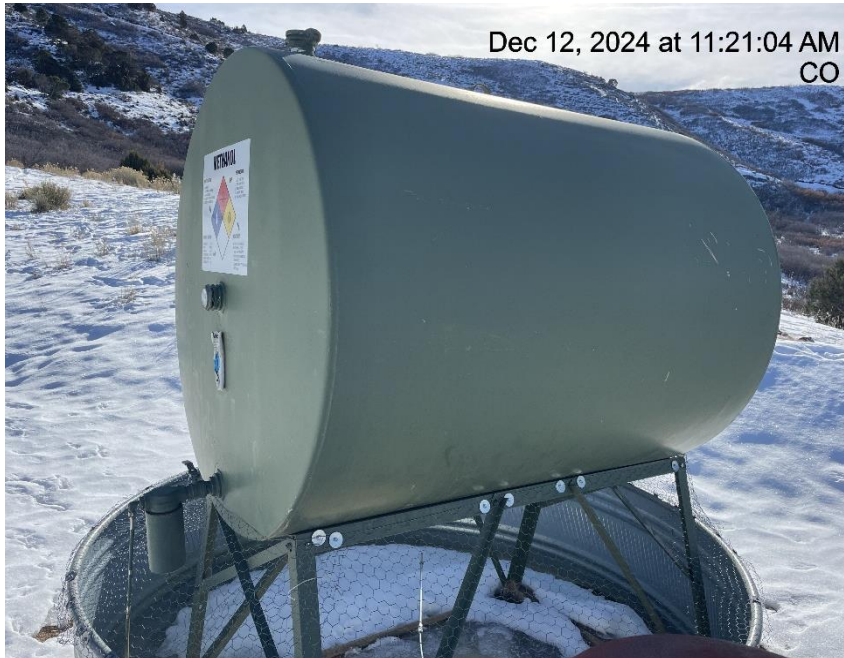
Photo # 3391 From inspection 708905234 conducted on 12/12/2024 Methanol tank improperly labeled/missing some required information

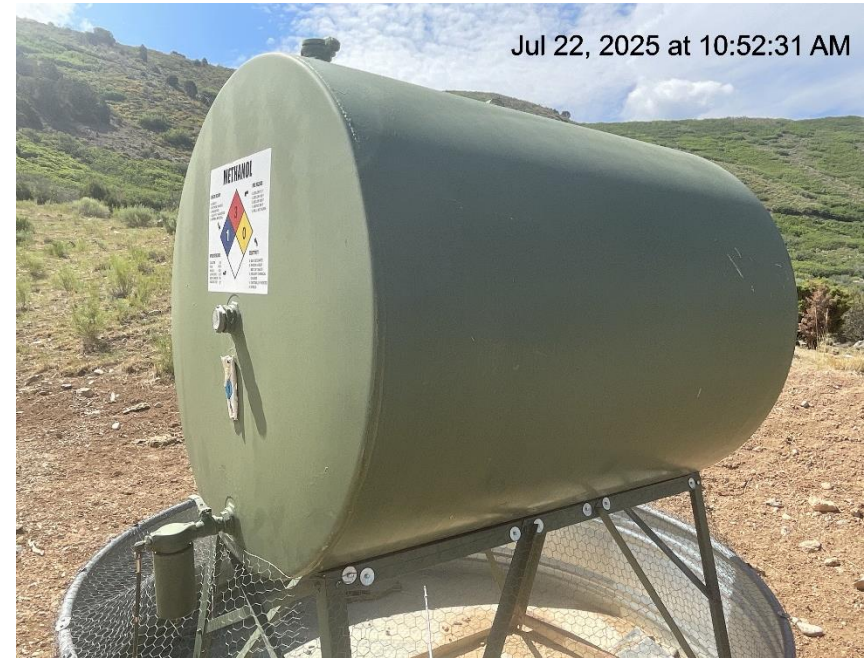
Photo # 3537 Methanol tank improperly labeled/missing some required information

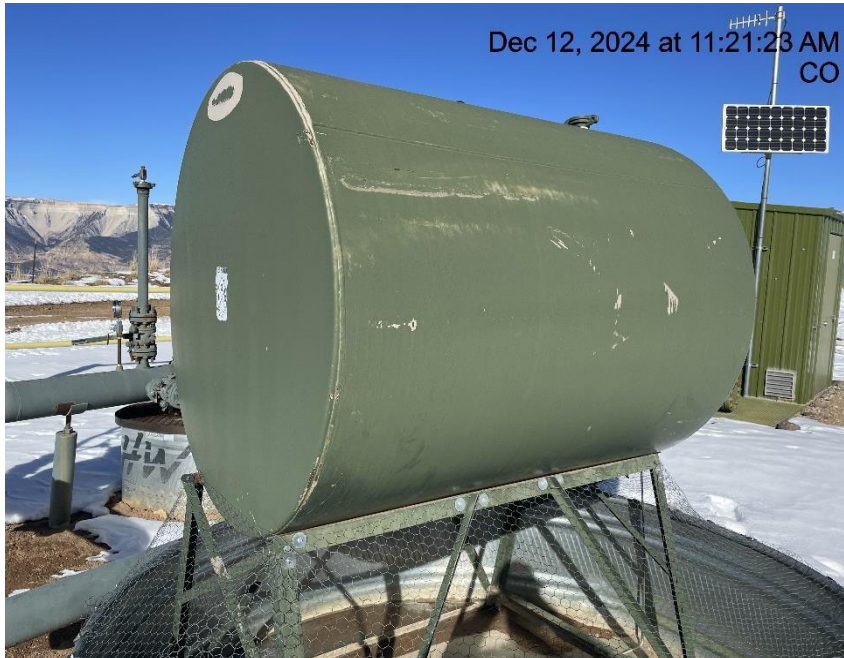
Photo # 3392 From inspection 708905234 conducted on 12/12/2024 Methanol tank improperly labeled/missing some required information

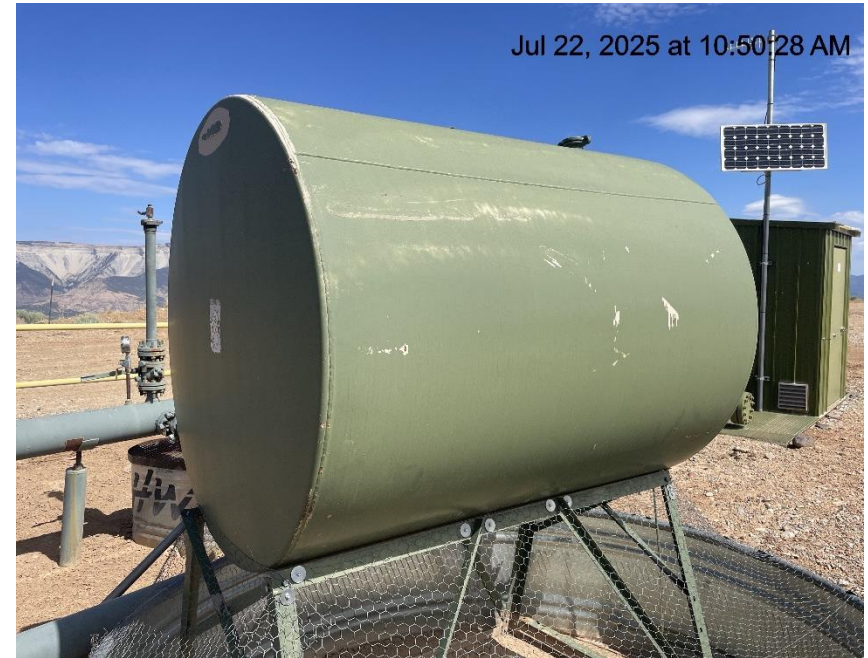
Photo # 3538 Methanol tank improperly labeled/missing some required information

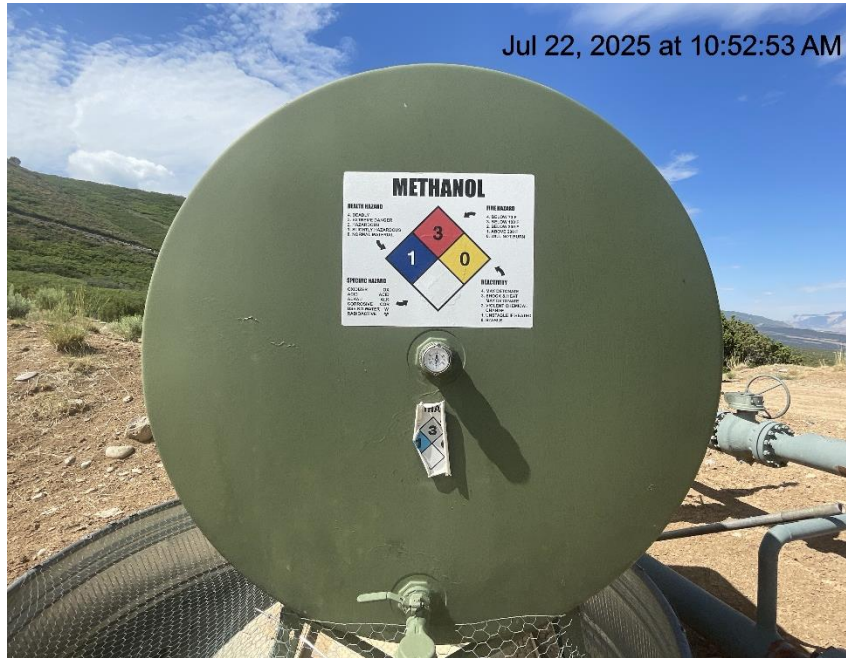
Photo # 3539 Methanol tank improperly labeled/missing some required information

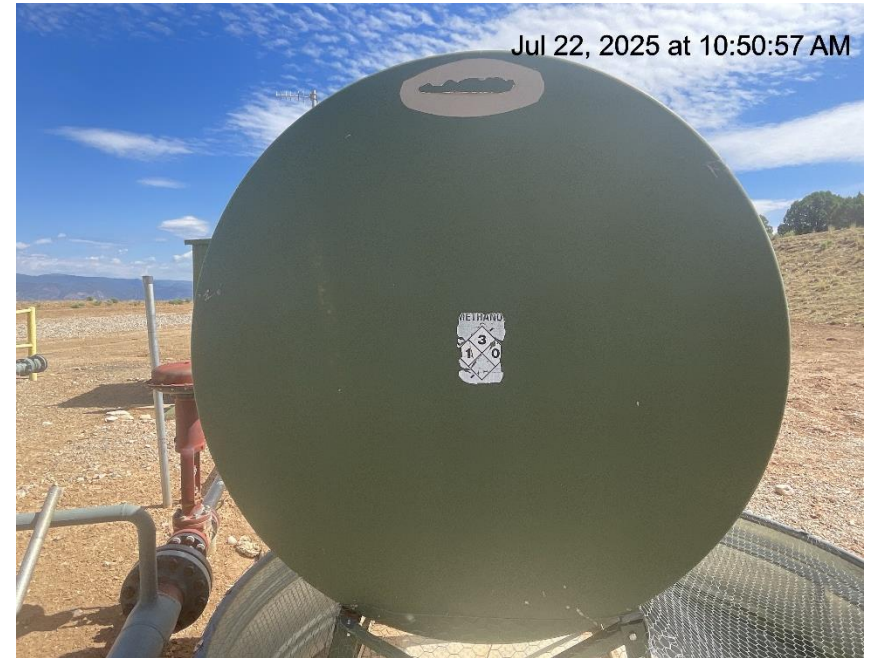
Photo # 3540 Methanol tank improperly labeled/missing some required information

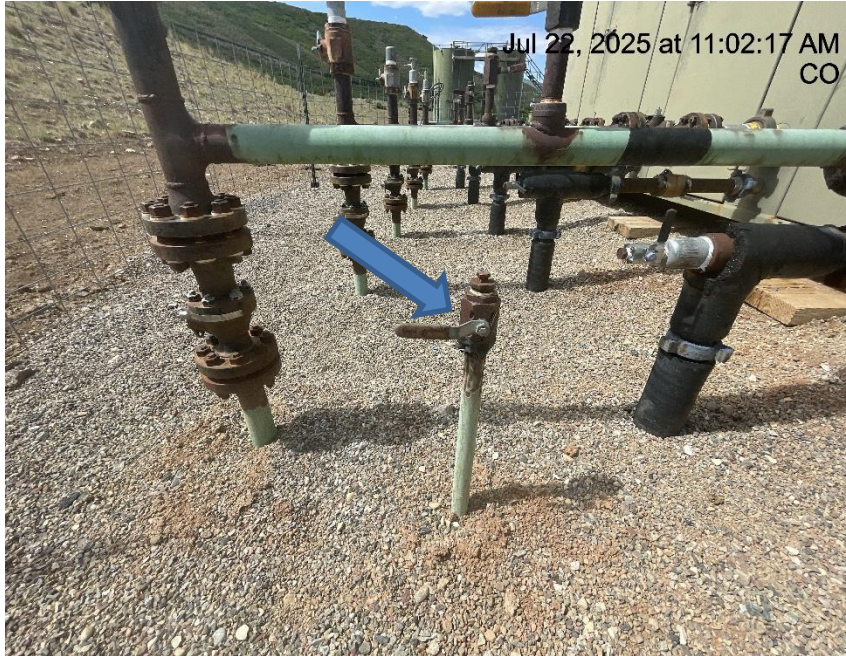
Photo # 3541 Unused flowline lacks lockout tagout (OOSLAT)

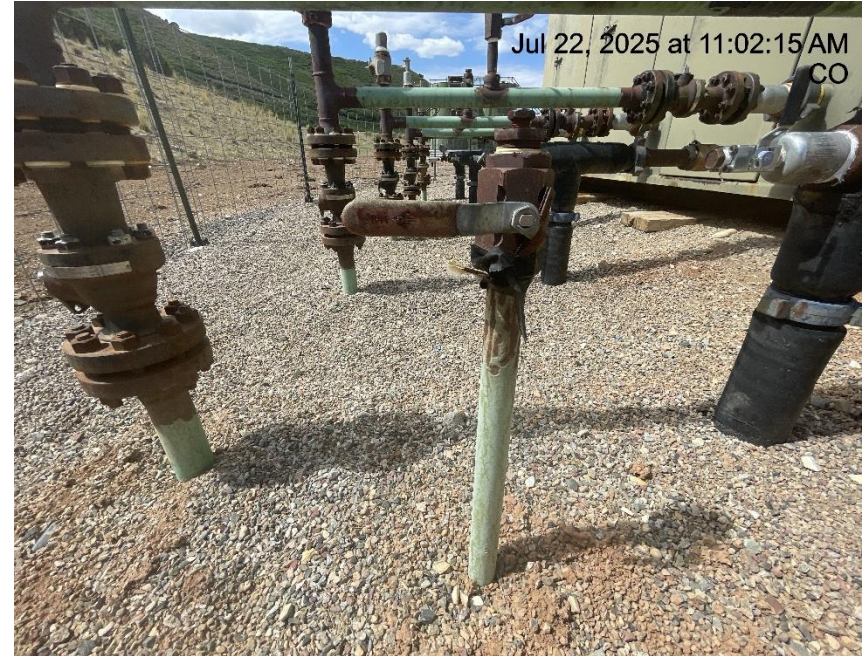
Photo # 3542 Unused flowline lacks lockout tagout (OOSLAT)

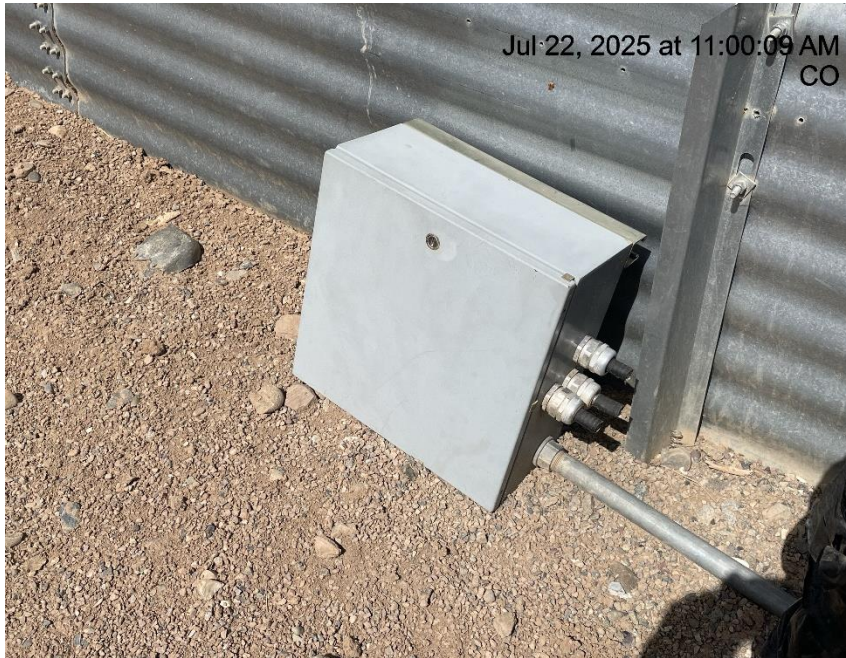
Photo # 3543 Debris

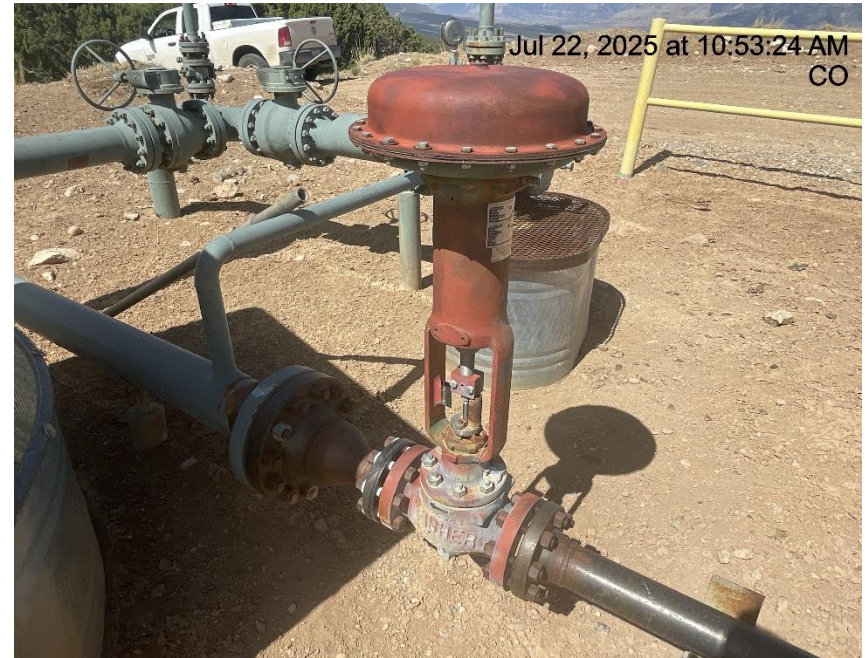
Photo # 3544 Pneumatic control valve on Summit Midstream pipeline has been modified/valve no longer has the ability to close

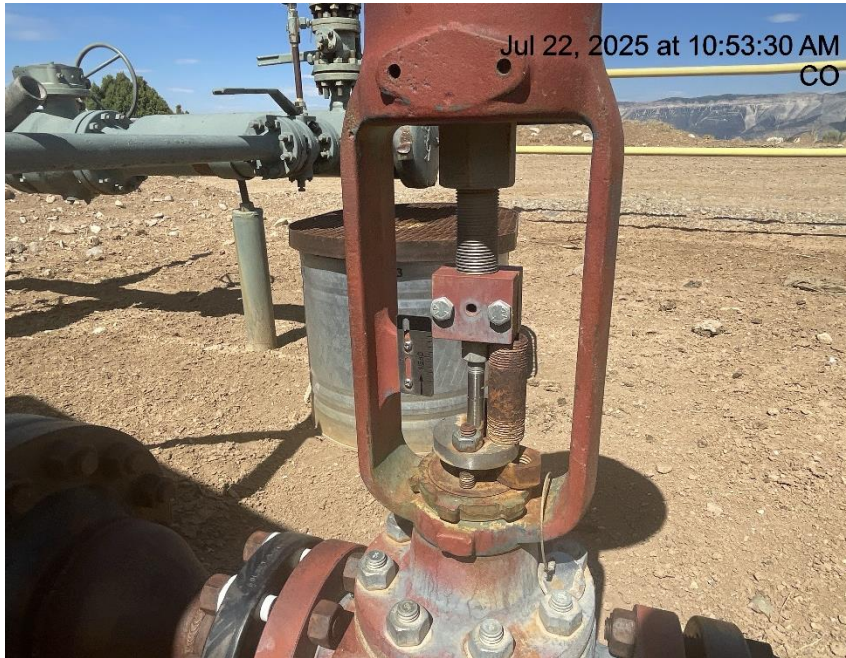
Photo # 3546 Pneumatic control valve on Summit Midstream pipeline has been modified/valve no longer has the ability to close

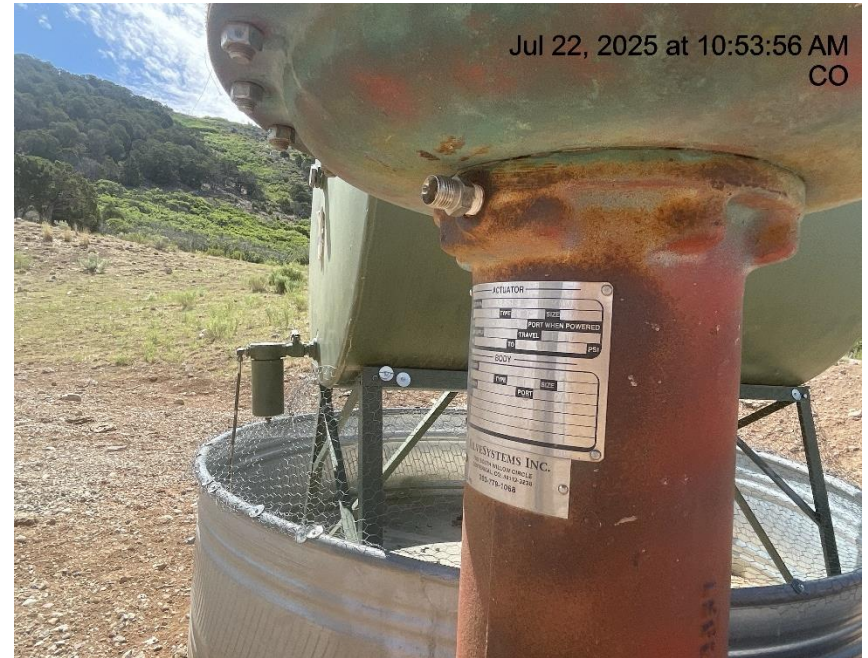
Photo # 3547 Supply gas line for Summit Midstream control valve disconnected/valve no longer operable
