Federal Albatross 33-12/Federal Falcon 33-6  
15-Jul-25 15:10:31  
ECMC Environmental Inspection

**ECMC**  
**Environmental**  
**Field Inspection**

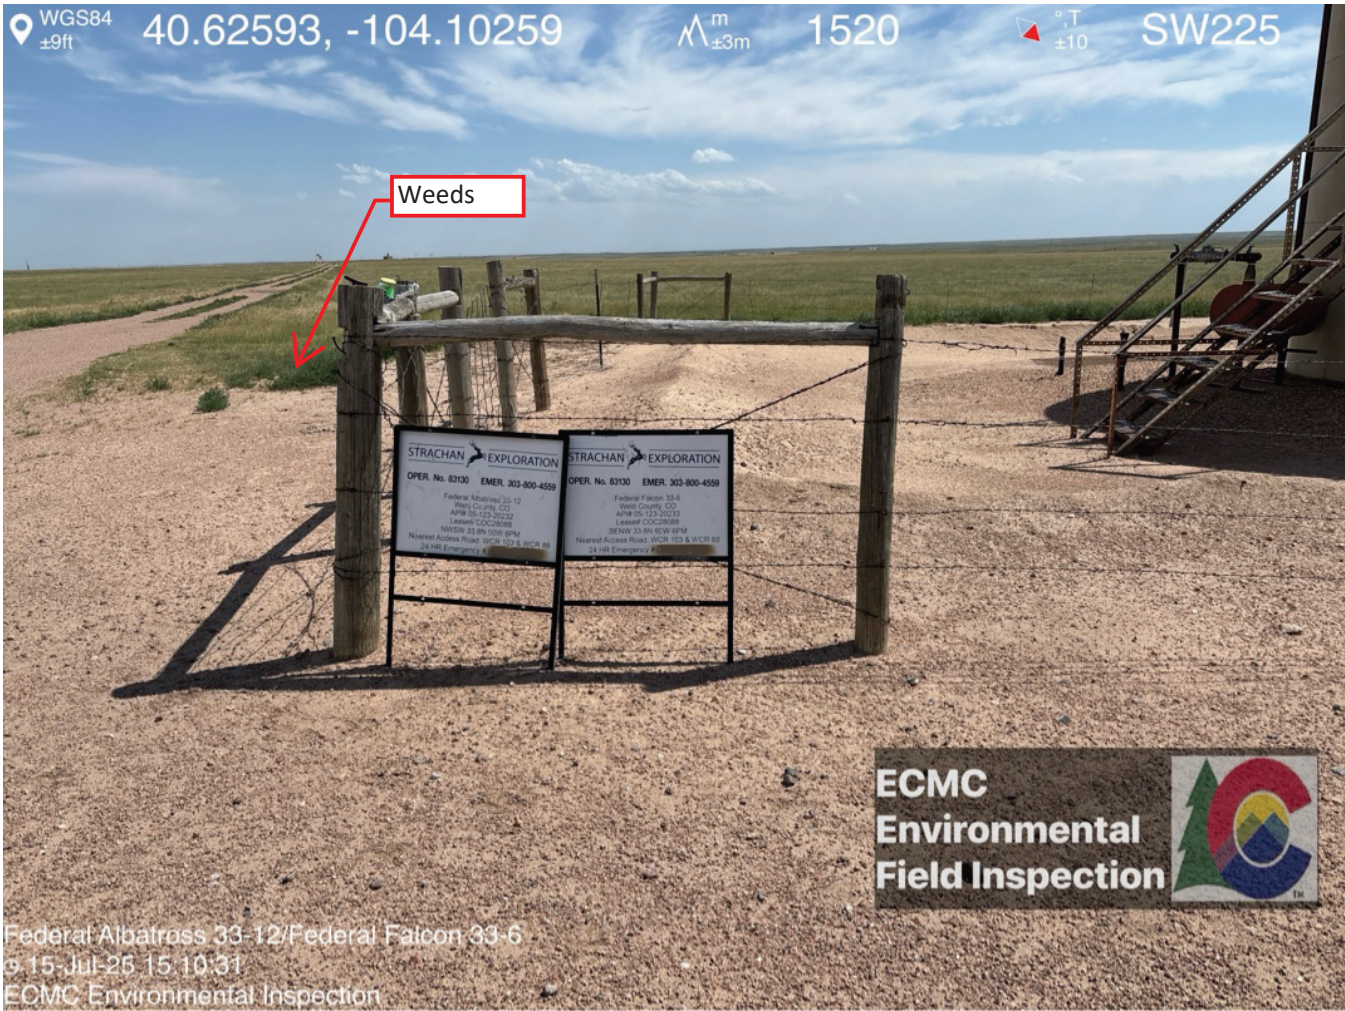
Signage at Federal Falcon #33-06 tank battery (Location ID 467686)  
Weeds

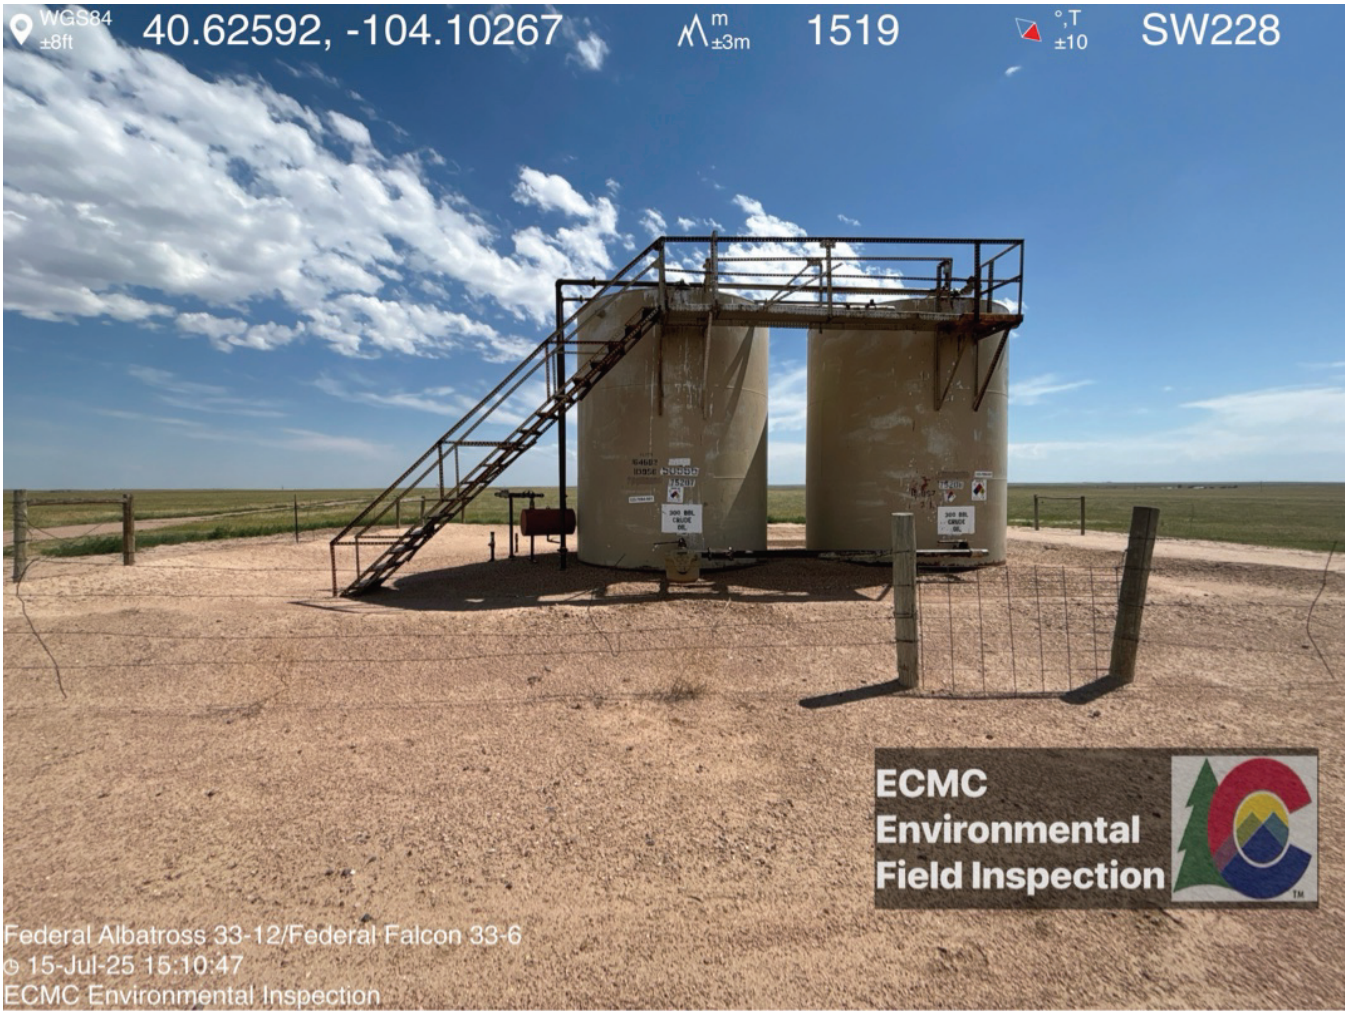
Federal Falcon #33-06 tank battery (Location ID 467686)  
Two (2) 300-bbl steel crude oil aboveground storage tanks (ASTs)  
Shared earthen secondary containment berm has started to erode  
Fencing adequate

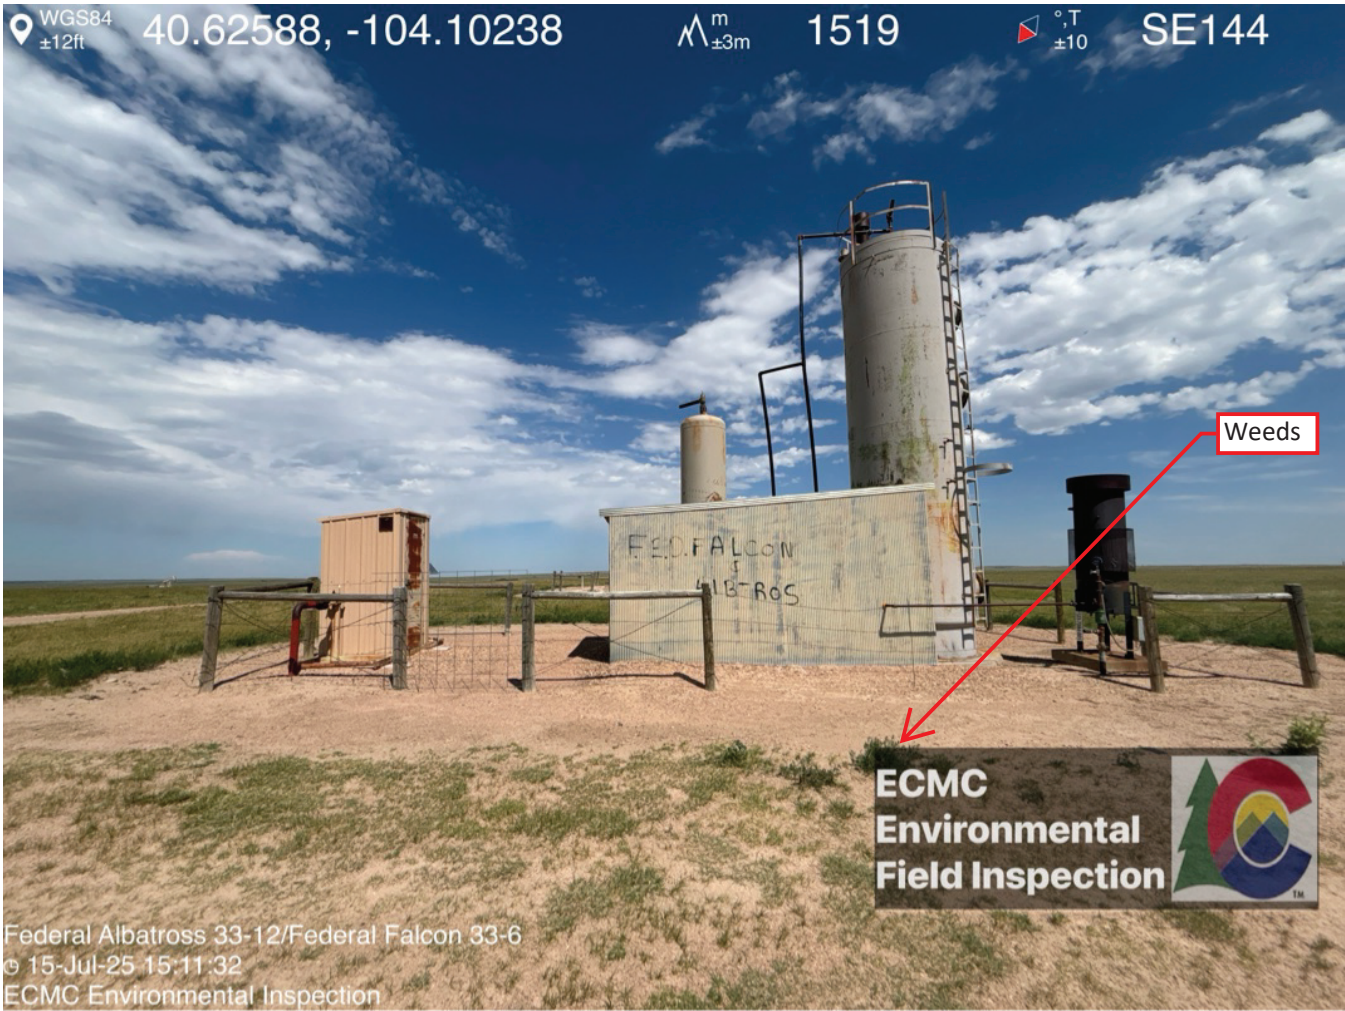
Federal Falcon #33-06 tank battery (Location ID 467686)  
Meter shed, vertical heater treater, ECD - Fencing adequate  
Weeds

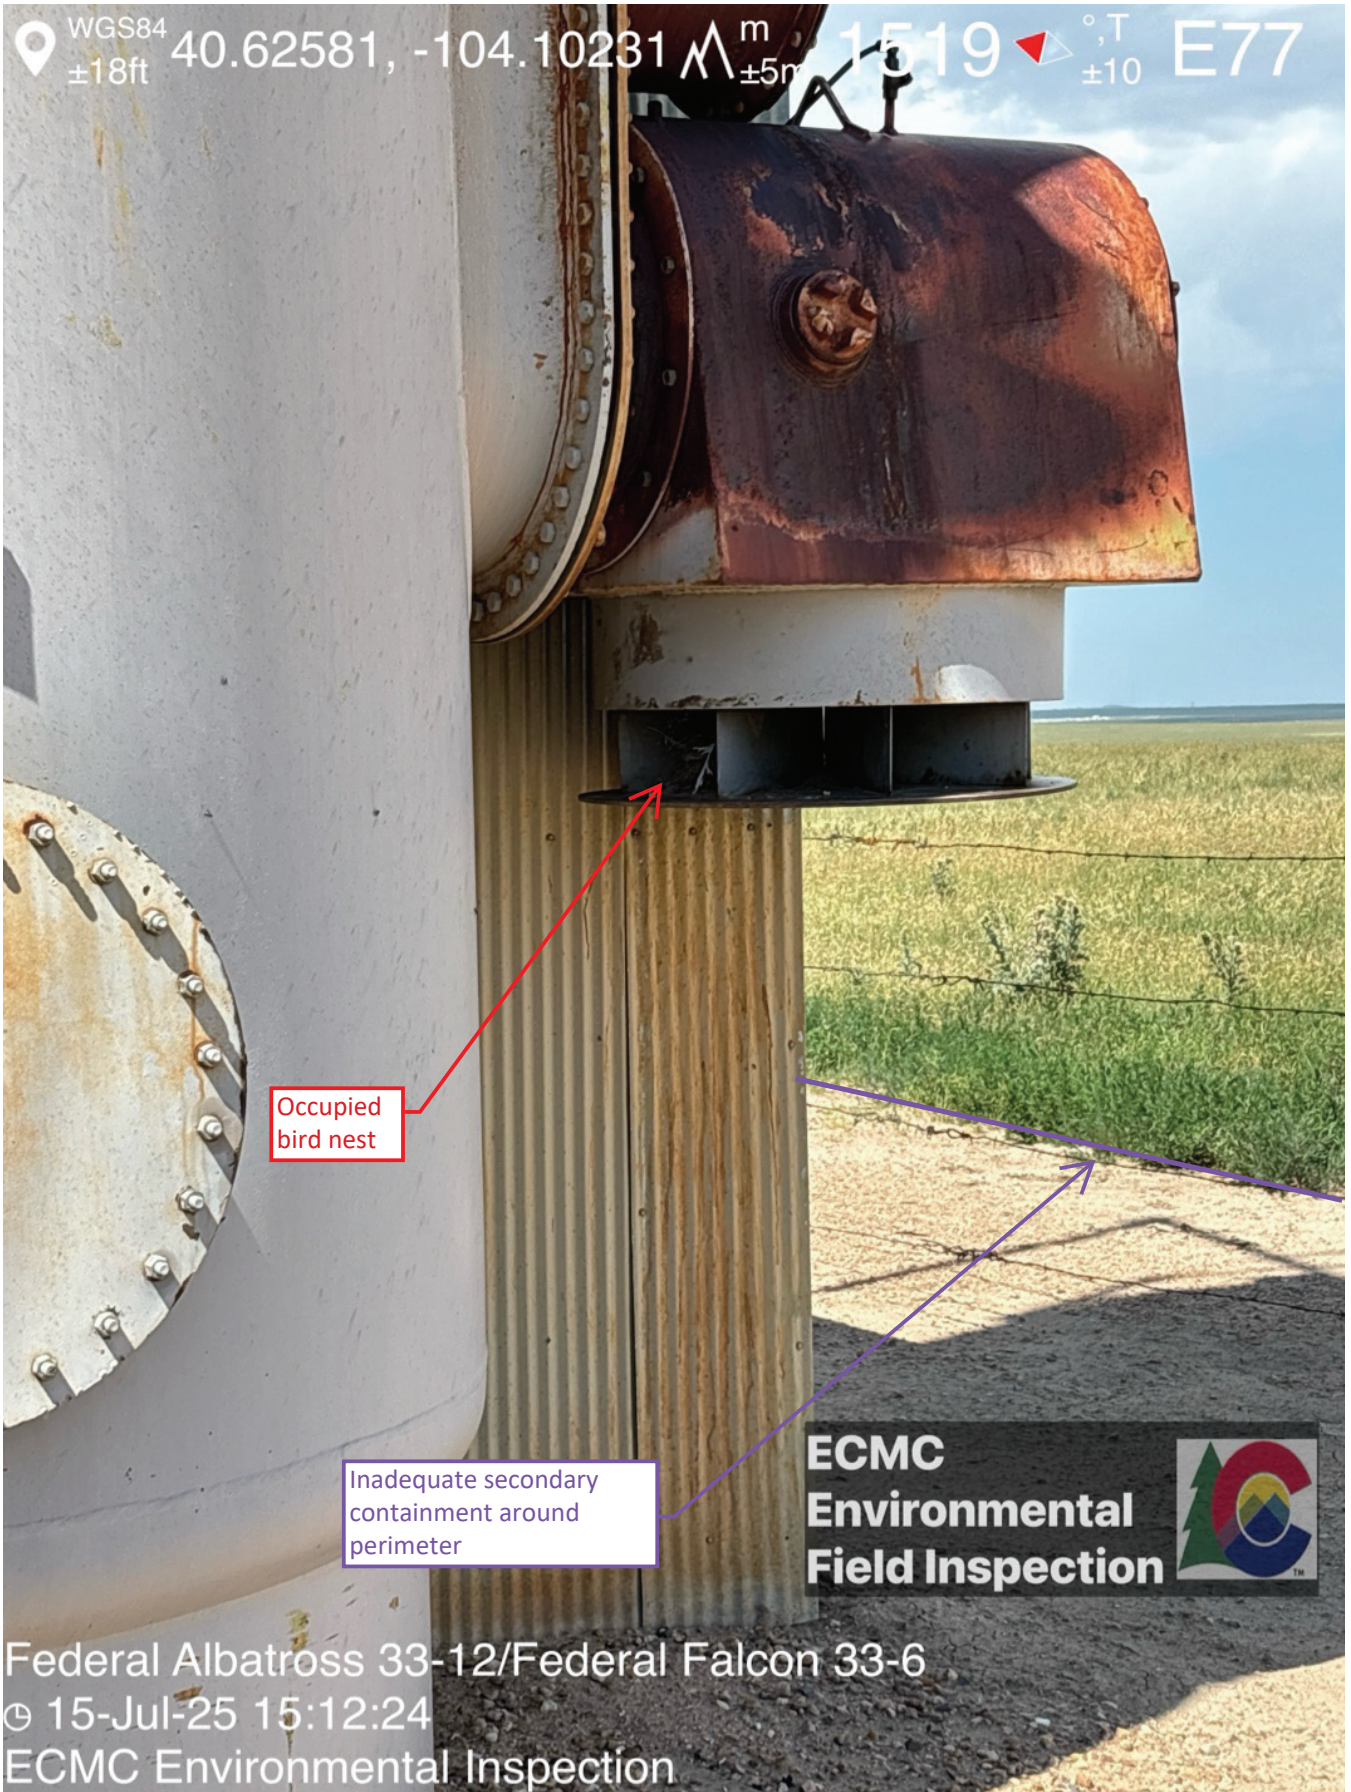
Occupied  
bird nest

Inadequate secondary  
containment around  
perimeter

Federal Falcon #33-06 tank battery (Location ID 467686)  
Occupied bird nest in vertical heater treater firetube intake  
Inadequate secondary containment surrounding vertical heater treater

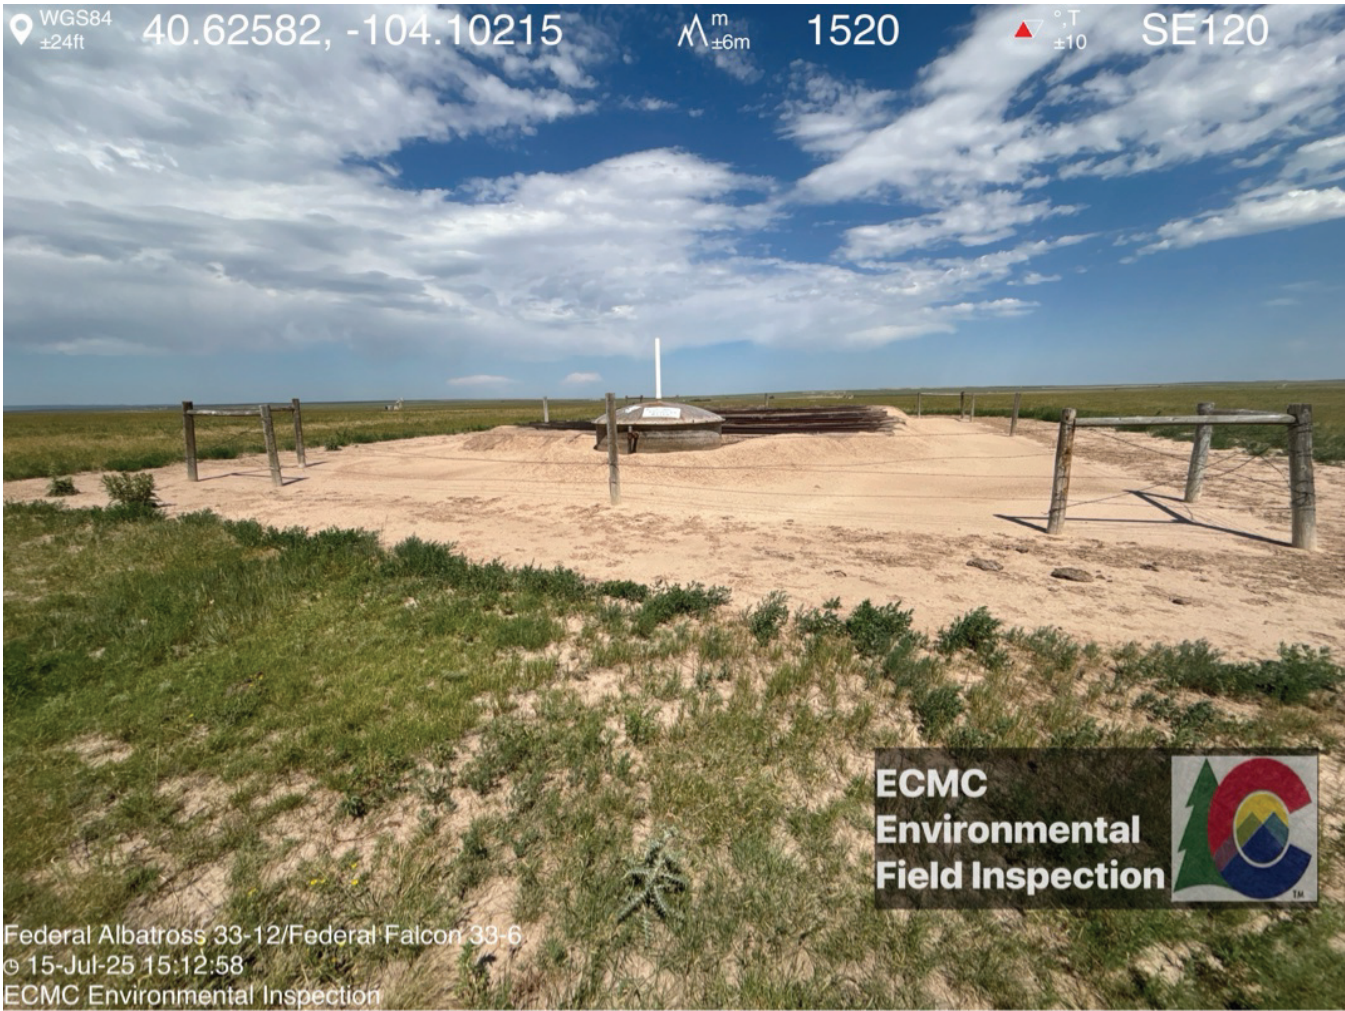
Federal Falcon #33-06 tank battery (Location ID 467686)  
50-bbl partially buried fiberglass skim tank and earthen pit.  
Adequate fencing.  
Earthen secondary containment berms are showing signs of erosion.  
Weeds.

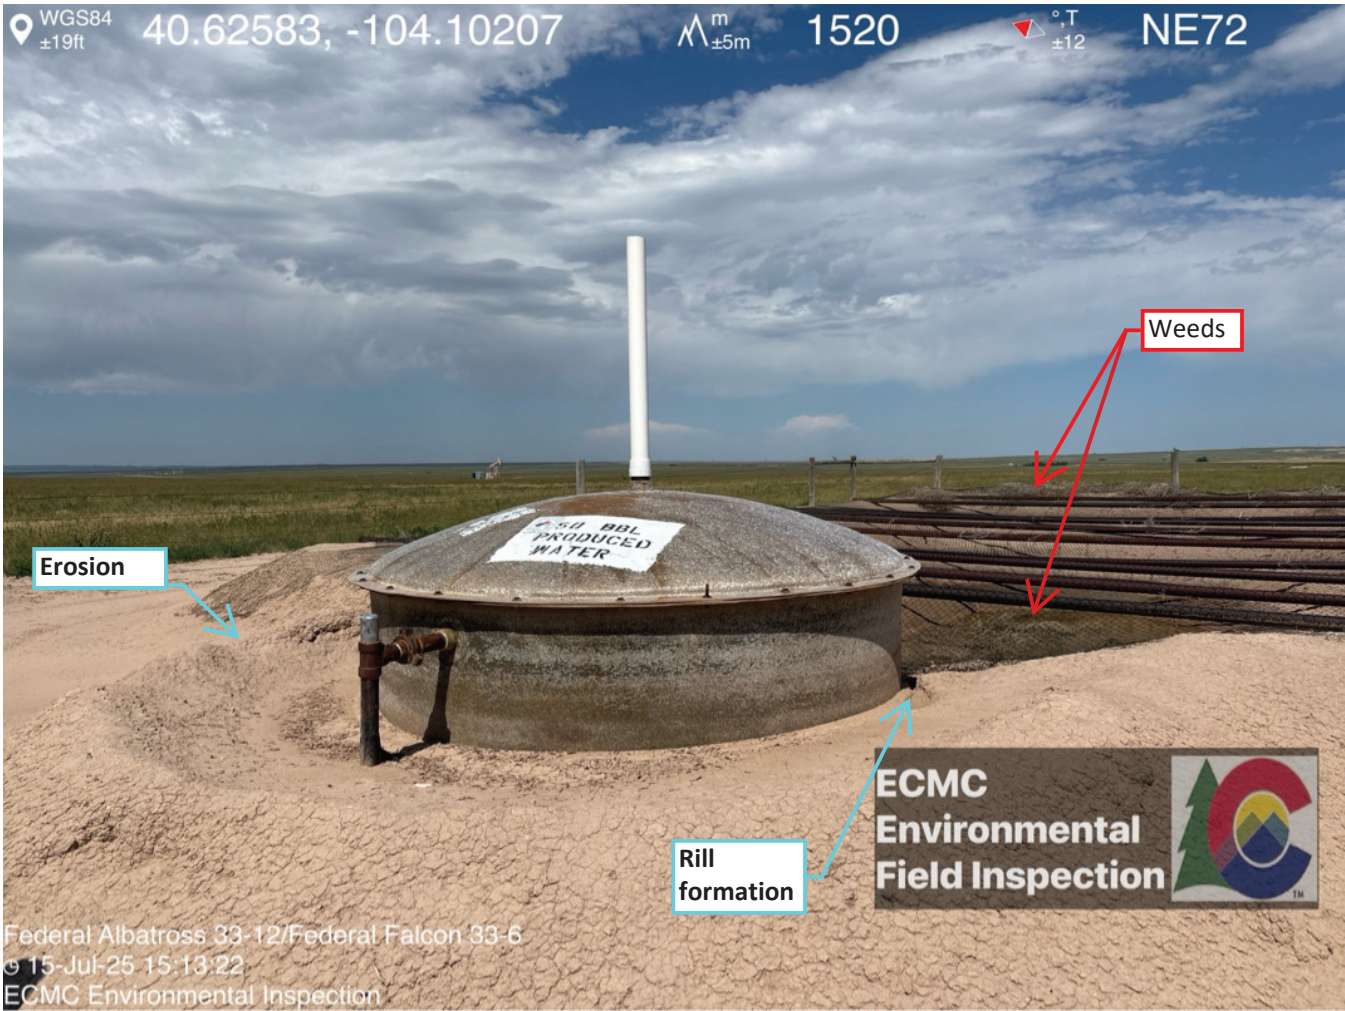
Federal Falcon #33-06 tank battery (Location ID 467686)  
50-bbl partially buried fiberglass skim tank and earthen pit.  
Adequate fencing.  
Wildlife netting installed.  
Earthen secondary containment berms are showing signs of erosion (formation of rills).  
Weeds observed within/around the earthen pit and berm.

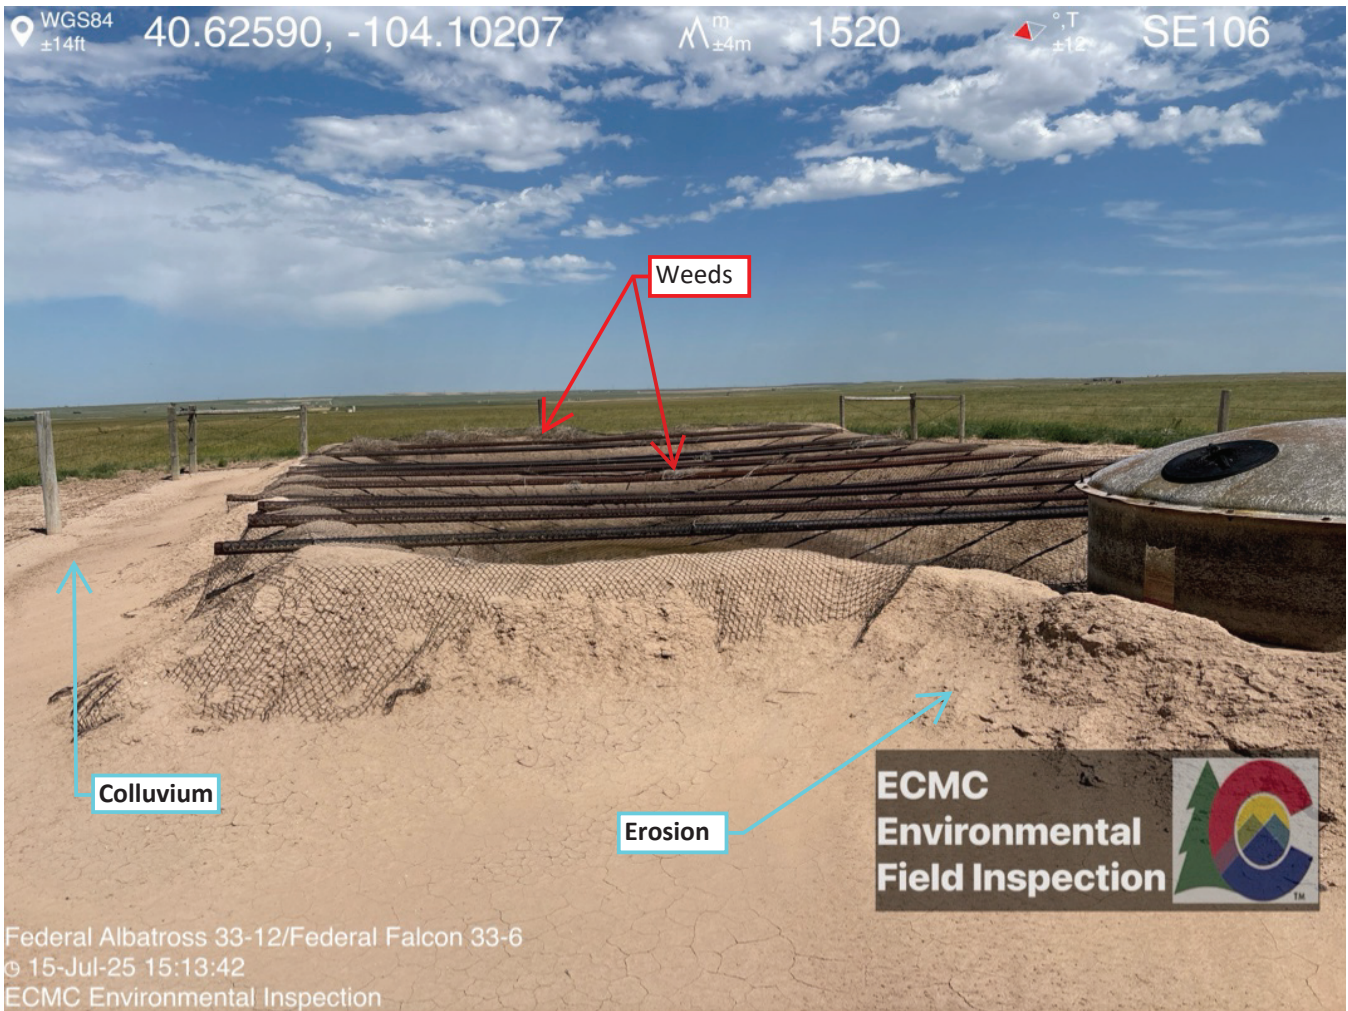
Federal Falcon #33-06 tank battery (Location ID 467686)  
50-bbl partially buried fiberglass skim tank and earthen pit.  
Adequate fencing.  
Wildlife netting installed.  
Earthen secondary containment berms are showing signs of erosion.  
Weeds observed within/around the earthen pit and berm.  
Wind and stormwater have eroded sediment from the berms then transported and deposited the sediment (colluvium) along the perimeter and into the open pit.

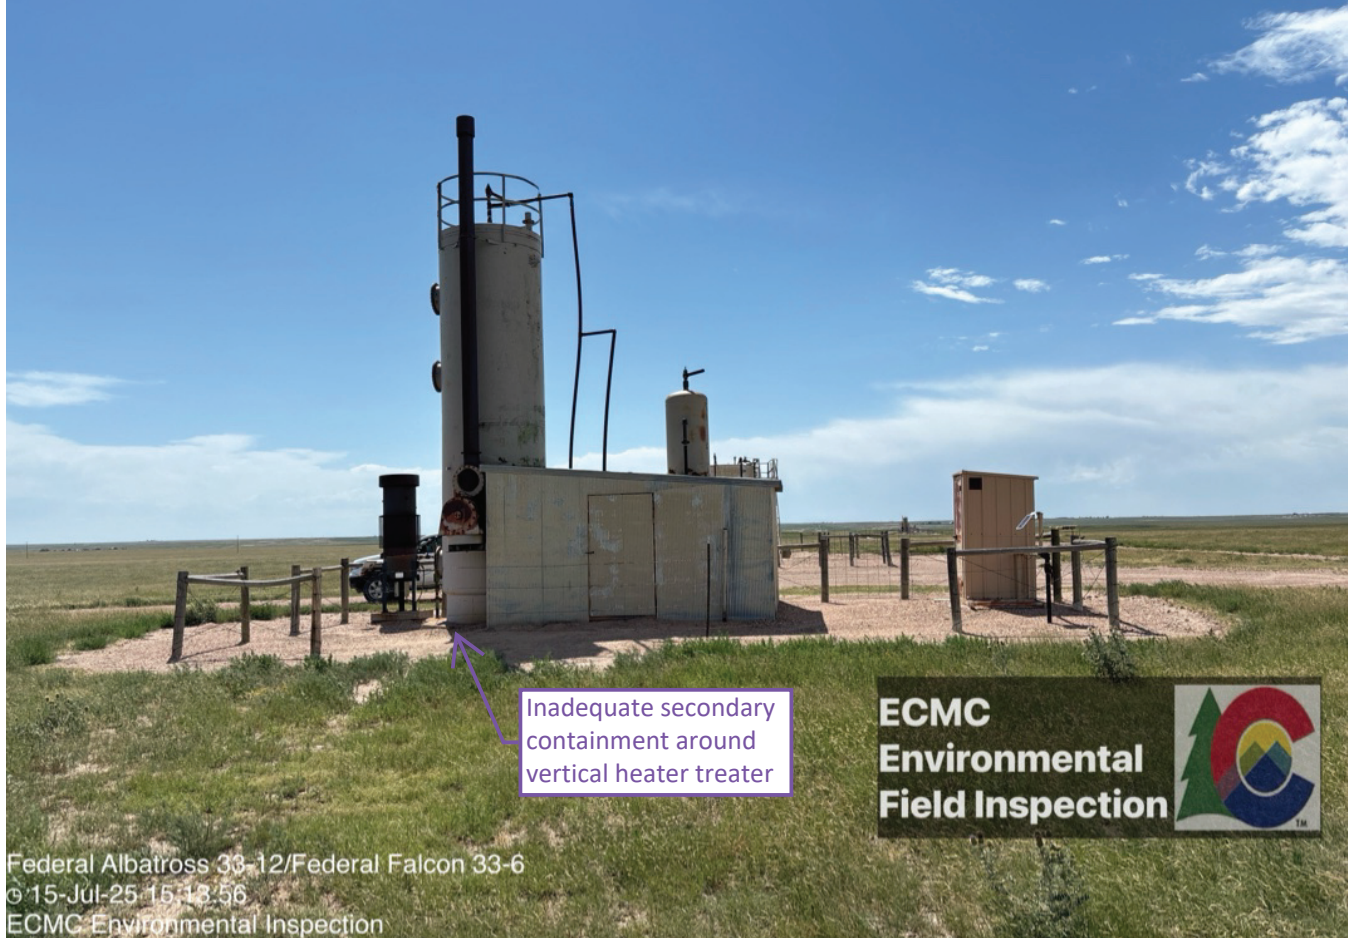
Inadequate secondary  
containment around  
vertical heater treater

Federal Falcon #33-06 tank battery (Location ID 467686)  
Meter shed, vertical heater treater, ECD - Fencing adequate.  
Inadequate secondary containment around vertical heater treater.

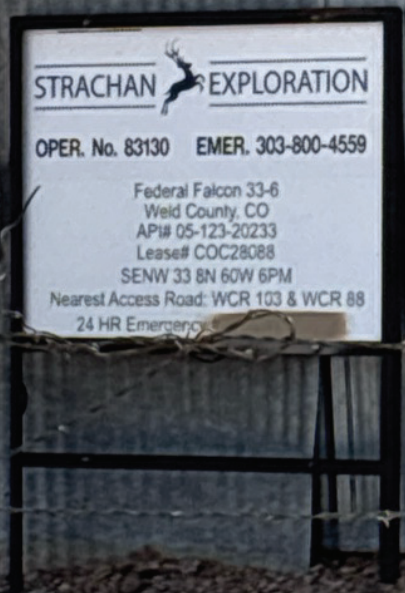
Signage at Federal Falcon #33-06 Well (API 123-20233)

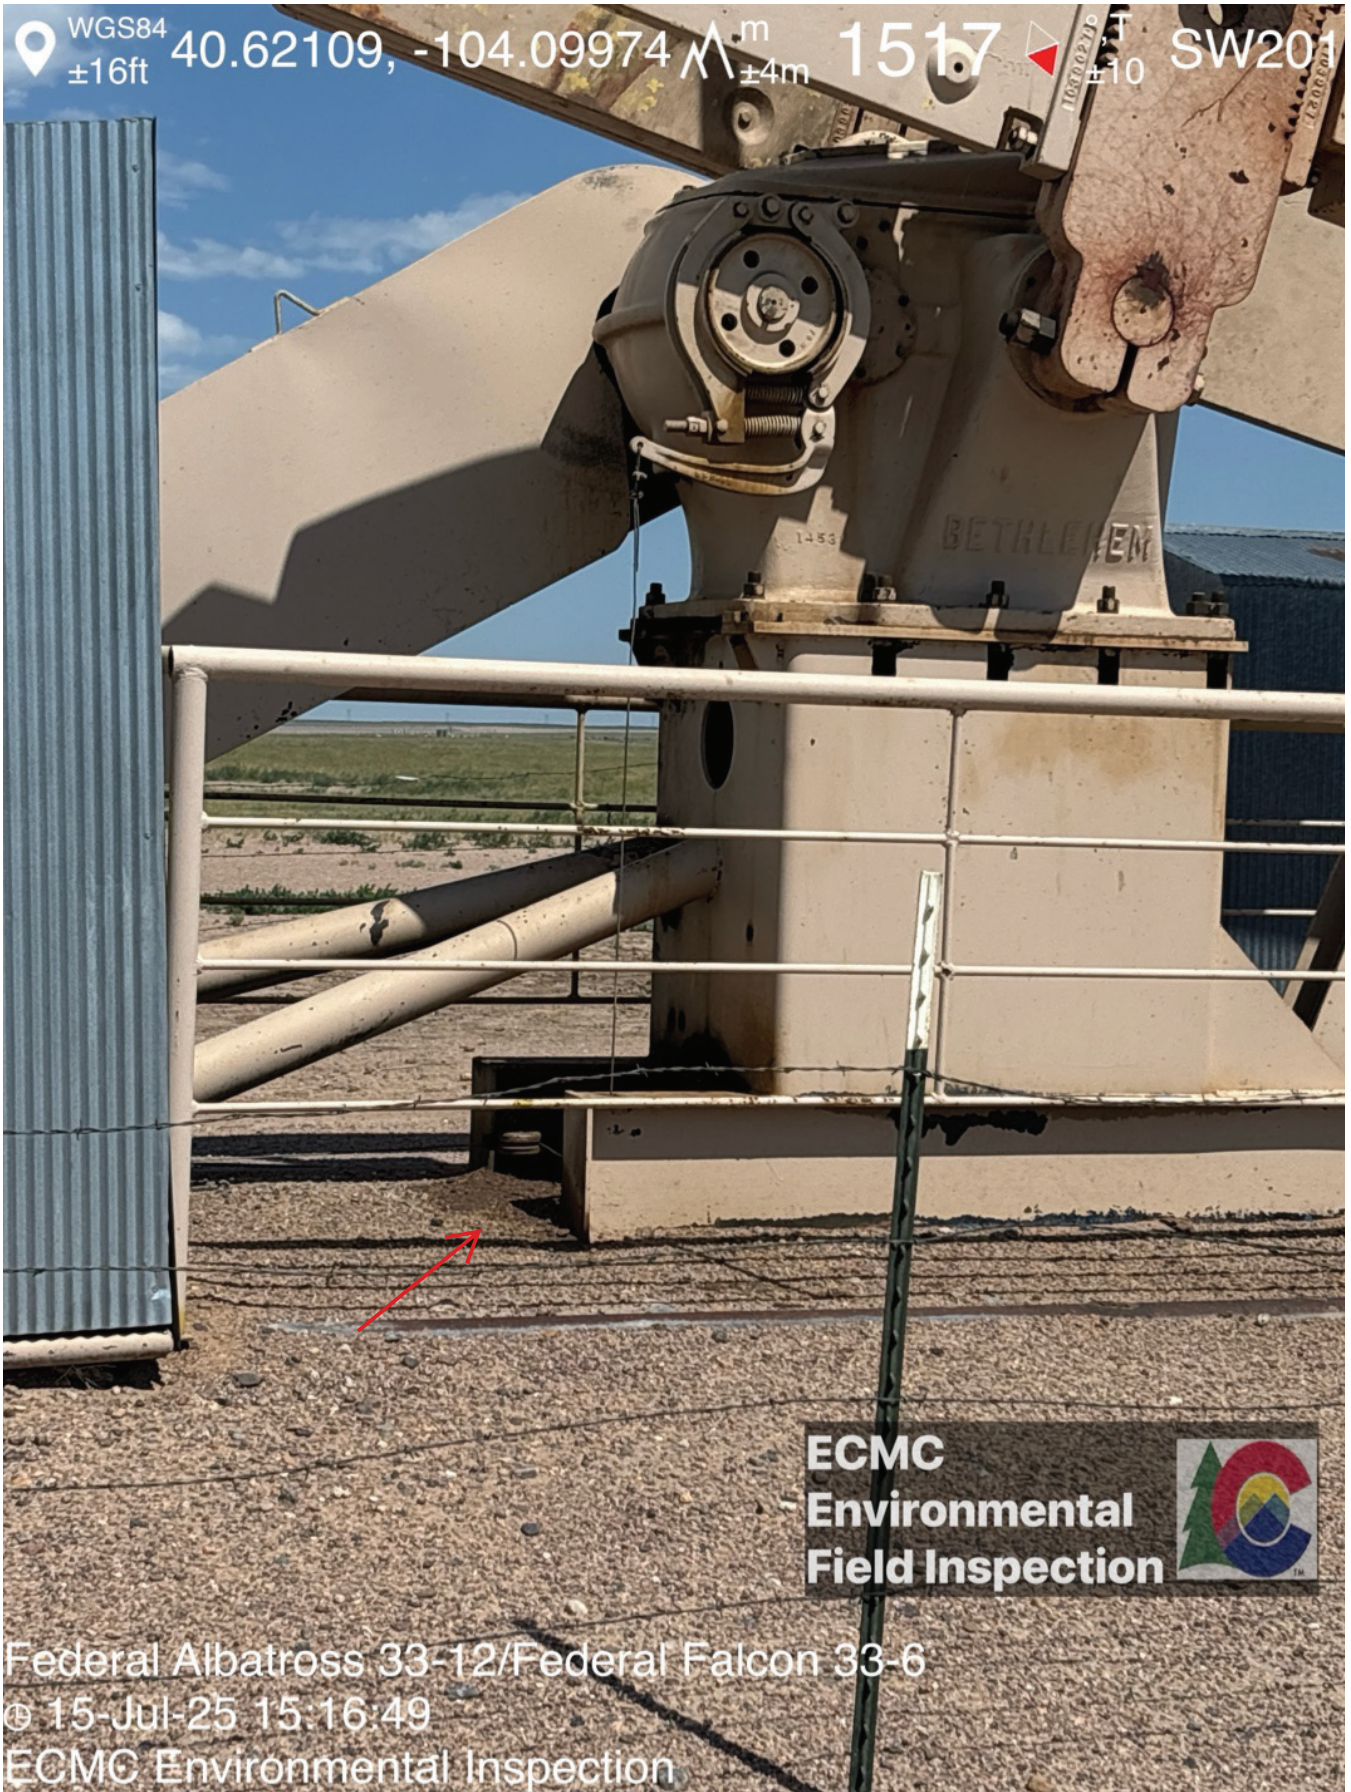
Stained soil beneath pumping unit at Federal Falcon #33-06 Well (API 123-20233)

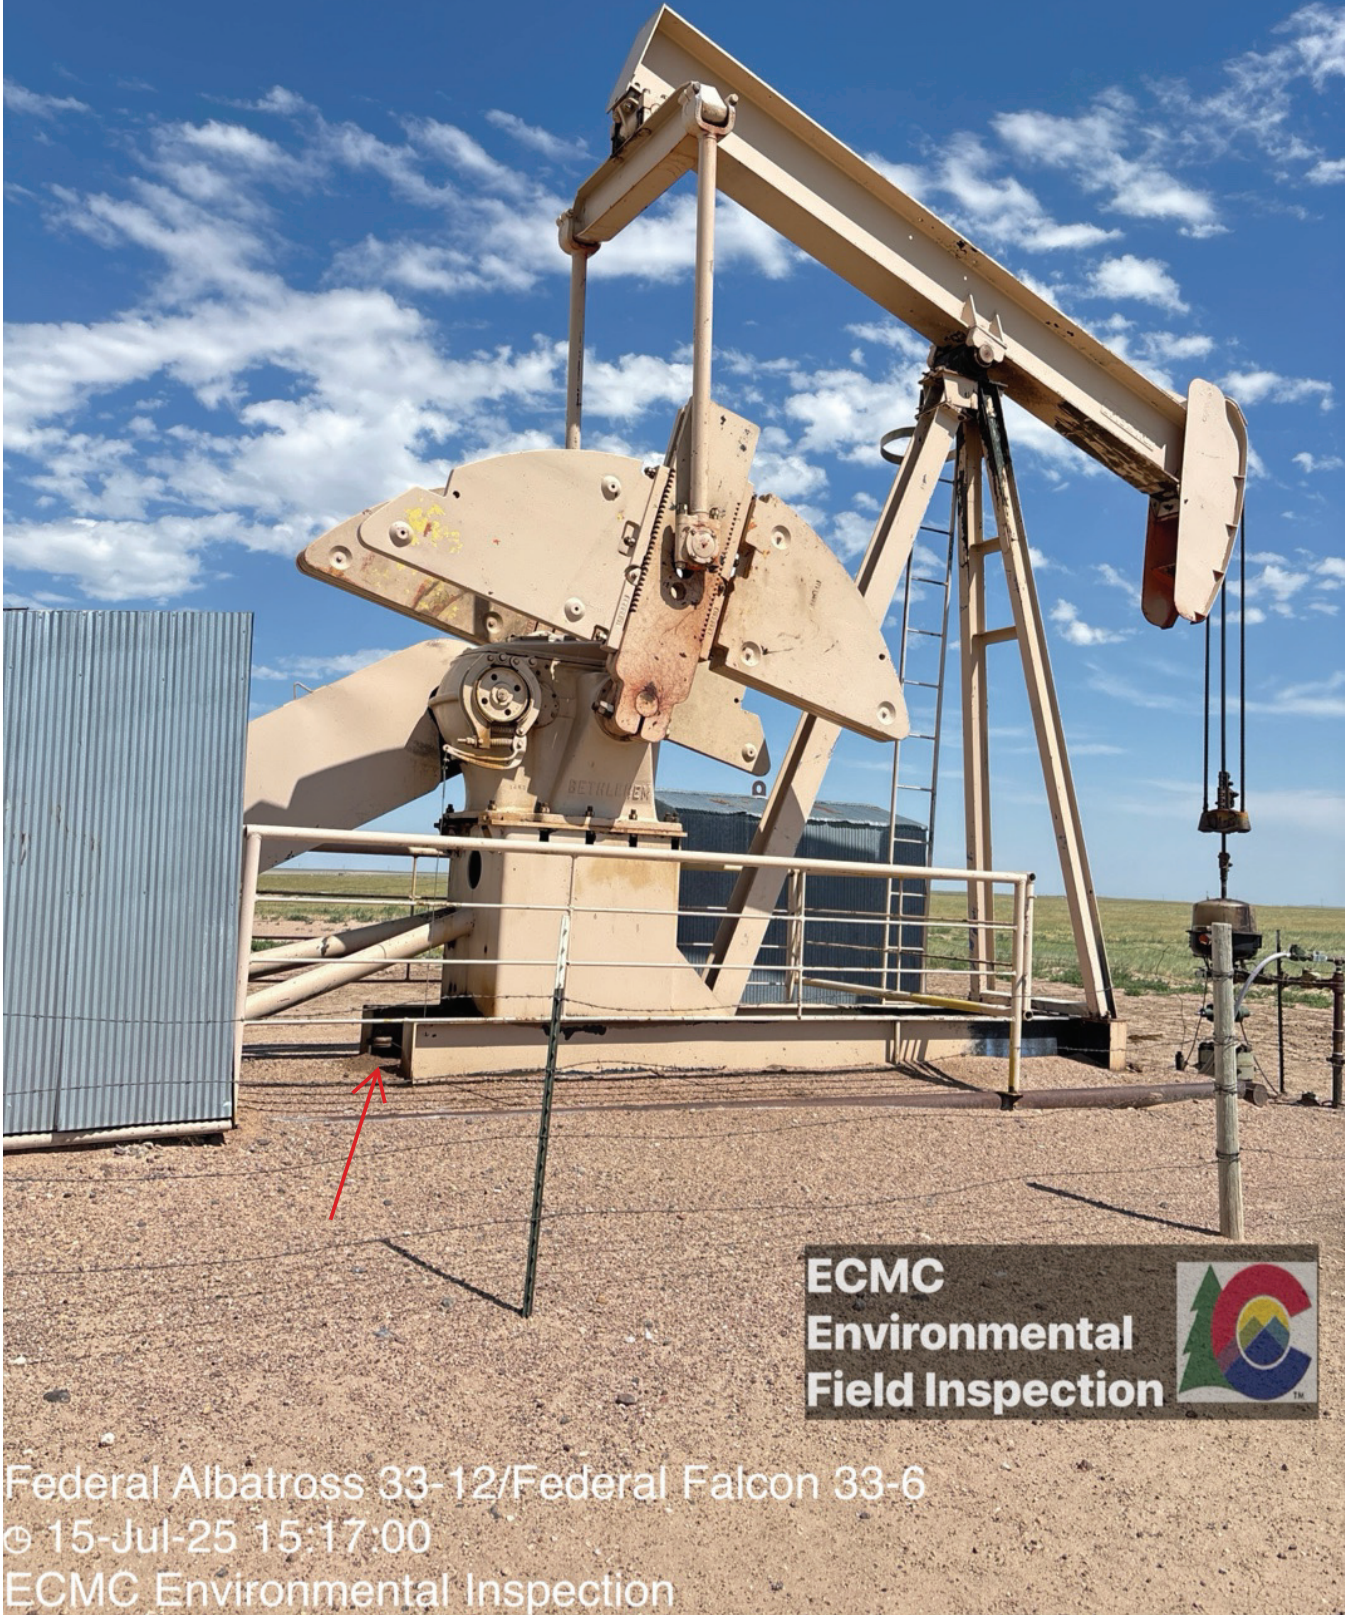
Stained soil beneath pumping unit at Federal Falcon #33-06 Well (API 123-20233)

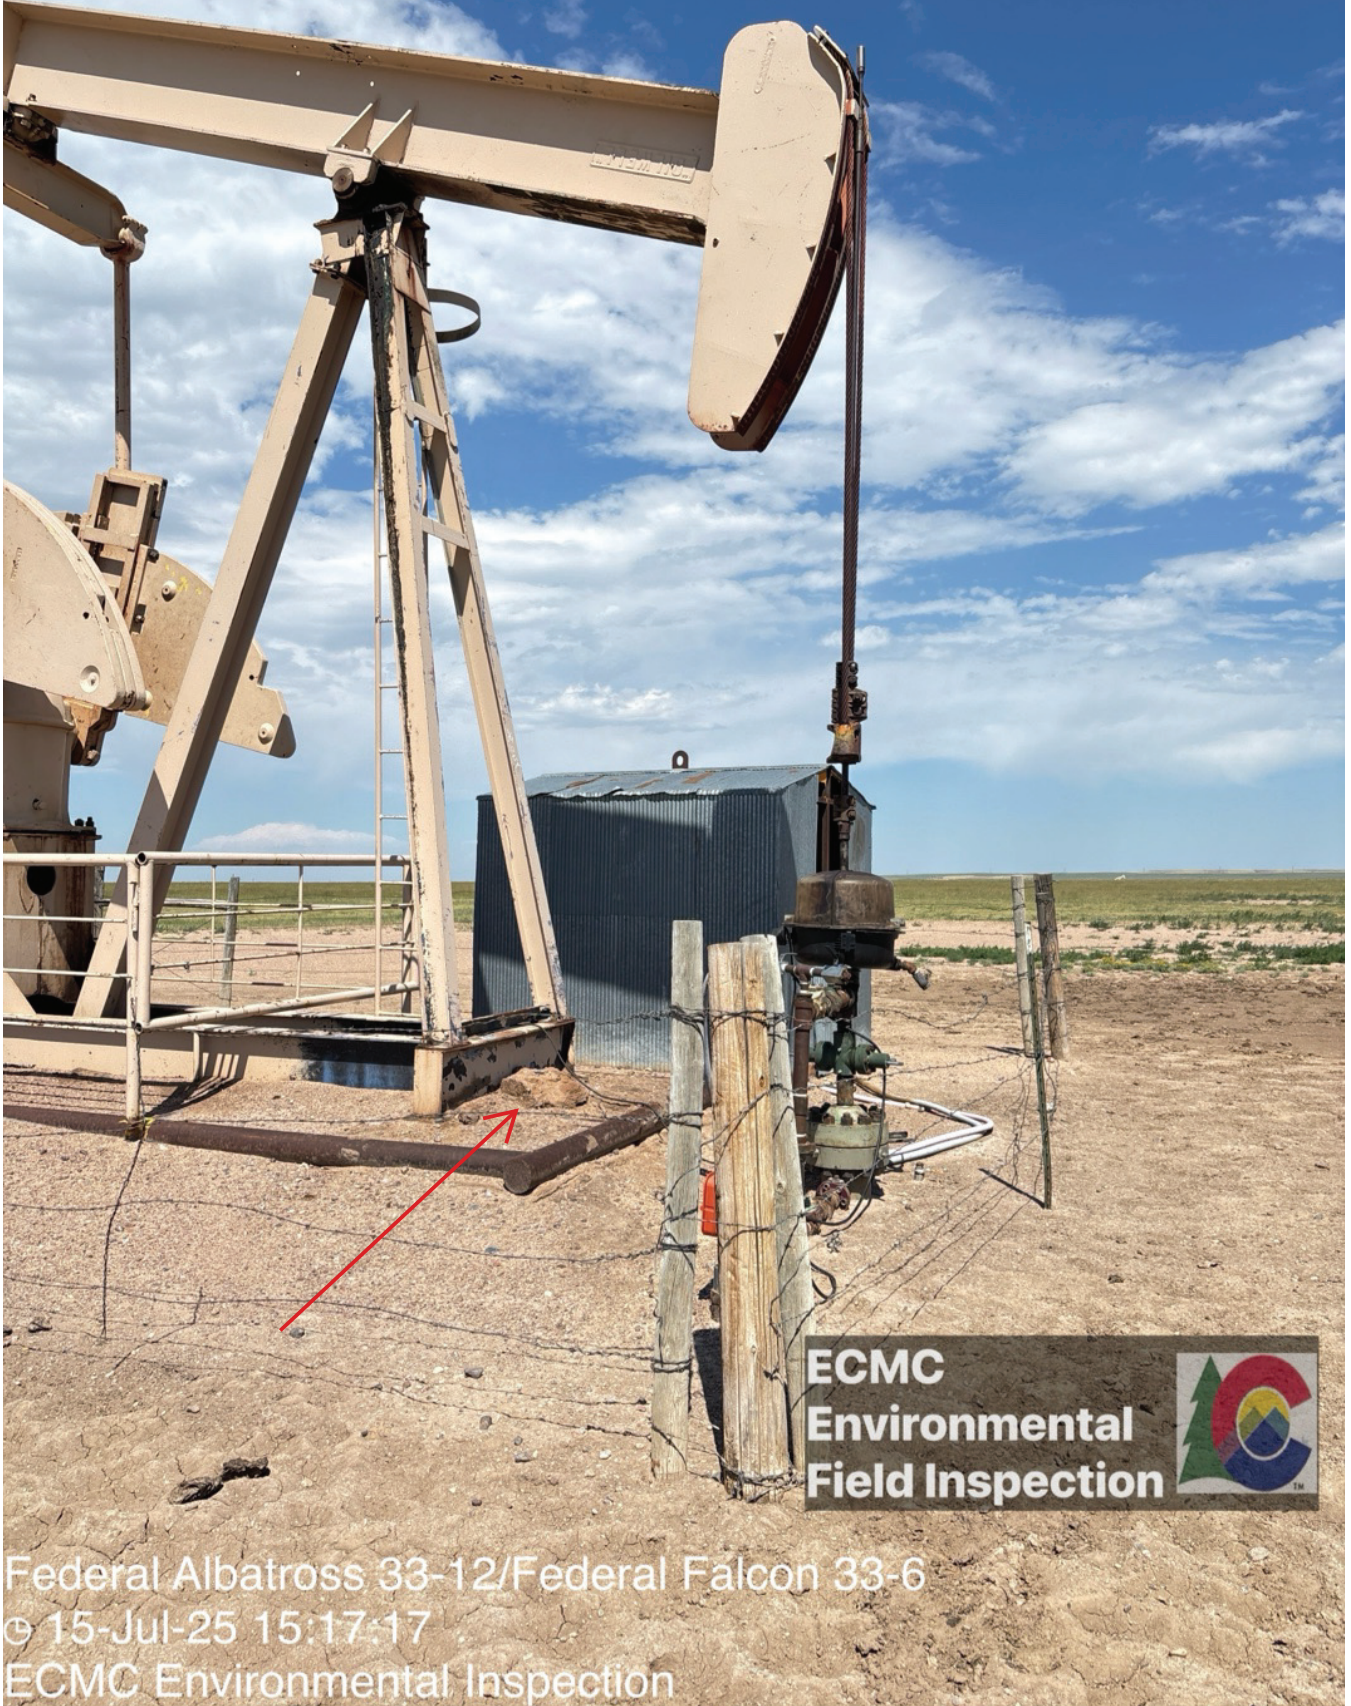
Stained soil adjacent to pumping unit at Federal Falcon #33-06 Well (API 123-20233)

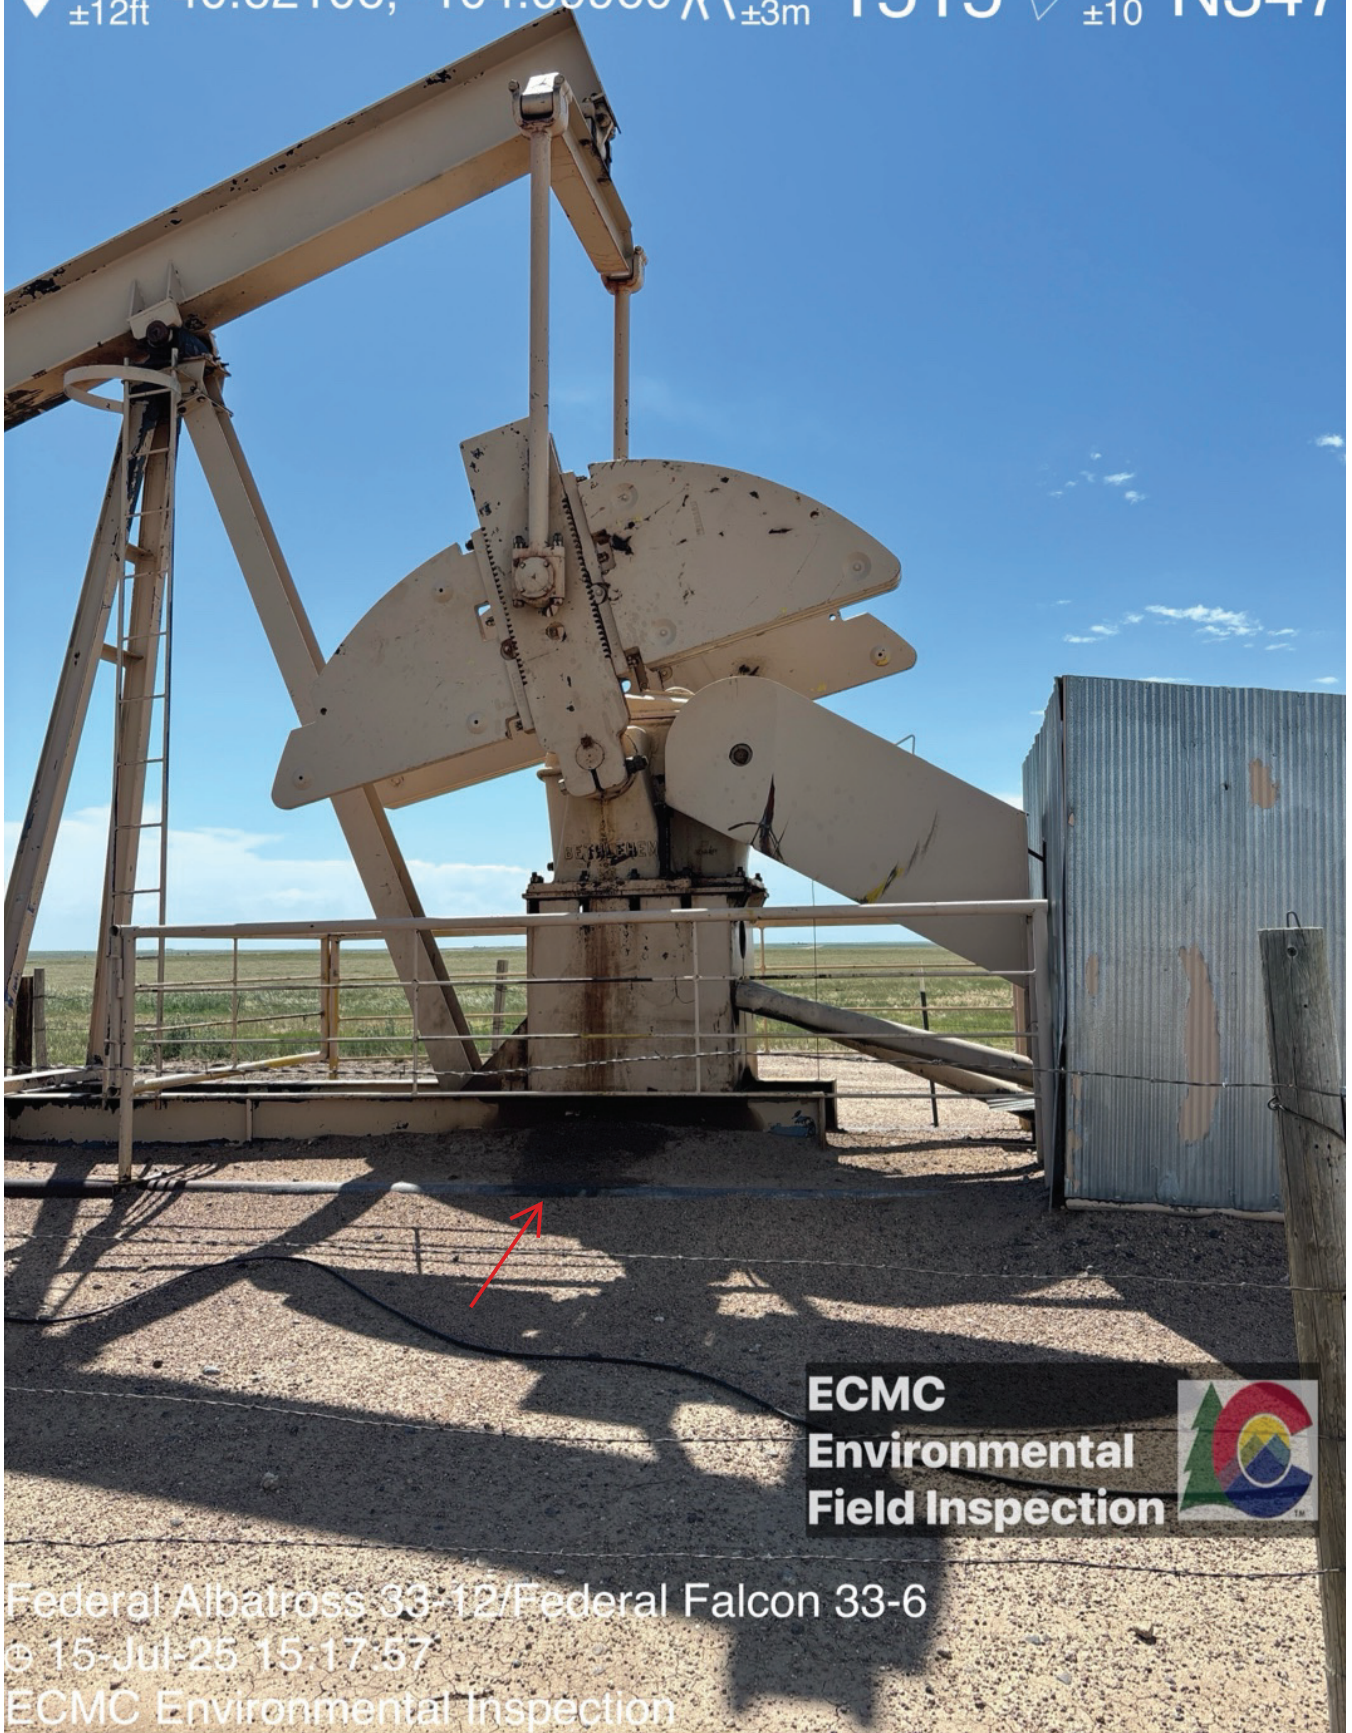
Stained soil adjacent to pumping unit at Federal Falcon #33-06 Well (API 123-20233)

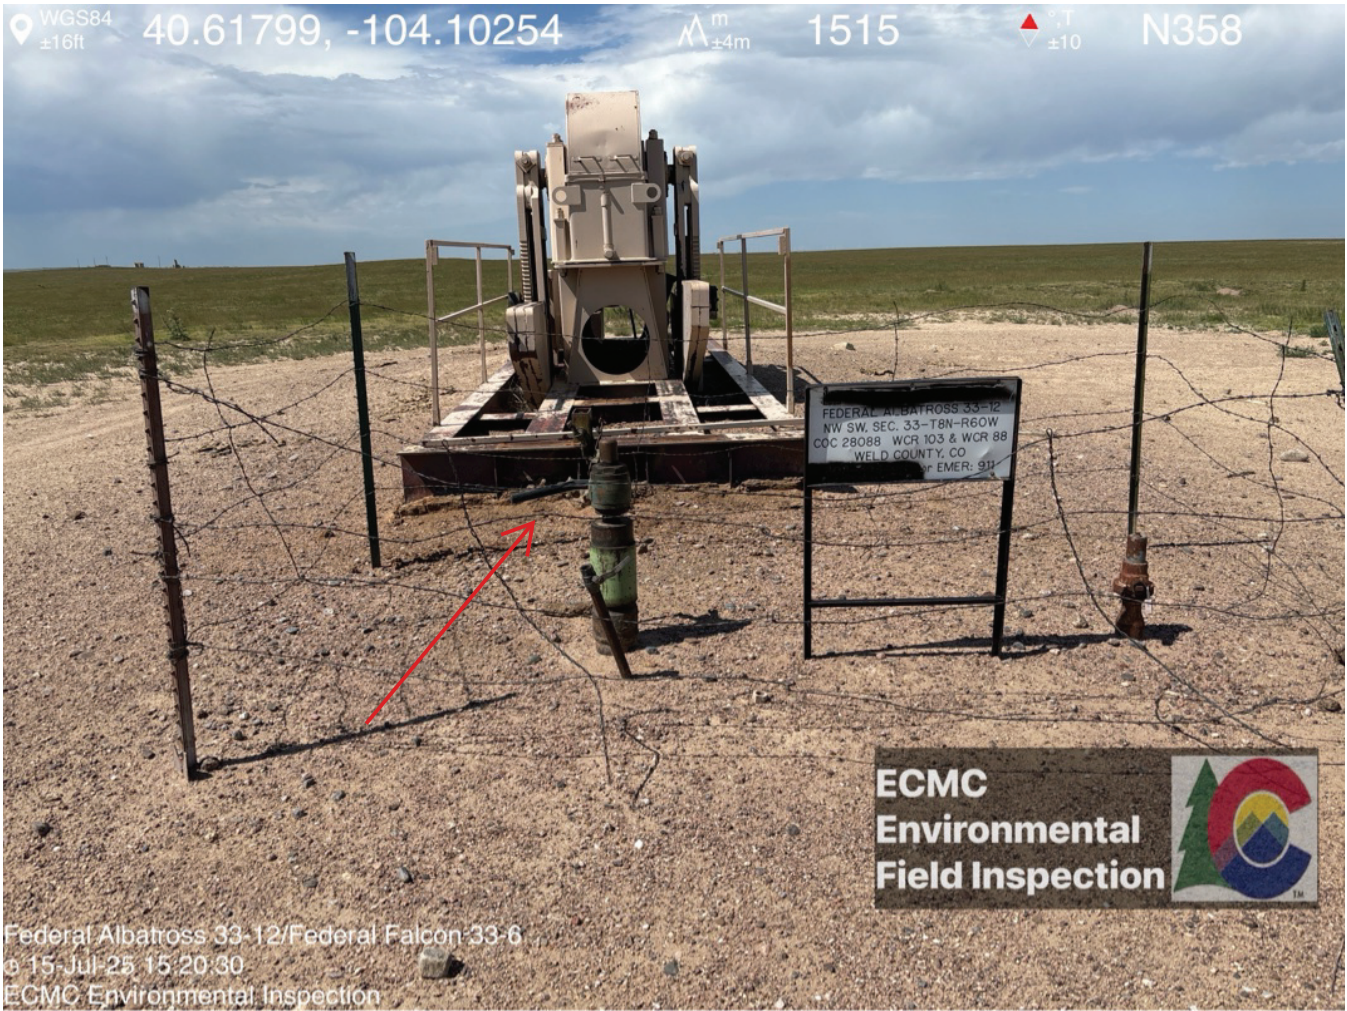
Stained soil adjacent to pumping unit at Federal Albatross #33-12 Well (API 123-20232)  
Signage inadequate - Missing API and Operator Emergency Contact info.
