Federal Albatross 33-12/Federal Falcon 33-6  
15-Jul-25 15:10:31  
ECMC Environmental Inspection

**ECMC**  
**Environmental**  
**Field Inspection**

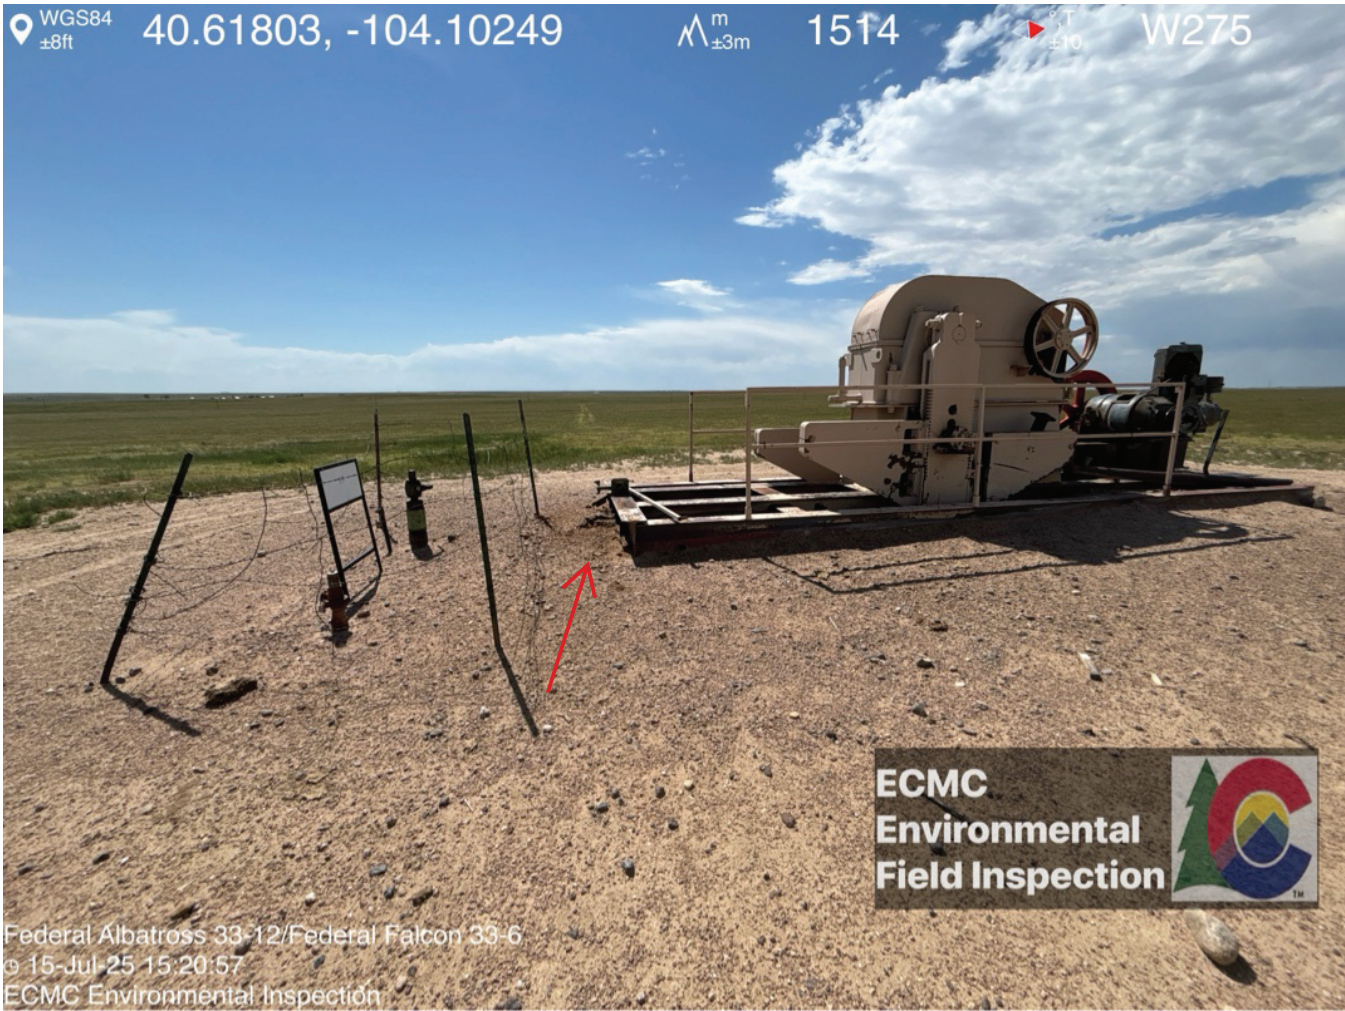
Stained soil adjacent to pumping unit at Federal Albatross #33-12 Well (API 123-20232)

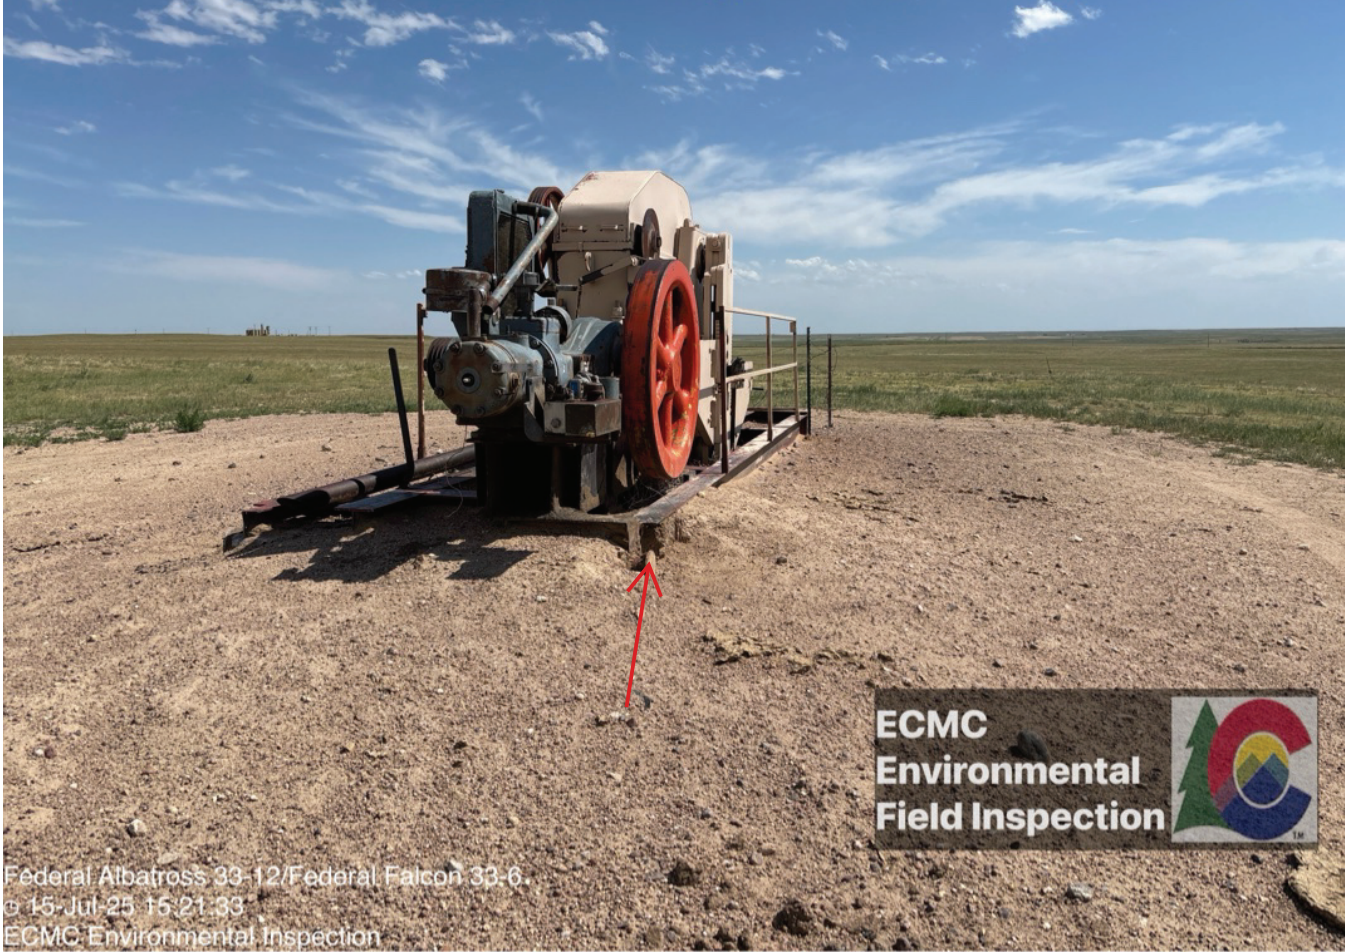
Stained soil adjacent to pumping unit at Federal Albatross #33-12 Well (API 123-20232)
