**QB ENERGY OPERATING LLC
GMR-66S93W 27NWNW (D27NW)
Facility # 335326**

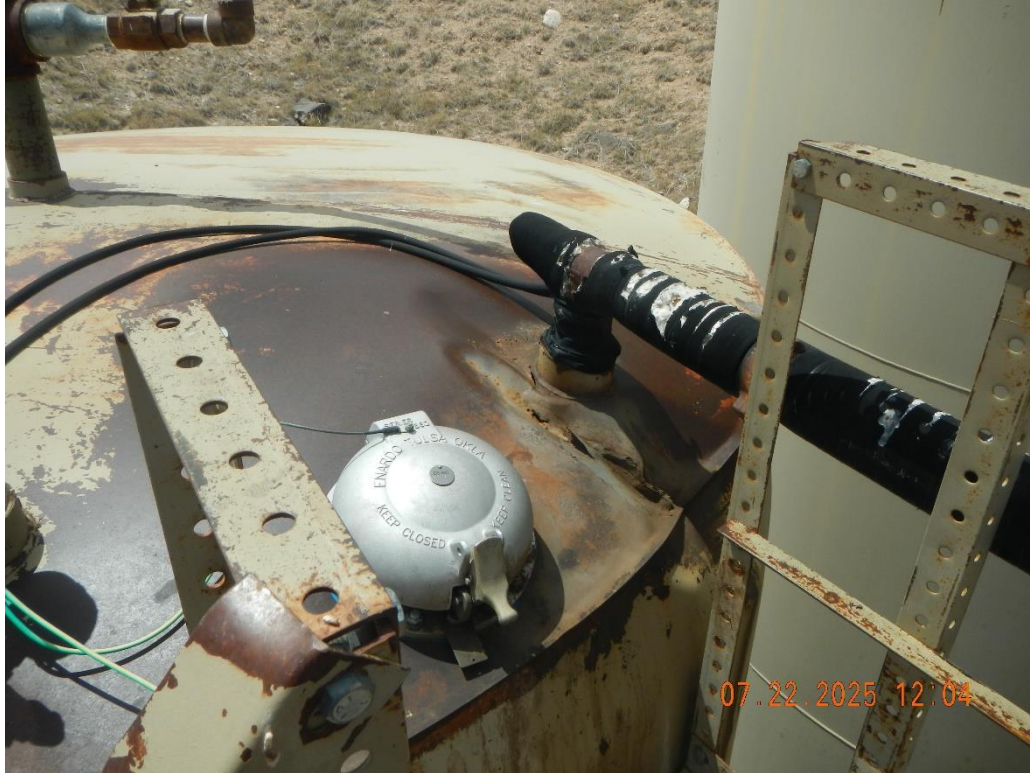
Top of 300 bbl tank is damaged. The top of the tank is rust through at the dumpline inlet. The open holes allow venting of the tank.

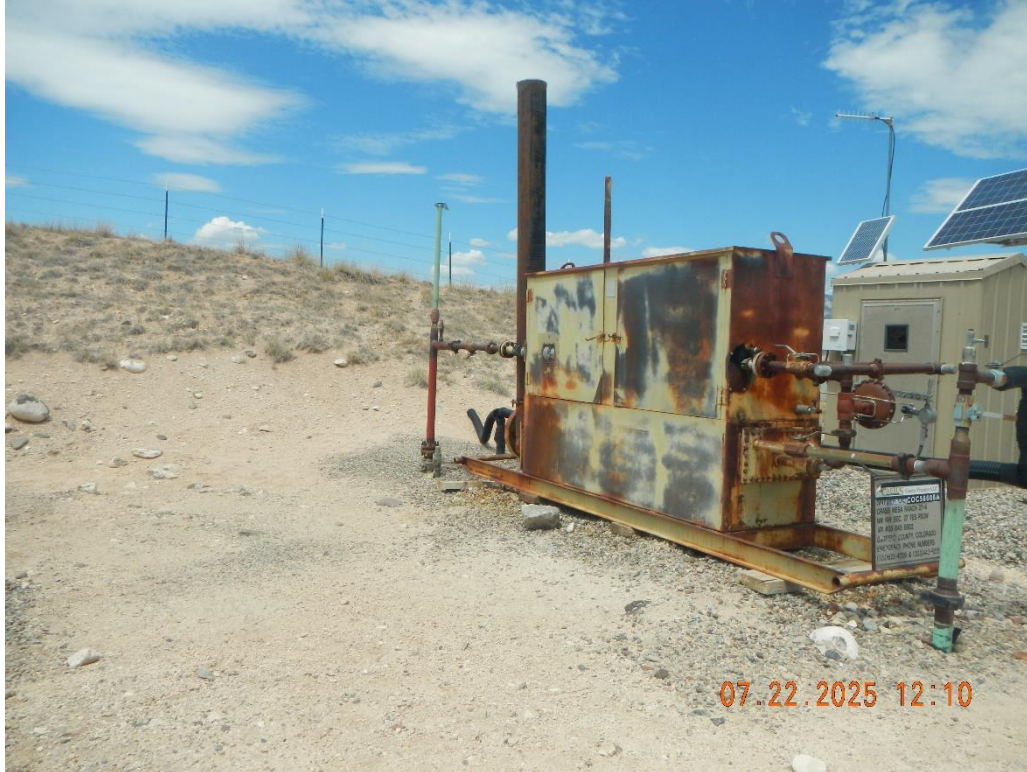
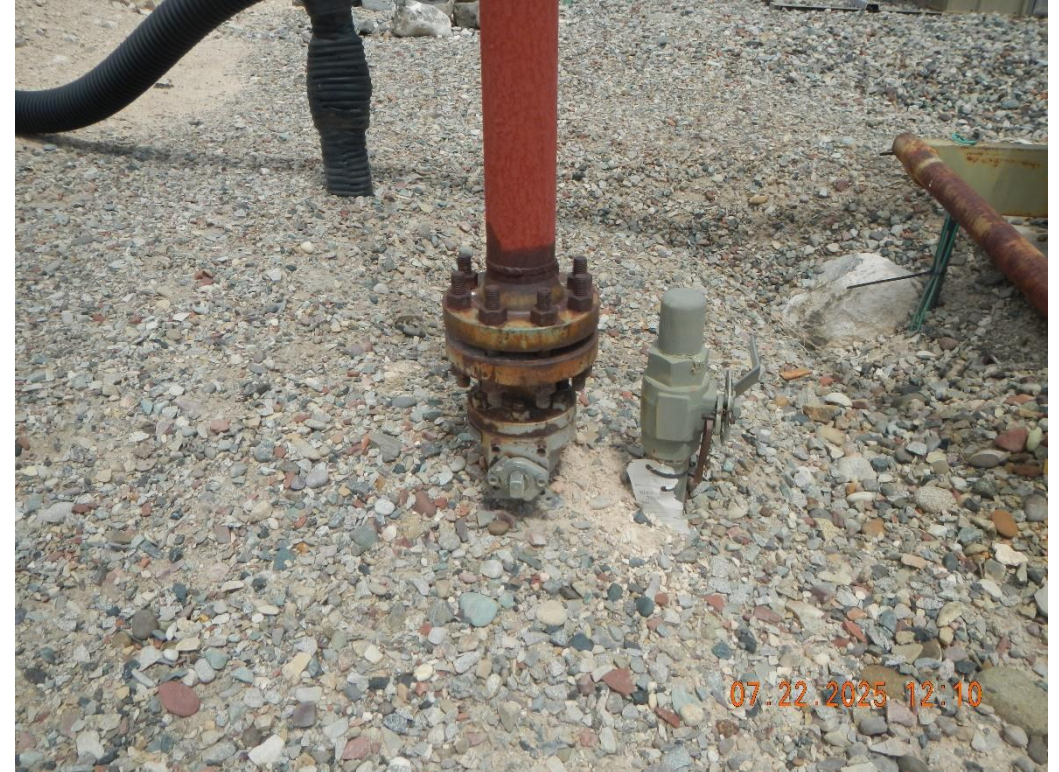
There is a shutin riser behind the separator of GMR 27-4 and the OOSLAT tag is broken and needs replaced.

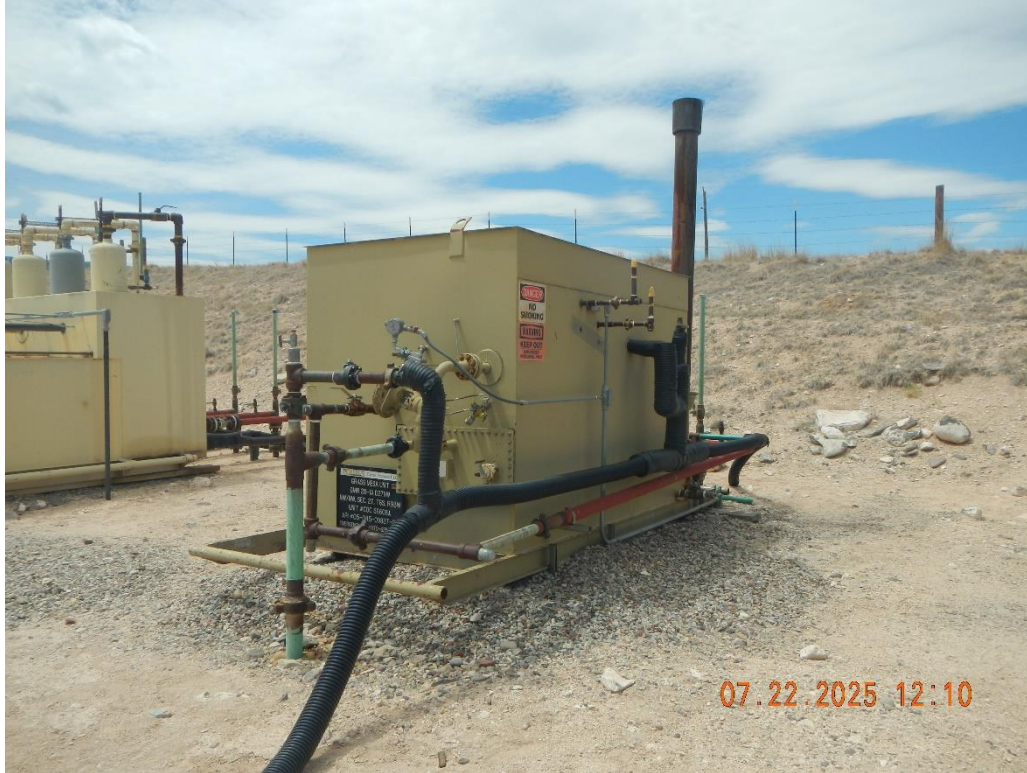
2" dumpline is disconnected behind the separator for GMR 28-1A. No OOSLAT is on the line.

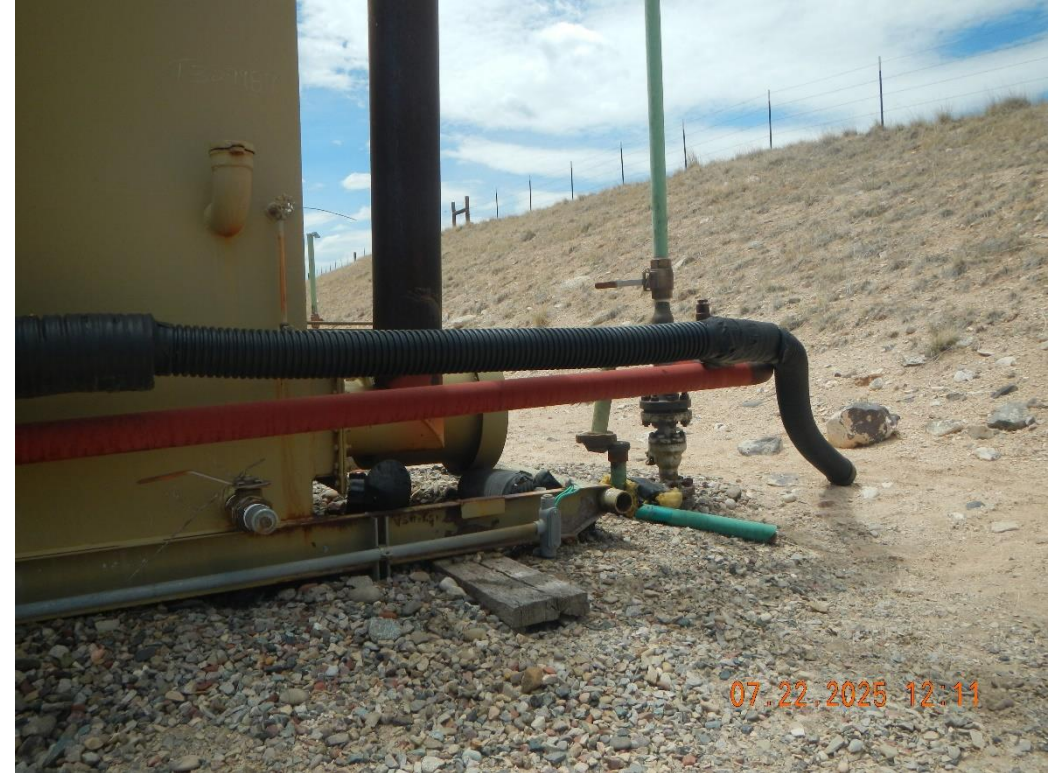
2" dumpline is disconnected behind the separator for GMR 28-1A. No OOSLAT is on the line.

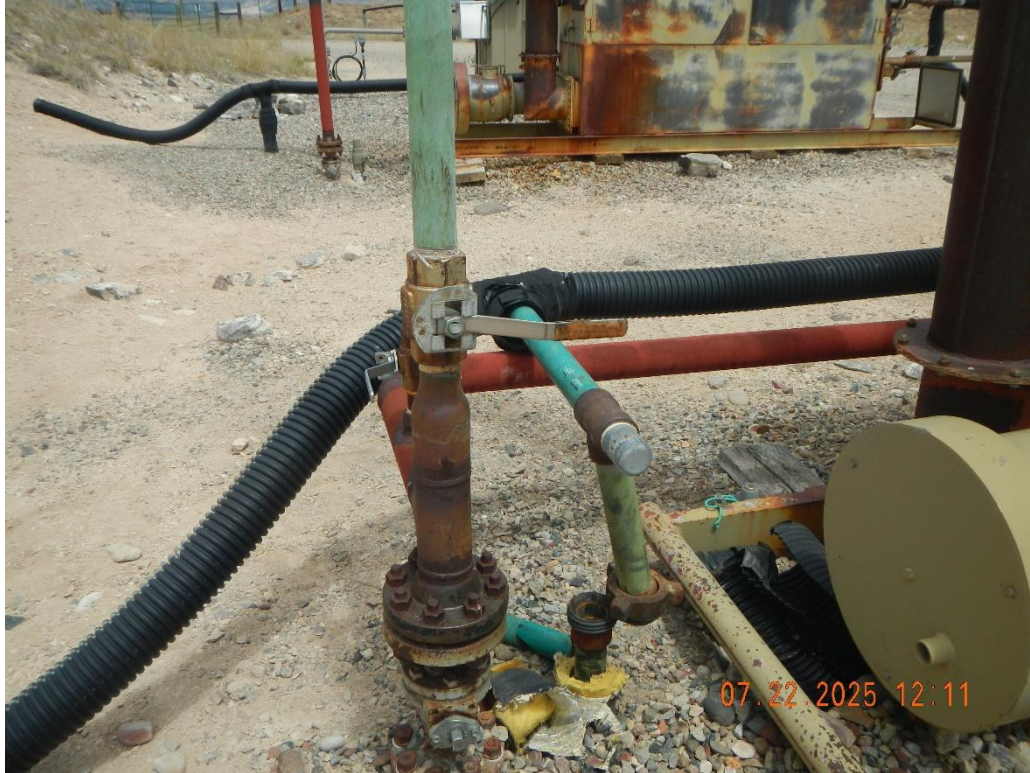
2" dumpline is disconnected behind the separator for GMR 28-1A. No OOSLAT is on the line.
