Final Reclamation Inspection

Operator: NOBLE ENERGY INC - 100322

Location ID: 328451

Inspection Photos
Location Name: DUNCAN D #20-2
Location ID: 328451

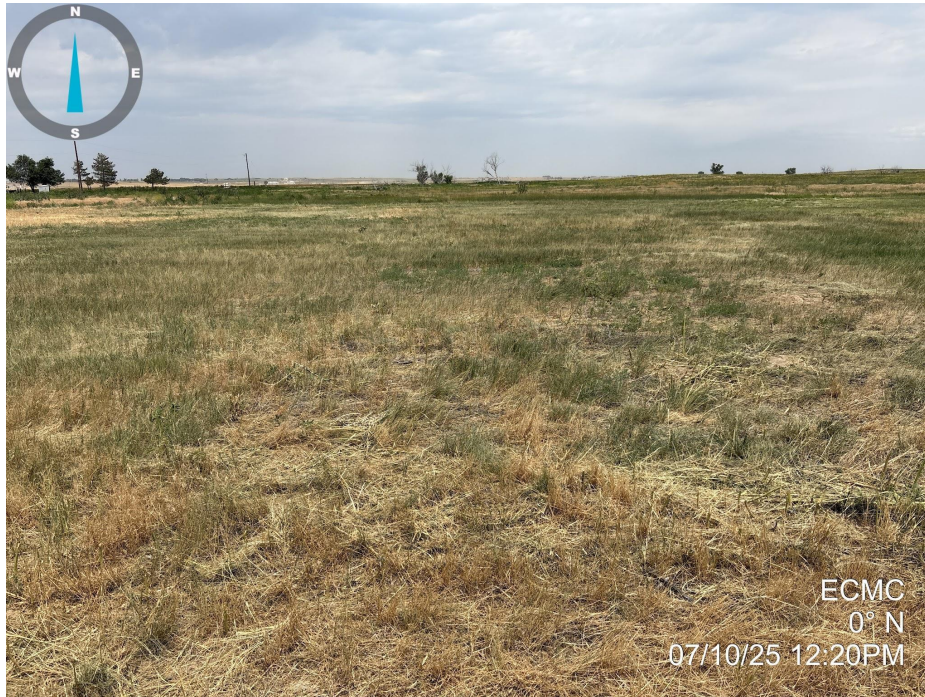
Photo 1. Photo taken from the well location, facing North. Photo illustrates that final reclamation activities appear to have taken place, but vegetation has not established to Rule 1004 standards as the location is dominated by weedy annual vegetation. At the time of this inspection, the location has been recently mowed.

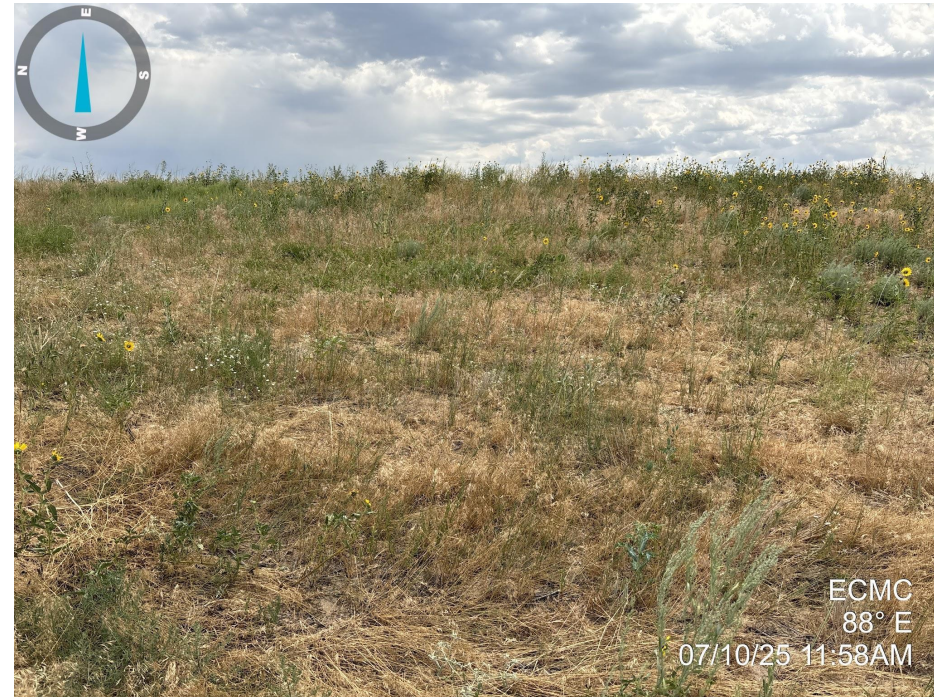
Photo 2. Photo taken from the well location, facing East. See comments under Photo 1.

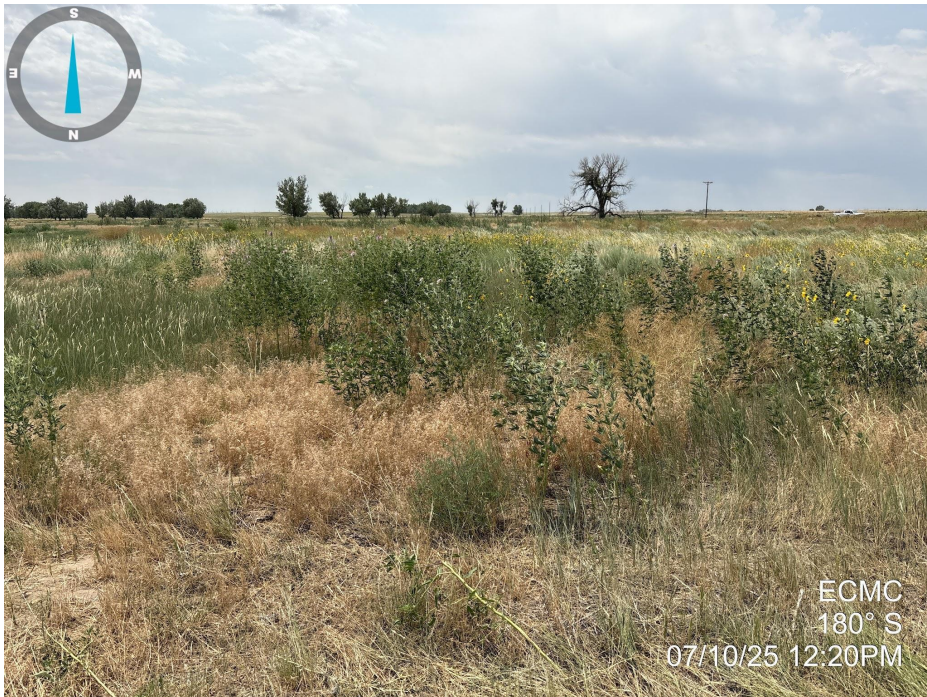
Photo 3. Photo taken from the well location, facing South. See comments under Photo 1.

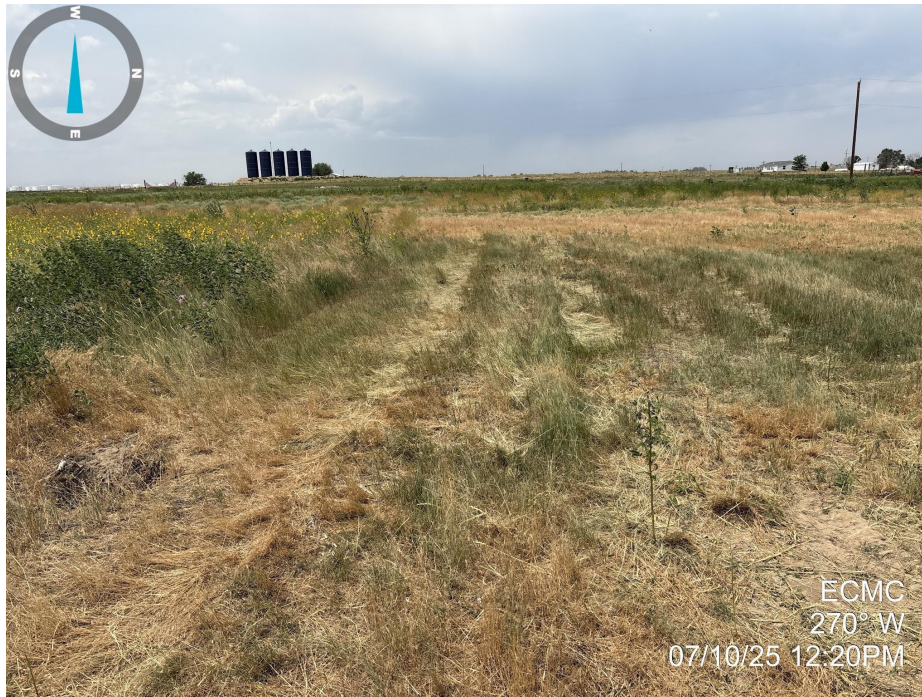
Photo 4. Photo taken from the well location, facing West. See comments under Photo 1.

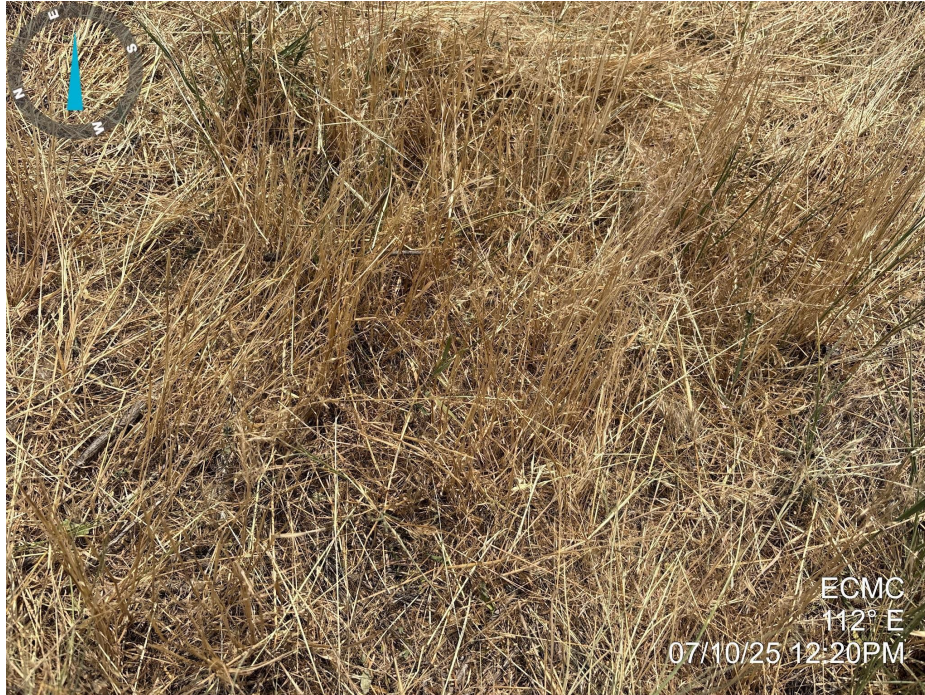
Photo 5. Photo taken of ground cover at the well location. Photo illustrates weedy annual vegetation including cheatgrass (*Bromus tectorum*), a List C Noxious Weed species.

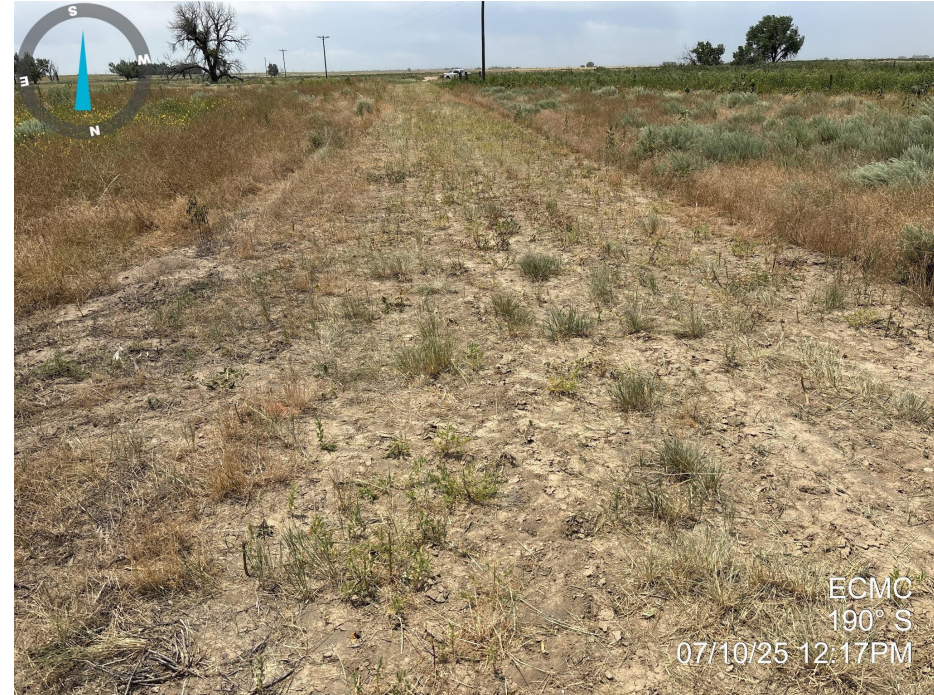
Photo 6. Photo taken of the access road to the tank battery location, facing south. Photo illustrates that final reclamation activities have taken place, with evidence of drill row seeding, but vegetation establishment does not meet Rule 1004 standards. Weedy annual vegetation was observed across the location, including cheatgrass (*Bromus tectorum*).

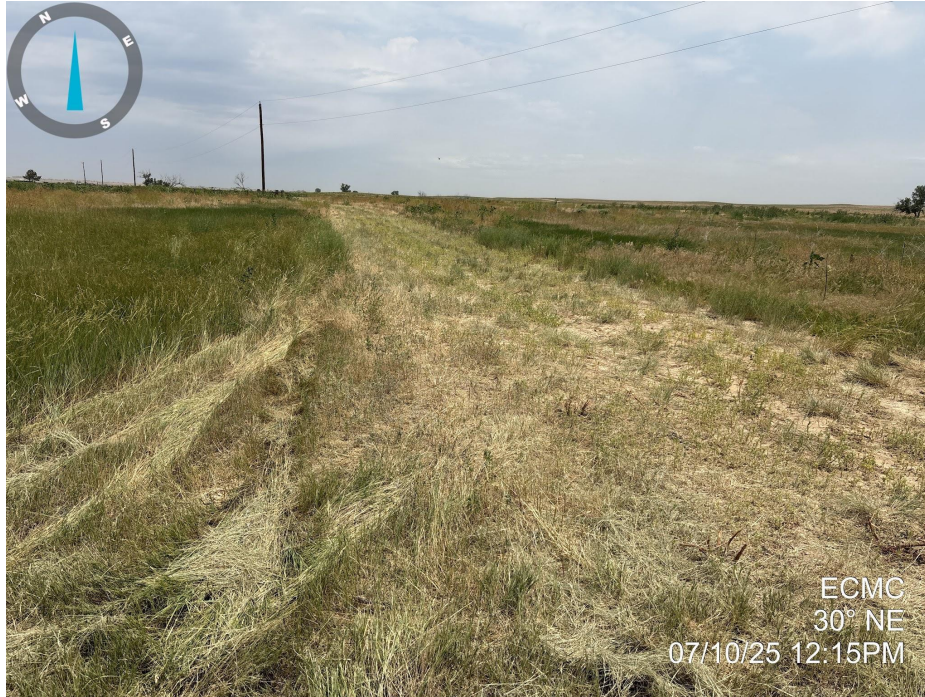
Photo 7. Photo taken of the access road to the location, facing northeast. See comments under Photo 6.

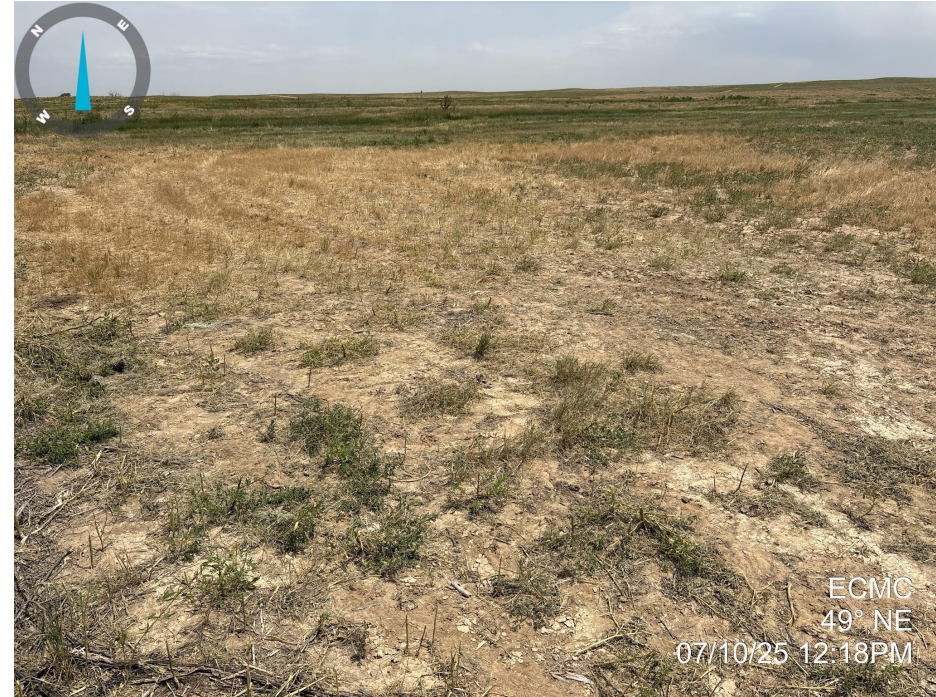
Photo 8. Photo taken of the tank battery location, facing northeast. Photo illustrates that final reclamation activities have taken place, with evidence of drill row seeding, but vegetation establishment does not meet Rule 1004 standards. Weedy annual vegetation was observed across the location, including cheatgrass (*Bromus tectorum*). At the time of this inspection, the location has been recently mowed.

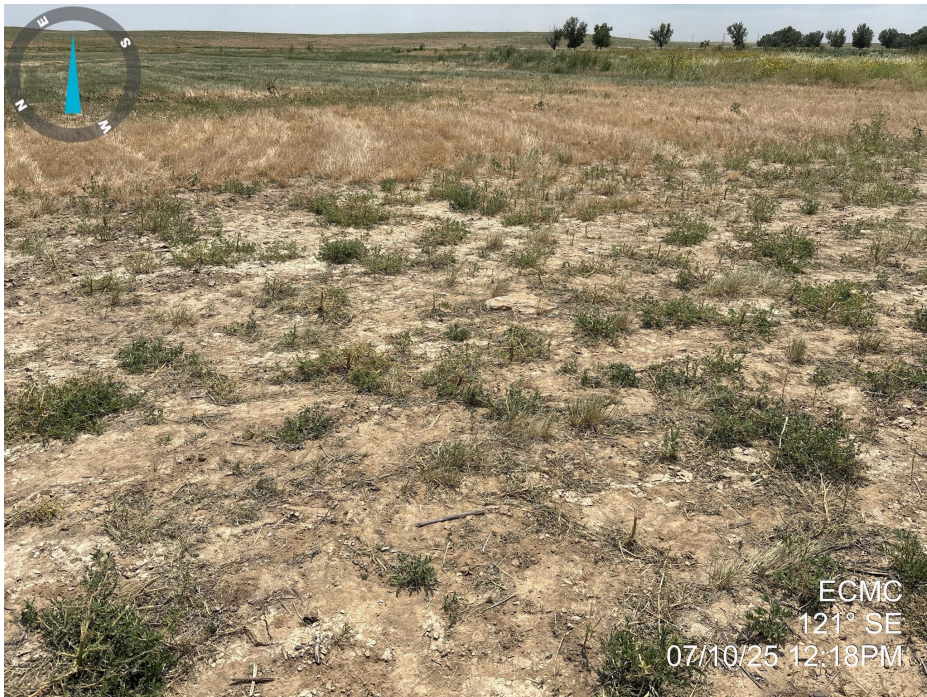
Photo 9. Photo taken of the tank battery location, facing southeast. See comments under Photo 8.

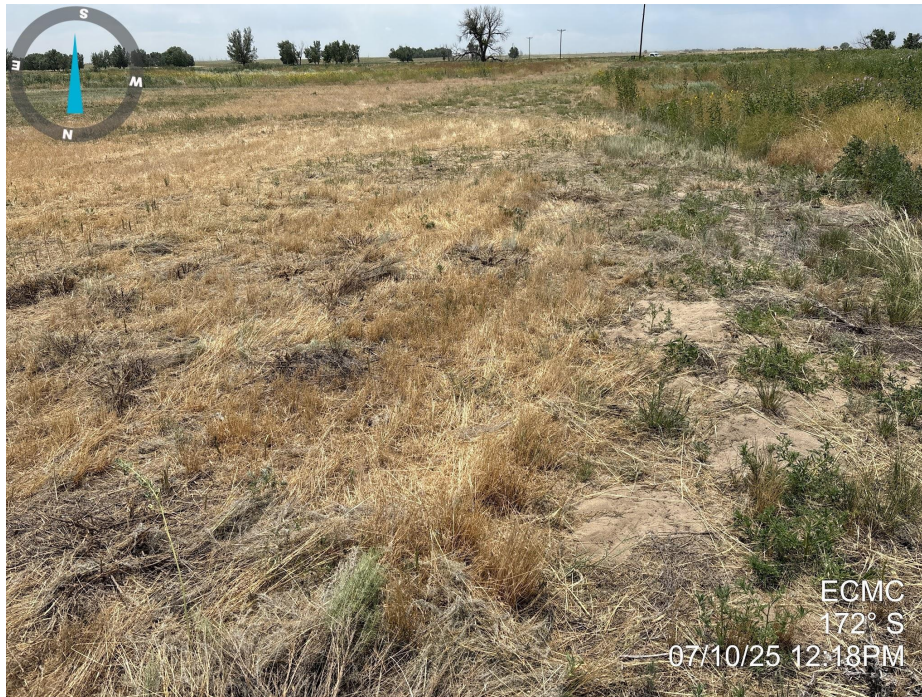
Photo 10. Photo taken of the tank battery location, facing south. See comments under Photo 8.

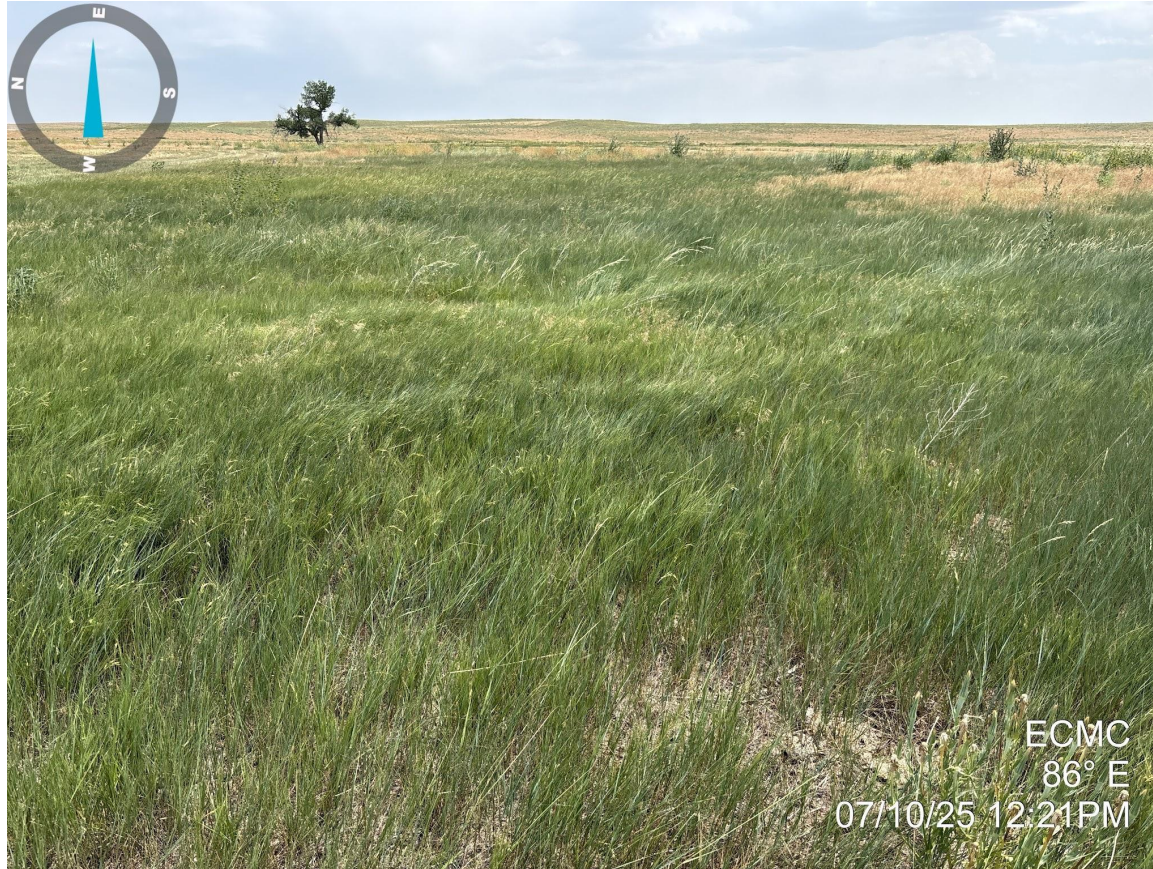
Photo 11. Photo taken of the reference area south of the location, facing east. Photo illustrates perennial grass vegetation.
