# Final Reclamation Inspection

Operator: NOBLE ENERGY INC - 100322

Location ID: 328767

Inspection Photos  
Location Name: DUNCAN D #20-15  
Location ID: 328767

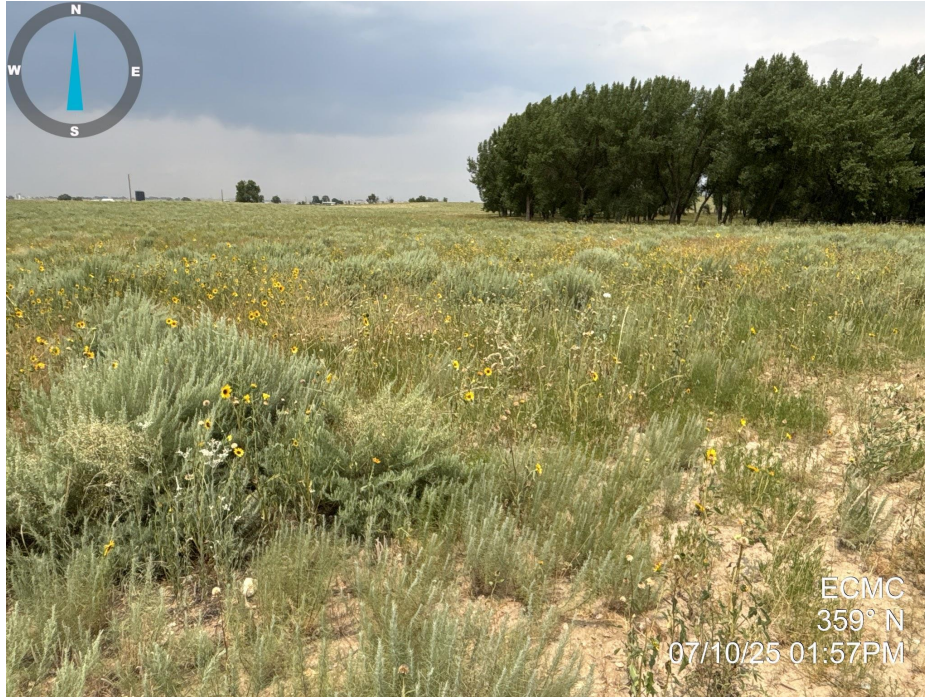
**Photo 1.** Photo taken from the well location, facing North. Photo illustrates that final reclamation activities have taken place, with evidence of drill row seeding, but vegetation establishment does not meet Rule 1004 standards. Weedy annual vegetation including russian thistle (*Salsola tragus*) and kochia (*Bassia scoparia*) was observed across the location.

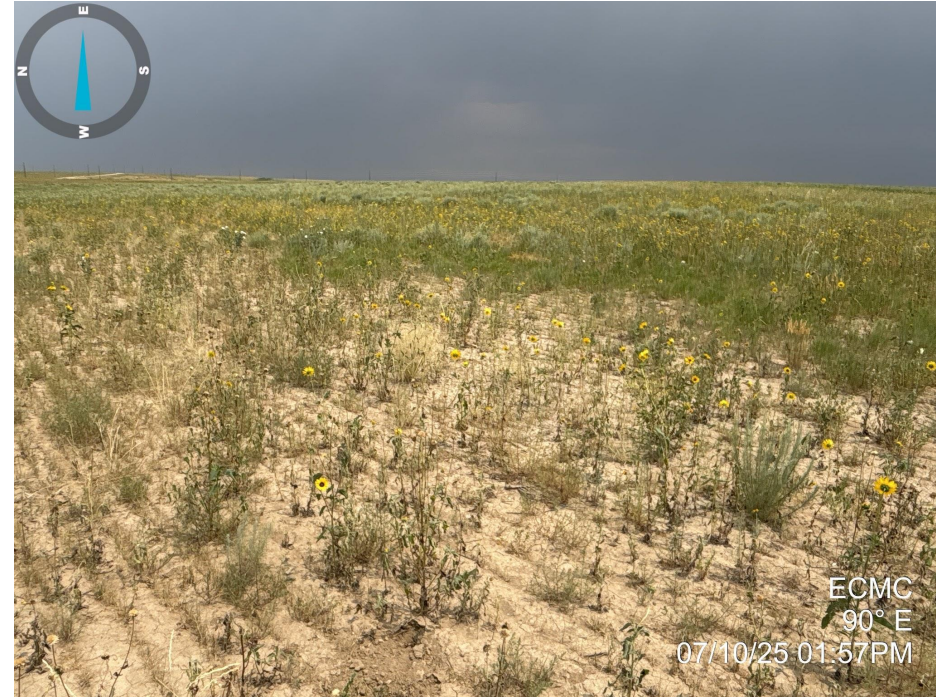
**Photo 2.** Photo taken from the well location, facing East. See comments under Photo 1.

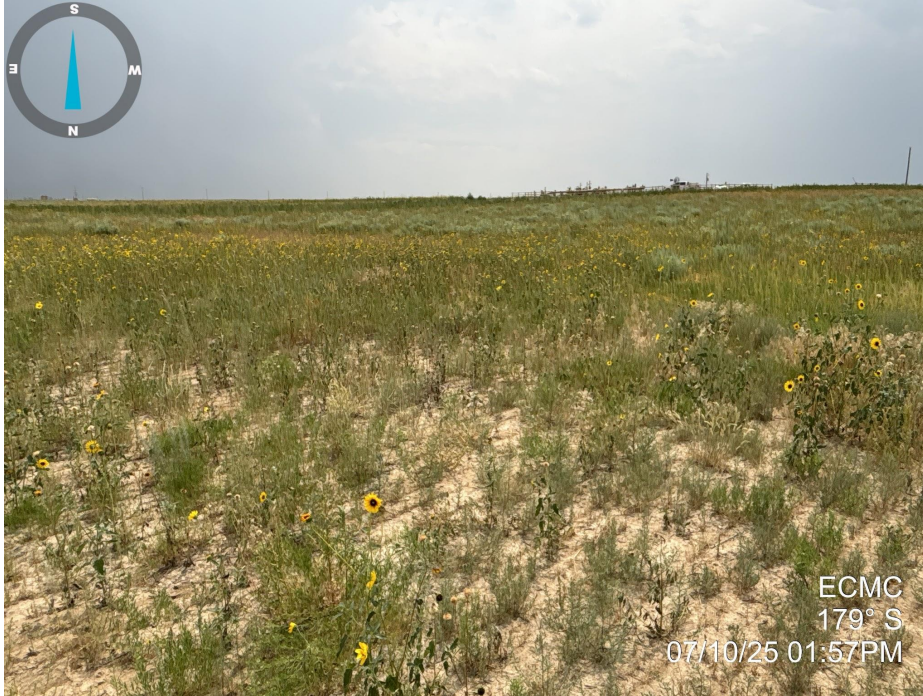
**Photo 3.** Photo taken from the well location, facing South. See comments under Photo 1.

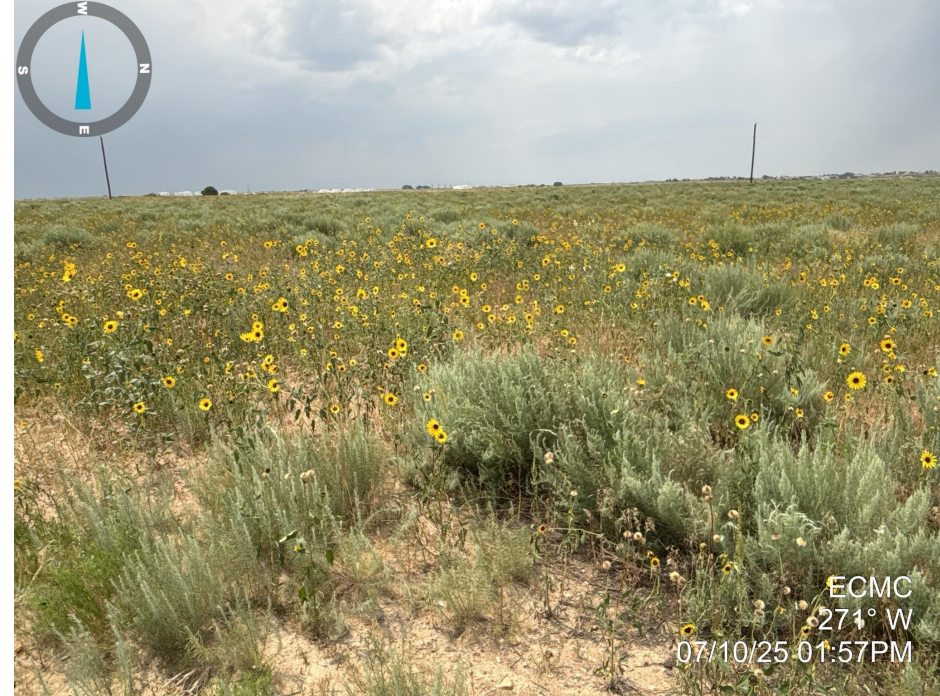
**Photo 4.** Photo taken from the well location, facing West. See comments under Photo 1.

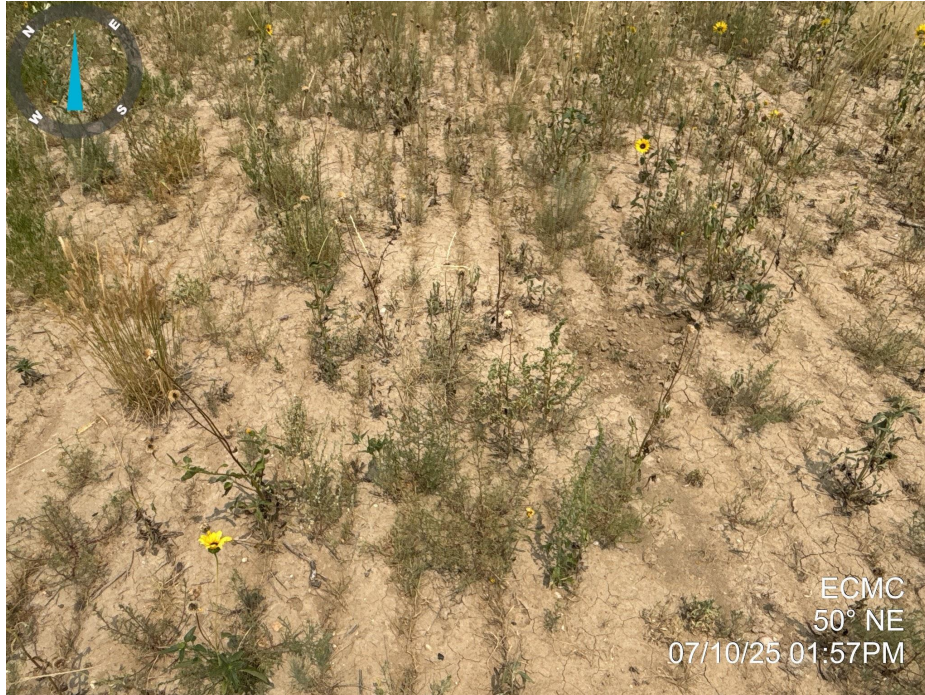
**Photo 5.** Photo taken of ground cover at the location. Photo illustrates drill rows from seeding, bare ground, and weedy annual vegetation including russian thistle (*Salsola tragus*) and kochia (*Bassia scoparia*).

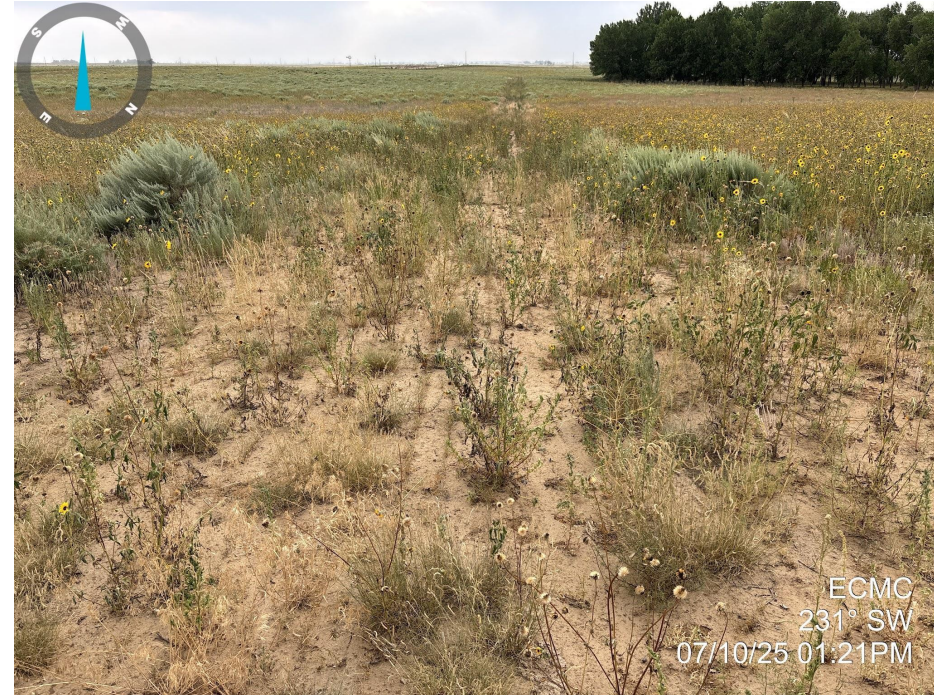
**Photo 6.** Photo taken of the access road to the location, facing southwest, towards the location. Photo illustrates that final reclamation activities have taken place, with evidence of drill row seeding, but vegetation establishment does not meet Rule 1004 standards.

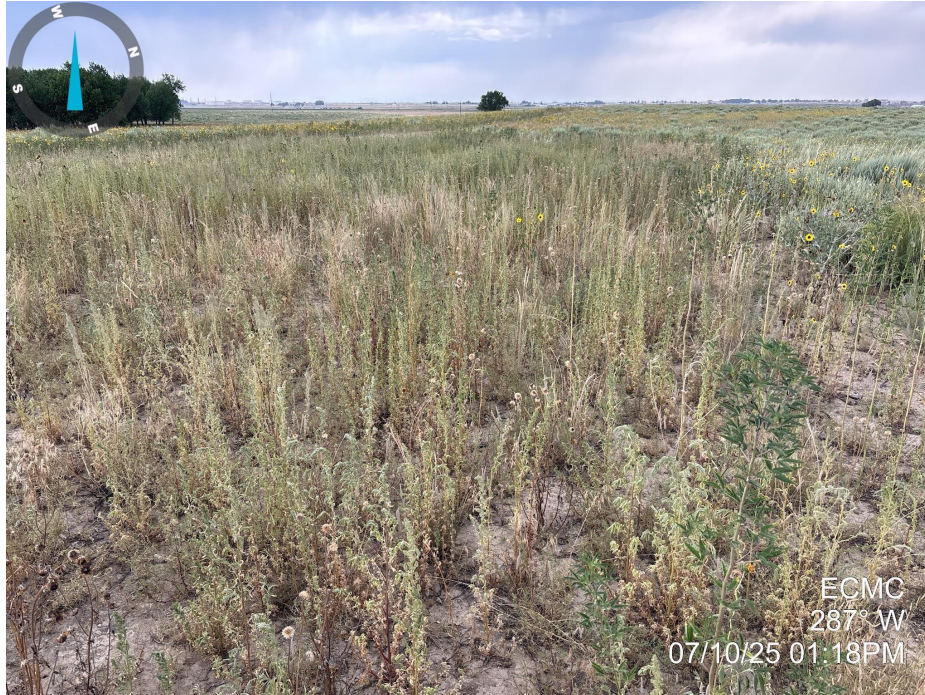
**Photo 7.** Photo taken of the tank battery location, facing west. Photo illustrates that final reclamation activities have taken place, but vegetation establishment does not meet Rule 1004 standards and the site is dominated by weedy annual vegetation.

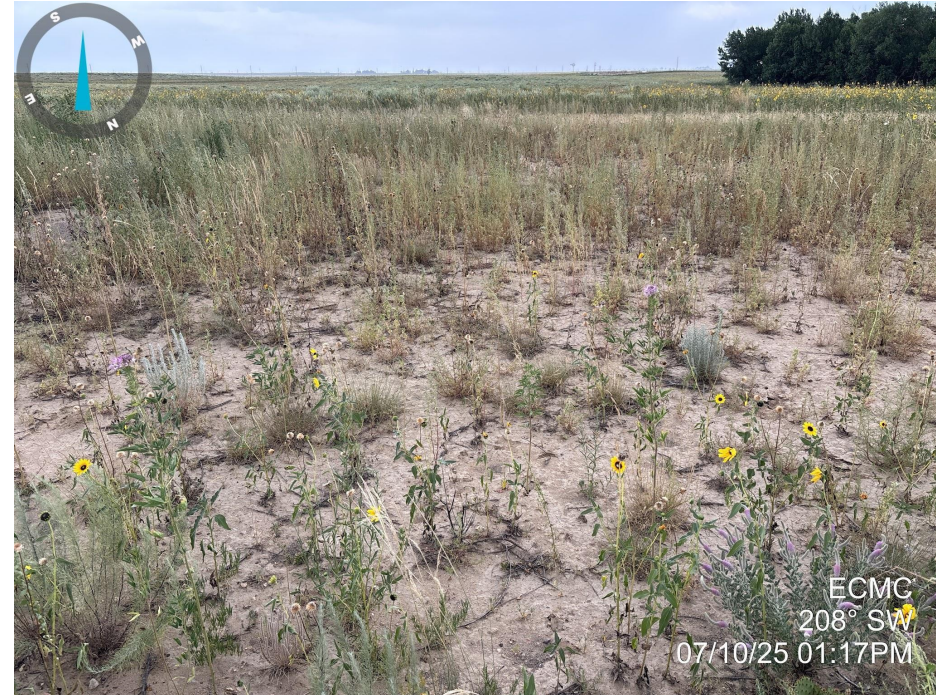
**Photo 8.** Photo taken of the tank battery location, facing southwest. See comments under Photo 7.

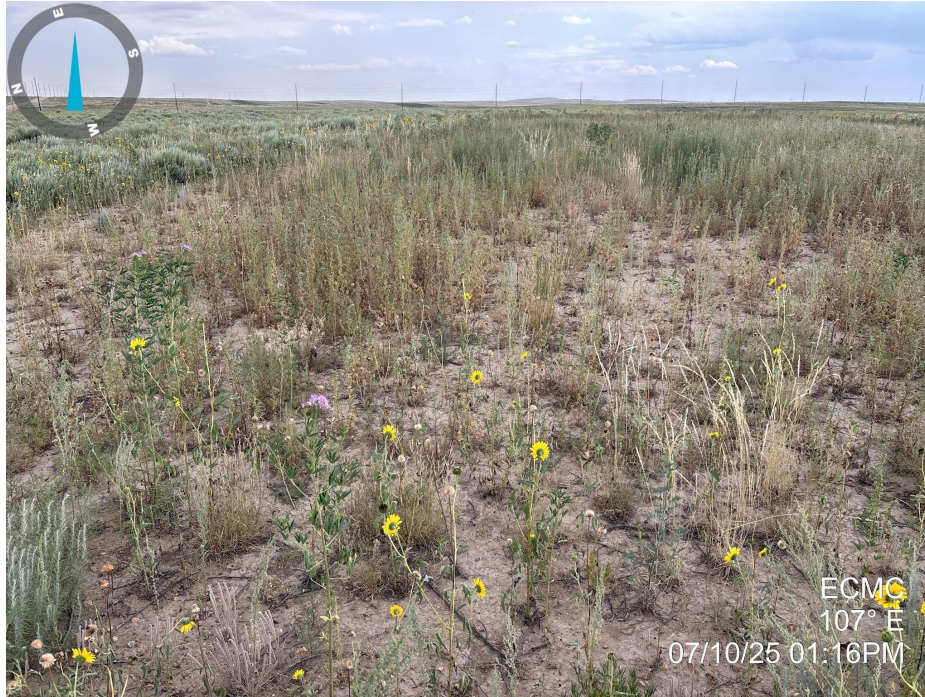
**Photo 9.** Photo taken of the tank battery location, facing east. See comments under Photo 7.

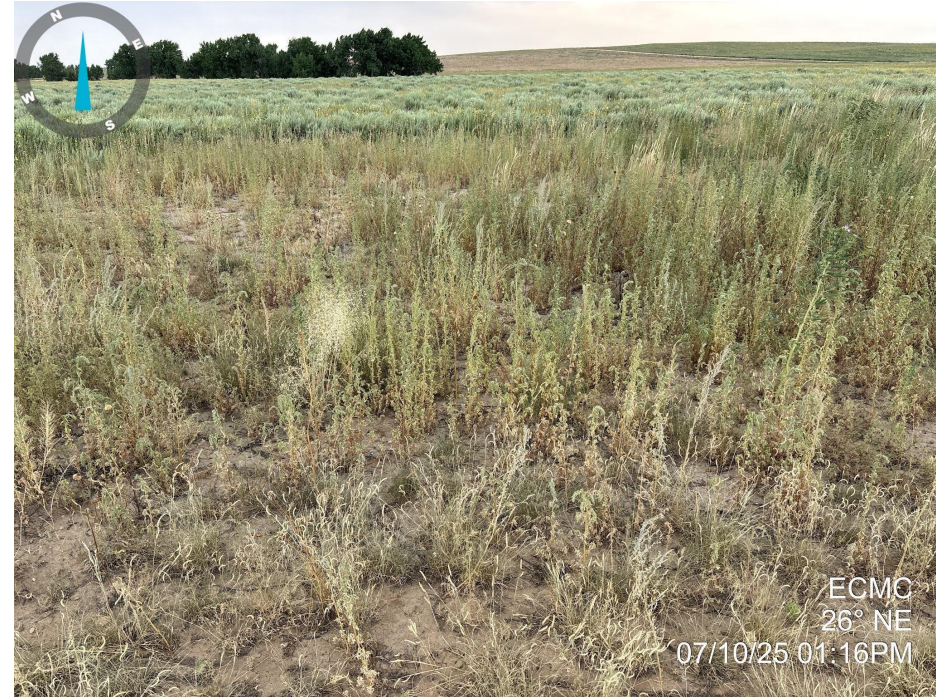
**Photo 10.** Photo taken of the tank battery location, facing northeast. See comments under Photo 7.
