Inspection/Audit Photos

Location: UTAH GAS OP LTD DBA UTAH GAS CORP SOUTH DOUGLAS CREEK #7325 PAD

Location ID: 311788

Date: 07/24/2025

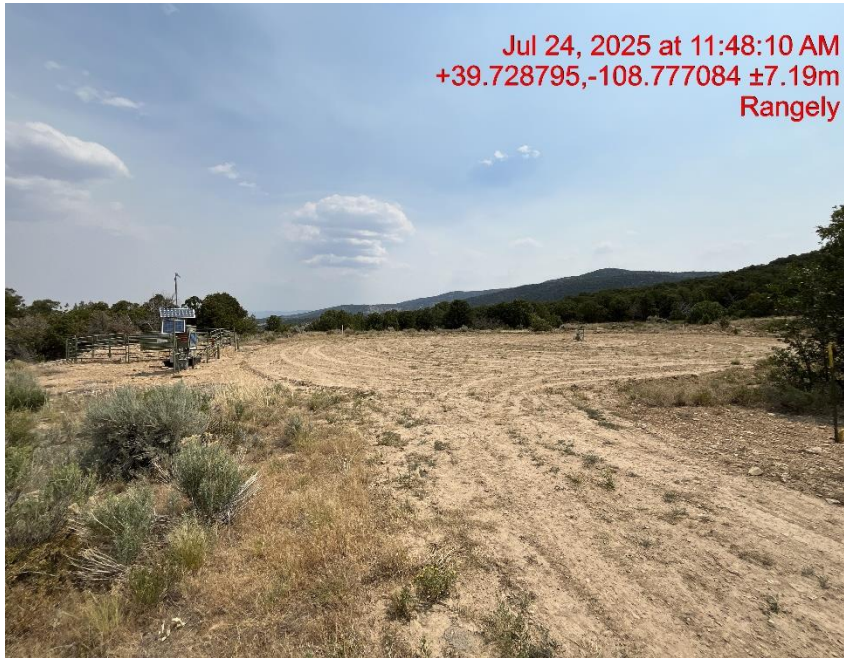
Photo # 0832 Entrance to location

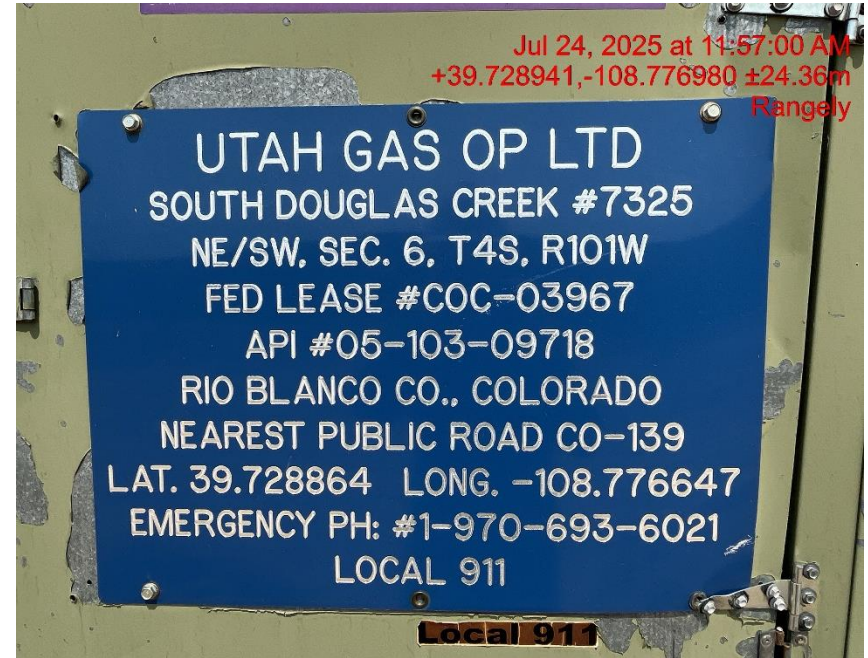
Photo # 0838 Location

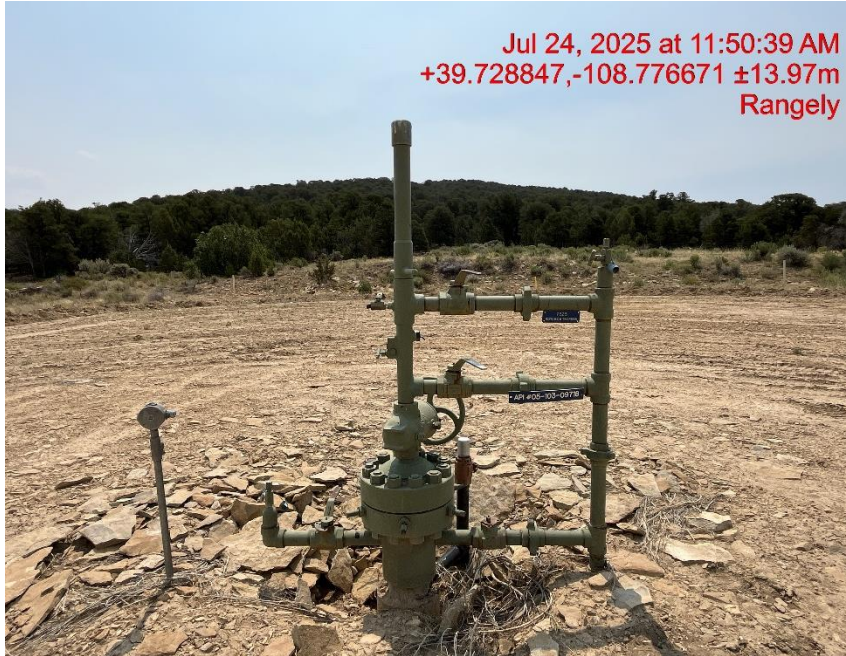
Photo # 0833 Location

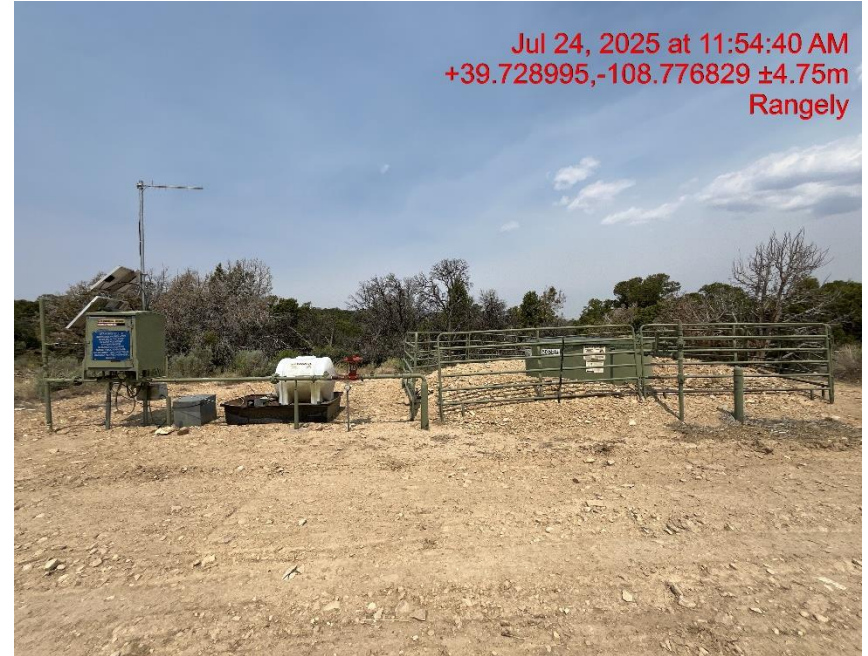
Photo # 0836 Location

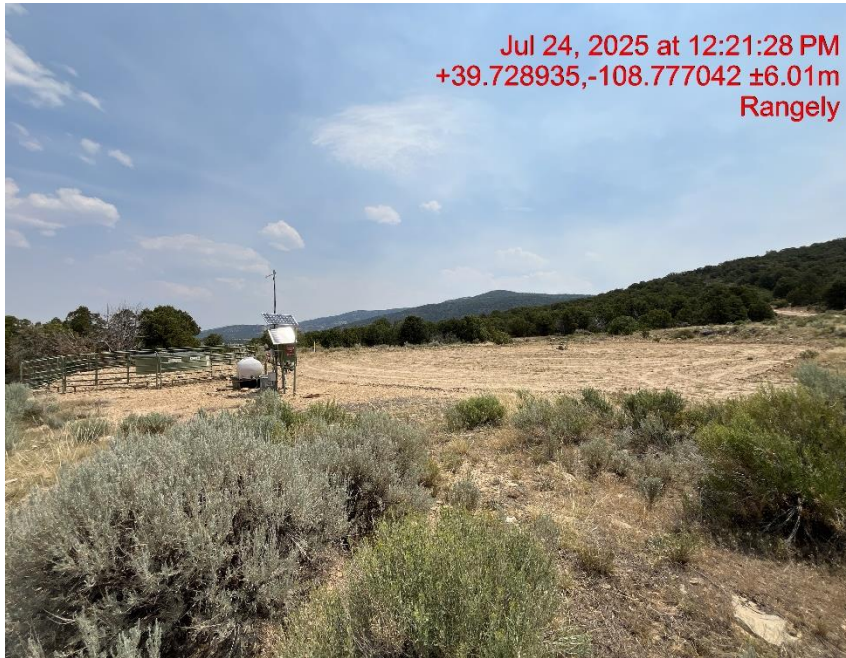
Photo # 0859 SW corner of location

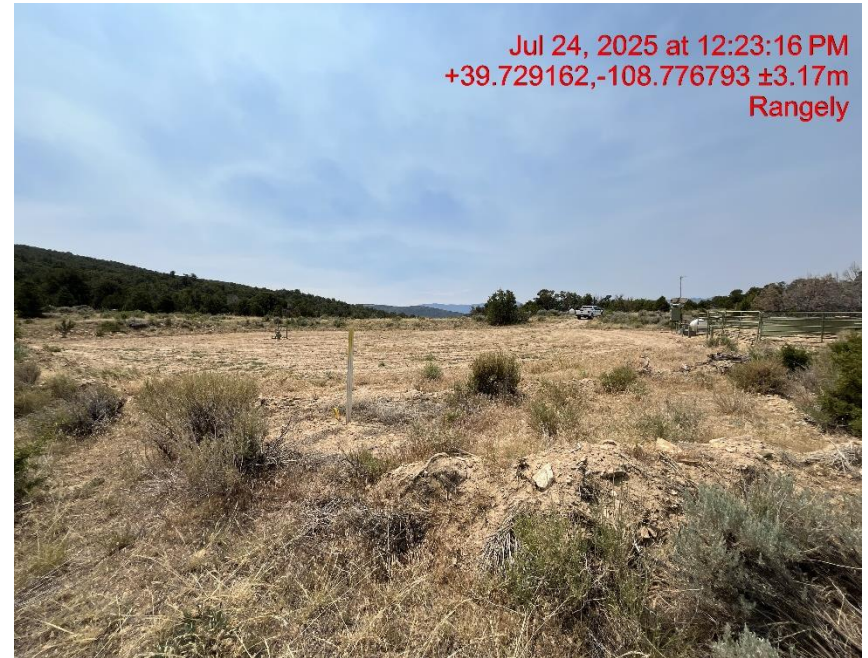
Photo # 0860 NW corner of location

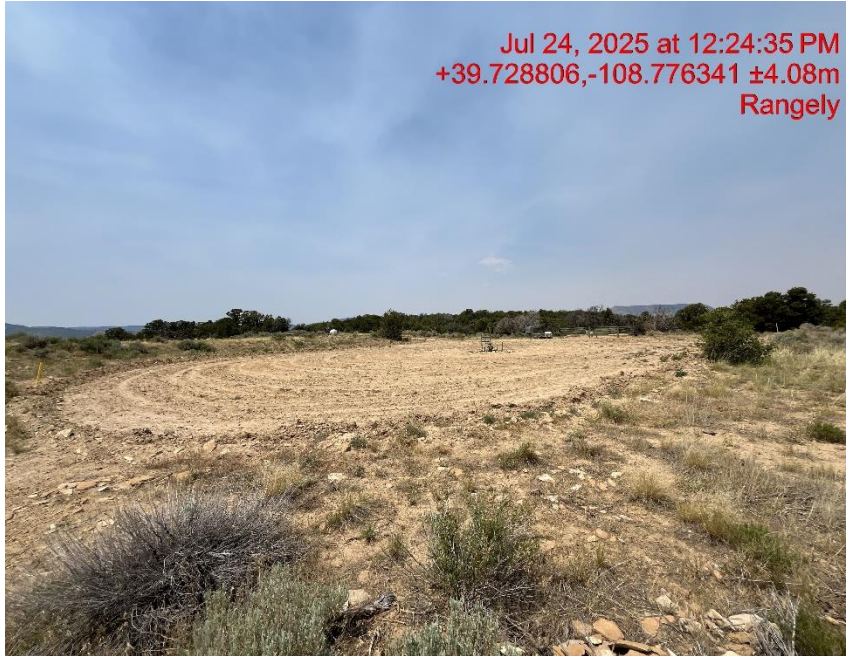
Photo # 0861 NE corner of location

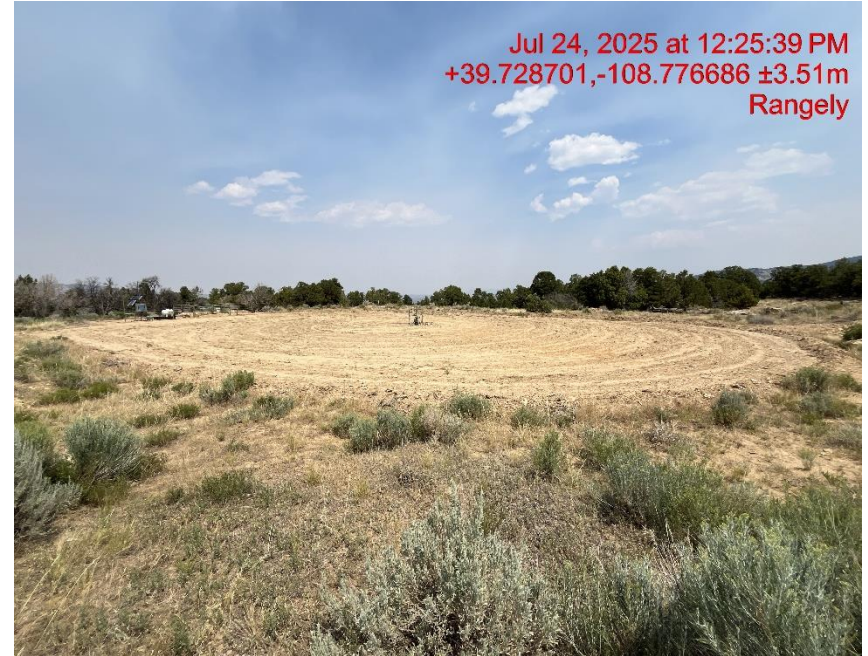
Photo # 0862 SE corner of location

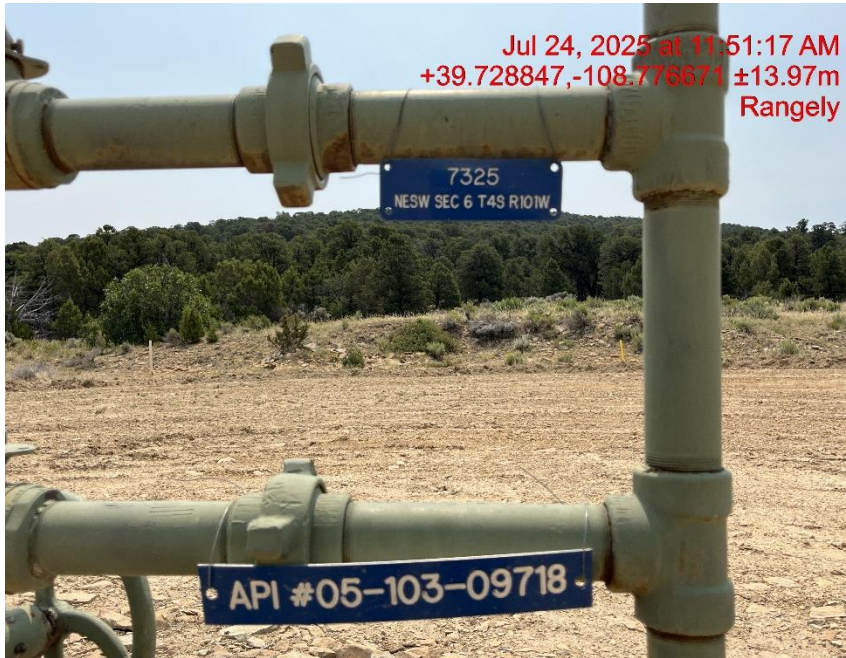
Photo # 0834 Wellhead sign lacks required information/not in compliance with CECMC rules

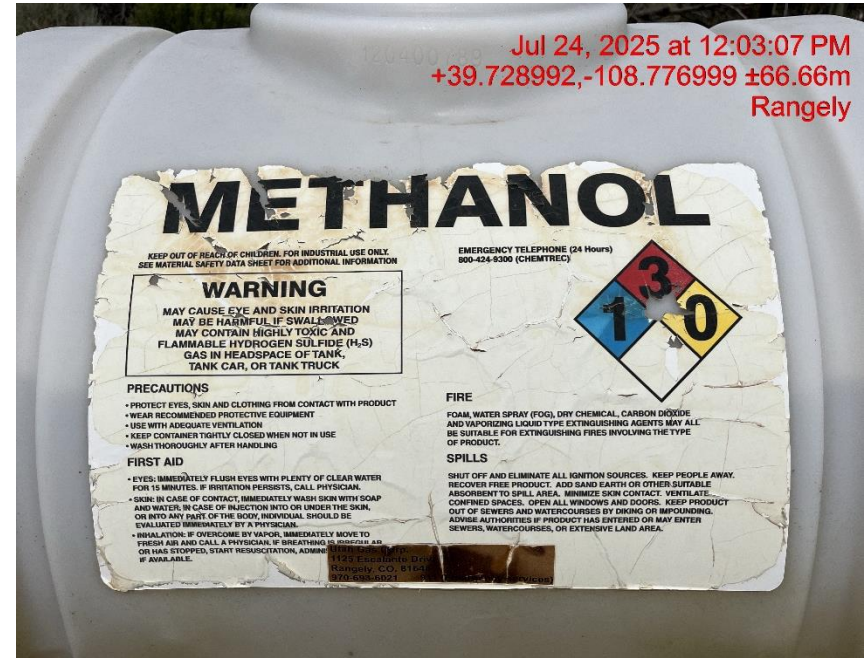
Photo # 0844 Chemical tank label is weathered & cracking/starting to become illegible

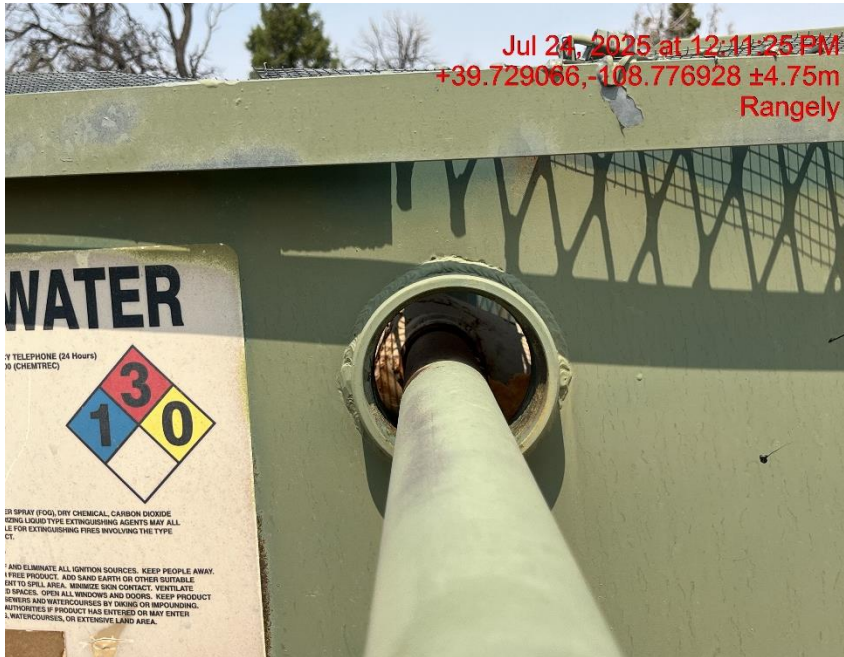
Photo # 0853 Open port on production tank/wildlife hazard/available for entry by wildlife

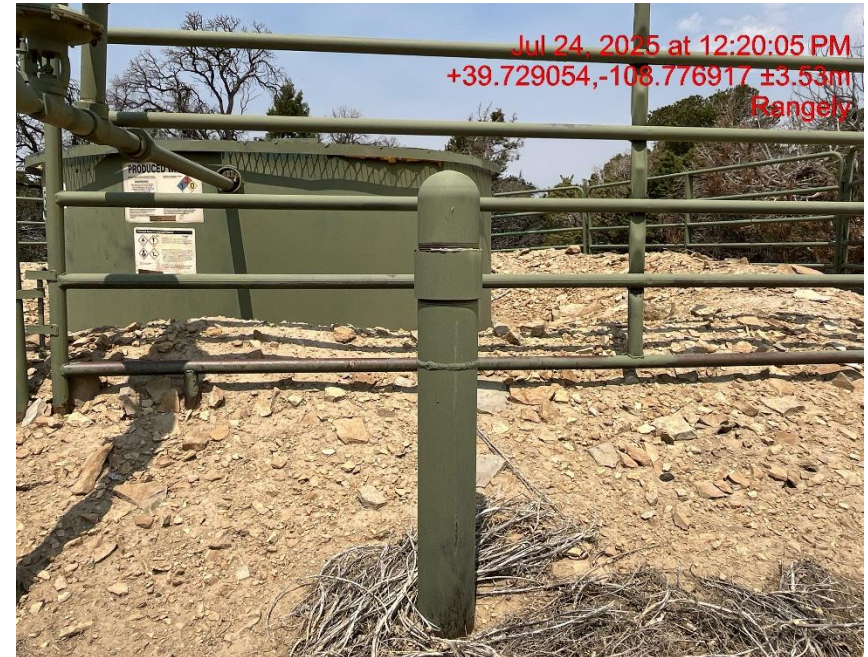
Photo # 0858 Unused flowline does not comply with CECMC 600 & 1100 series rules

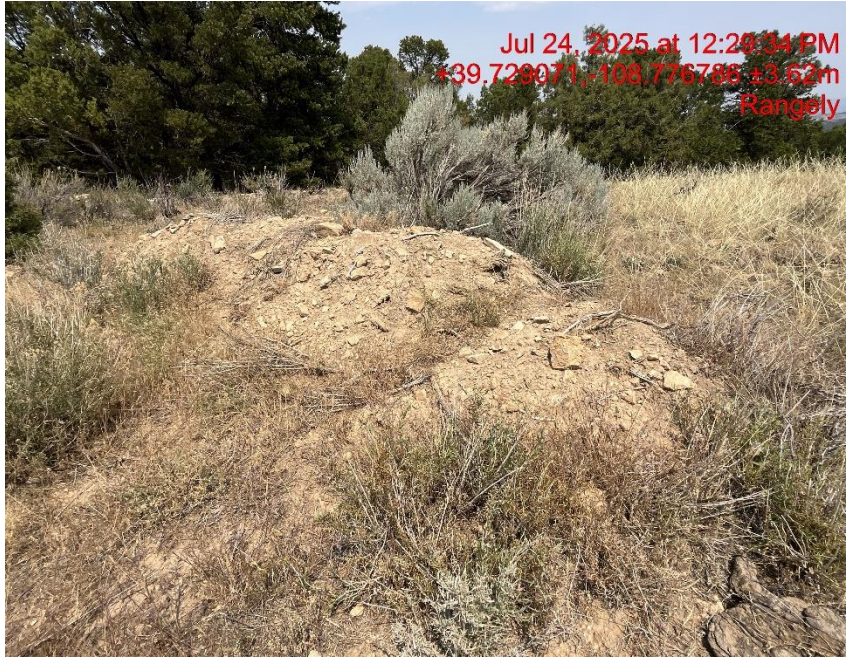
Photo # 0867 Stockpiled soils with no BMP's

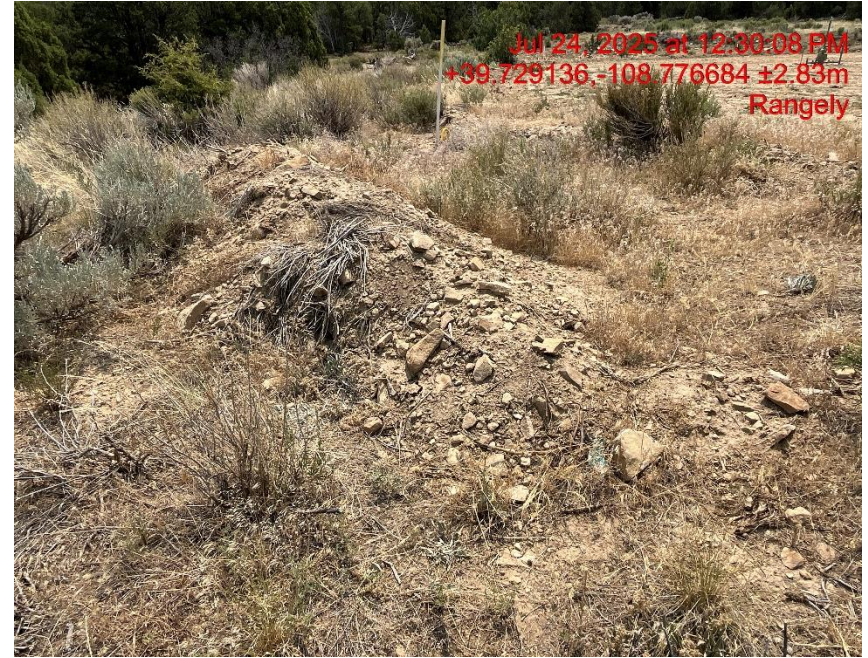
Photo # 0868 Stockpiled soils with no BMP's
