Inspection/Audit Photos

Location Name: TEP ROCKY MOUNTAIN LLC GM 42-3 Frac Pad

Location ID: 323951

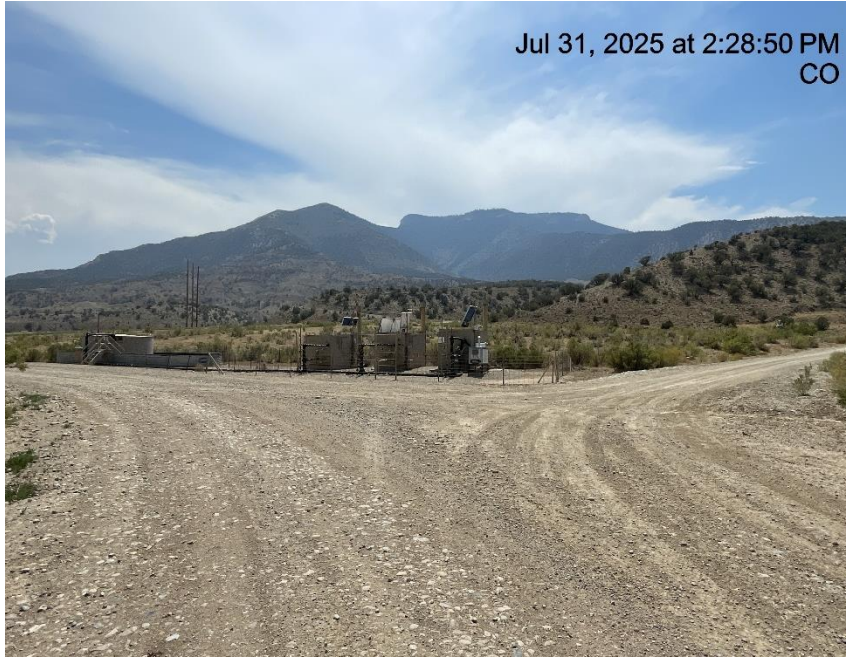
Photo # 6385 From entrance to location

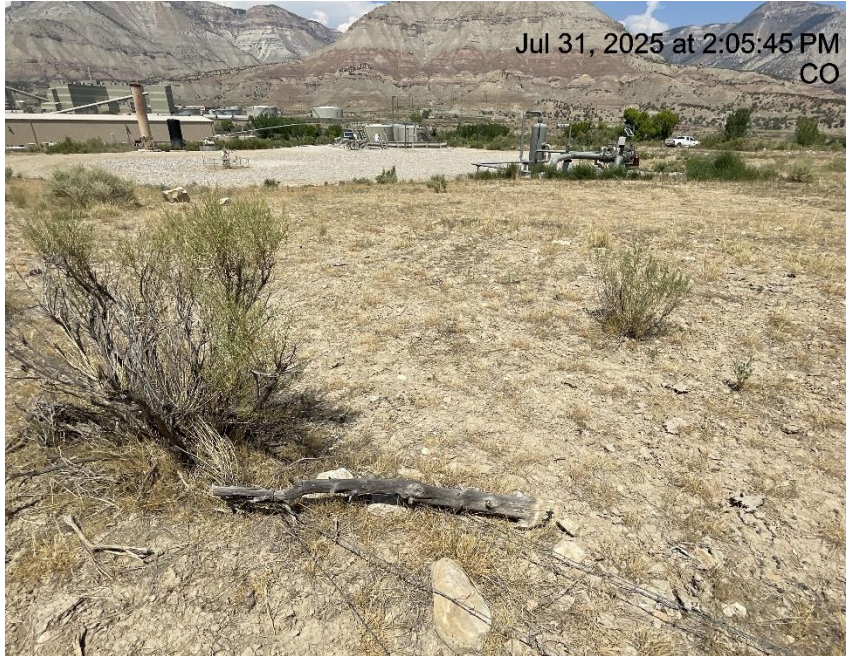
Photo # 6397 Barbed wire fence needs maintenance/wildlife hazard

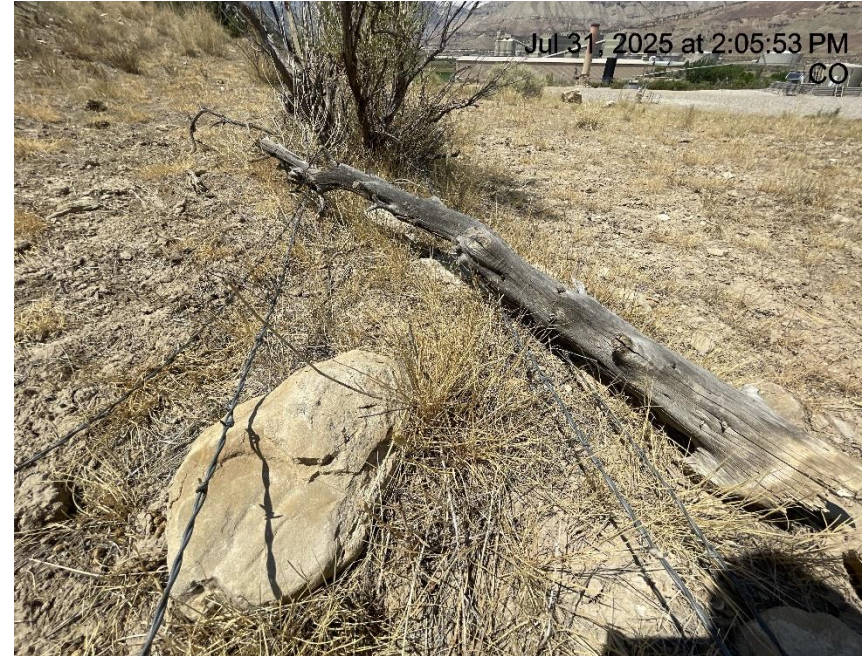
Photo # 6398 Barbed wire fence needs maintenance/wildlife hazard

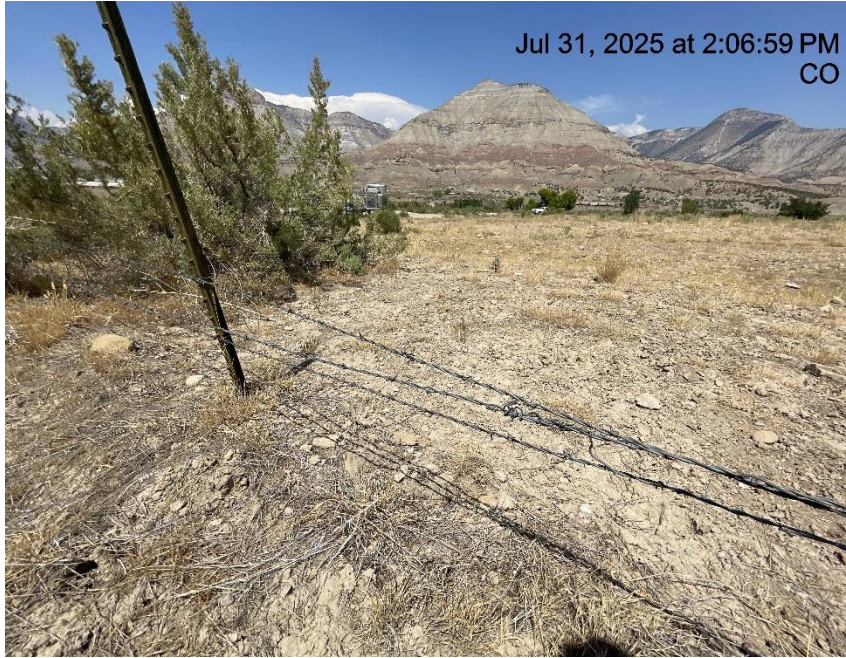
Photo # 6399 Barbed wire fence needs maintenance/wildlife hazard

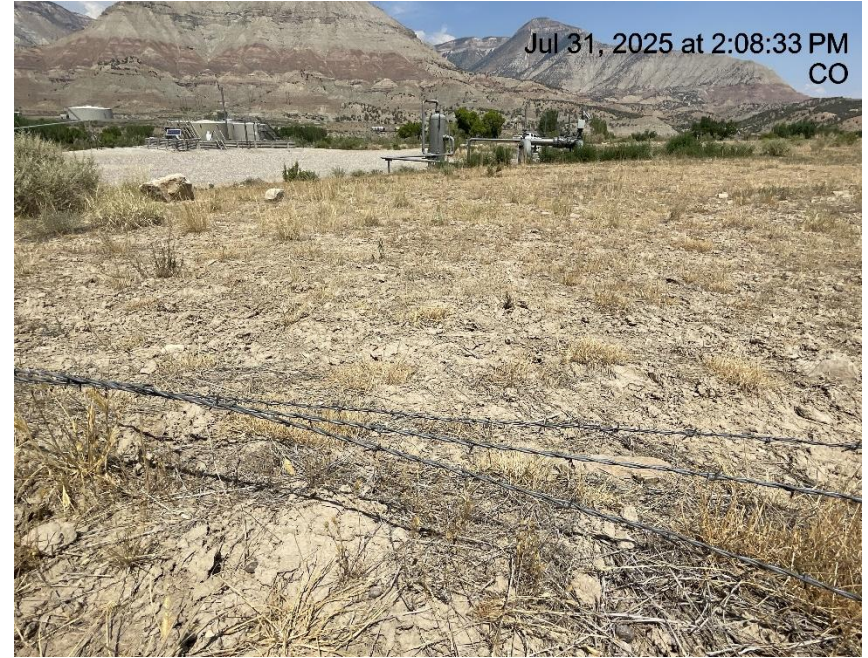
Photo # 6400 Barbed wire fence needs maintenance/wildlife hazard

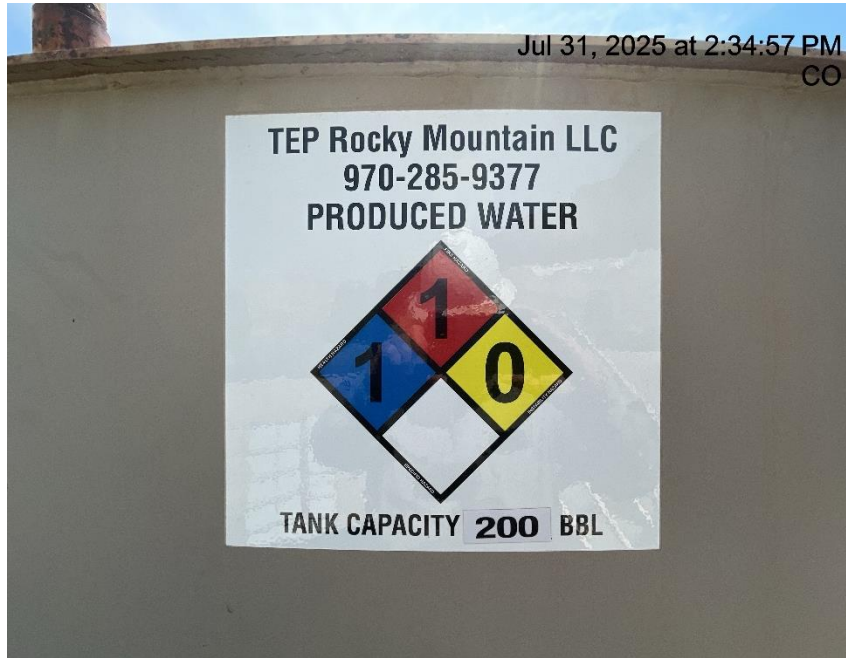
Photo # 6401 Tank capacity incorrect

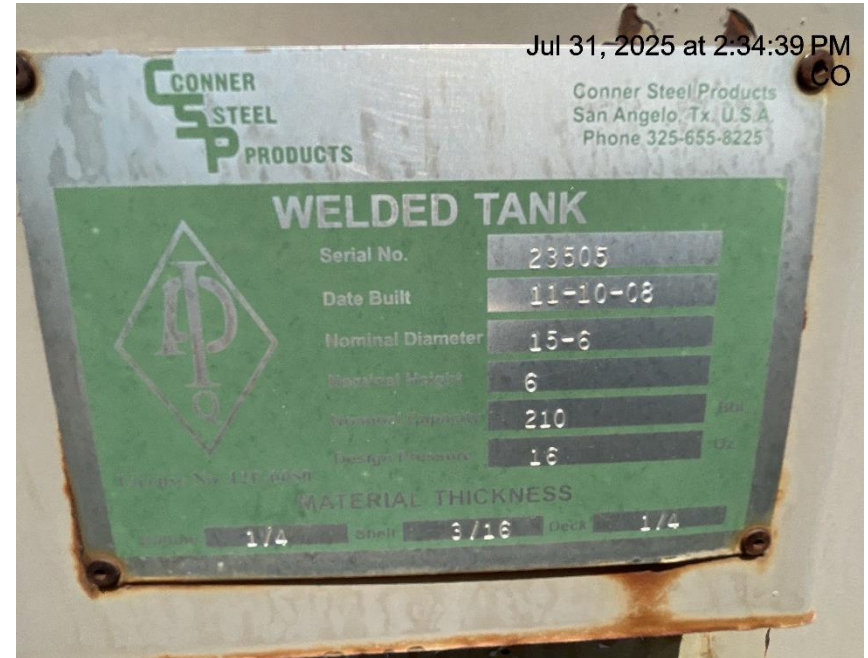
Photo # 6402 Tank capacity

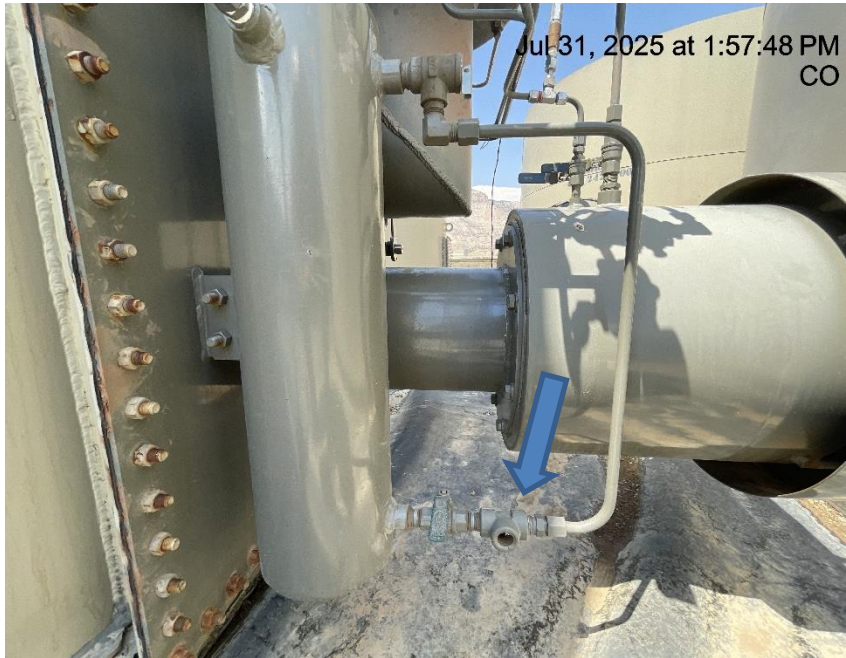
Photo # 6403 PRV vent line on tank burner does not comply with CECMC pressure safety device rules & general safety rules

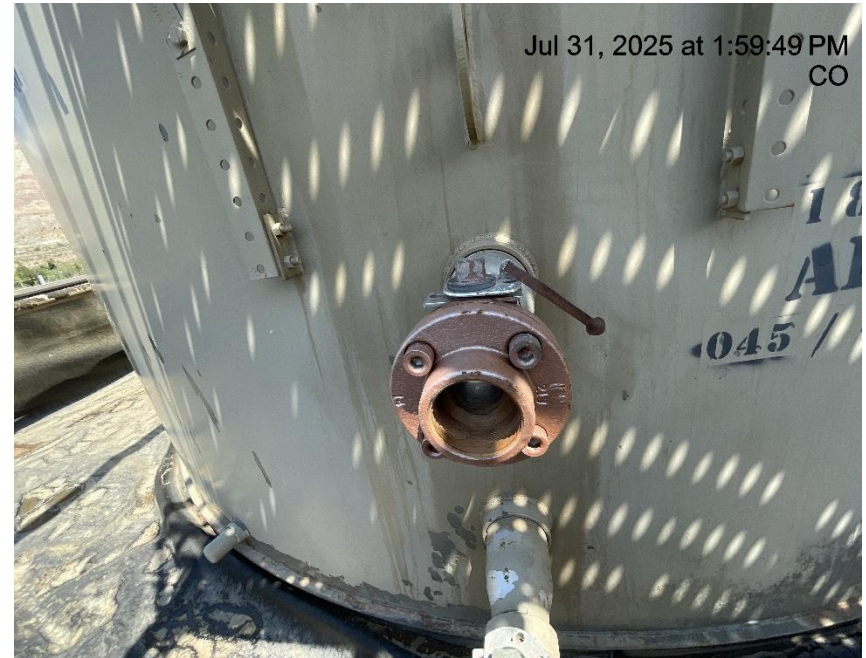
Photo # 6404 Open ended load line
