Final Reclamation and Stormwater Inspection

Operator: KERR MCGEE OIL & GAS ONSHORE LP - 47120

Location ID: 305233

Well Name: MATTORANO #42-9

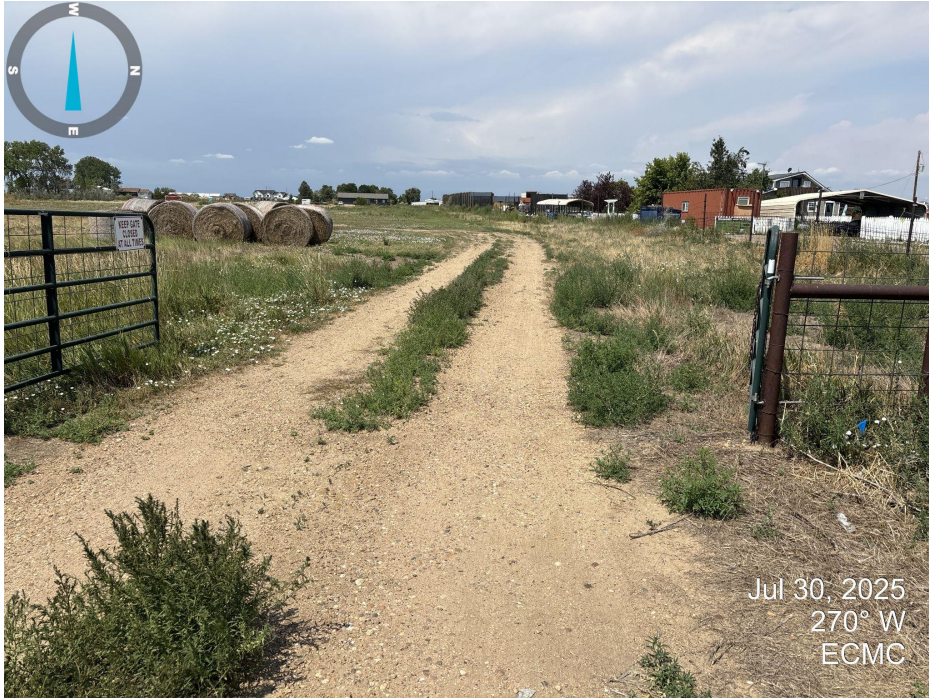
Photo 1. Looking west down the access road. It appears a new access road unrelated to oil and gas has been constructed partially overlapping the original access road.

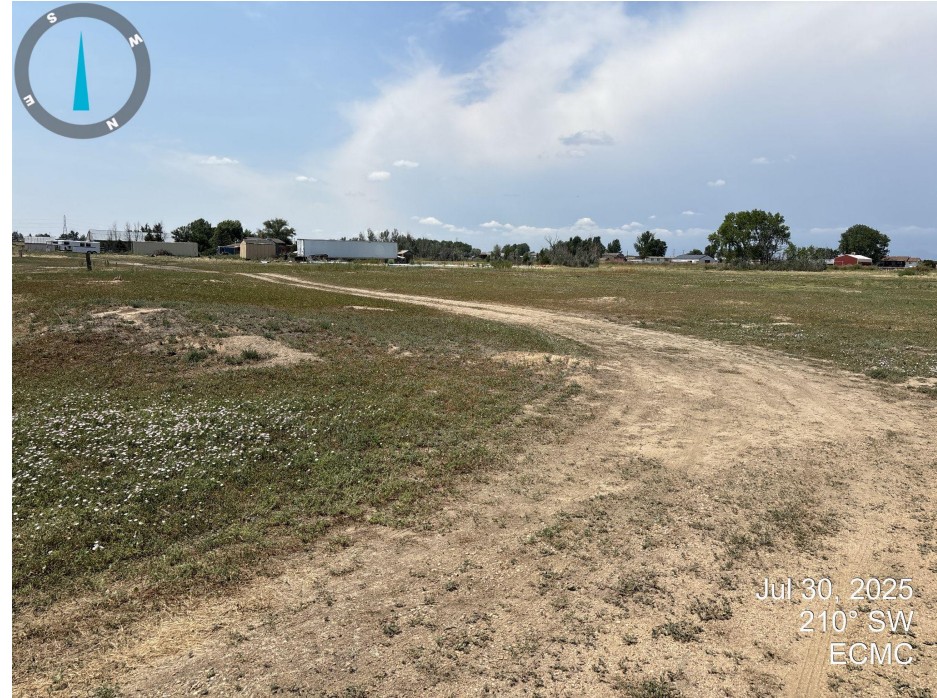
Photo 2. Approximately 200 ft in from the gate a new road is present. It appears this road is being used to access outbuildings on the property.

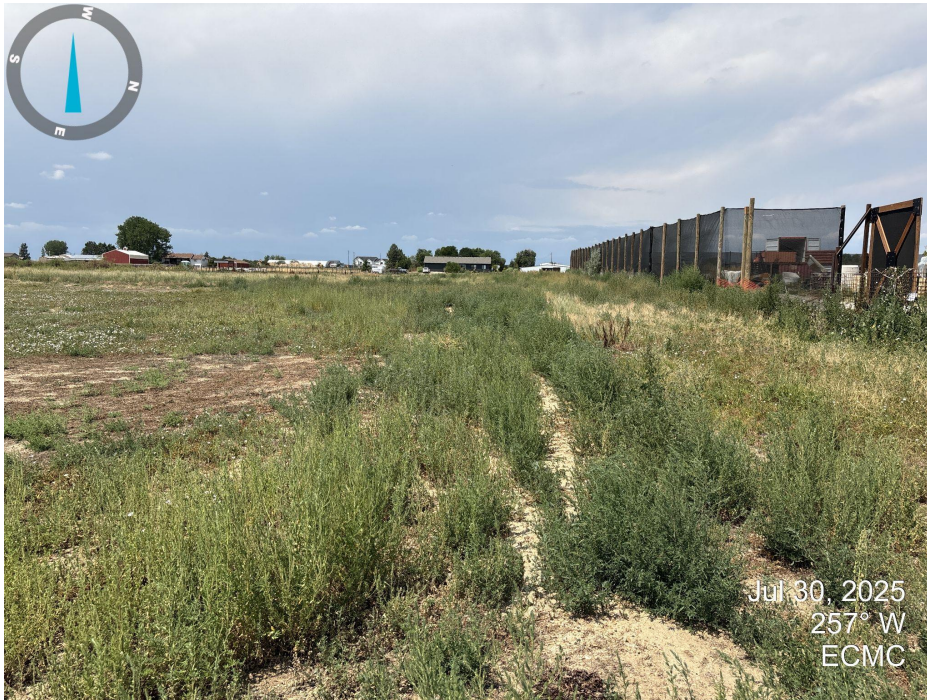
Photo 3. Picture taken at the junction of the new and old access road looking west down the road towards the tank battery. Vegetation on the access road is primarily undesirable weed kochia.

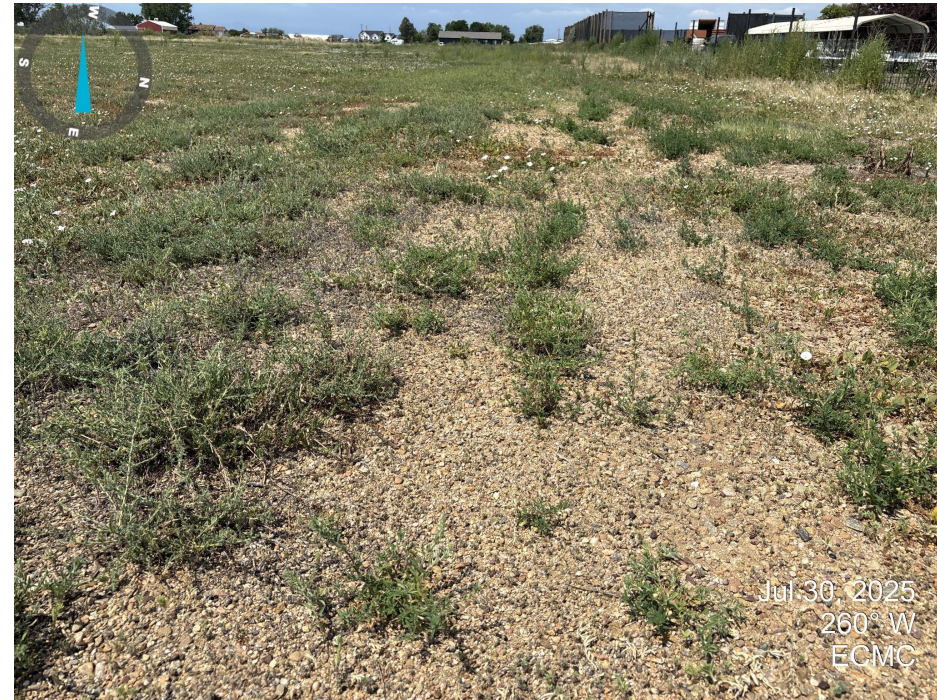
Photo 4. This portion of access road appears to be unused and has a relatively large amount of gravel.

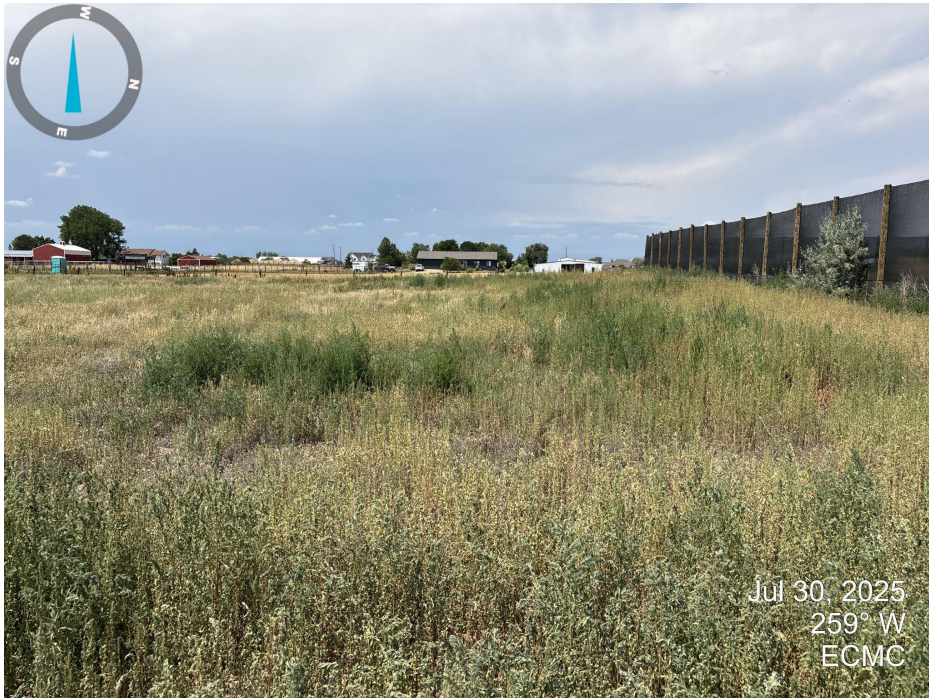
Photo 5. Looking west across the former tank battery location. No oil and gas equipment remains. At the time of inspection vegetation is primarily undesirable weed kochia and list C noxious weed cheatgrass.

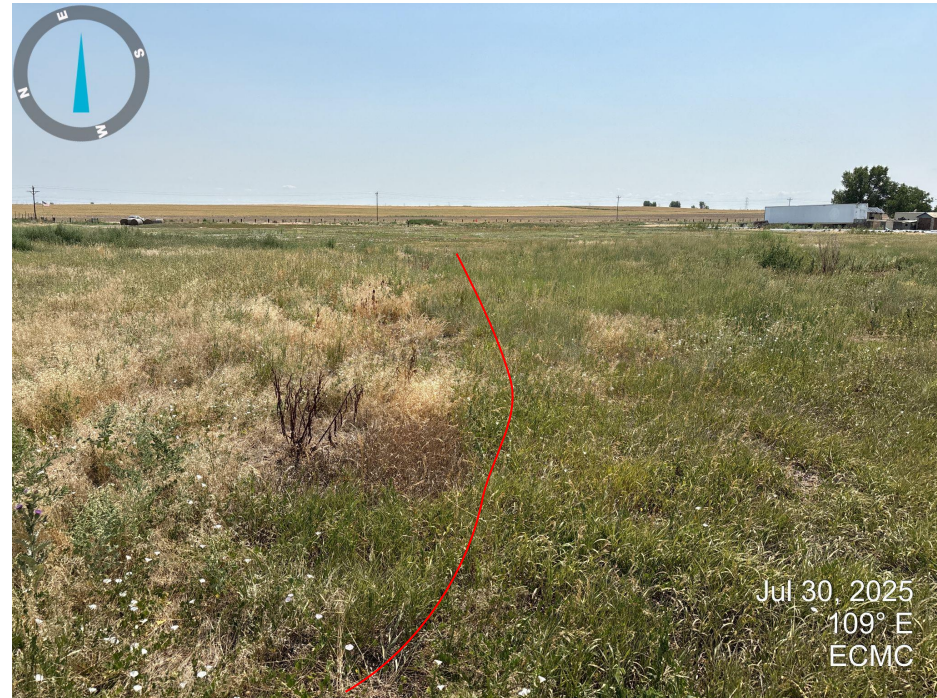
Photo 6. Looking east down the south side of the tank battery. Illustrating difference in vegetation between the tank battery and interim reclamation area (tank battery on the left side of the red line). The interim reclamation area on the southwest side of the location appears to have established perennial vegetation.

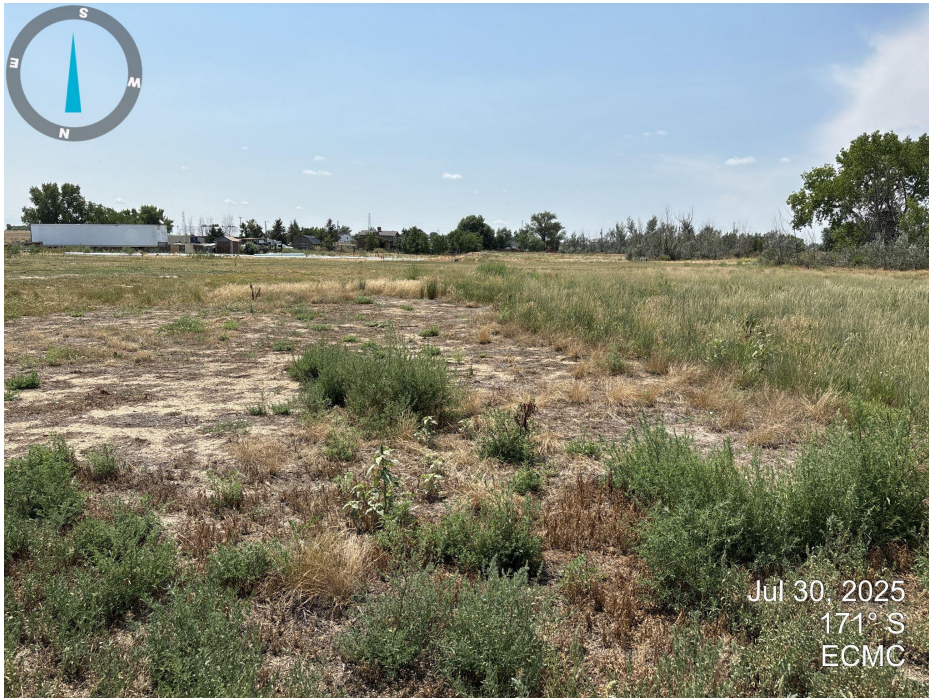
Photo 7. Looking south from the tank battery towards the well location. The access road and wellbore area are partially located in an area with low vegetation coverage. Undesirable weeds such as kochia and list C noxious weed cheatgrass are present in this area. Desirable perennial grass species area also present to the southwest.

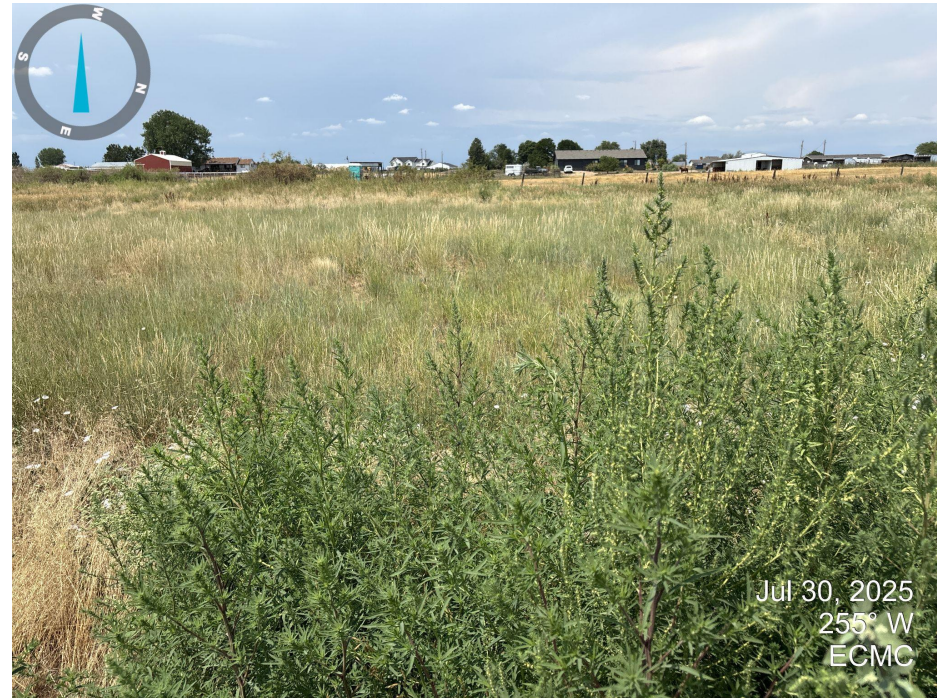
Photo 8. Looking west from the wellbore area. See photo 7 comments.

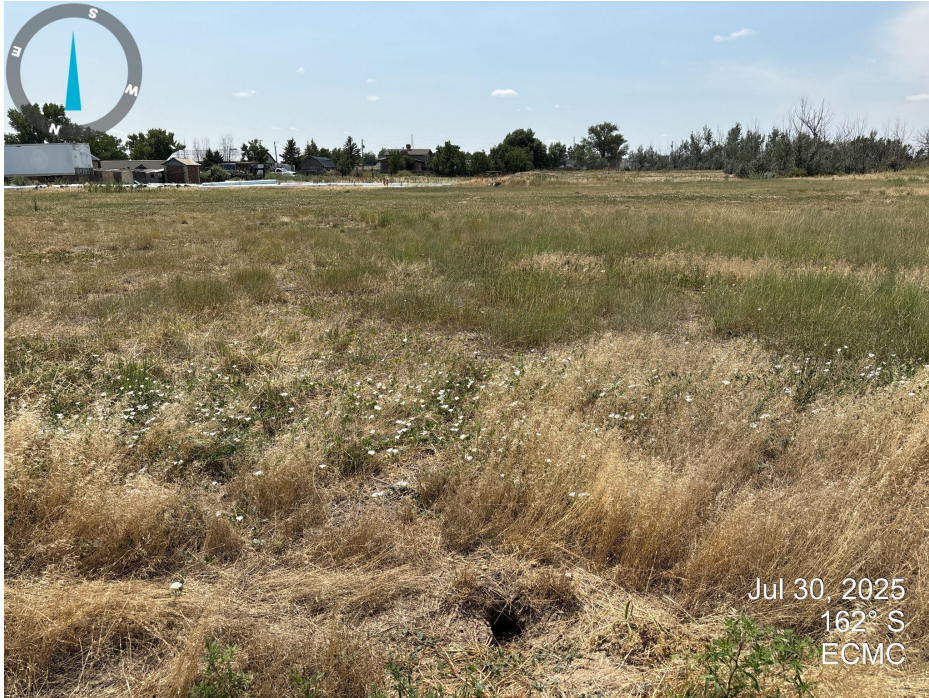
Photo 9. Looking south from the wellbore area. See photo 7 comments.

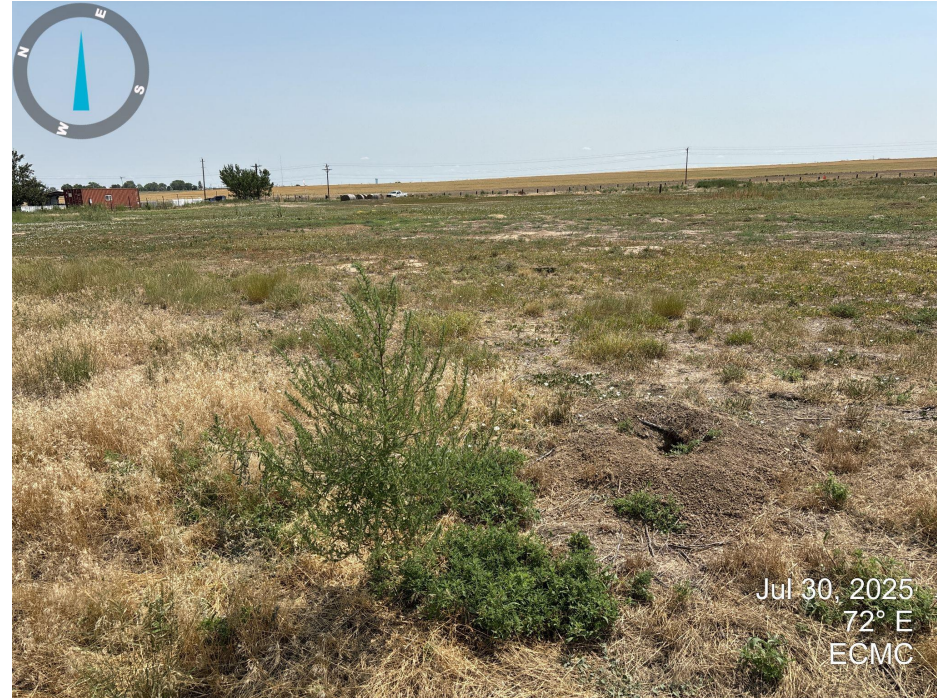
Photo 10. Looking east from the wellbore area. See photo 7 comments.

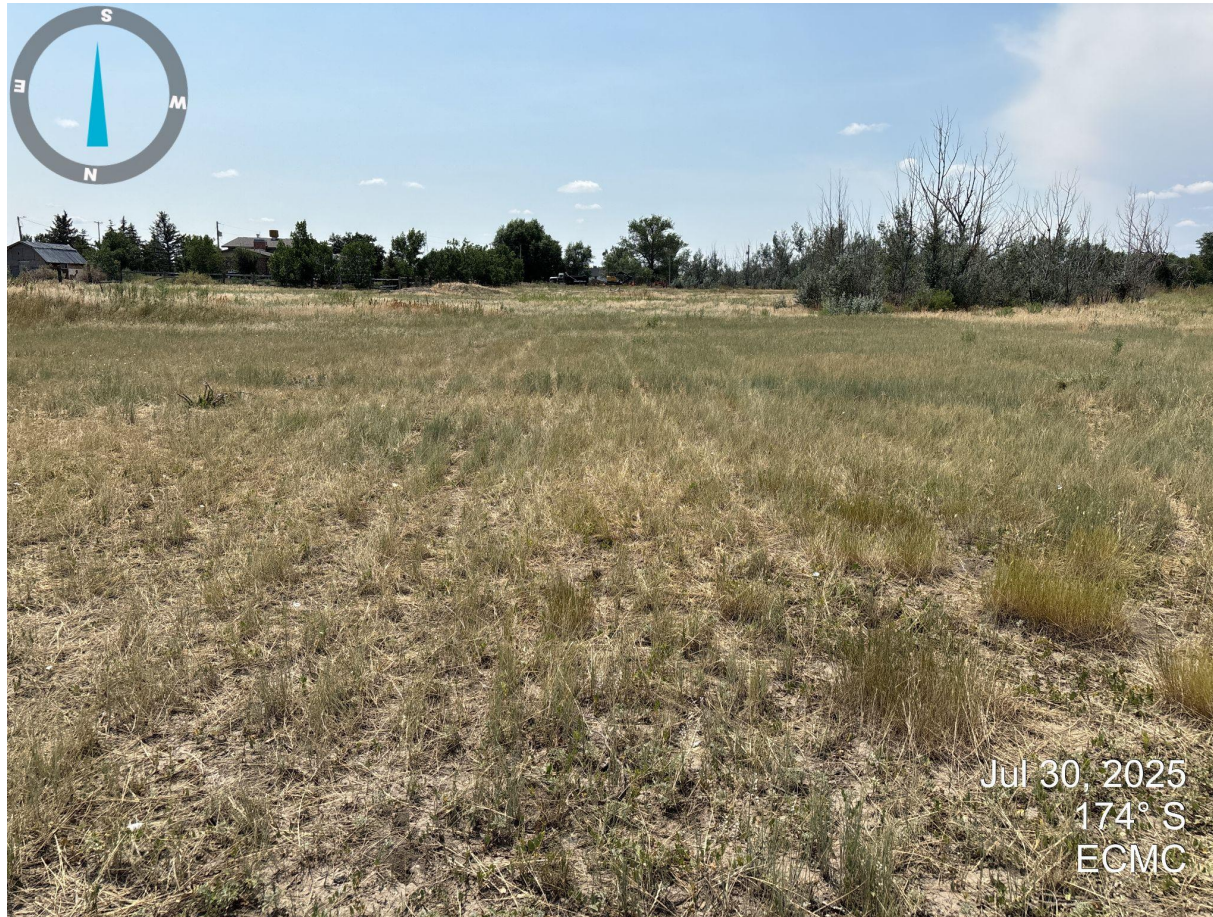
Photo 11. Reference vegetation to the south of well location.
