Inspection/Audit Photos

Location Name: TEP ROCKY MOUNTAIN LLC GM 13-33 Tank Pad

Location ID: 439256

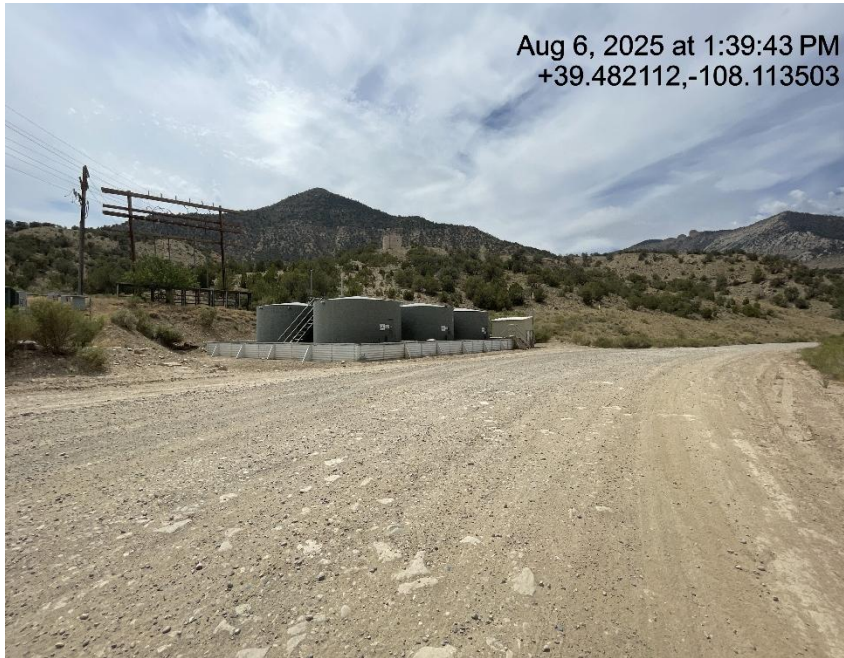
Photo # 8402 From entrance to location

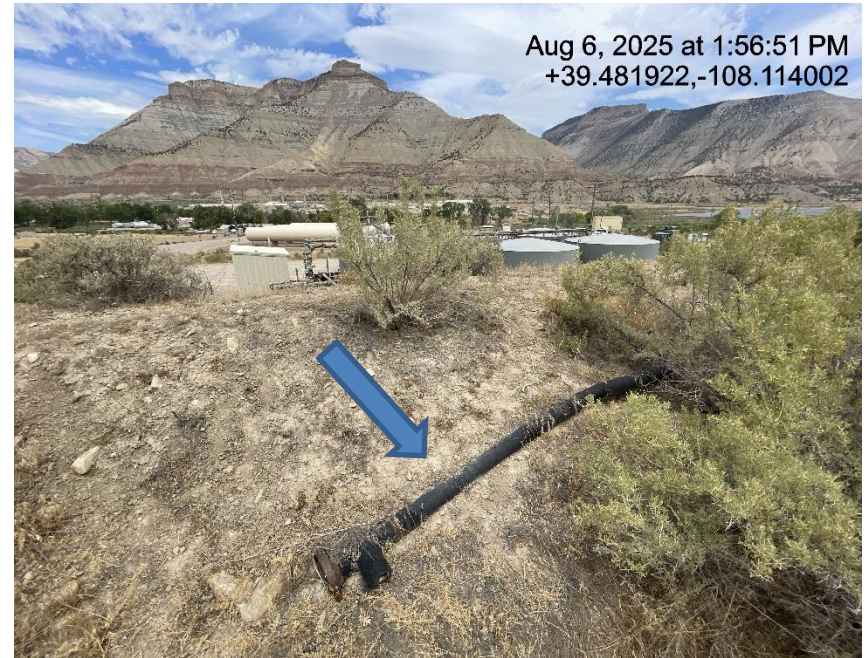
Photo # 8407 Debris

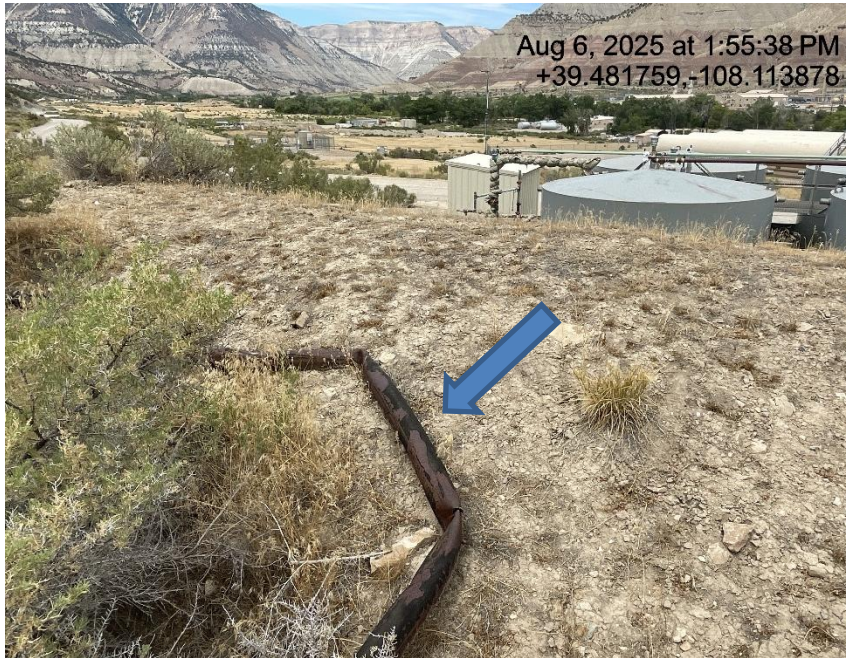
Photo # 8408 Debris

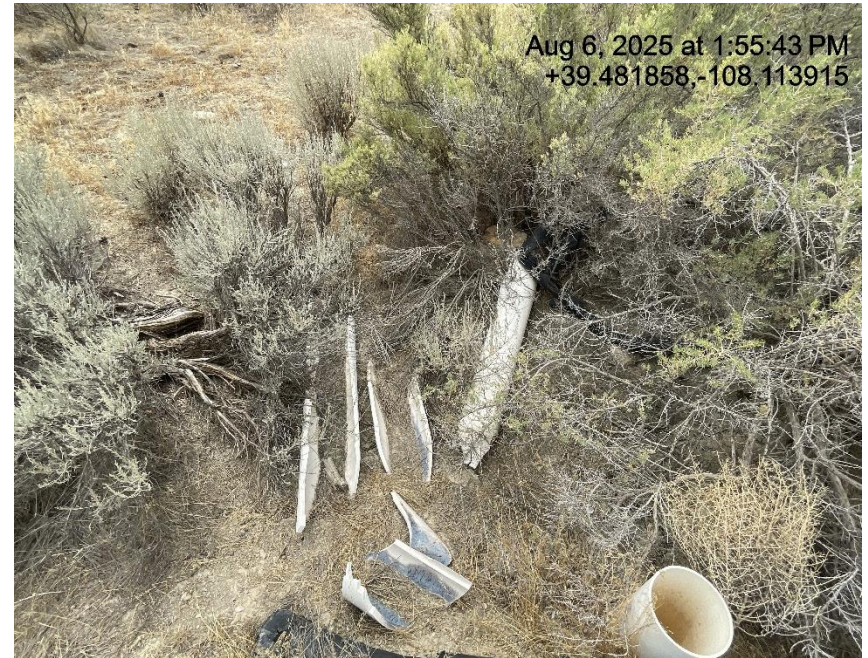
Photo # 8409 Debris

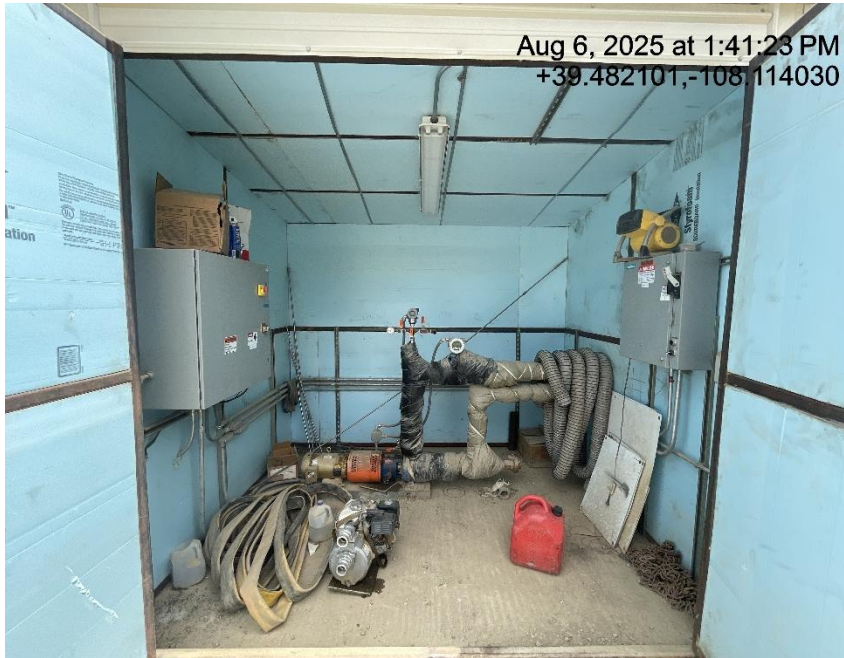
Photo # 8410 Improper storage of flammable liquids in shed/shed not in compliance with CECMC Rule 610

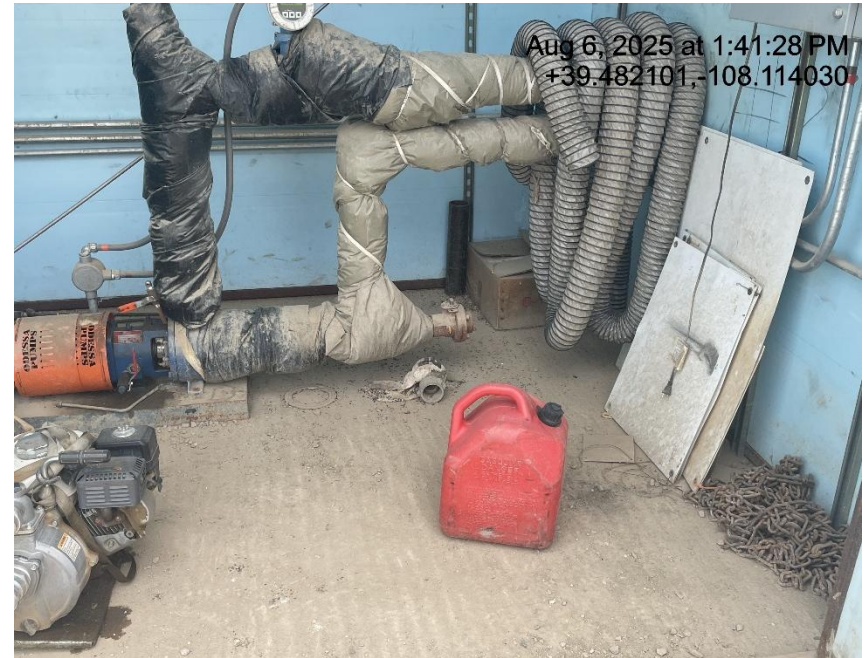
Photo # 8411 Improper storage of flammable liquids in shed/shed not in compliance with CECMC Rule 610

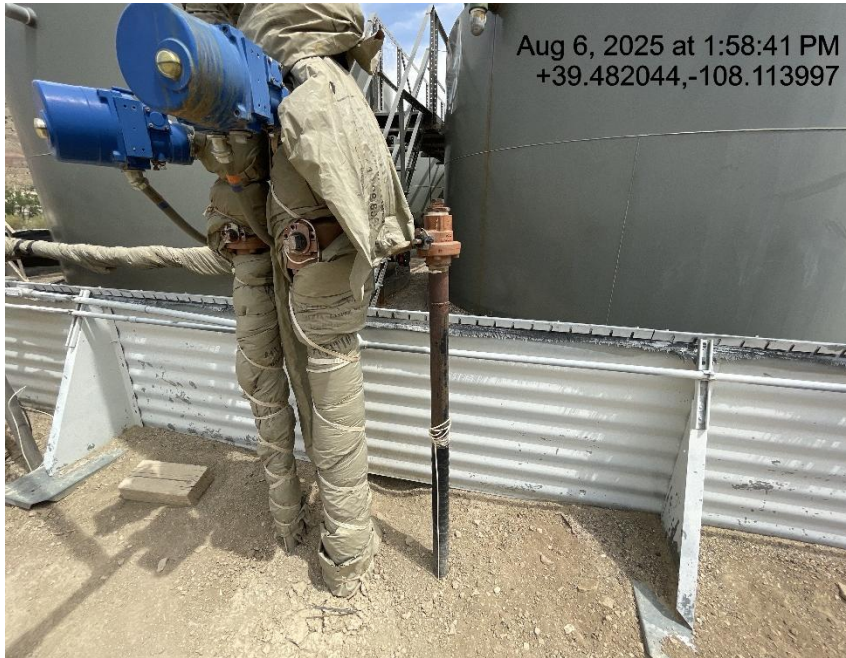
Photo # 8412 Unused flowline lacks lockout tagout (OOSLAT)

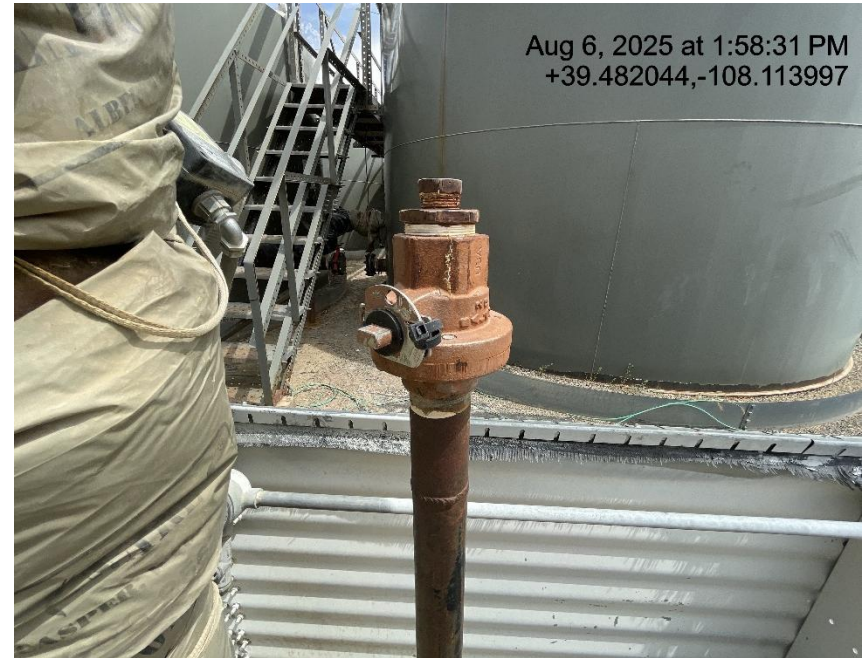
Photo # 8413 Unused flowline lacks lockout tagout (OOSLAT)

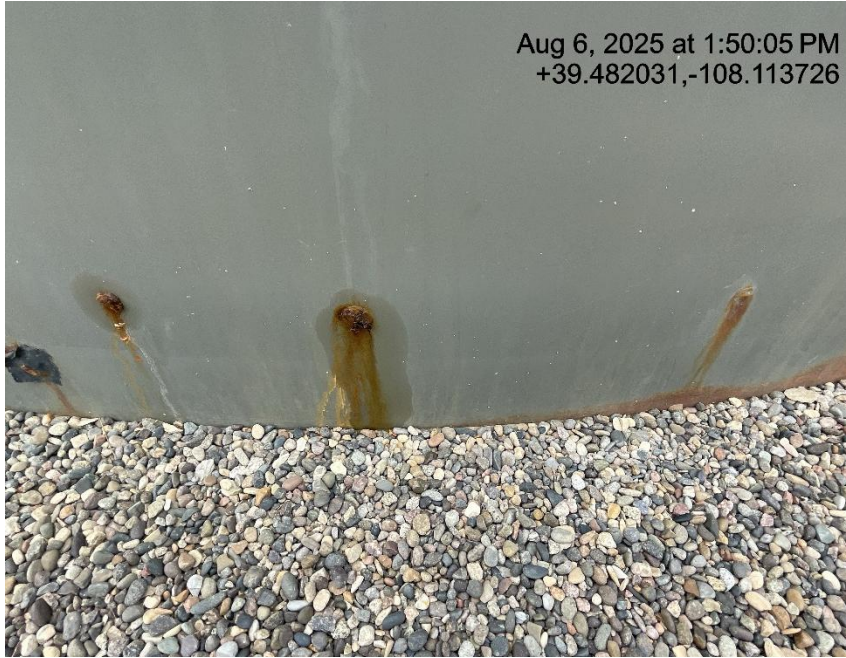
Photo # 8414 Possible tank failure/tank appears to lack integrity

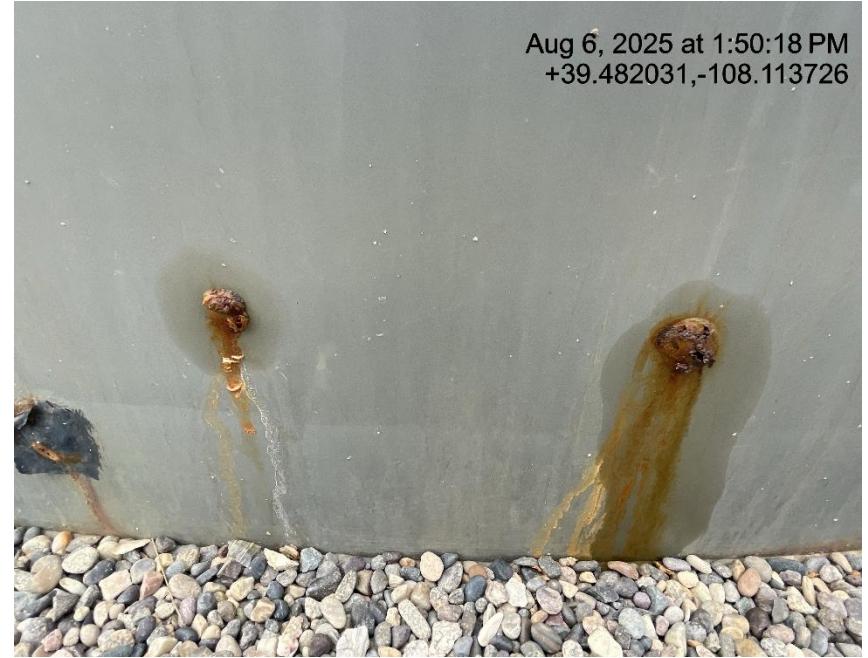
Photo # 8415 Possible tank failure/tank appears to lack integrity

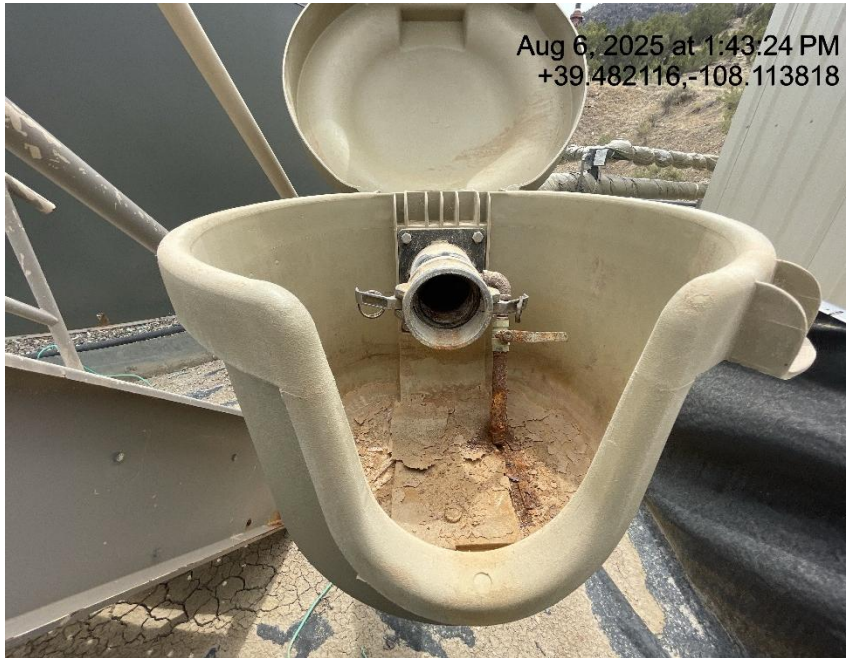
Photo # 8416 Open ended load line

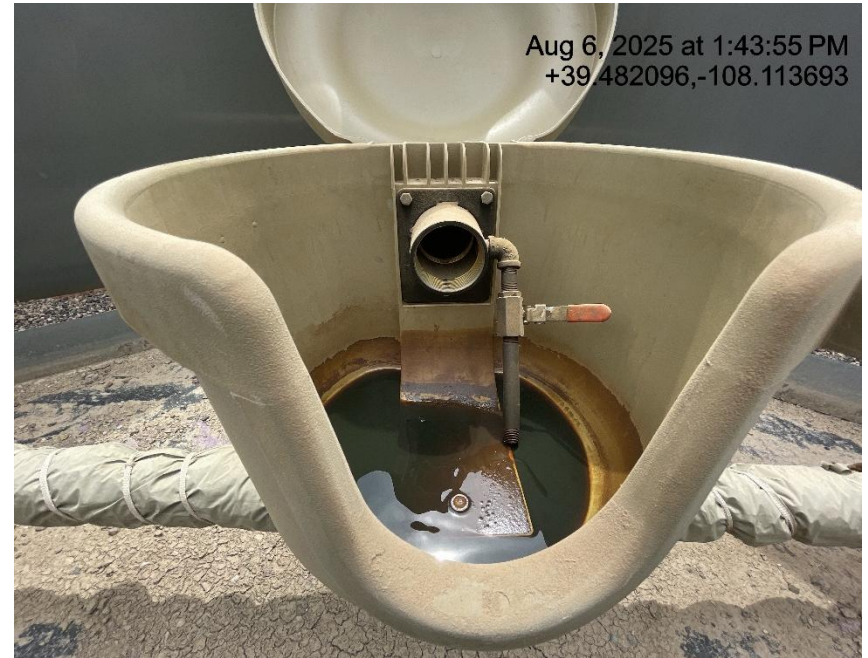
Photo # 8417 Open ended load line

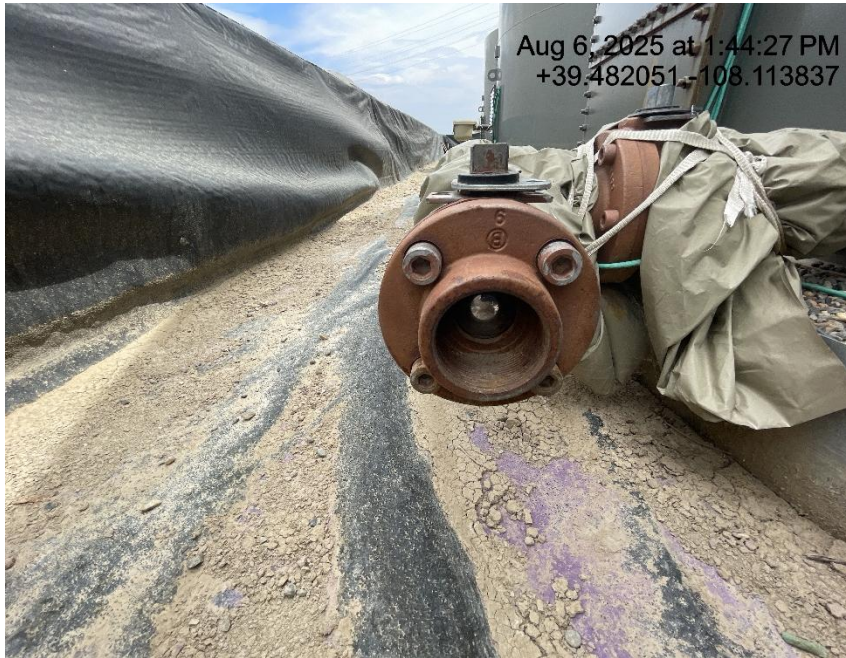
Photo # 8418 Open ended load line

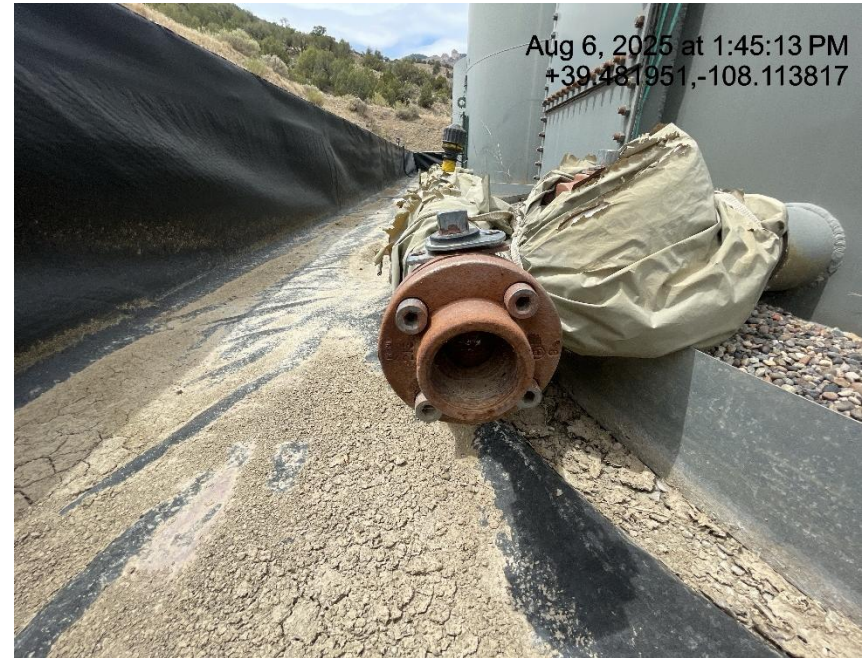
Photo # 8419 Open ended load line

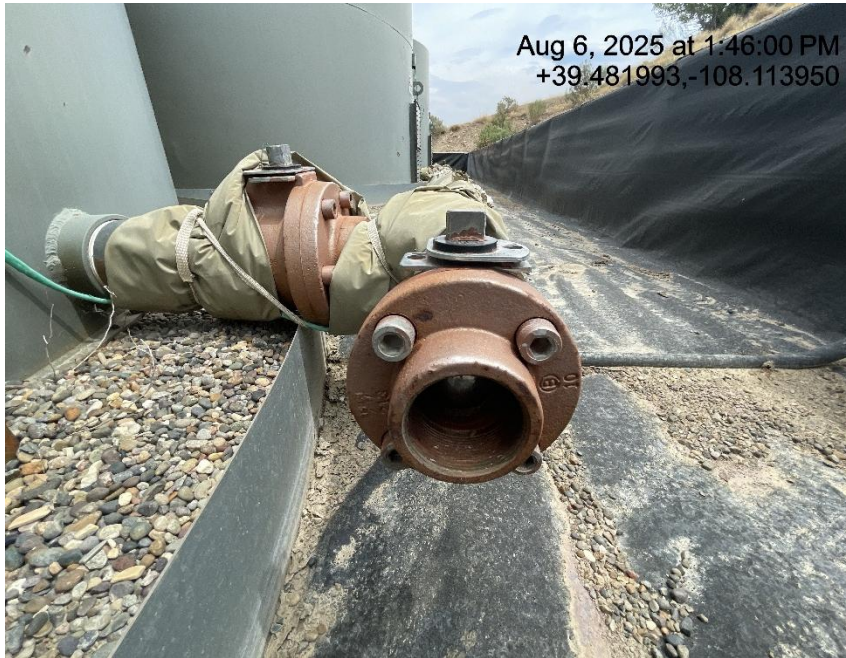
Photo # 8420 Open ended load line

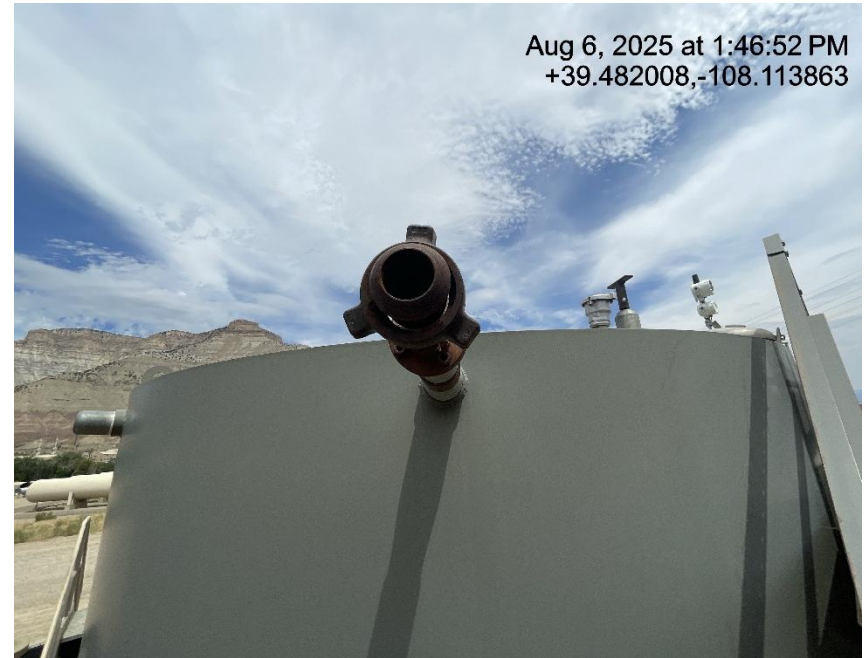
Photo # 8421 Open ended piping/load line

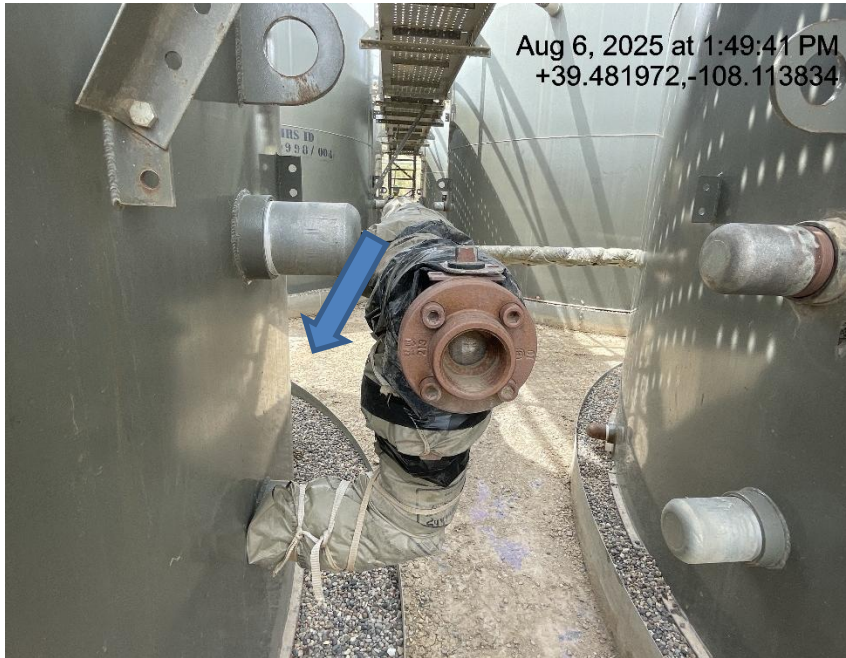
Photo # 8422 Open ended load line

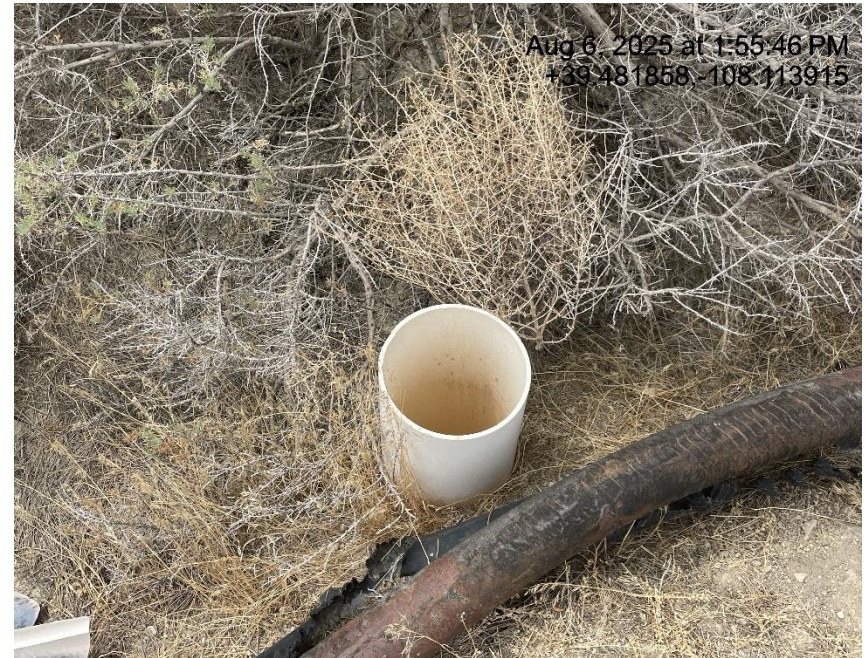
Photo # 8423 Open ended piping/wildlife hazard/available for entry by wildlife

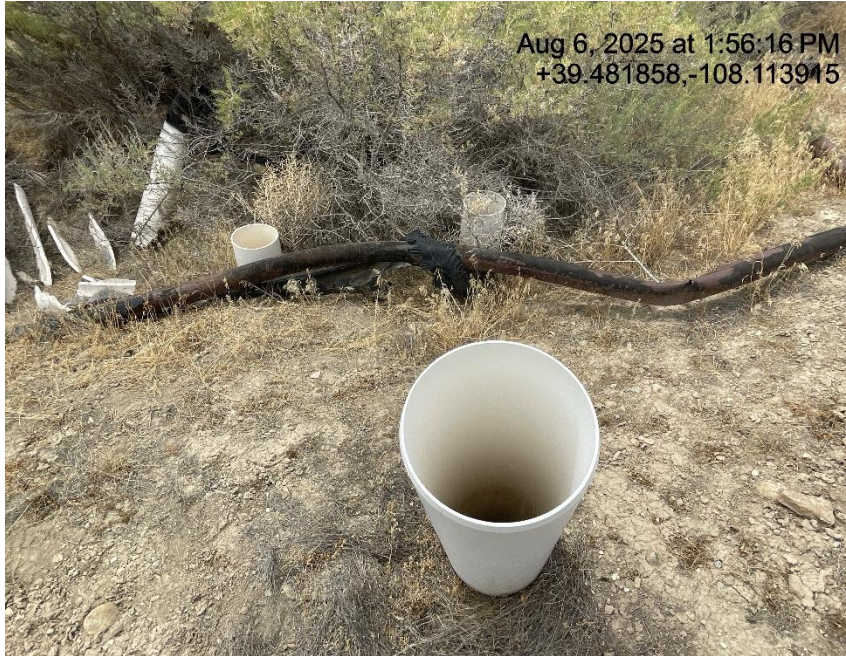
Photo # 8424 Open ended piping/wildlife hazard/available for entry by wildlife

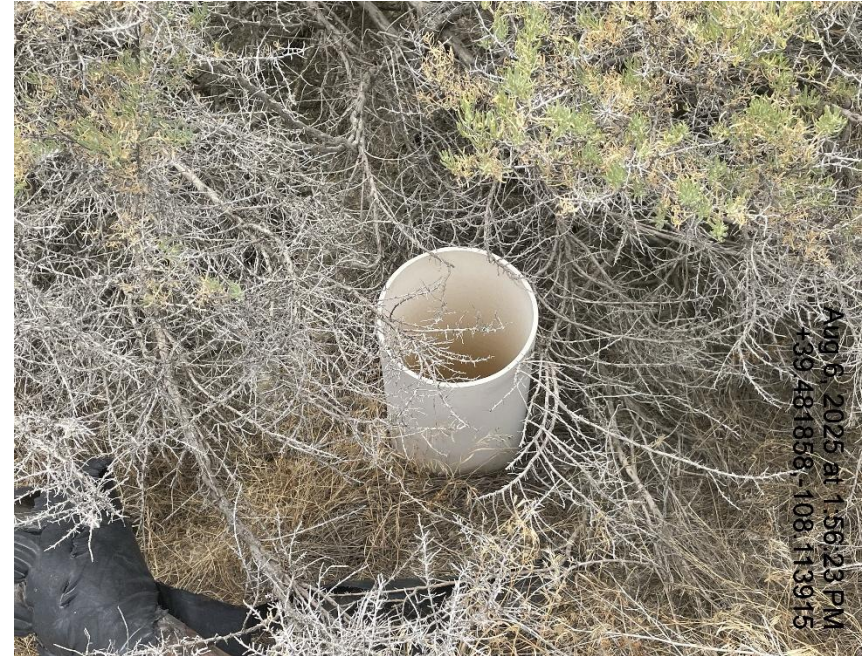
Photo # 8425 Open ended piping/wildlife hazard/available for entry by wildlife

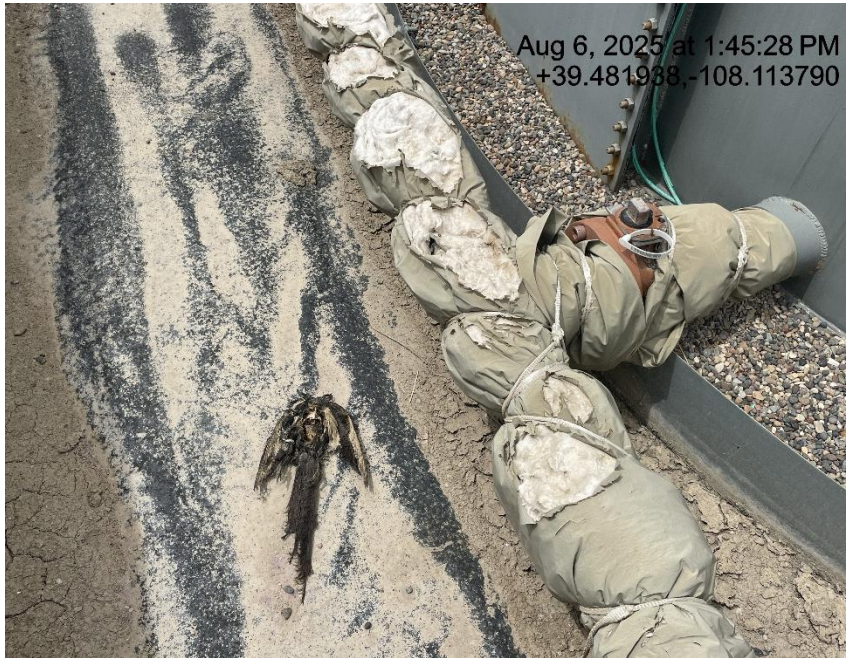
Photo # 8426 Dead bird in secondary containment

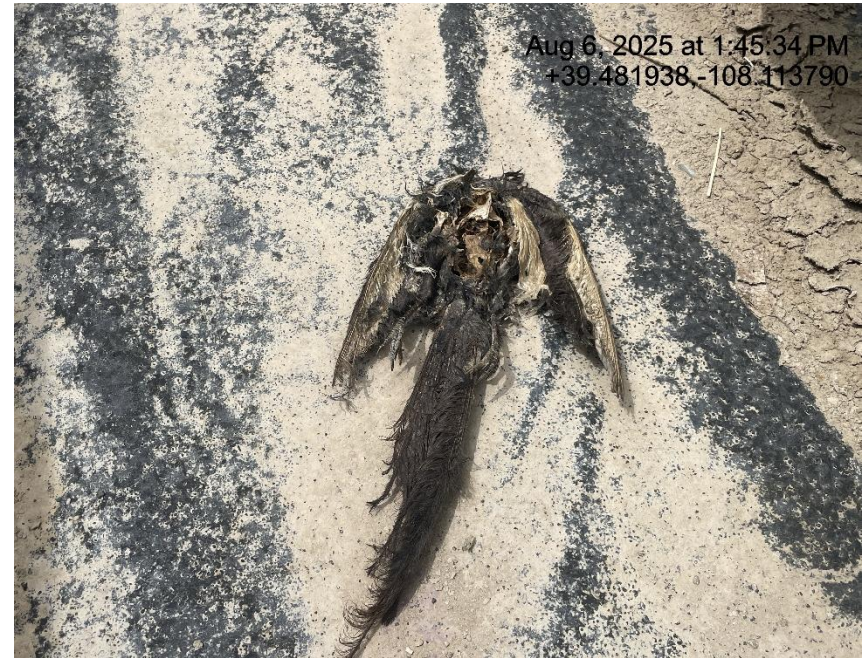
Photo # 8427 Dead bird in secondary containment
