## Inspection/Audit Photos

Location: UTAH GAS OP LTD DBA UTAH GAS CORP DOUGLAS CREEK UNIT #18 PAD

Location ID: 314972

Date: 08/1/2025

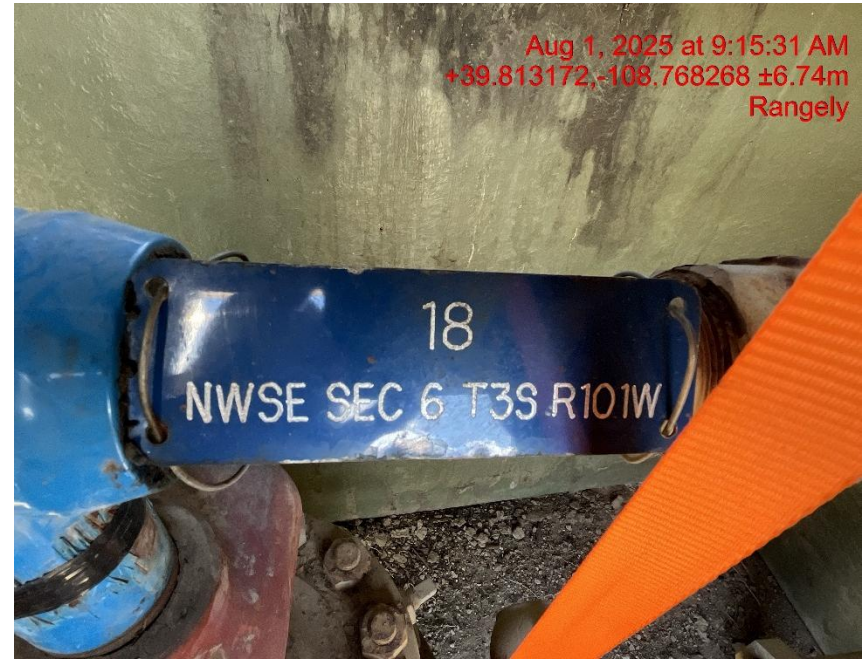
Photo # 1092 Wellhead sign lacks required information

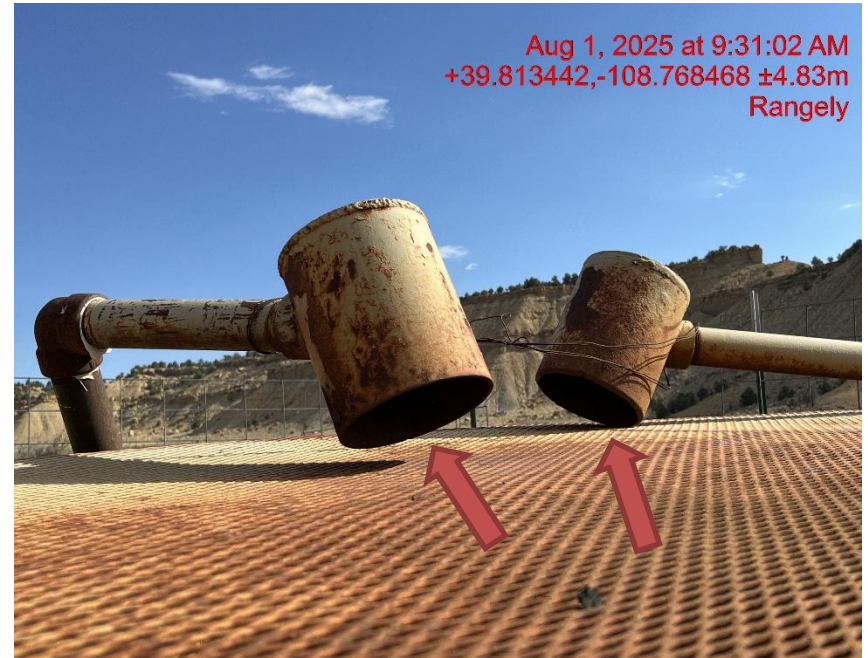
Photo # 1110 Open ended piping/wildlife hazard/available for entry by wildlife

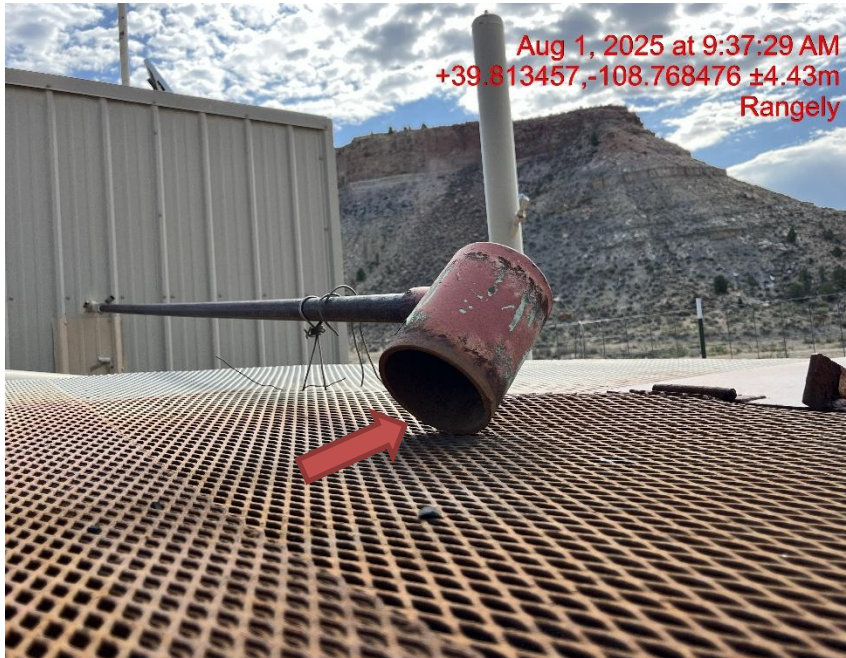
**Photo # 1118 Open ended piping/wildlife hazard/available for entry by wildlife**

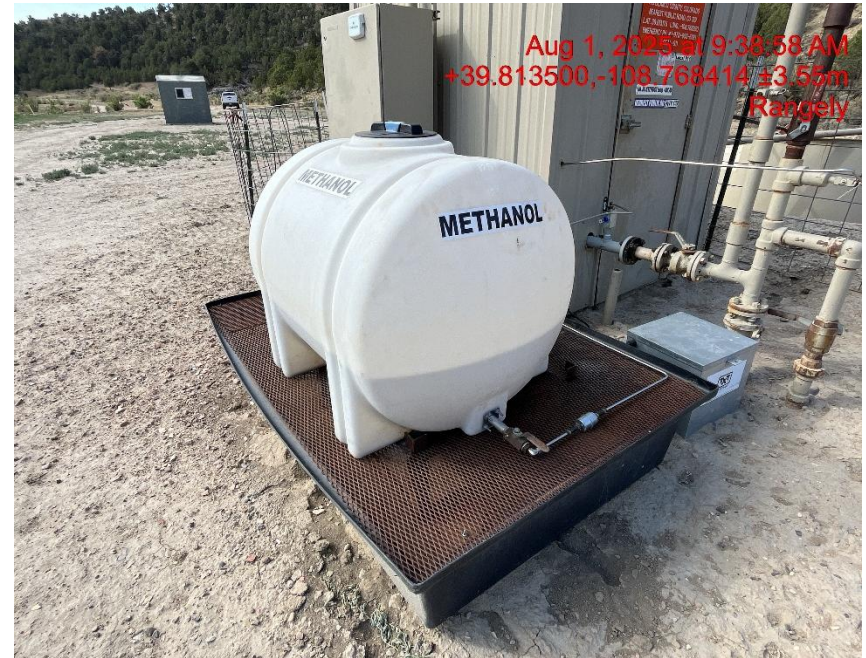
**Photo # 1119 Chemical tank lacks required labeling**

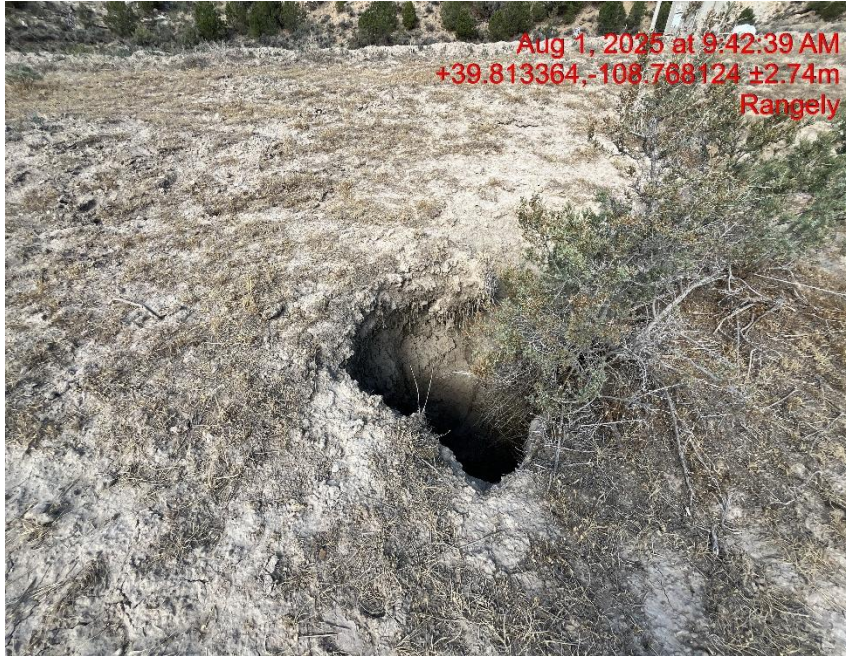
**Photo # 1122 Tunnel erosion on location, additionally is a wildlife hazard/personnel safety hazard**

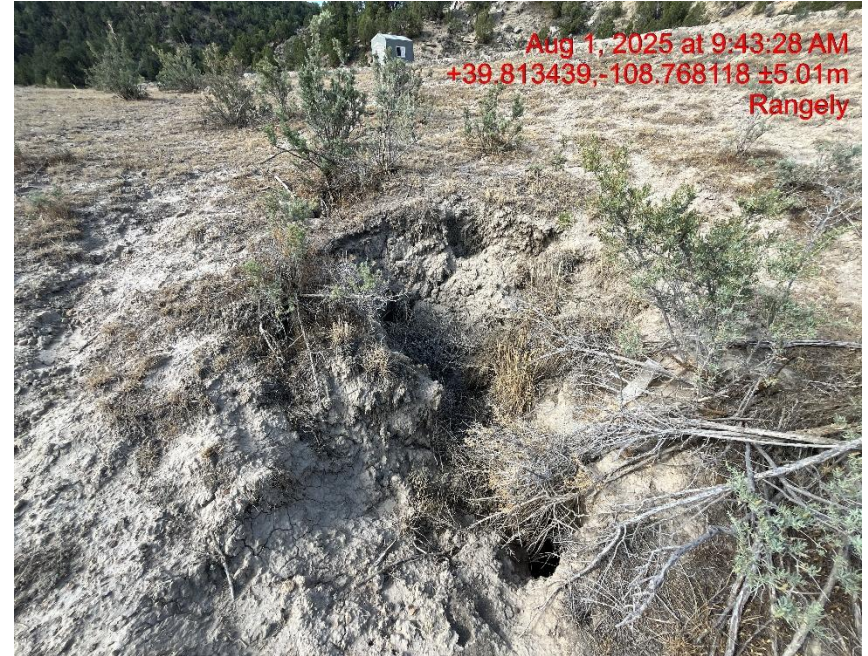
**Photo # 1123 Tunnel erosion on location, additionally is a wildlife hazard/personnel safety hazard**

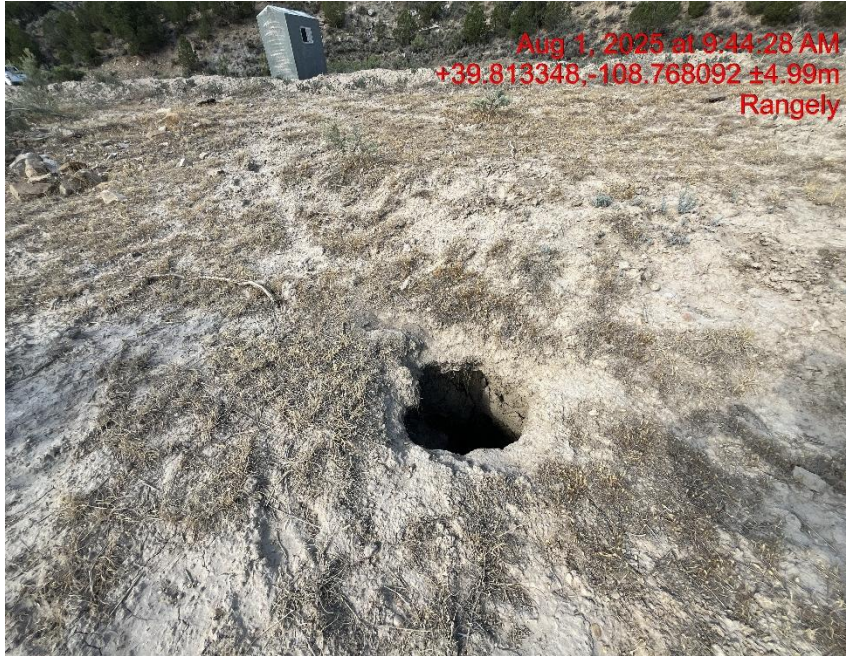
**Photo # 1124 Tunnel erosion on location, additionally is a wildlife hazard/personnel safety hazard**

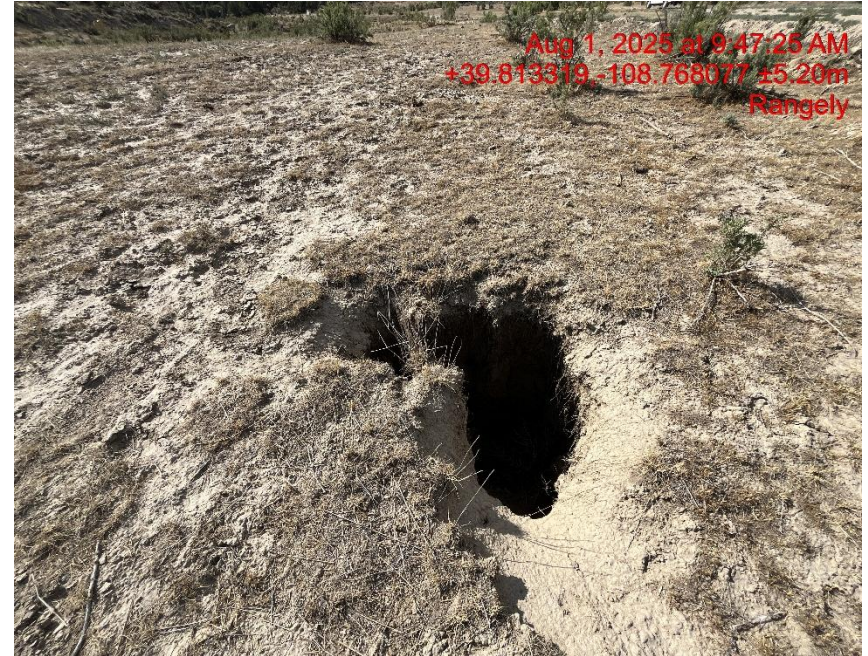
**Photo # 1125 Tunnel erosion on location, additionally is a wildlife hazard/personnel safety hazard**

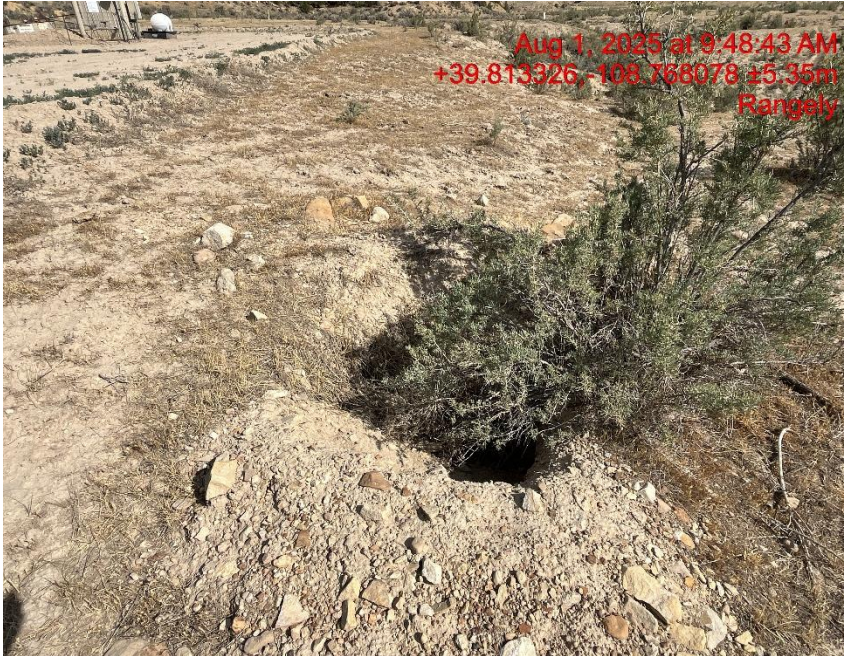
**Photo # 1126 Tunnel erosion on location, additionally is a wildlife hazard/personnel safety hazard**

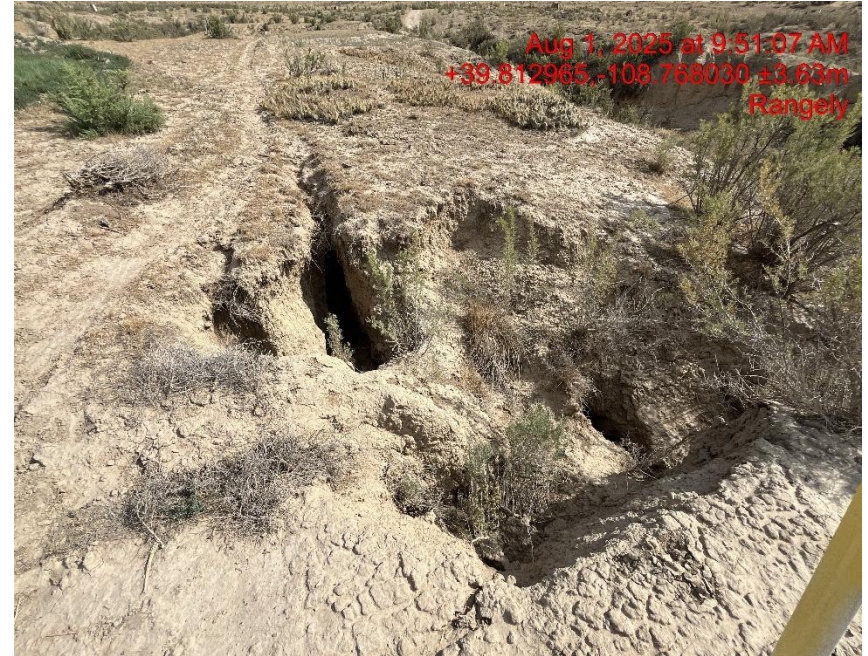
**Photo # 1127 Tunnel erosion on location, additionally is a wildlife hazard/personnel safety hazard**

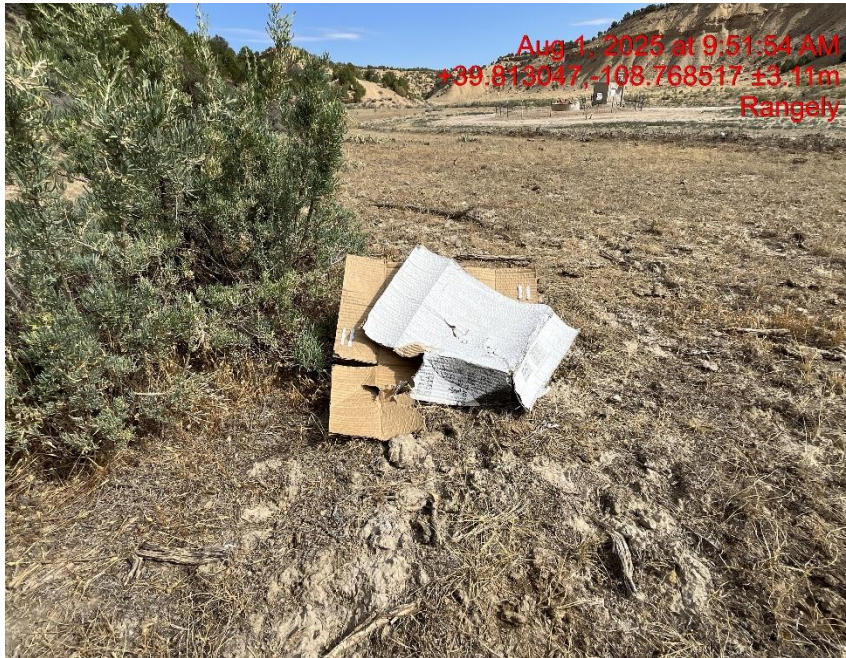
Photo # 1128 Debris on location

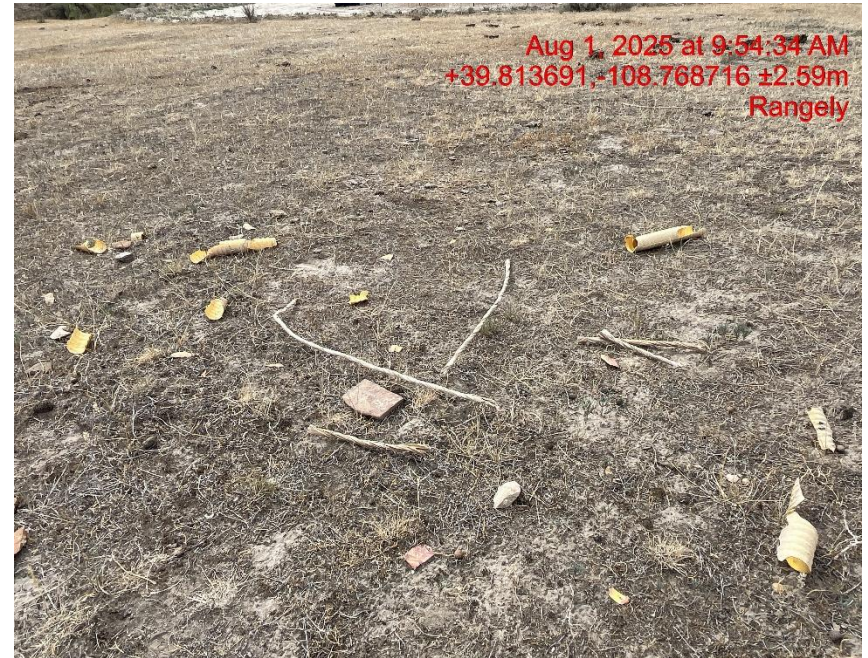
Photo # 1130 Debris on location
