Inspection Photos

Operator: PUCKETT LAND COMPANY - 10341

Location ID: 322527

Inspection Doc: 718100705

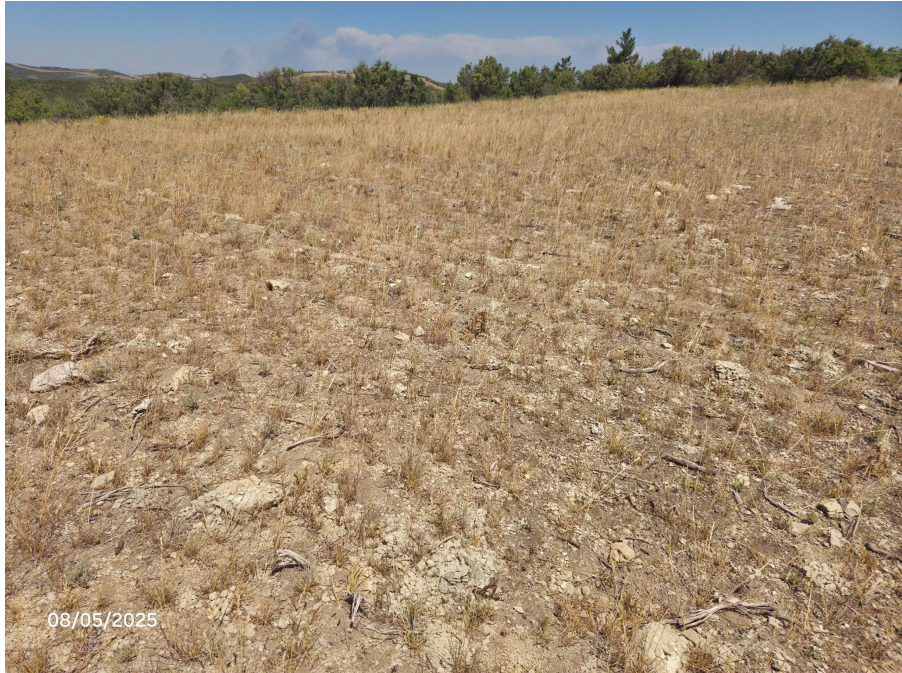
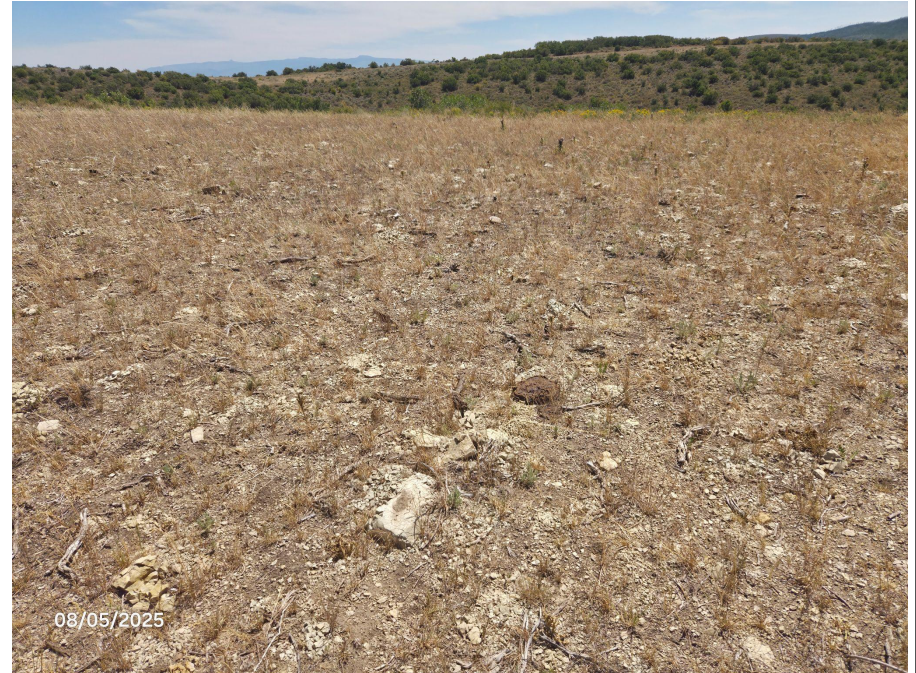
Photo 1: Photos 1-2 taken from the central areas of the Location. Photos provide an overview of the Location from northeast, southeast, southwest to northwest.

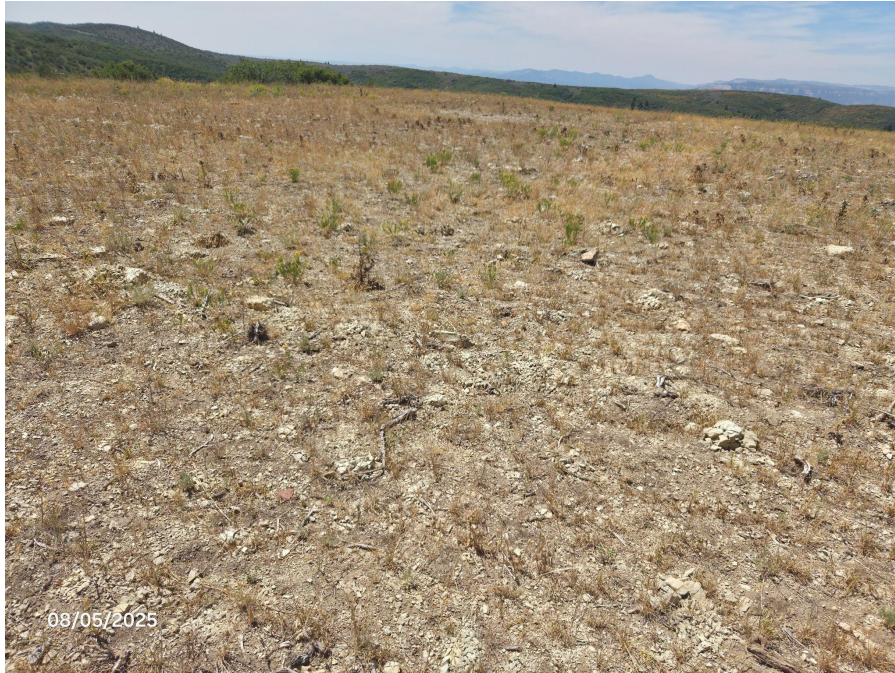
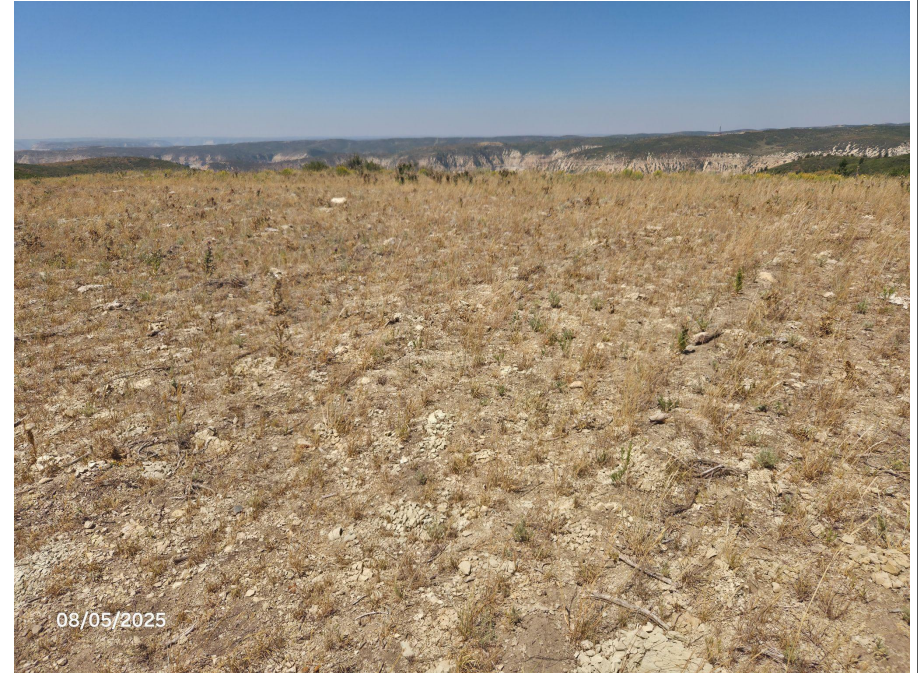
Photo 2: See comments under photo 1.

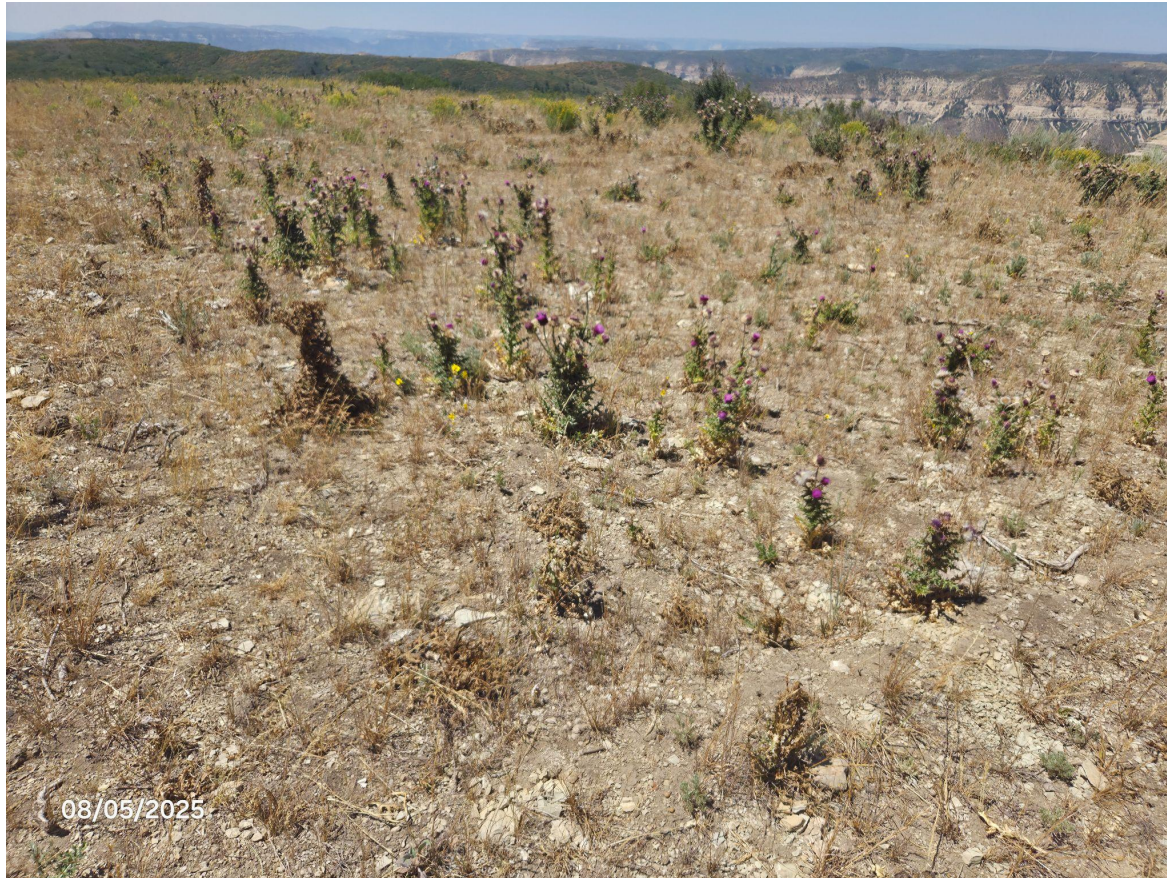
Photo 3: Photo taken from the north end of the Location, facing northwest. Photo example showing Noxious weed establishment (Musk thistle) observed throughout the Location. Though previous weed management efforts appear to have been performed, work was insufficient; weeds remain viable throughout the Location, and have reached seed-head maturity. Additional and ongoing weed management efforts required.

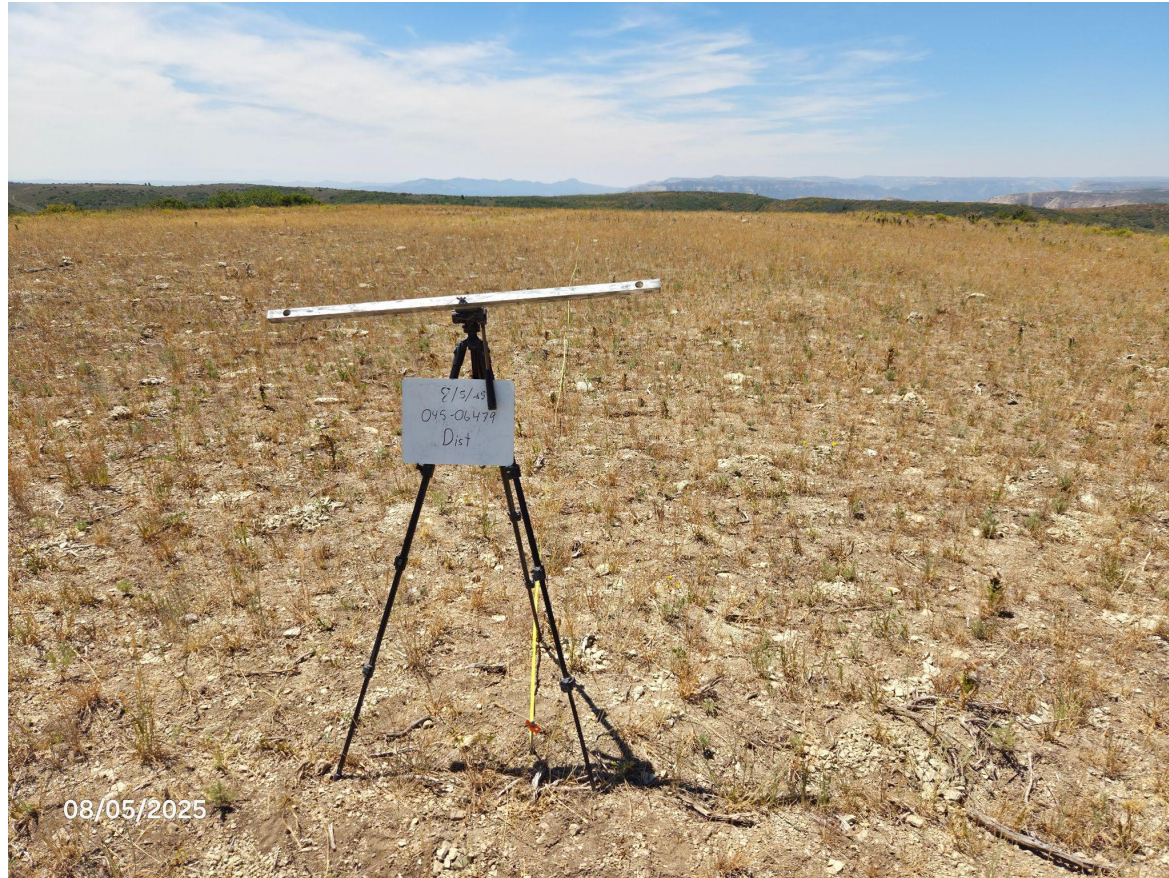
Photo 4: Photo taken from the eastern areas of the Location, facing southwest. Photo shows the starting point for the “Disturbance area” (Location) transect.

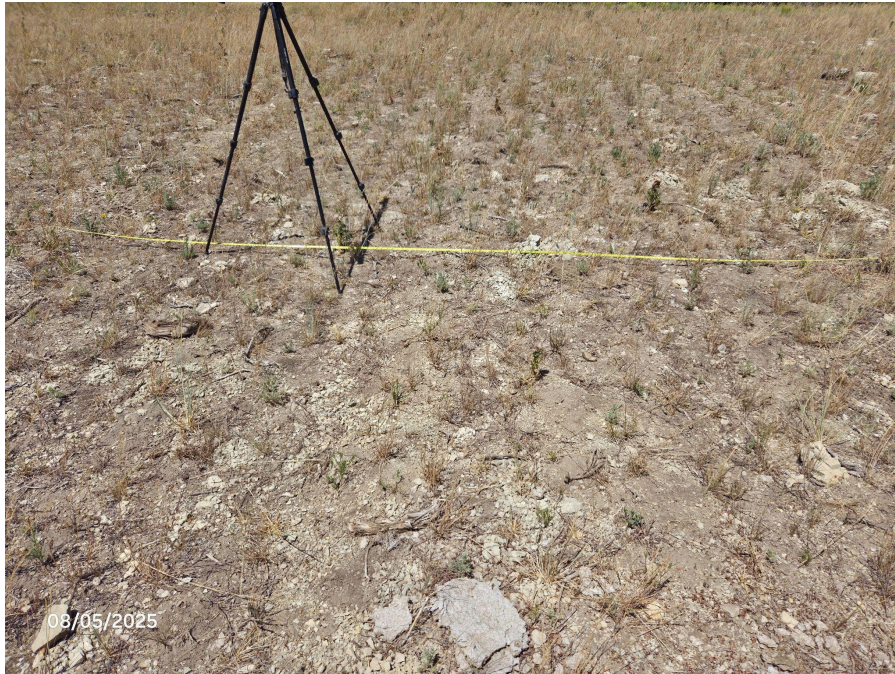
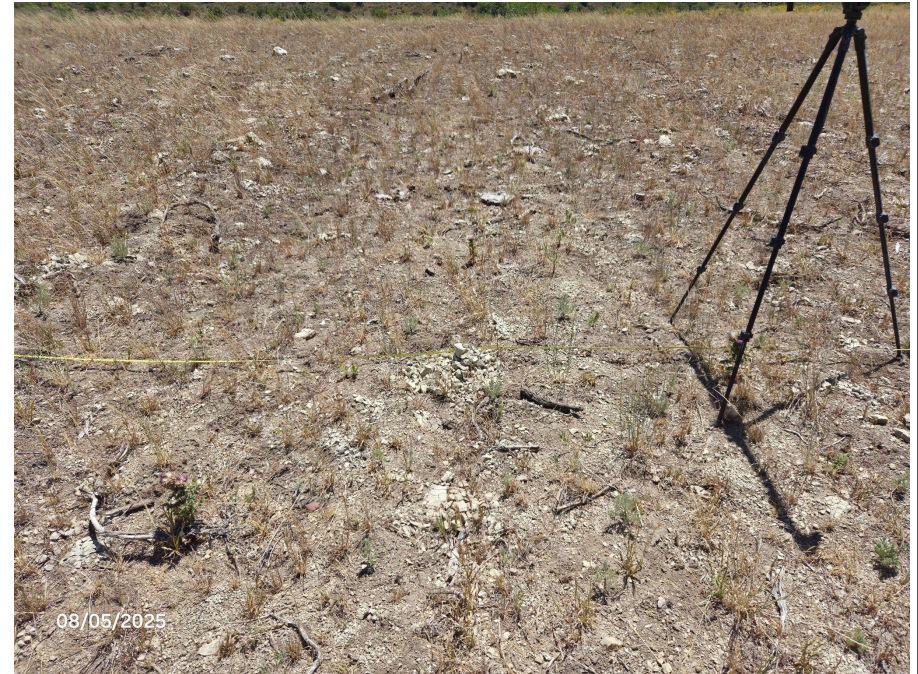
Photo 5: Photo taken from the 50th point of the Disturbance Area transect; facing north and south respectively.

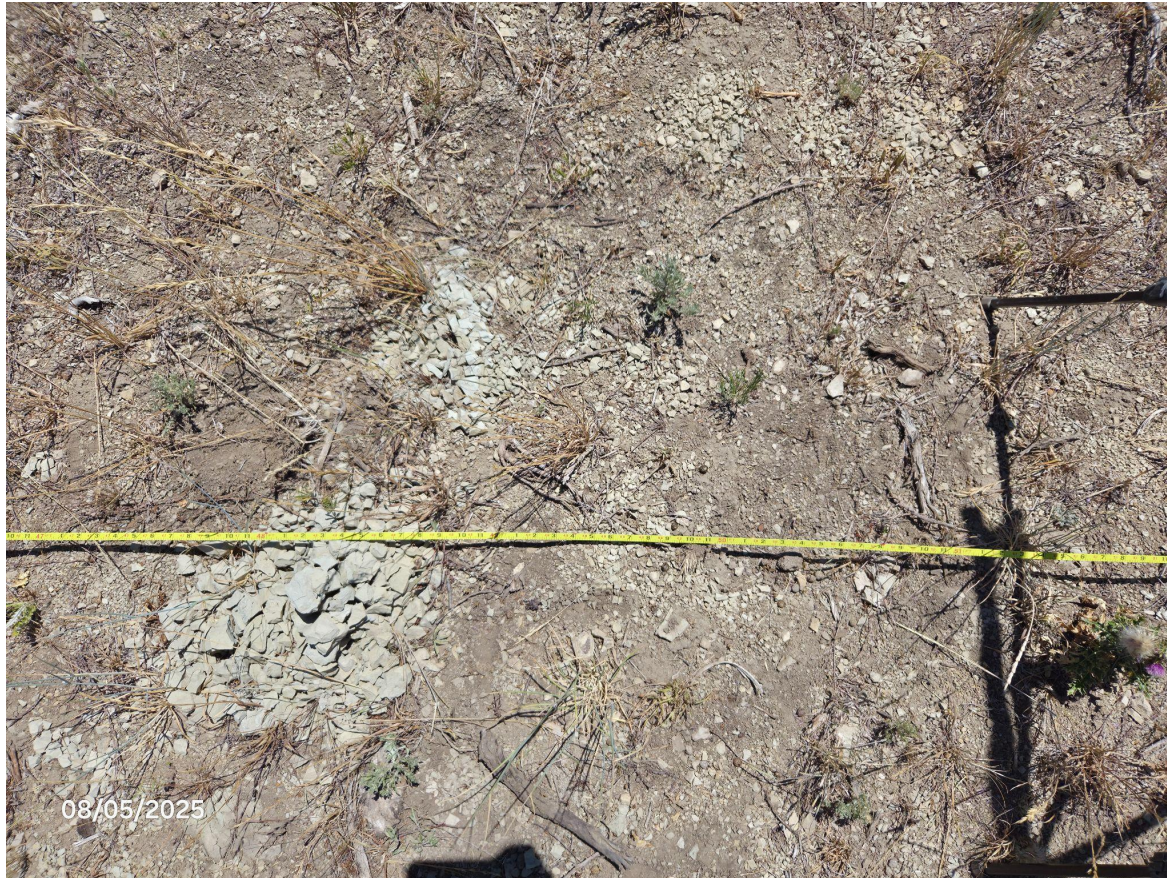
Photo 6: Photo taken from the 50th point of the Disturbance Area transect. Photo shows surface of the Location, including soils and vegetation.

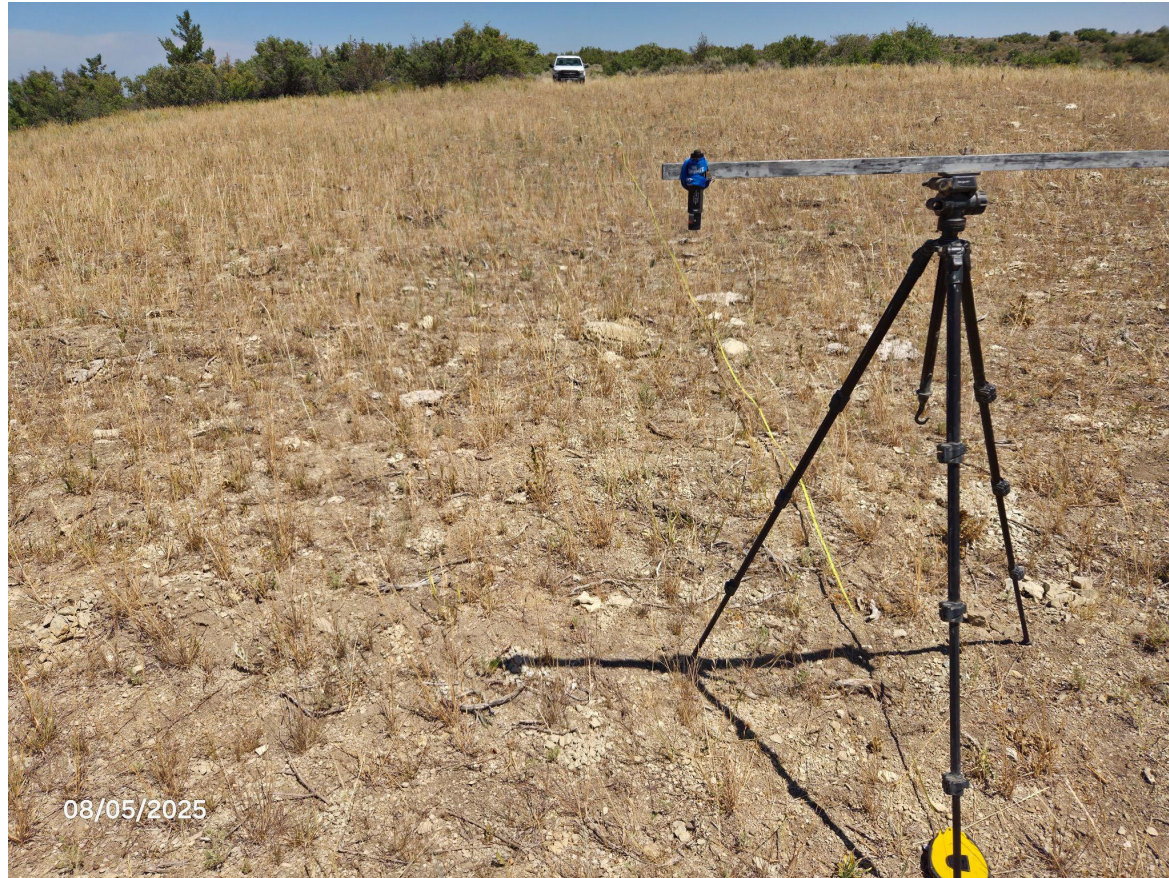
Photo 7: Photo taken from the western areas of the Location, facing northeast. Photo shows the end point for the Disturbance area transect.

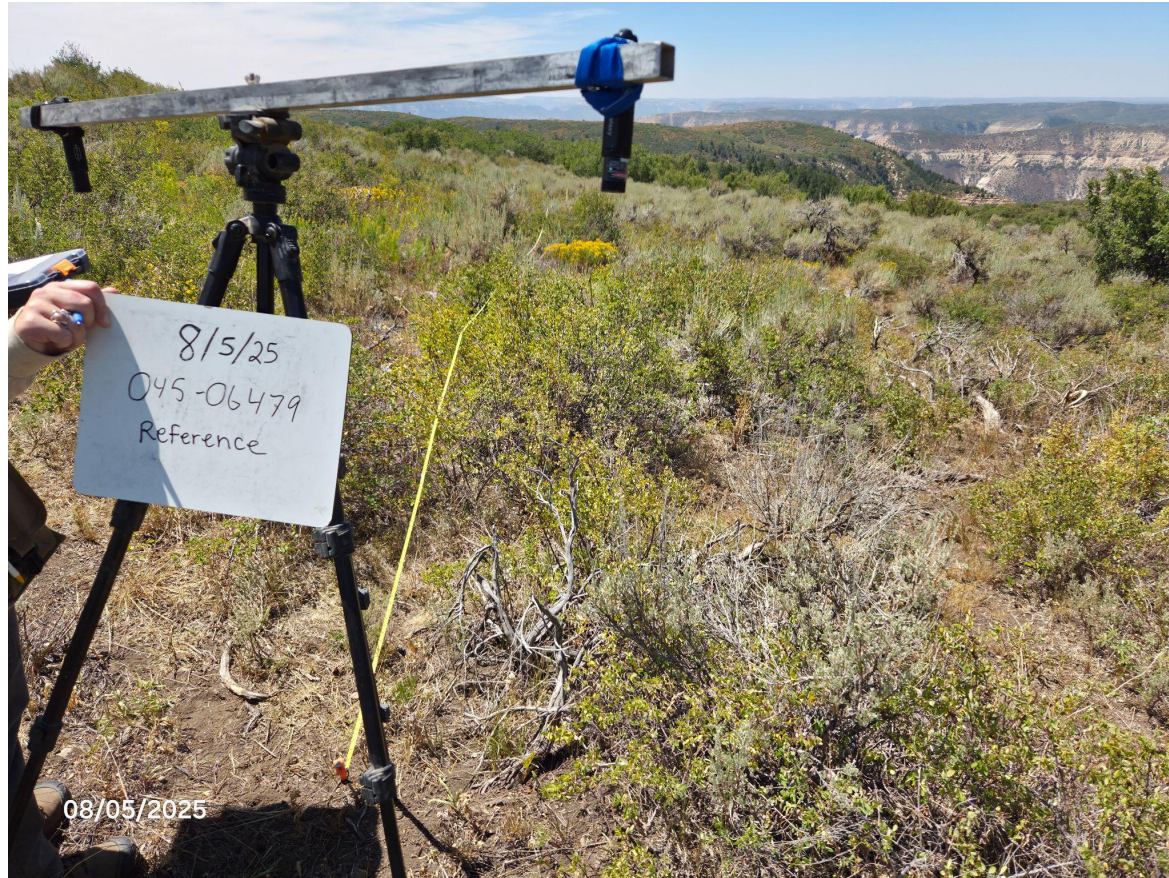
Photo 8: Photo taken from the adjacent reference area, facing west. Photo shows the starting point for the Reference Area transect.

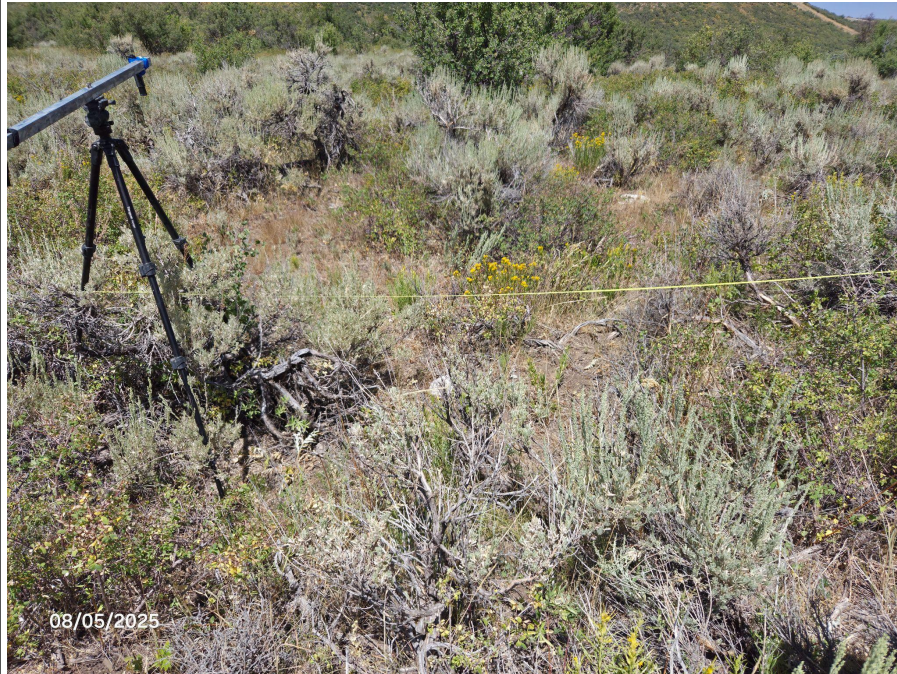
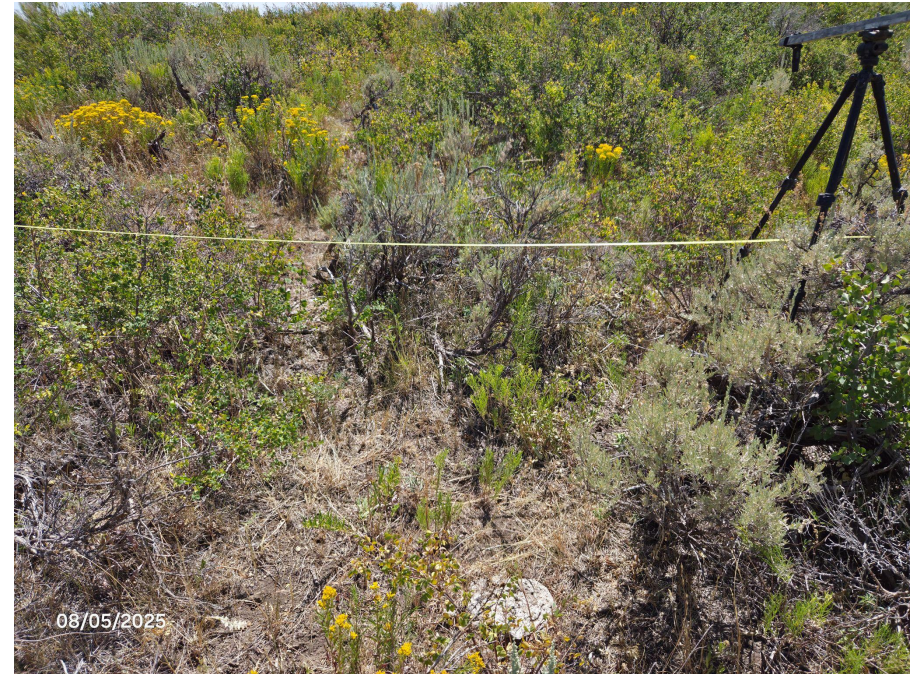
Photo 9: Photo taken from the 50th point of the Reference Area transect; facing north and south respectively.

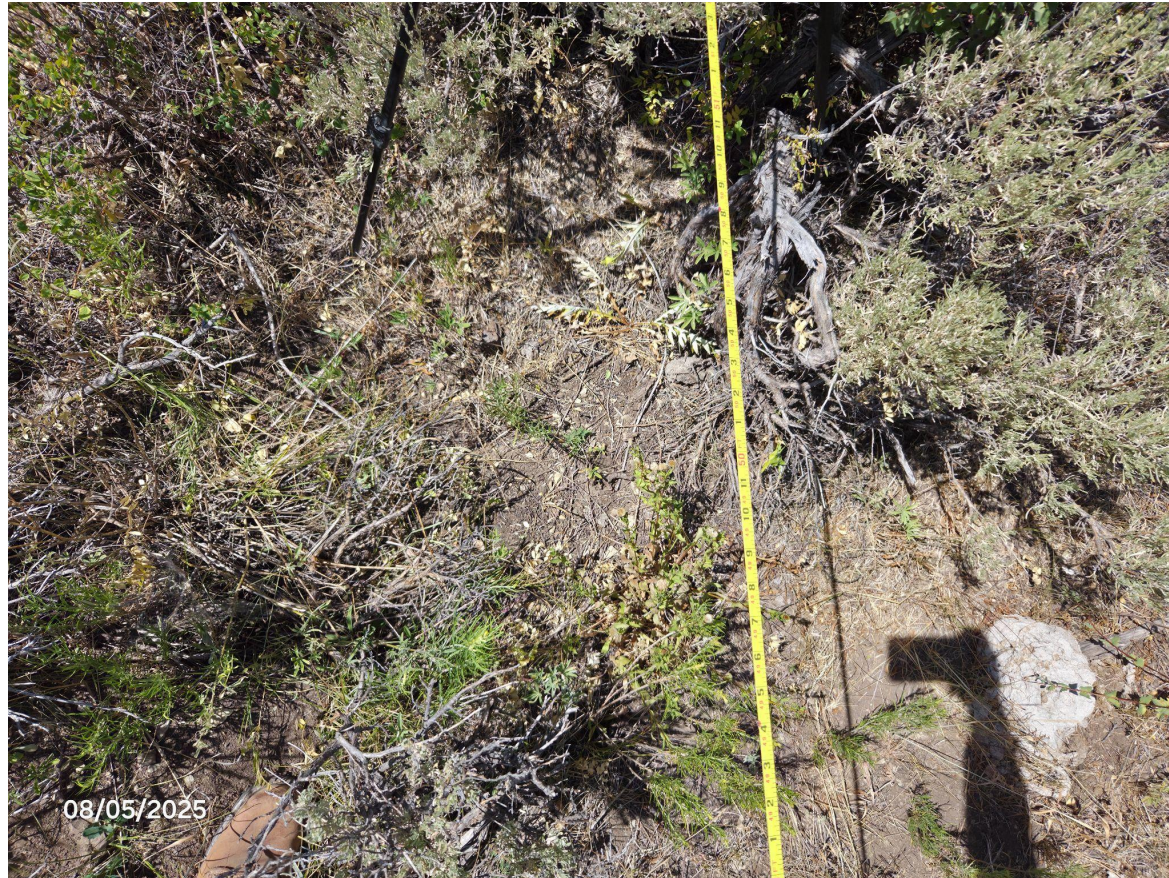
Photo 10: Photo taken from the 50th point of the Reference Area transect. Photo shows surface of the Reference areas, including soils and vegetation.

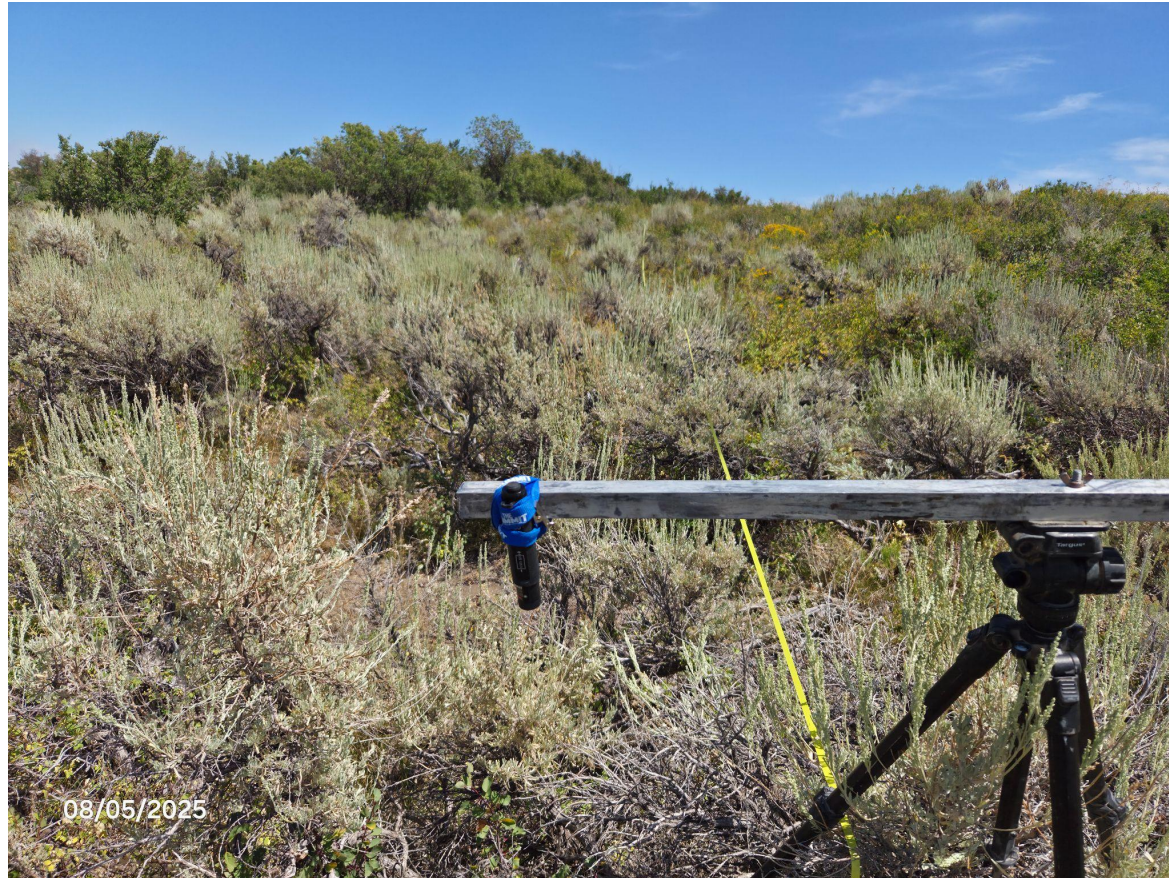
Photo 11: Photo taken from the adjacent reference area, facing east. Photo shows the end point for the Reference Area transect.

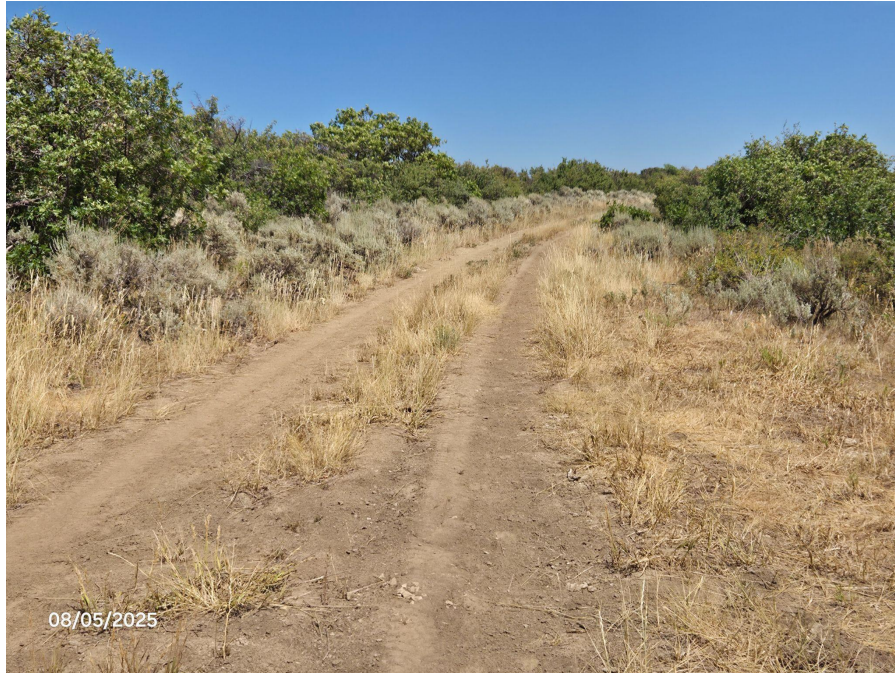
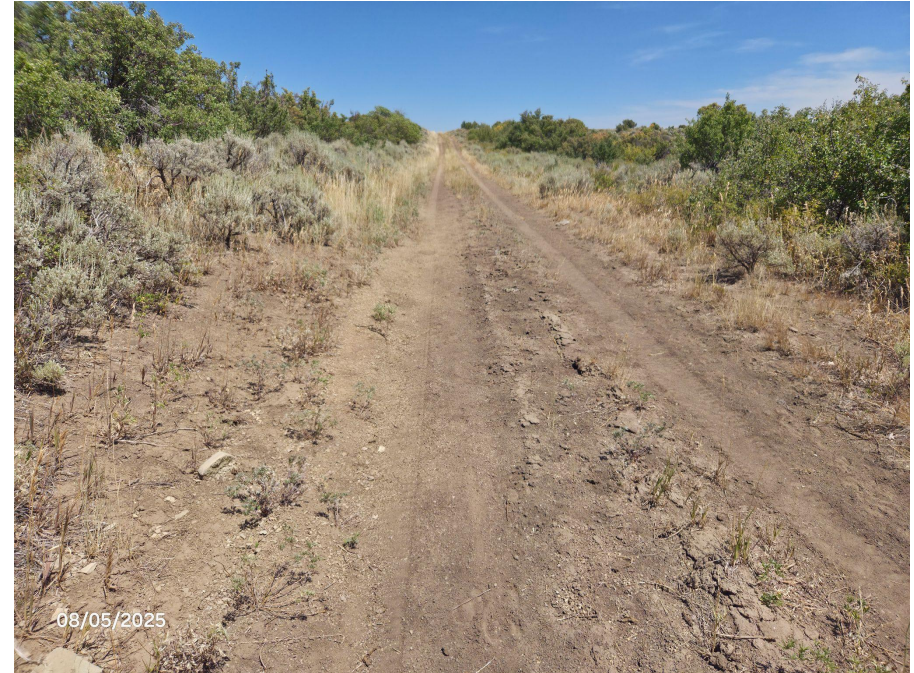
Photo 12: Photos 12-13 taken from the O&G access road leading to the Location. Photos examples showing that the Road has not been reclaimed; access road did not exist prior to the Location, and was constructed for the purpose of accessing an Oil and Gas Location and is therefore subject to 1004 Reclamation Requirements.

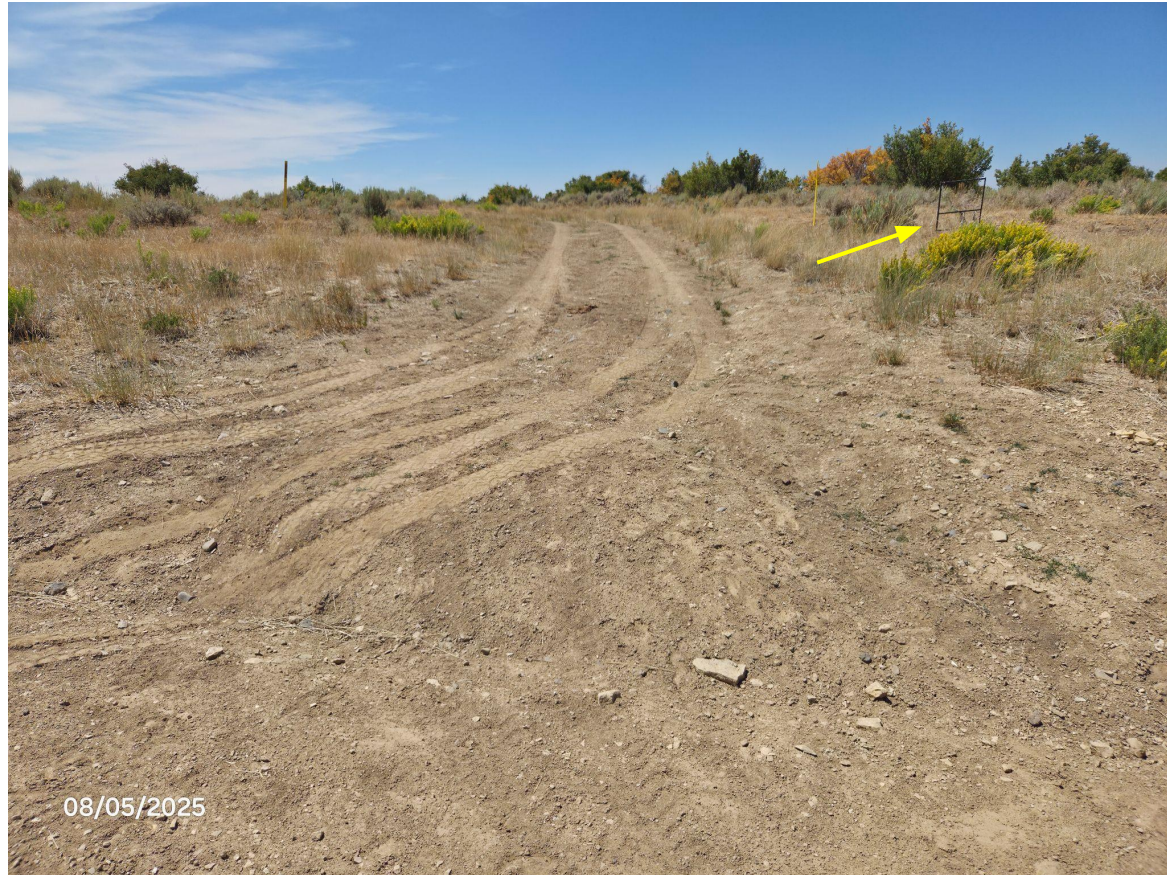
Photo 13: See comments under photo 12. Yellow arrow shows sign frame for the Location remaining at the access road (see photo 14).

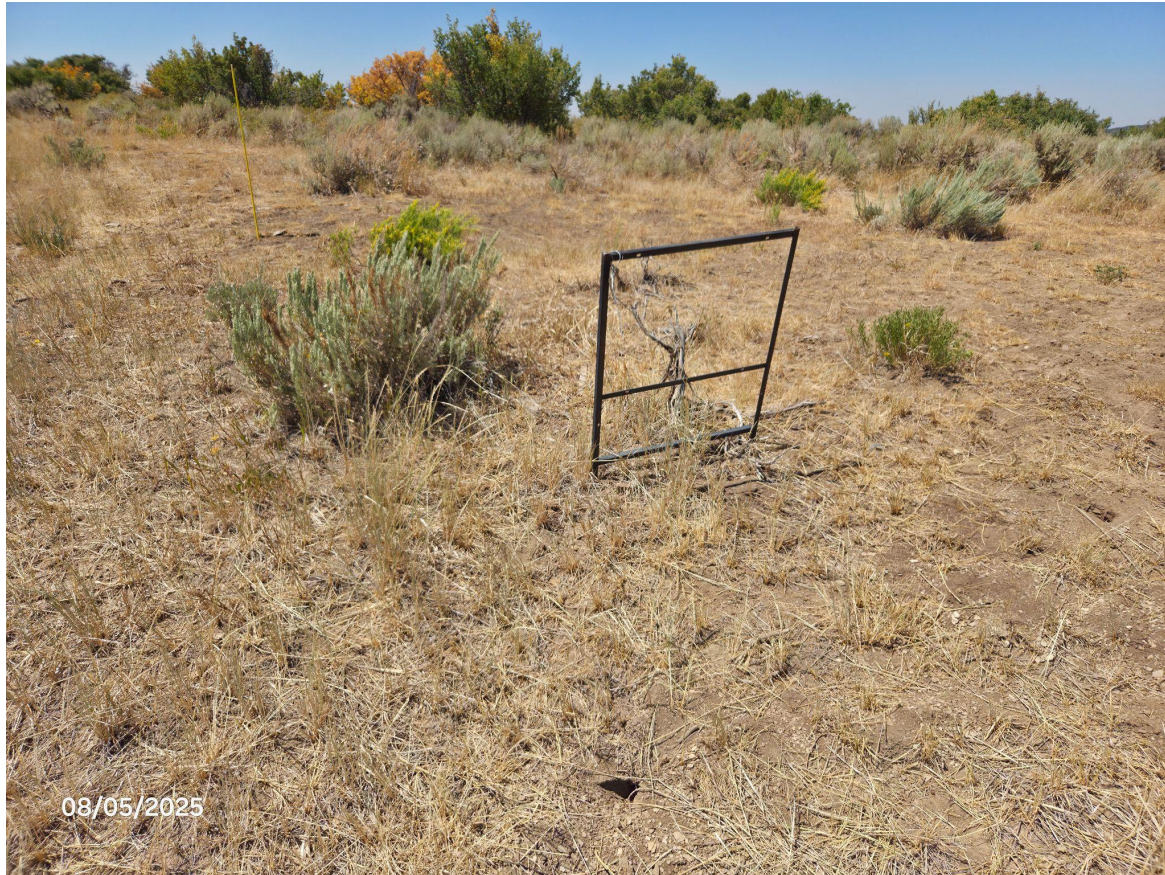
Photo 14: Continued from photo 13. Photo shows sign frame for the Location remaining at the access road
