Inspection Photos

Operator: QB ENERGY OPERATING LLC -
10844

Location ID: 335842

Inspection Doc: 718100714

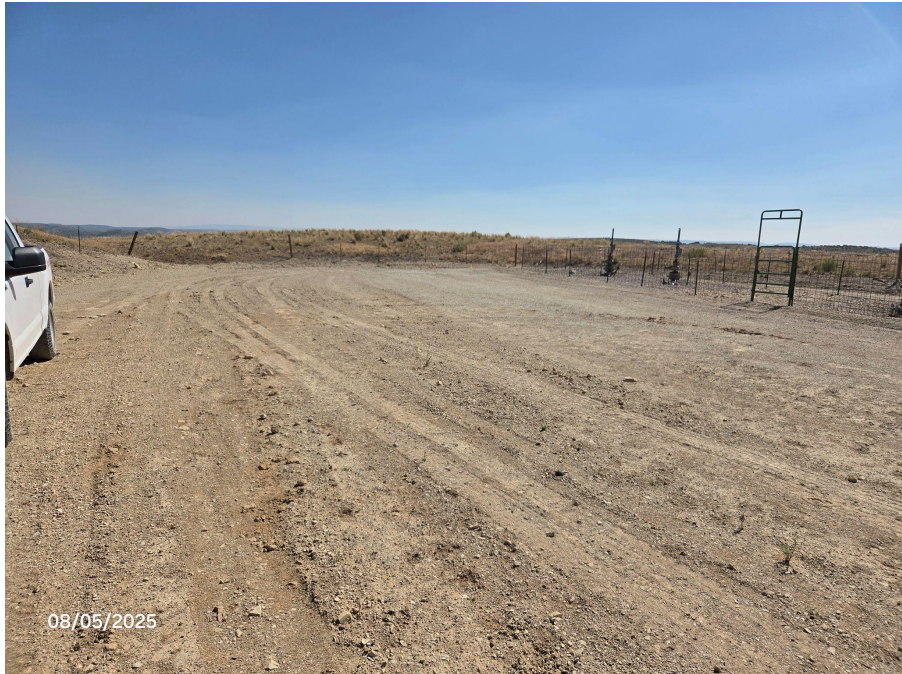
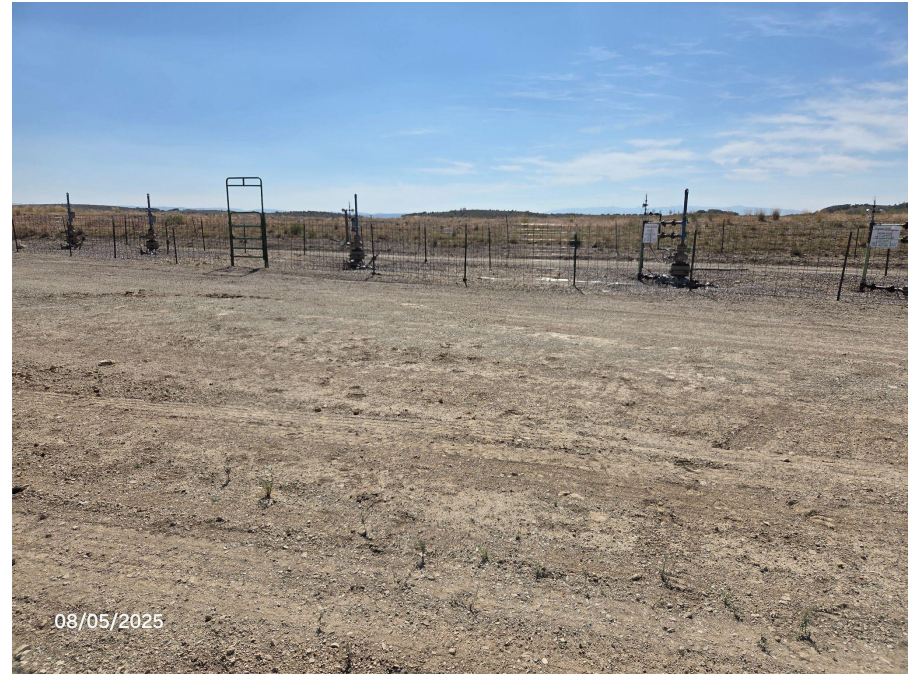
Photo 1: Photos 1-2 taken from the working pad surface on the northwest end of the Location. Photos provide an overview of the Location from northeast, east, south to southwest.

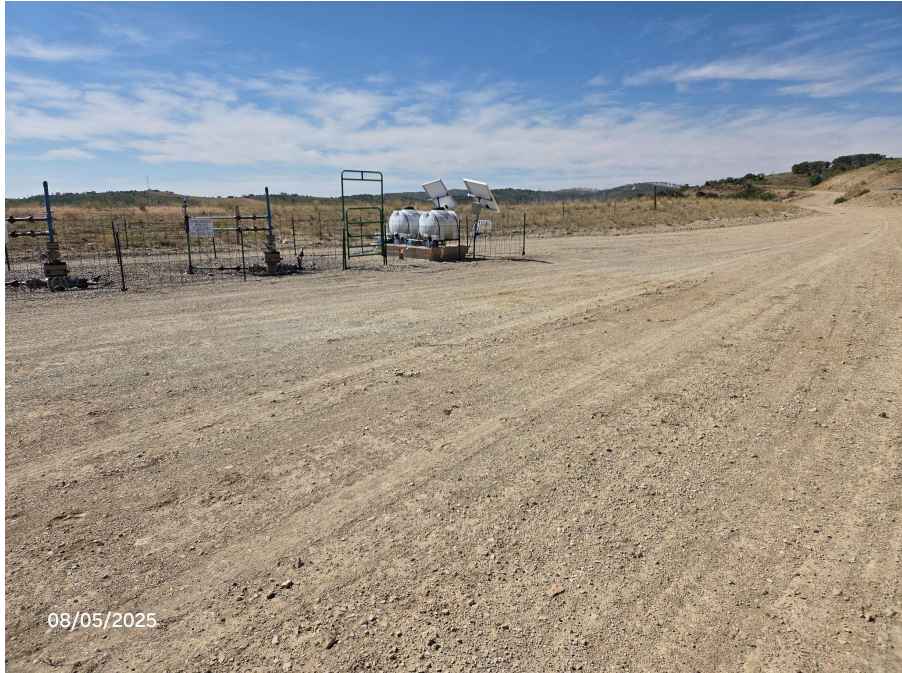
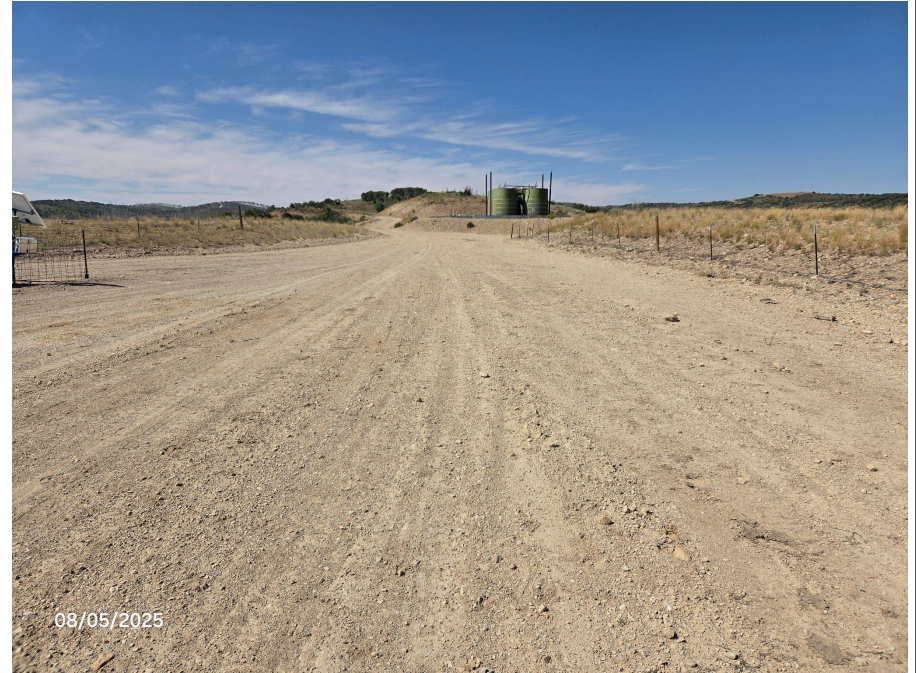
Photo 2: See comments under photo 1.

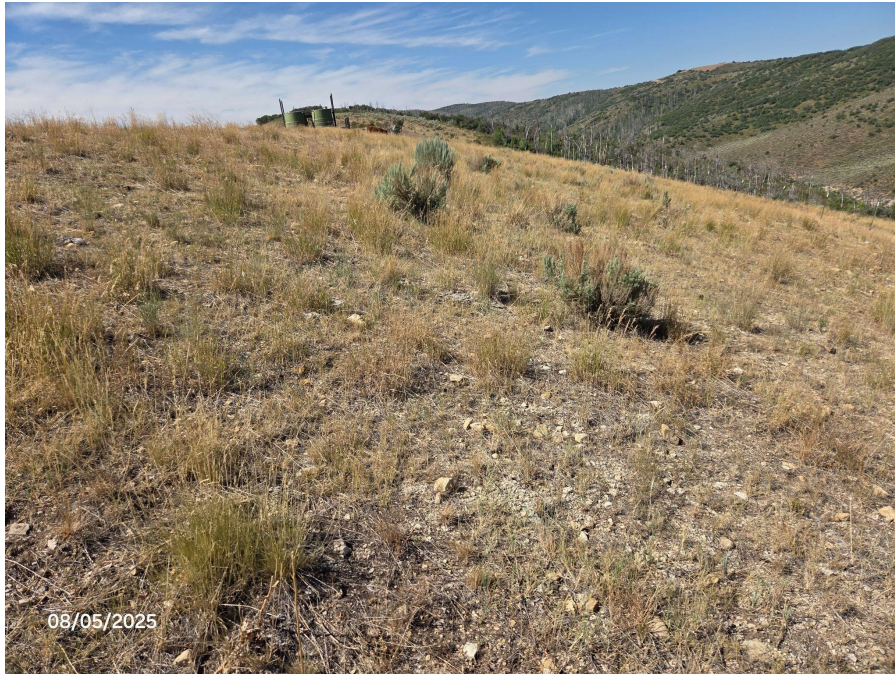
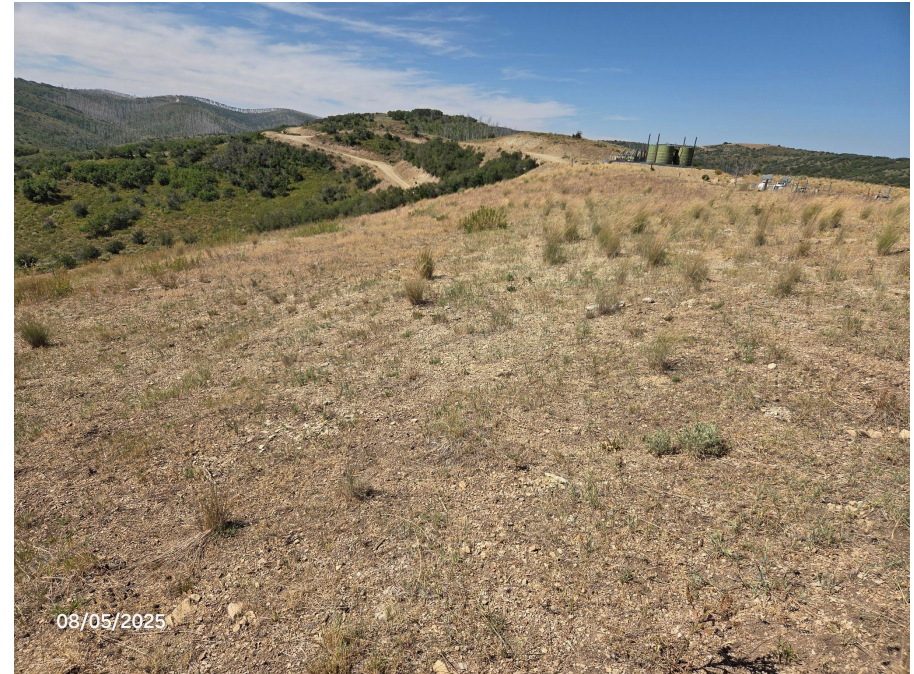
Photo 3: Photo left taken from interim areas on the north end of the Location, facing southwest; photo right taken from the interim areas on the south end of the Location, facing southwest. Photo examples showing interim areas appear to be progressing towards 1003 standards.

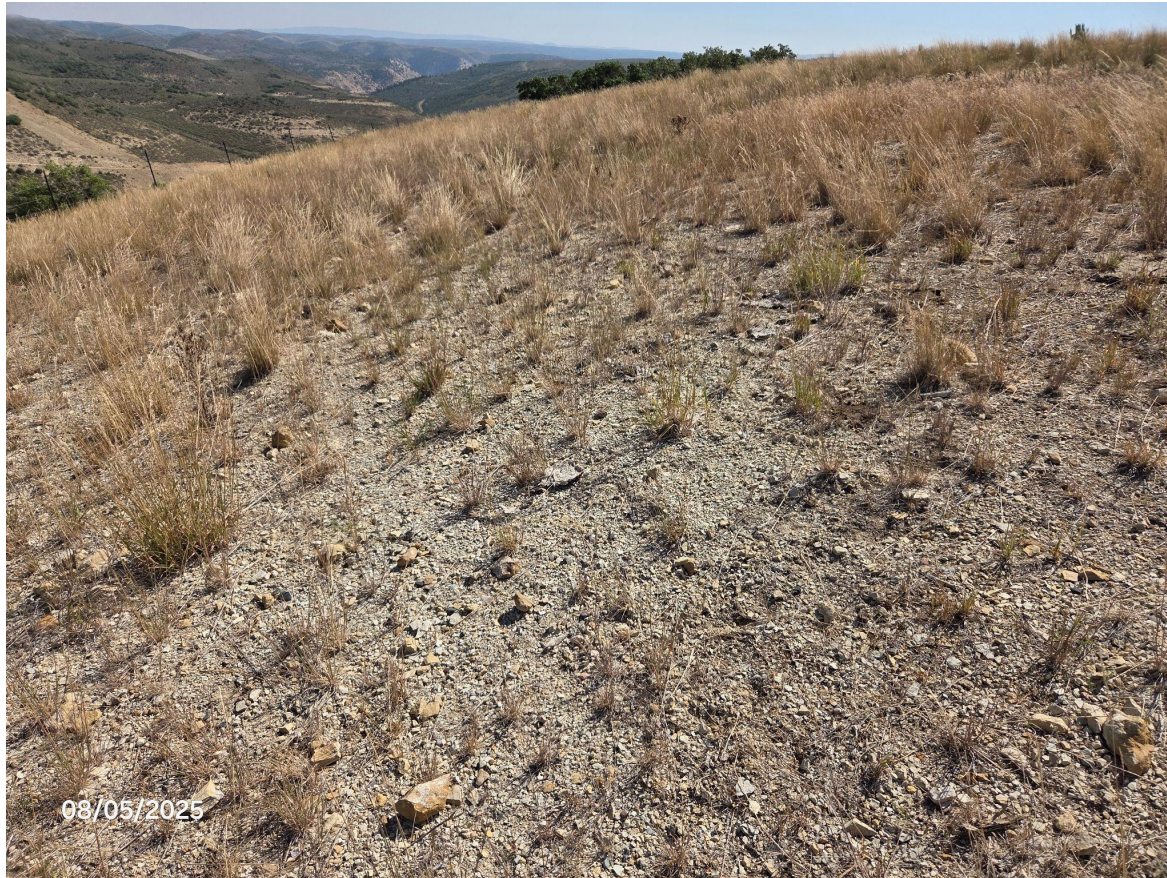
Photo 4: Photo taken from the interim areas on the north end of the Location, facing north. Photo example showing areas where topsoil is scarce, or does not appear to have been replaced.

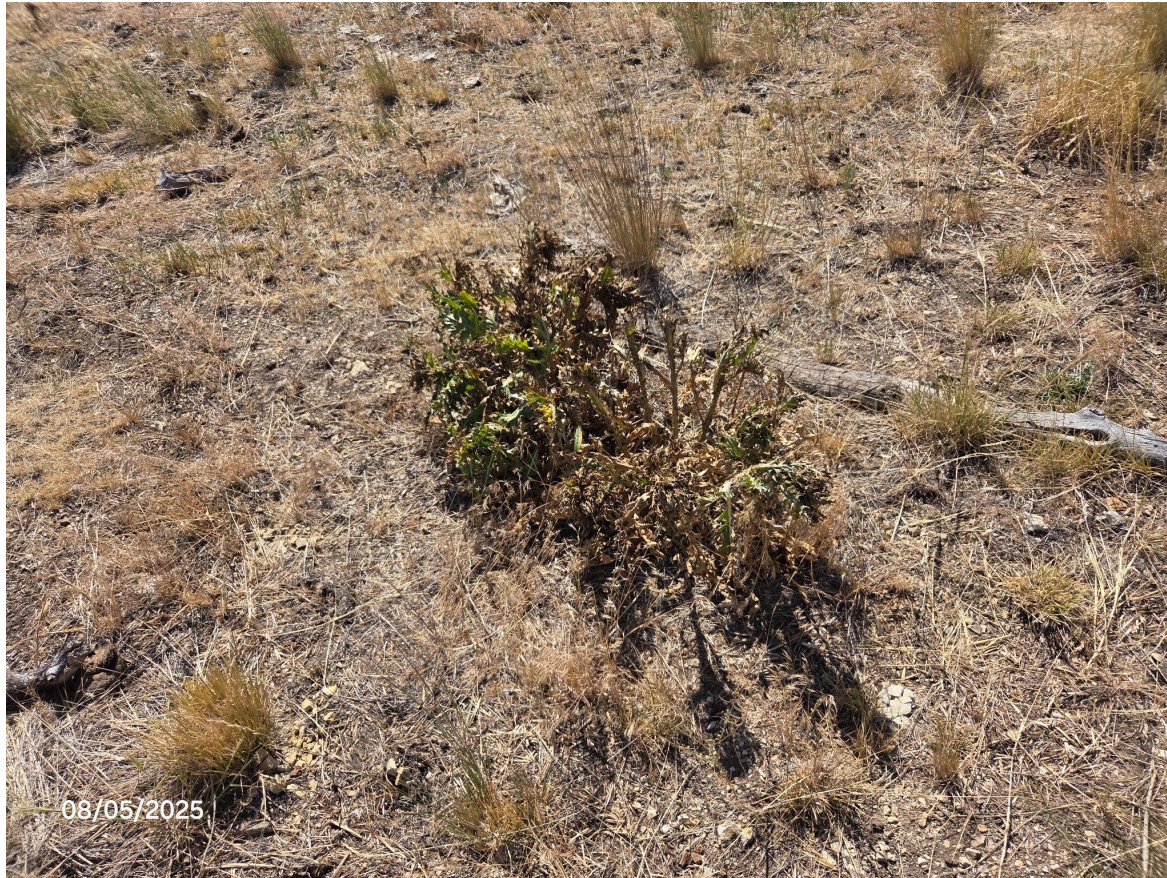
Photo 5: Photo example showing weed management efforts on the Location are evident.

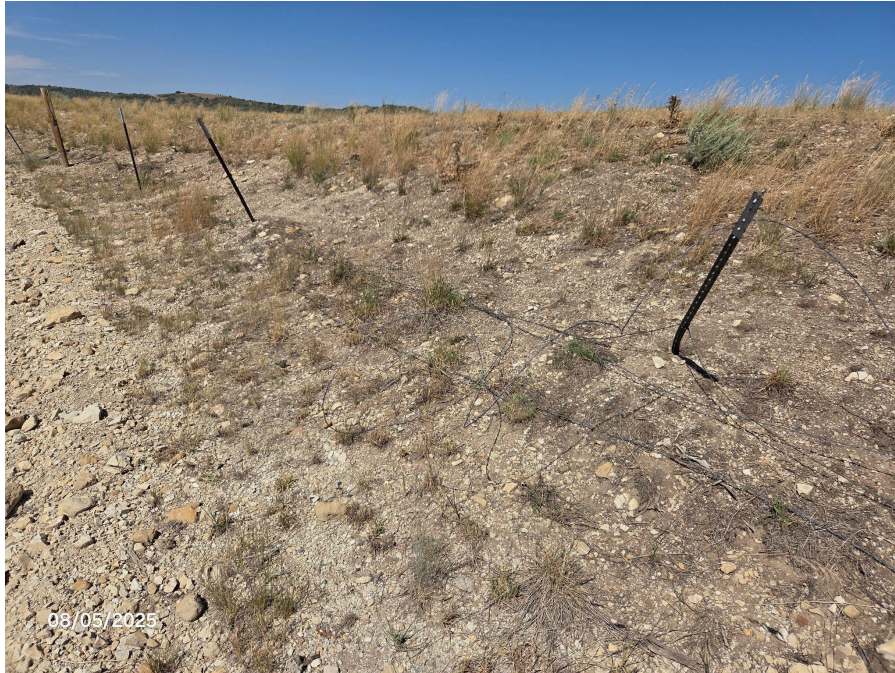
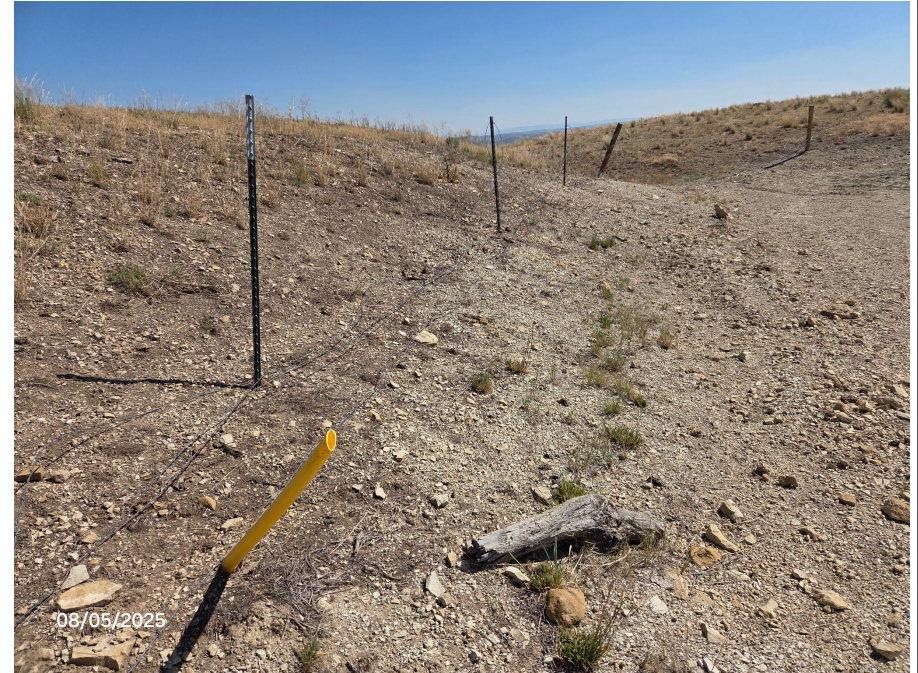
Photo 6: Photos taken from the edge of the working pad surface. Photos examples showing the fence on the Location is in disrepair. Maintenance required.

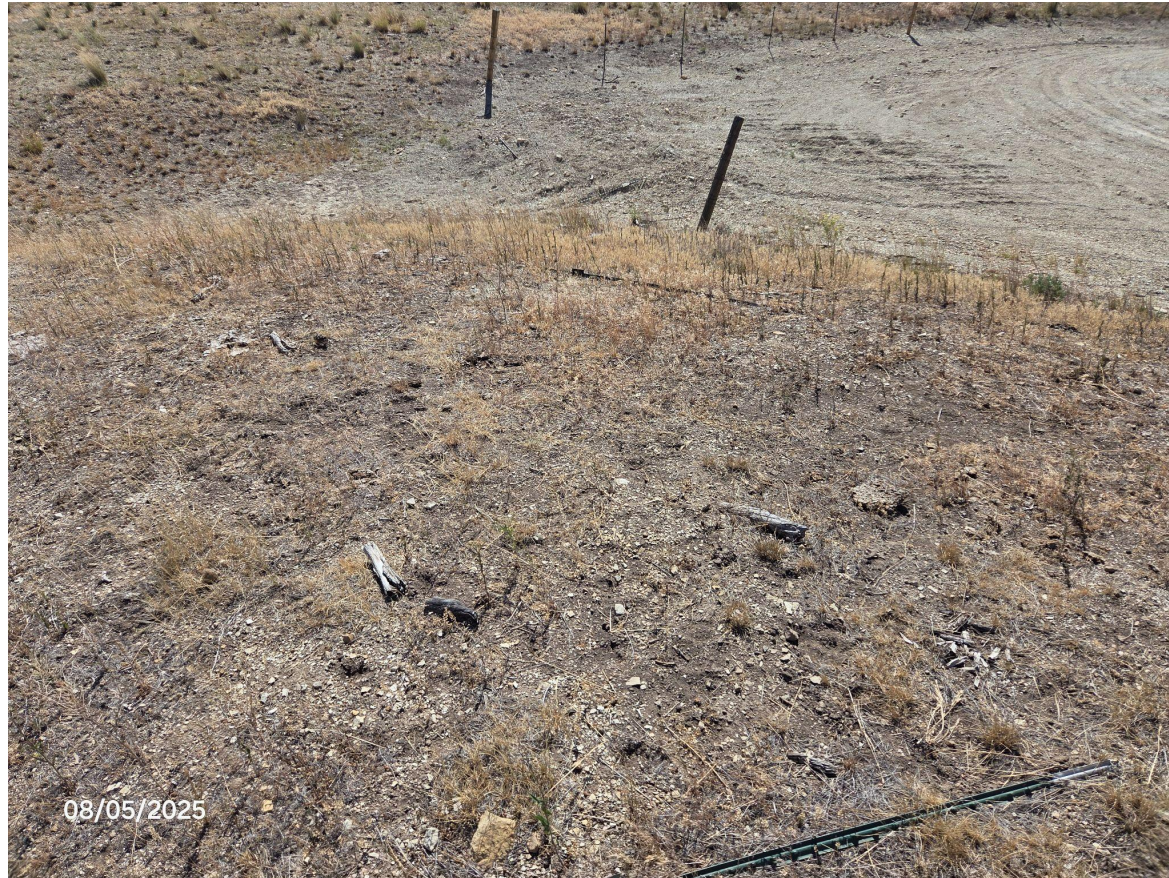
Photo 7: Photo taken from the interim areas on the north end of the Location, facing east. Photo examples showing fencing materials/debris observed within interim areas of the Location.

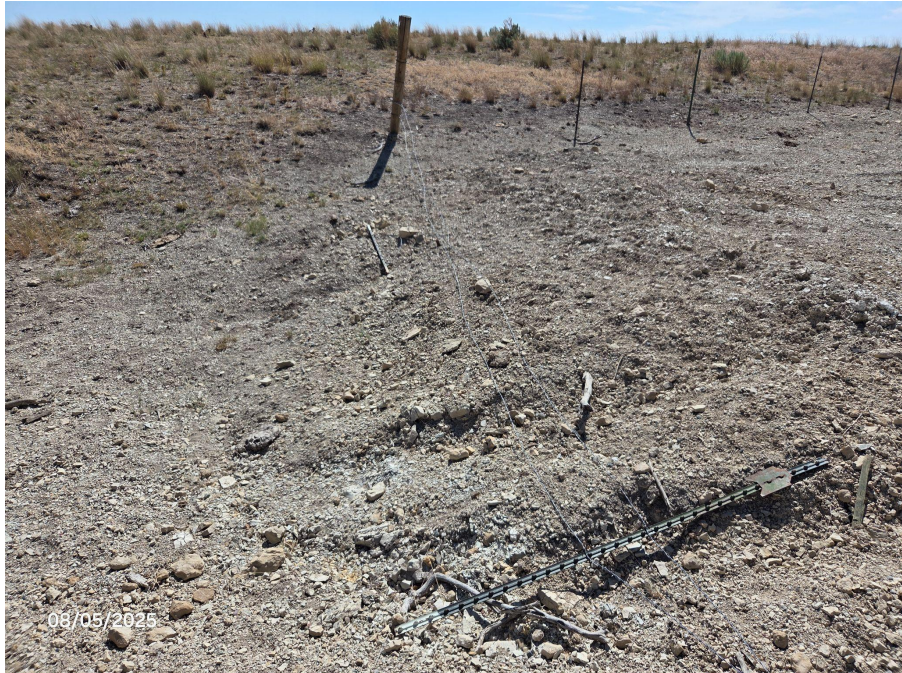
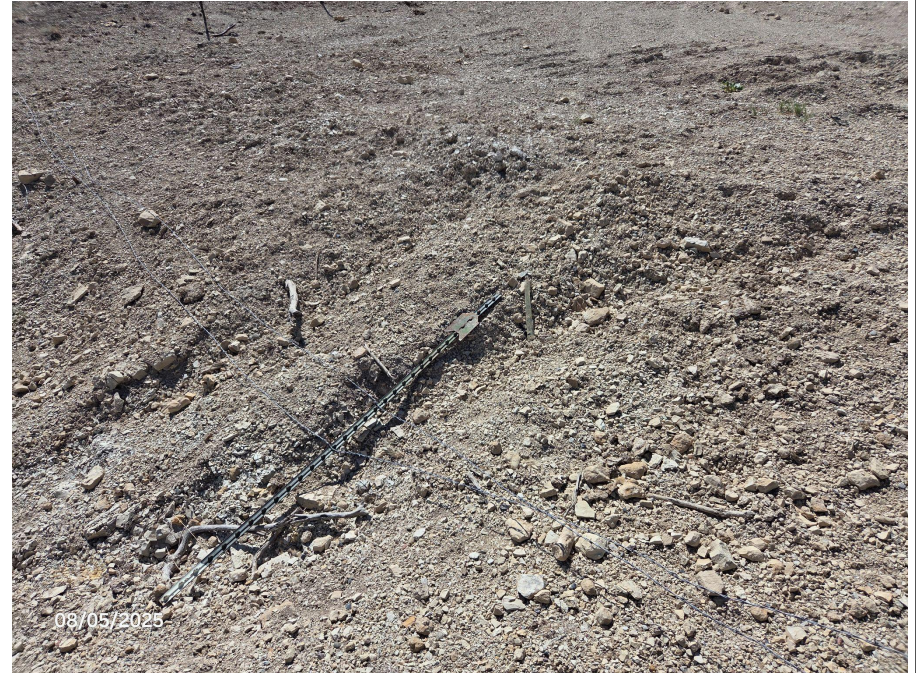
Photo 8: Photo taken from the stormwater outlet on the north end of the working pad surface. Photo example showing the fence on Location in disrepair. Maintenance required. Photo also shows erosion degradation at the BMP is becoming evident. Maintenance advised.

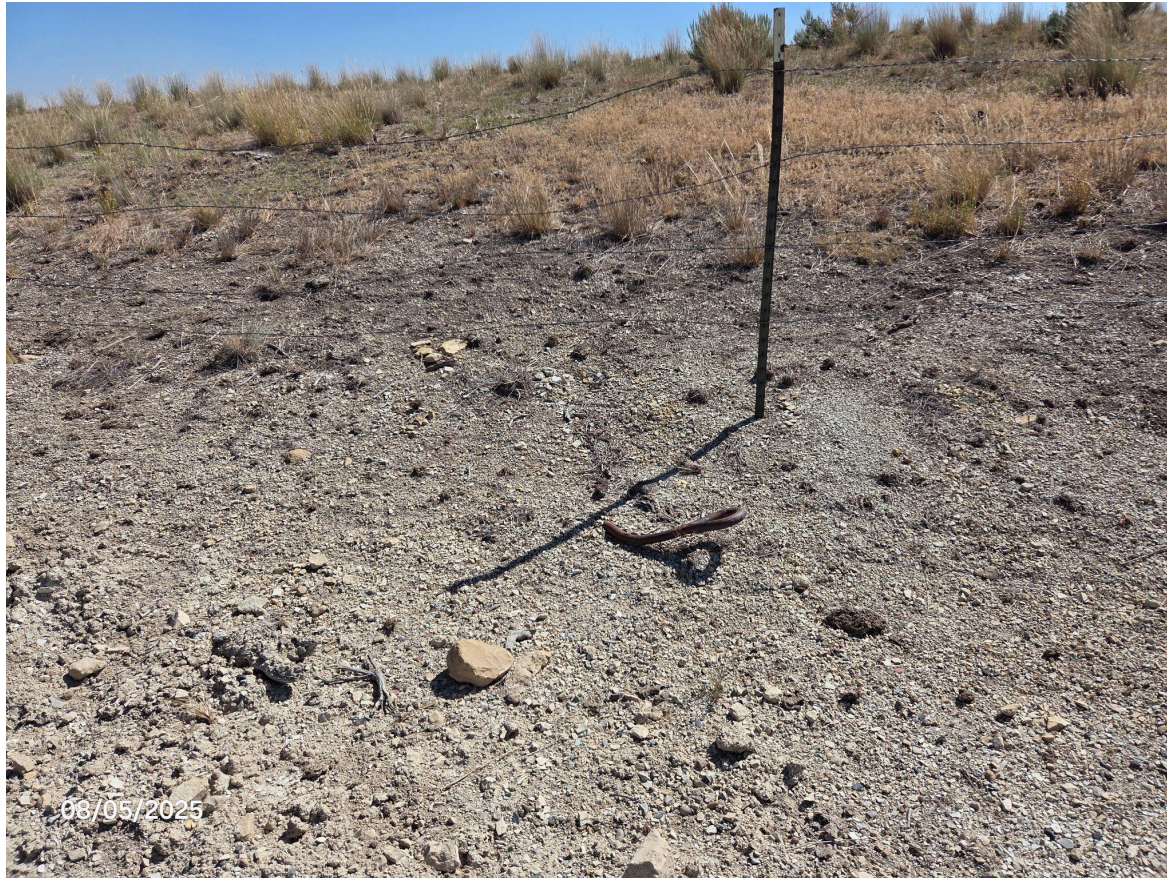
Photo 9: Photo taken from the northeast end of the working pad surface. Photo example showing an anchor missing required marking.

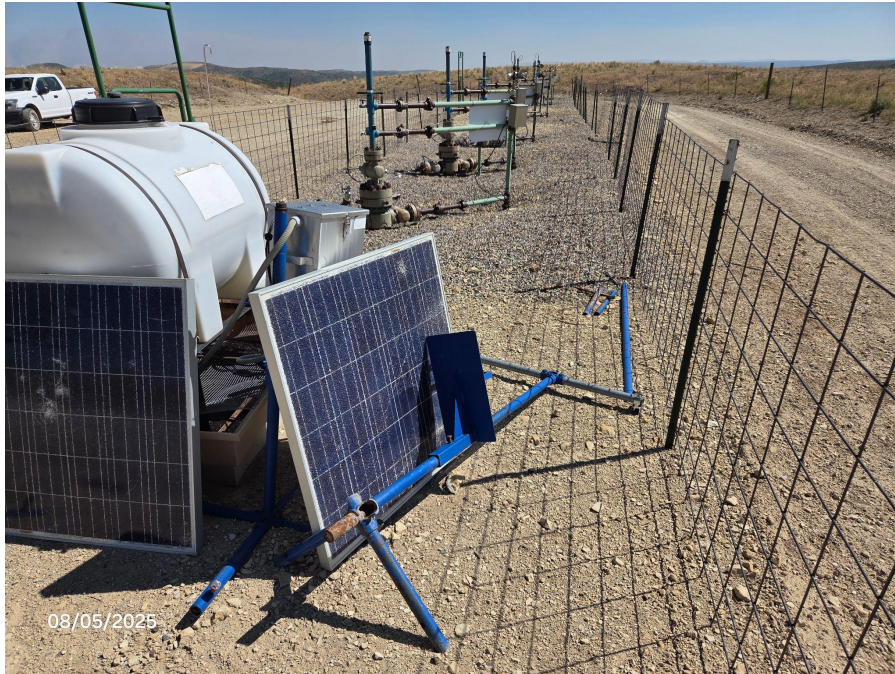
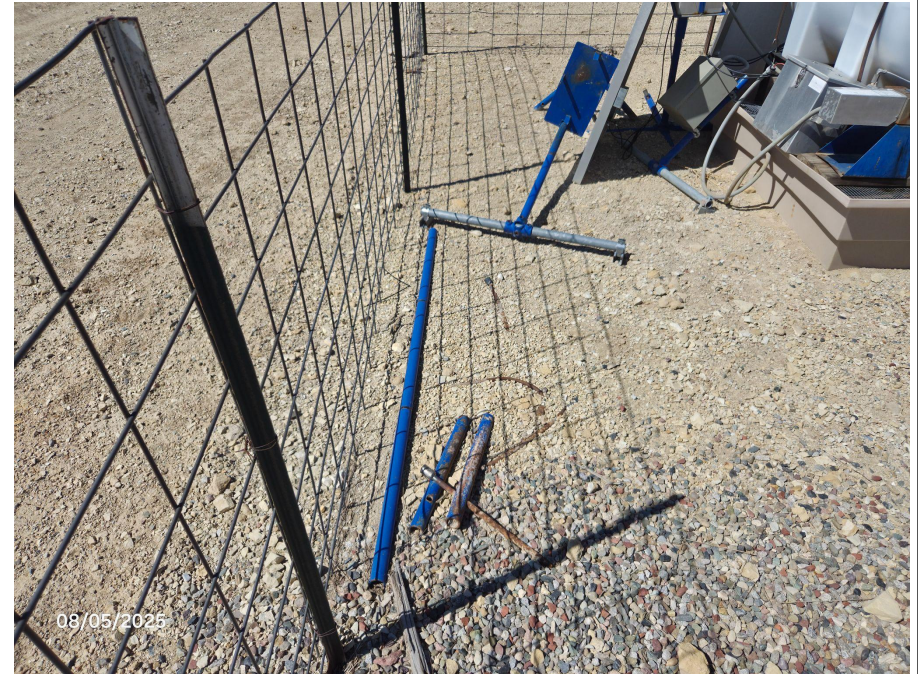
Photo 10: Photo taken from the well string, facing northeast. Photo shows solar panels on the Location. Equipment appears to be damaged. Unclear if equipment is still in use however various parts associated with the equipment is spread around near the wells.

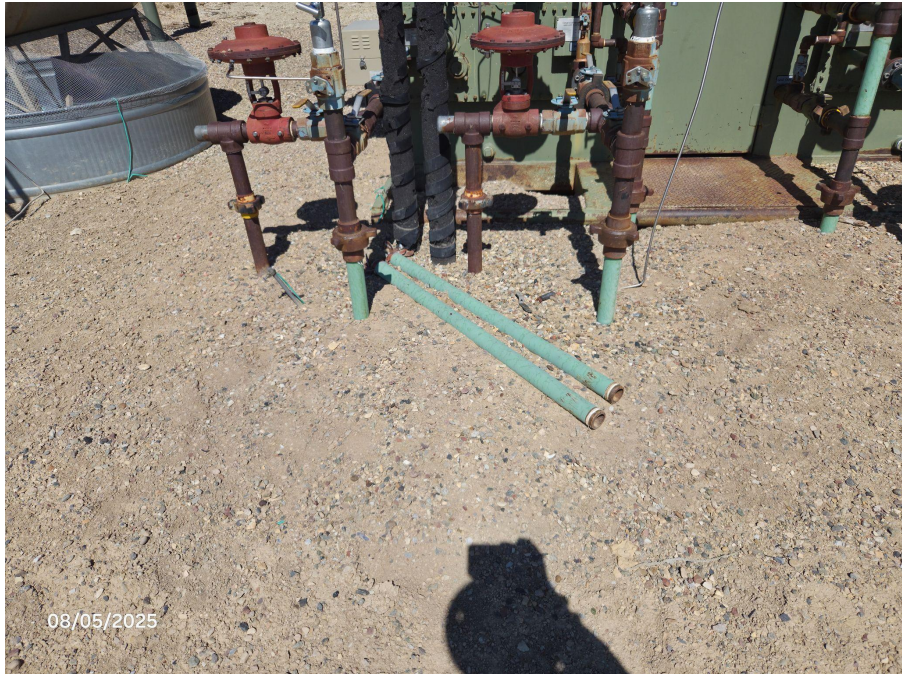
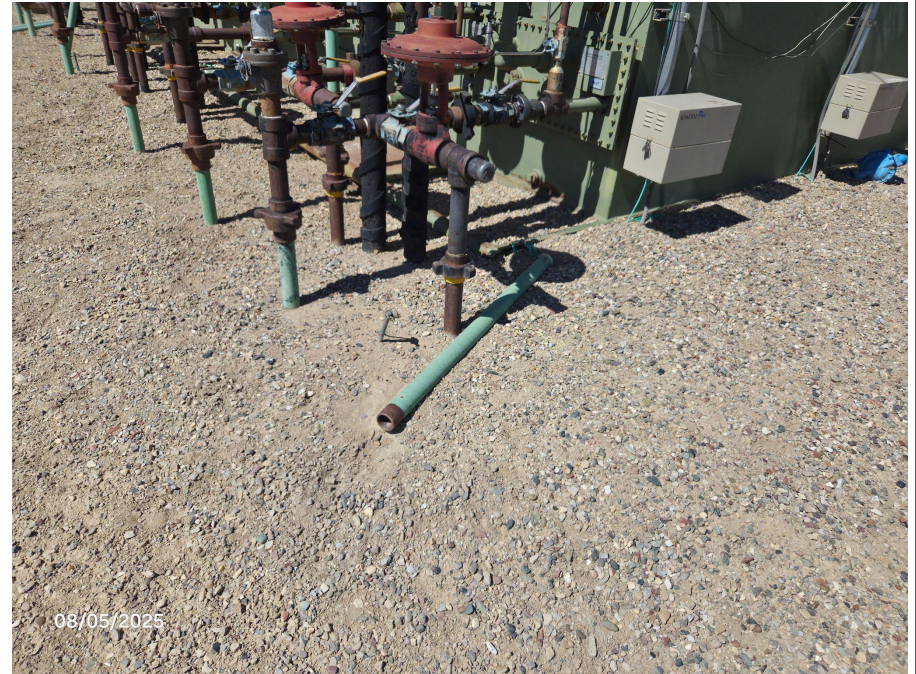
Photo 11: Photos 11-14 examples showing various trash, debris and/or unused equipment on the Location. Photos taken from the separator equipment.

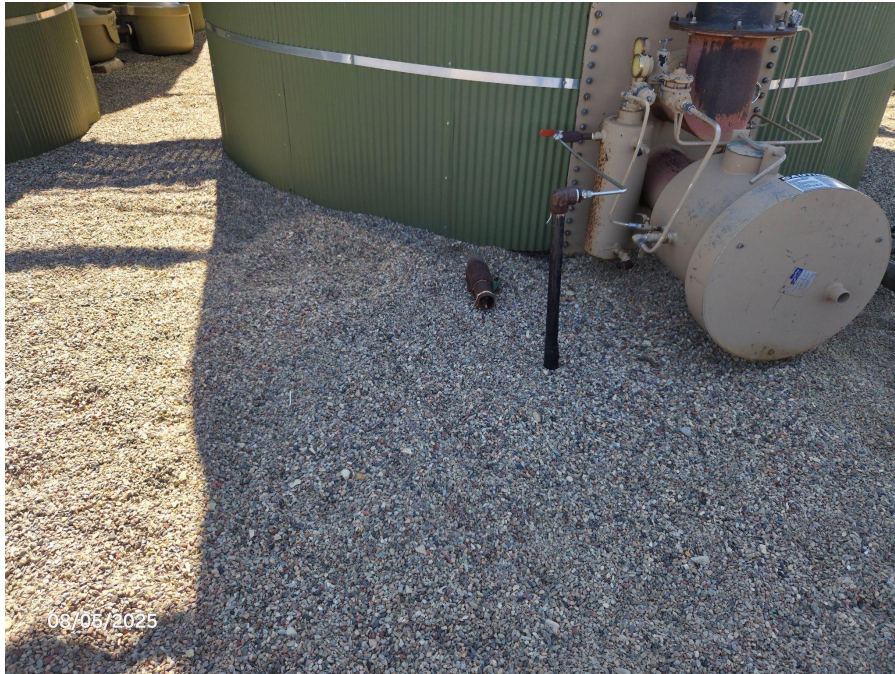
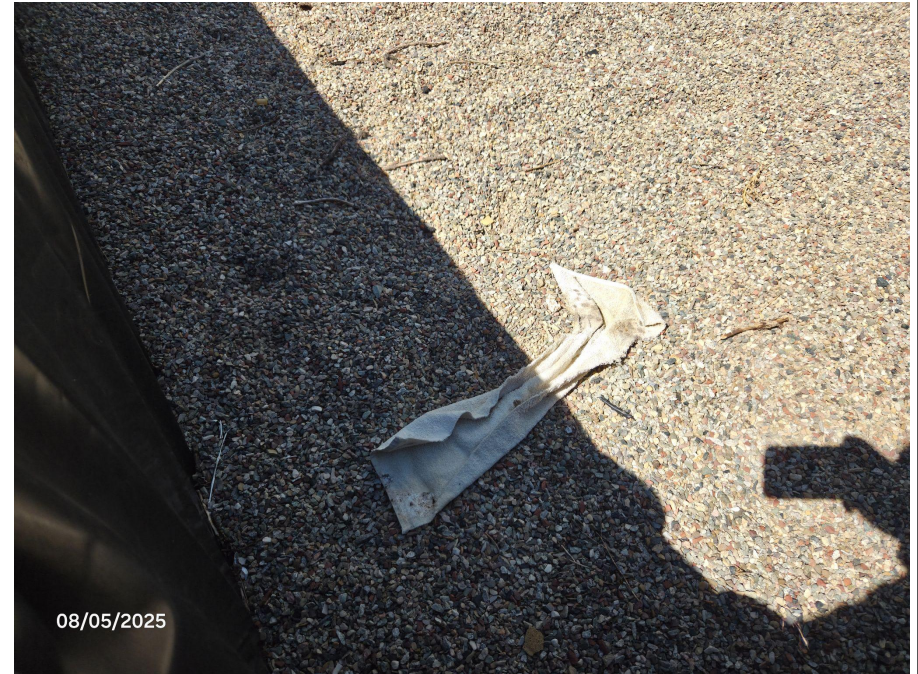
Photo 12: Photos taken from the tank battery facility. See comments under photo 11.

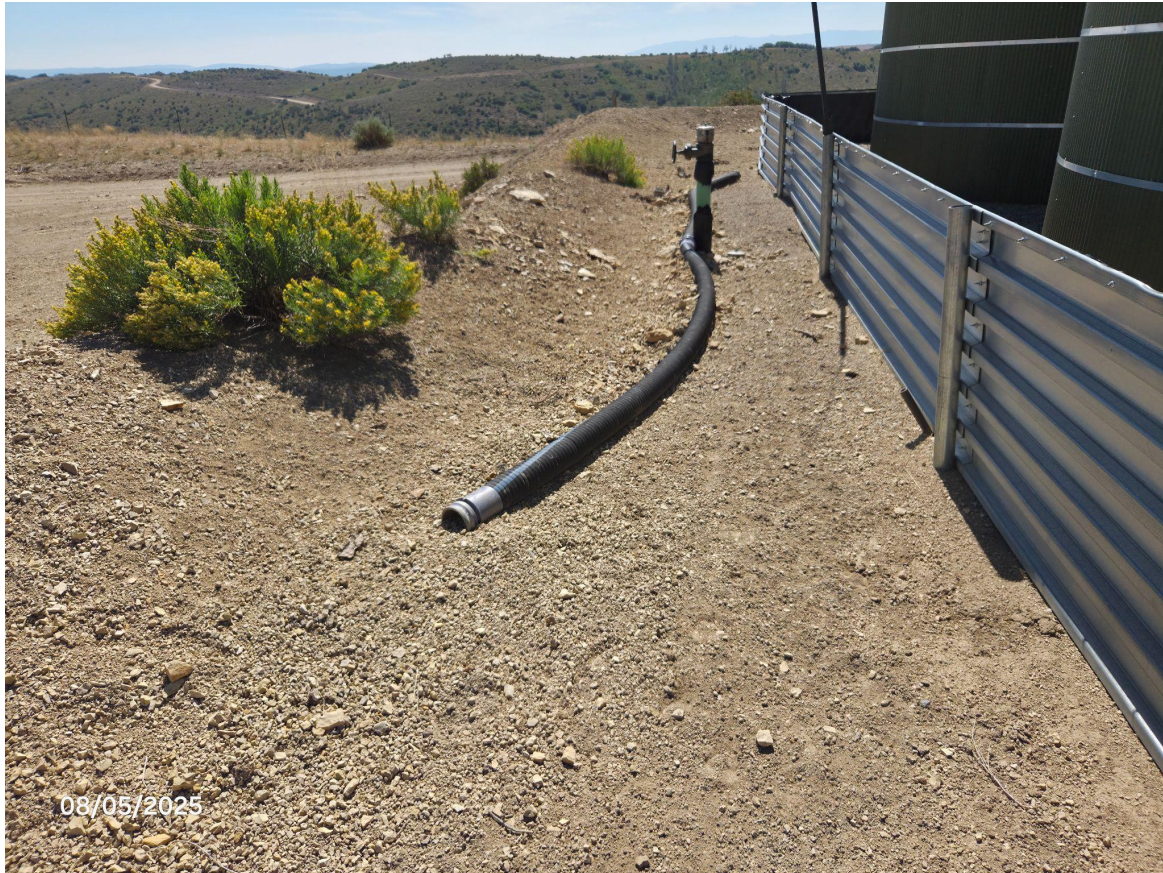
Photo 13: Photo taken from the north end of the tank battery. See comments under photo 11.

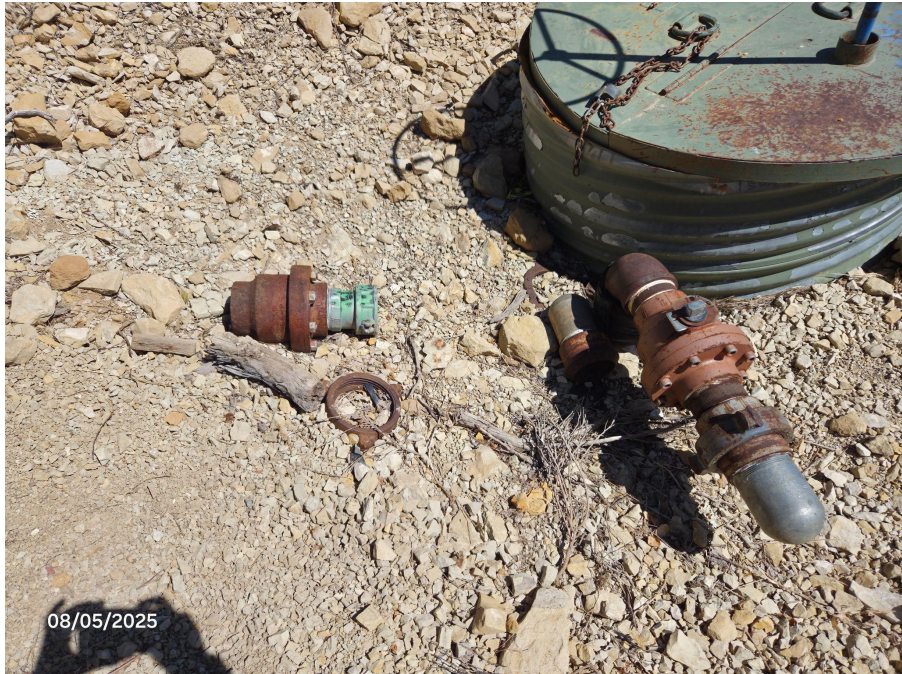
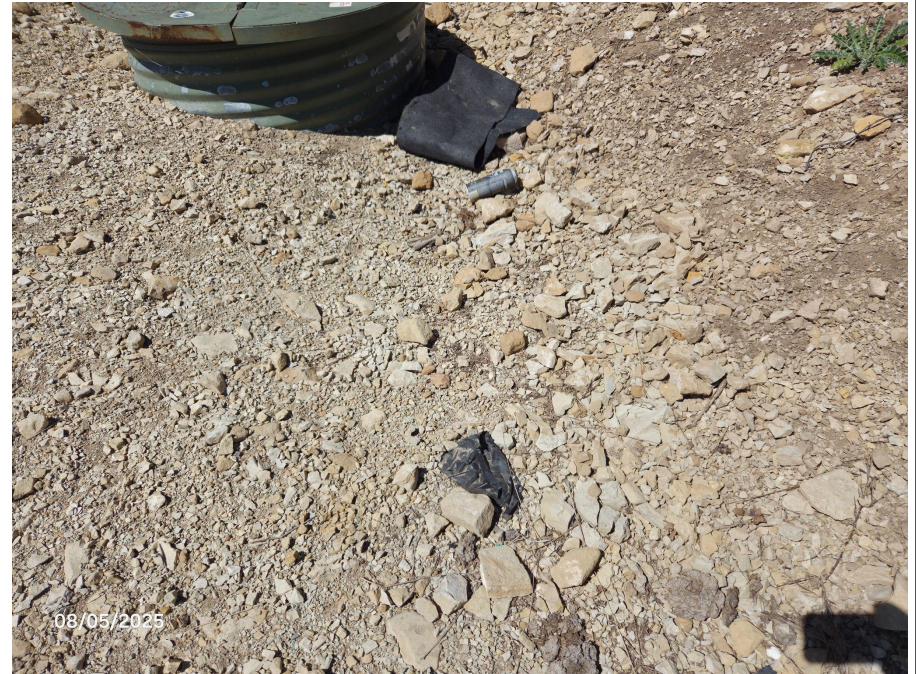
Photo 14: Photos taken from the valve can to the north of the battery facility. See comments under photo 11.

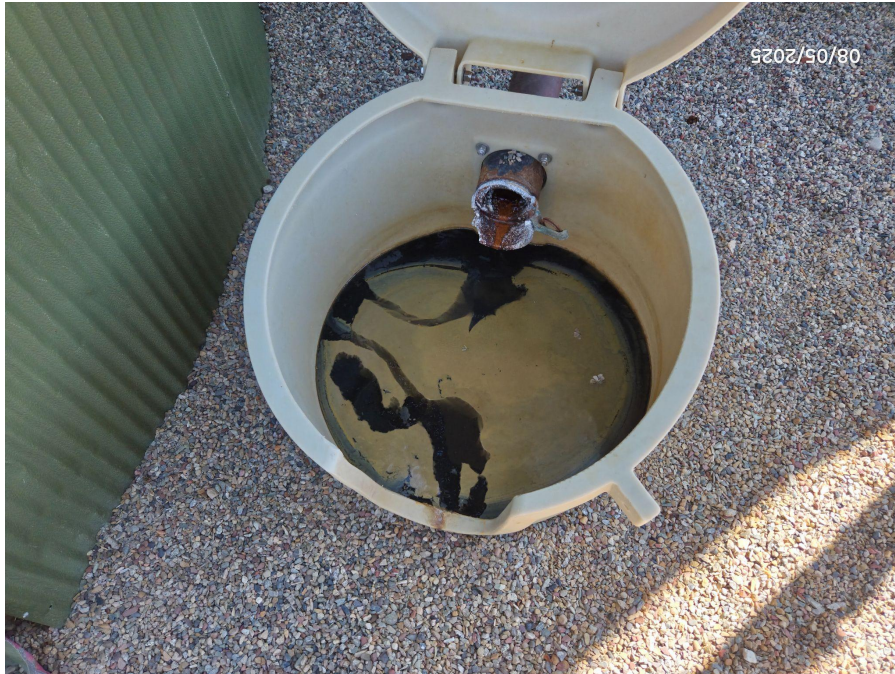
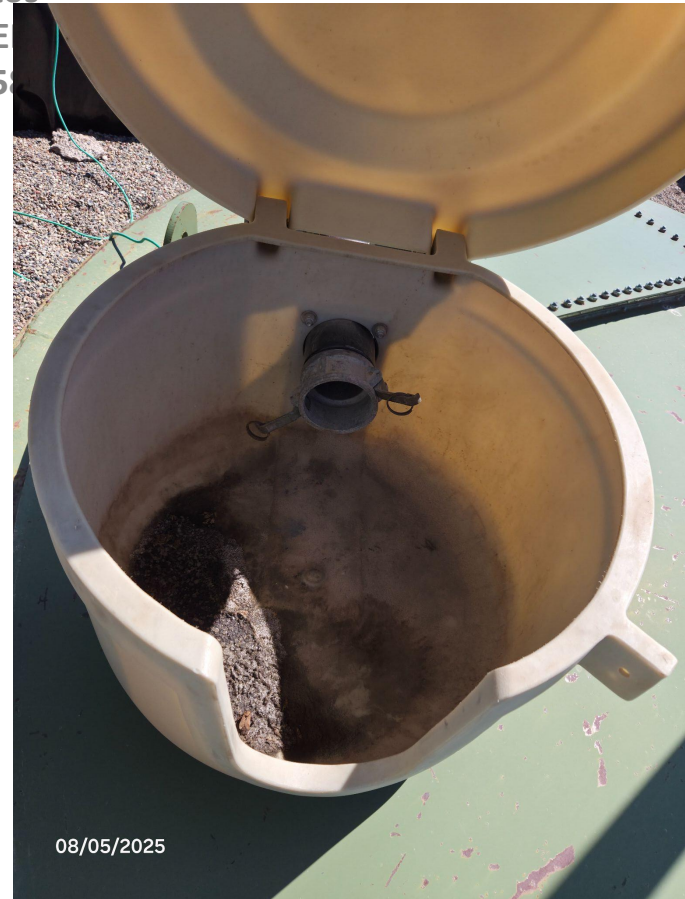
Photo 15: Photos taken from the battery facility. Photos show lines at tanks missing cap/plug. Photo left also shows fluids spilled within containment.

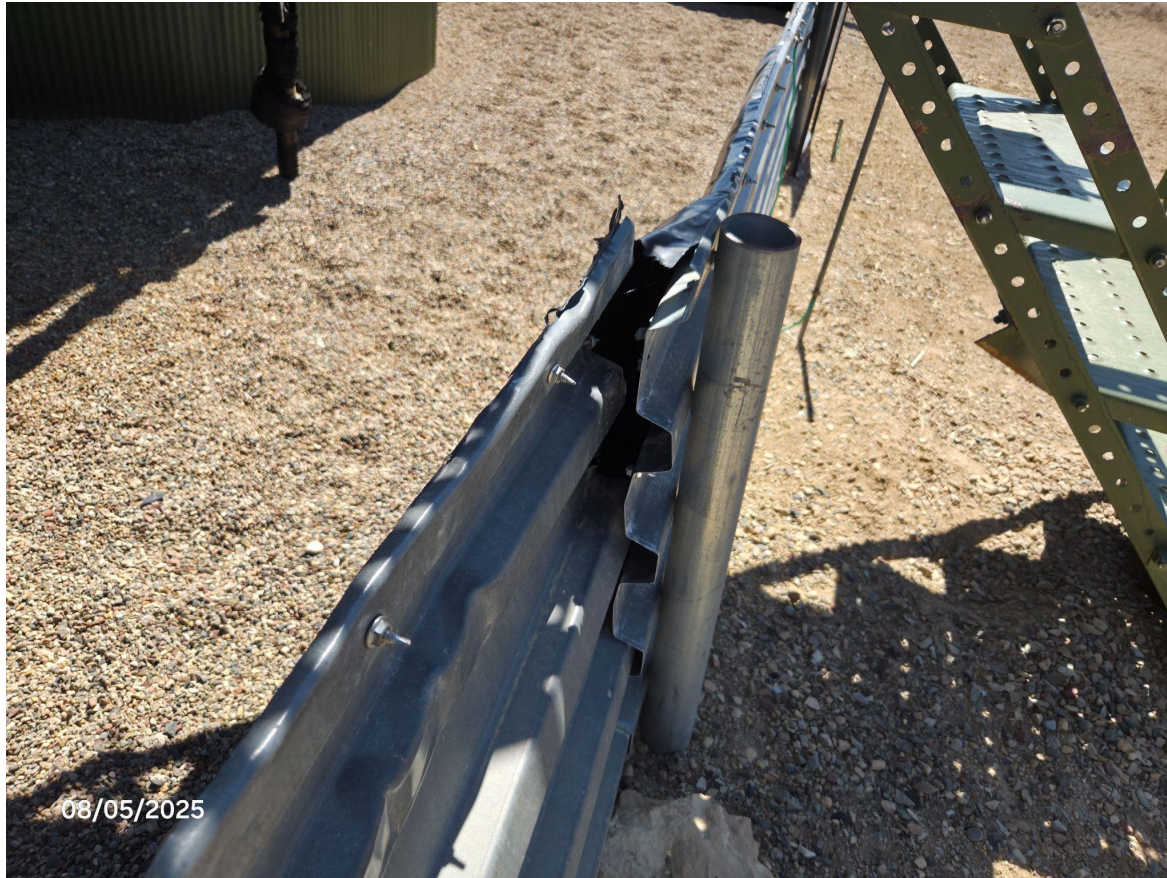
Photo 16: Photos 16-17 taken from the tank battery facility. Photo shows the metal berm has become separated.

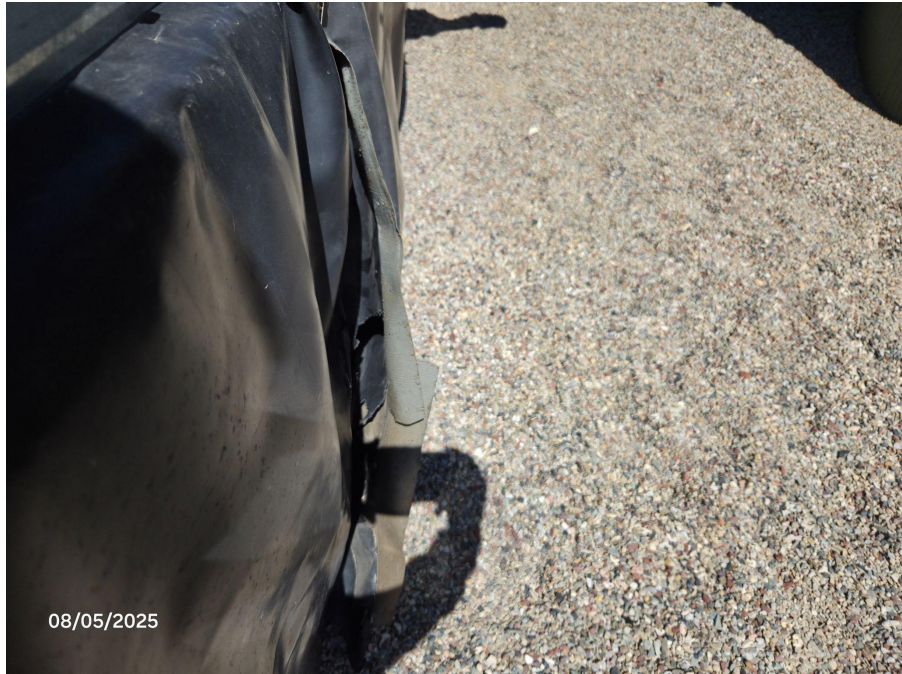
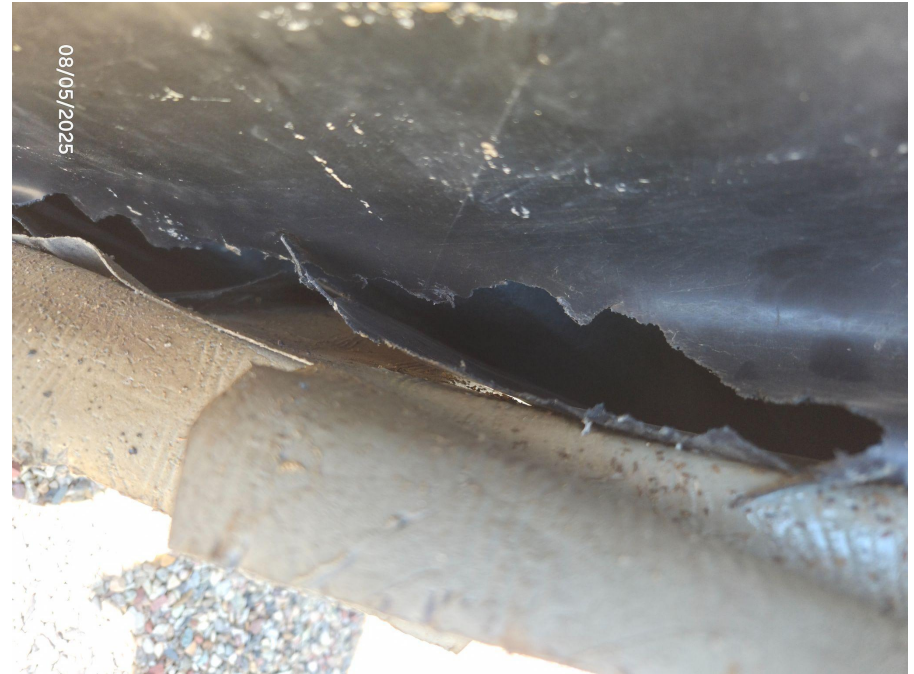
Photo 17: Photo shows tear observed within liner at the tank battery facility.

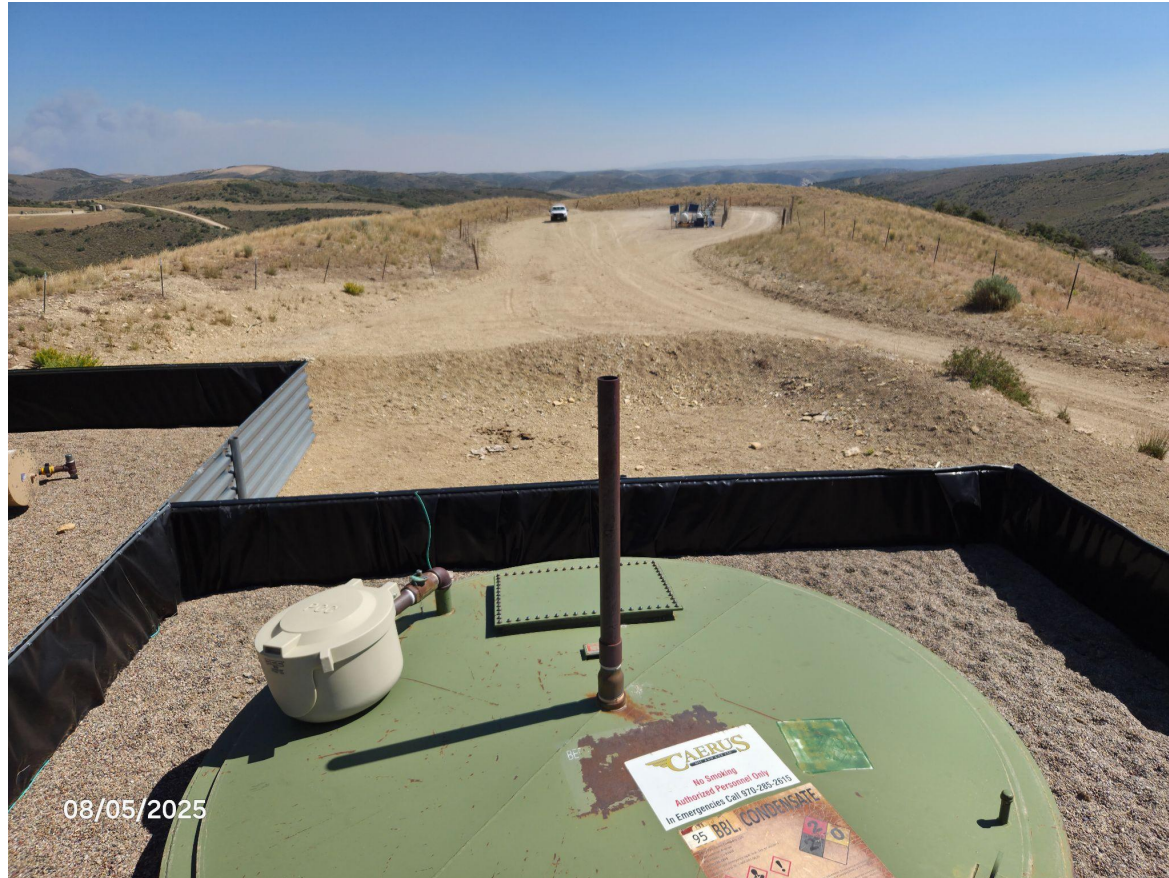
Photo 18: Photo taken from the 95 bbl tank, facing northeast. Photo shows open-ended pipe at tank. Wildlife protection BMPs missing at pipe.

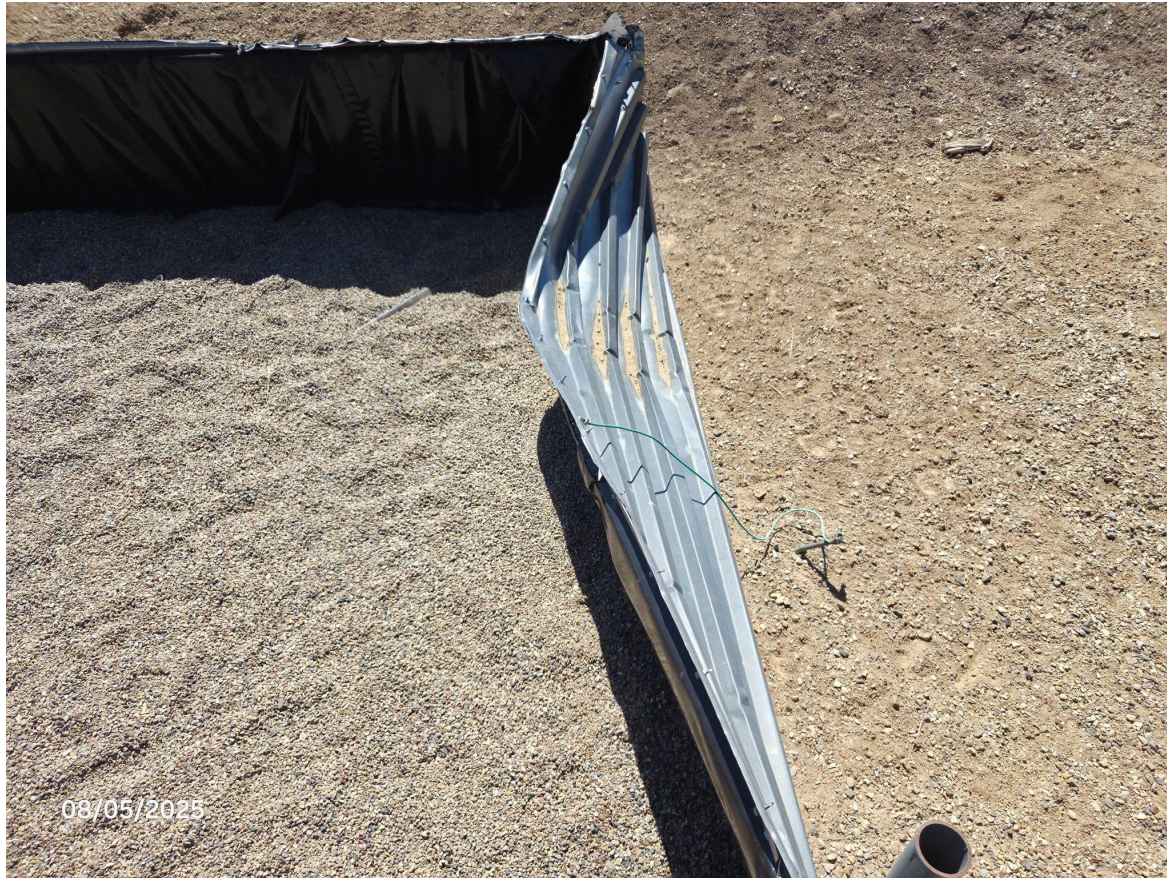
Photo 19: Continued from photo 18. Damage evident at the containment BMP. Unclear if BMP remains sufficiently impervious to contain a spill or release.
