Inspection Photos

Operator: QB ENERGY OPERATING LLC -
10844

Location ID: 335842

Inspection Doc: 718100714

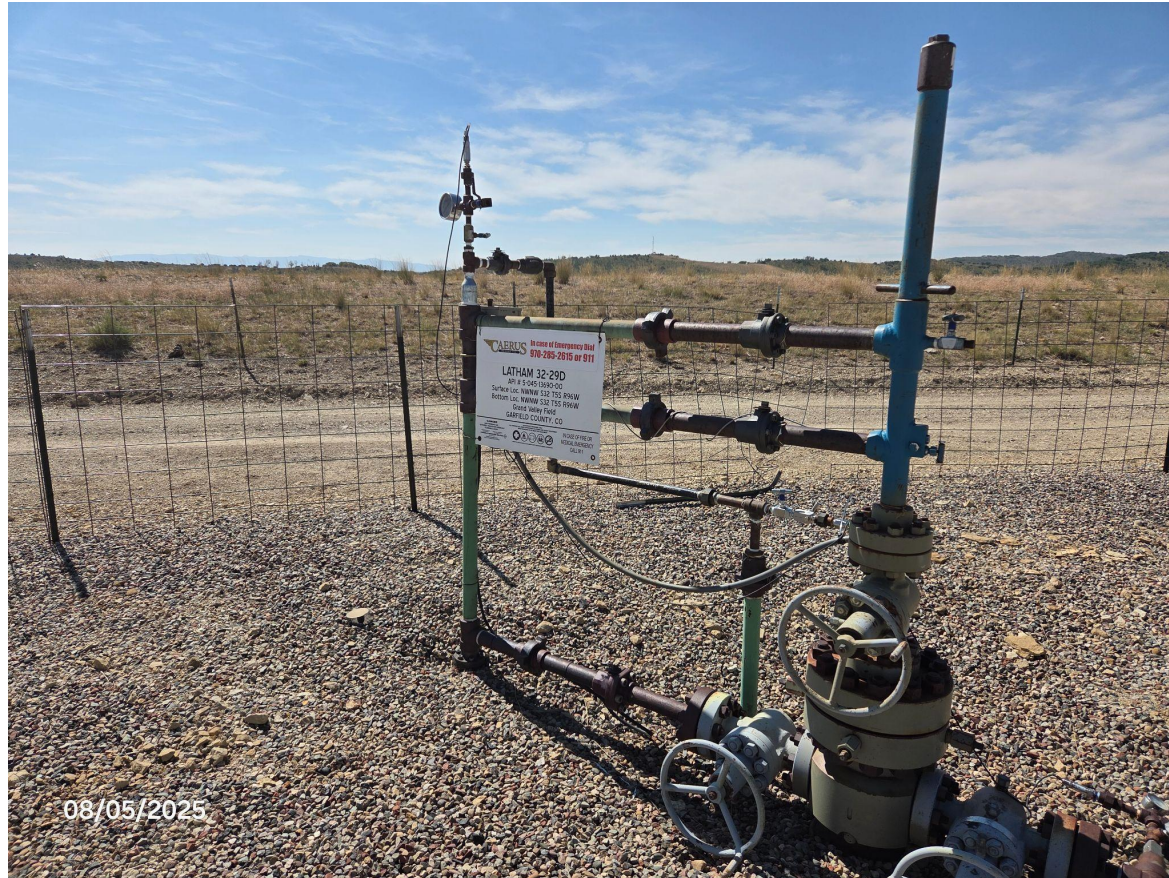
Photo 20: Photo example of signage on the Location with the incorrect Operator listed. Signage at wells/tanks/battery require updating.
