Inspection/Audit Photos

Location Name: TEP ROCKY MOUNTAIN LLC CS_Starkey

Facility ID: 464837

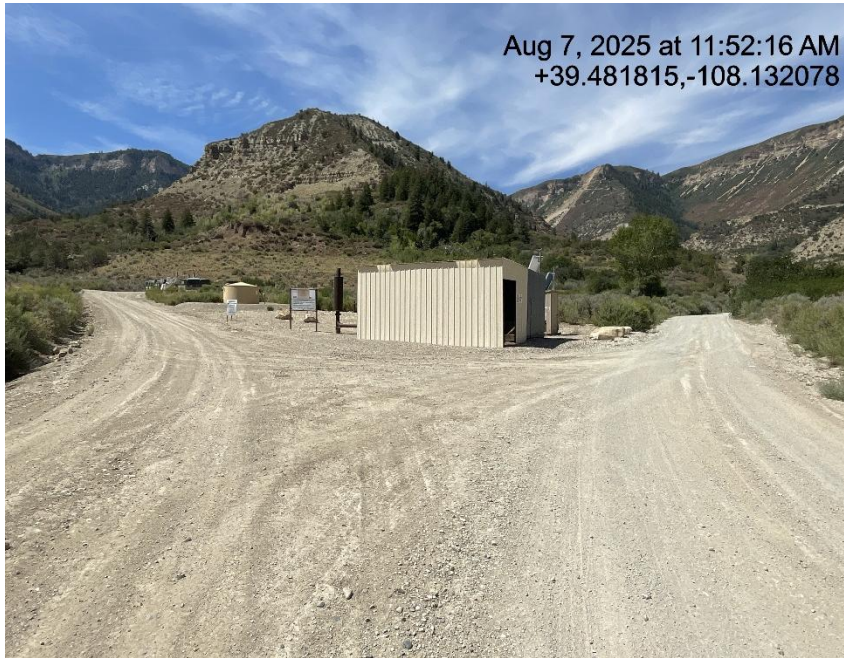
Photo # 9123 From entrance to location

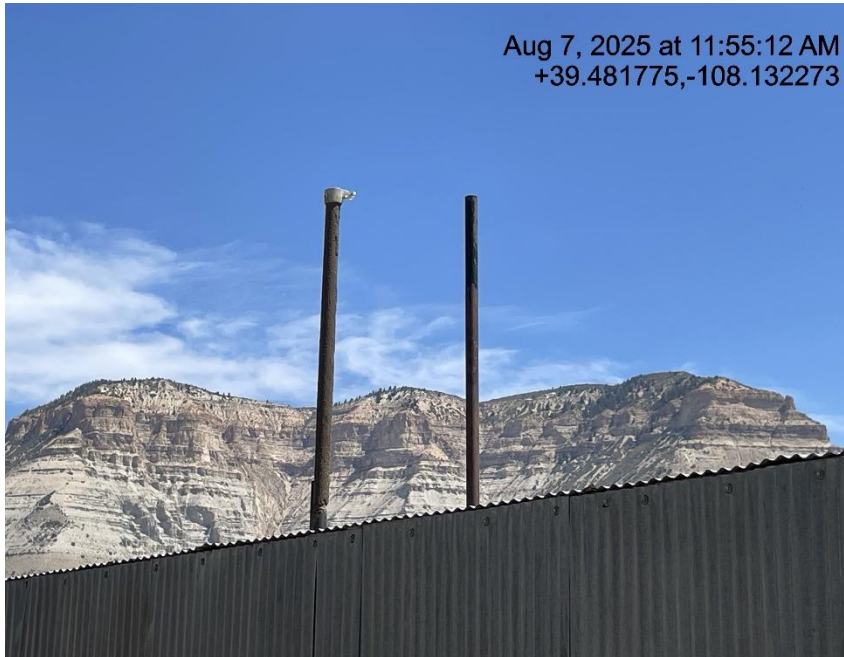
Photo # 9131 PRV vent lines do not comply with CECMC pressure safety device rules

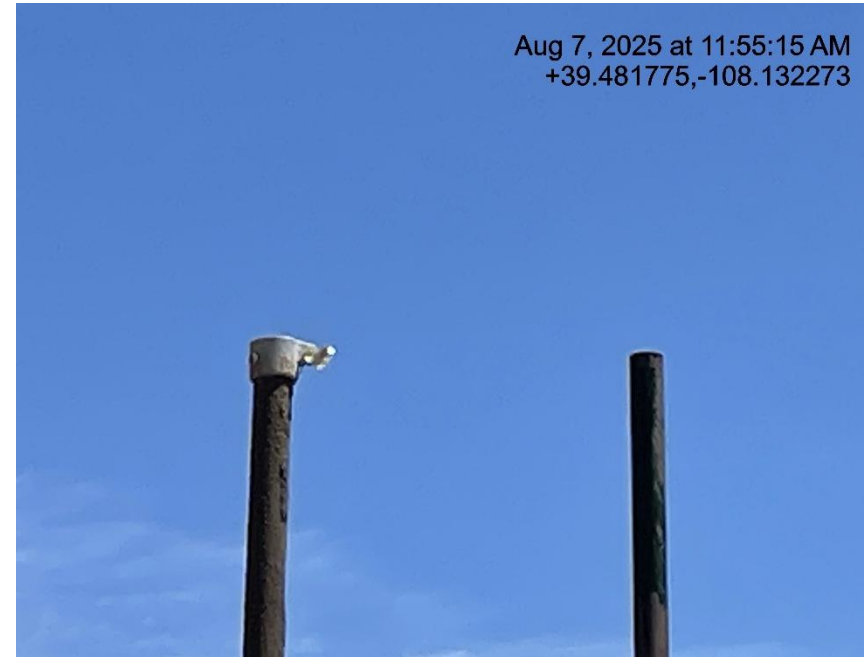
Photo # 9132 PRV vent lines do not comply with CECMC pressure safety device rules

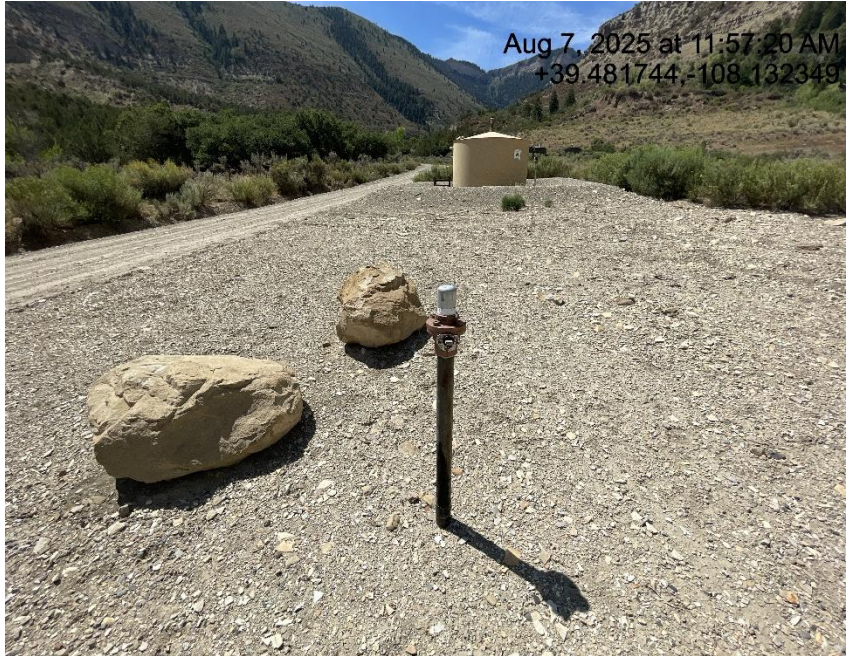
Photo # 9133 Unused flowline lacks lockout tagout (OOSLAT)

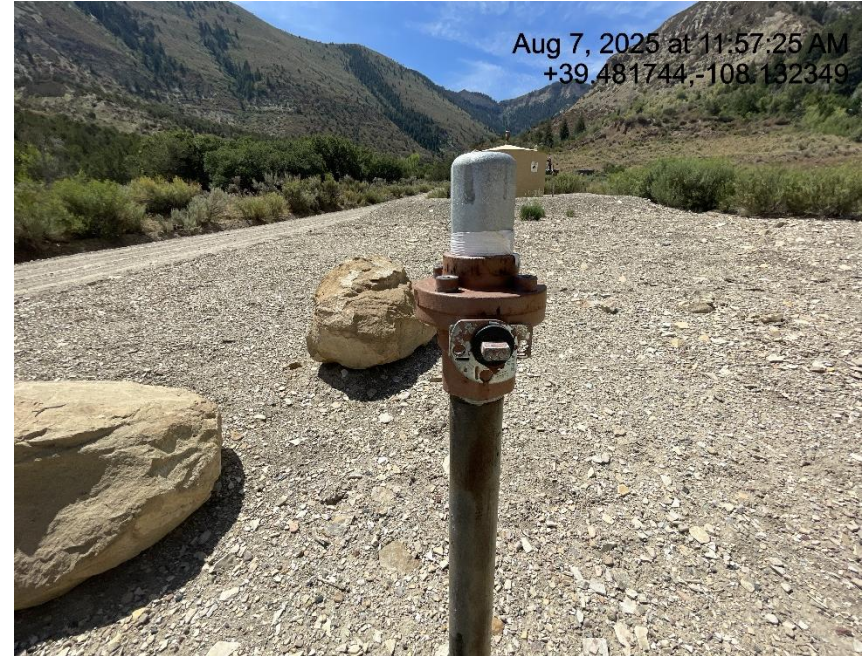
Photo # 9134 Unused flowline lacks lockout tagout (OOSLAT)

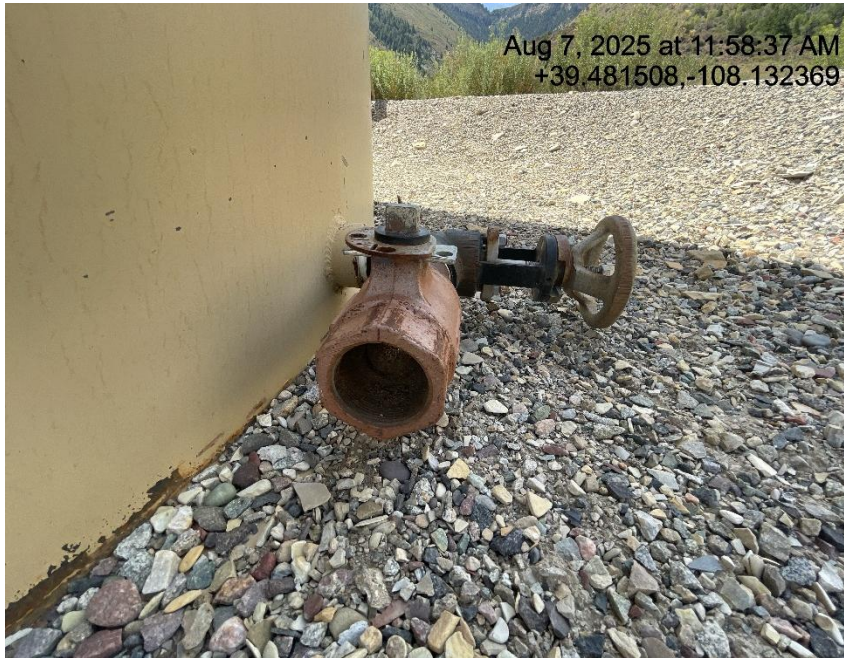
Photo # 9135 Open ended load line

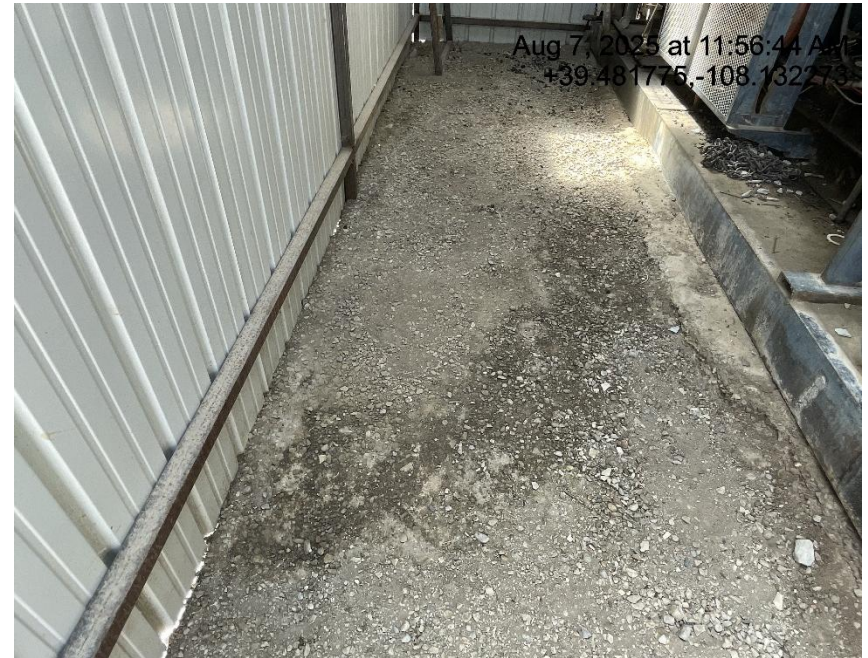
Photo # 9136 Staining near compressor
