Inspection Photos

August 6th, 2025

Operator: Hilcorp Energy Company

Location ID: 306932

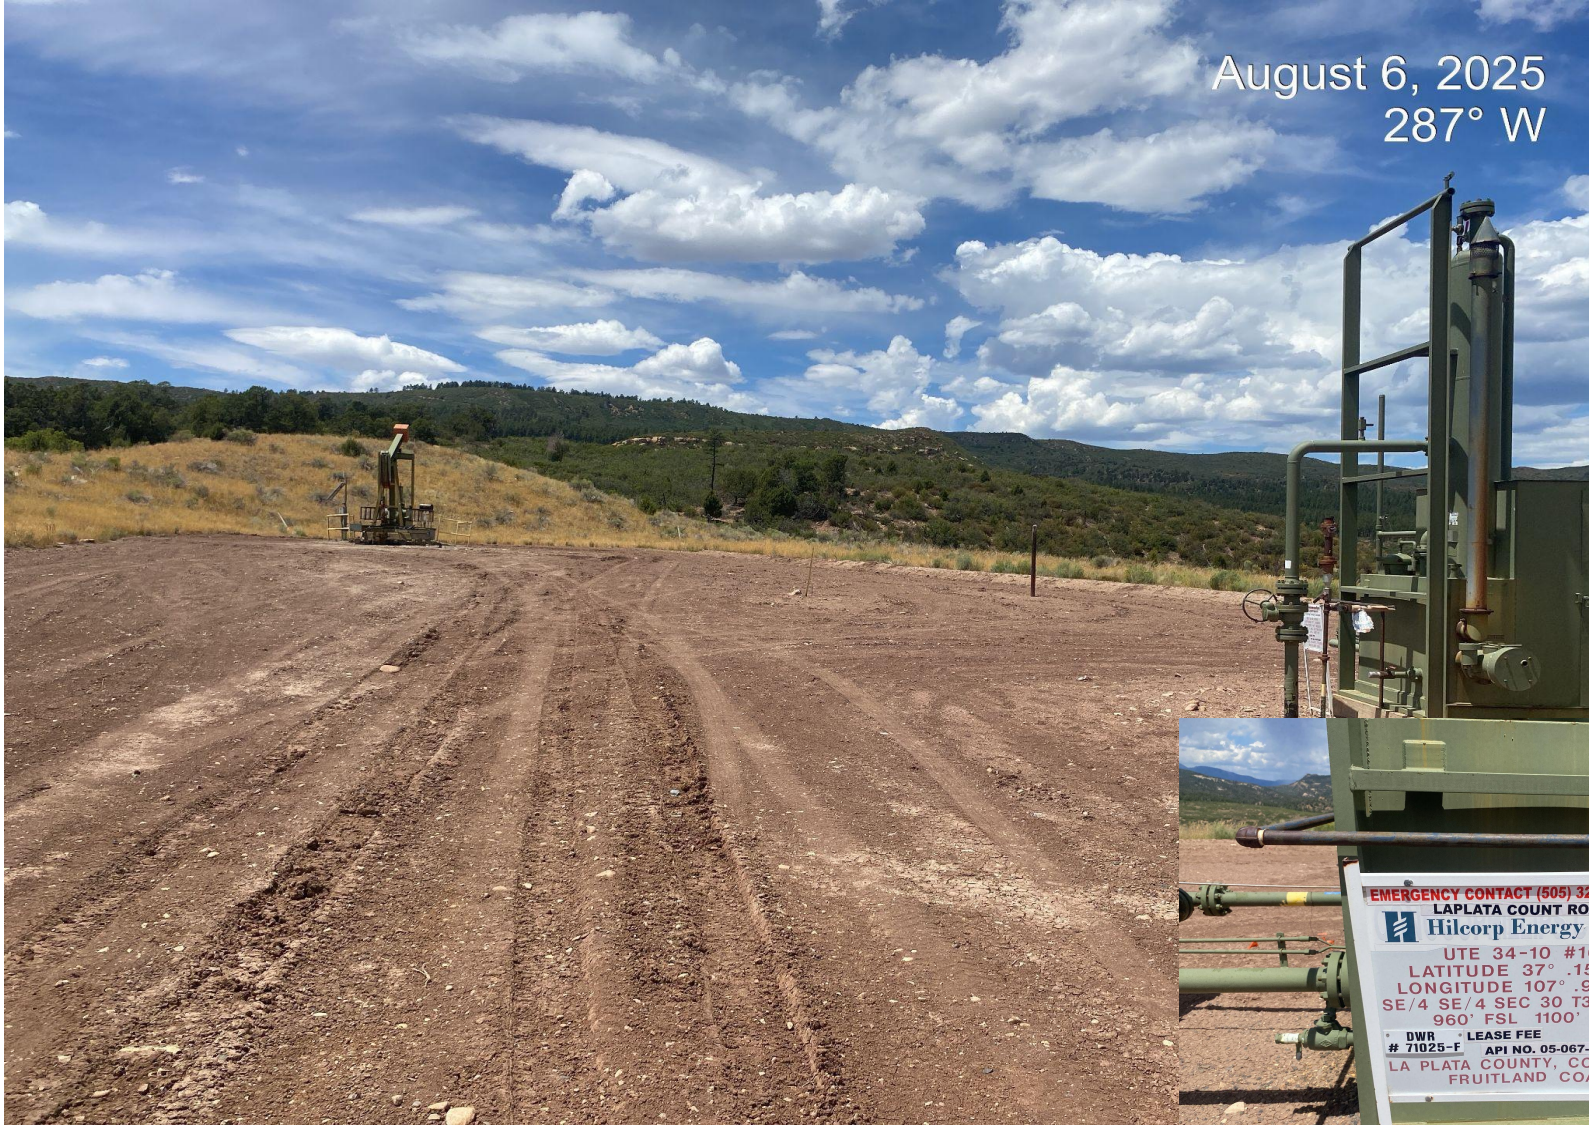
Photo 1. View of the project area taken from the access point facing center.

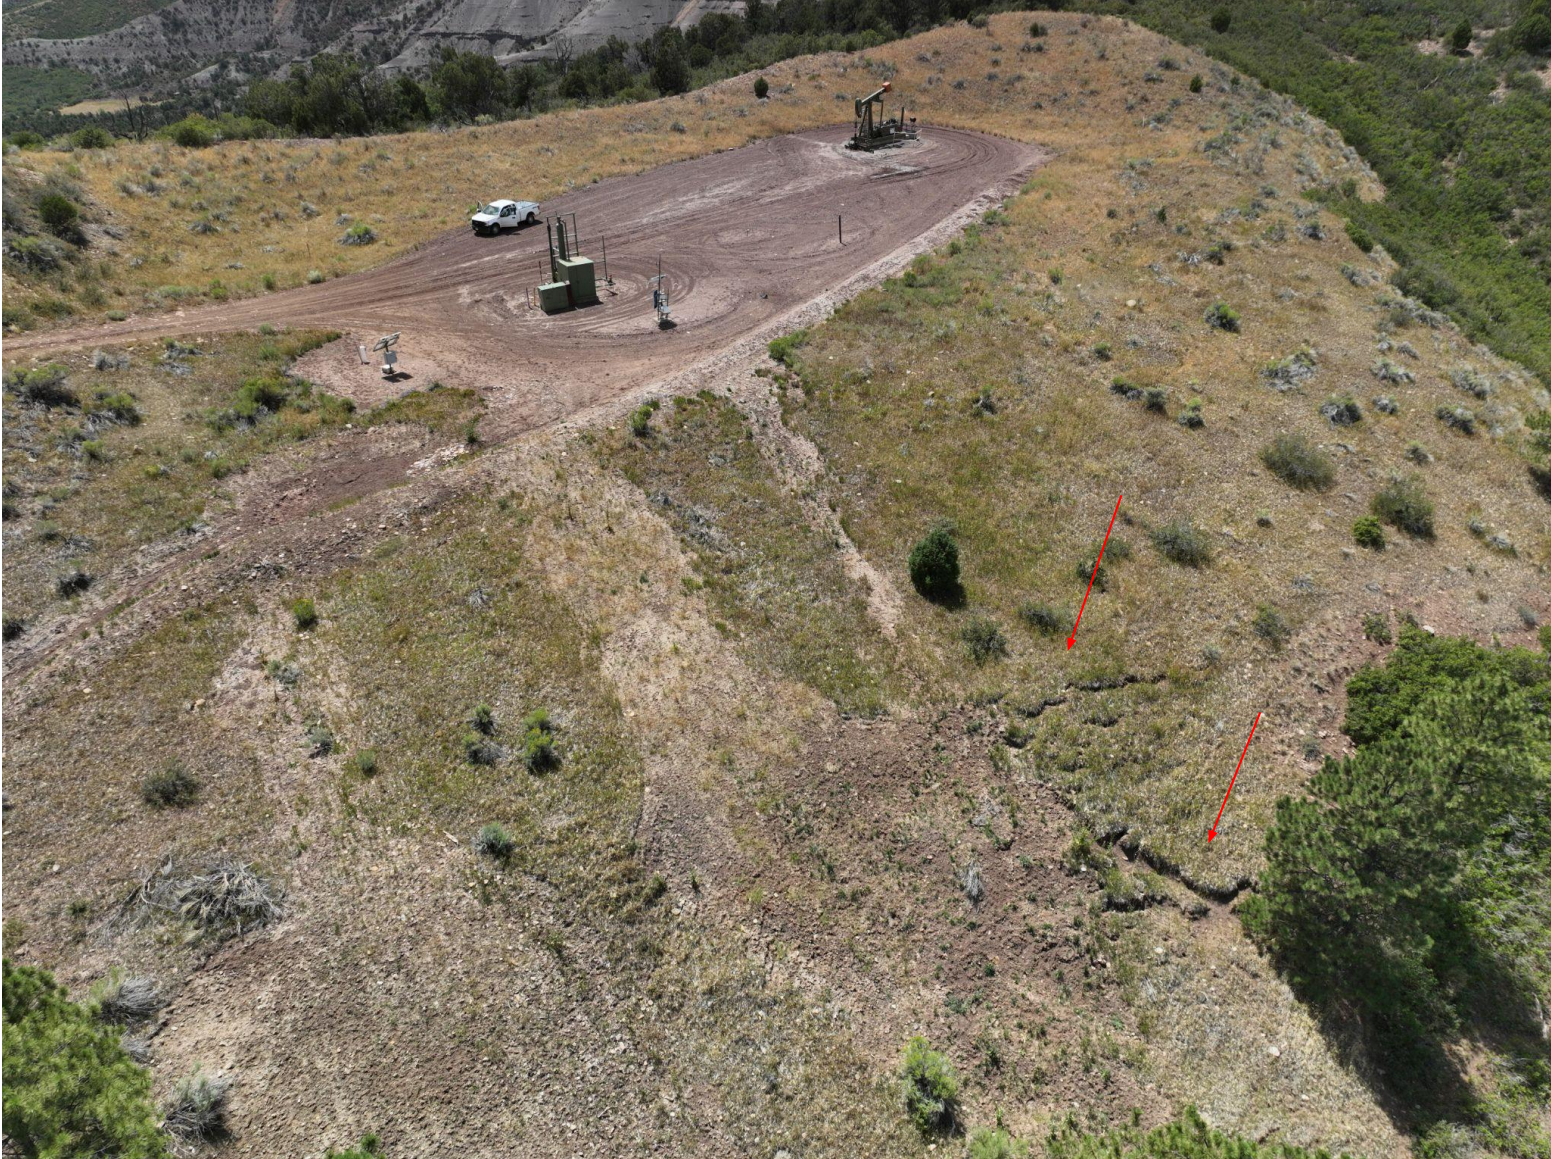
Photo 2. Drone photo of previous active gully erosion area which has been collapsed, filled in and reseeded (evidence of germinating desirable species were observed). Smaller slumping, and erosion observed on the furthest downslope section (red arrow).

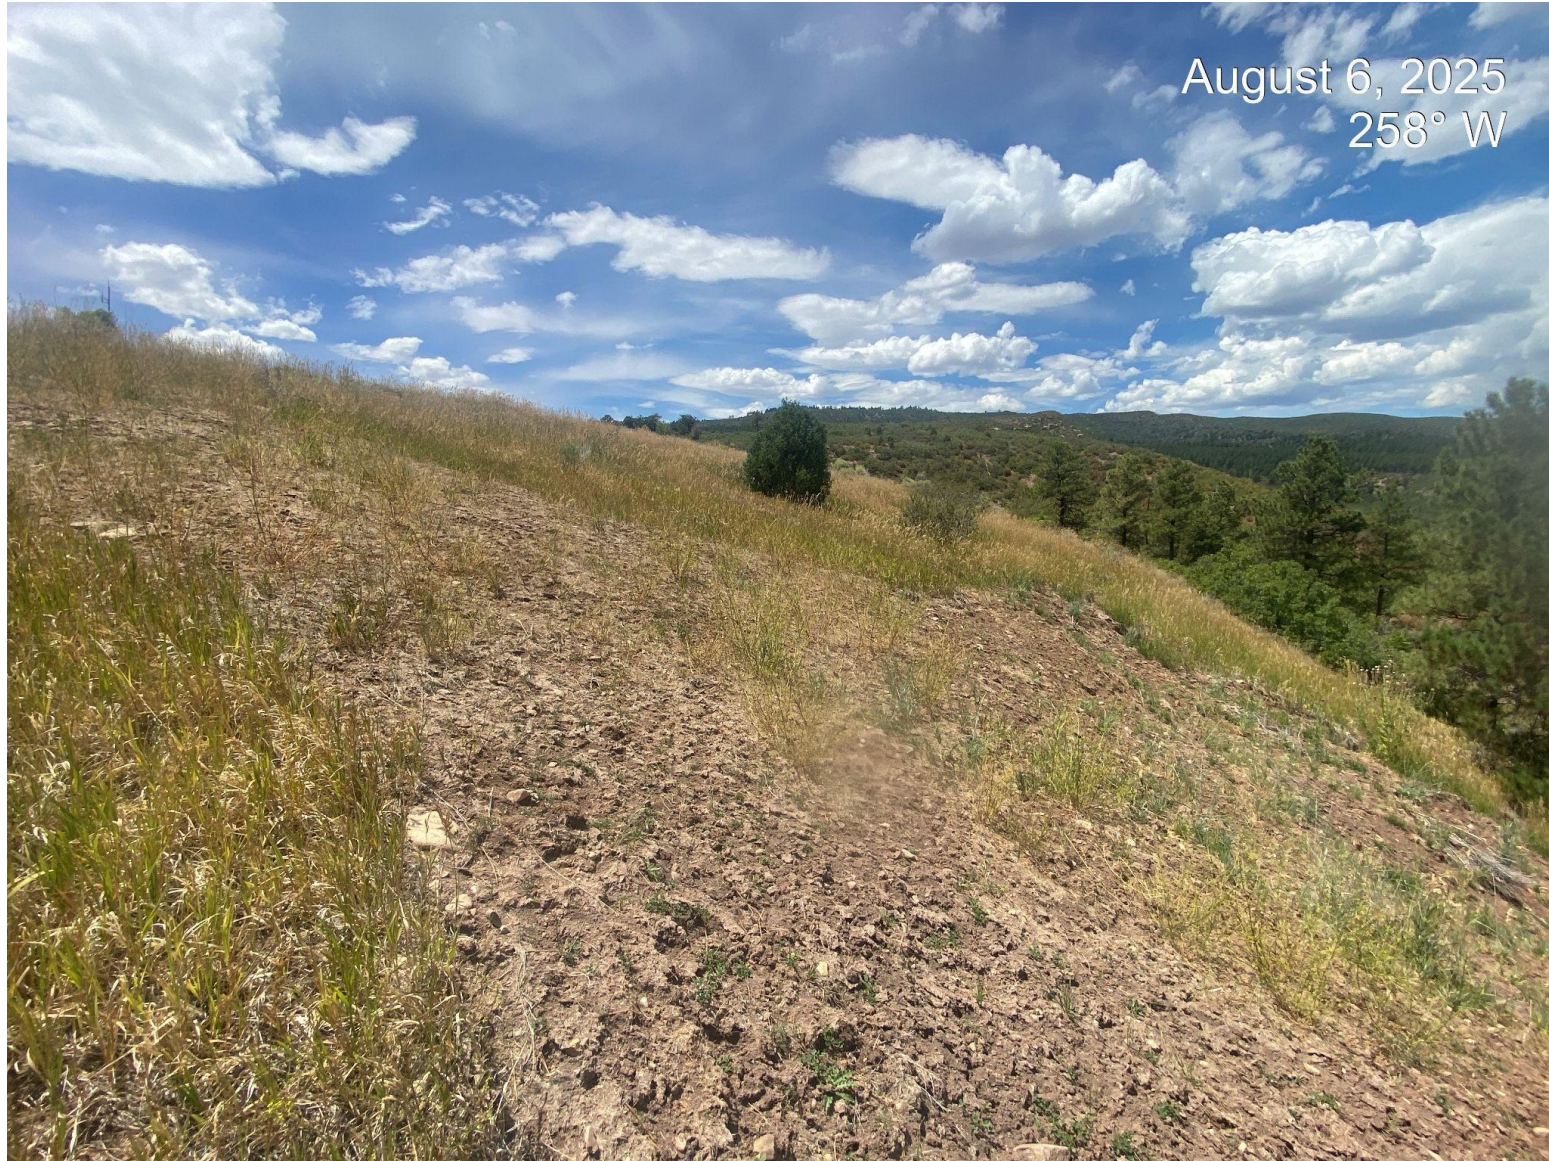
Photo 3. Ground view of collapsed gully erosion and reseeded area.

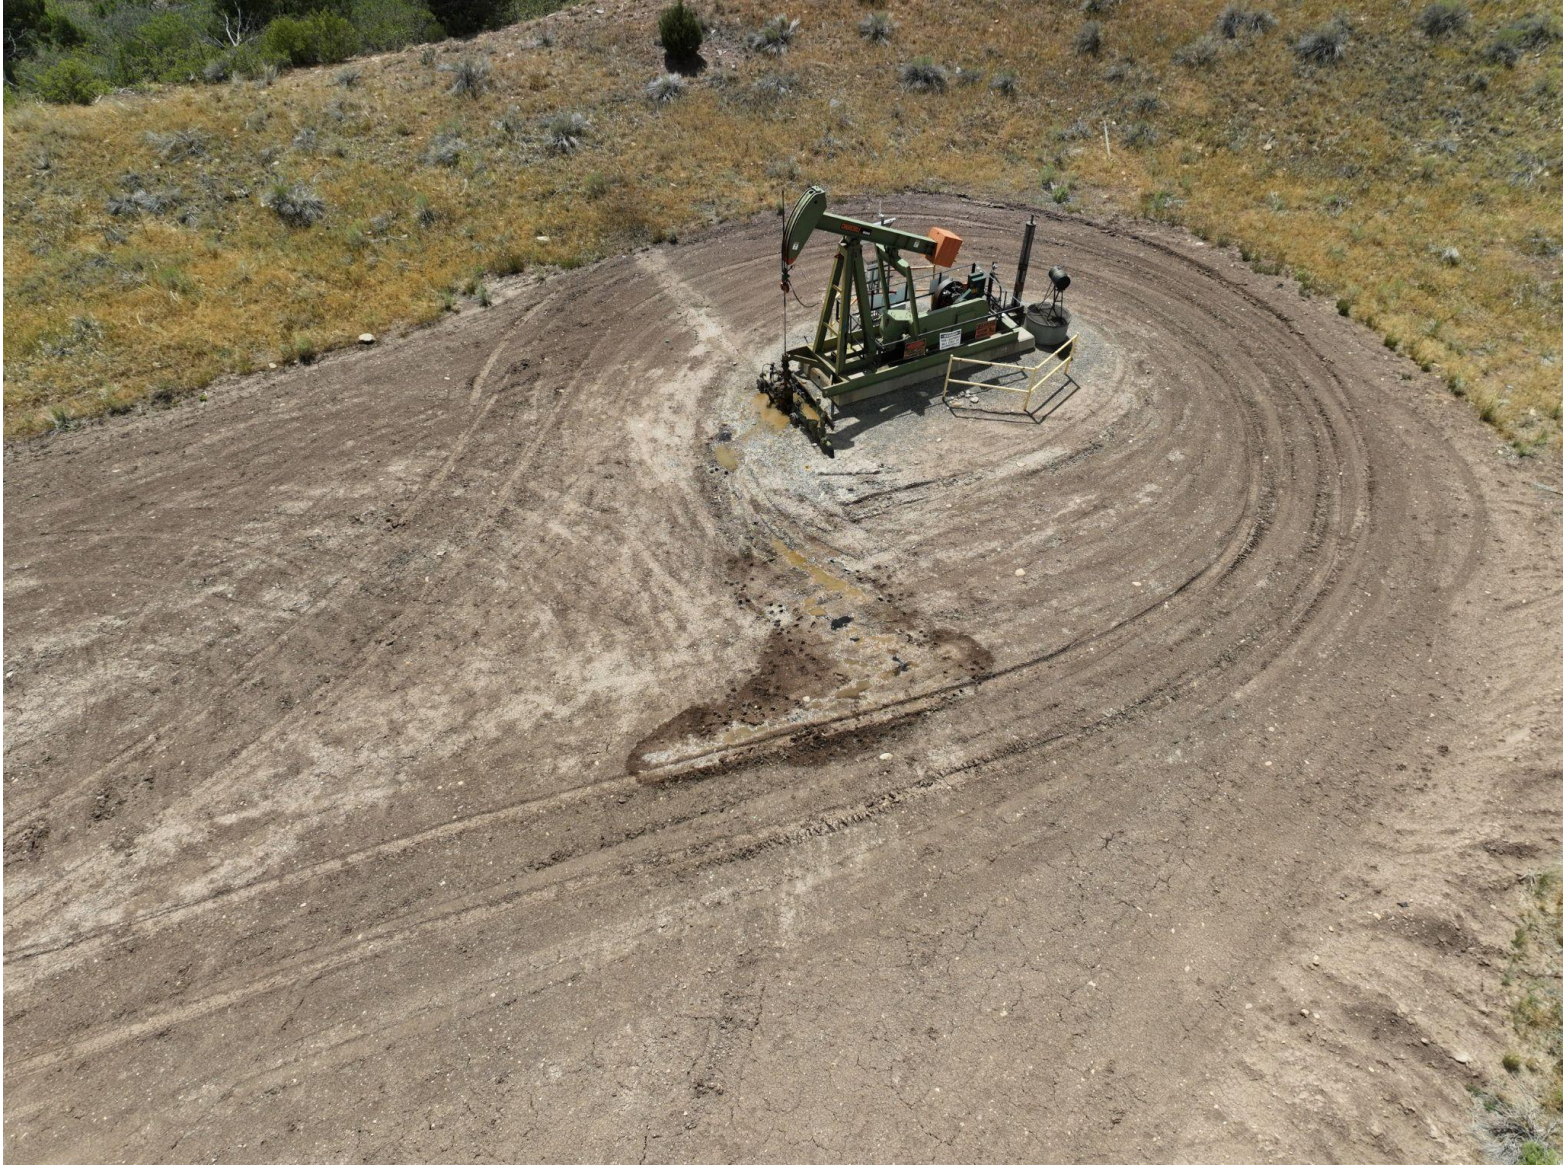
Photo 5. Drone photo showing extent of active spill.
