Inspection/Audit Photos

Location Name: TEP ROCKY MOUNTAIN LLC OXY USA INC MV 45-10 Pad

Location ID: 323862

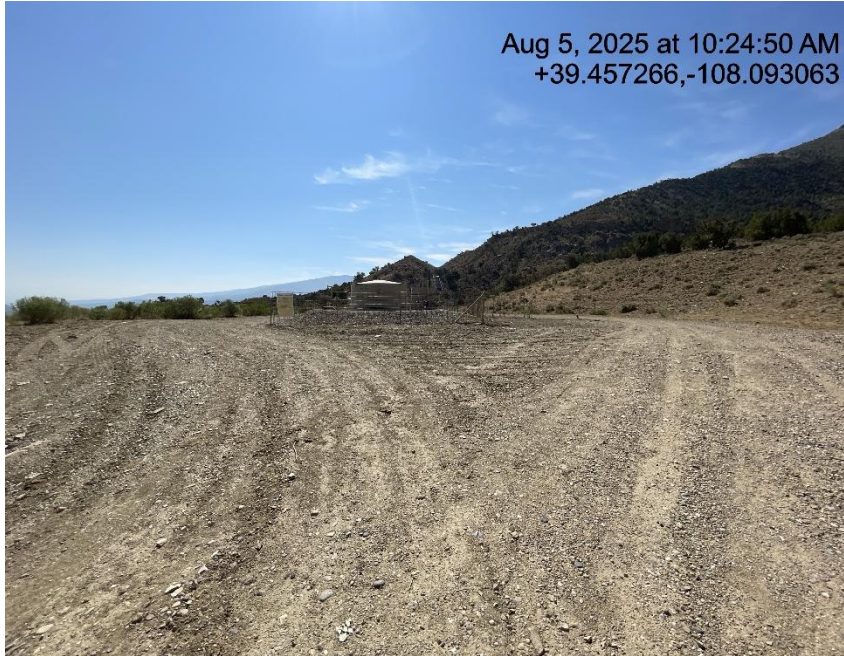
Photo # 7893 From entrance to location

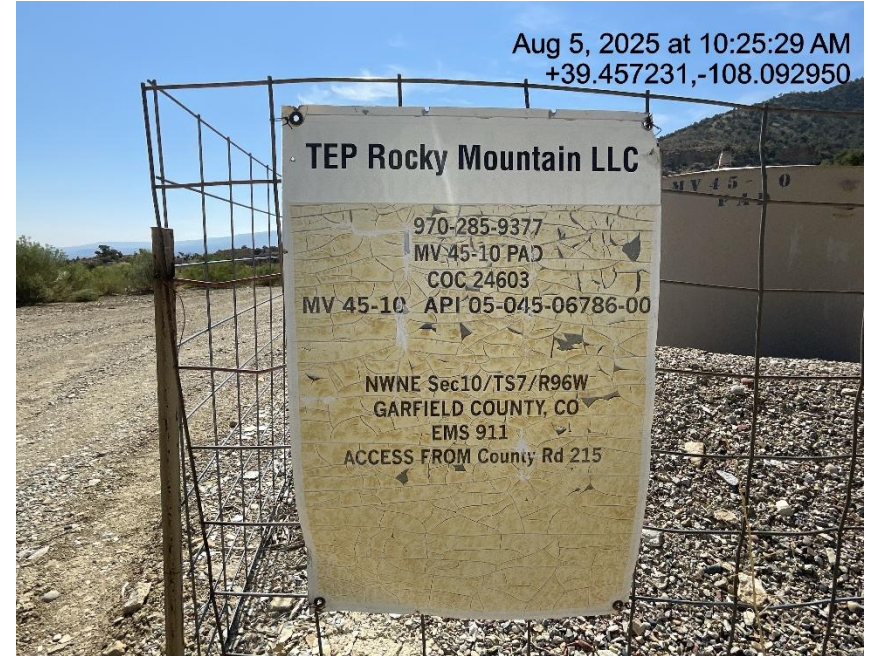
Photo # 7894 Location

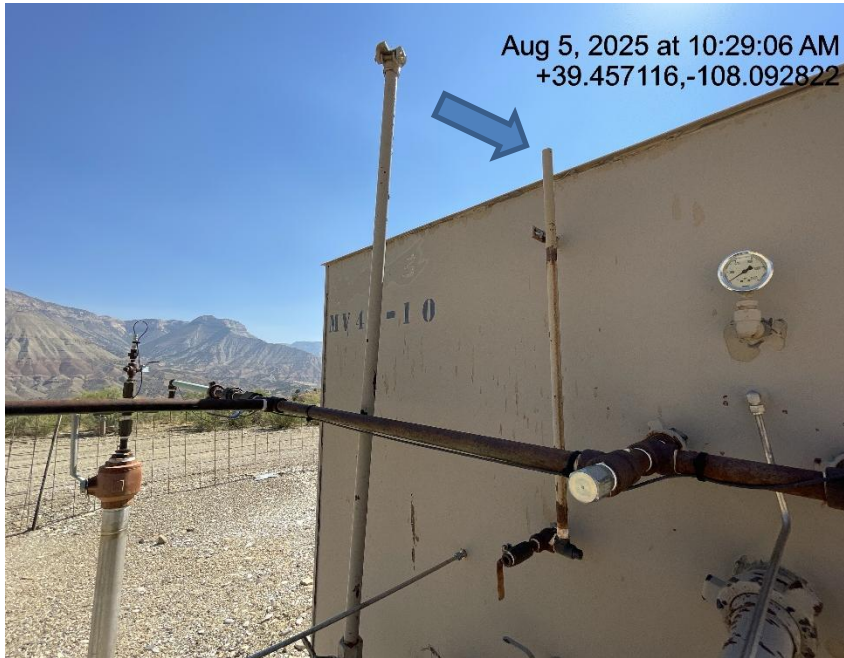
Photo # 7899 PRV vent line does not comply with CECMC pressure safety device rules

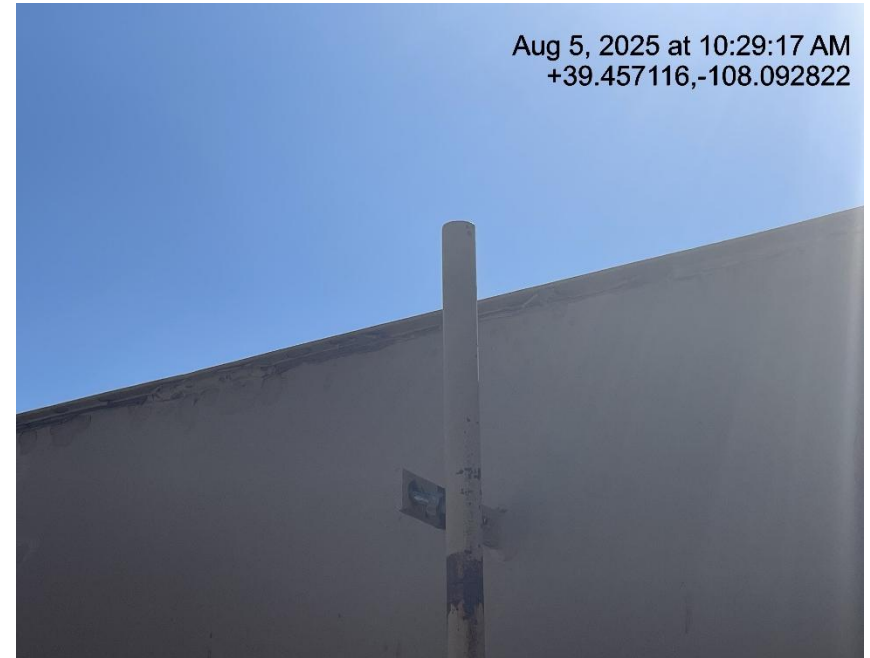
Photo # 7900 PRV vent line does not comply with CECMC pressure safety device rules

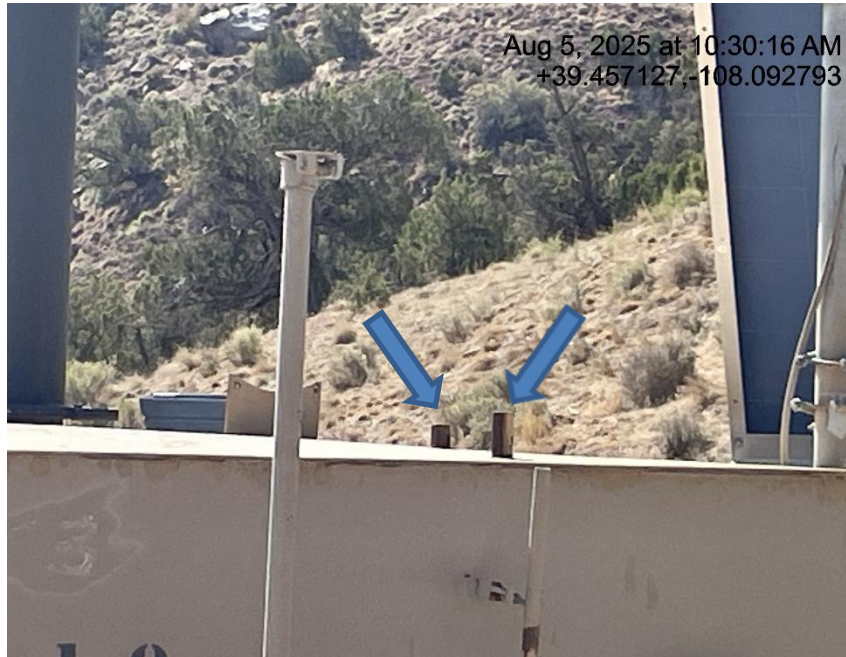
Photo # 7901 PRV & rupture disc vent lines do not comply with CECMC pressure safety device rules

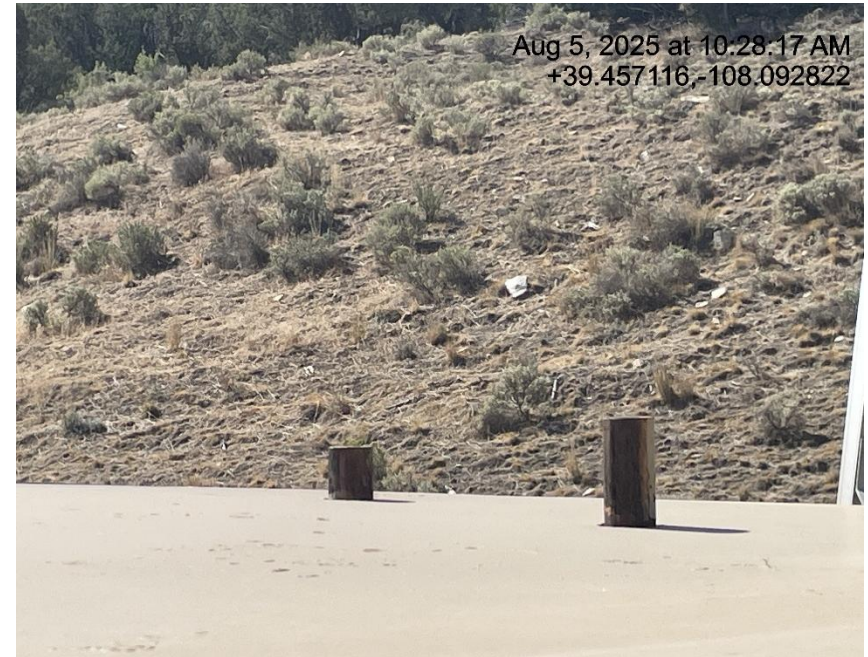
Photo # 7902 PRV & rupture disc vent lines do not comply with CECMC pressure safety device rules
