Inspection/Audit Photos

Location Name: TEP Rocky Mountain LLC REDA TANK FARM

Location ID: 335111

Facility ID: 434770

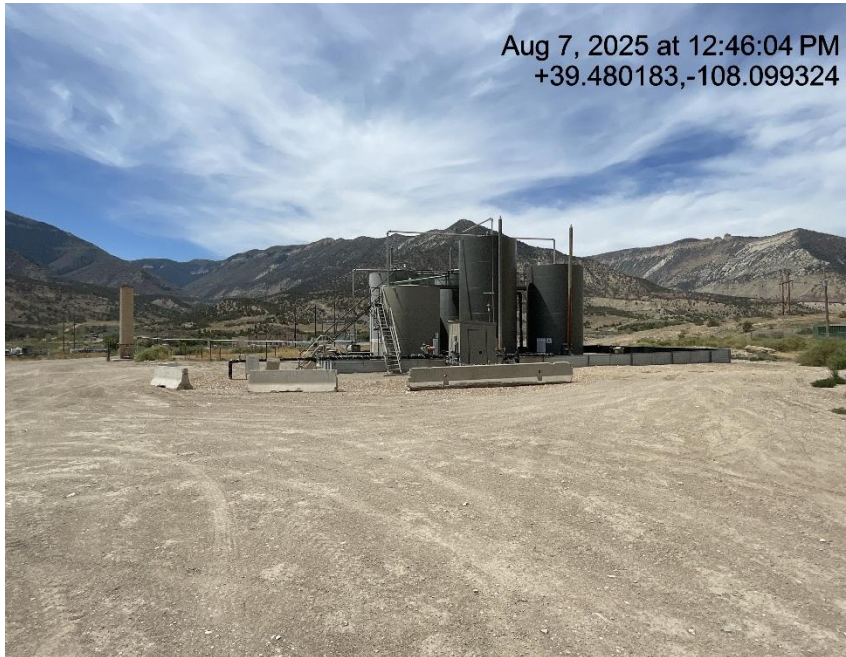
Photo # 9291 From entrance to location

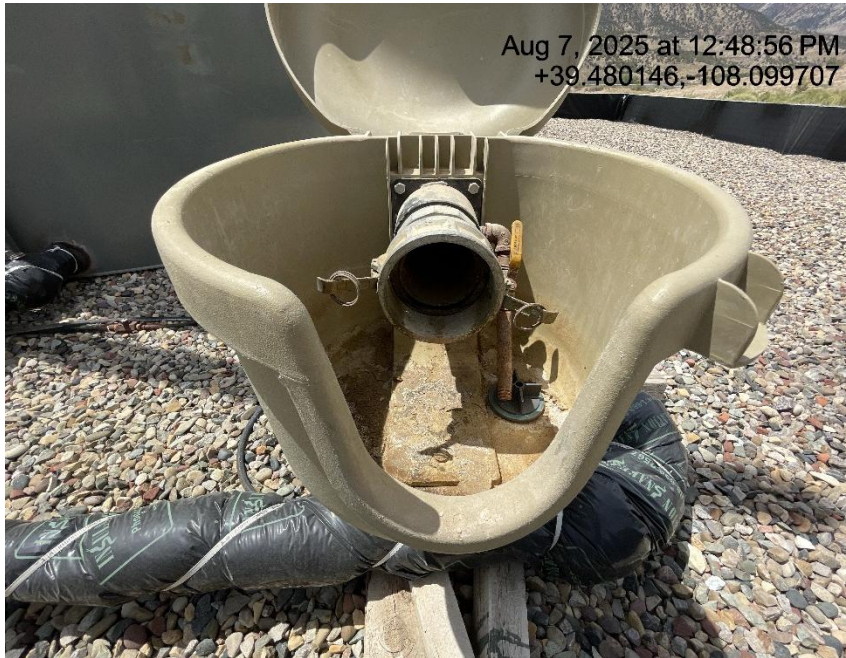
Photo # 9297 Open ended load line

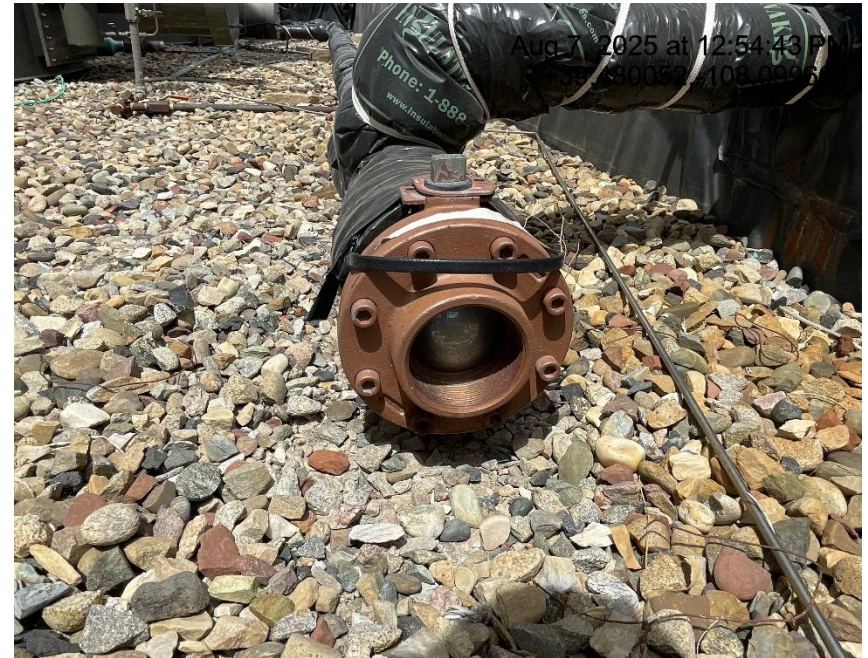
Photo # 9298 Open ended load line

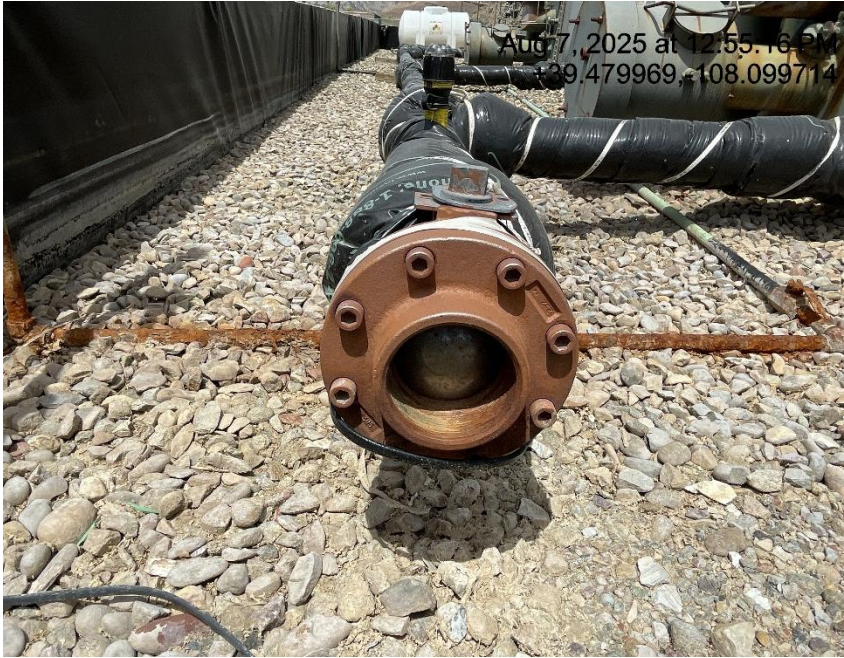
Photo # 9299 Open ended load line

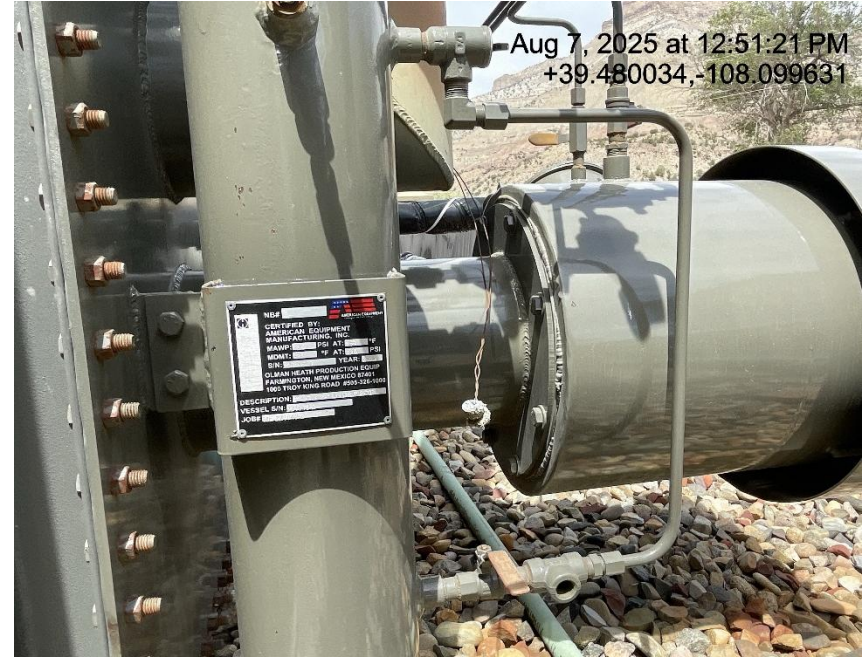
Photo # 9300 PRV vent line on tank burner does not comply with CECMC pressure safety device rules & general safety rules

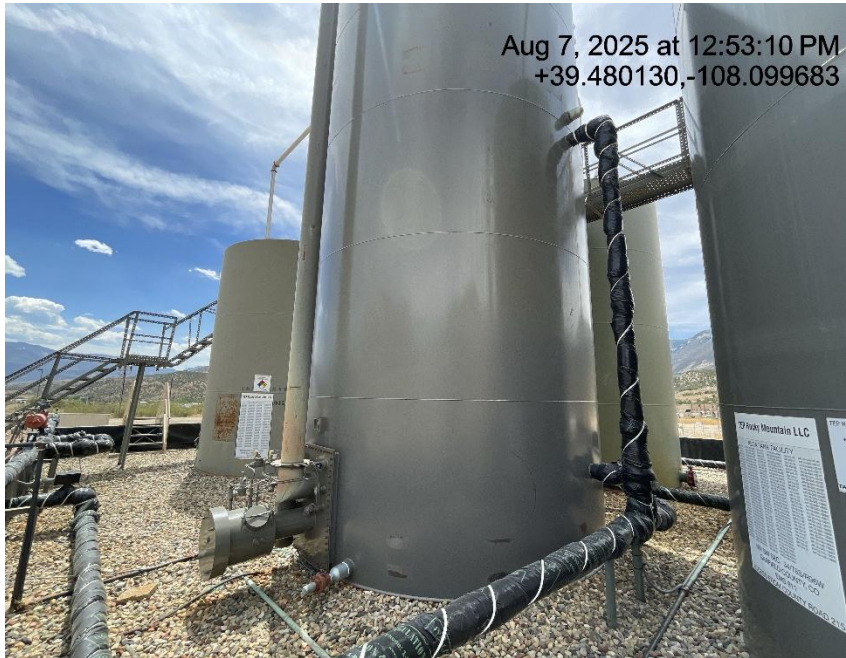
Photo # 9301 Tank lacks required labeling

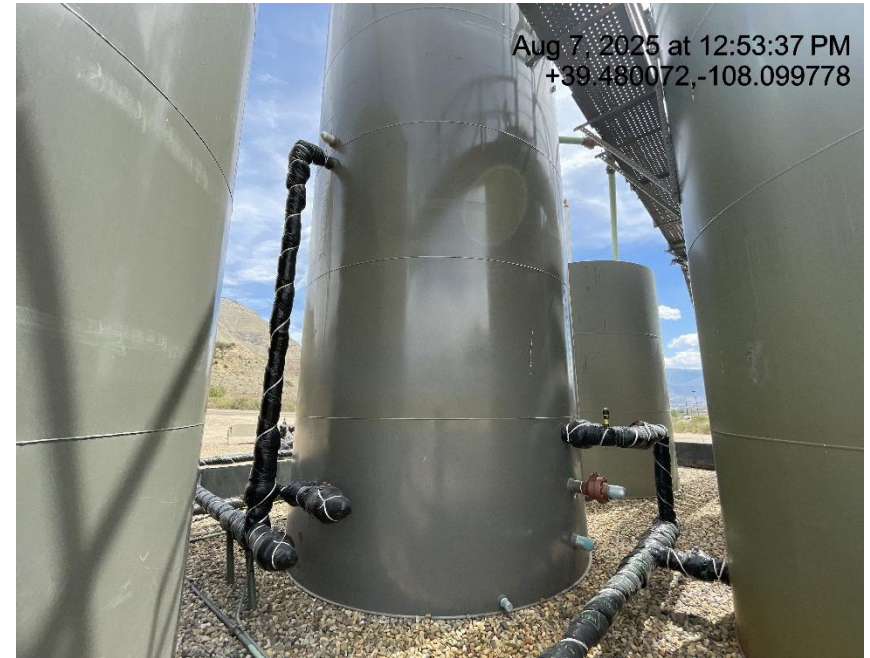
Photo # 9302 Tank lacks required labeling

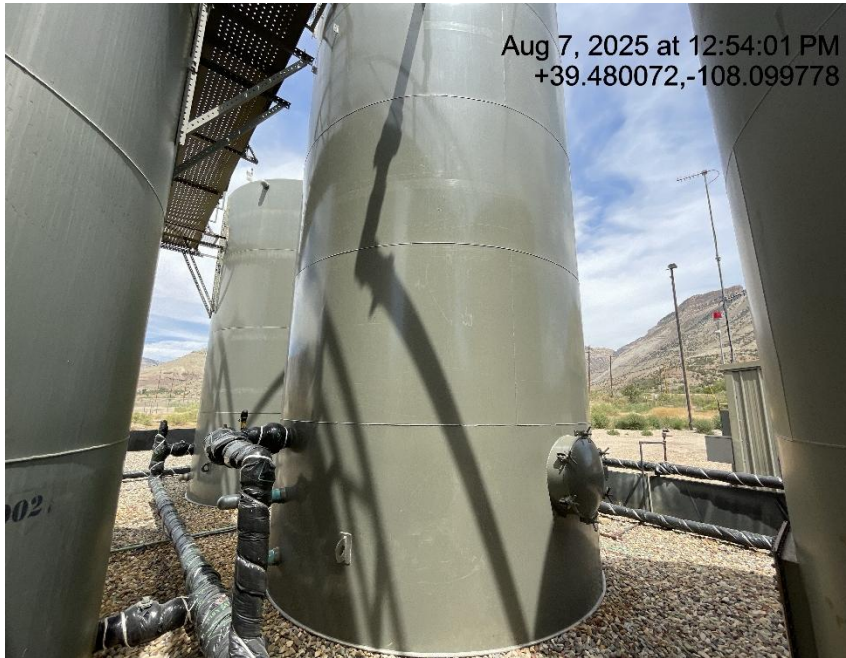
Photo # 9303 Tank lacks required labeling

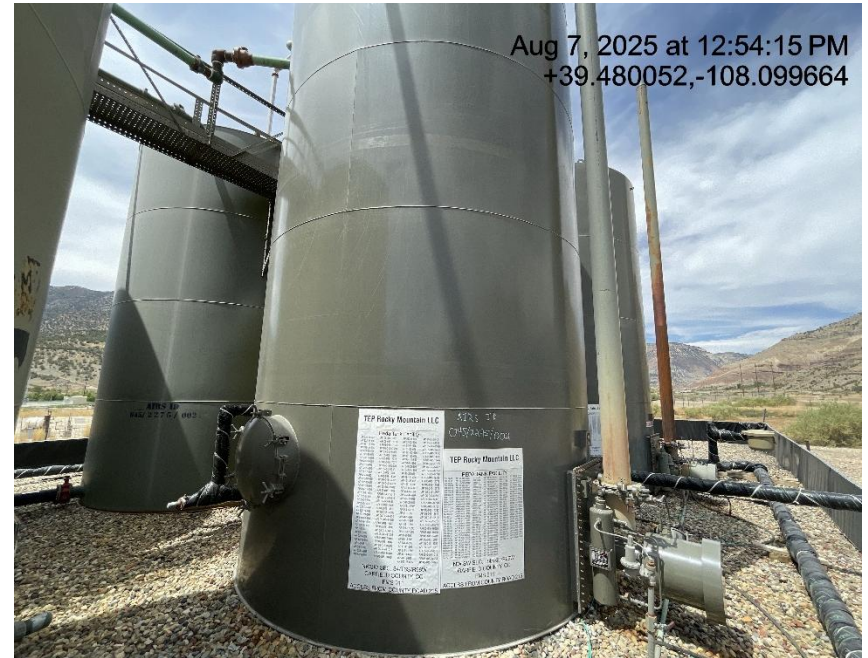
Photo # 9304 Tank lacks required labeling
