WELL NAME: MUFFINS 14-18, API #: 071-8759, INSP. # 716301357

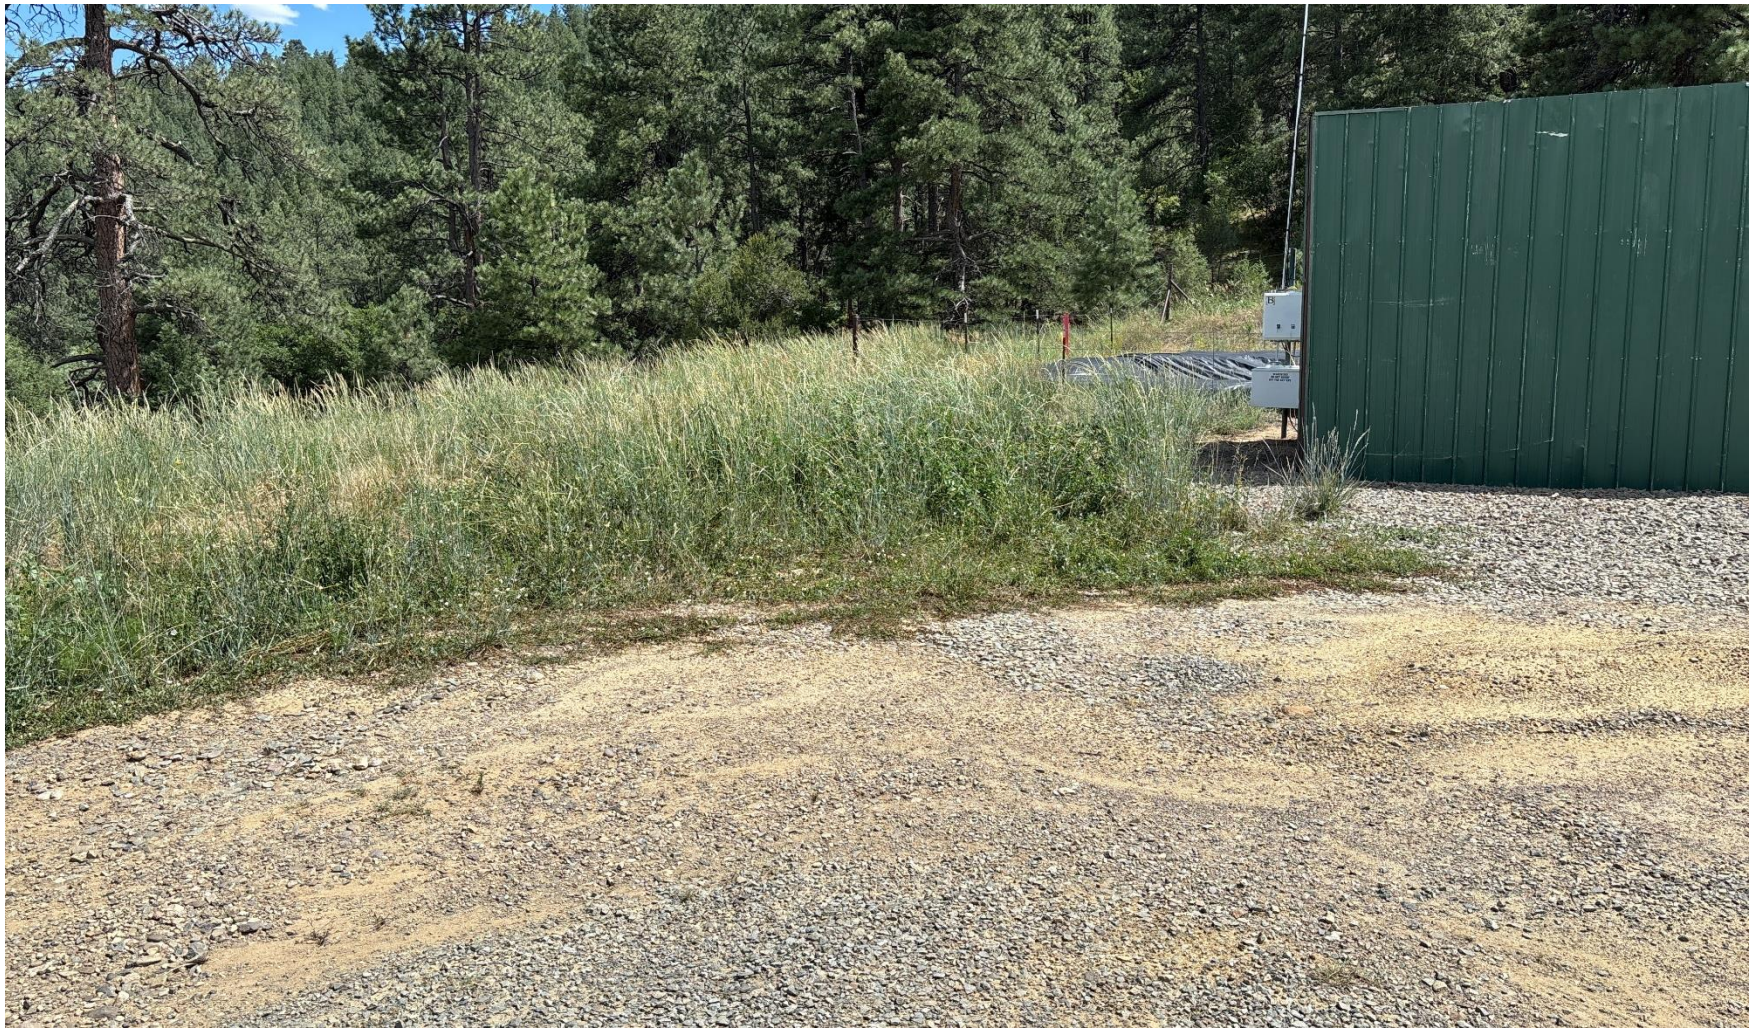
PHOTO 4: WEEDS ARE ENCROACHING ON WELLHEAD EQUIPMENT. MAINTAIN WEEDS PER RULE 606. CA DATE 8-16-2025.

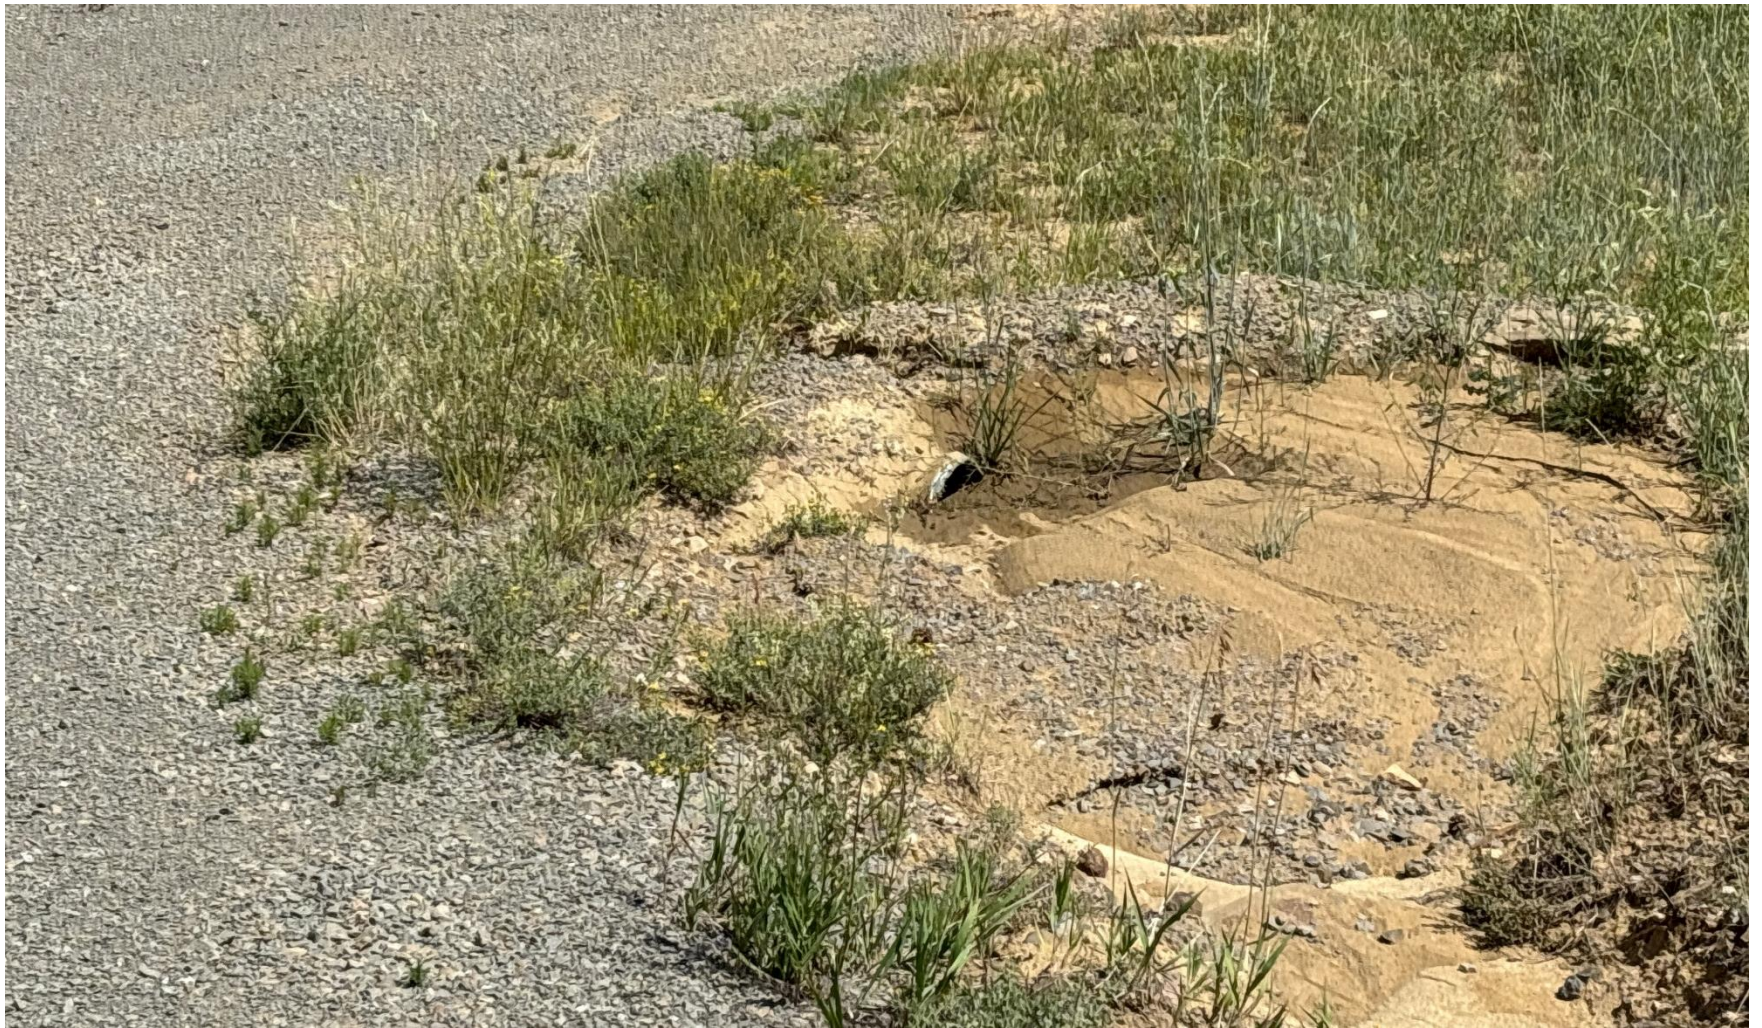
PHOTO 5: CULVERT IS PLUGGED. Install or repair required BMPs per Rule 1002.f.(2)C . CA DATE 6/13/2025.

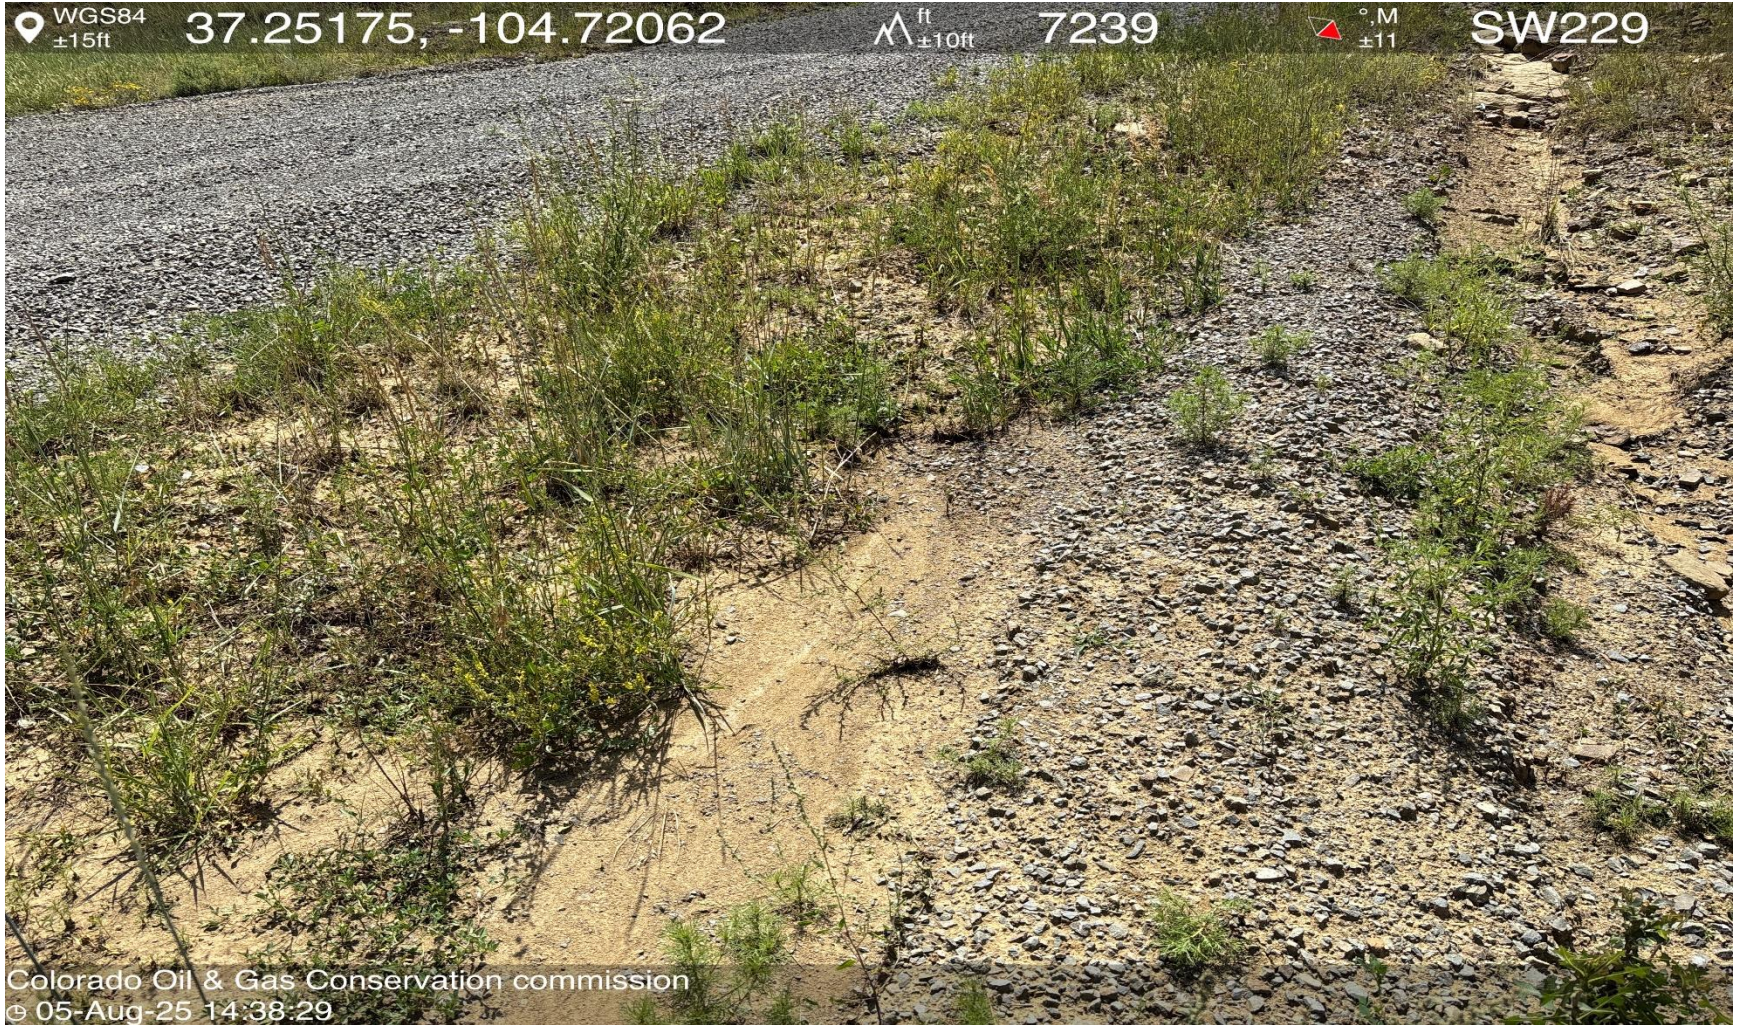
PHOTO 6: DOWN SLOP SIDE OF CULVERT IS COMPLETELY COVERED. Install or repair required BMPs per Rule 1002.f.(2)C. THIS IS THE SECOND NOTICE FOR THIS CORRECTIVE ACTION, IMMEDIATE ACTION IS REQUIRED.

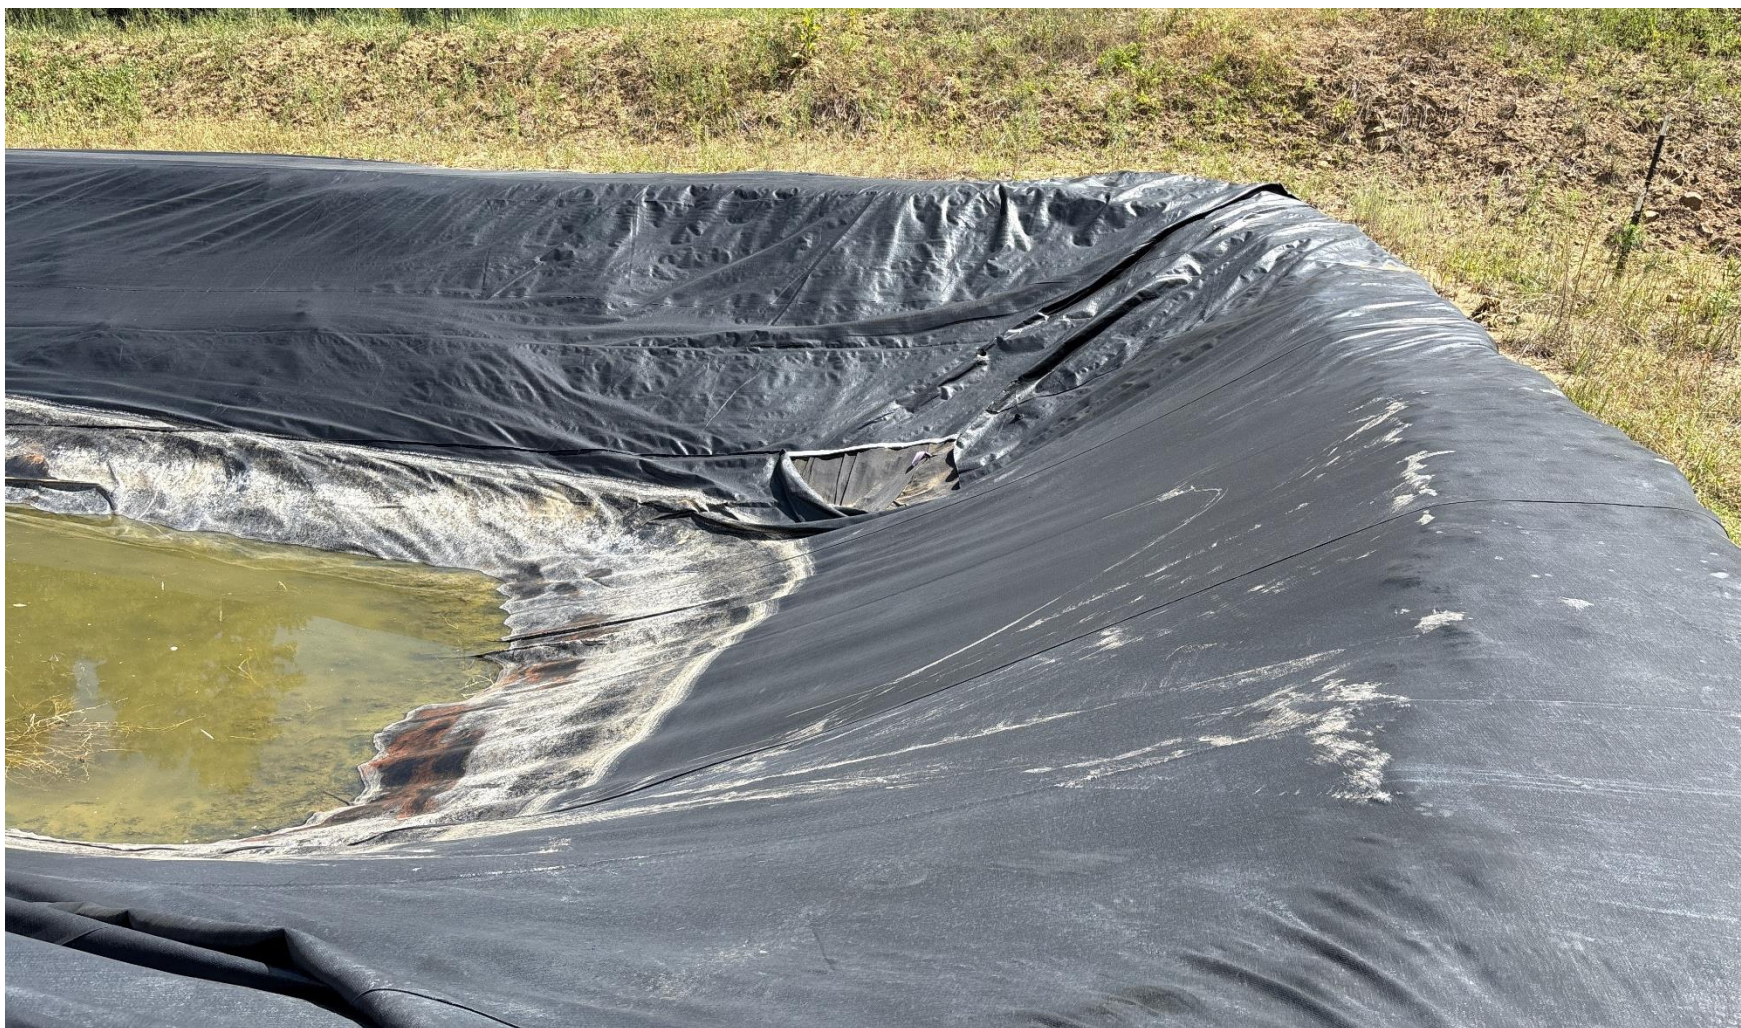
PHOTO 7: PRODUCE WATER PIT LINER IS COMPROMISED. REPAIR LINER OR (Rule 910) Reduce fluid level in pit, contact ECOM EPS staff for directives. THIS IS THE SECOND NOTICE FOR THIS CORRECTIVE ACTION IMMEDIATE ACTION IS REQUIRED.

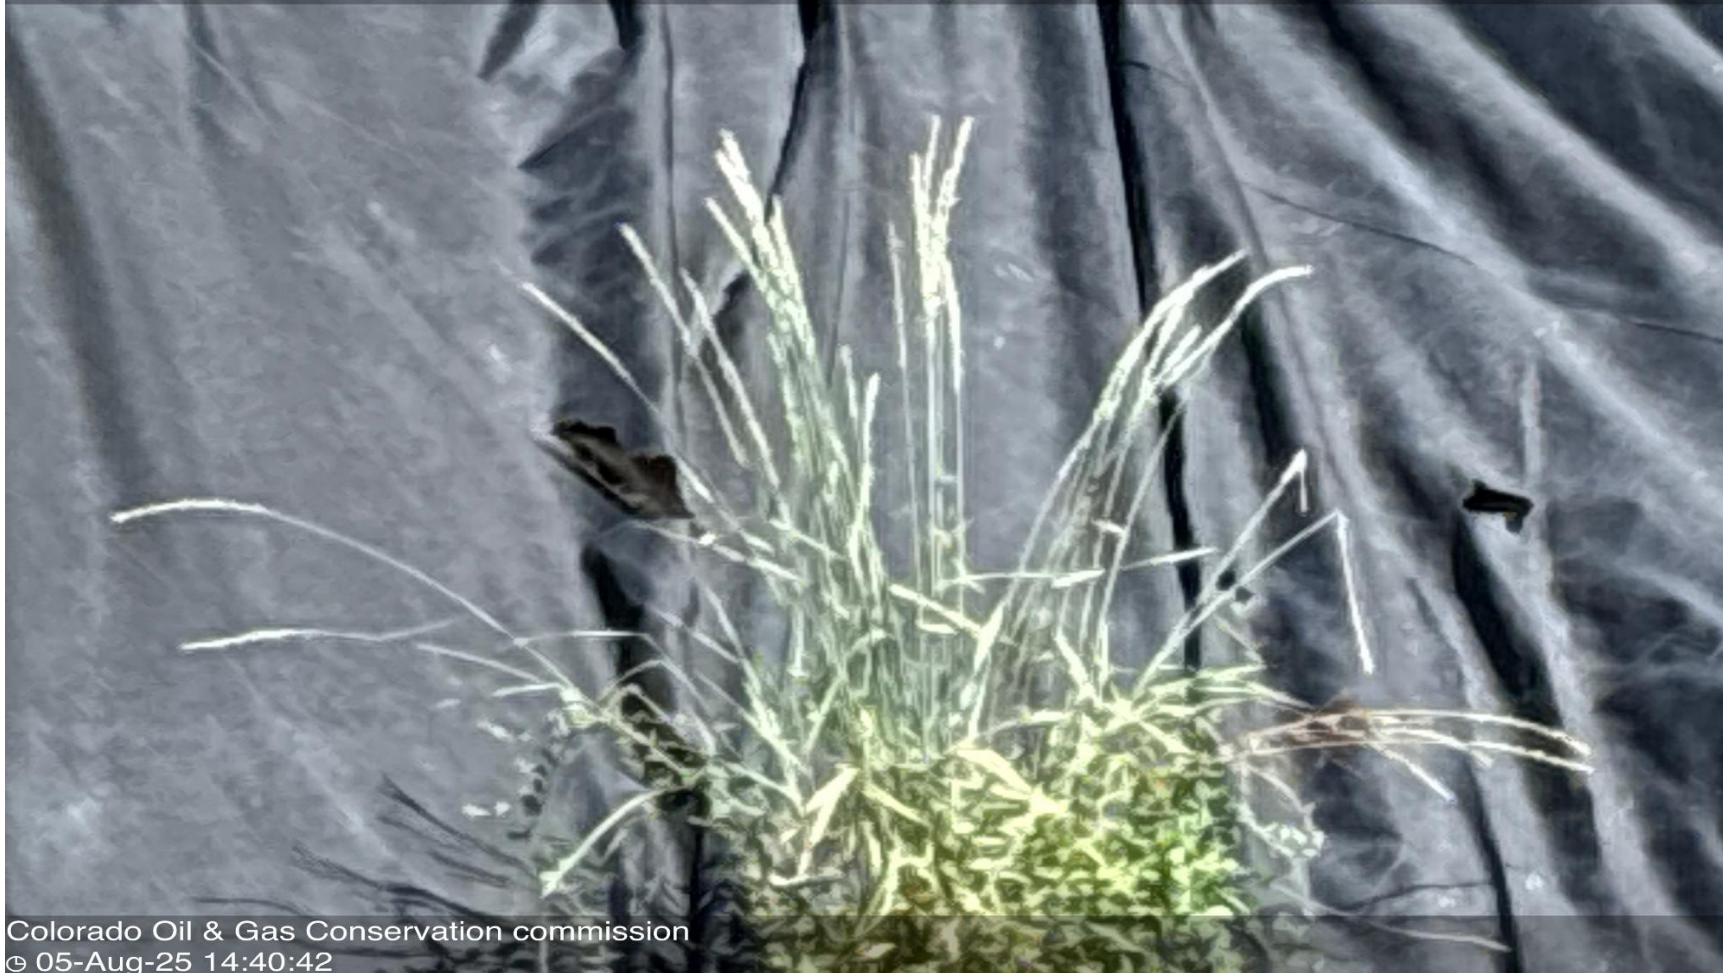
PHOTO 8: PRODUCE WATER PIT LINER IS COMPROMISED. REPAIR LINER OR (Rule 910) Reduce fluid level in pit, contact ECOM EPS staff for directives. THIS IS THE SECOND NOTICE FOR THIS CORRECTIVE ACTION IMMEDIATE ACTION IS REQUIRED.
