Inspection Photos
Location Name: Max Serafini 'B'-62N68W 28NESW
Location ID: 318224

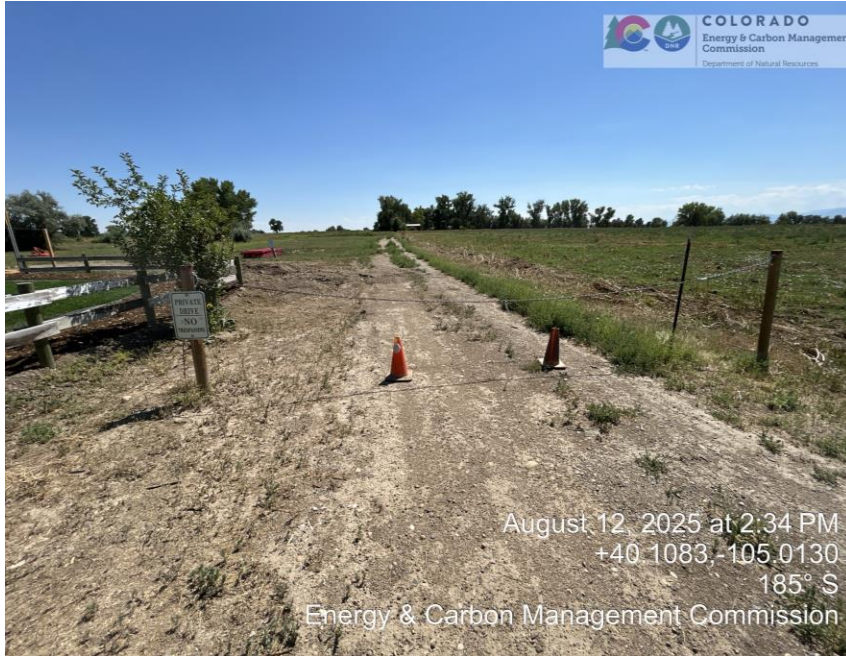
No access

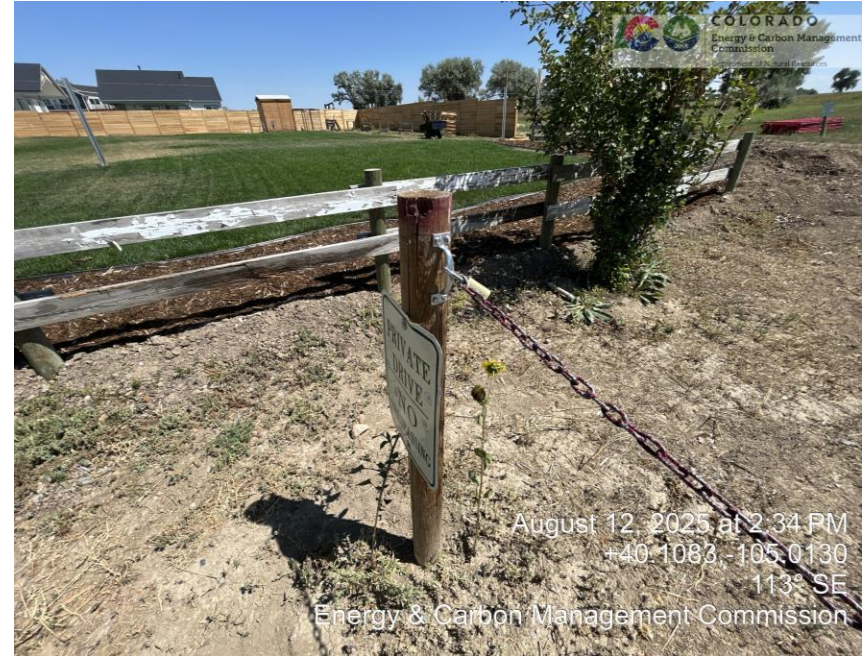
No access

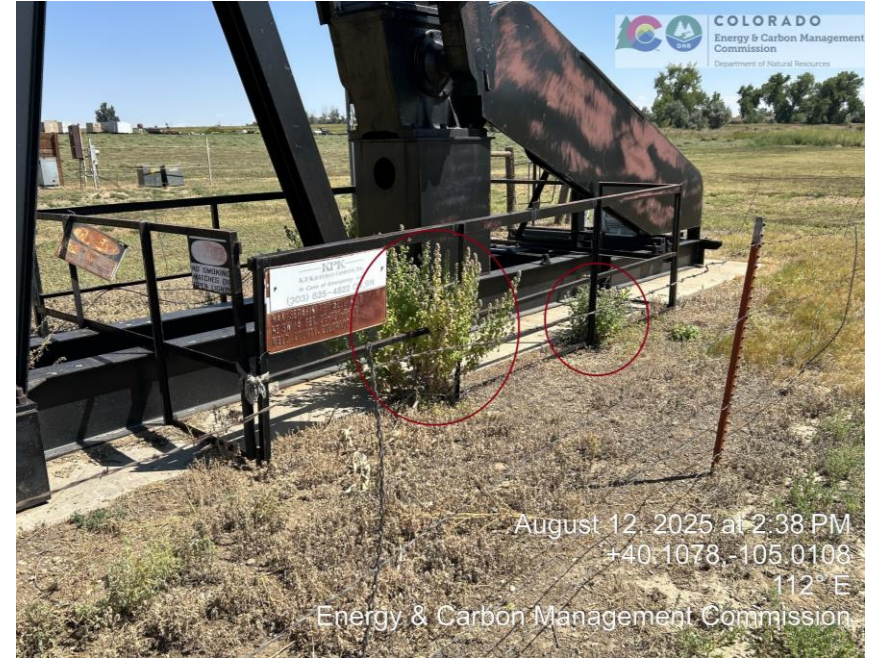
Overgrown Vegetation

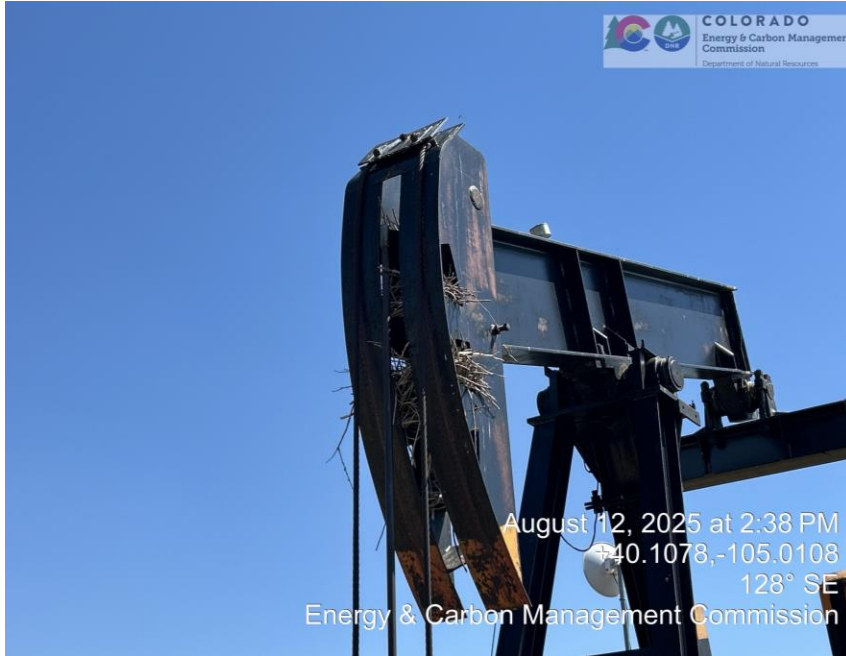
Horsehead on pumping unit appears to have bird nest but doesn't appear to be active. Consult with CPW.

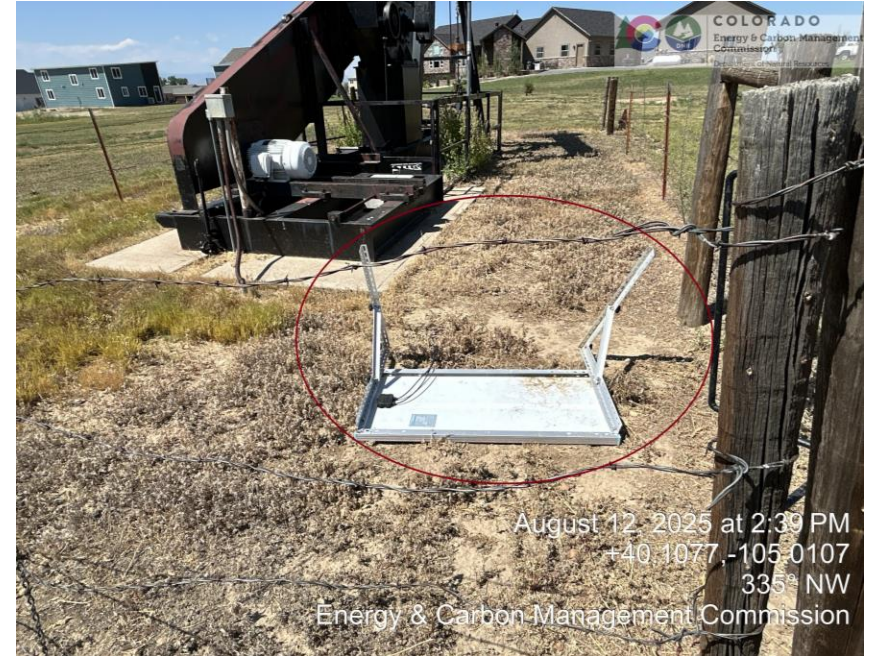
Unused Equipment

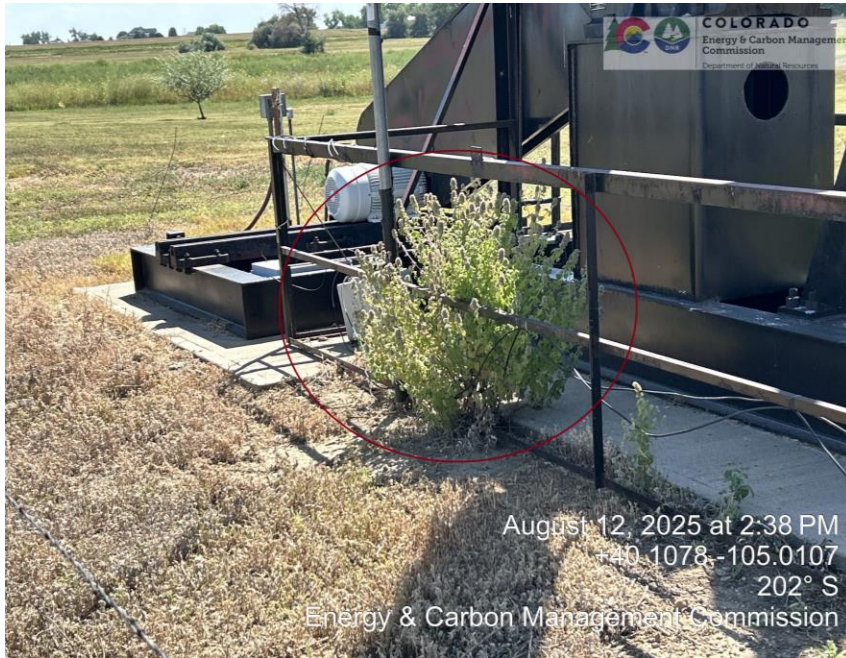
Overgrown Vegetation

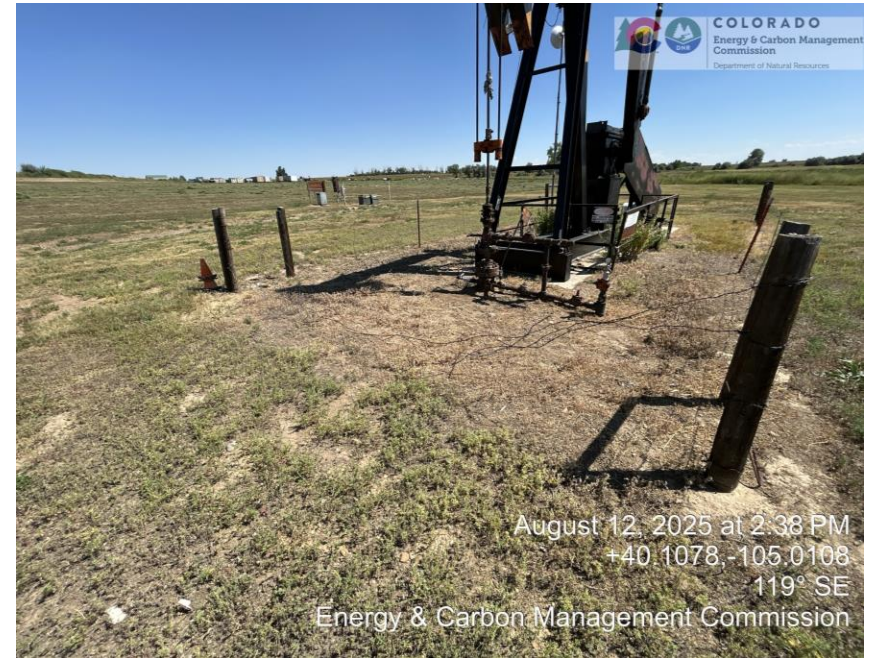
Torn down barbwire fence

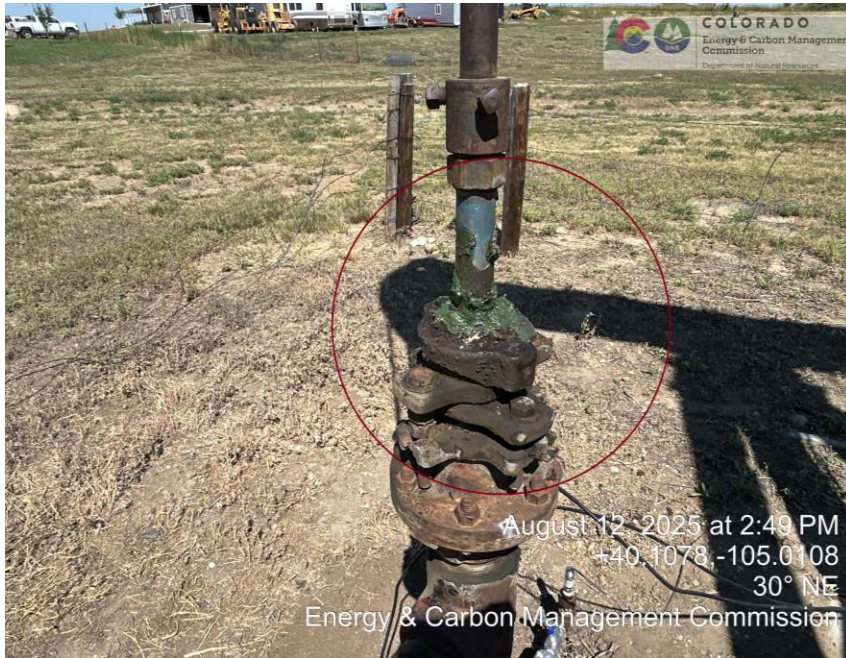
Packing on the well appears to be emitting emissions and needs to be fix or replaced.

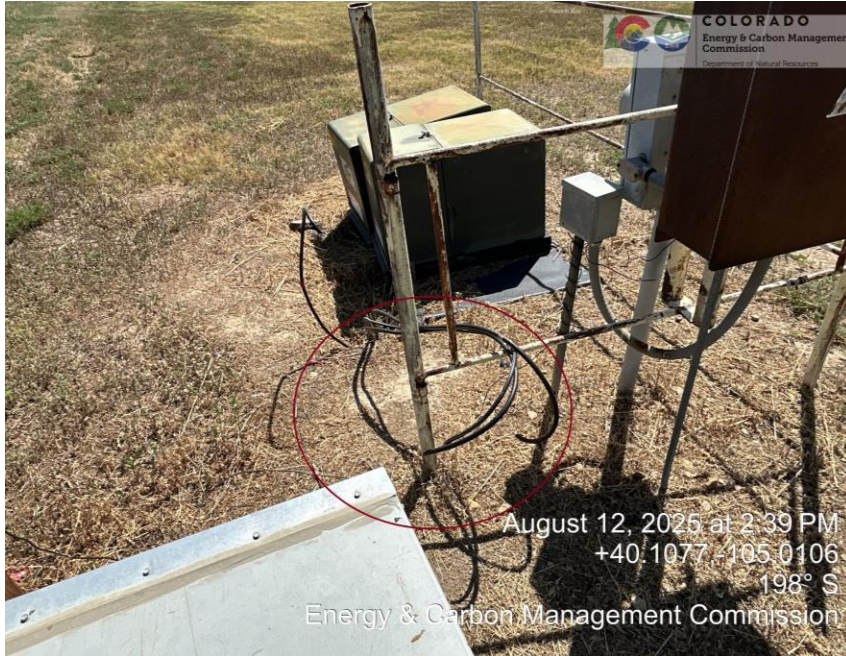
Exposed wires for pumping unit electrical box/ transformers appears to be a safety hazard.

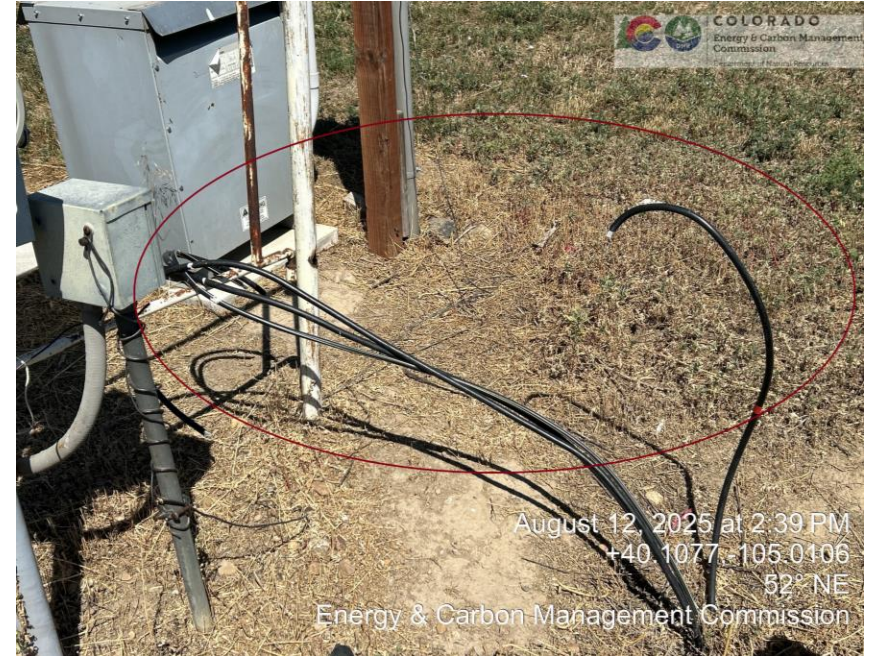
Exposed wires for pumping unit electrical box/ transformers appears to be a safety hazard.

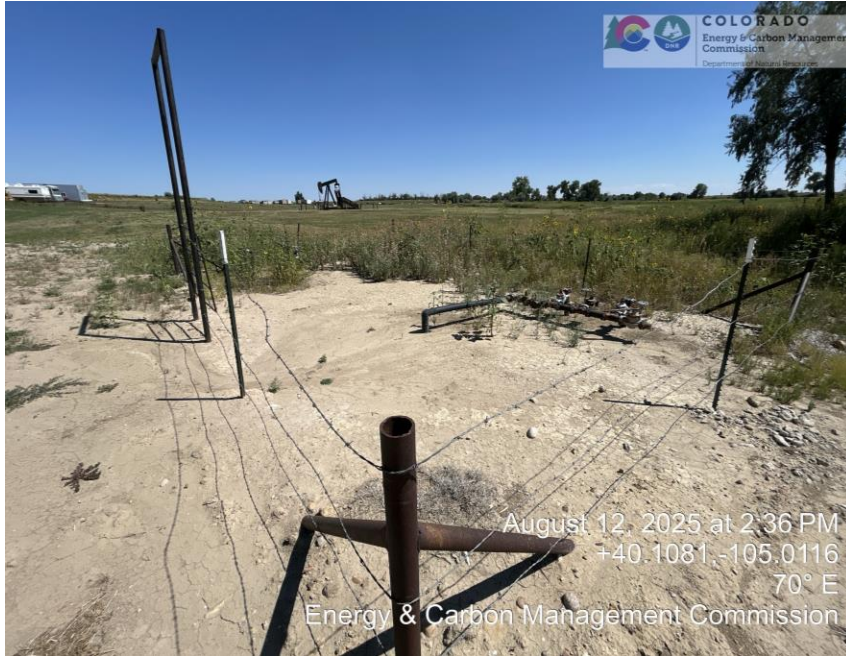
Header Location/ overgrown vegetation

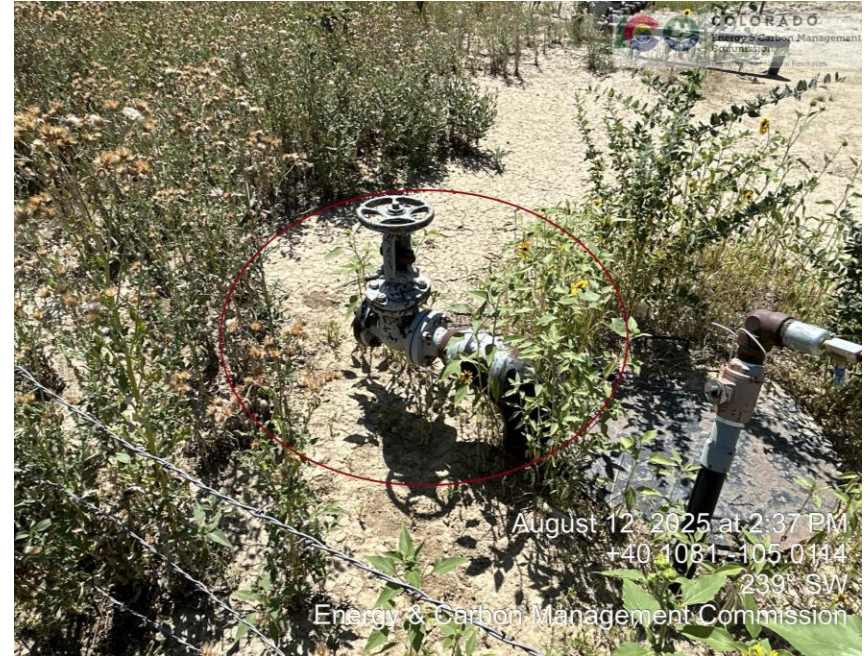
Unmarked Risers/ Overgrown vegetation

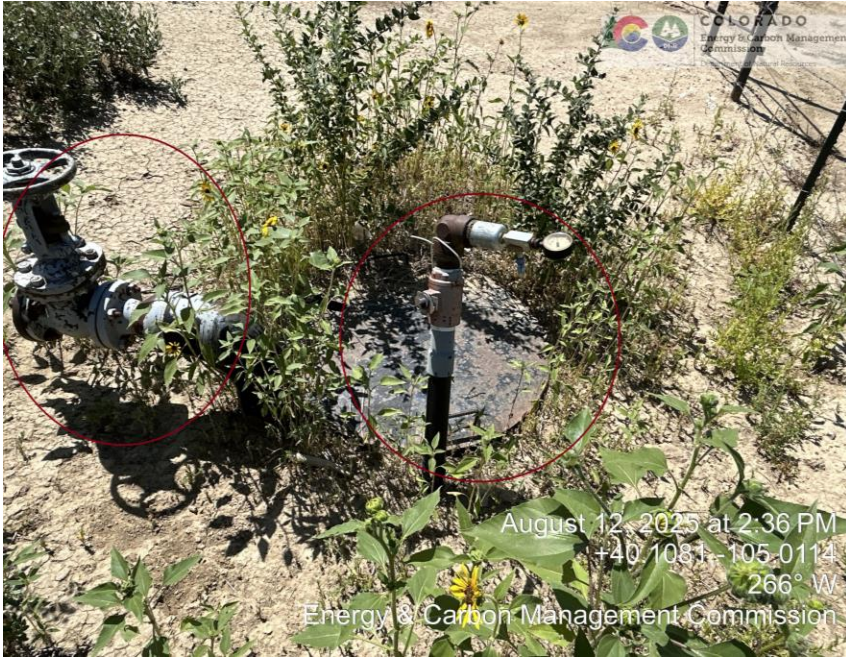
Unmarked Risers/ Overgrown vegetation

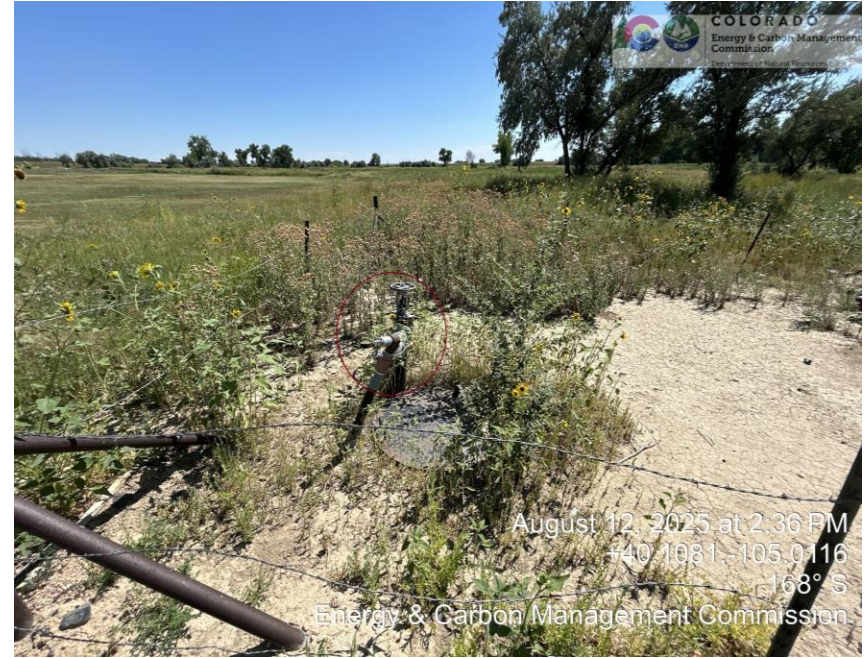
Unmarked Risers/ Overgrown vegetation
