Dwinell
© 03-Jun-25 01:52:09 PM
ECMC Environmental Inspection

ECMC
Environmental
Field Inspection

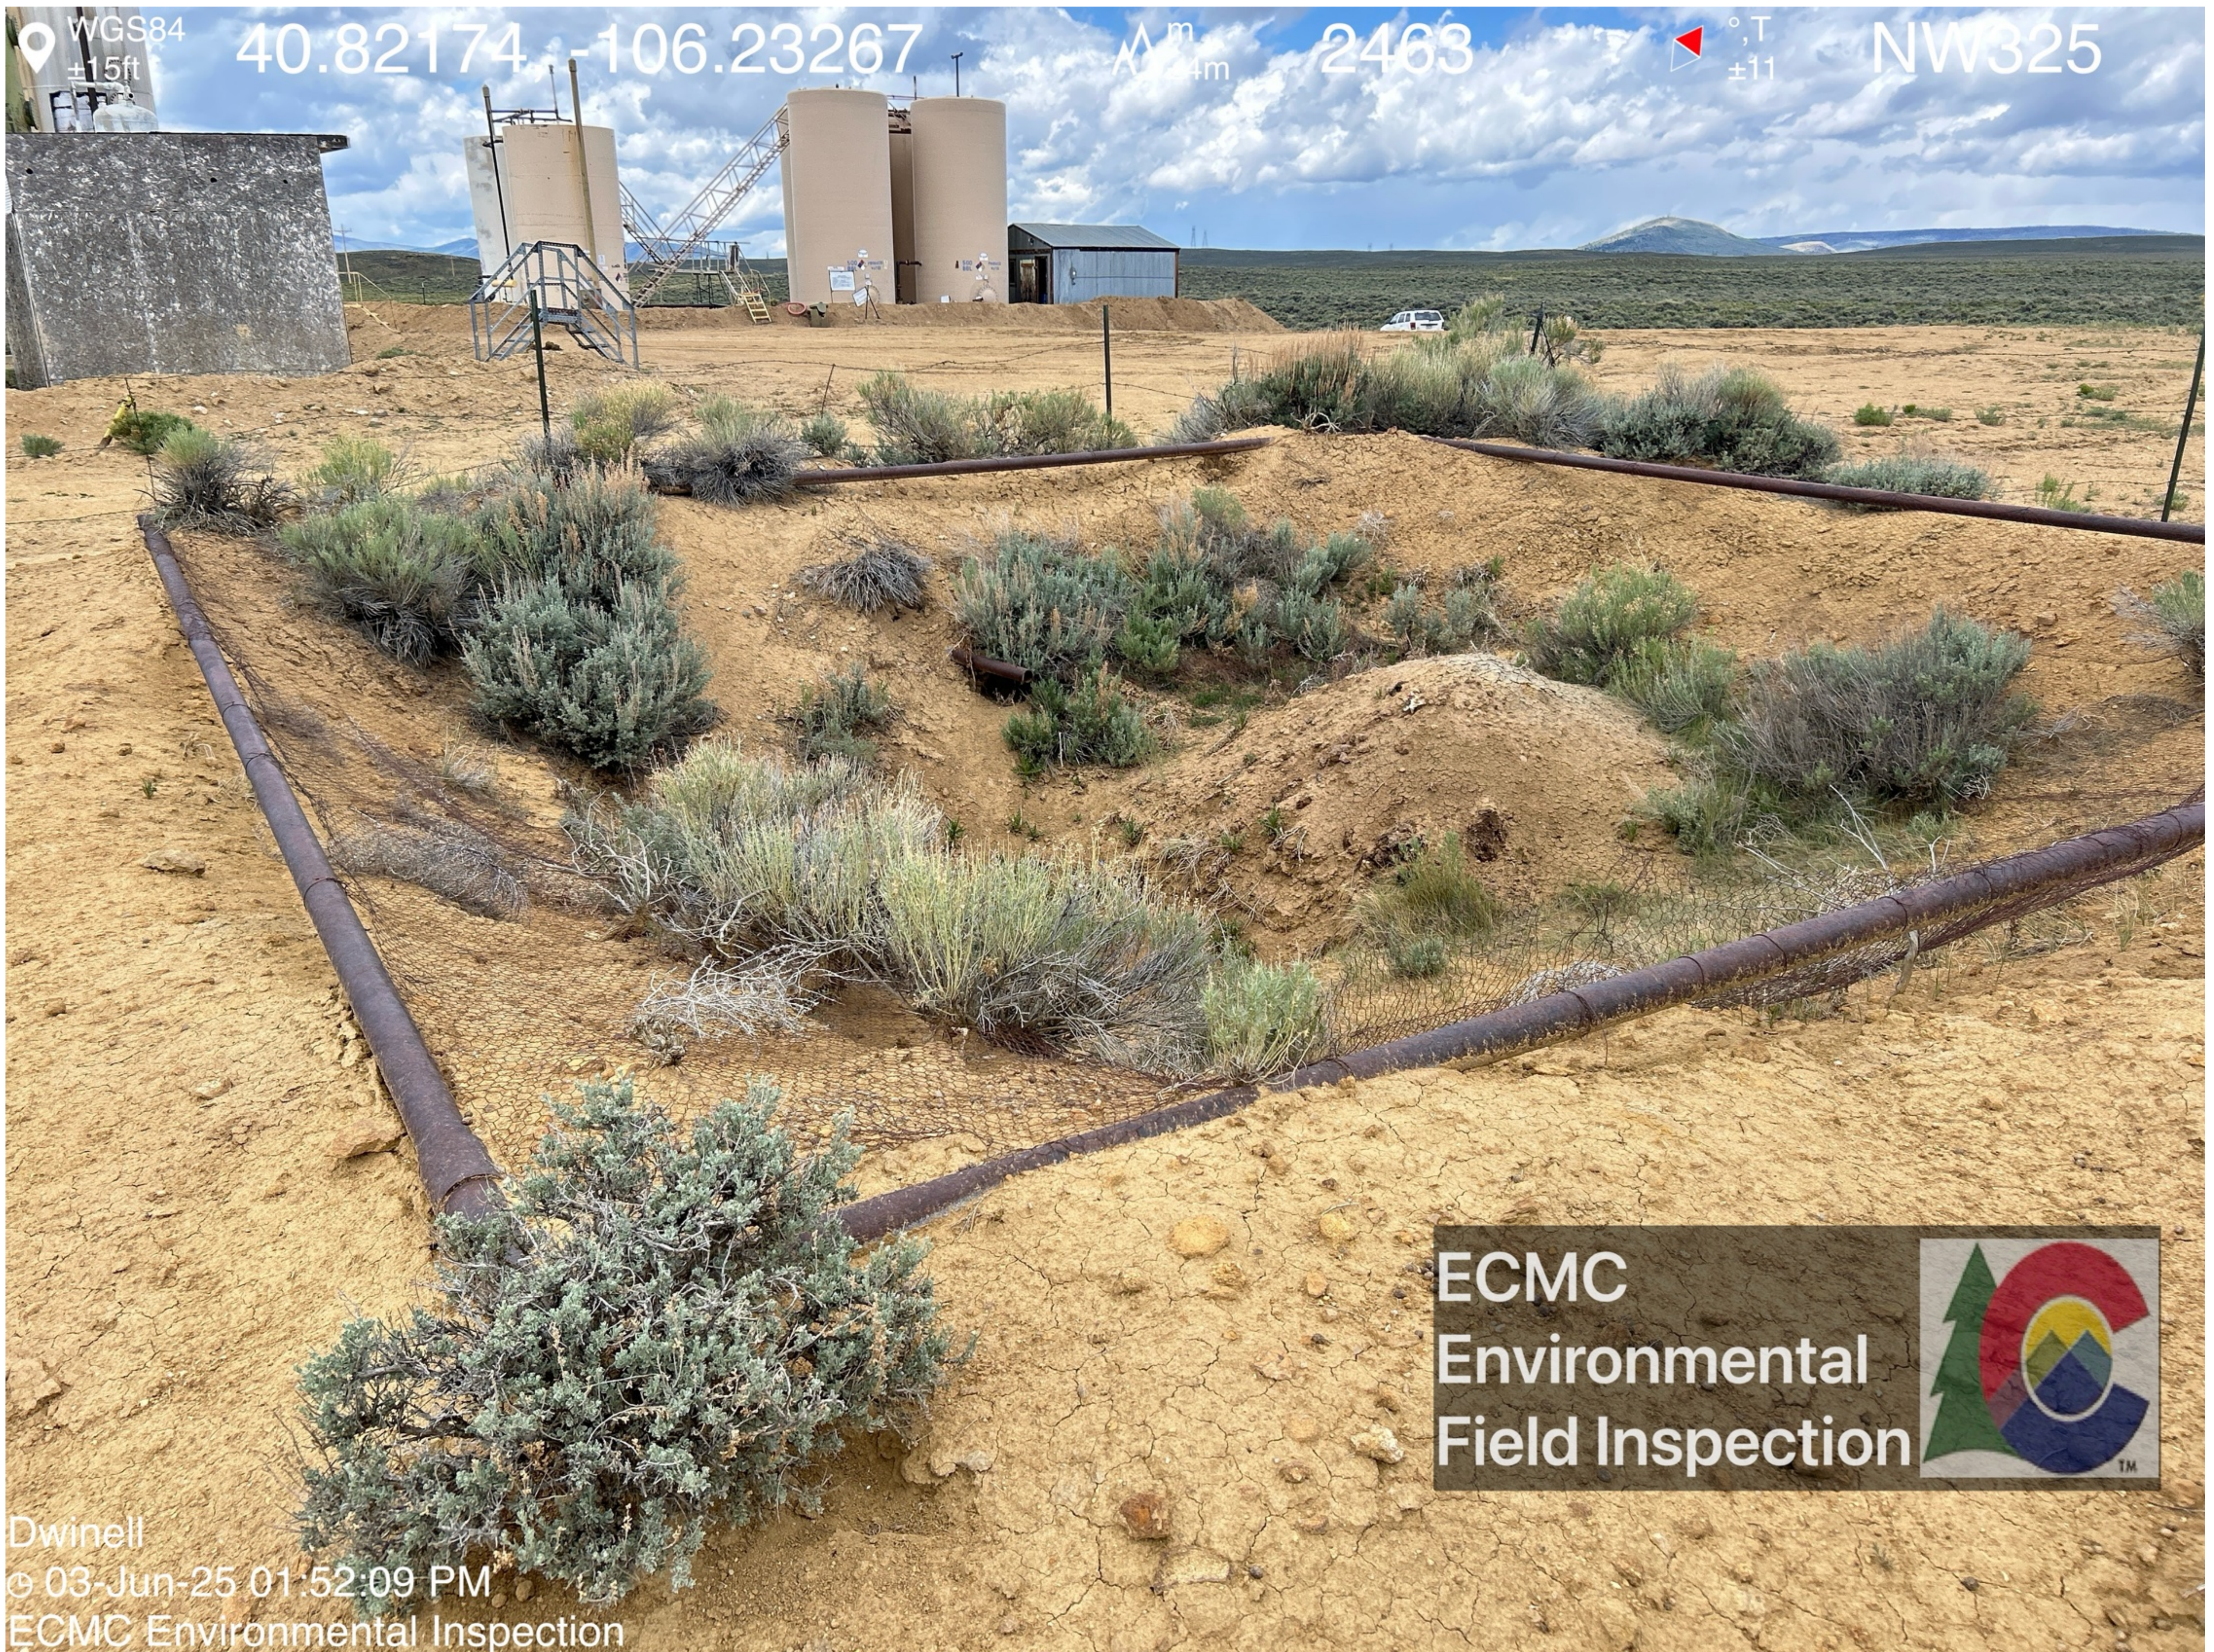
An earthen pit was visible on location. No liner was visible. No fluid was visible in the pit. An uncapped metal flowline was visible on the western side of the pit.

The Dwinell Tank Battery (Facility ID 465486) is visible in the background and will be addressed in a separate inspection.

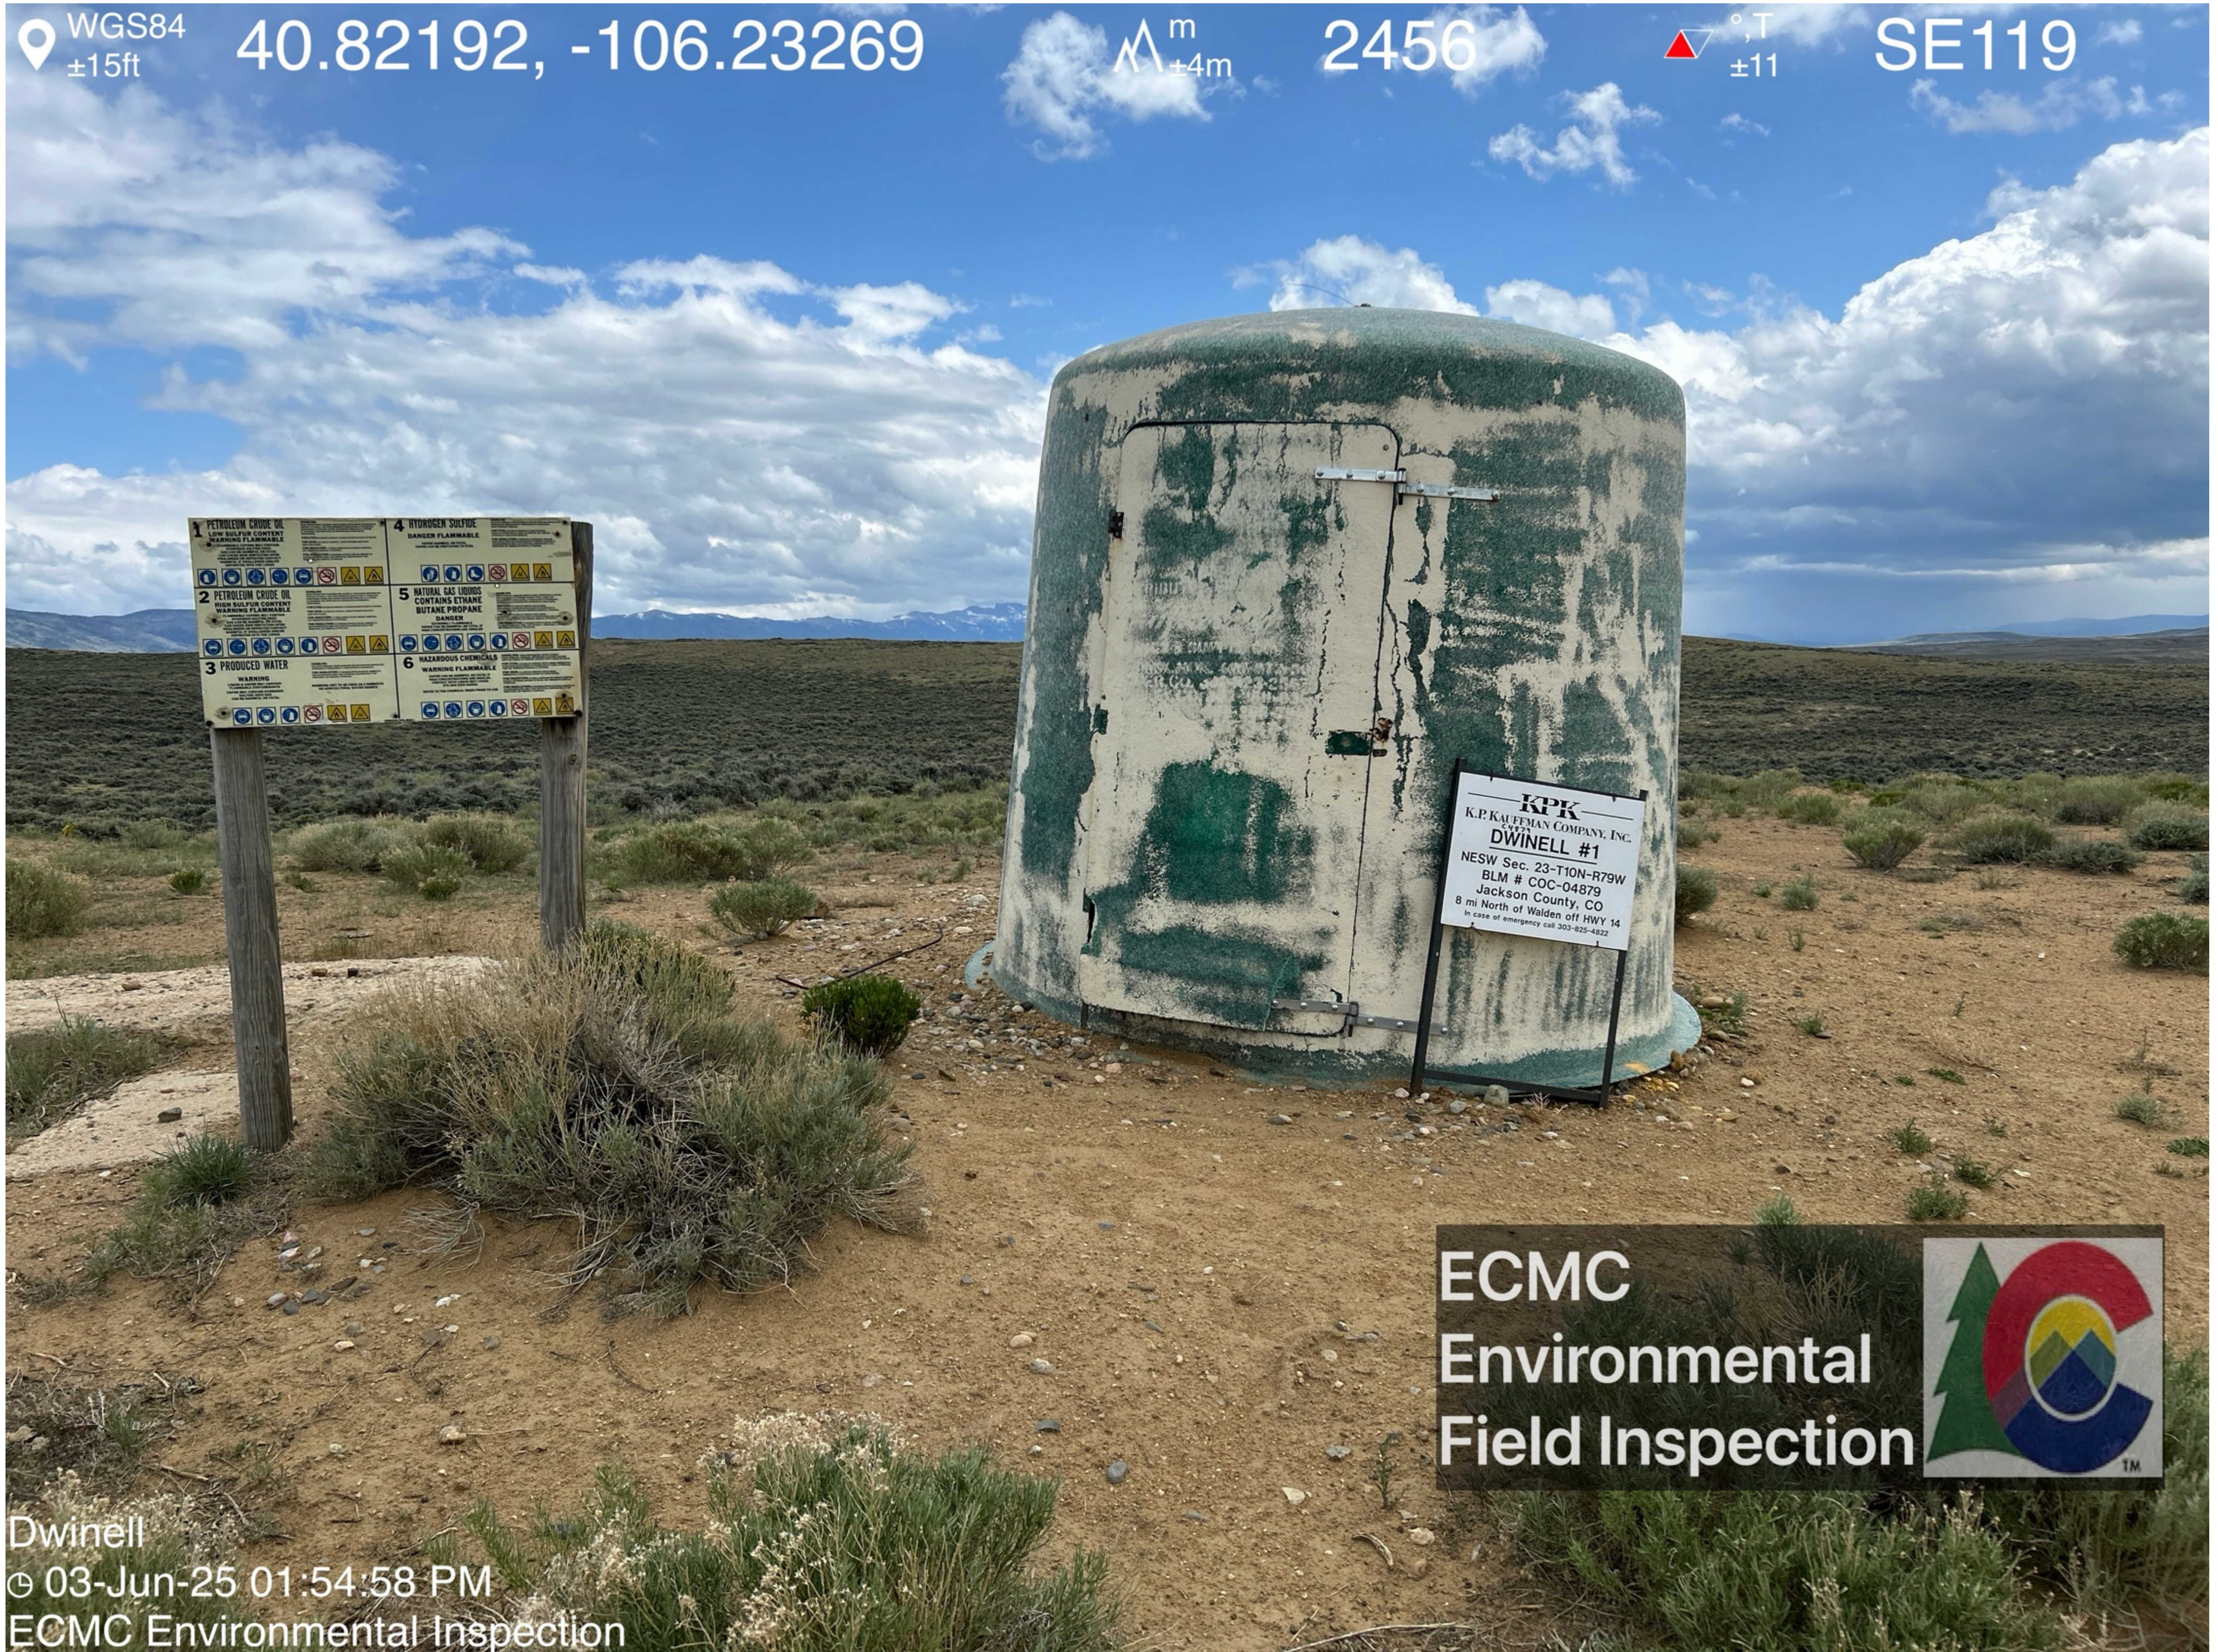
Weeds were visible within the pit. Metal netting/fencing was visible covering portions of the pit.

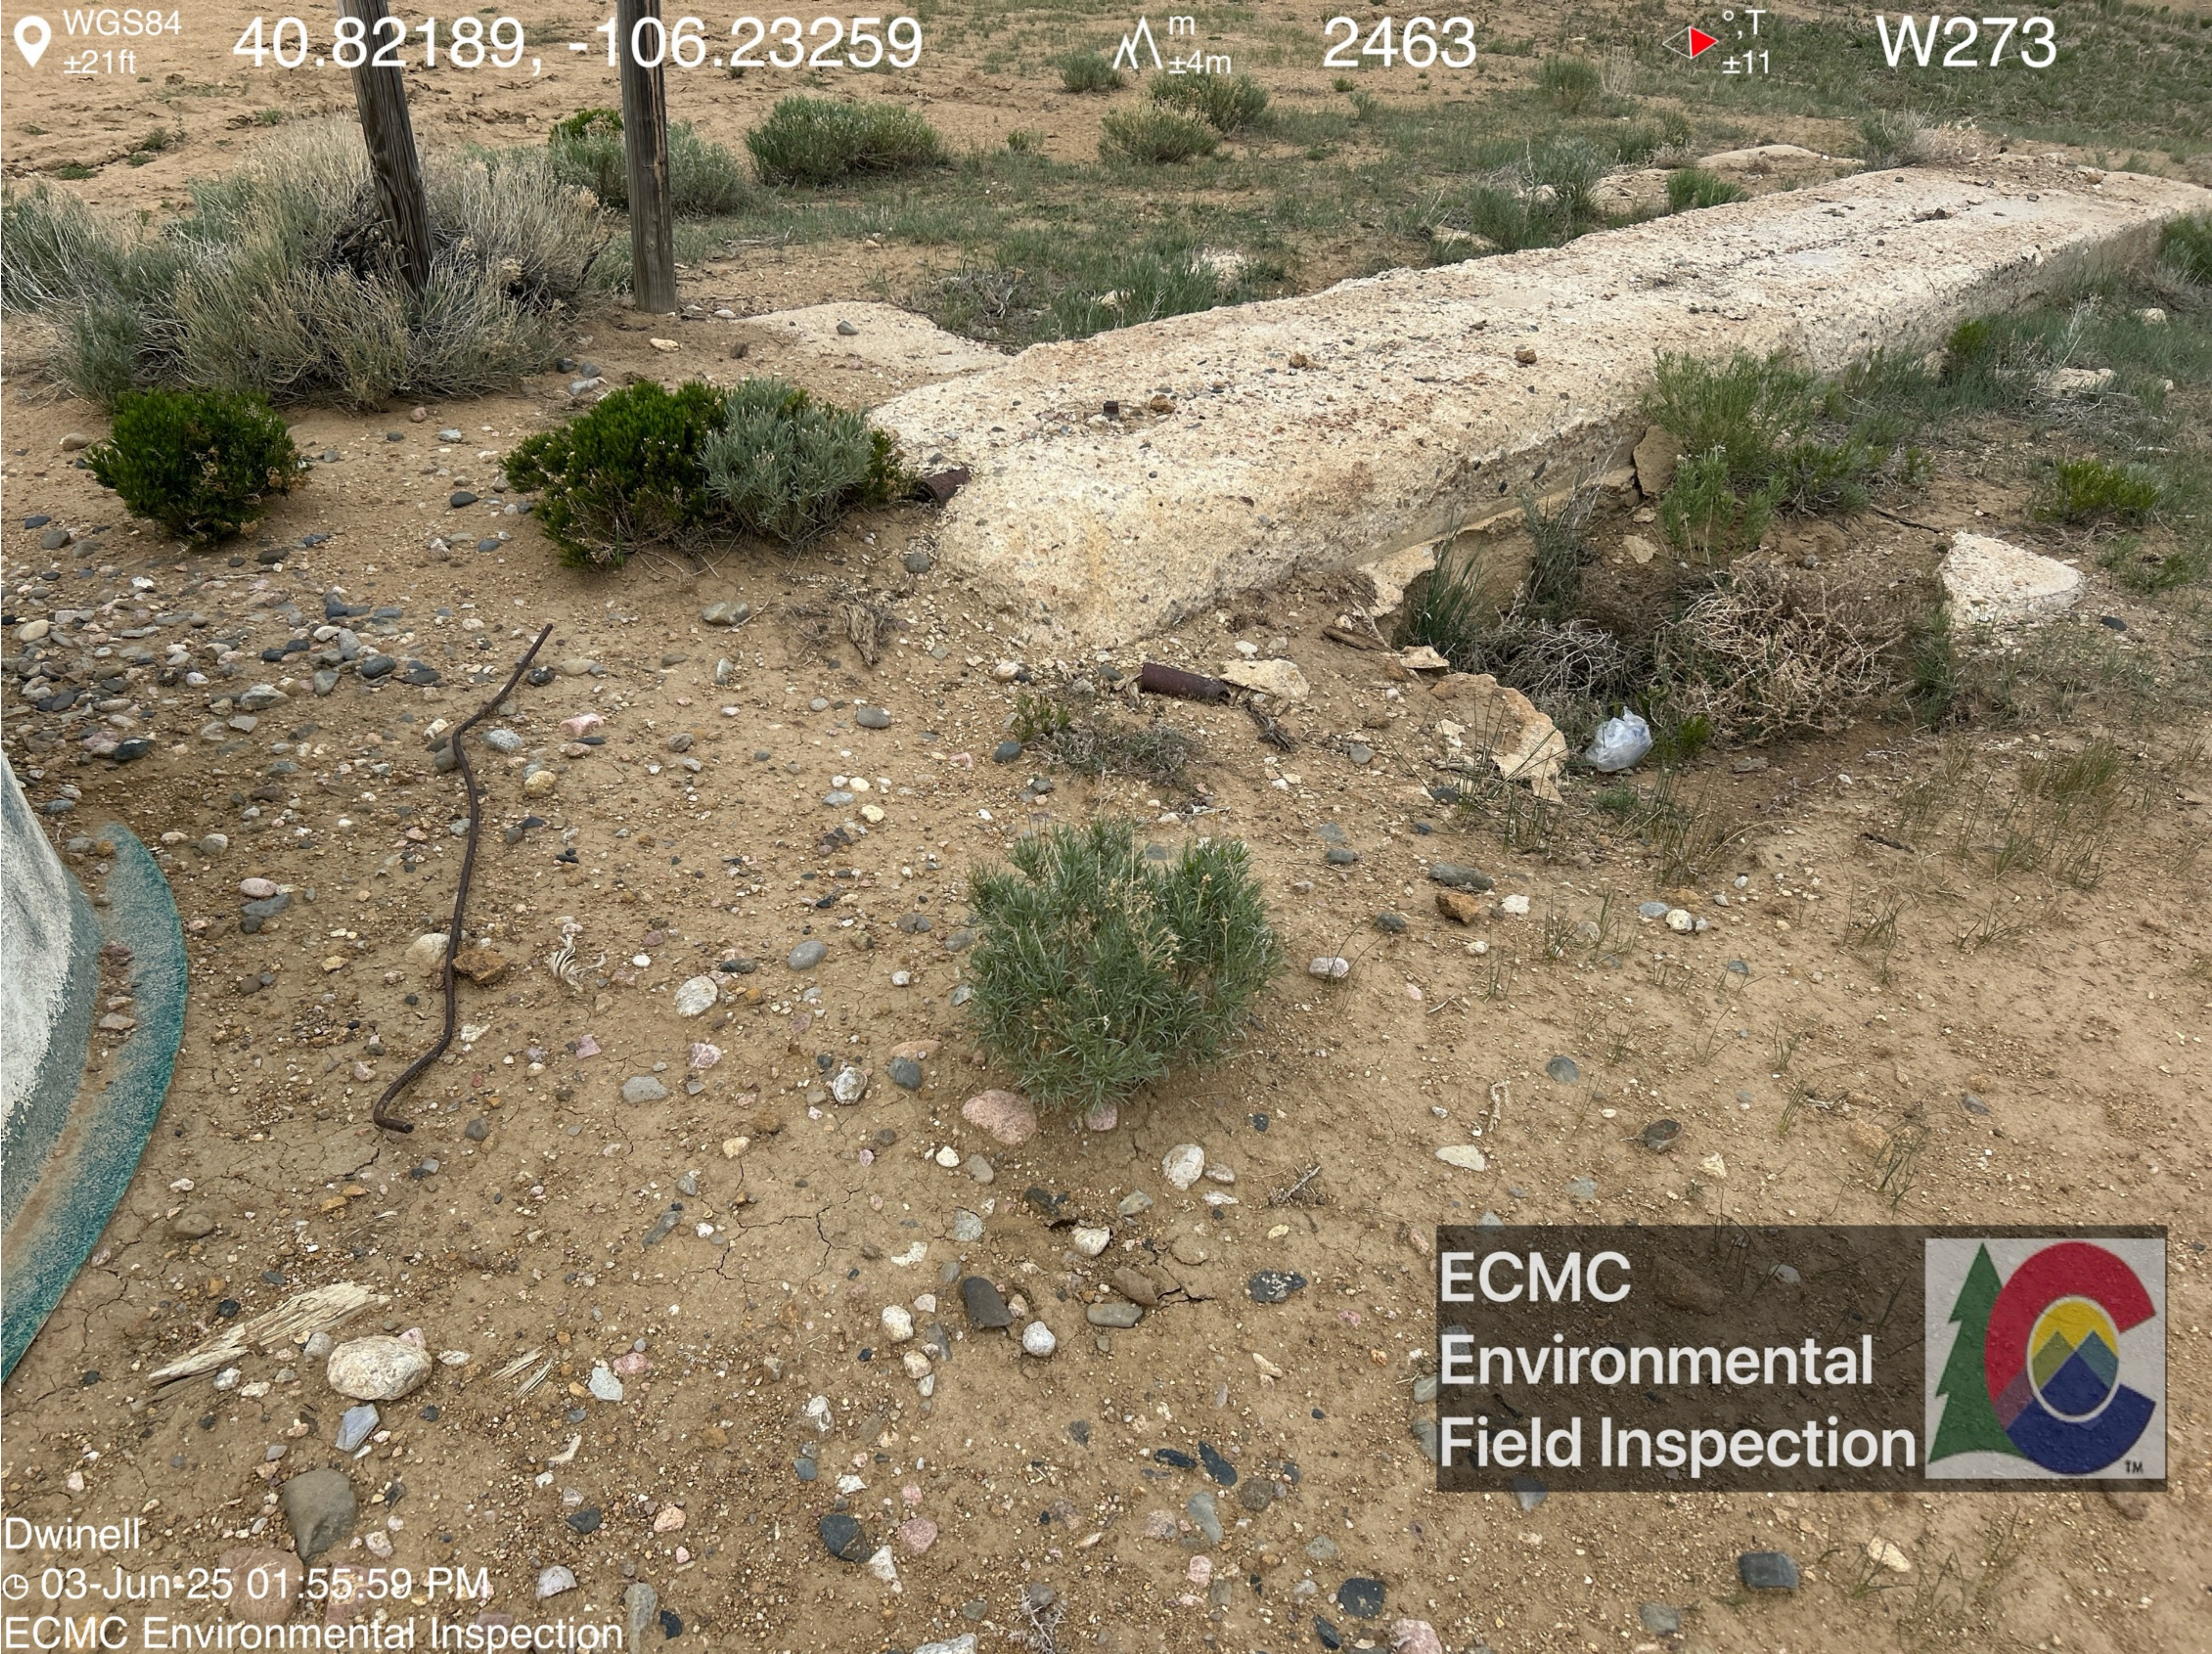
An oily rag was visible within the well house.
