MCCALLUM UNIT-610N79W 34NESW  
© 03-Jun-25 04:14:37 PM  
ECMC Environmental Inspection

ECMC  
Environmental  
Field Inspection

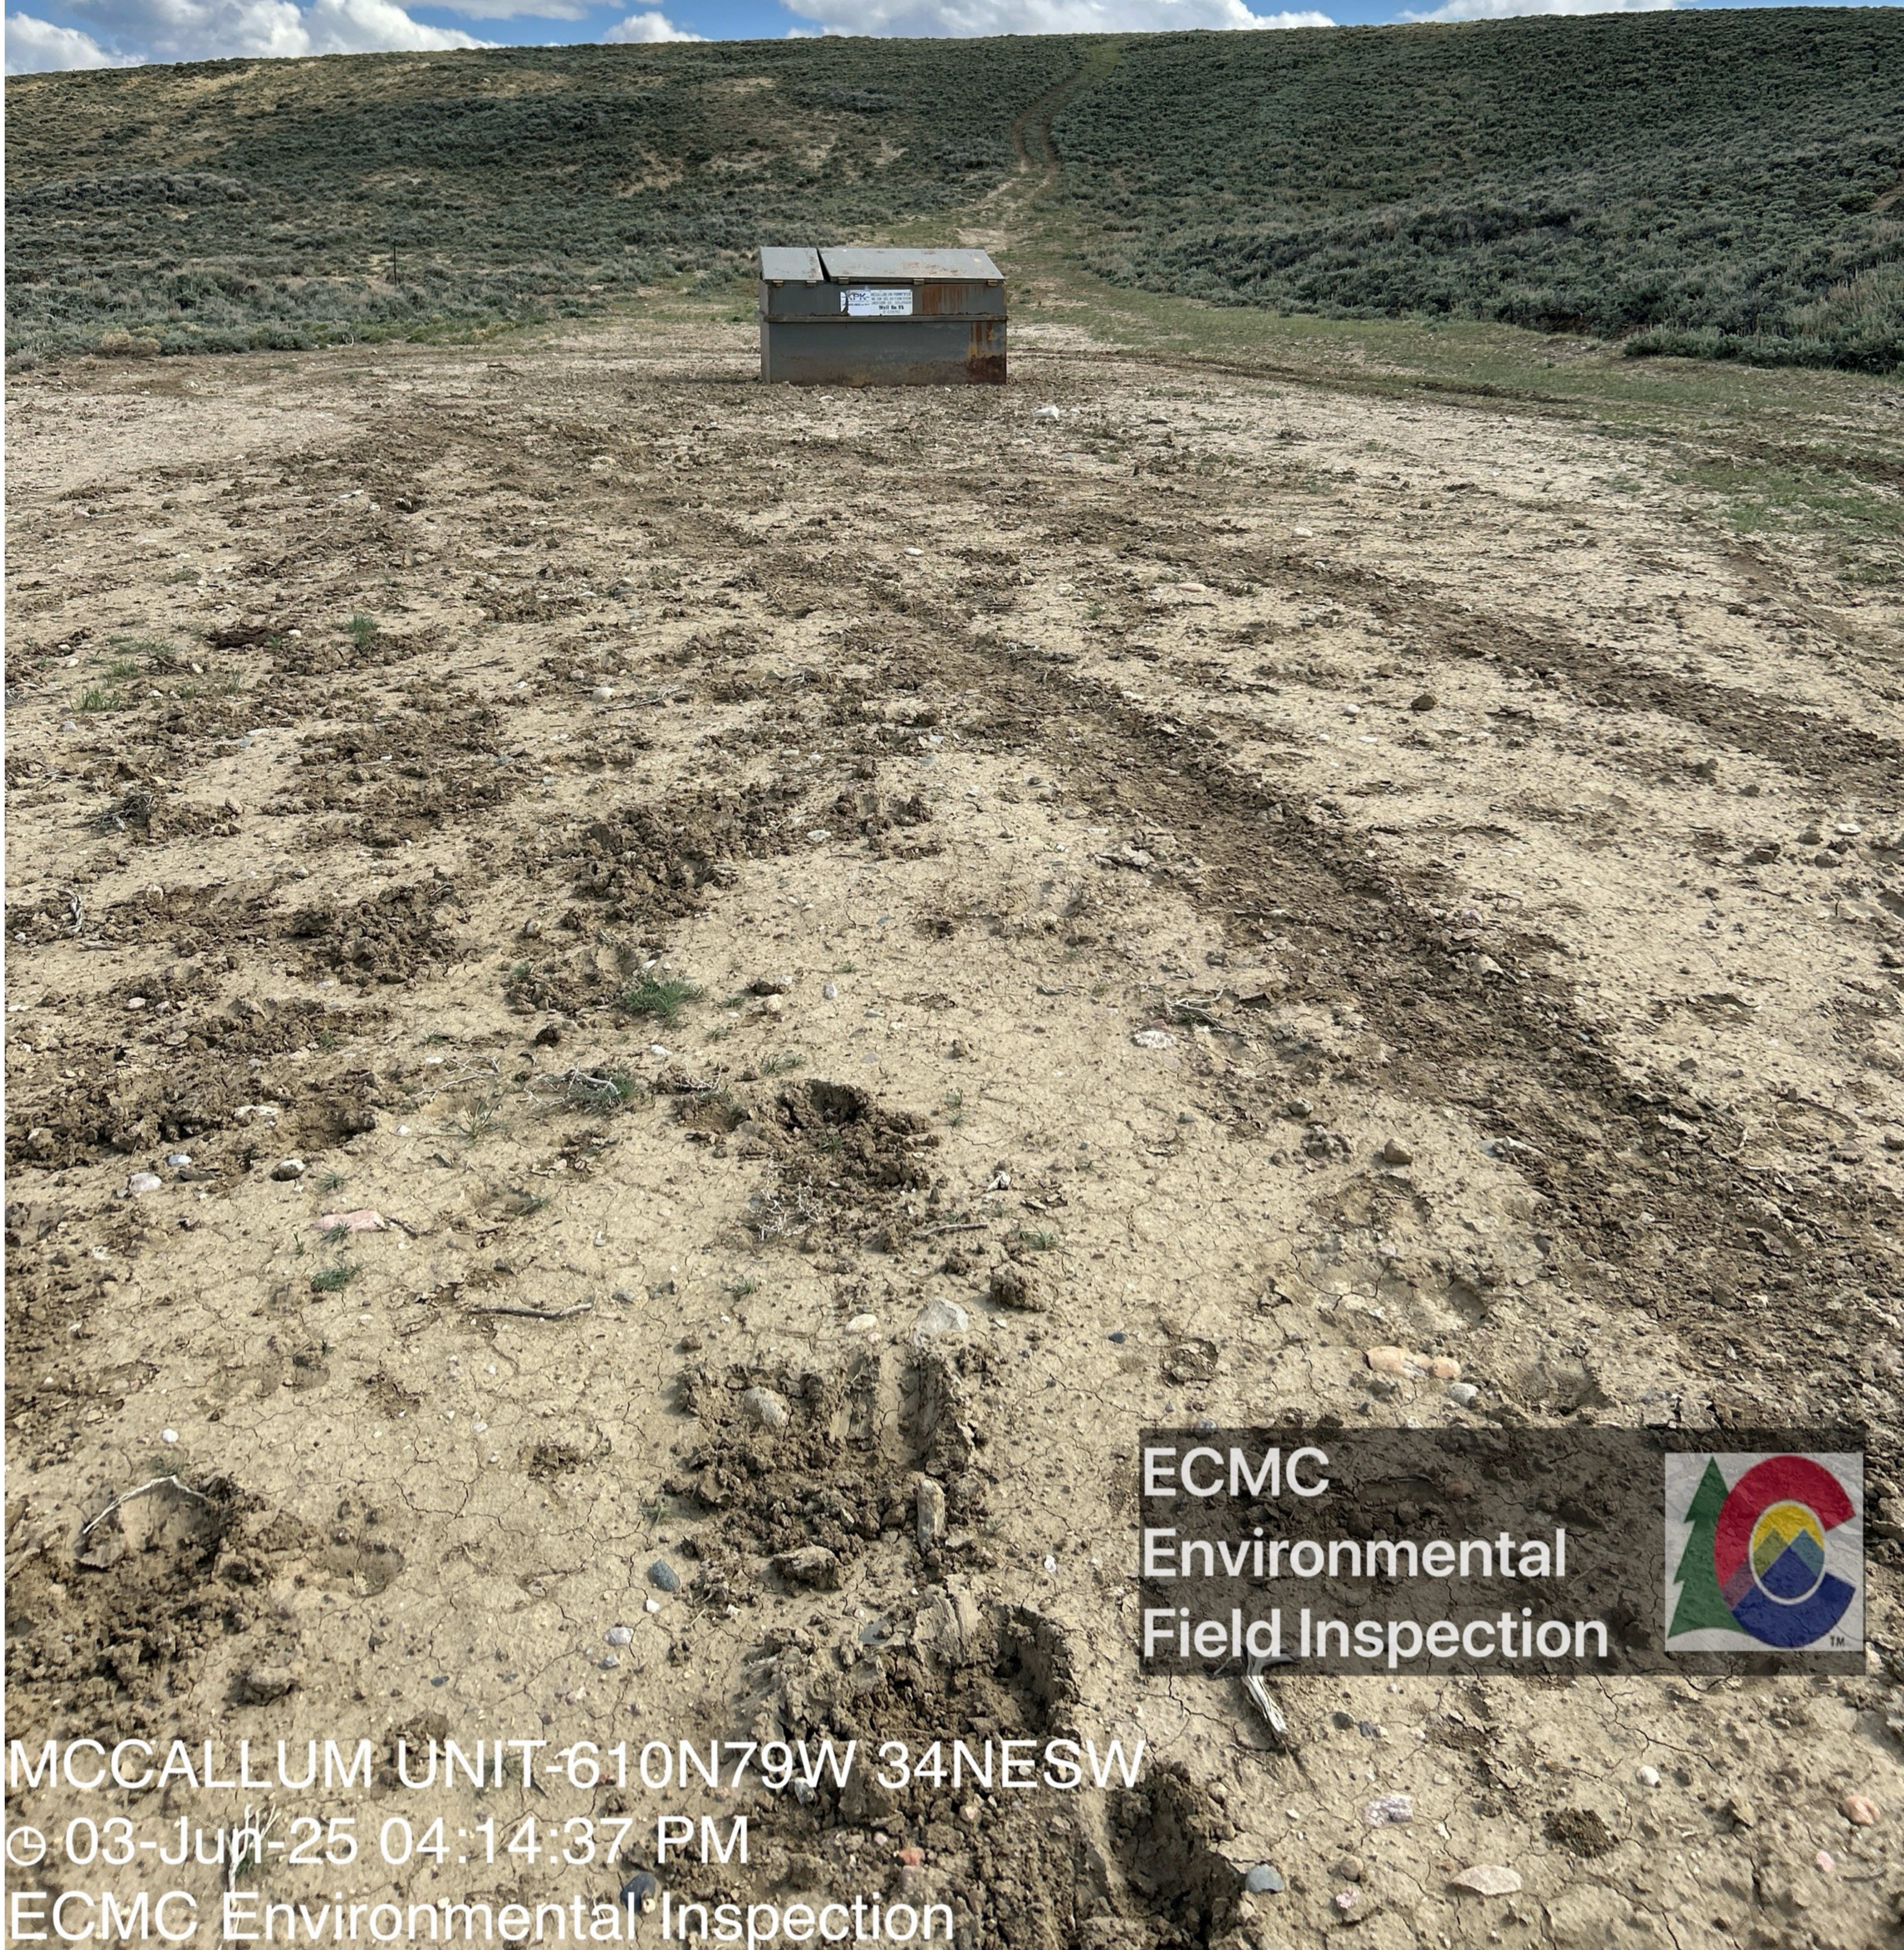
Looking at the southern portion of the spill footprint, towards the MCCALLUM UNIT-610N79W 34NESW well.

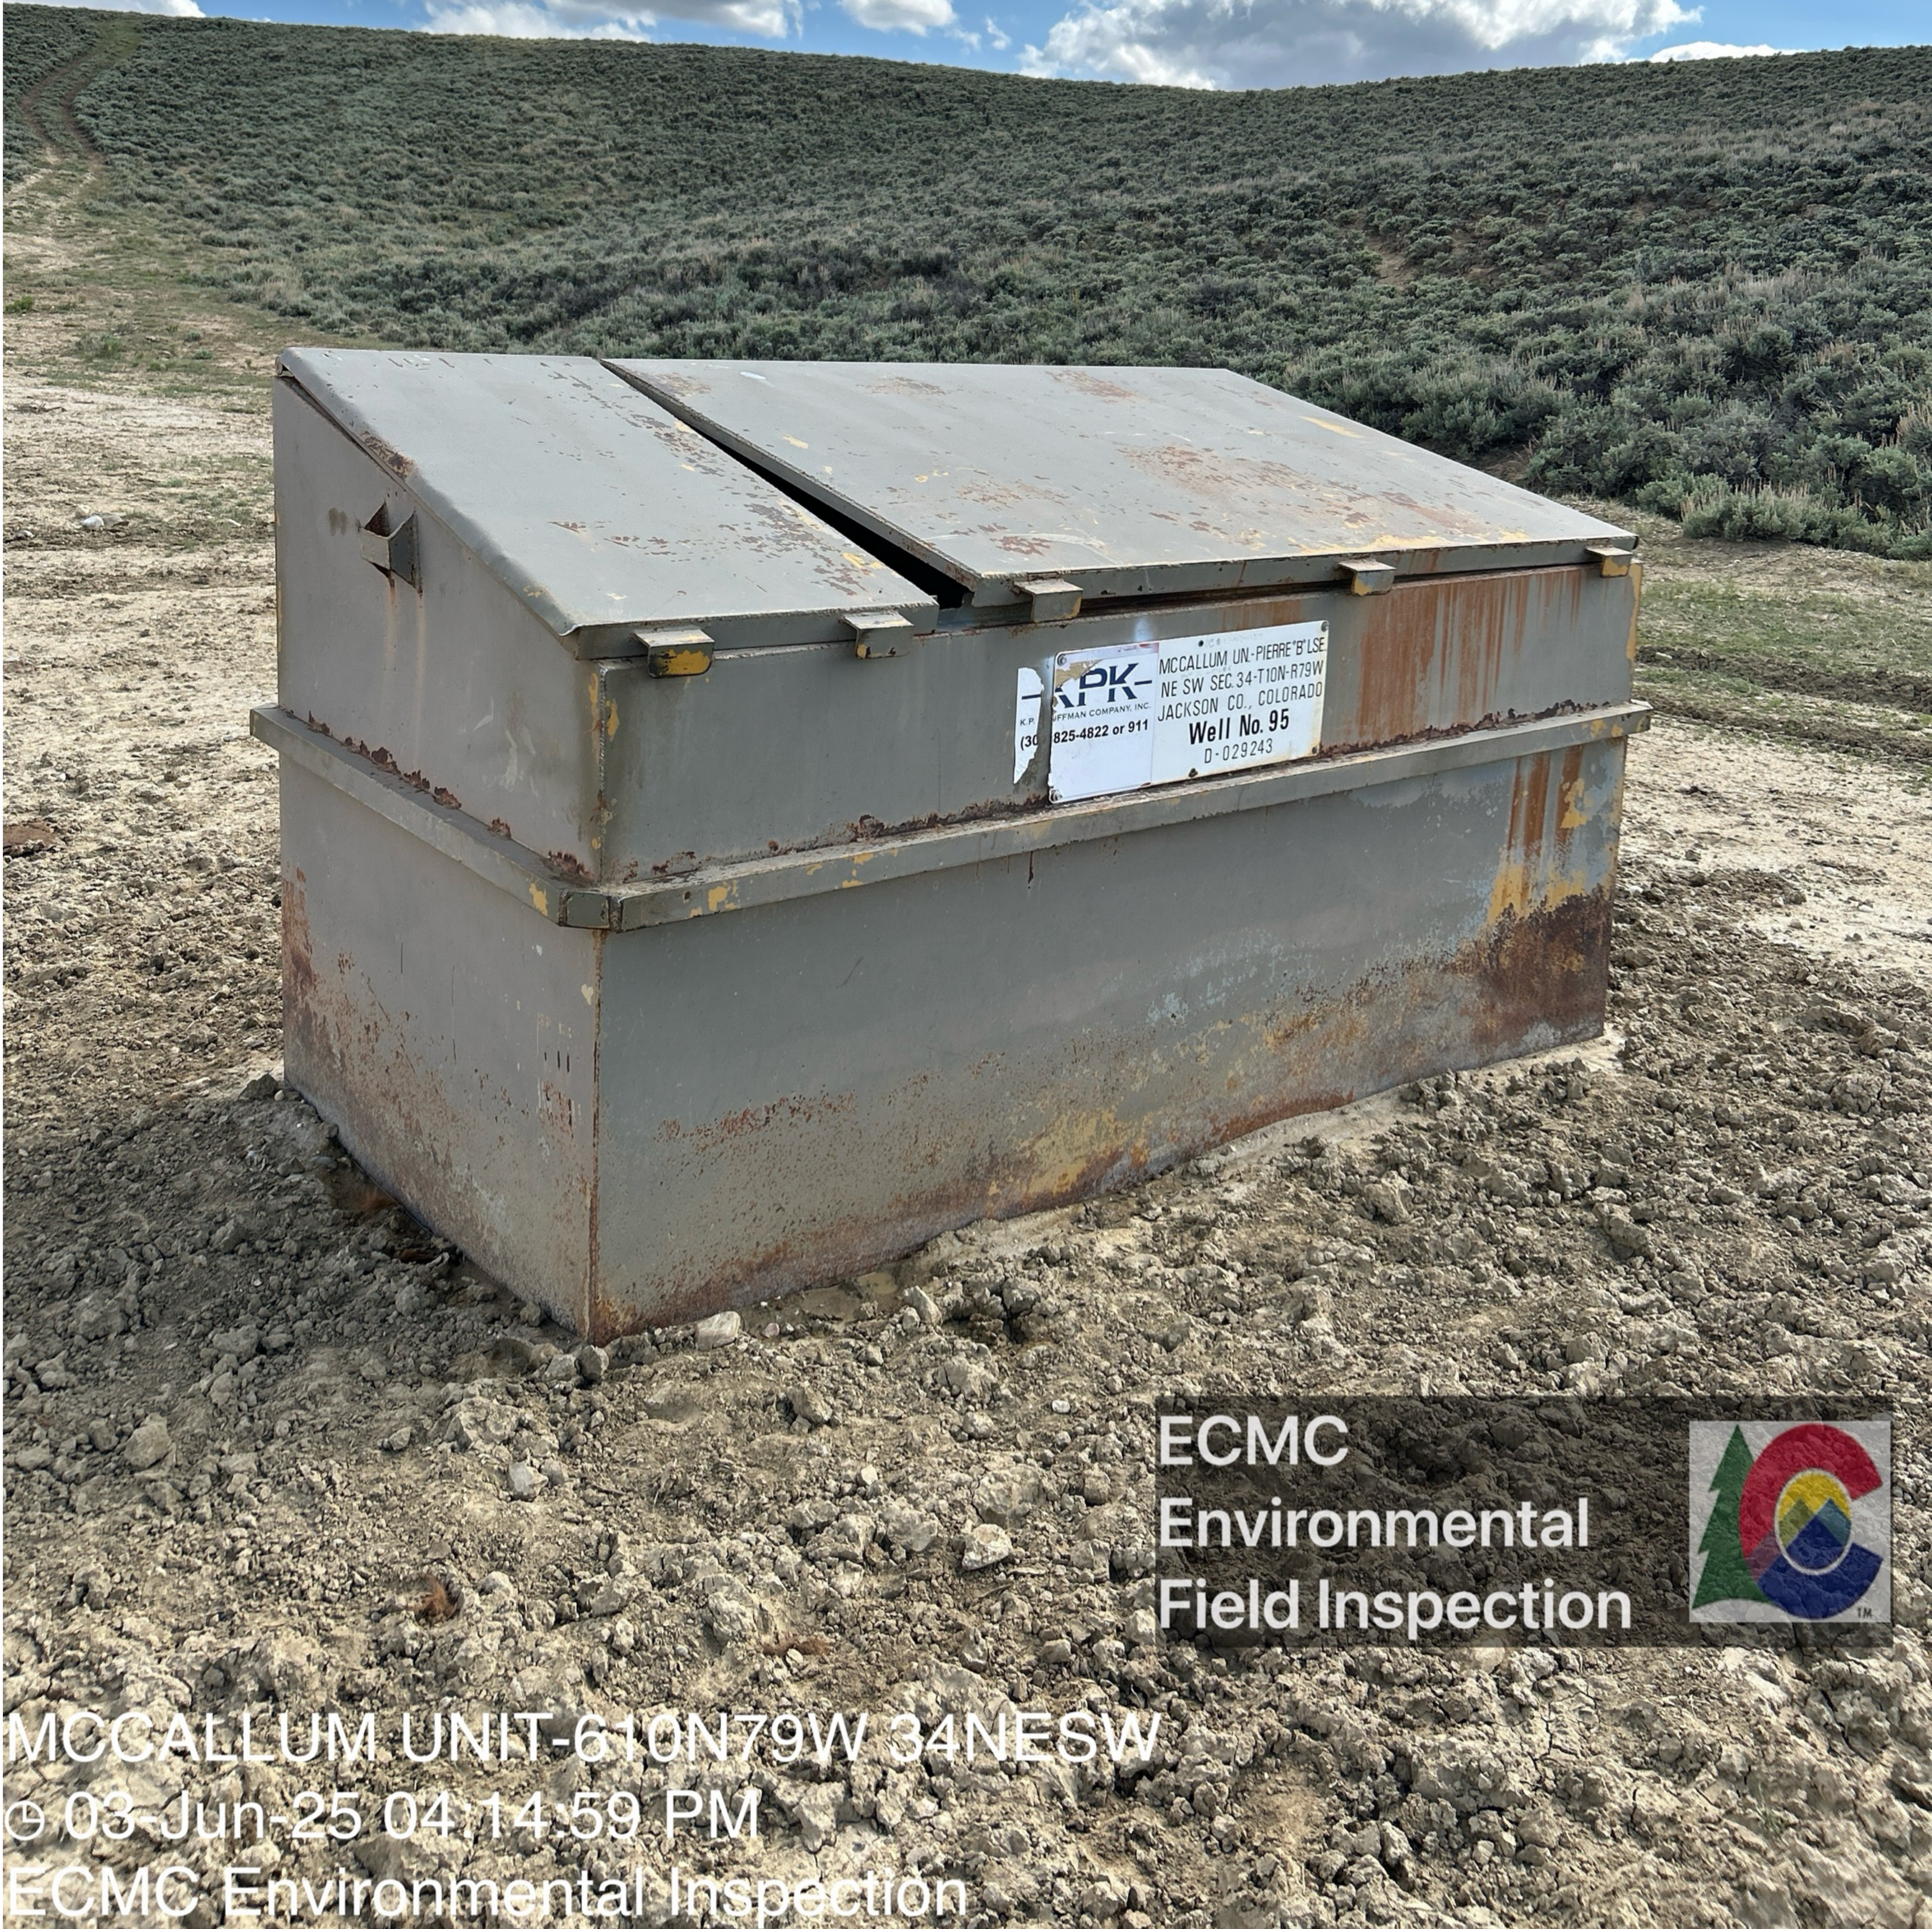
Signage with emergency contact number is peeling and becoming illegible at the MCCALLUM UNIT-610N79W 34NESW well.

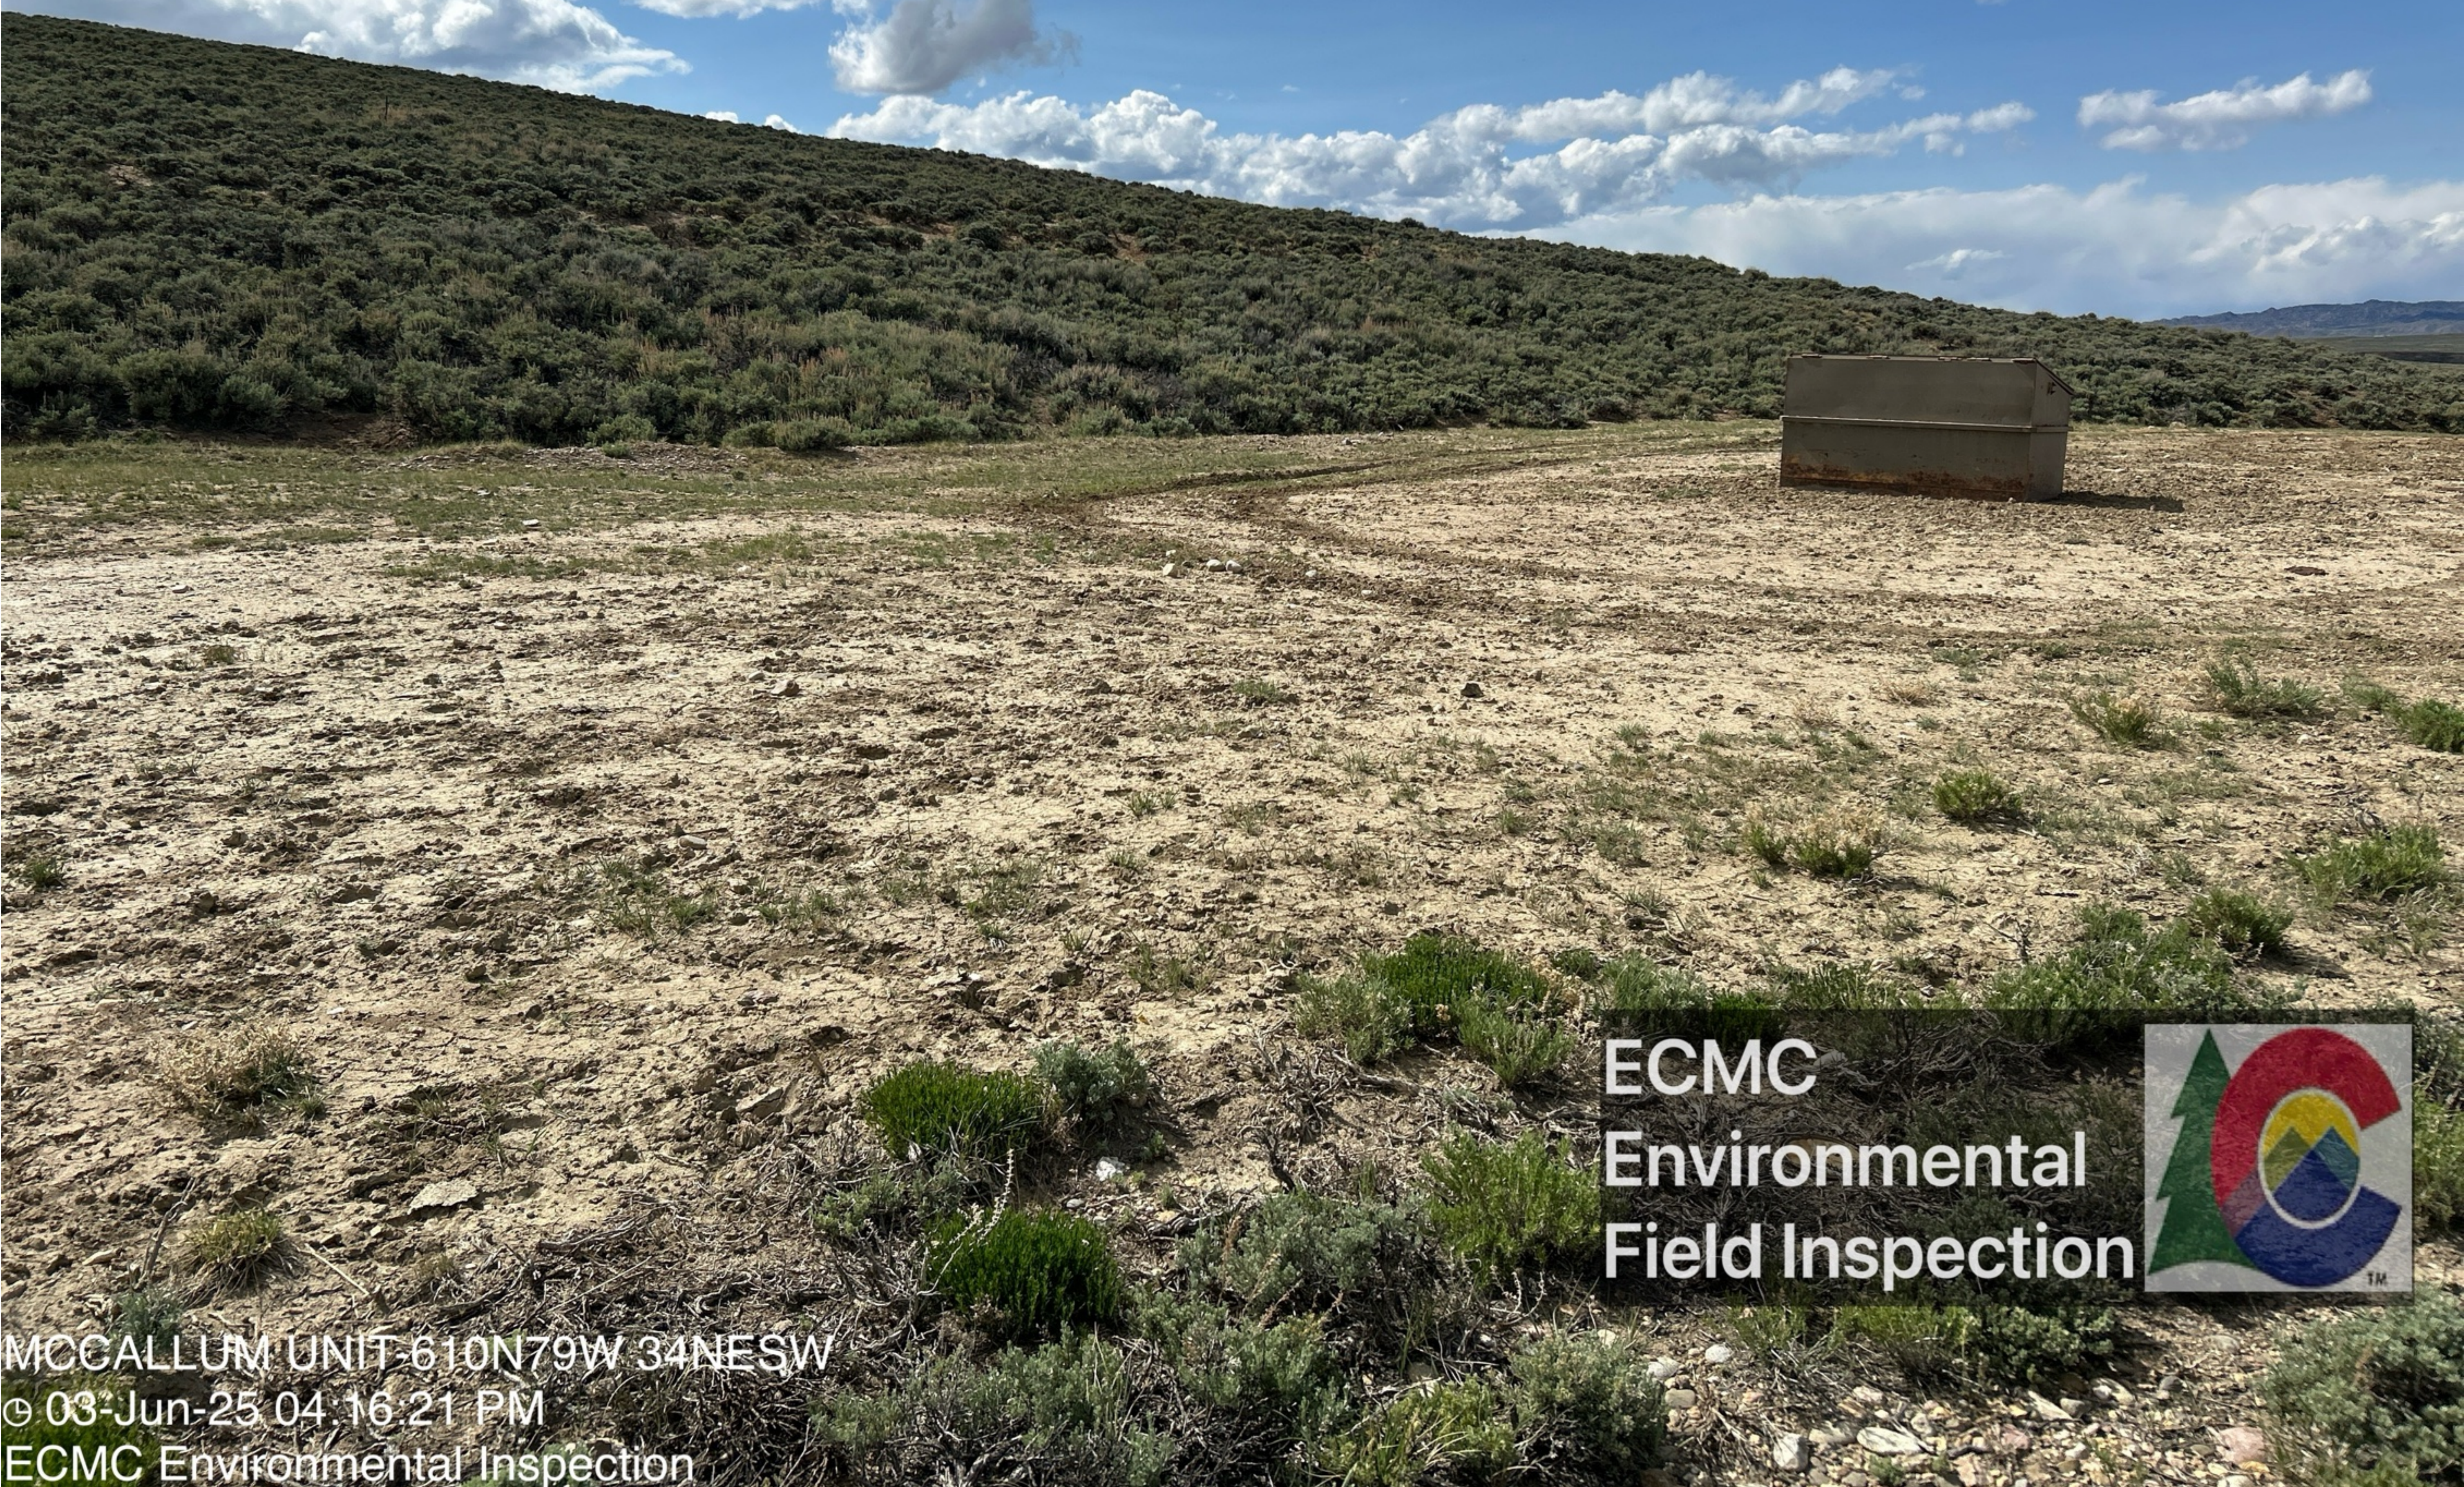
Looking inside the MCCALLUM UNIT-610N79W 34NESW well containment. A sheen was not observed on the water within the containment. A tag reads "Do not operate".

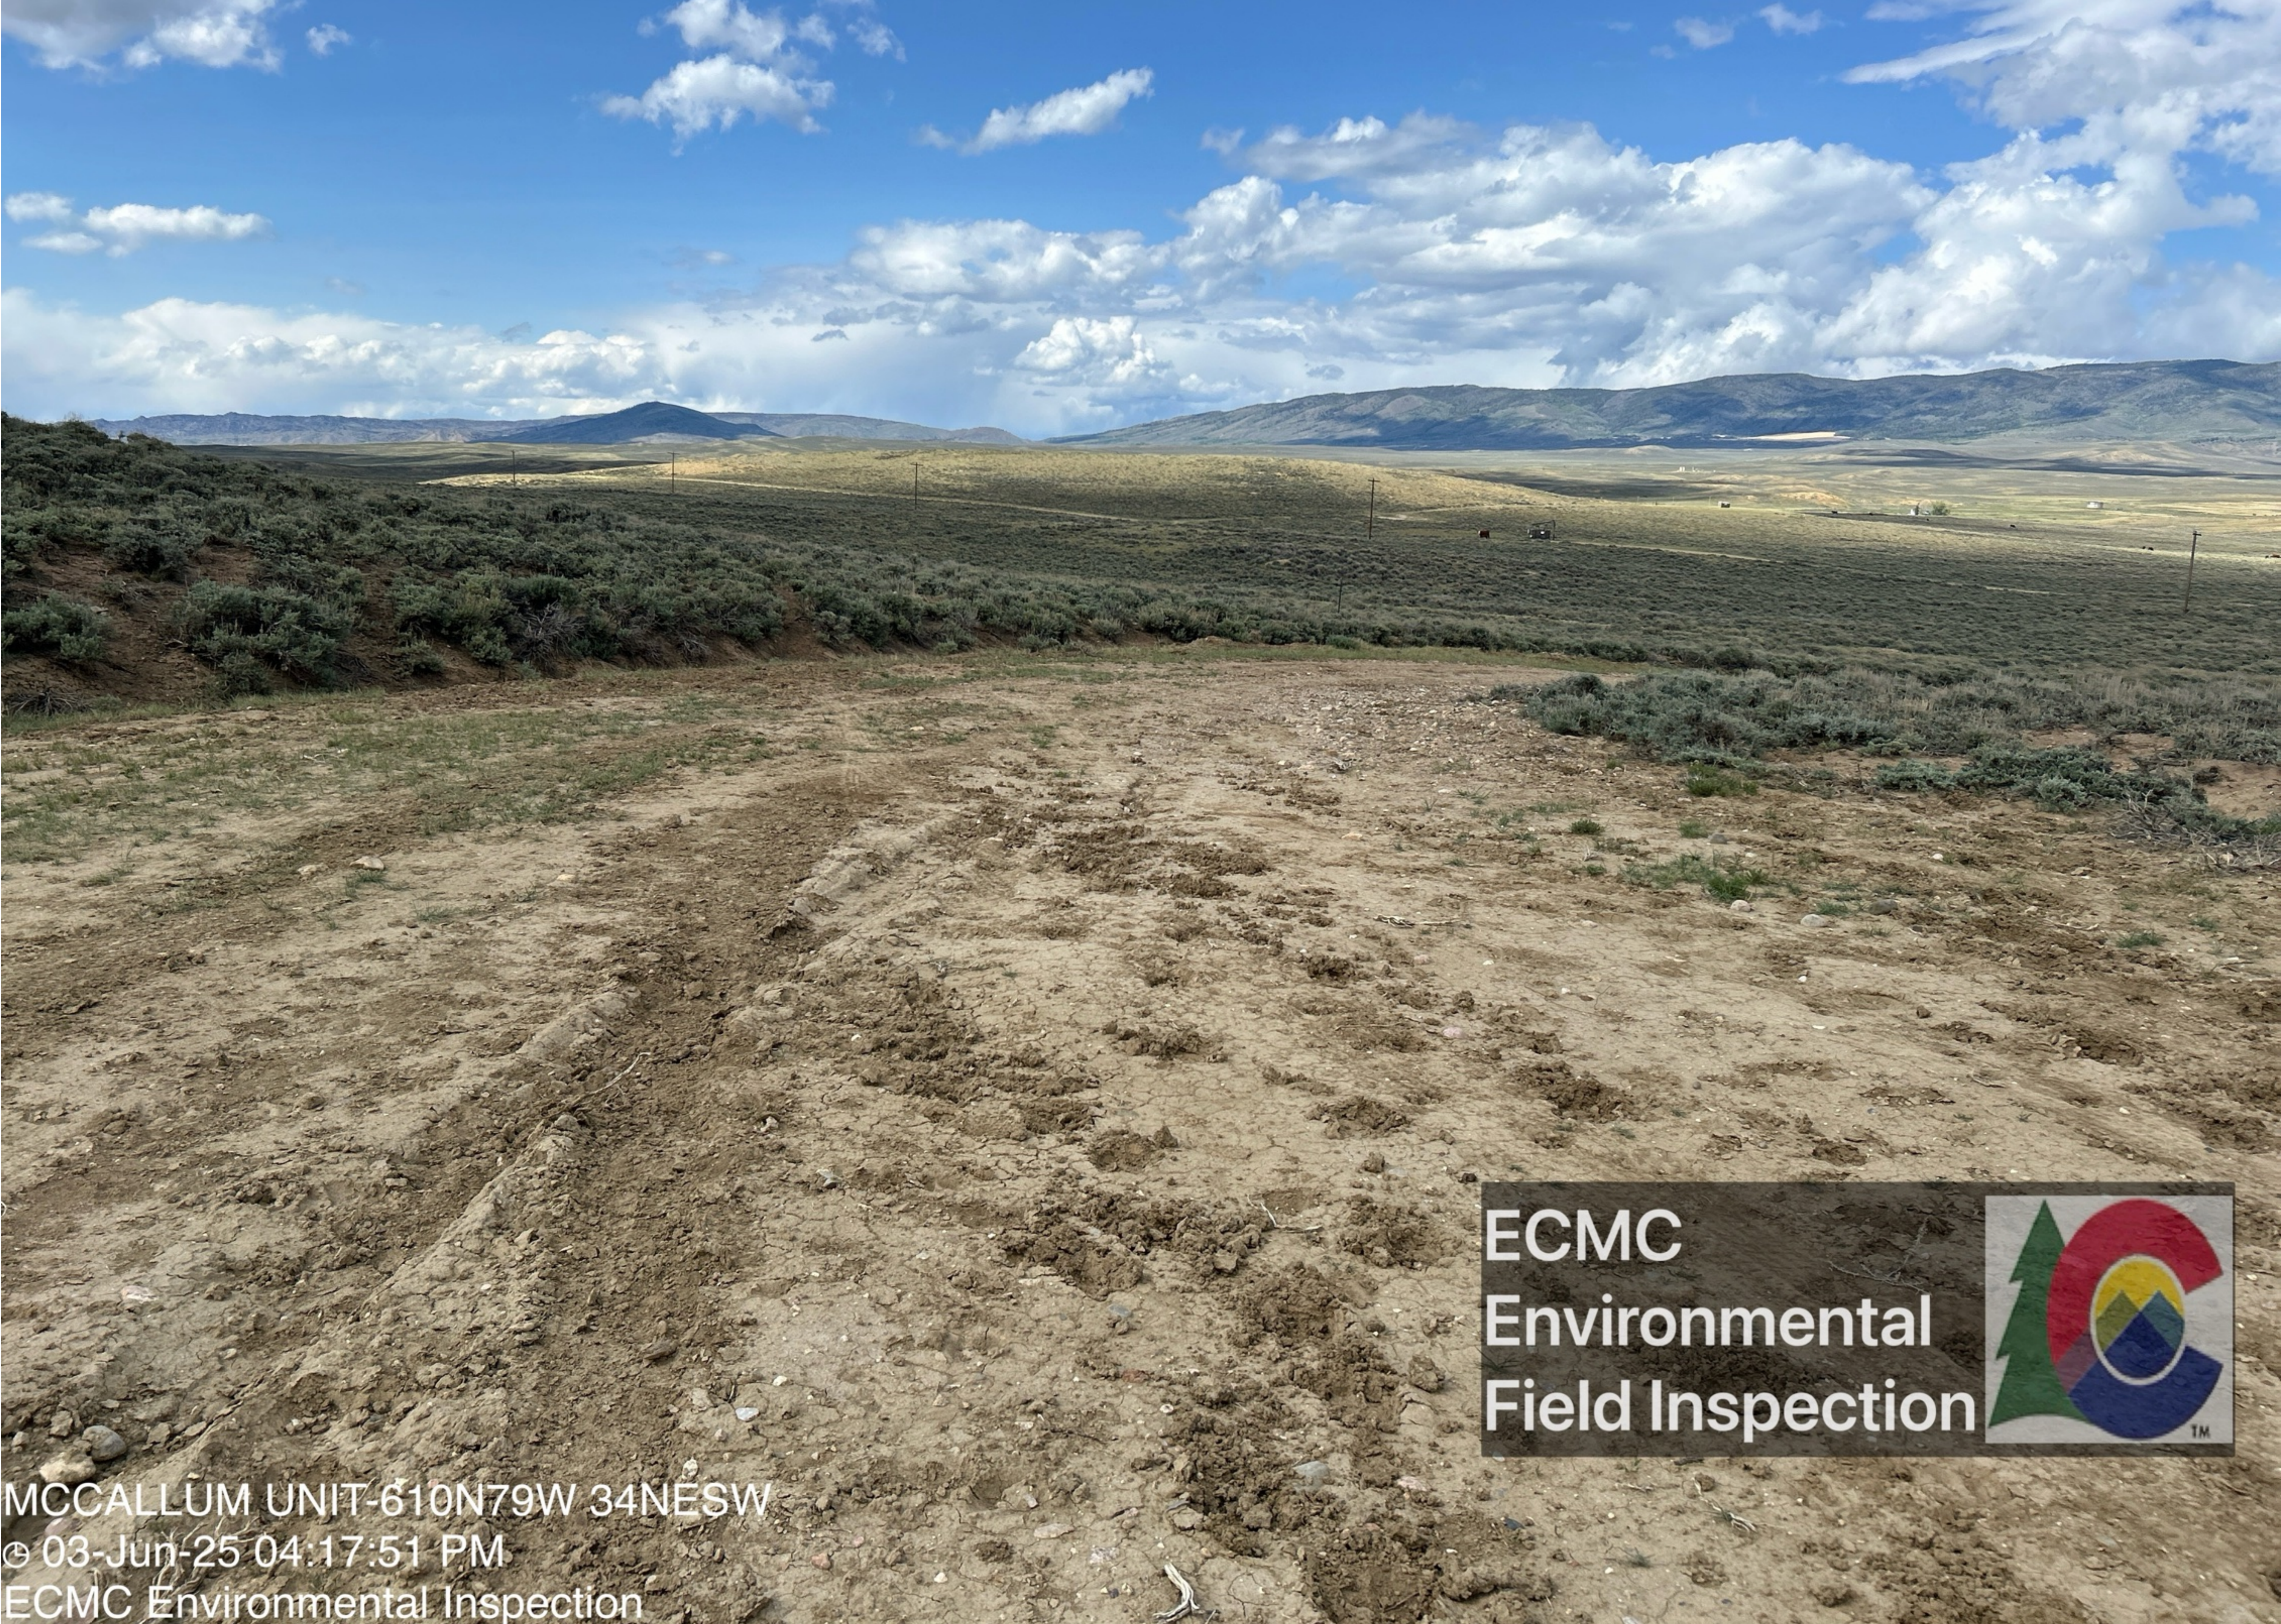
Looking at the southern/topographically upgradient portion of the well pad, towards the MCCALLUM UNIT-610N79W 34NESW well.
