ECMC
Environmental
Field Inspection

Cody Production Battery
03-Jun-25 03:20:48 PM
ECMC Environmental Inspection

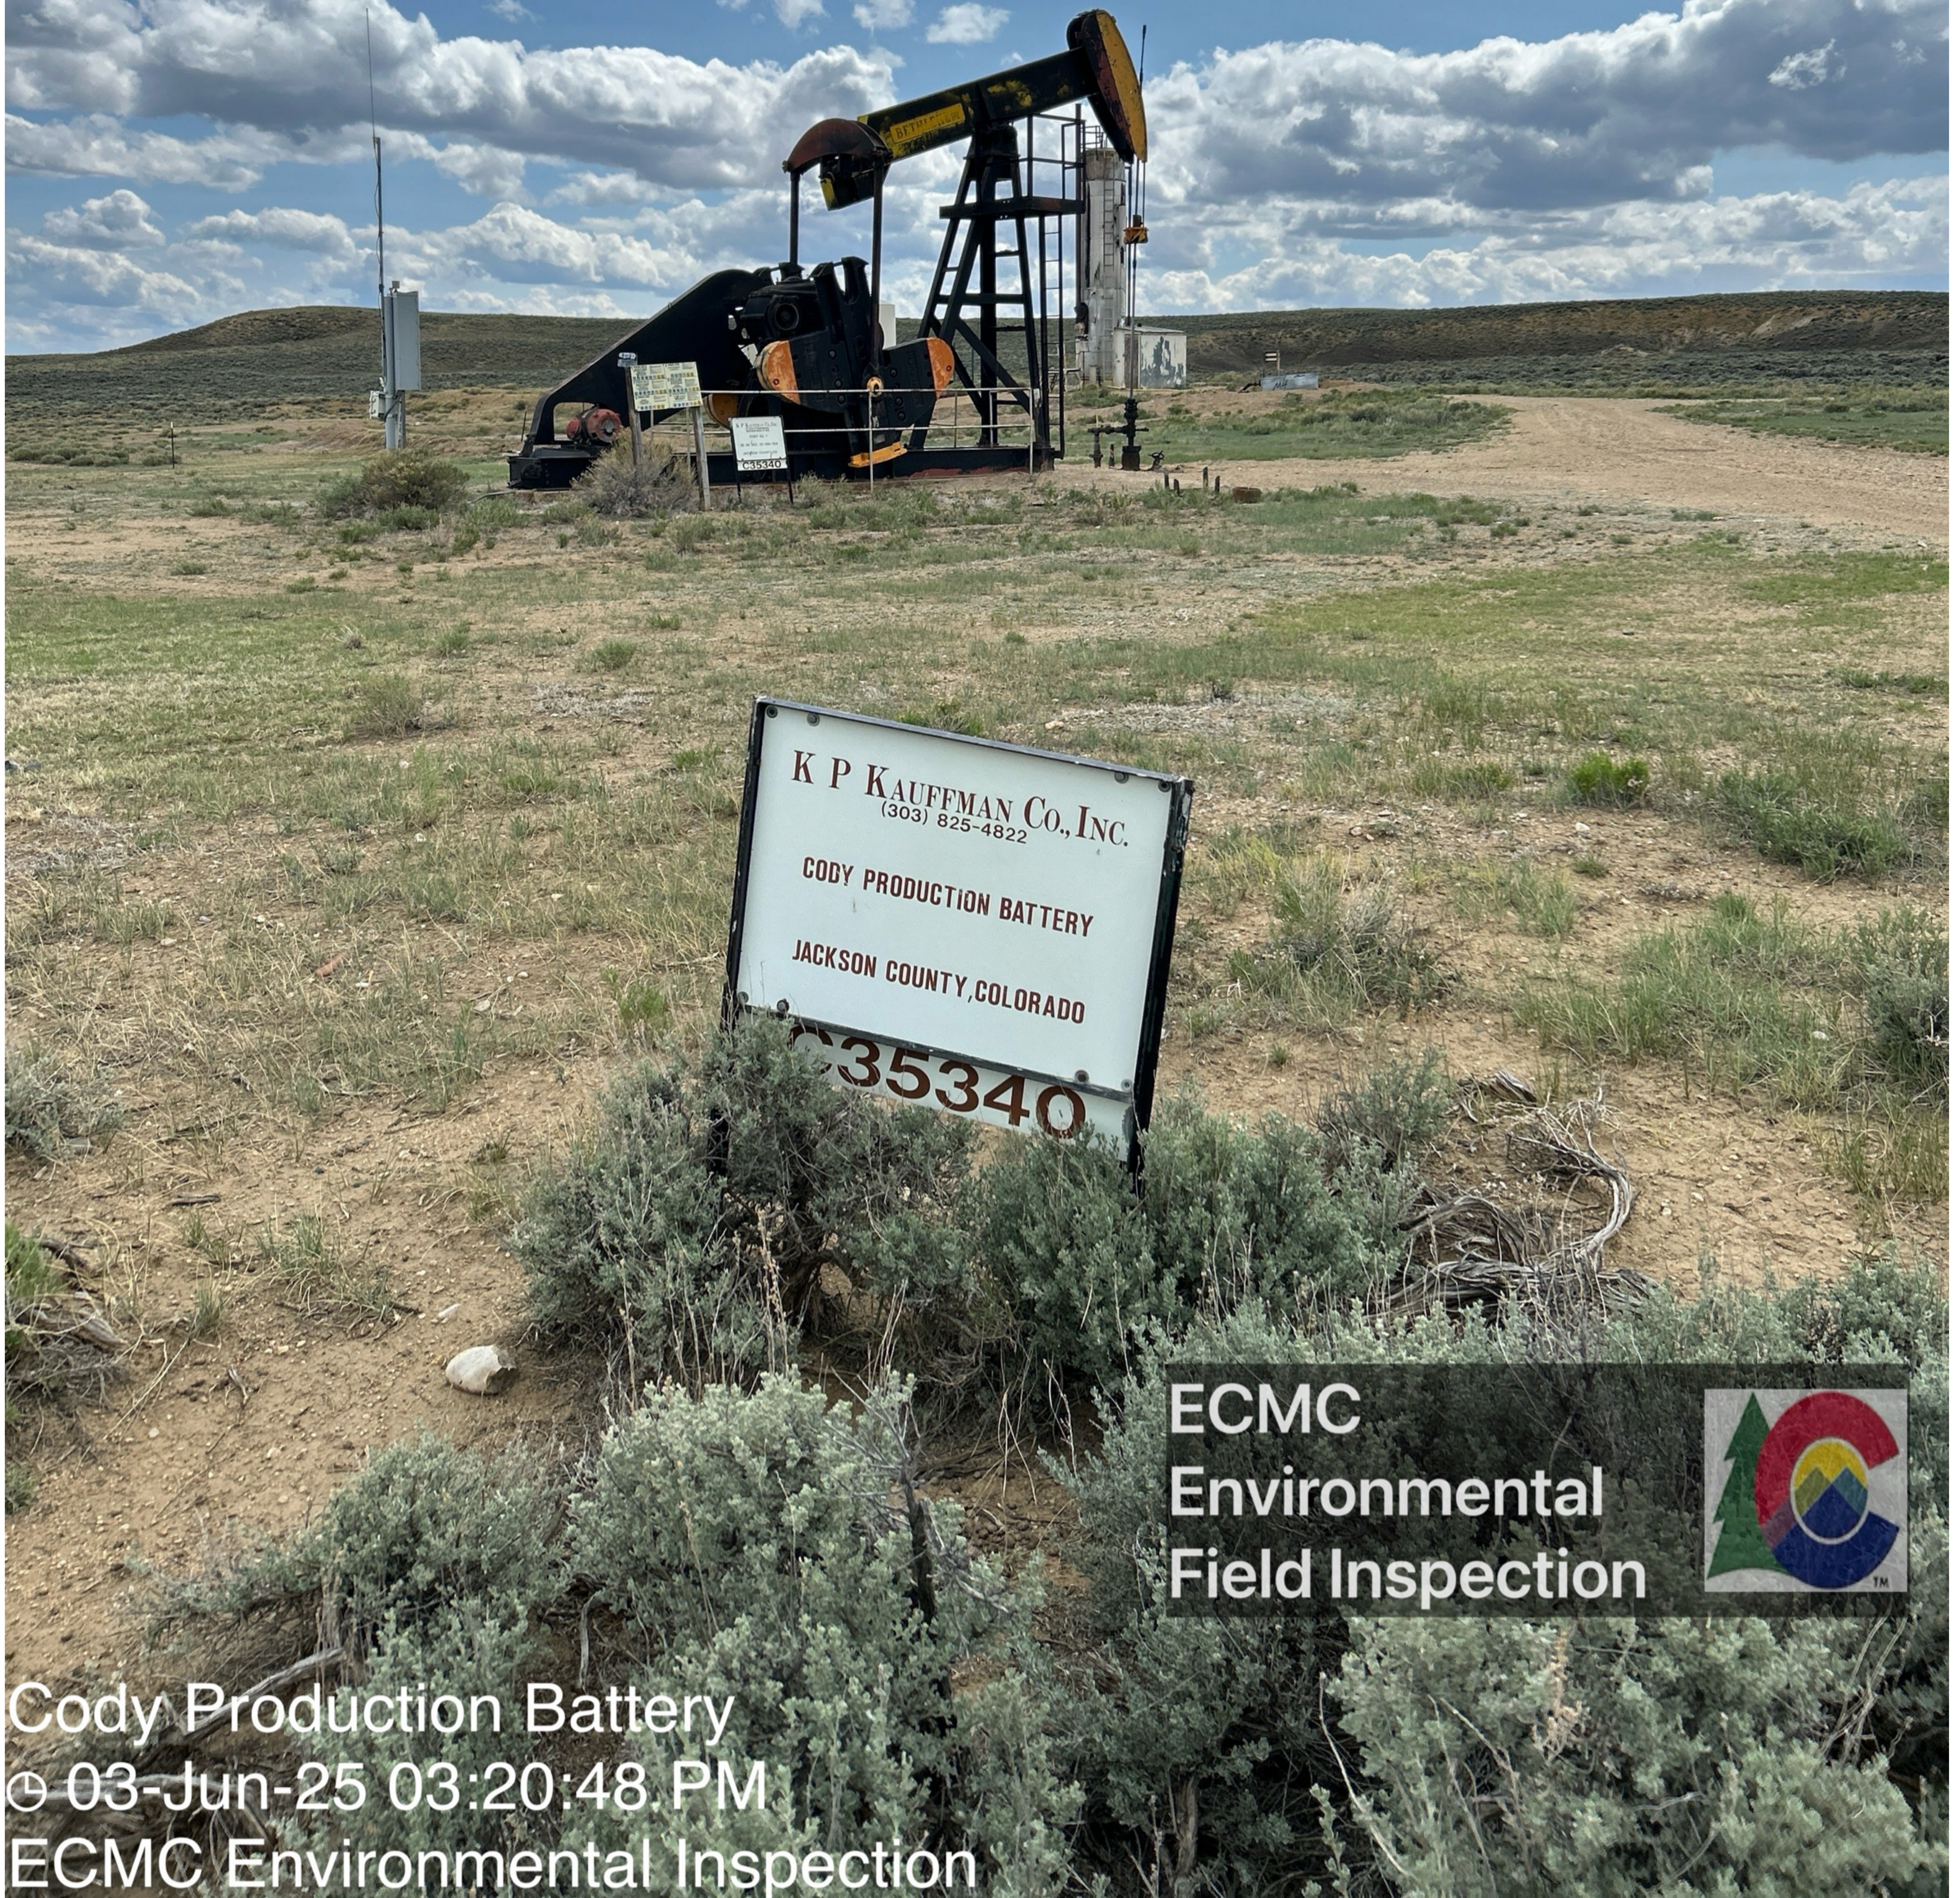
Looking at the Cody #1 well and Cody Production Tank Battery. Signage with emergency contact number is visible at both the tank battery and well. Weeds are visible around the well.

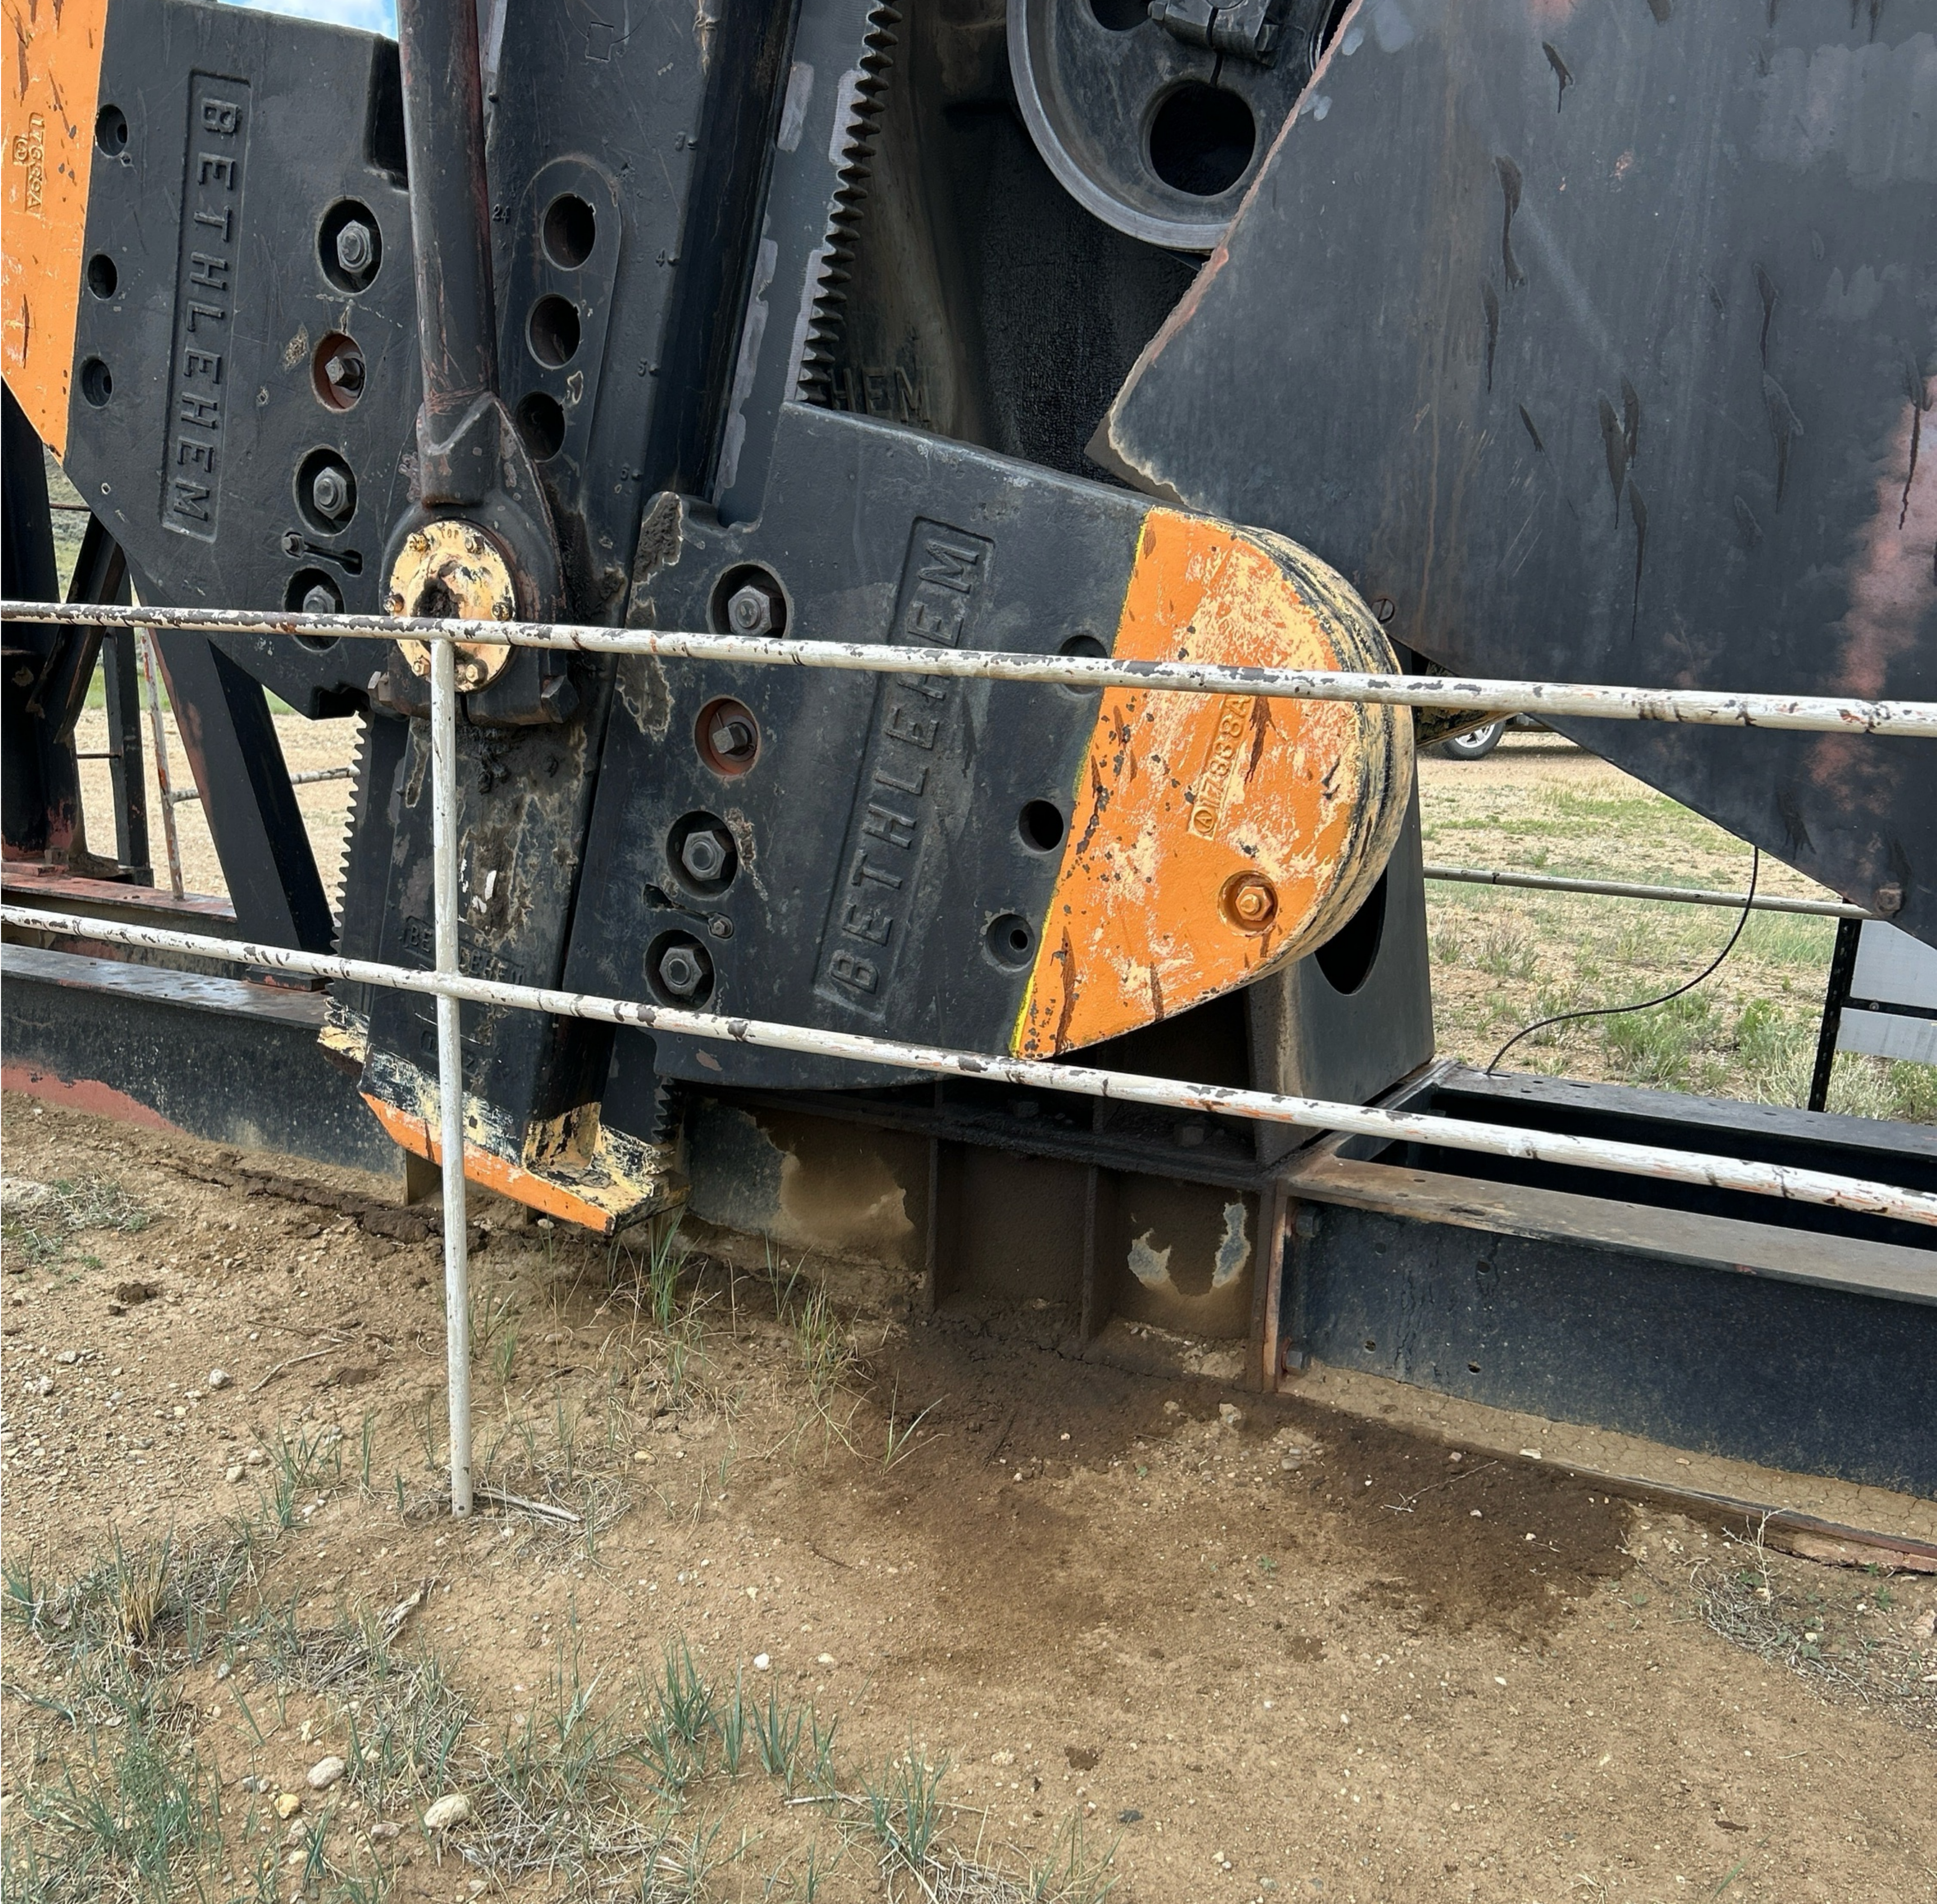
Stained soil is visible adjacent to/beneath the pumping unit. A strong petroleum hydrocarbon odor was observed when the stained soil was disturbed.

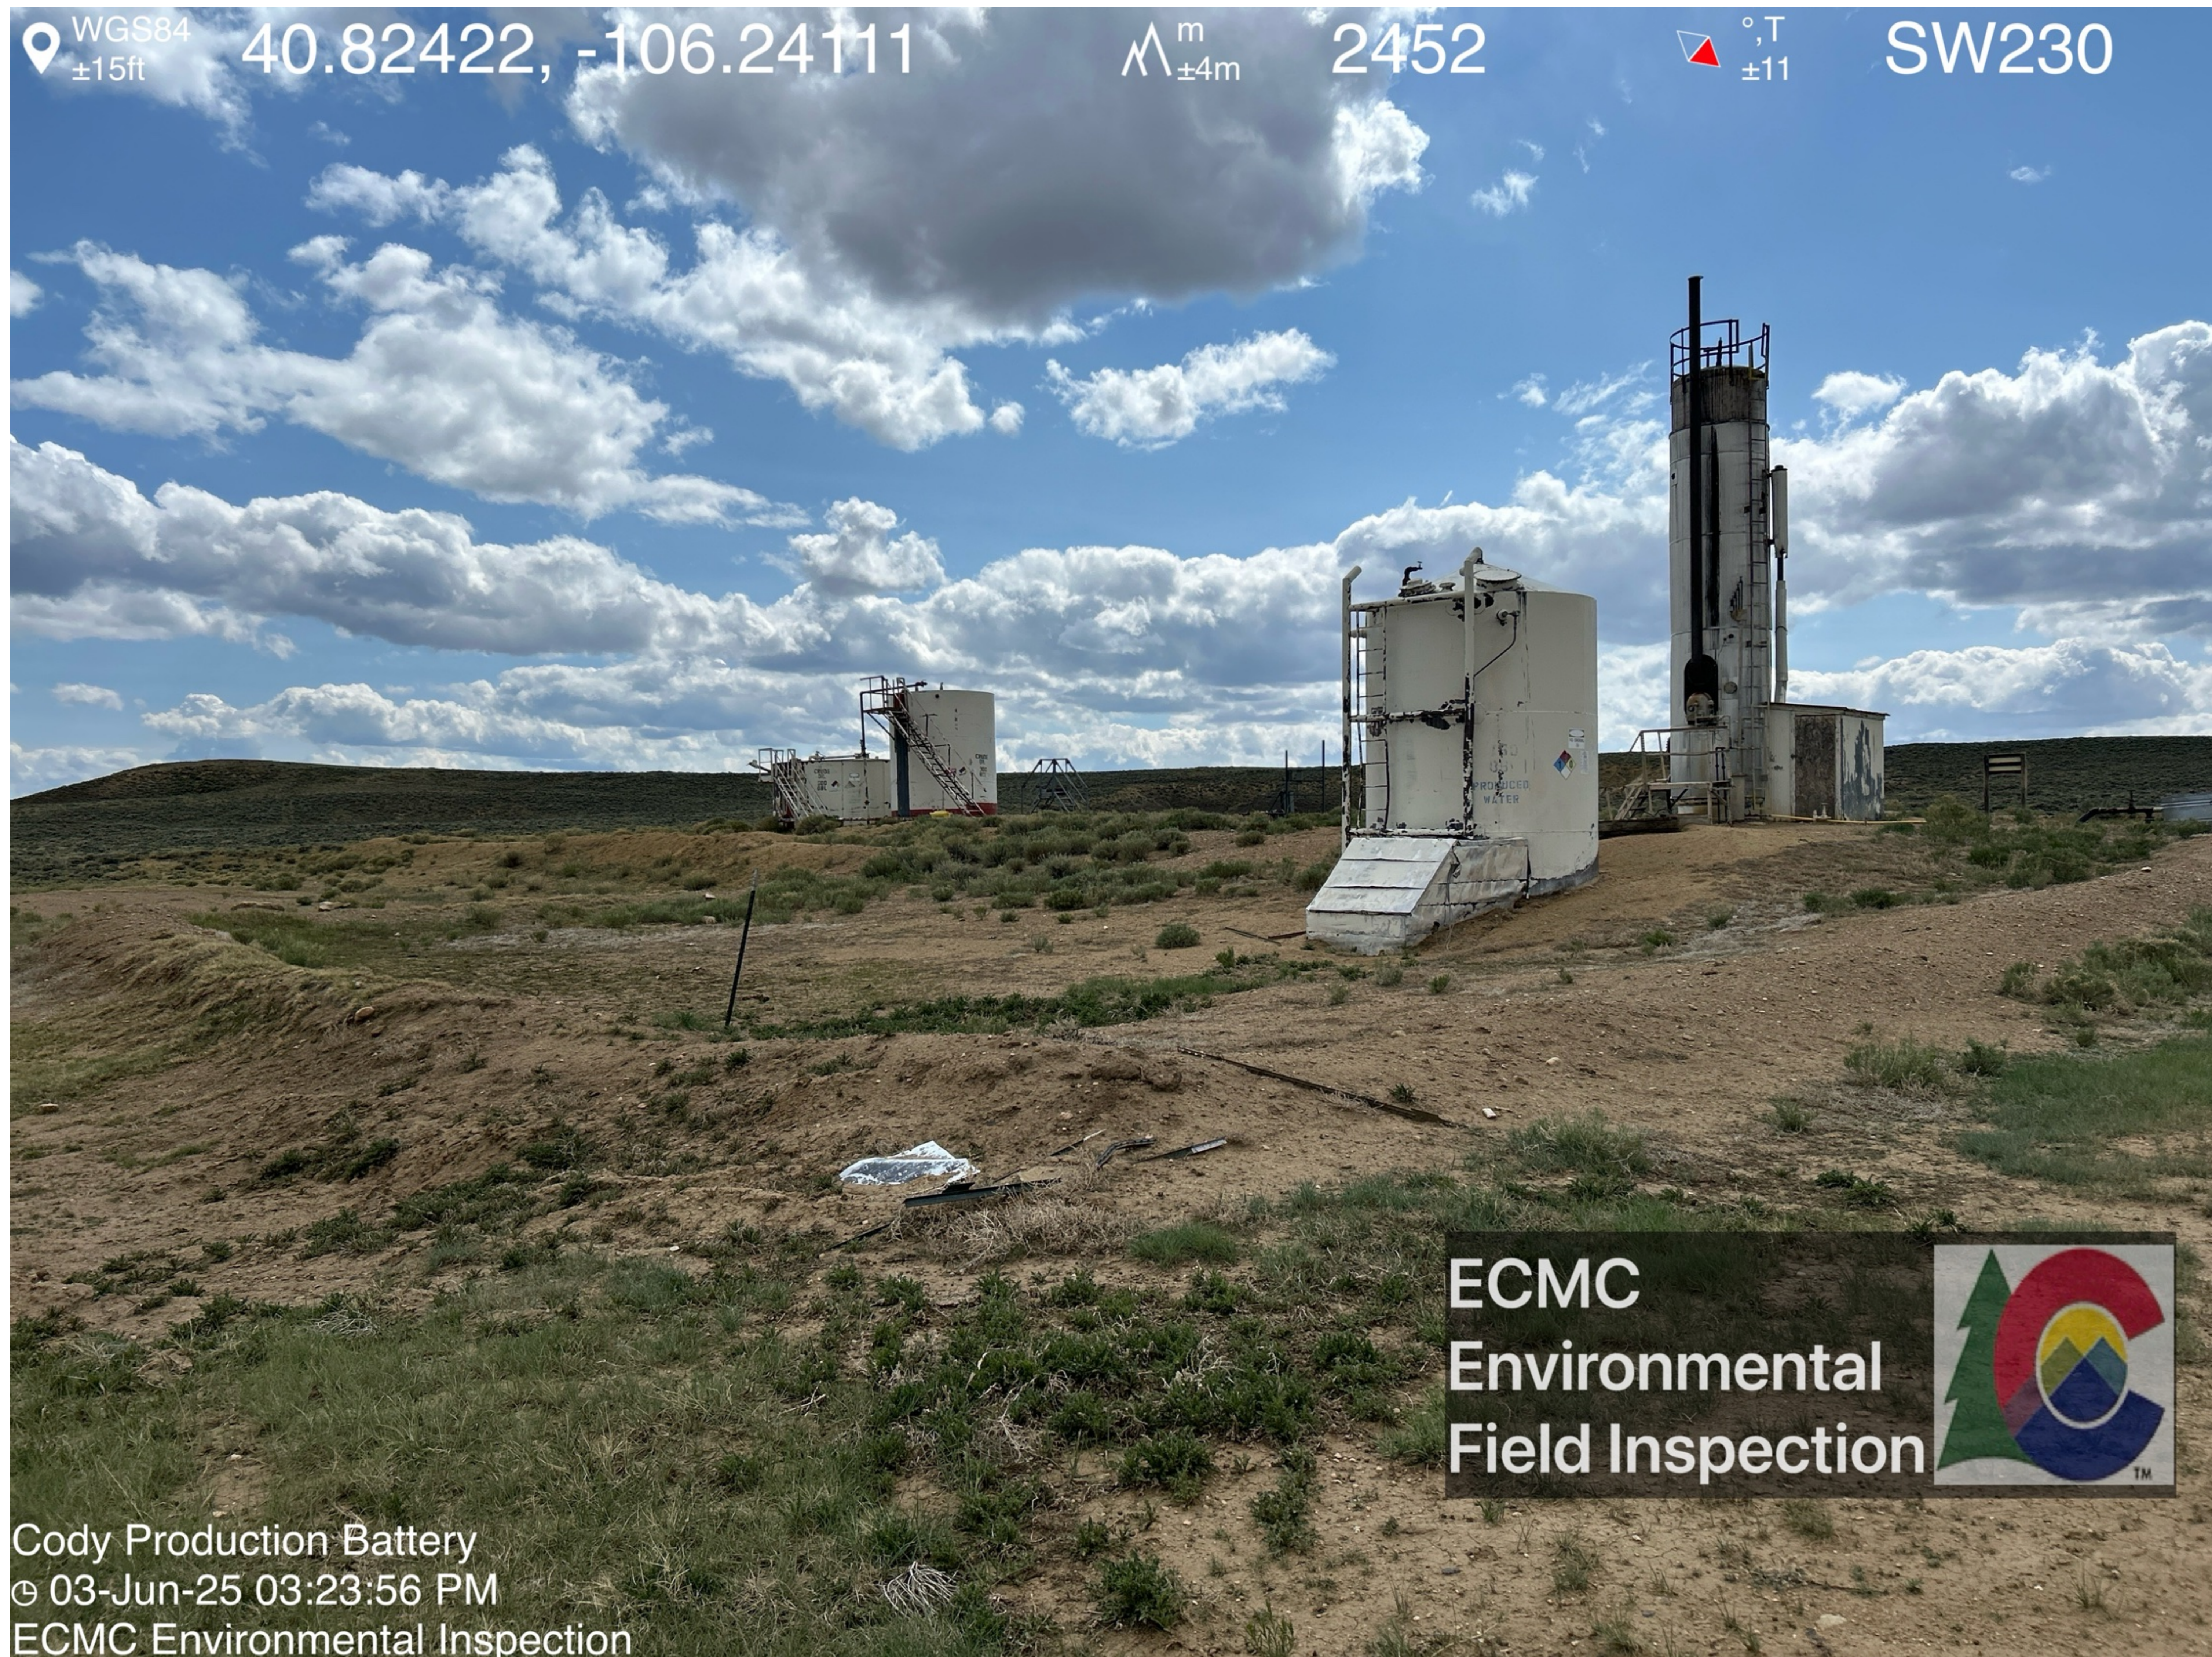
Looking at the Cody Production Battery. Earthen berms surround the tank battery; however, they appear to have been eroded. Trash and unnecessary equipment (fence posts) are visible on location. Weeds are visible throughout the location.

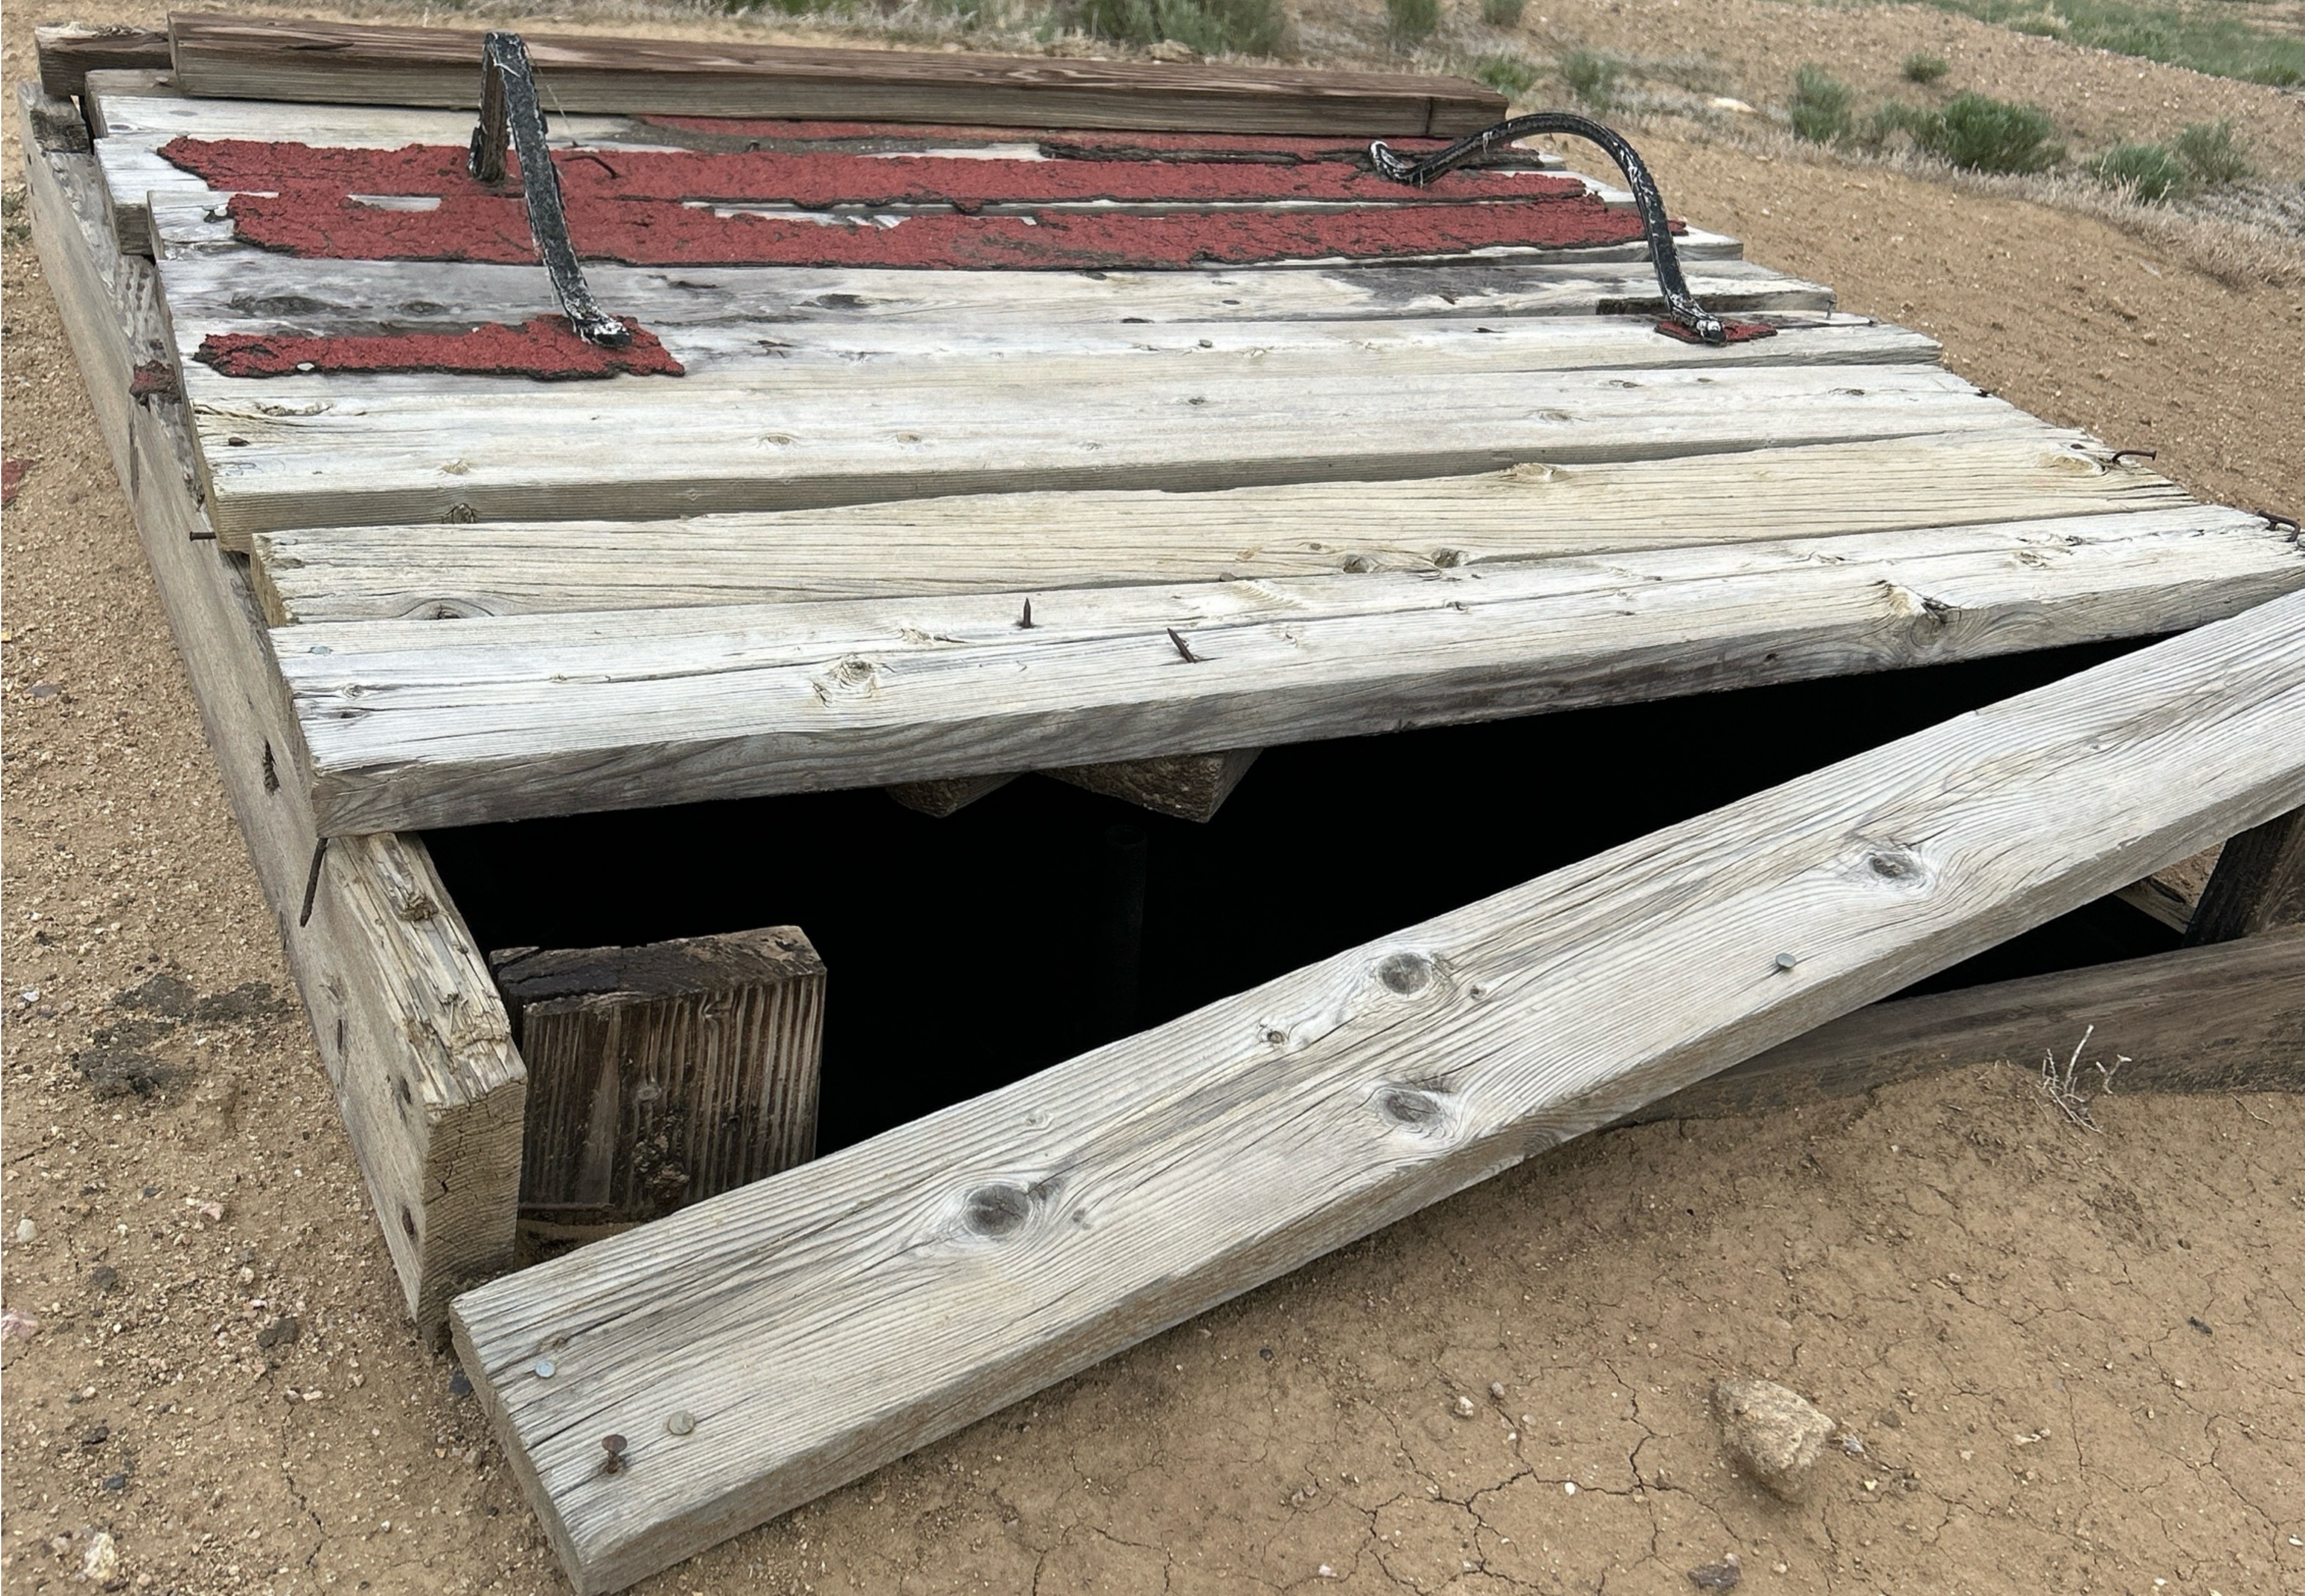
A hole partially covered by wood is visible on location.

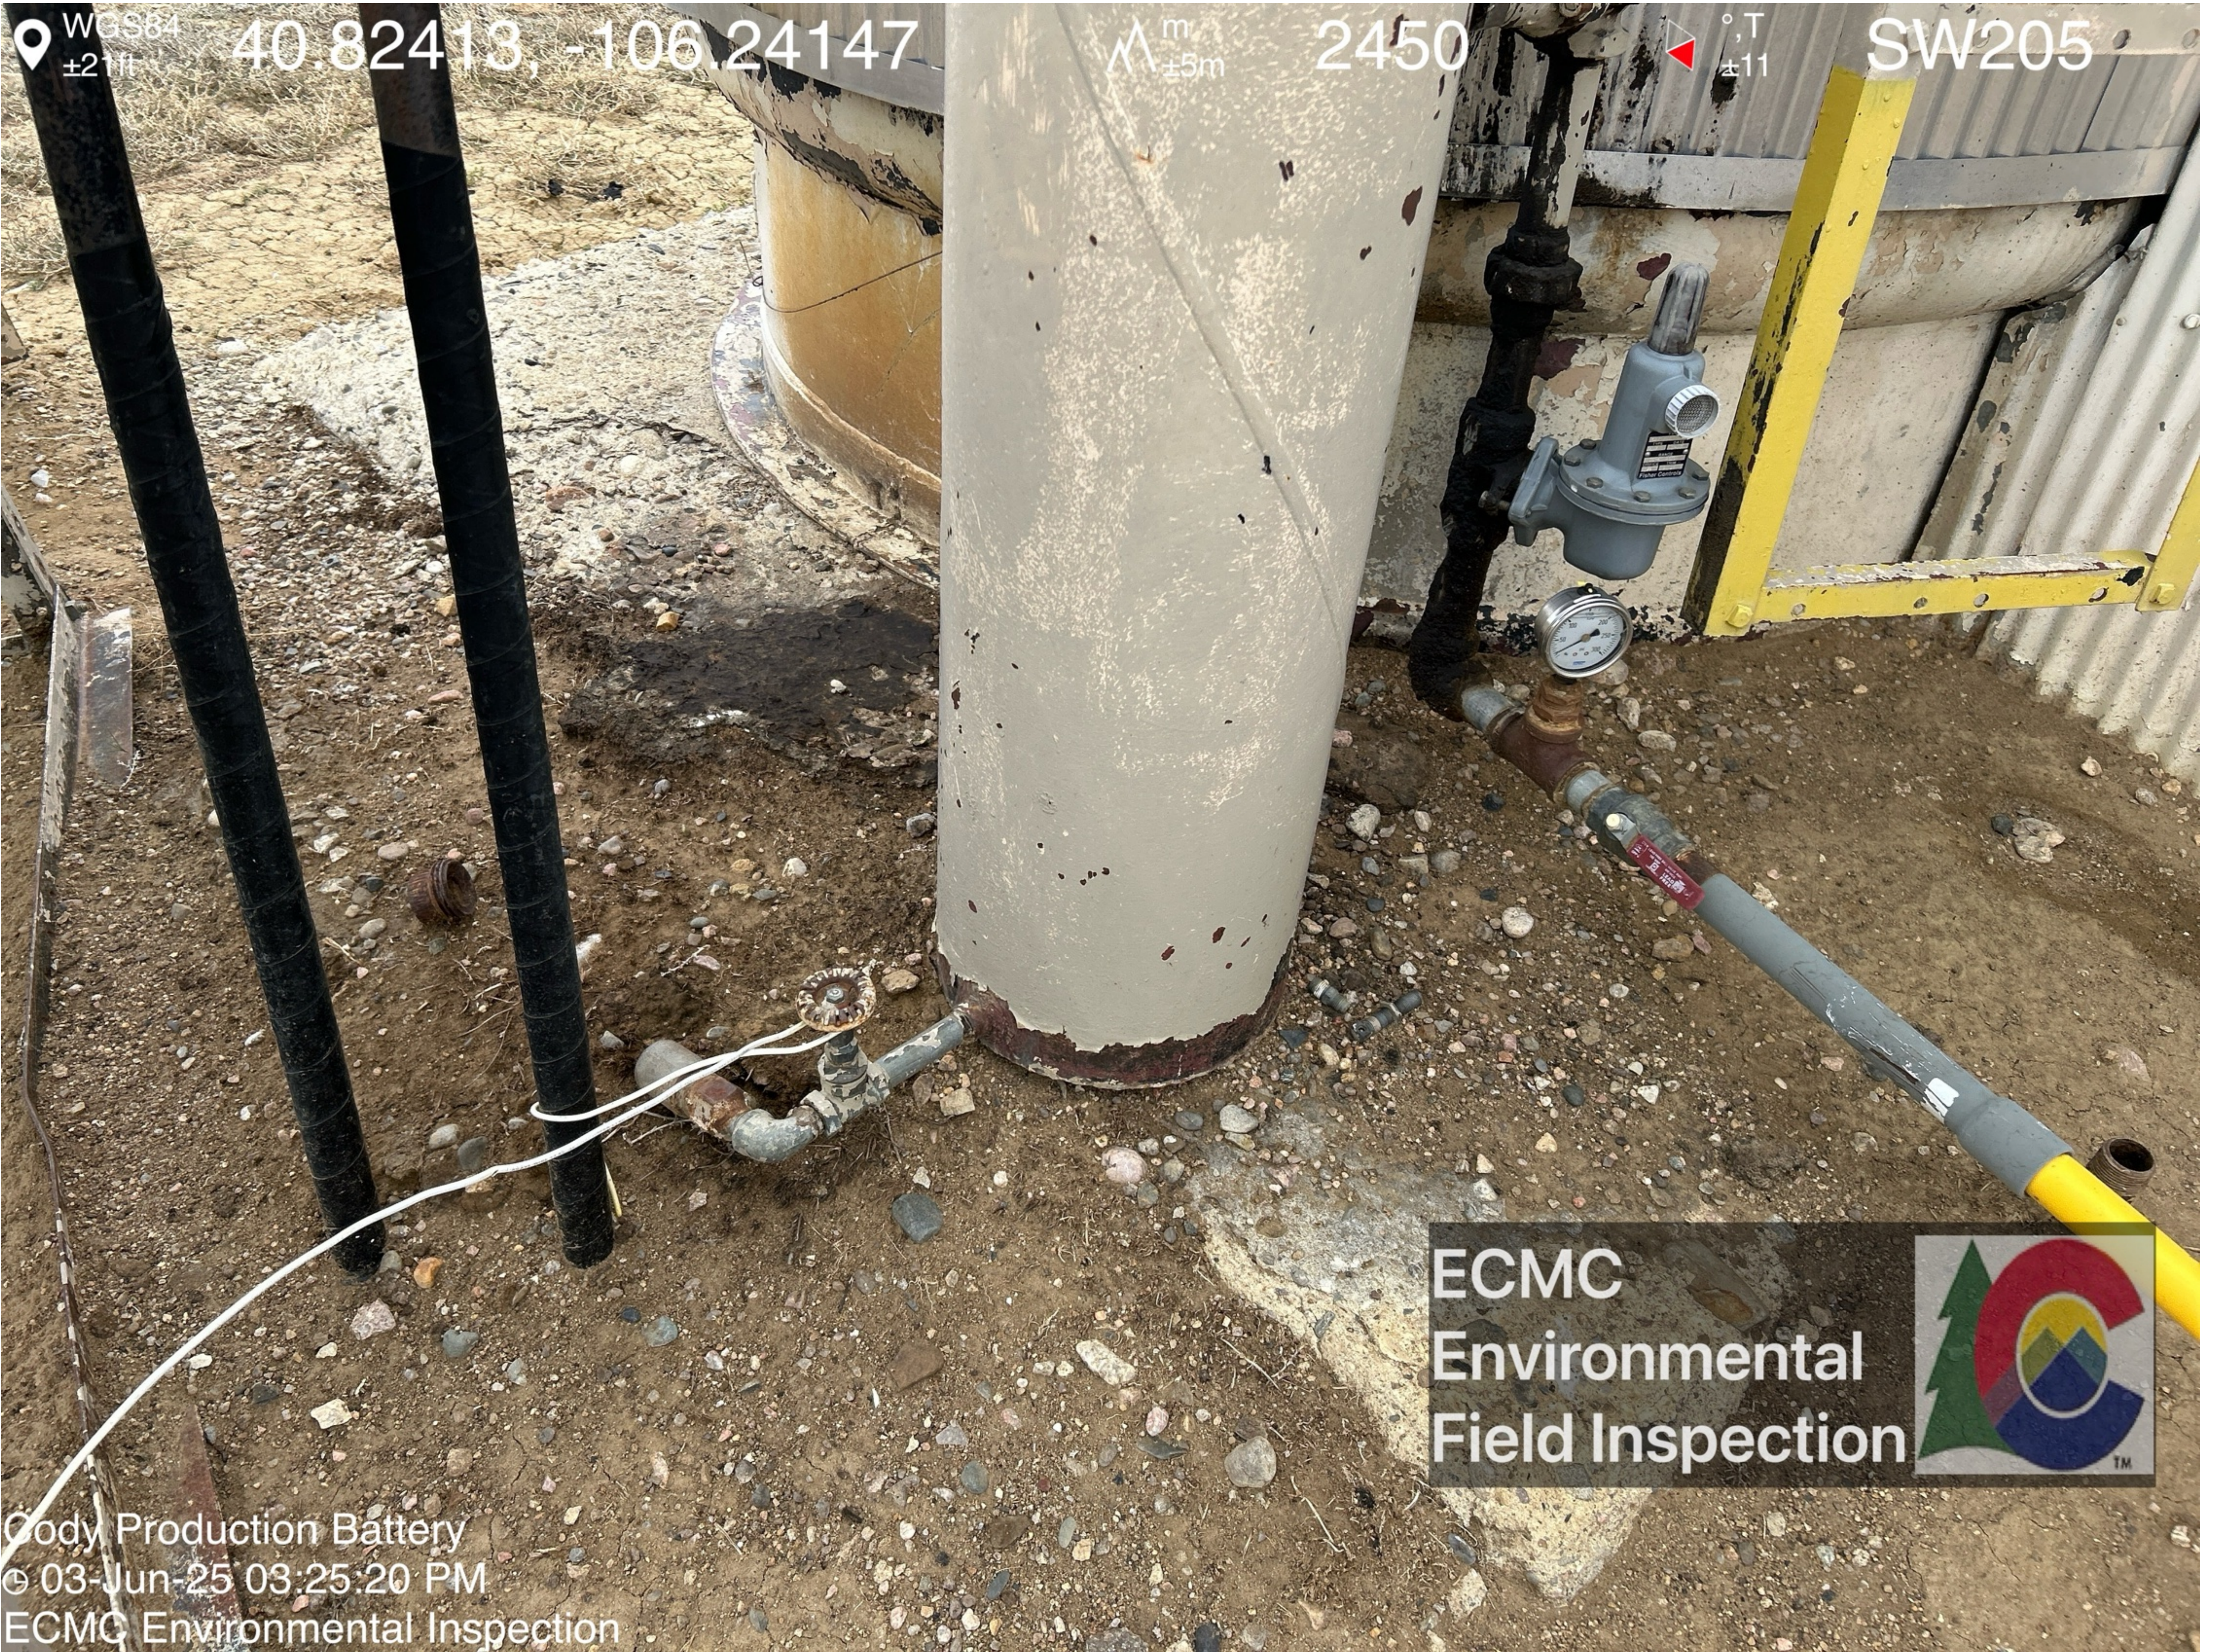
Stained soil is visible adjacent to the separator. A strong petroleum hydrocarbon odor was observed when the stained soil was disturbed.

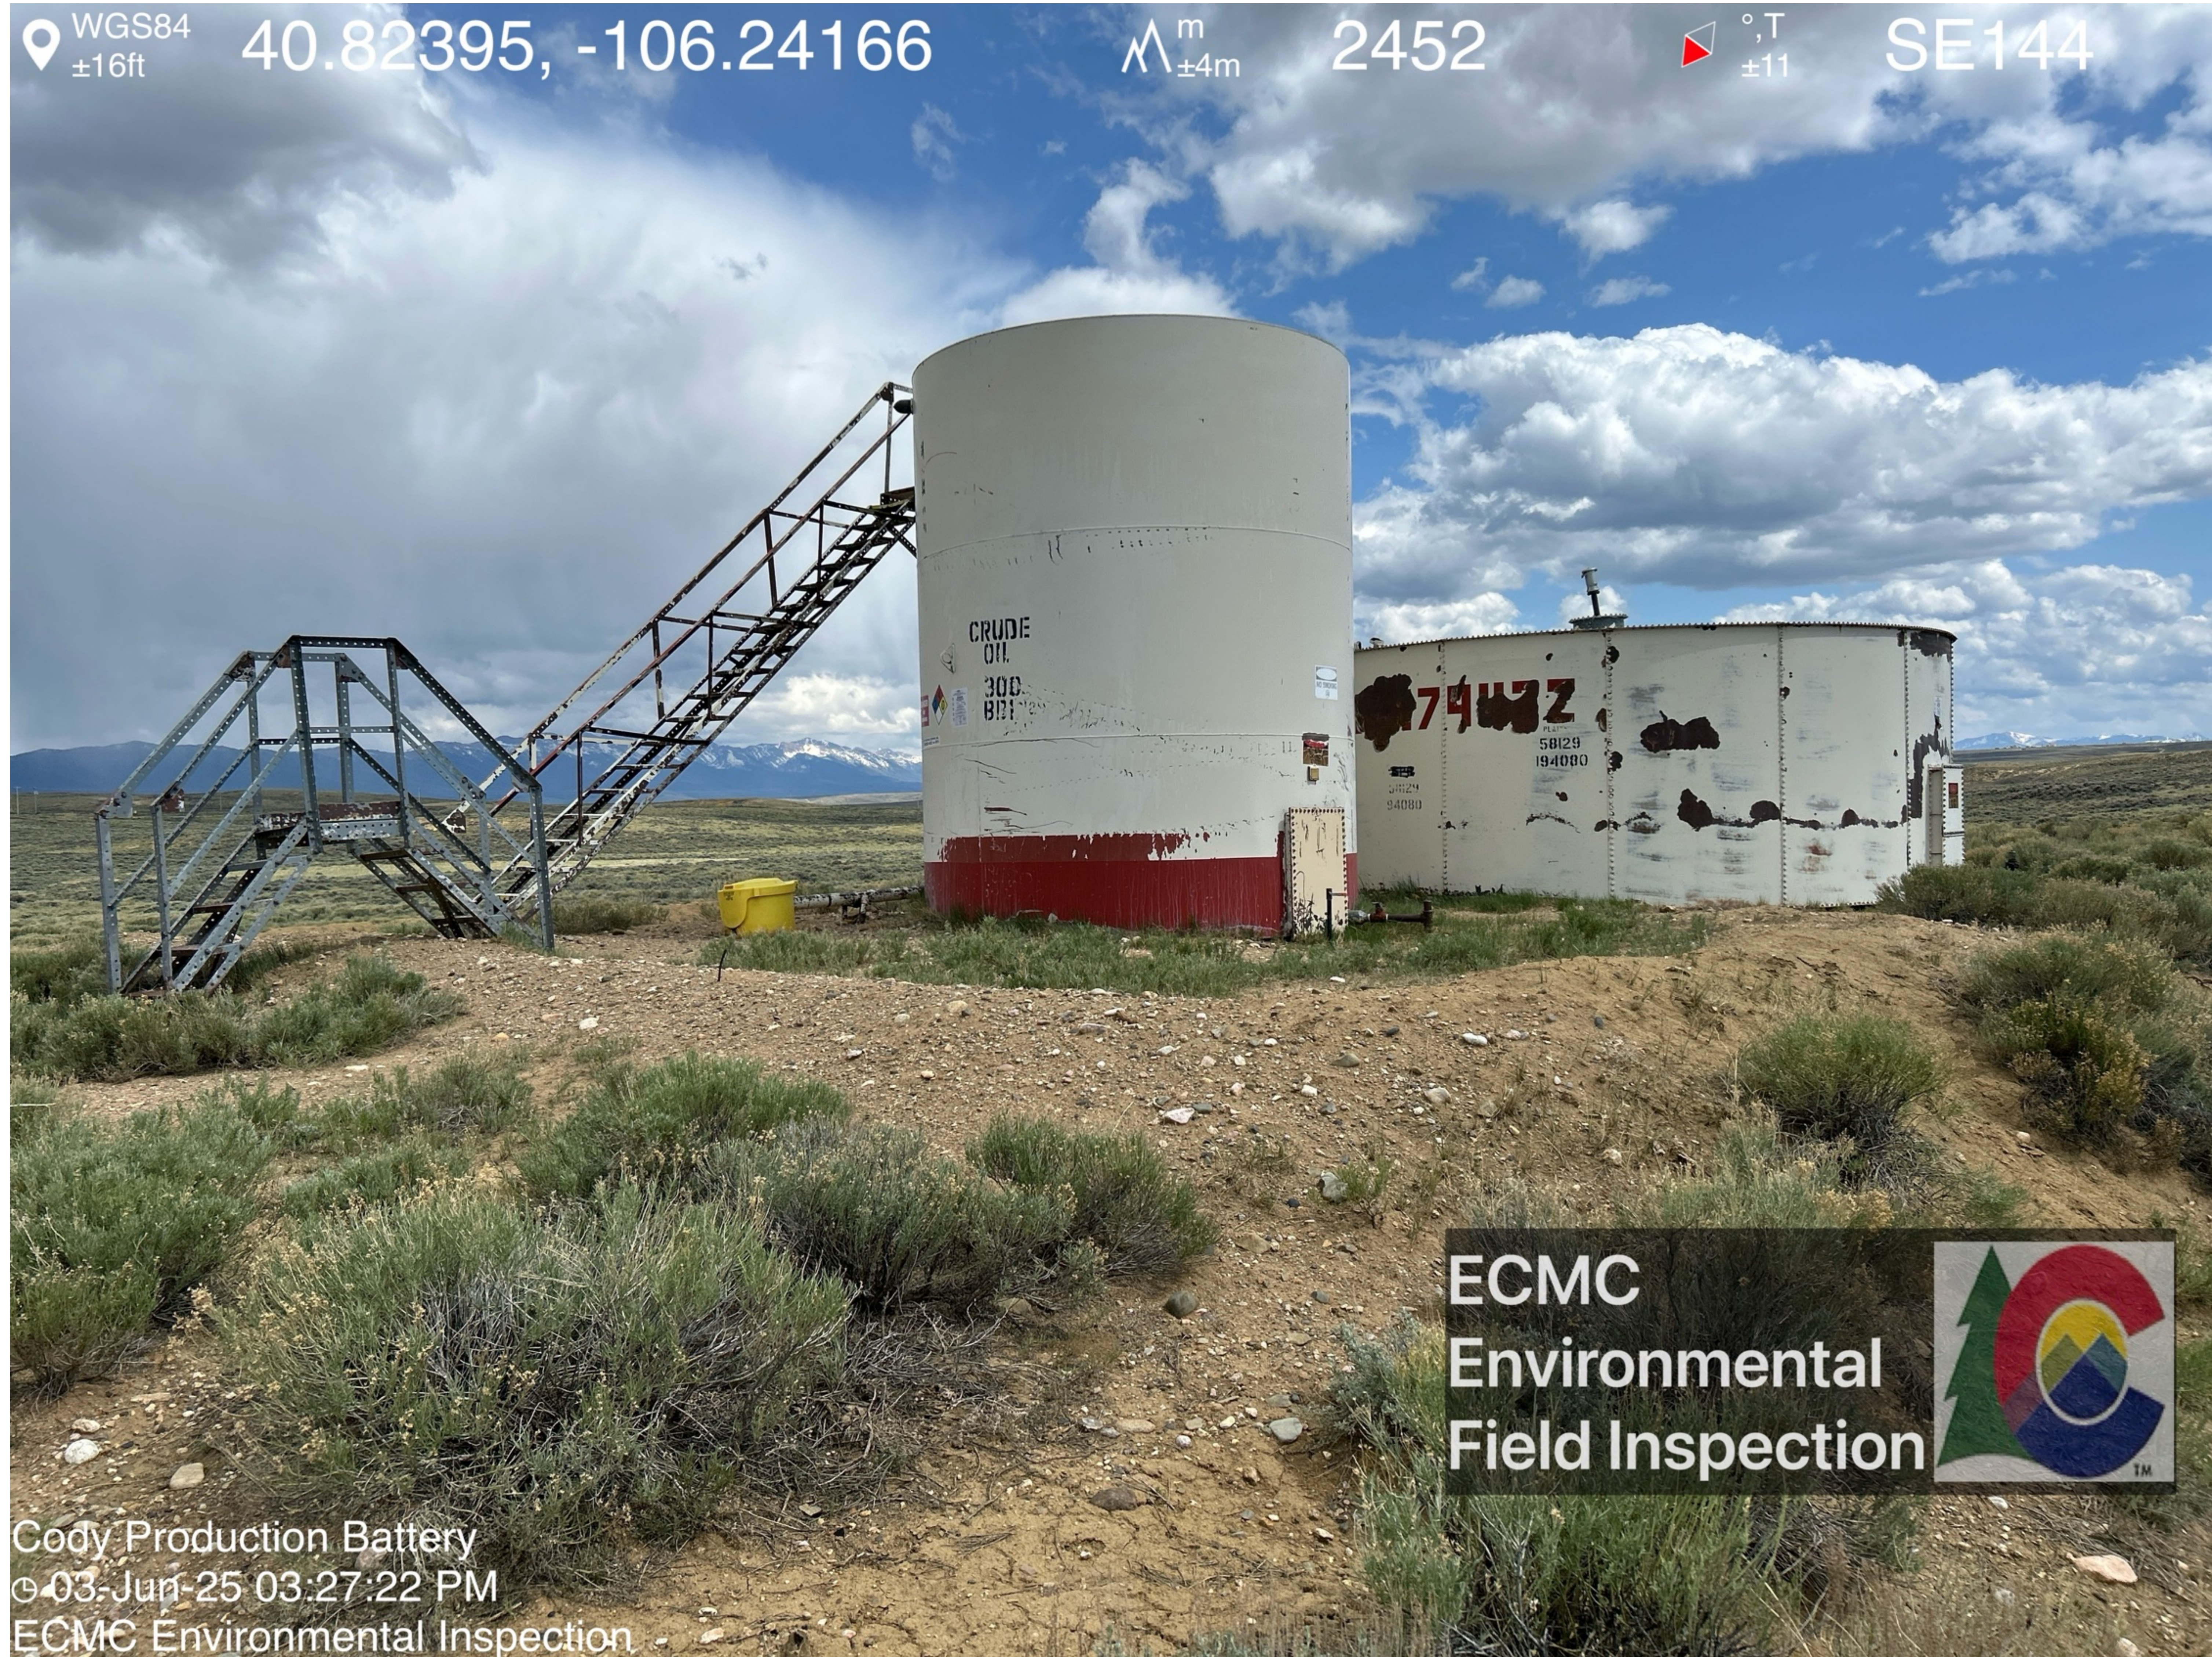
Labels/placards on production tanks are becoming illegible. Paint is peeling from a production tank (right).
