ECMC  
Environmental  
Field Inspection

DAKLAK Flowline  
© 03-Jun-25 05:10:59 PM  
ECMC Environmental Inspection

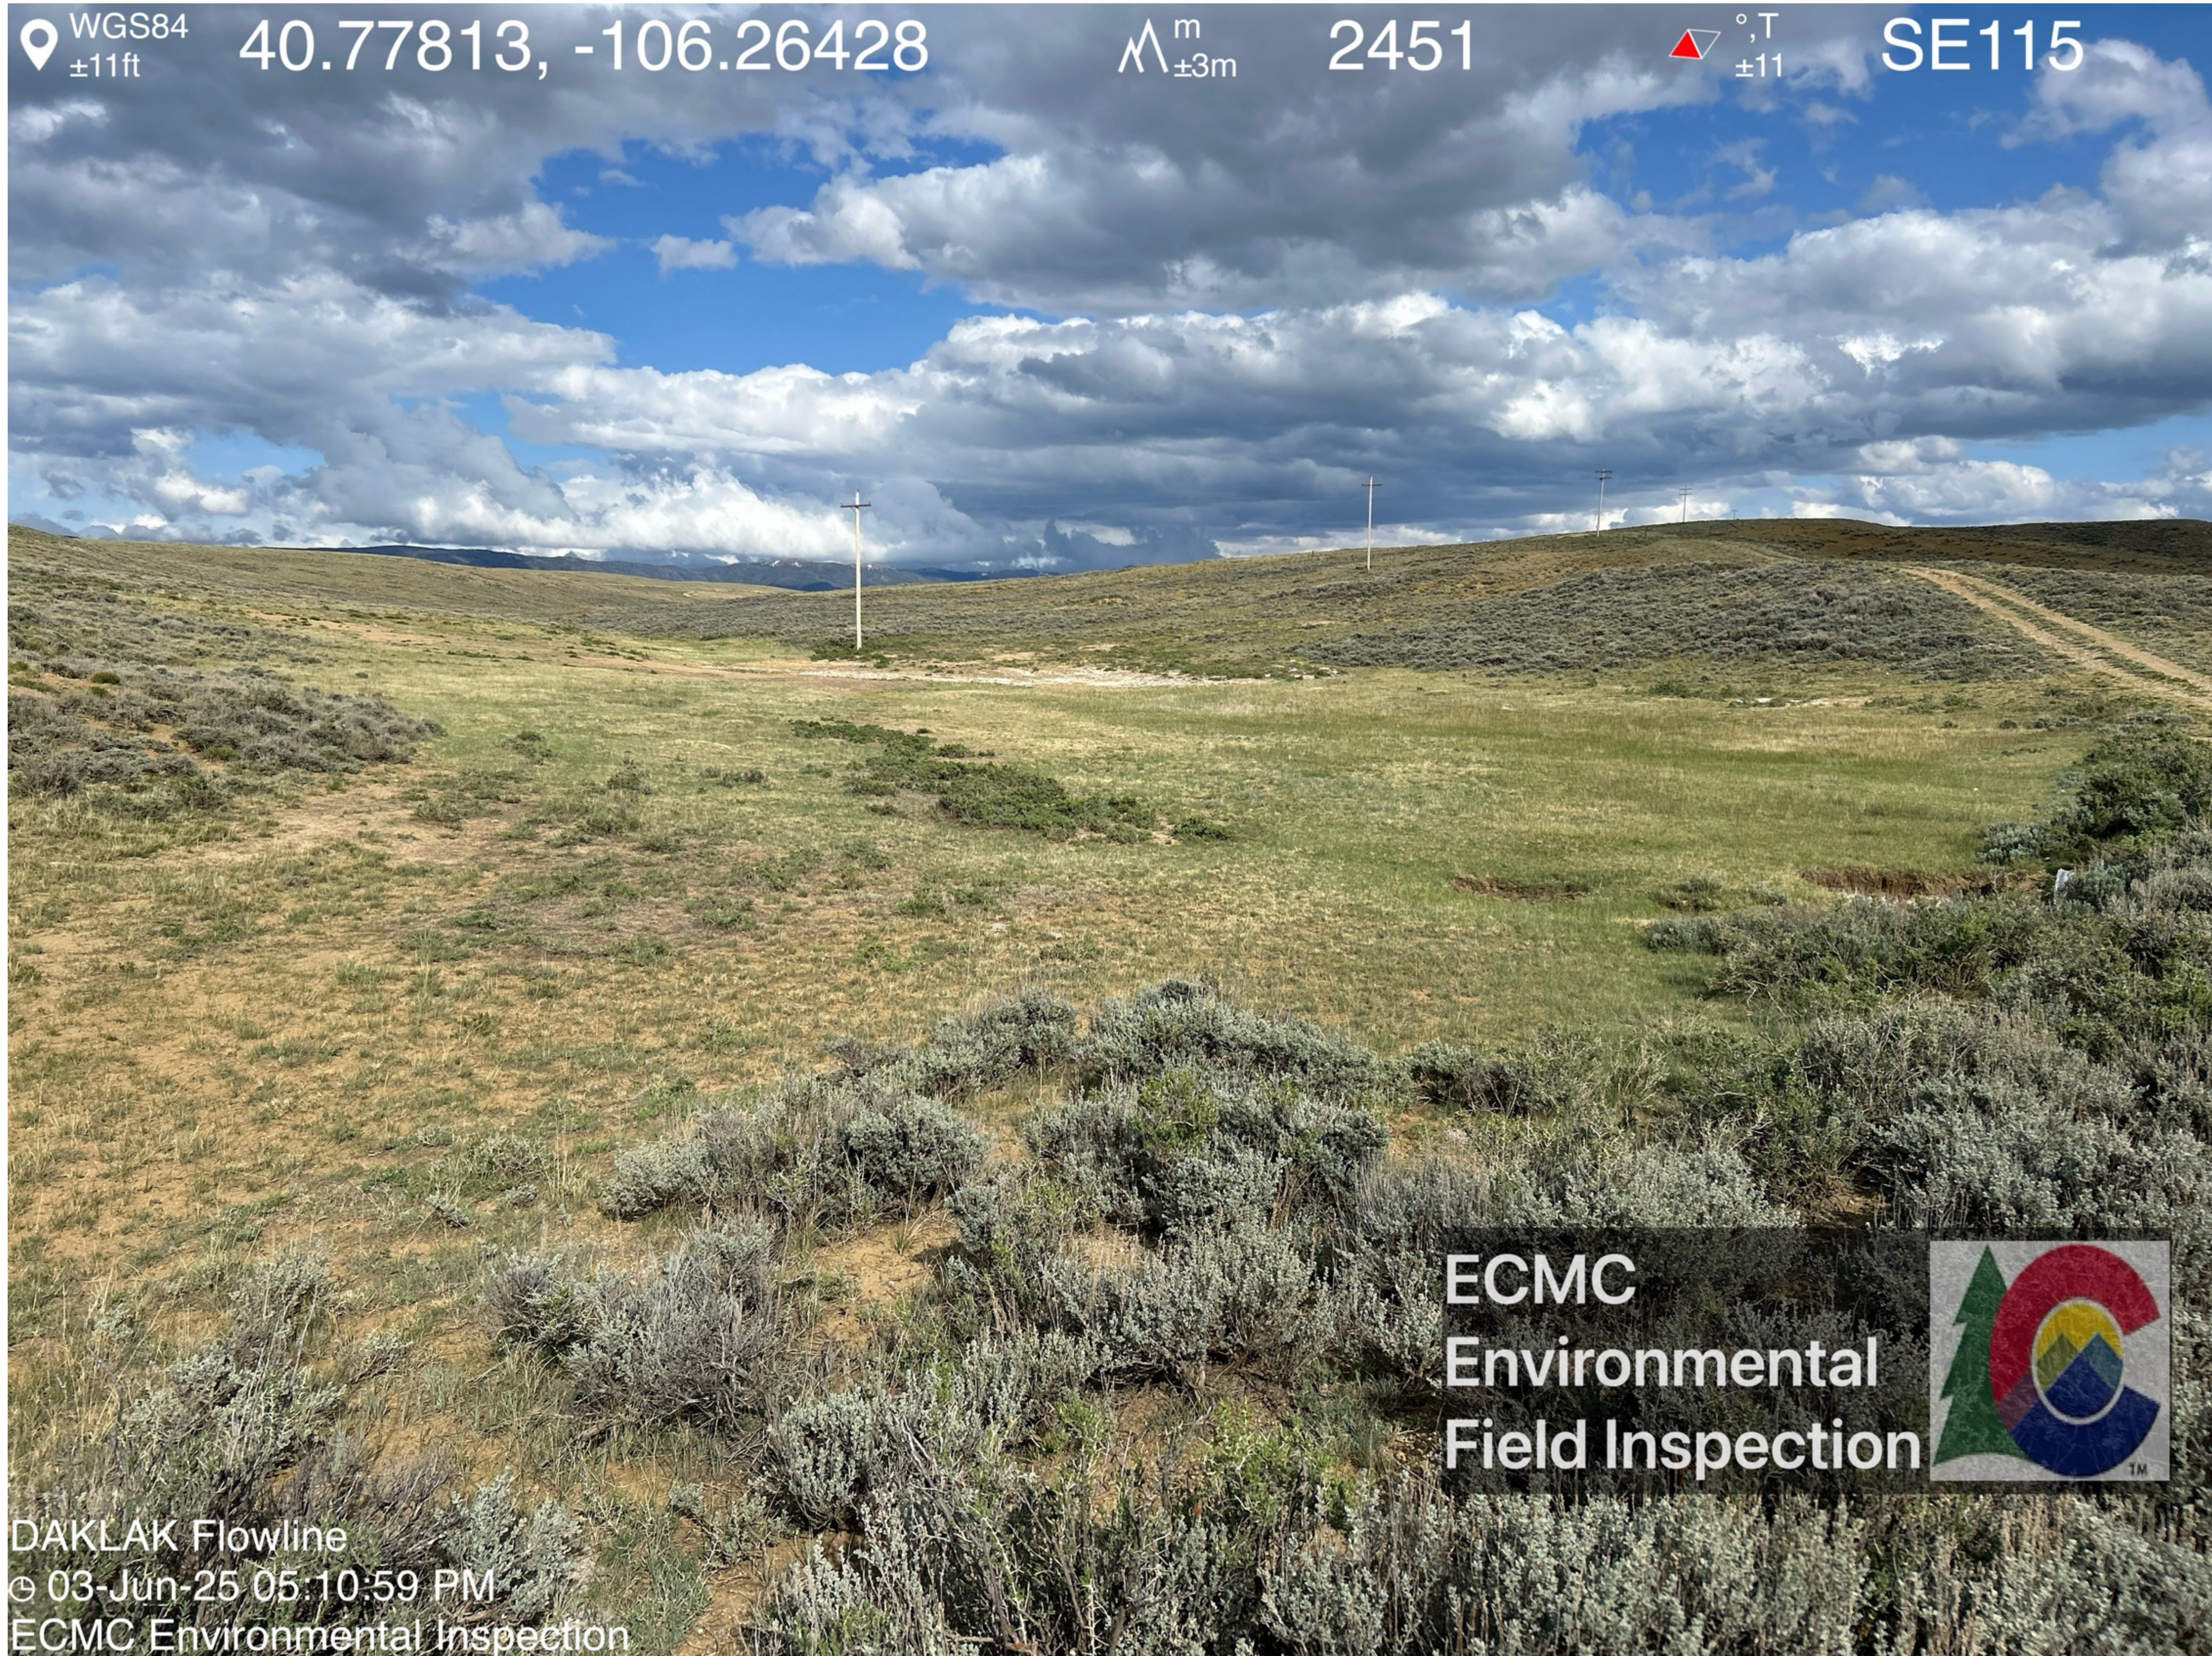
Looking at drainage towards spill location from the access road.

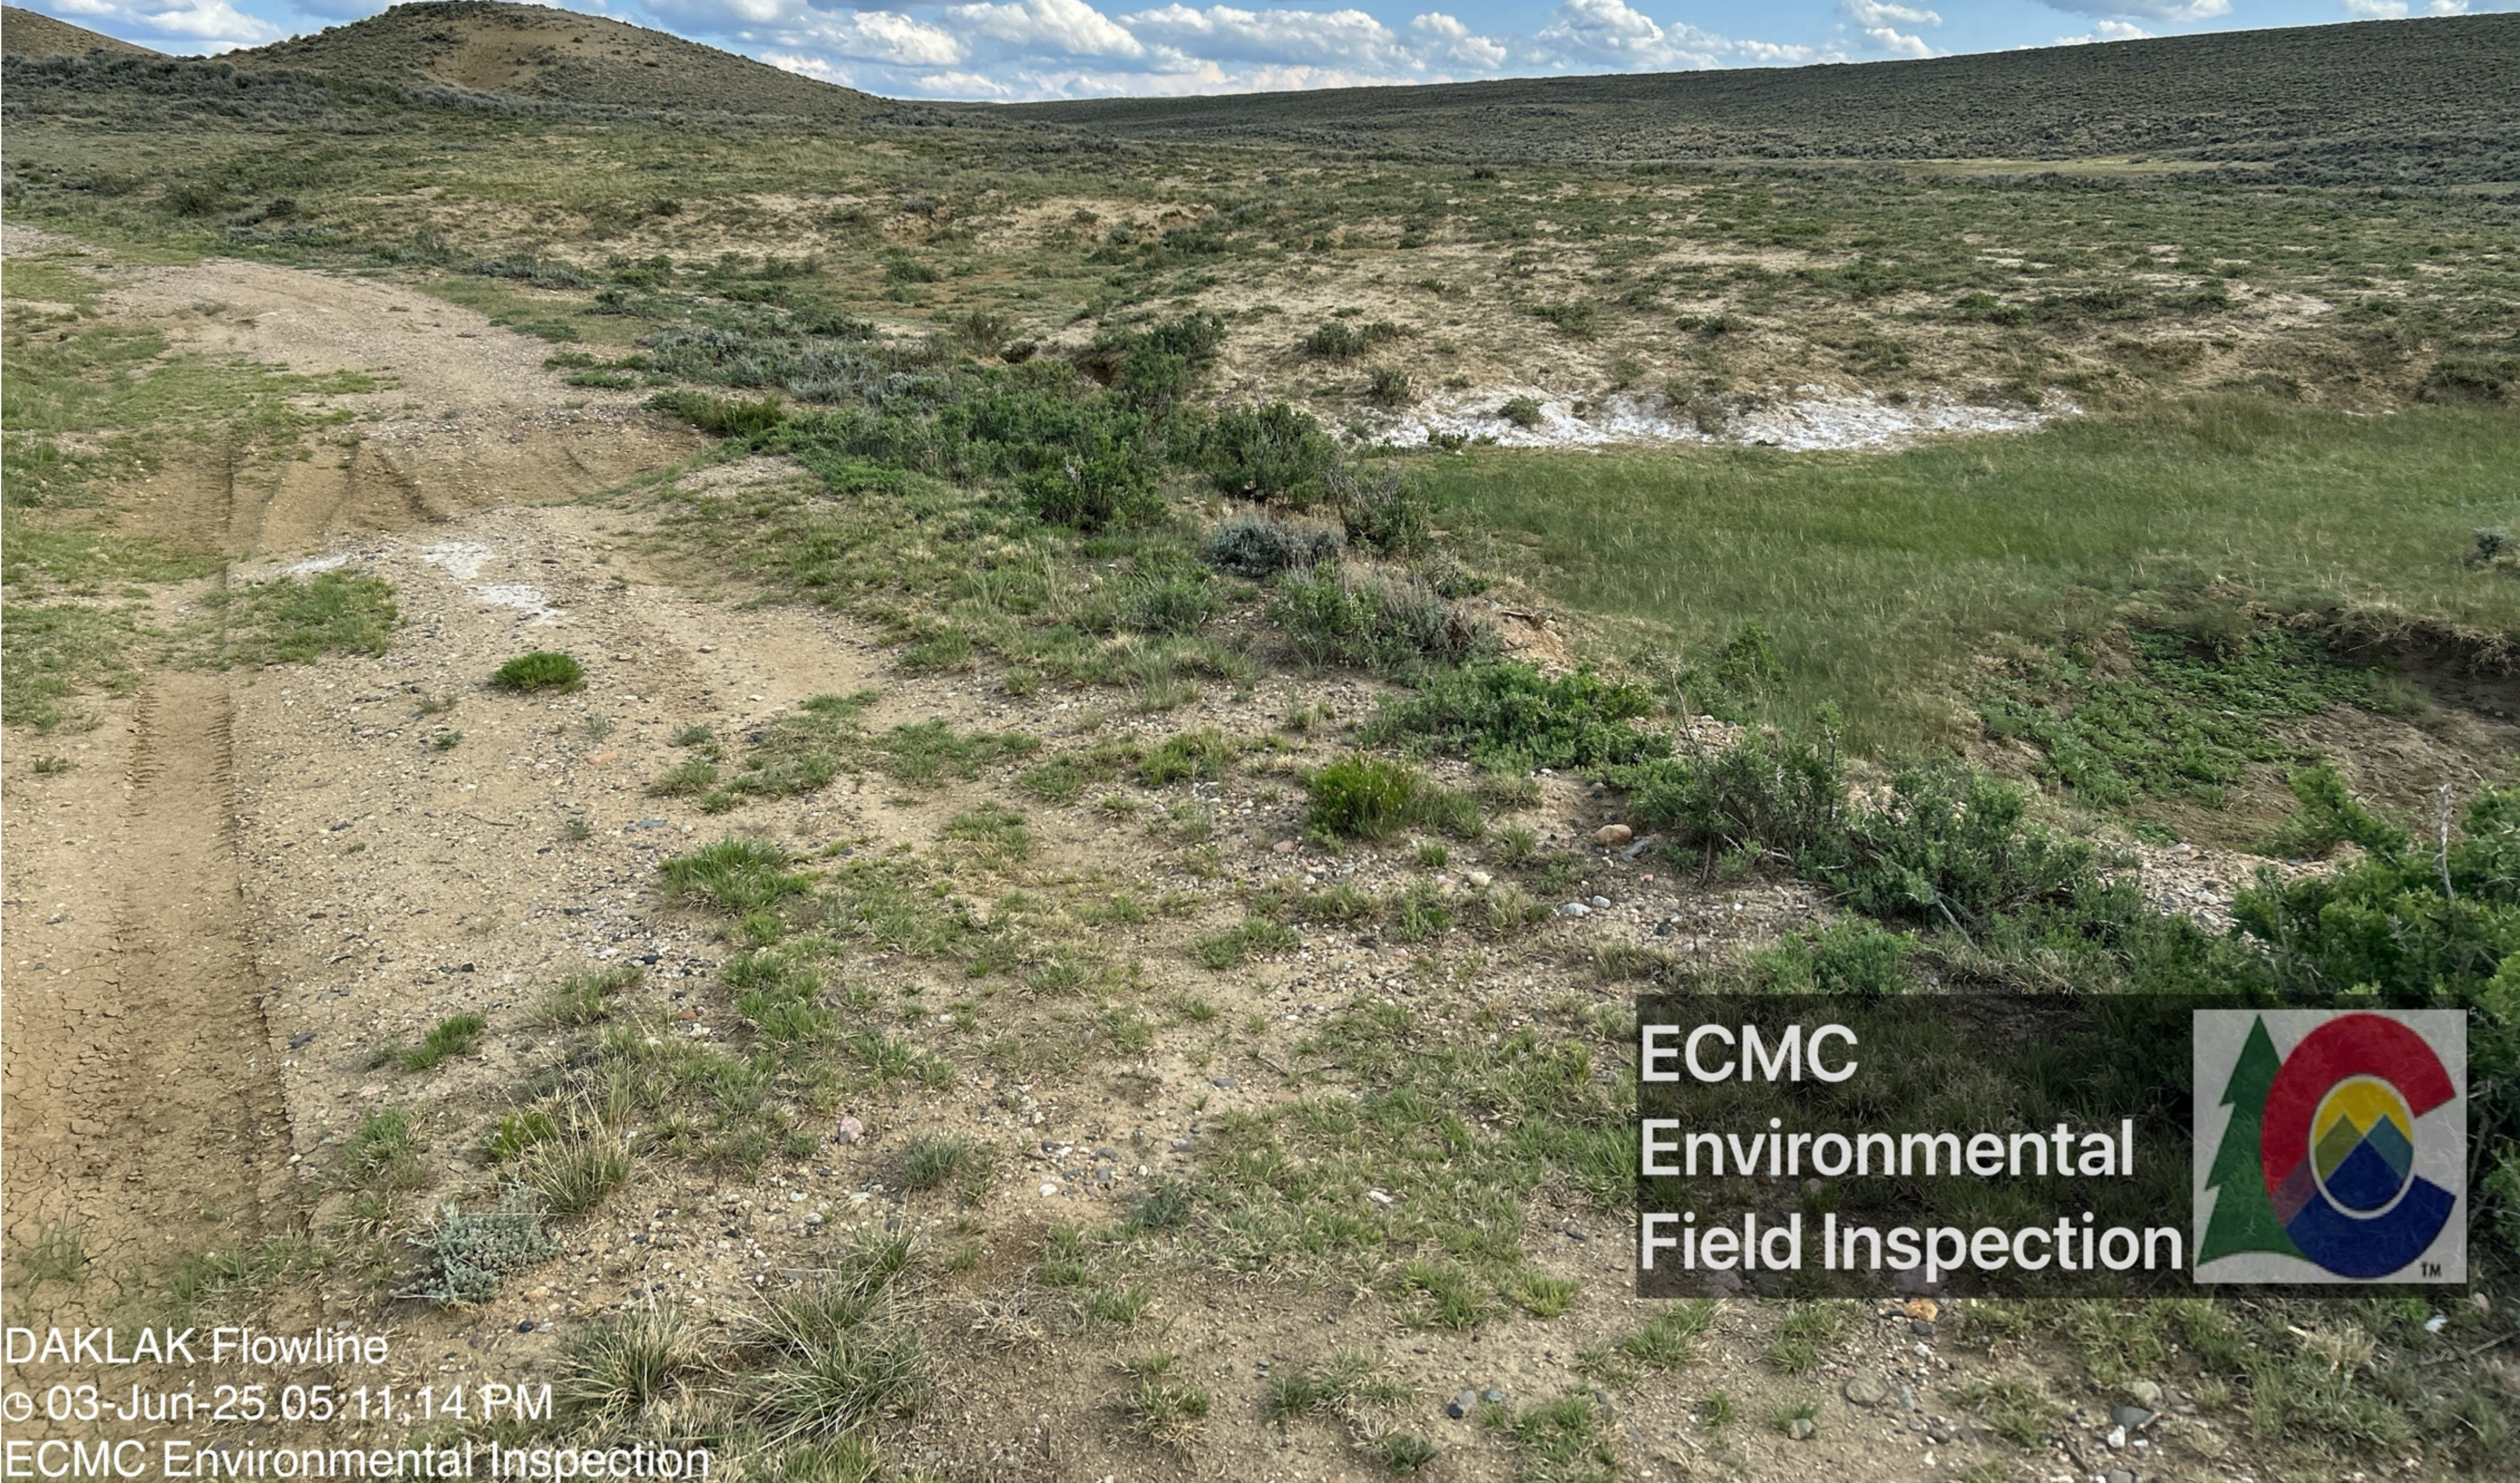
Looking at access road down-gradient of the spill location. Salt crusting is visible on both sides of the access road.

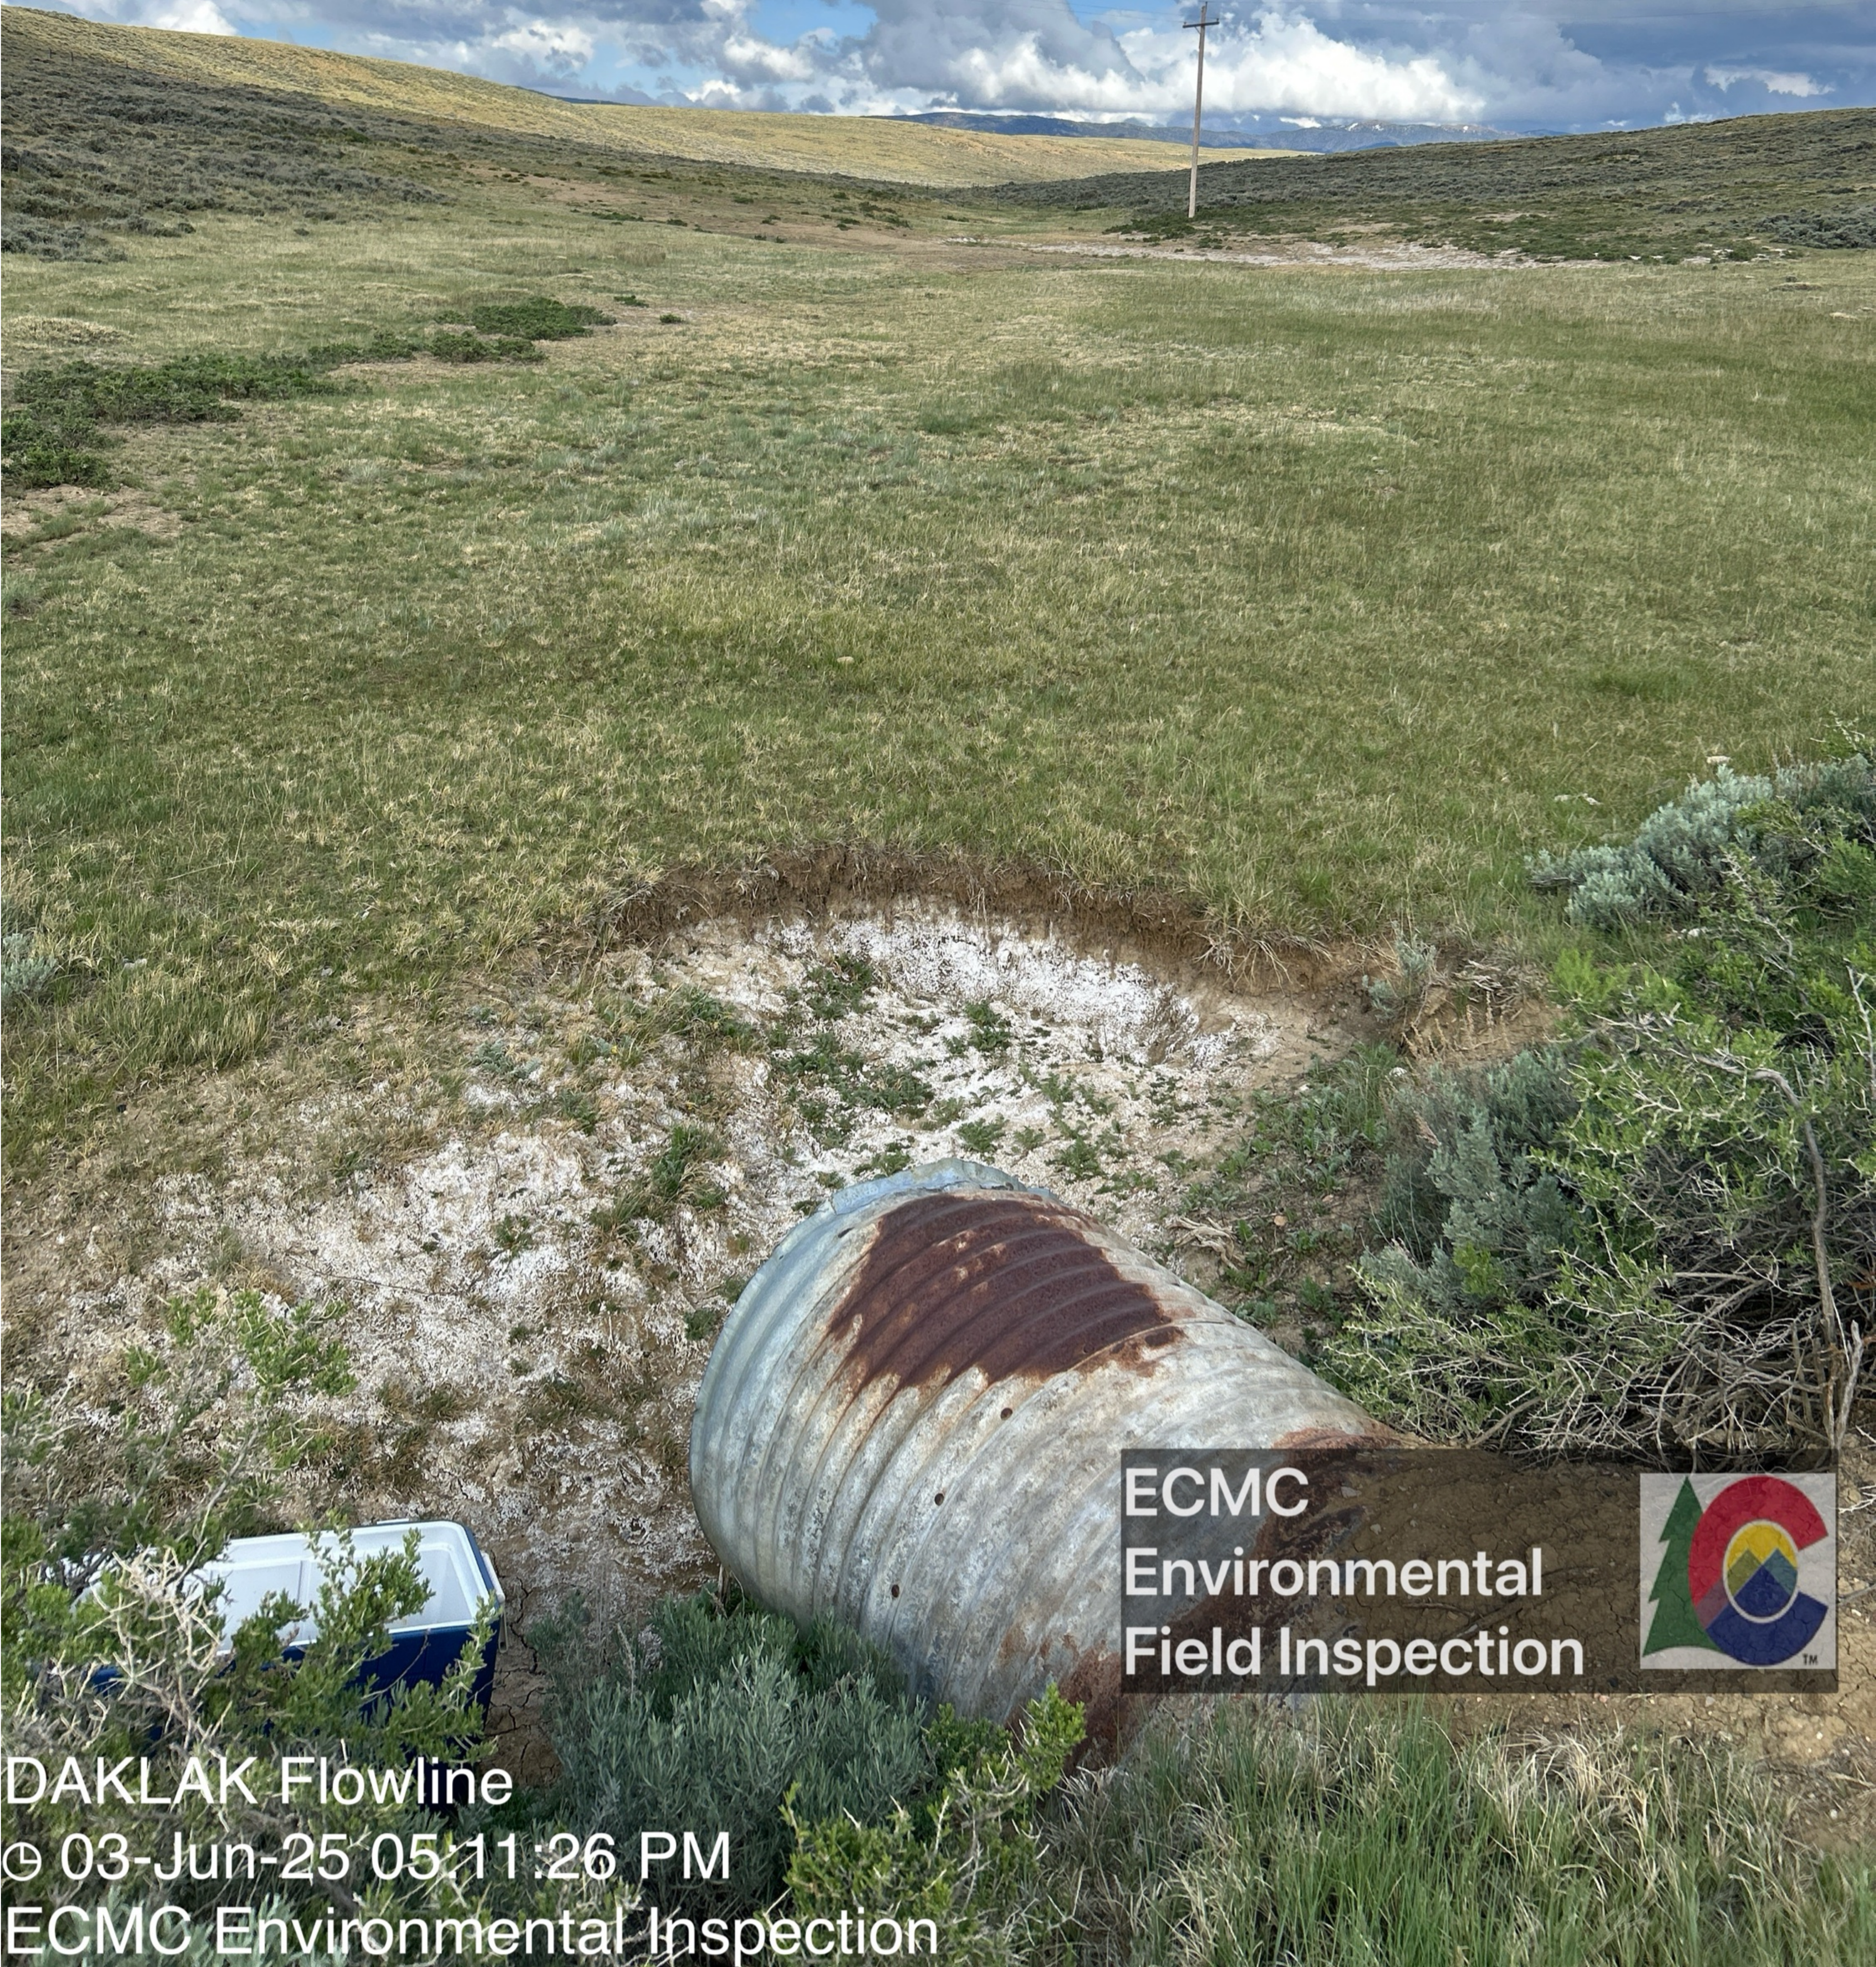
Looking at drainage towards spill location. Trash (a cooler) and salt crusting are visible adjacent to a culvert running under the access road.

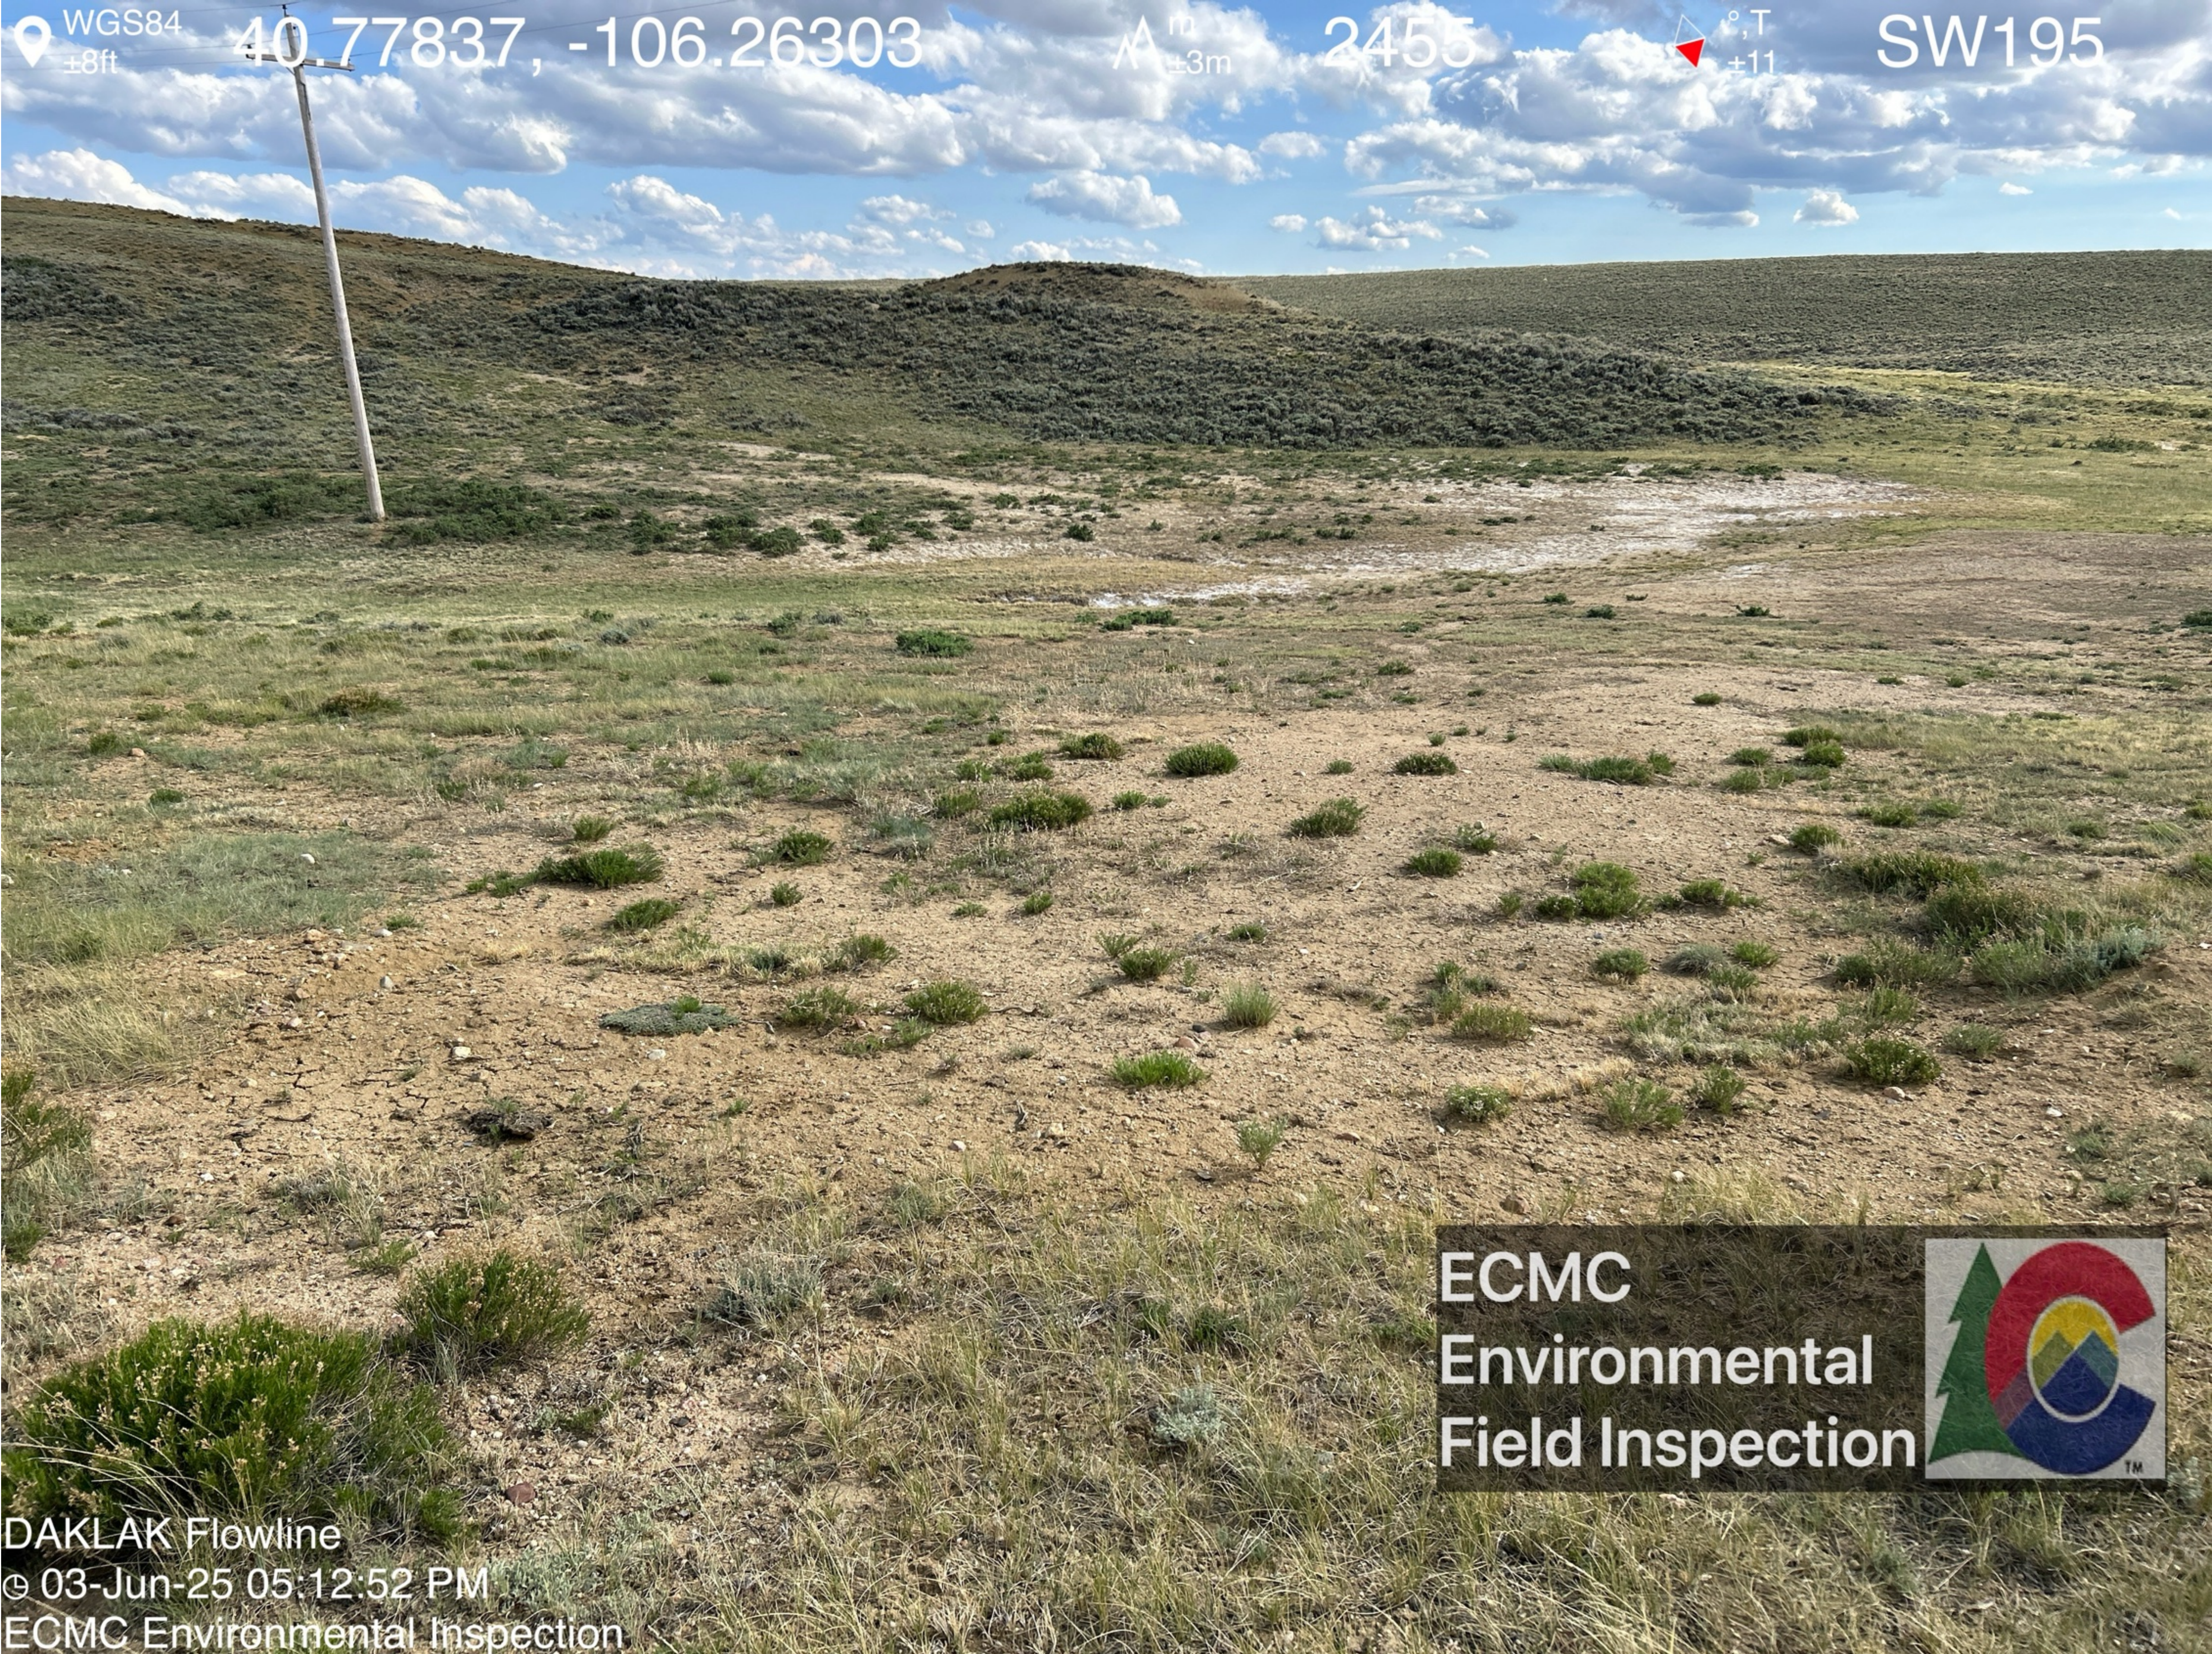
Looking at approximate spill location. The excavation and soil stockpile observed during previous inspections have been removed.

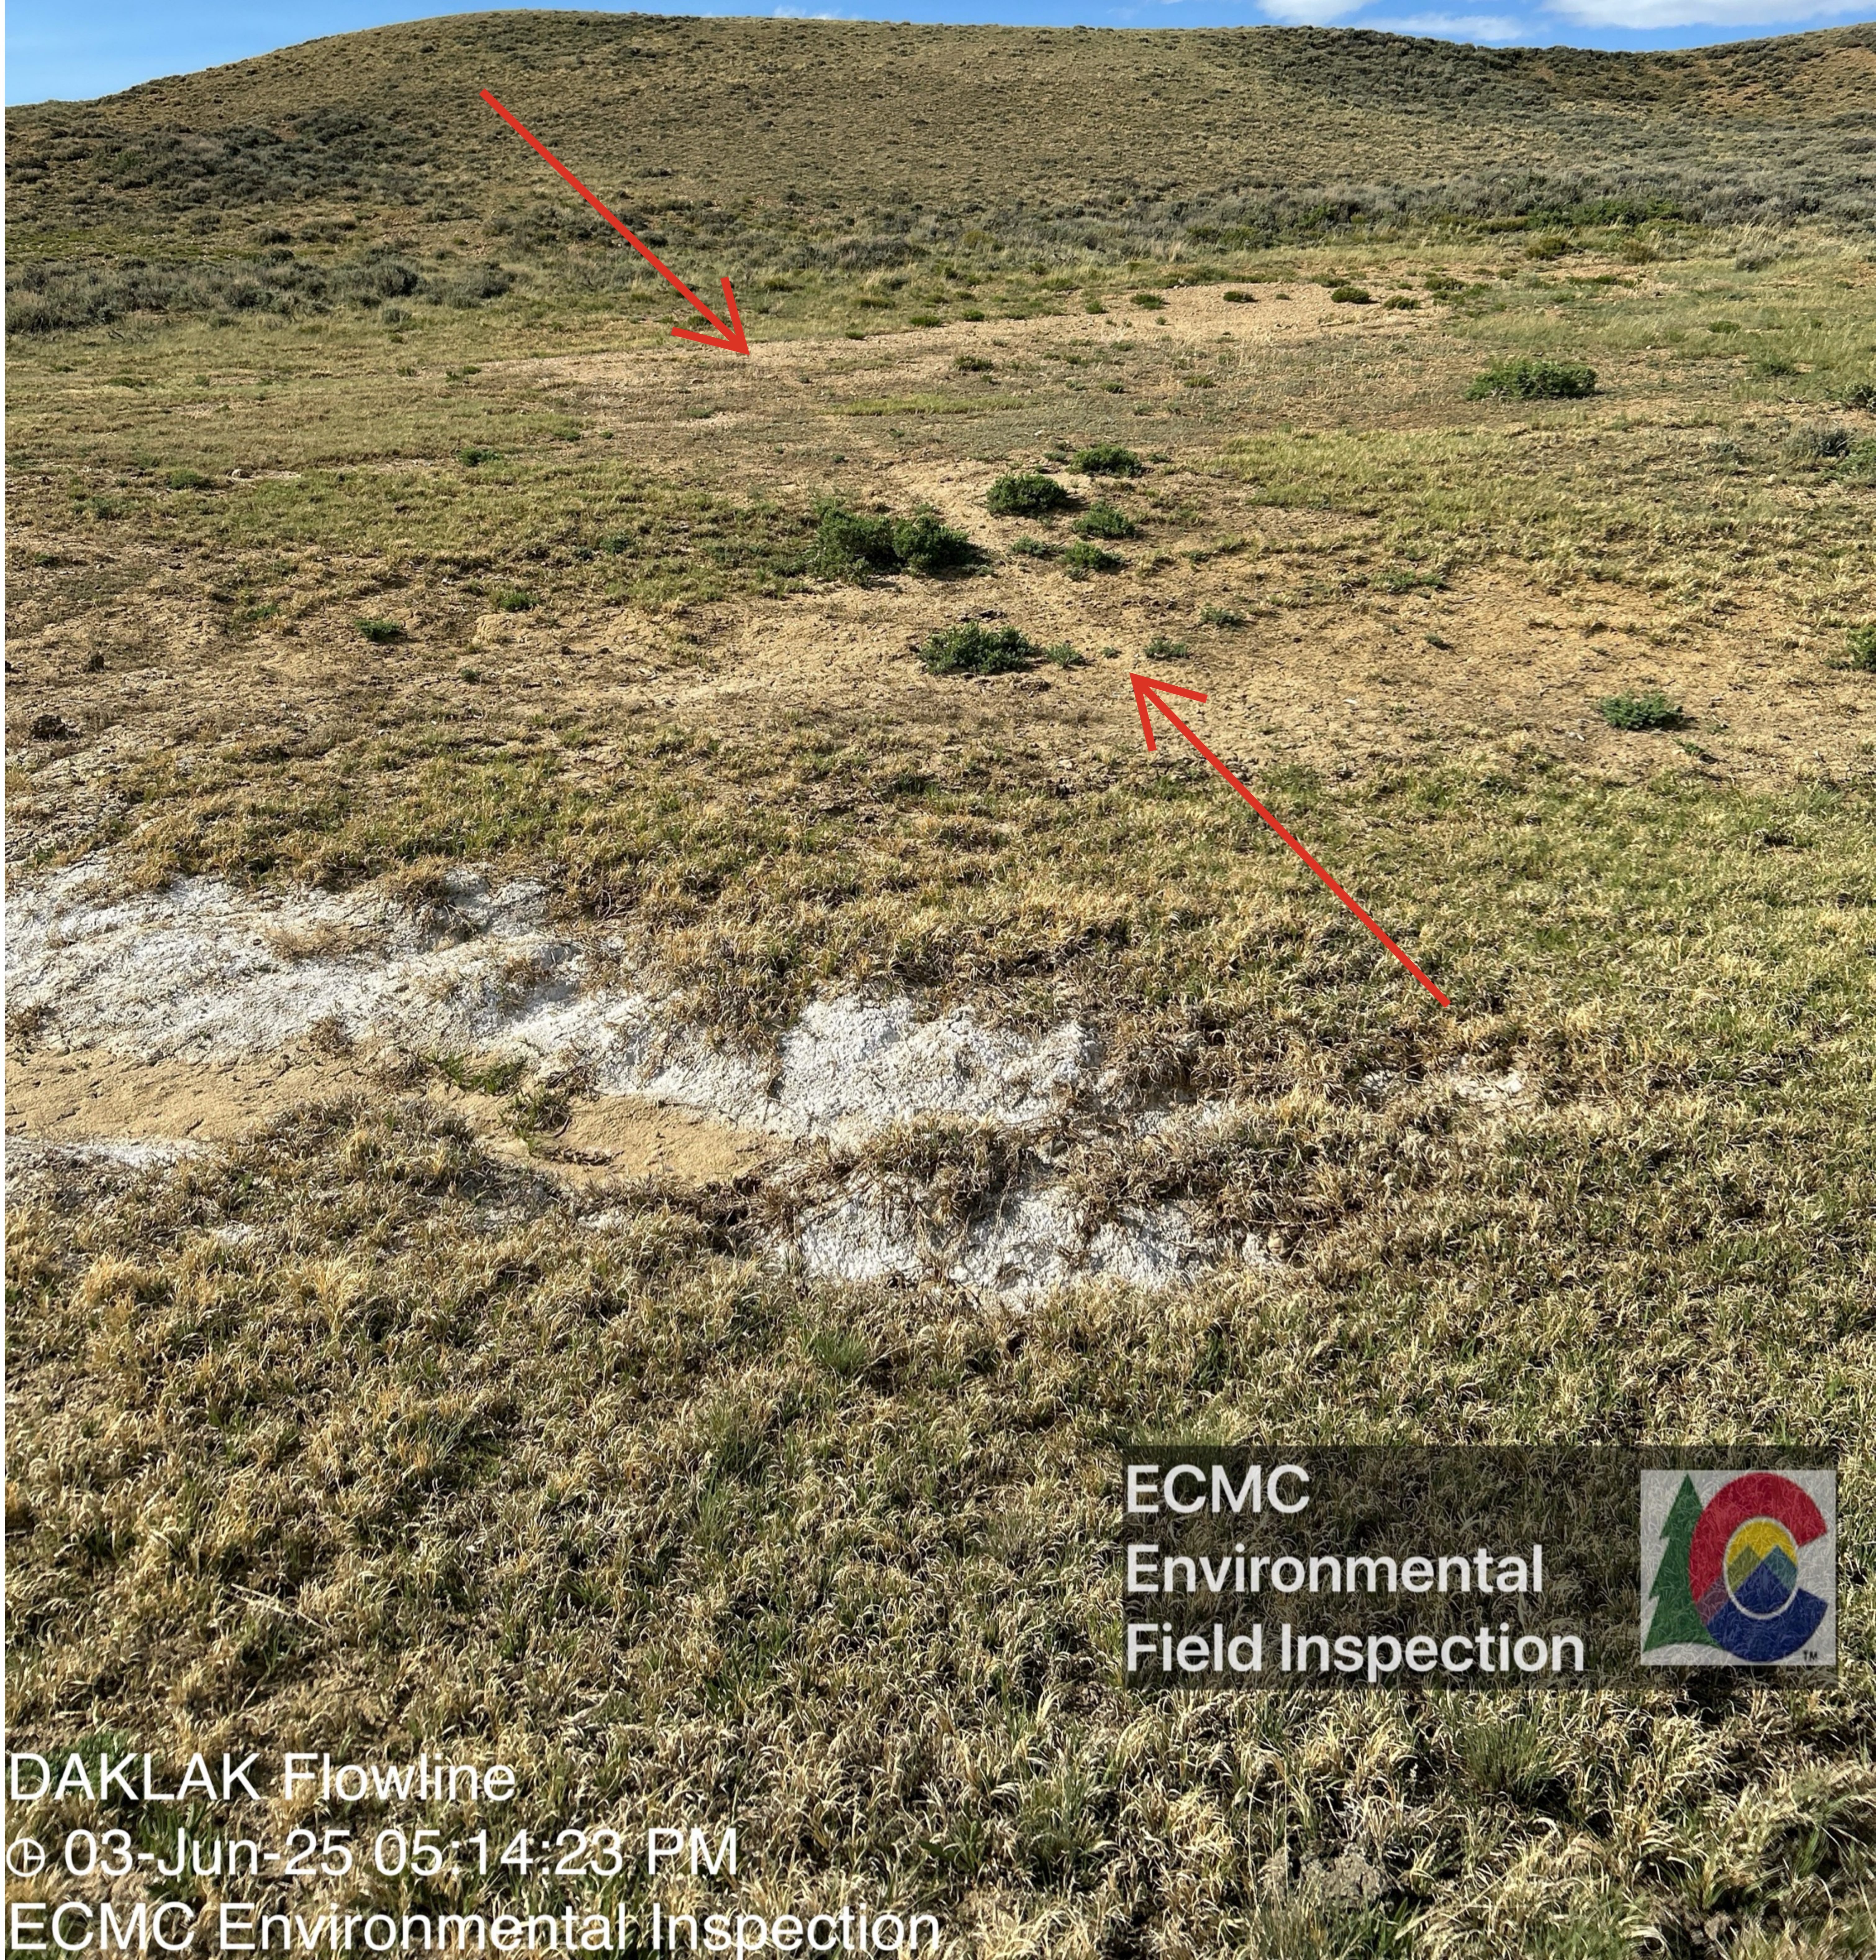
A line of less vegetation is visible in the approximate location of the flowline.

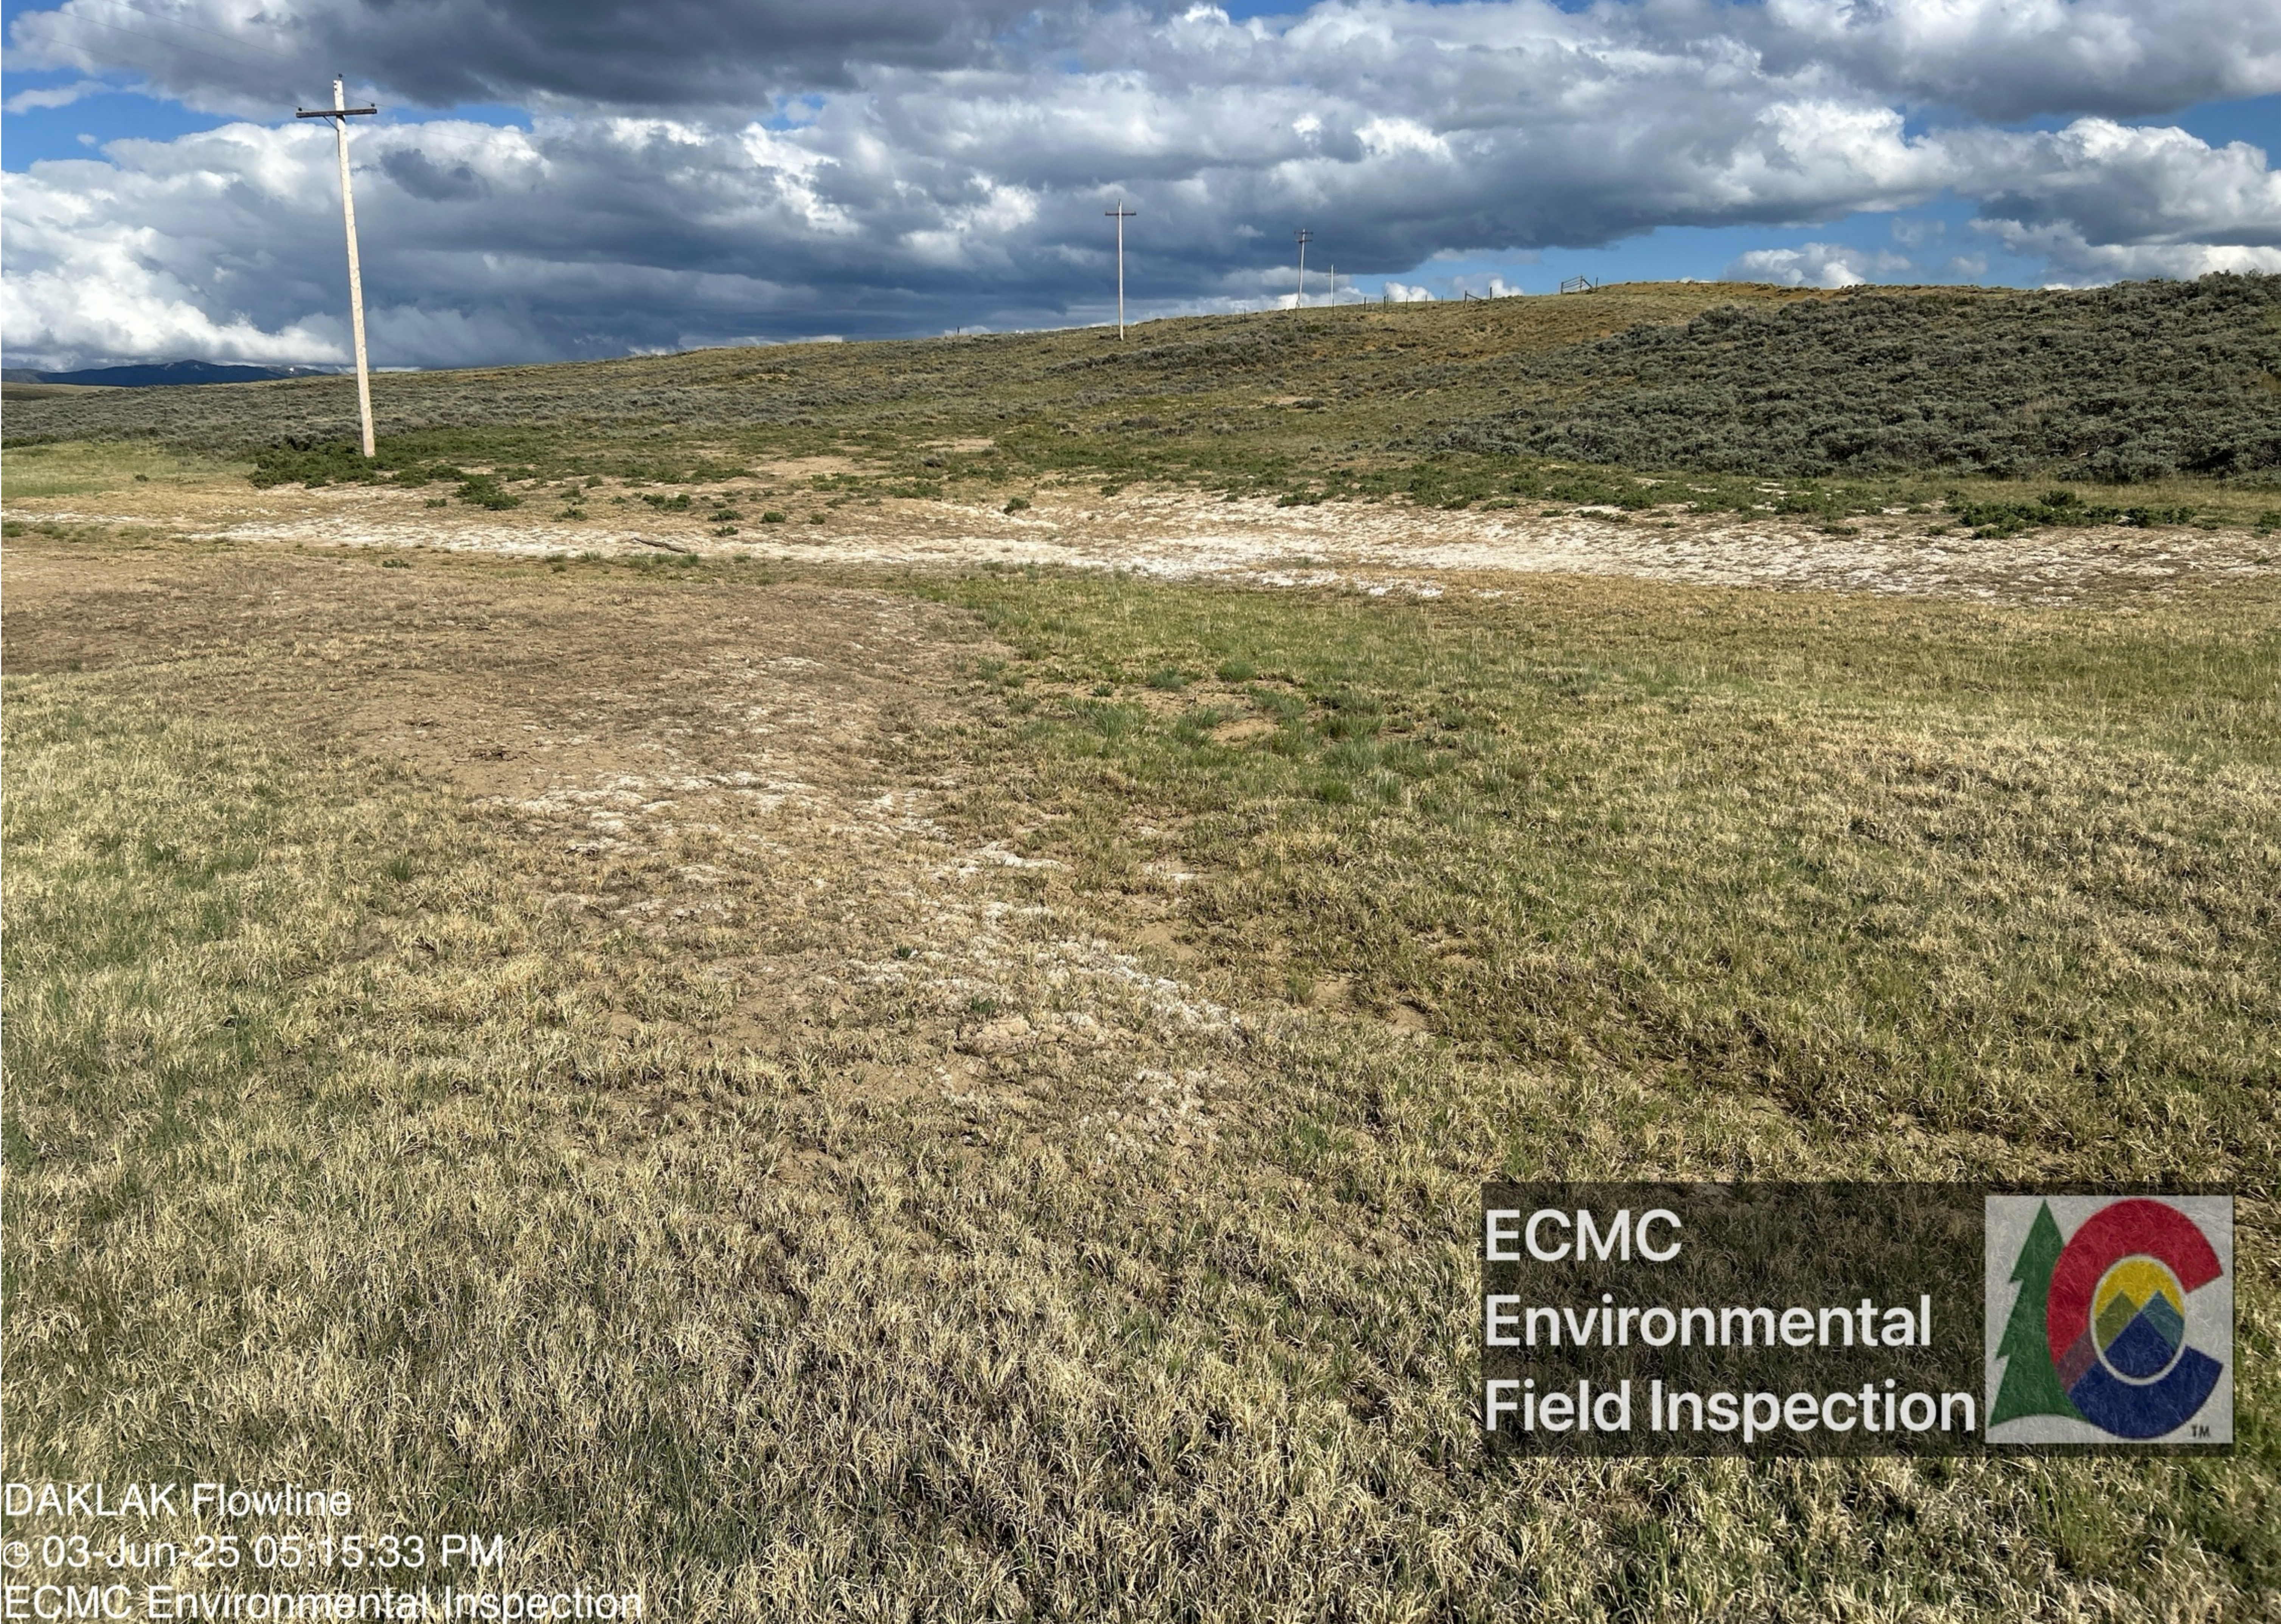
Salt crusting is visible across the drainage area.
