ECMC  
Environmental  
Field Inspection

McCallum 73 Flowline  
© 04-Jun-25 09:56:01 AM  
ECMC Environmental Inspection

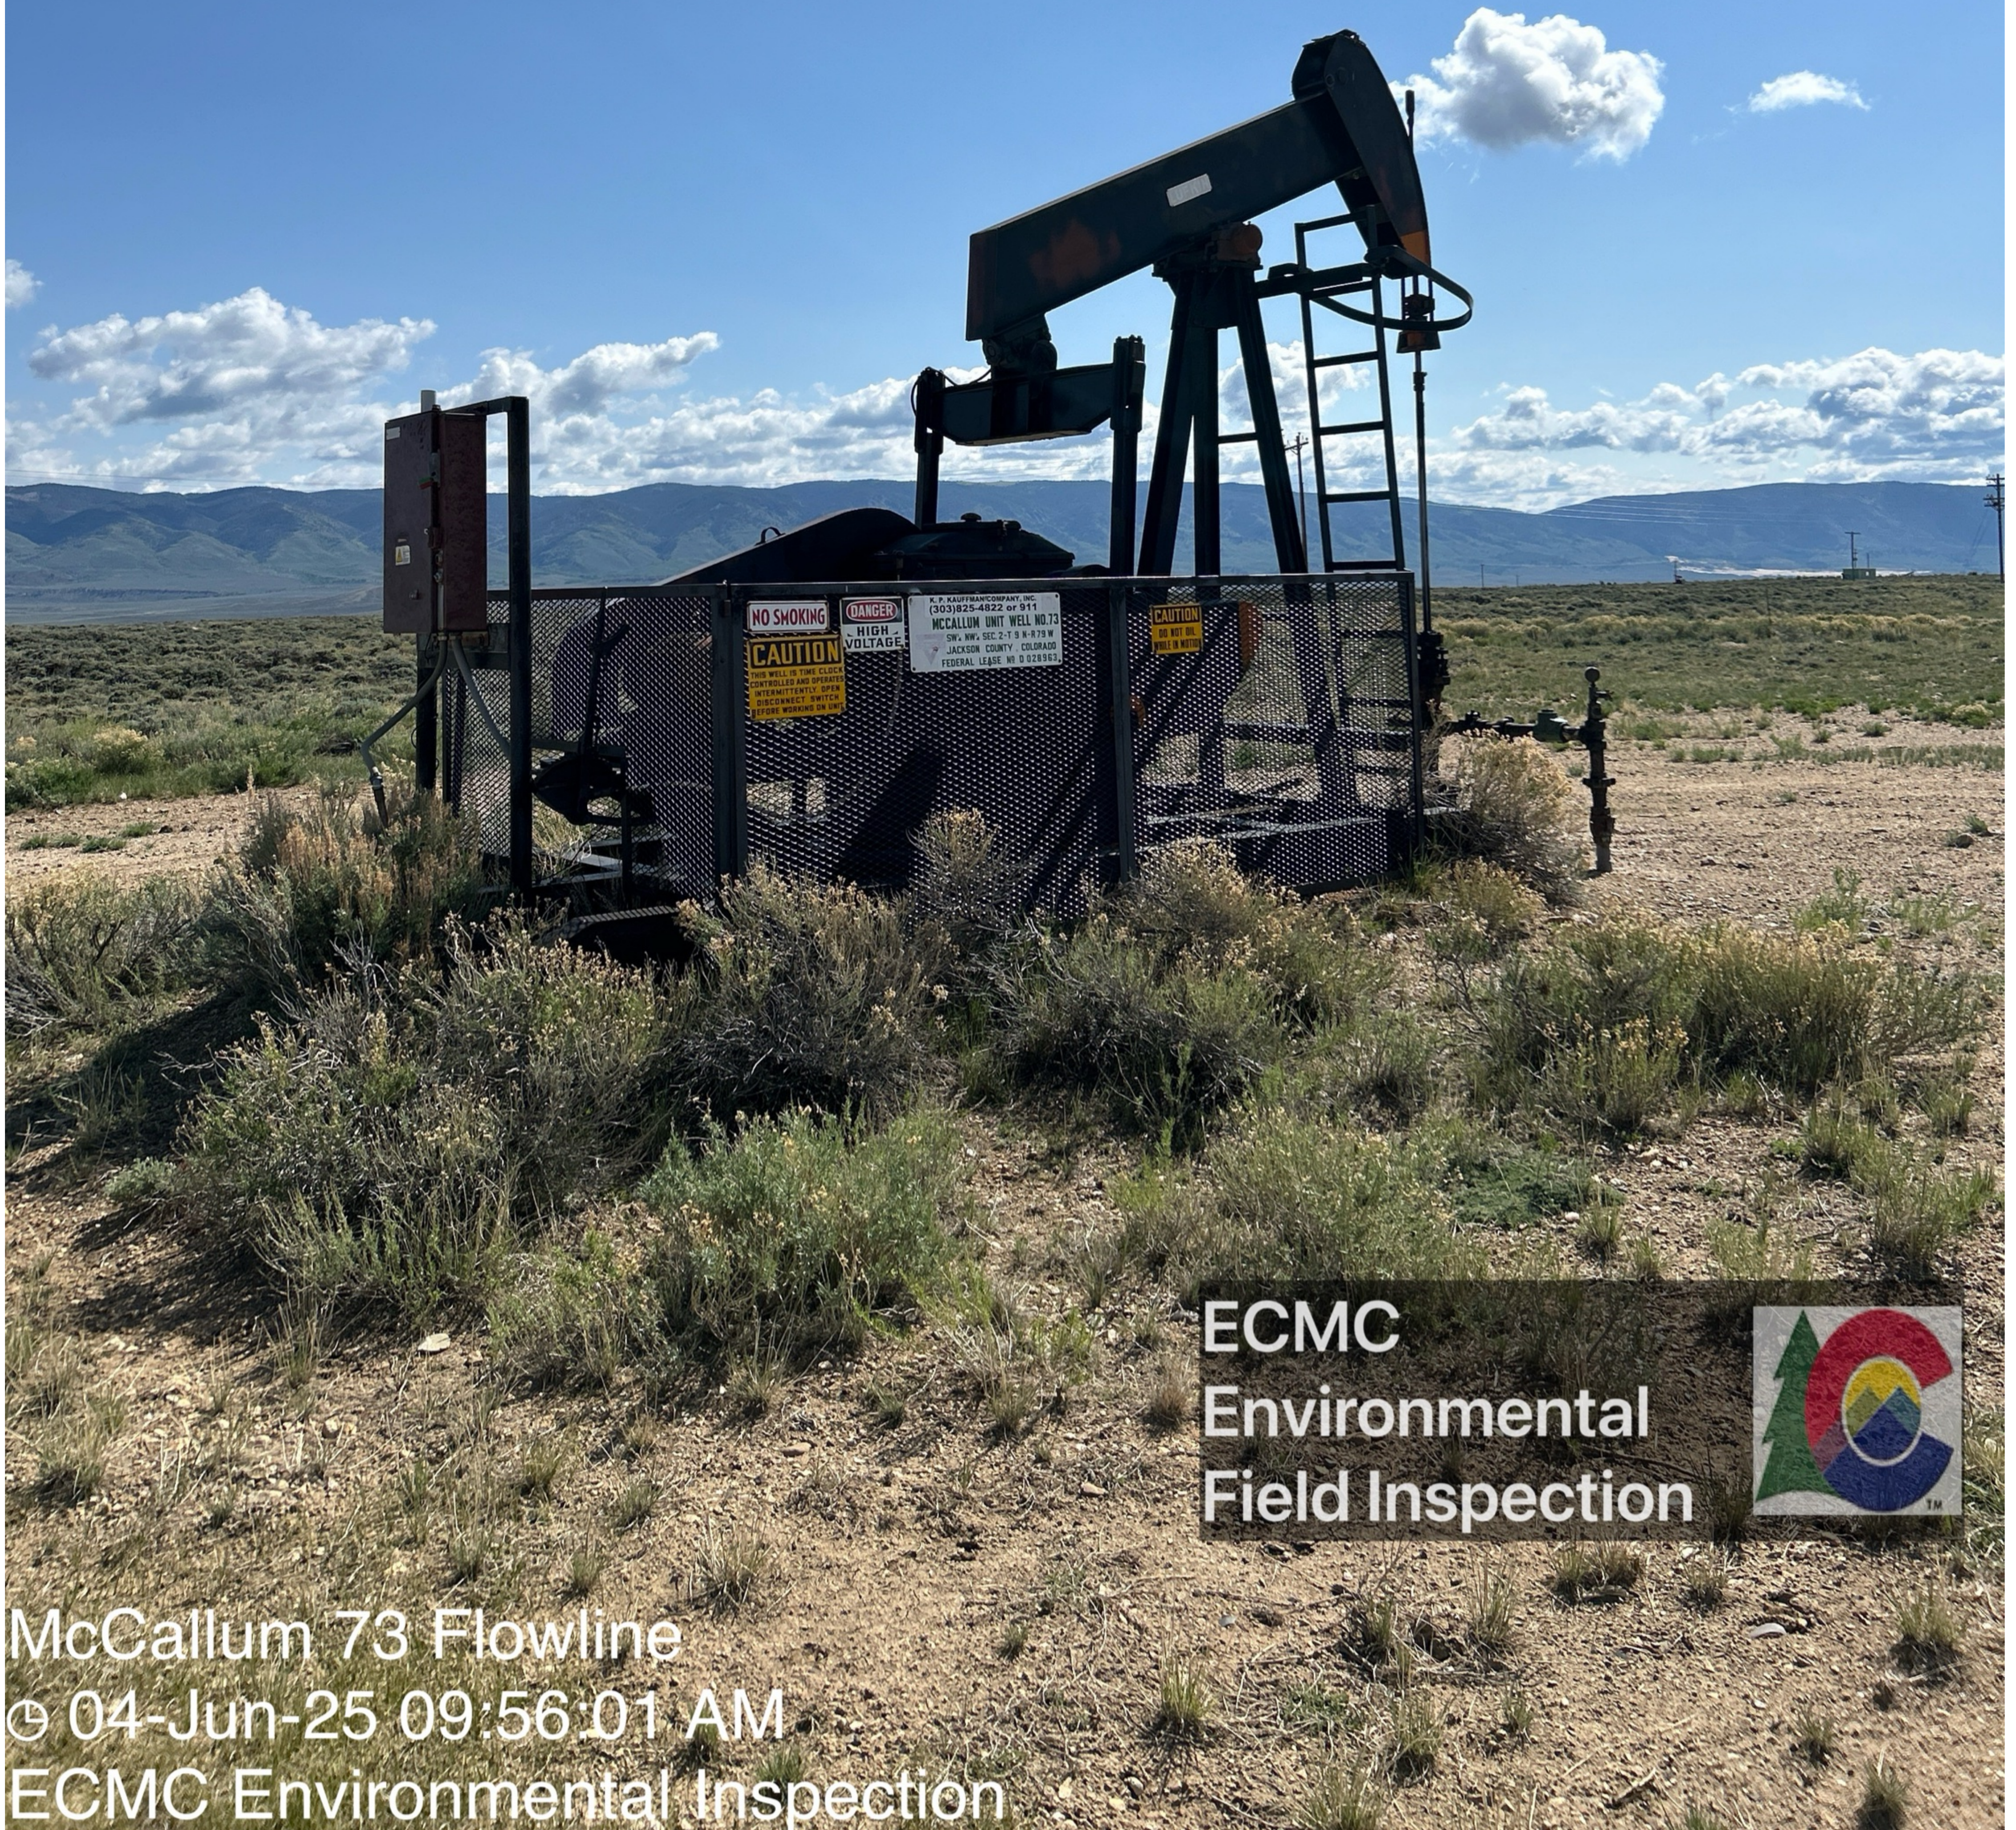
Looking at McCallum Unit 73 well. Signage with emergency contact number is visible. Weeds are visible adjacent to the well.

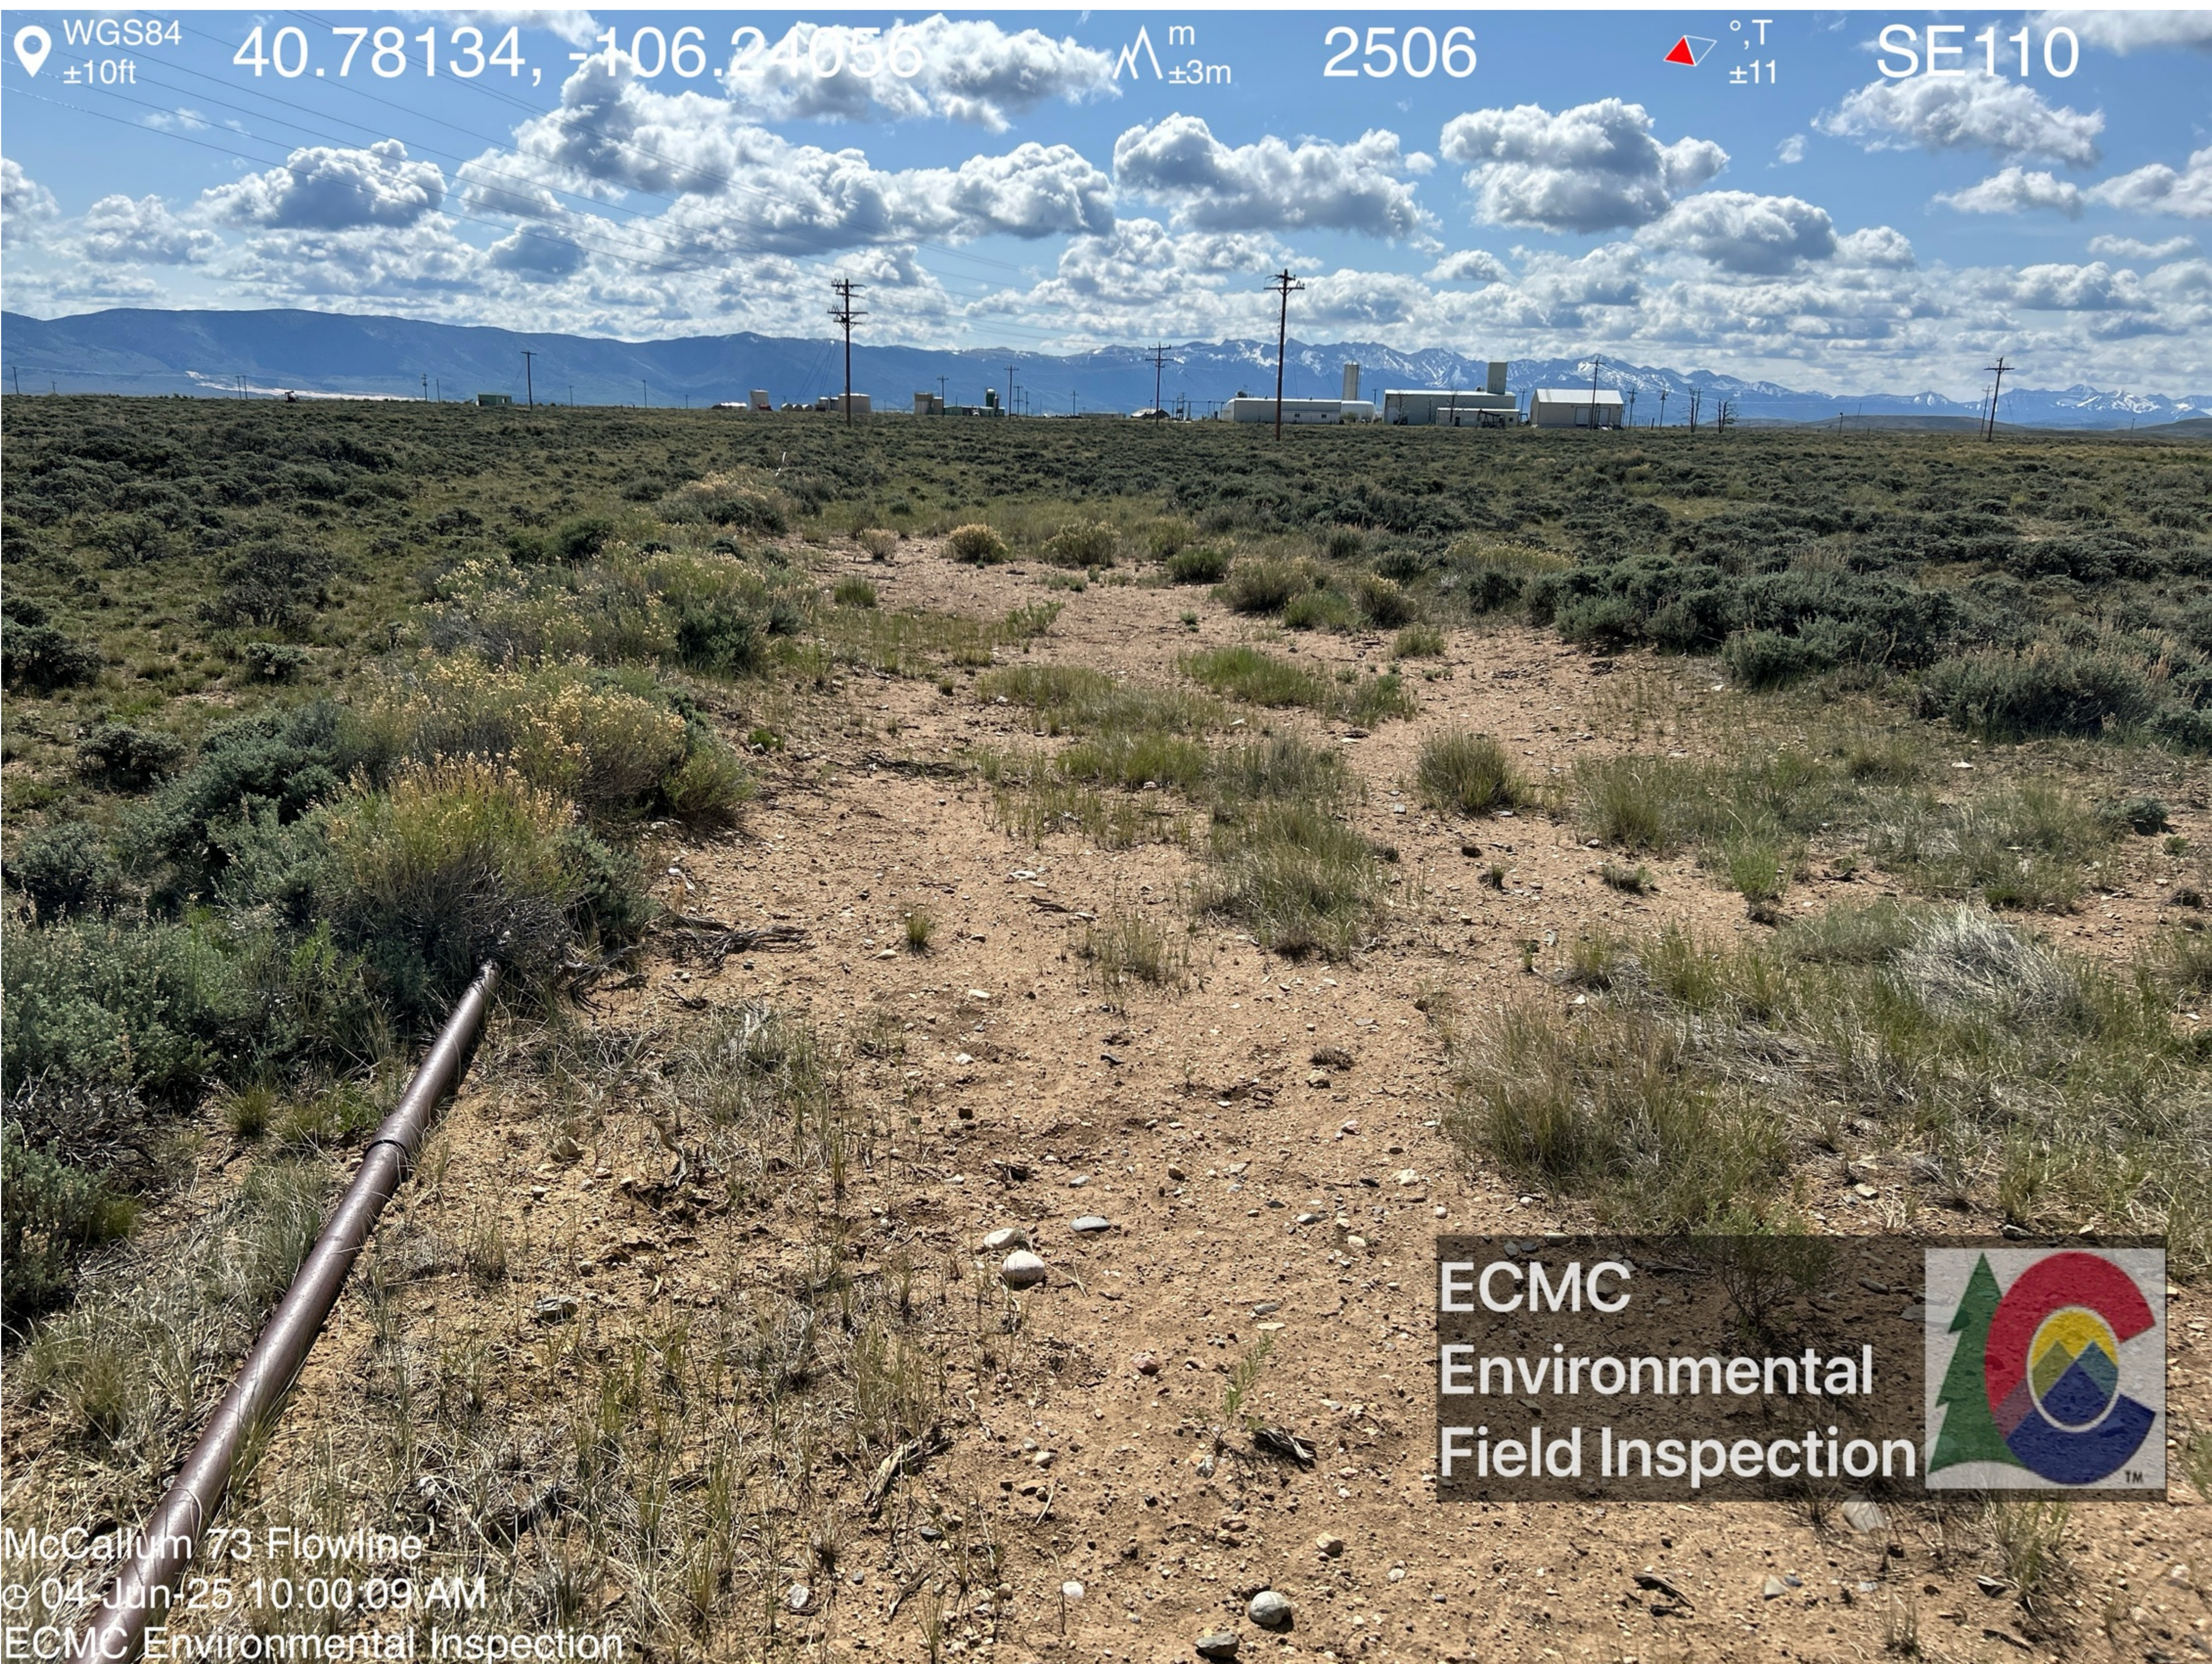
An above ground metal line is visible.
